Alexandra Bridge Foreshore Management Plan
For Shire of Augusta Margaret River

Vicki Winfield & Associates Pty Ltd

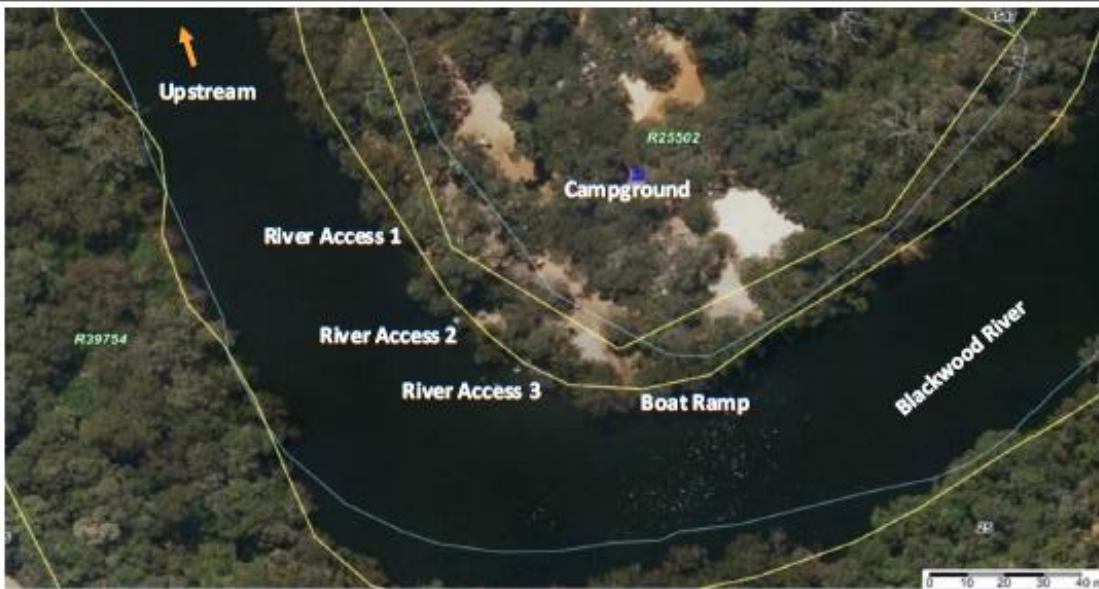
Campground adjacent to Blackwood River and approximate location of existing boat ramp and main river access points for swimming and boating.

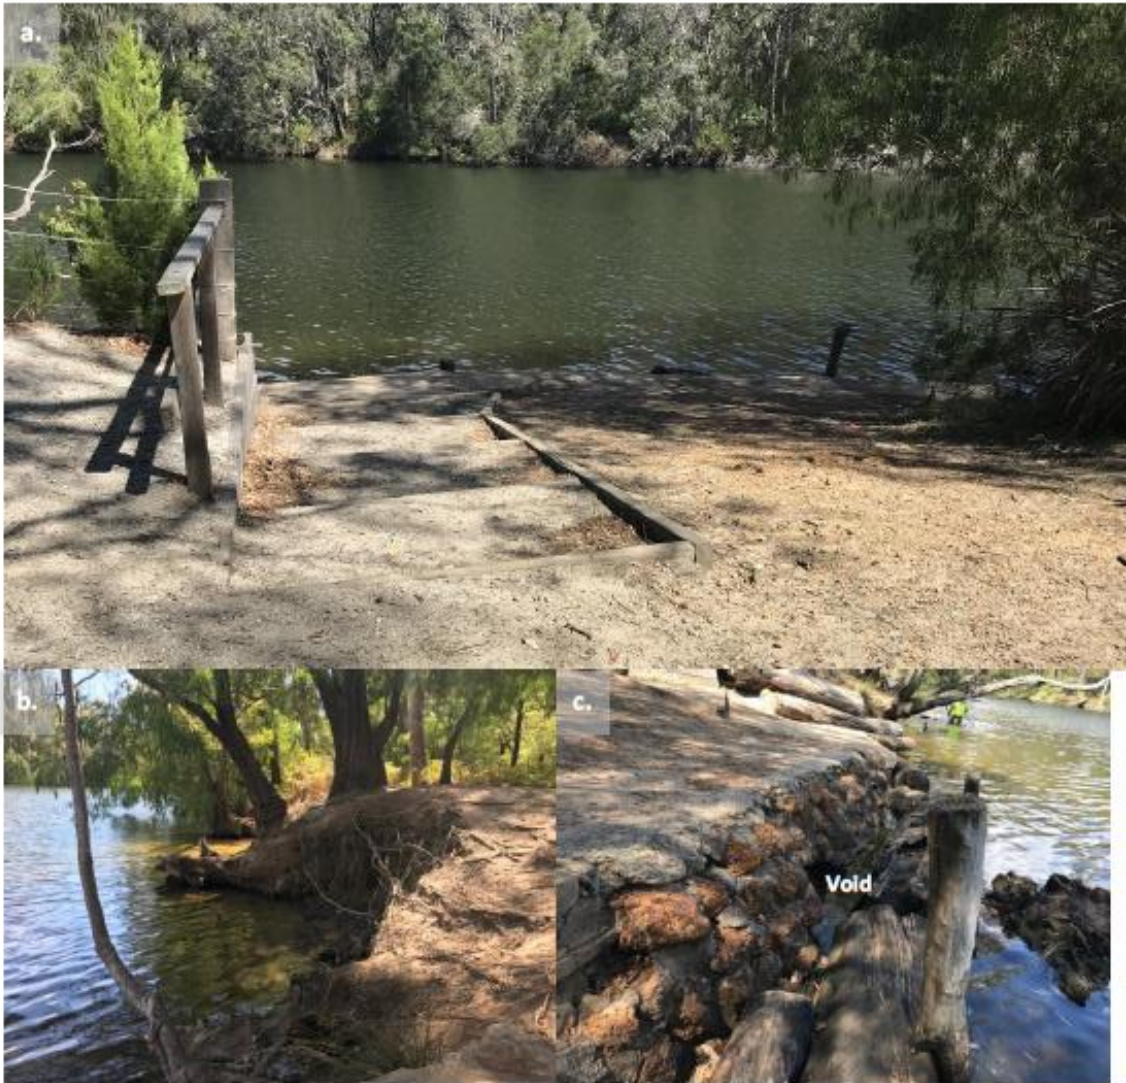
River Access 1 including a) compacted gravel stairs with timber supports and relatively steep sloped gravel bank, b) vertical undercut banks upstream which are sites of temporary boat mooring, and c) degraded cemented stone retaining wall with timber logs. Large void in wall in one area.

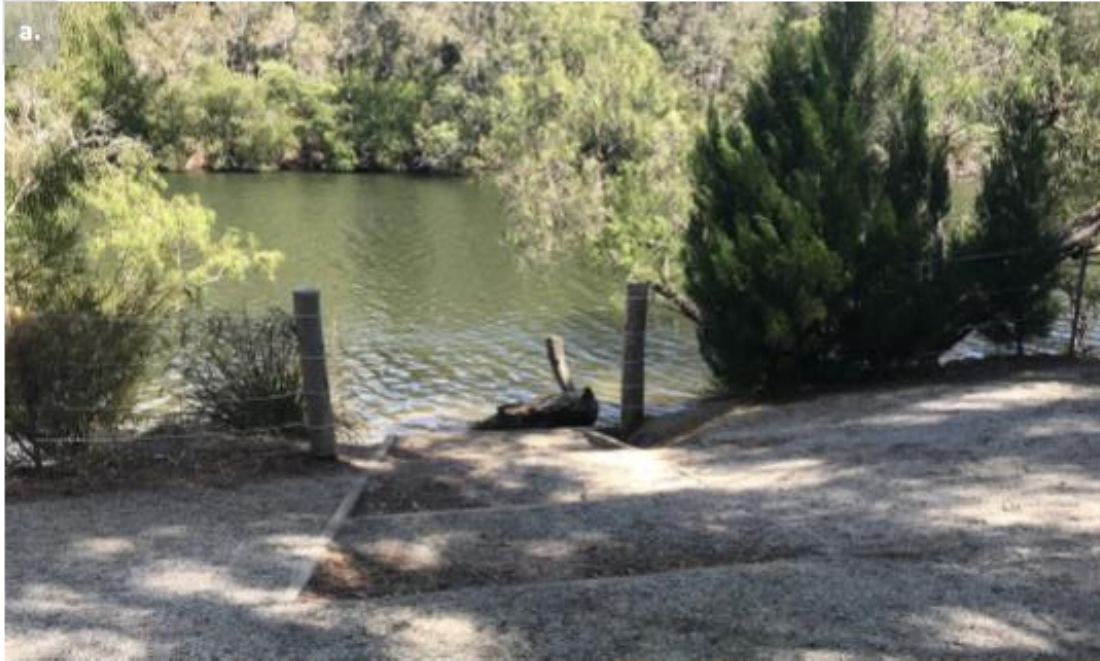
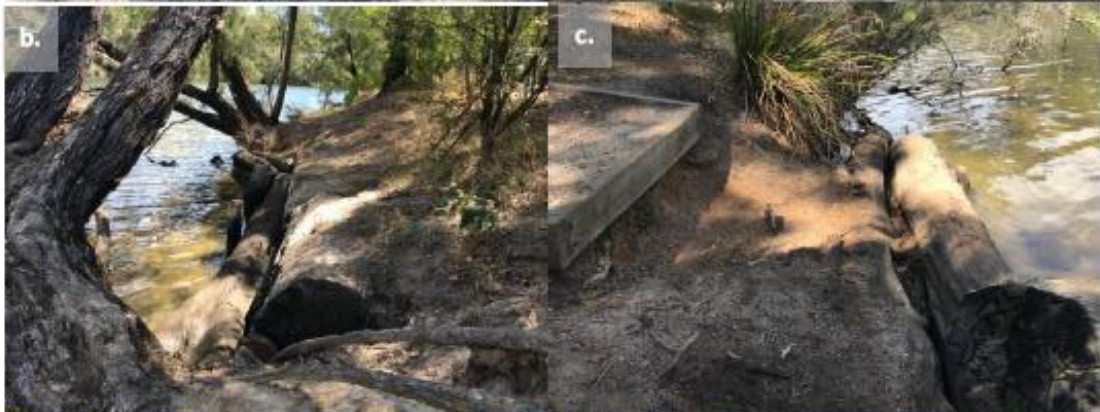
River Access 2 including a) compacted gravel stairs with timber supports b) stabilised bank to the north using timber logs, sloped upper embankment and fencing for managing pedestrian access, and c) undercutting of stairs and bank erosion.

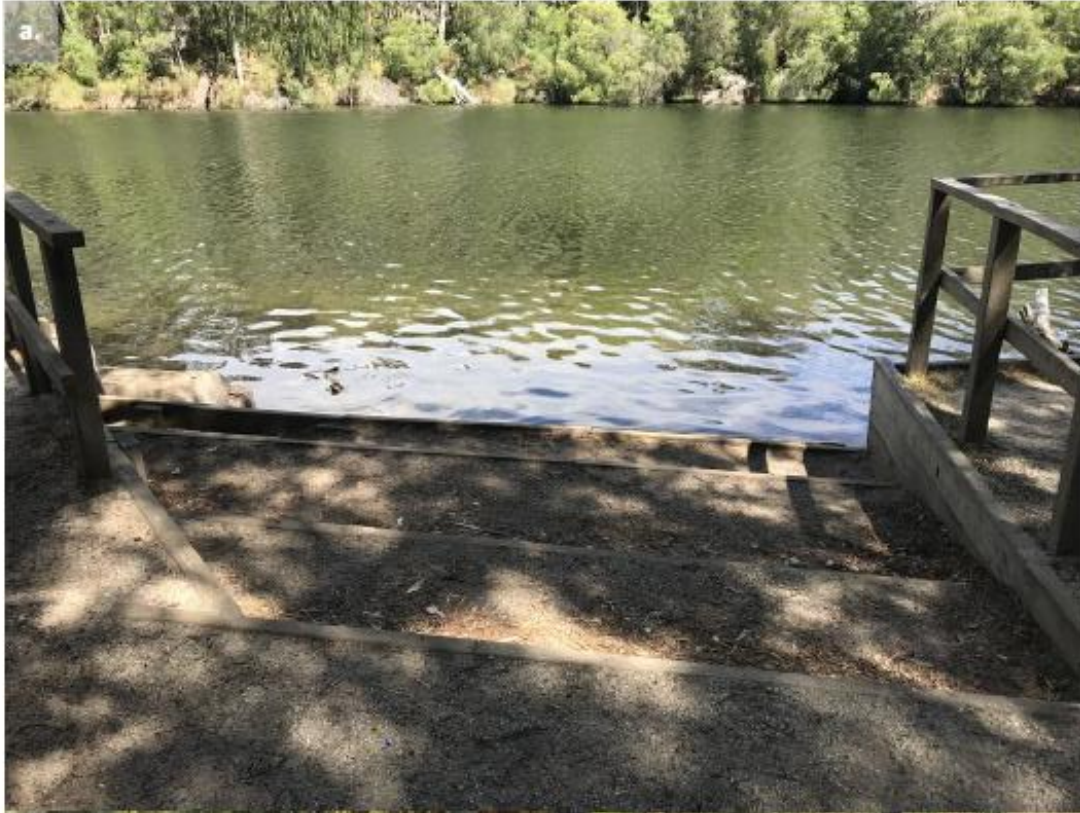
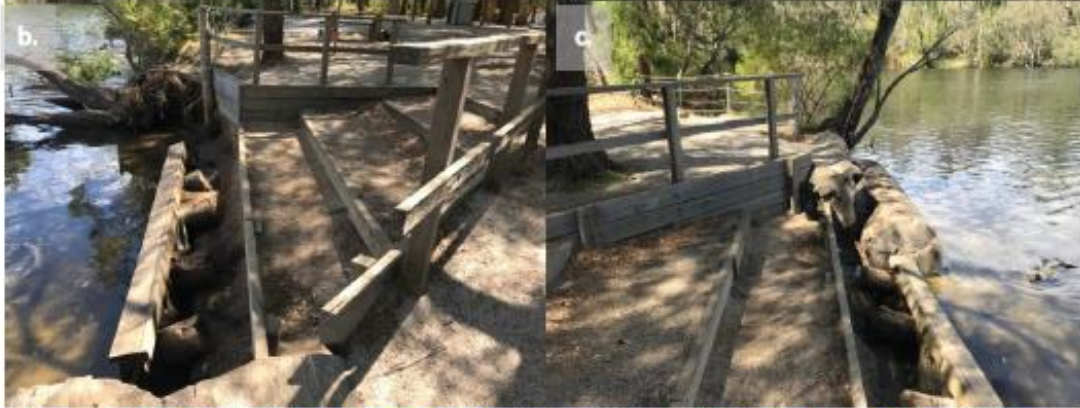
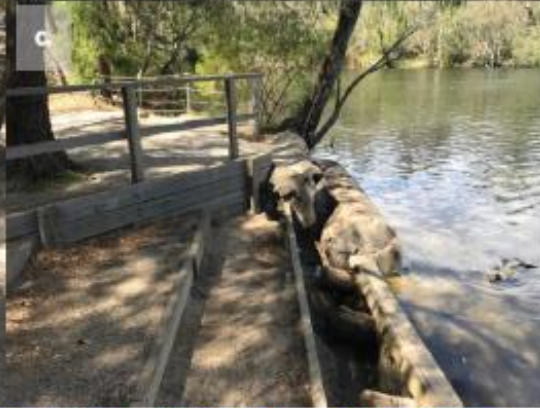
River Access 3 including a) compacted gravel stairs with timber supports, timber retaining walls and handrails, b) failed lower stair and undercutting of timber retaining wall on upstream side, and c) timber logs for bank protection downstream.

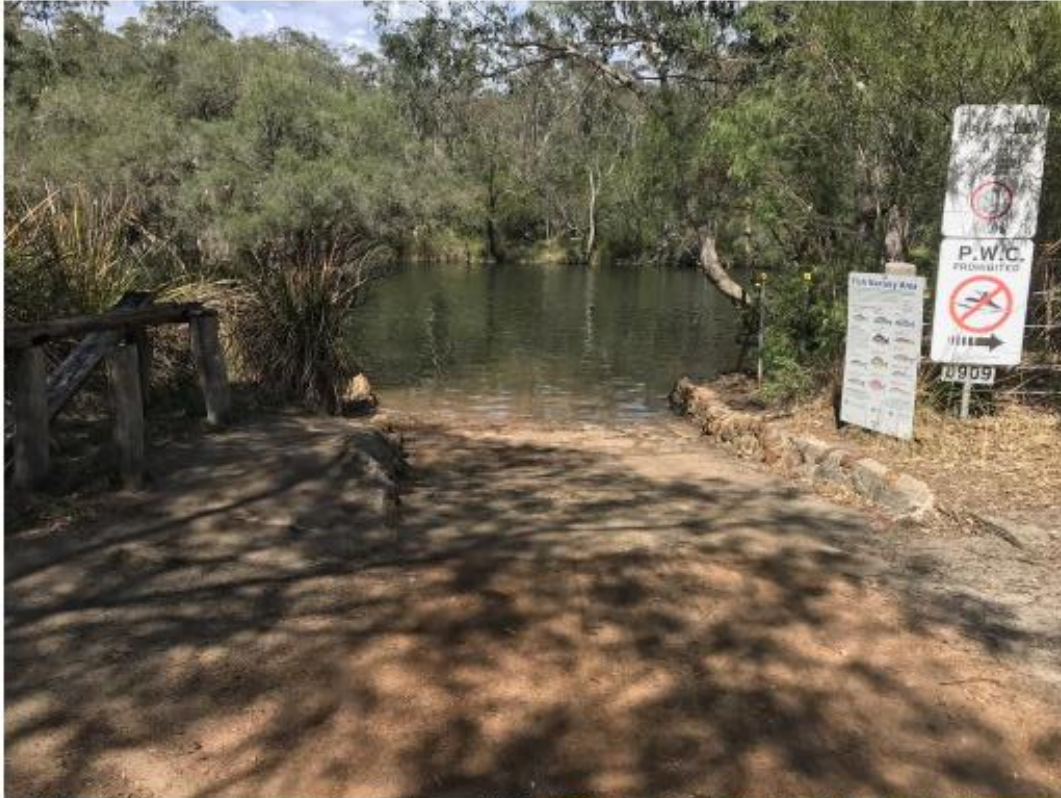
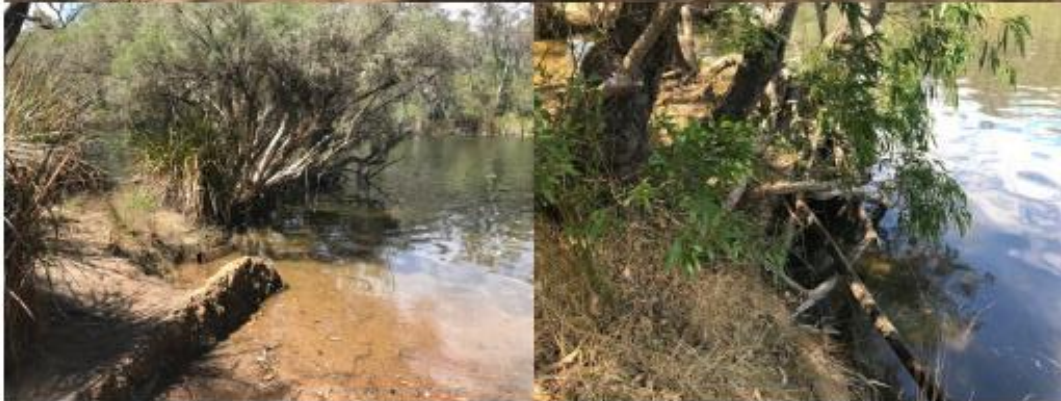
Boat ramp including a) relatively narrow (~3.5m) wide insitu concrete boat ramp and low cemented stone retaining walls of variable alignment, b) overhanging tree downstream and c) undercut bank near large tree upstream.

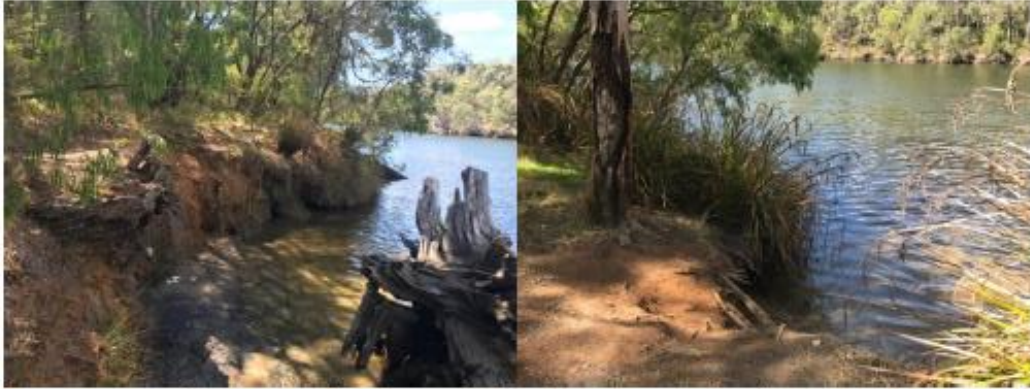
Downstream river banks showing variable elevation, embankment undercutting and informal access.
