Trees to be removed

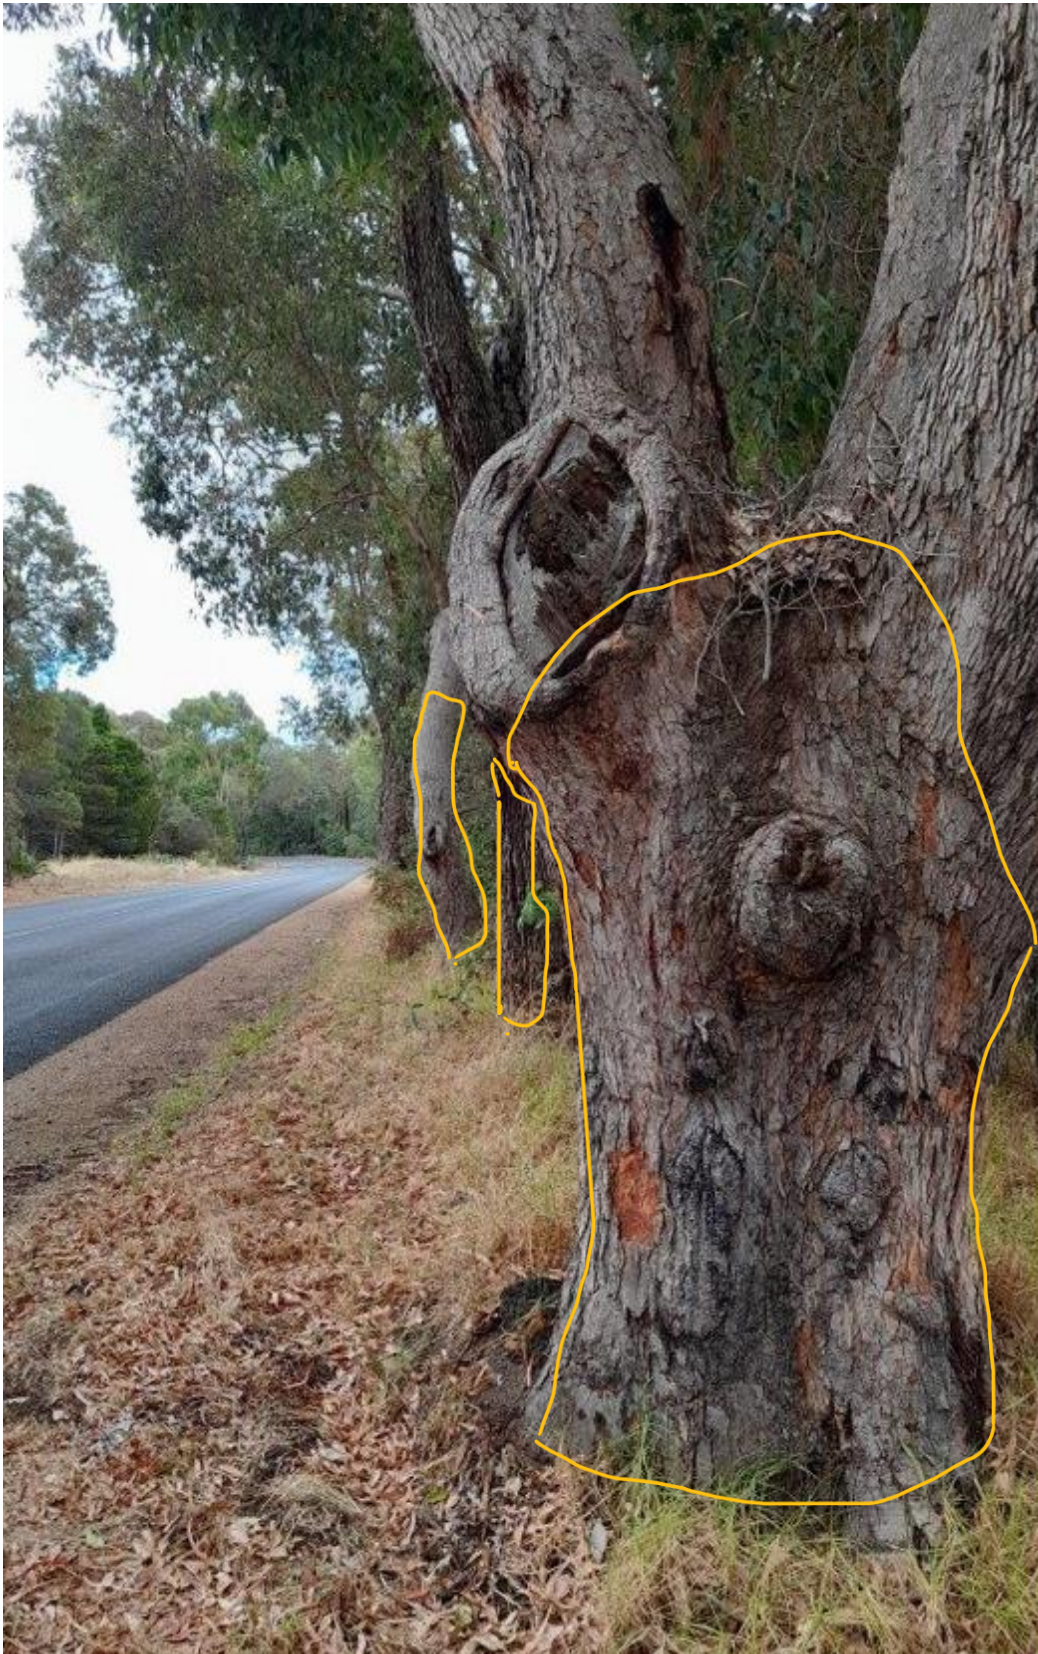
This photo is taken from a position closer to the road (than a person in a vehicle, or tractor would be when trying to enter the road) to show all 3 trees proposed to be removed.

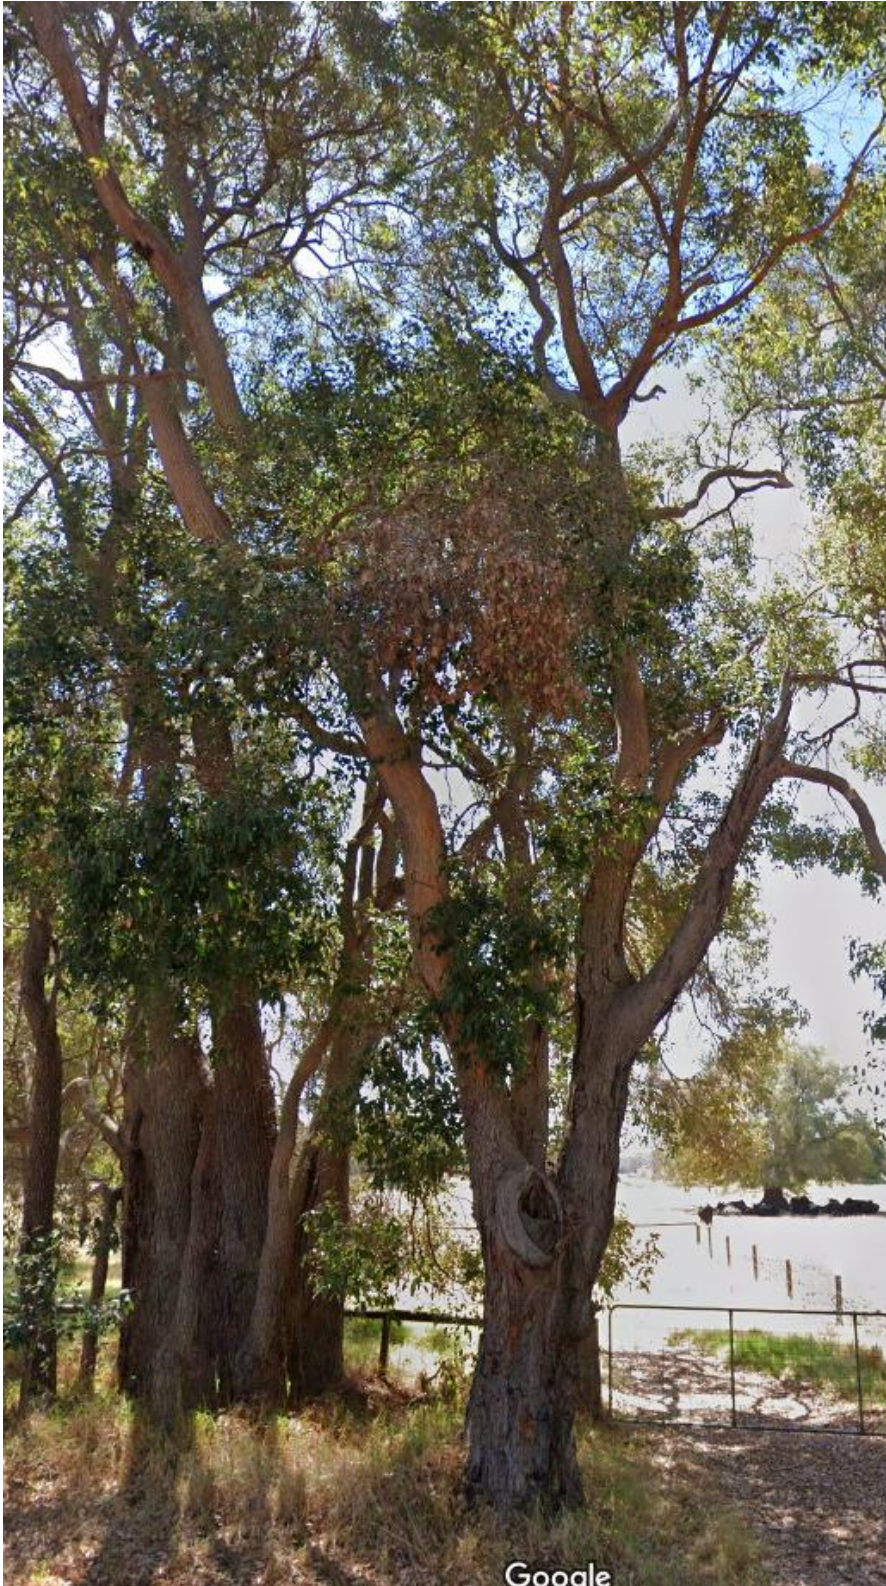
1. From Streetview 2025. This tree is closest to the crossover. The DBH is ~800mm. Upper branches not of sufficient size to have suitable Black Cockatoo nesting hollows.

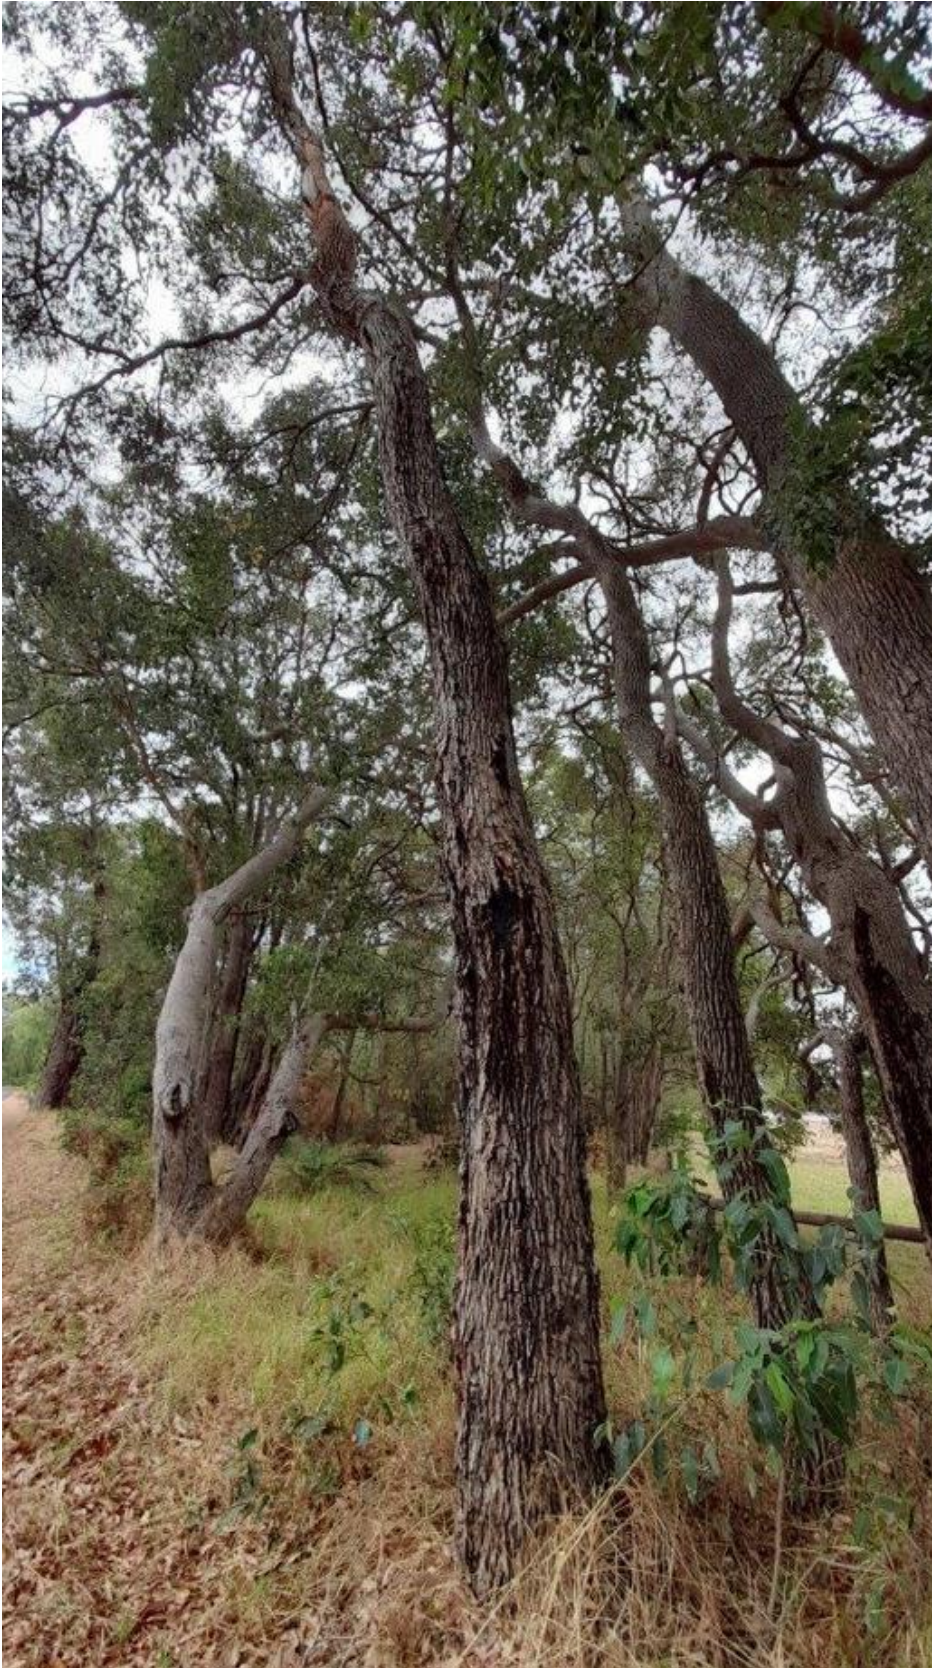
2. This is a photo of the second tree. The tree appears to have Marri canker. DBH ~350mm. Upper branches not of sufficient size to have suitable Black Cockatoo nesting hollows.

The understorey vegetation is predominantly Kikuyu grass

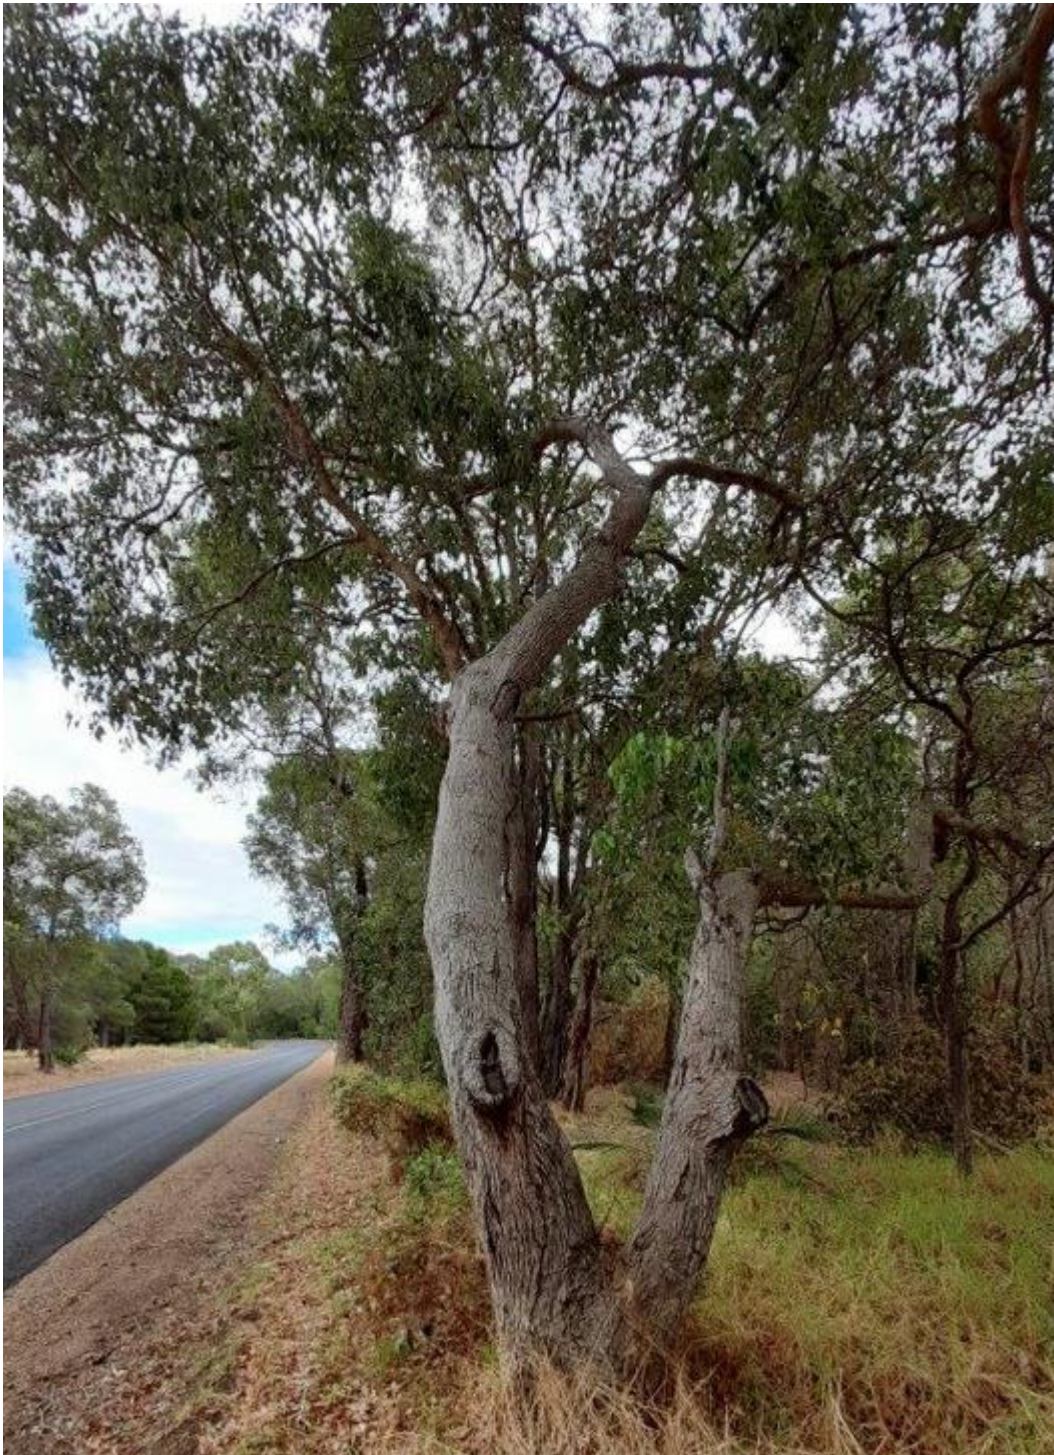
3. This is the third tree. The photo shows the entire tree. The trunk on the right side could be retained. DBH of left trunk ~450mm. The upper branches are too small to support Black Cockatoo nesting hollows.
