CLEARING REFERRAL SUPPORTING DOCUMENTATION

Samphire Staff Accommodation, Bushfire Asset Protection Zone

604-OEENPER-430227
19 January 2026
Rev 0

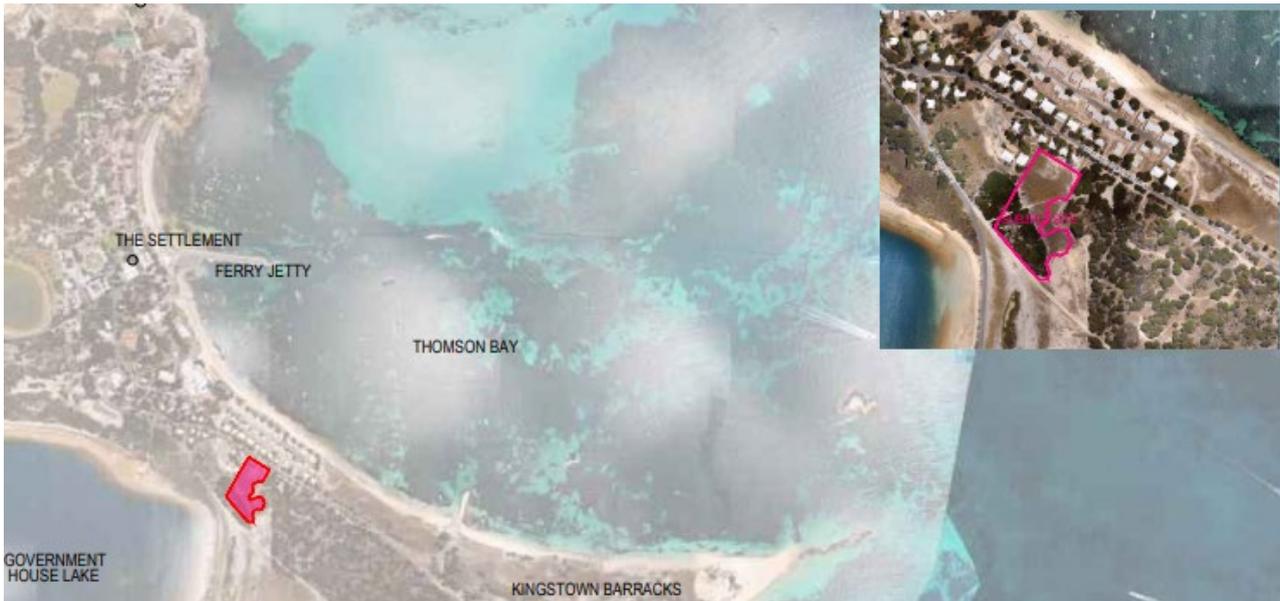
Figure 1: Samphire staff housing project footprint

The Prendiville Group proposes to construct staff housing on Rottneest Island (Wadjemup) to support the sustainable operation of the Sapphire Resort by providing 90 new accommodation units within a low-impact, modular design. The proposed staff housing will be constructed within the project footprint shown in Figure 1.

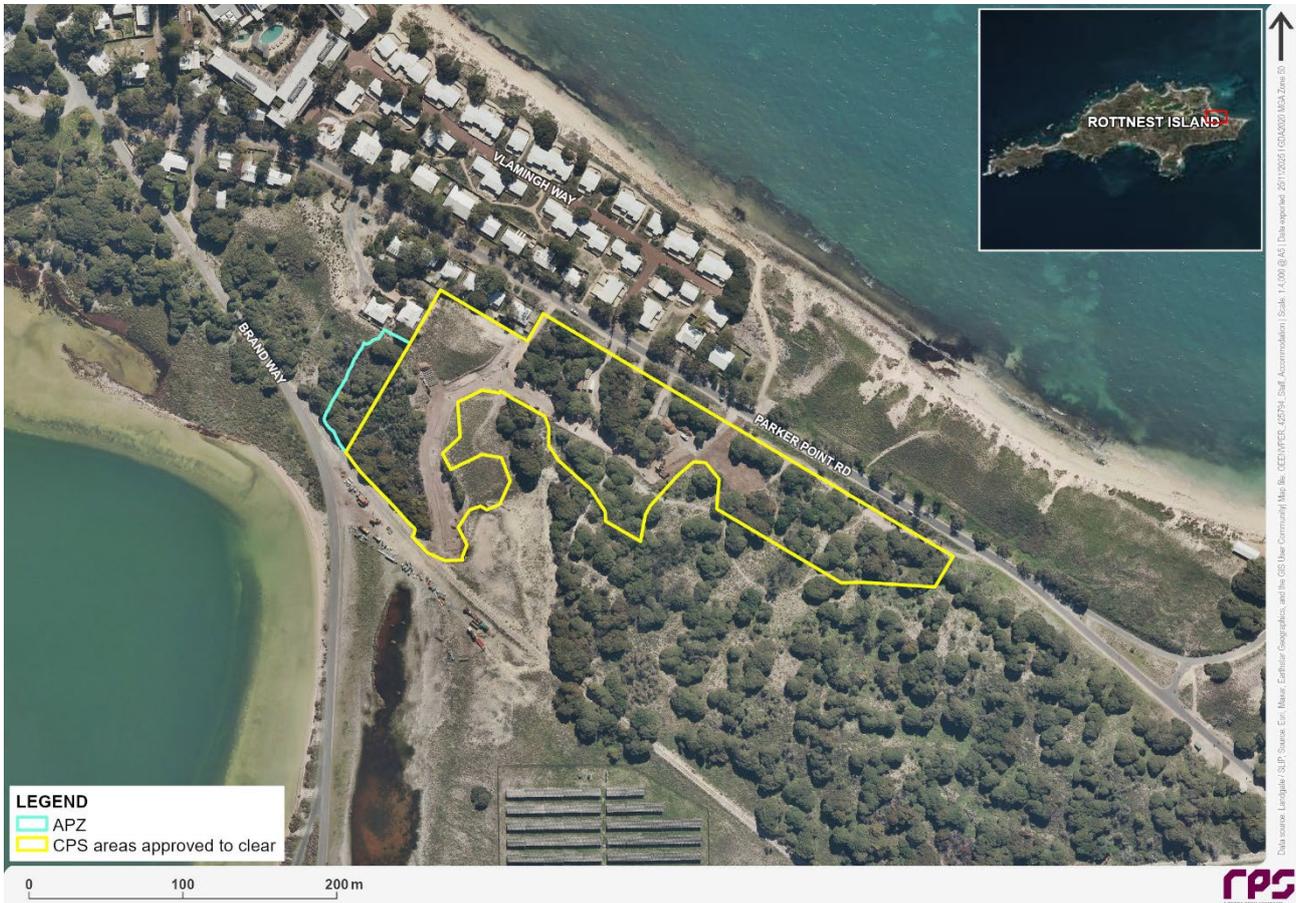
Figure 2: Clearing Permit (CPS 9883/1) area and APZ

A Clearing Permit (CPS 9883/1) was approved on 6 December 2023 which encompasses the project footprint. The approved clearing area is shown in Figure 2.

In order to comply with the Planning for Bushfire Guidelines (WAPC 2024), the maintenance of some native vegetation within the APZ identified by BPP will be required. 0.19 hectares (ha) of the APZ is located outside the approved CPS 9883/1 clearing area (Figure 2). This clearing application addressed the proposed activities within the APZ.

of the approved CPS 9883/1, however due to overhanging vegetation there are some overlaps with the APZ as shown in Figure 2. It is proposed that 0.003 ha of living native vegetation is removed within the APZ.

Vegetation maintenance is required within the APZ shown in Figure 2 to protect adjacent workers accommodation and infrastructure from potential bush fire. Of the 0.19 ha APZ, 0.1 ha is proposed to be cleared or managed as summarised below:

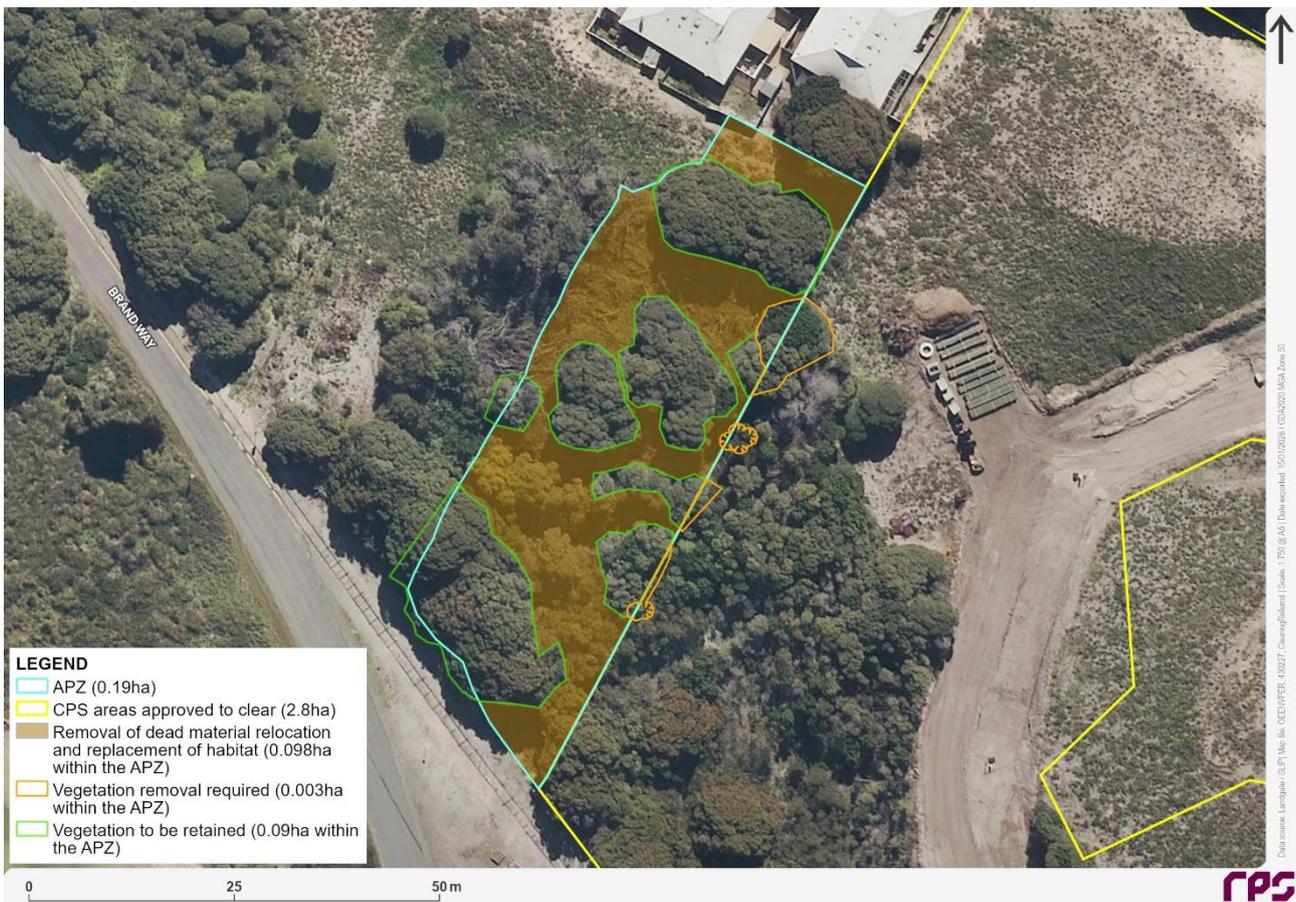
Figure 3: Proposed clearing area and vegetation maintenance areas

As shown in Figure 3, much of the proposed vegetation removal within the APZ is associated with the already approved vegetation clearing along the boundary of the CPS 9883/1.

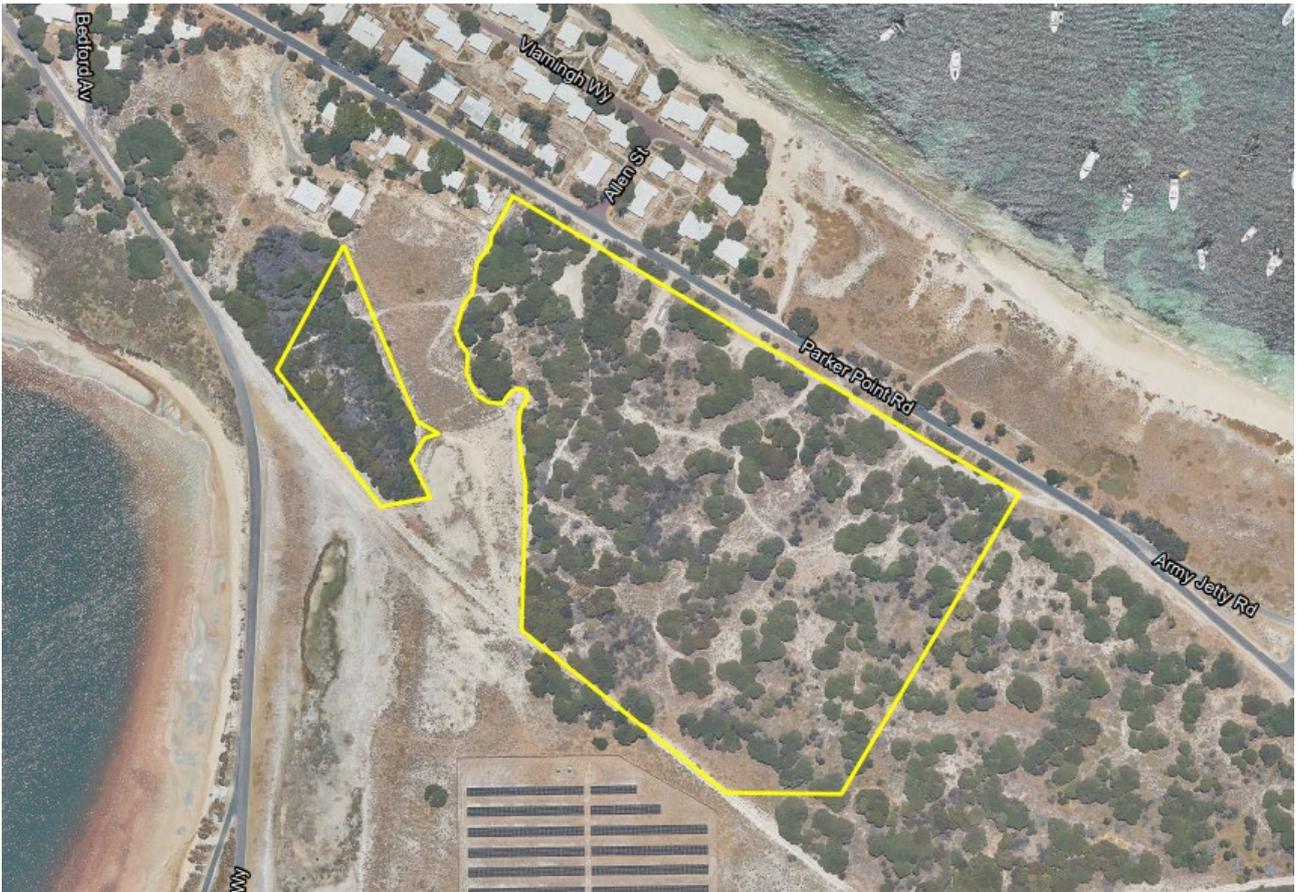
Figure 4: 360 Environmental survey area

- Parker Point Road, Rottnest; Native Vegetation Clearing Permit: Supporting Documentation (360 Environmental 2022). The survey area is shown in Figure 4
- Flora and vegetation survey; South Thomson and Kingstown, Rottnest Island (Wadjemup) (Focused Vision Consulting (FVC) 2023). The survey area is shown in Figure 5.

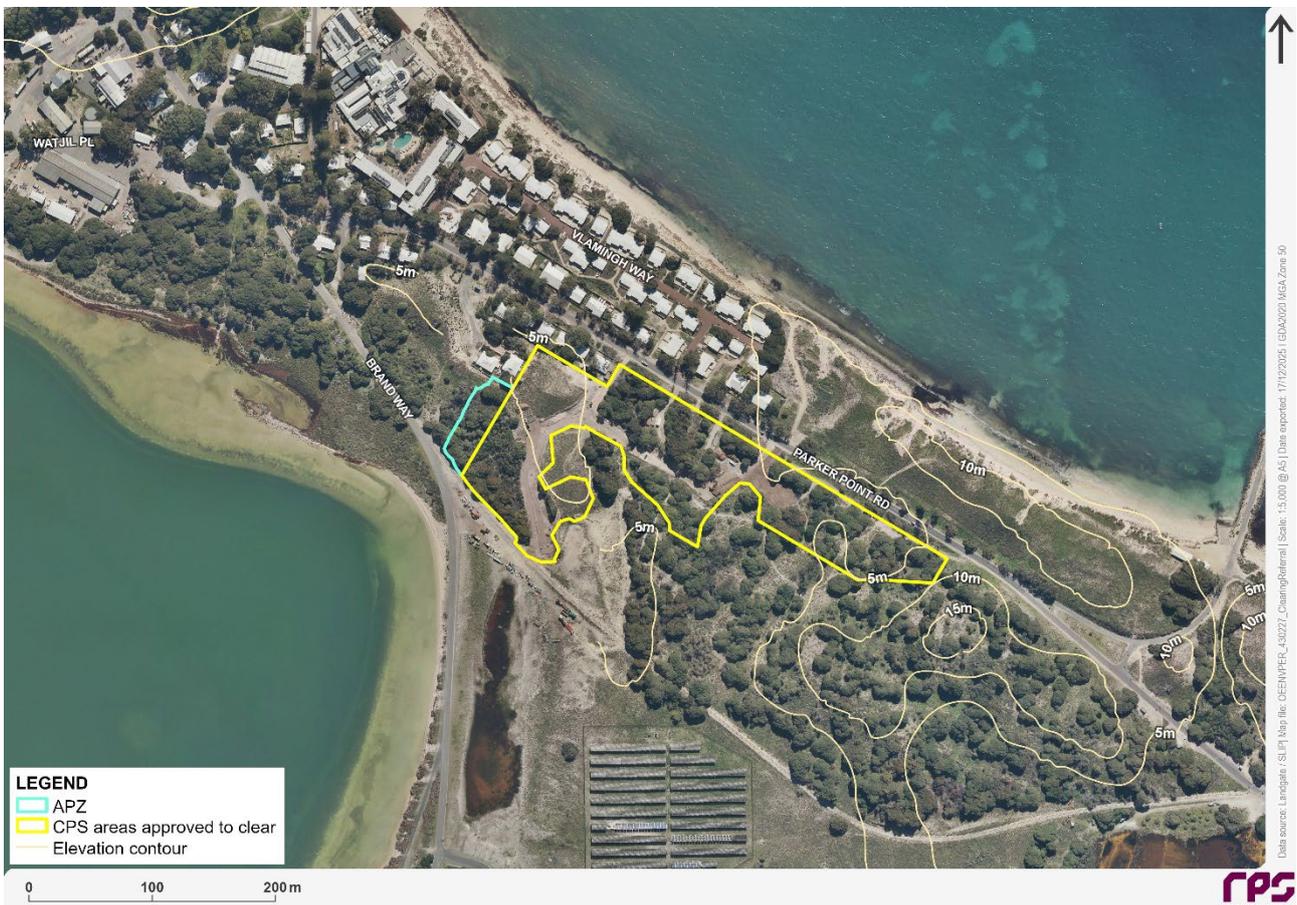
Figure 6: Topography

The topography of the APZ is relatively flat at approximately 5 m Australian Height Datum (AHD) (Figure 6). The topography is similar to that of the CPS 9883/1 area, which ranges from 7 m AHD in the southwest to 5 m AHD in the northeast (360 Environmental 2022).

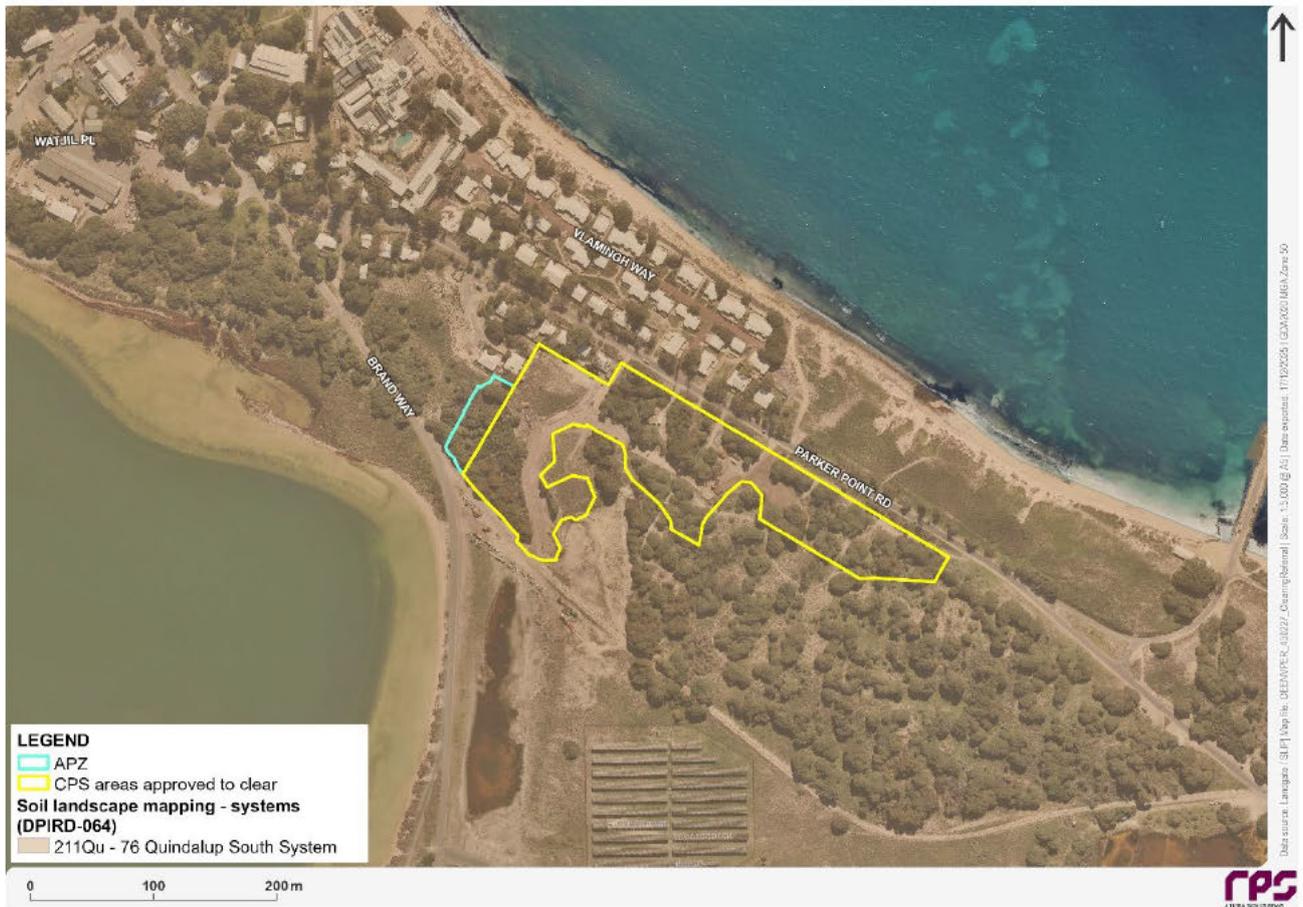
Figure 7: Soil landscape mapping

Soil landscapes and land system mapping of Western Australia describes the broad soil and landscape characteristics from regional to local scales. The APZ comprises the Quindalup South System (211Qu) which comprises coastal dunes of the Swan Coastal Plain, with calcareous deep sands and yellow sands. Coastal scrub (Figure 7).

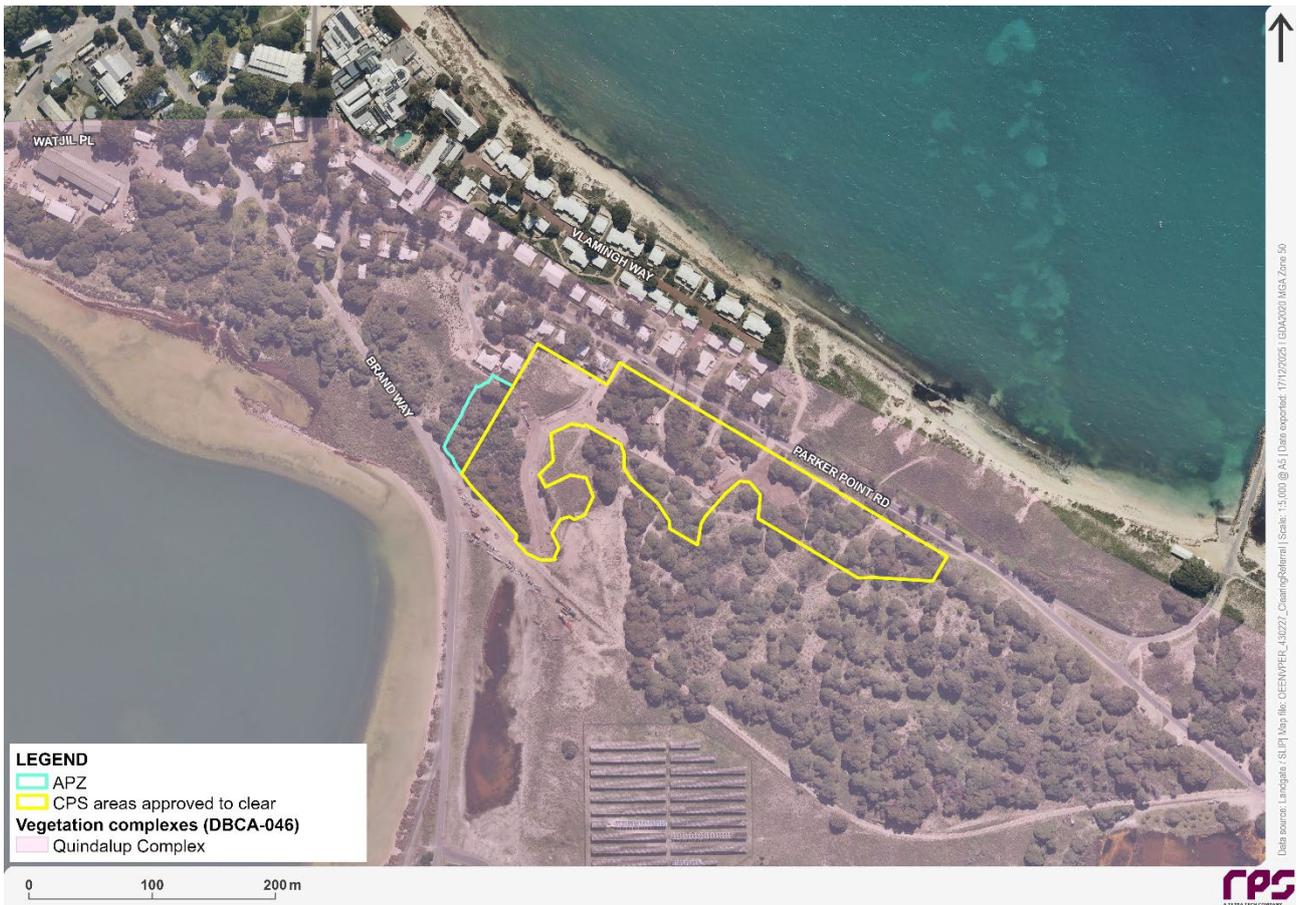
Figure 8: Vegetation complex

The vegetation complex within the APZ has been defined by Heddle et al. (1980) as the Quindalup Complex. This complex is described as coastal dune consisting of two alliances: the strand and fore-dune alliance and the mobile and stable dune alliance. Local variations include the low, closed forest of *Melaleuca lanceolata* (Rottneest teatree) – *Callitris preissii* (Rottneest Island pine), the closed scrub of *Acacia rostellifera* (summer-scented wattle) and the low, closed *Agonis flexuosa* (peppermint) forest of Geographe Bay (FVC, 2023).

The remaining extent for the Heddle et al. (1980) Quindalup Complex exceeds the 30% threshold for the Swan Coastal Plain IBRA region and City of Cockburn extents (Table 2).

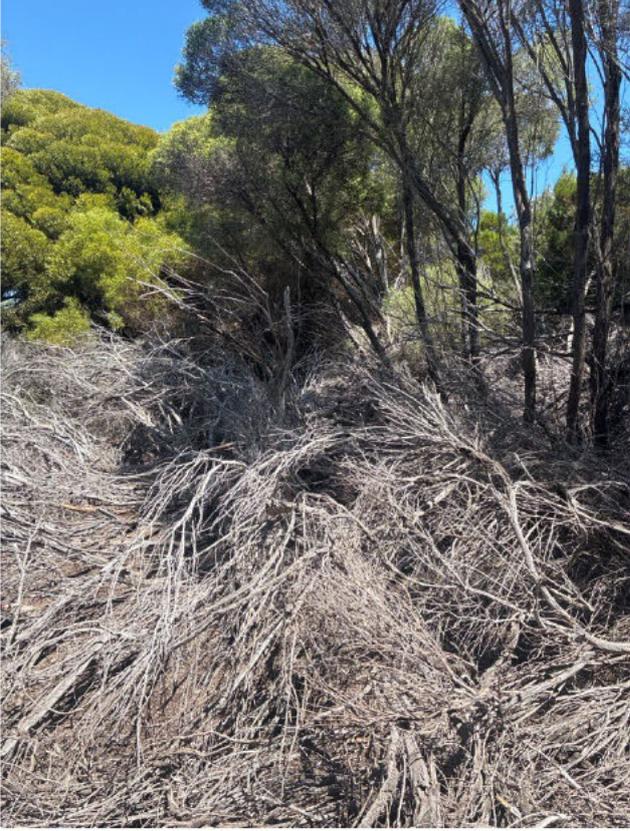
Vegetation unit code	Description	Area within the APZ	Photograph
CpMI	<i>Callitris preissii</i> and <i>Melaleuca lanceolata</i> tall shrubland.	0.18 ha <i>(previously mapped as 0.1 ha by FVC)</i>

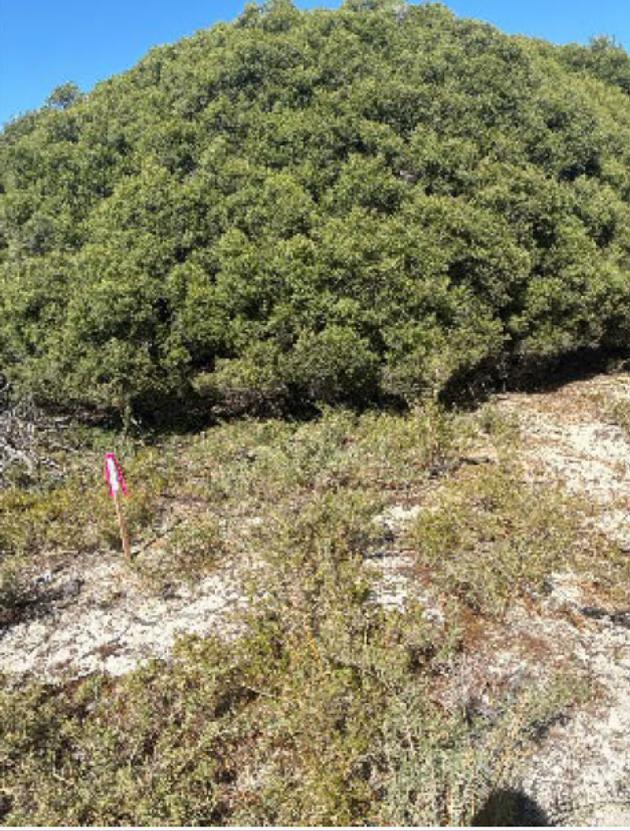
OaAp	<i>Olearia axillaris</i> tall sparse shrubland over <i>Acanthocarpus preissii</i> low open shrubland.	0.01 <i>(previously mapped as 0.07 ha by FVC)</i>

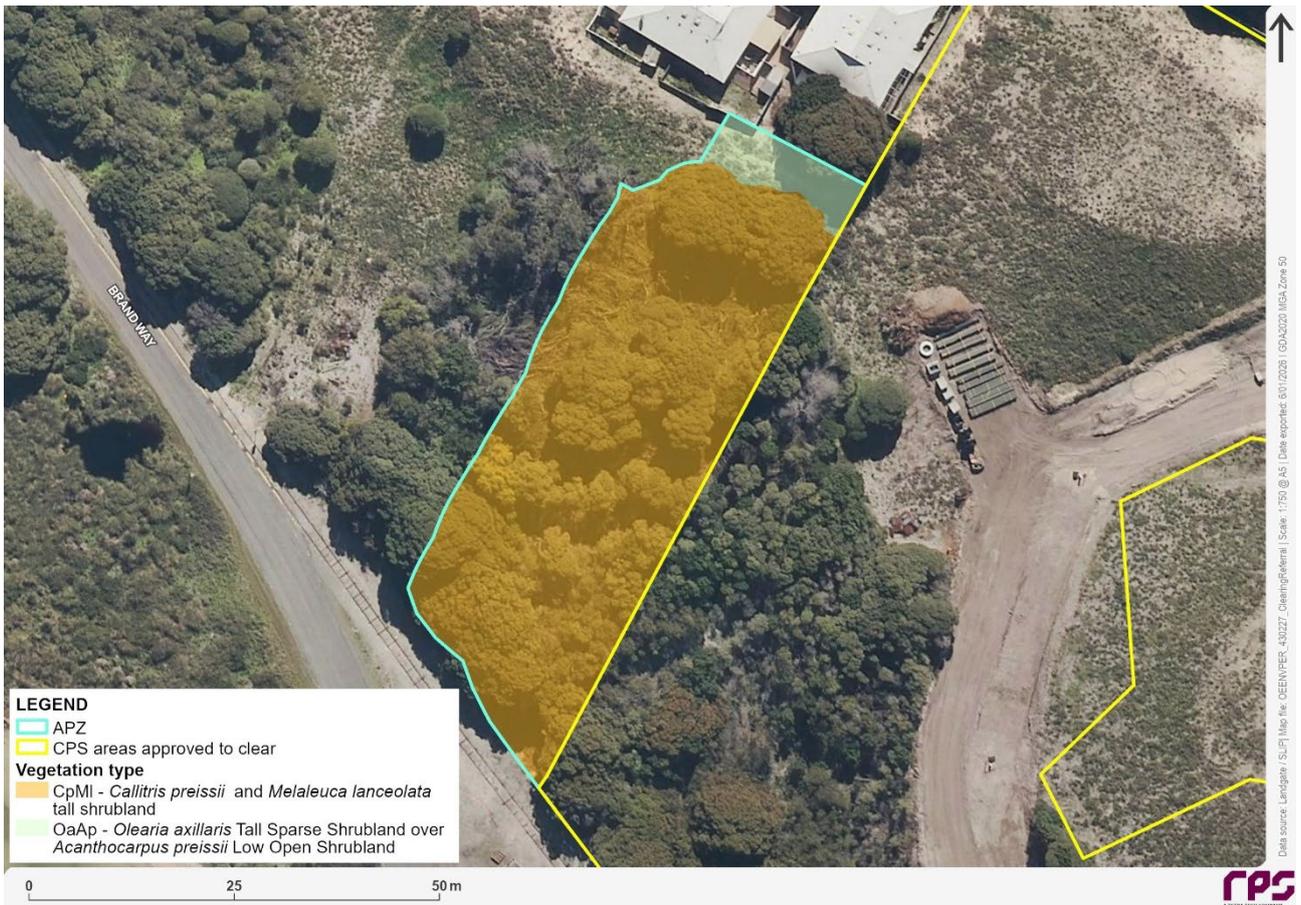
Figure 9: Vegetation types within the APZ

The mapping and areas of vegetation types CpMI and OaAp recorded by RPS within the APZ are described in Table 3 and shown in Figure 9.

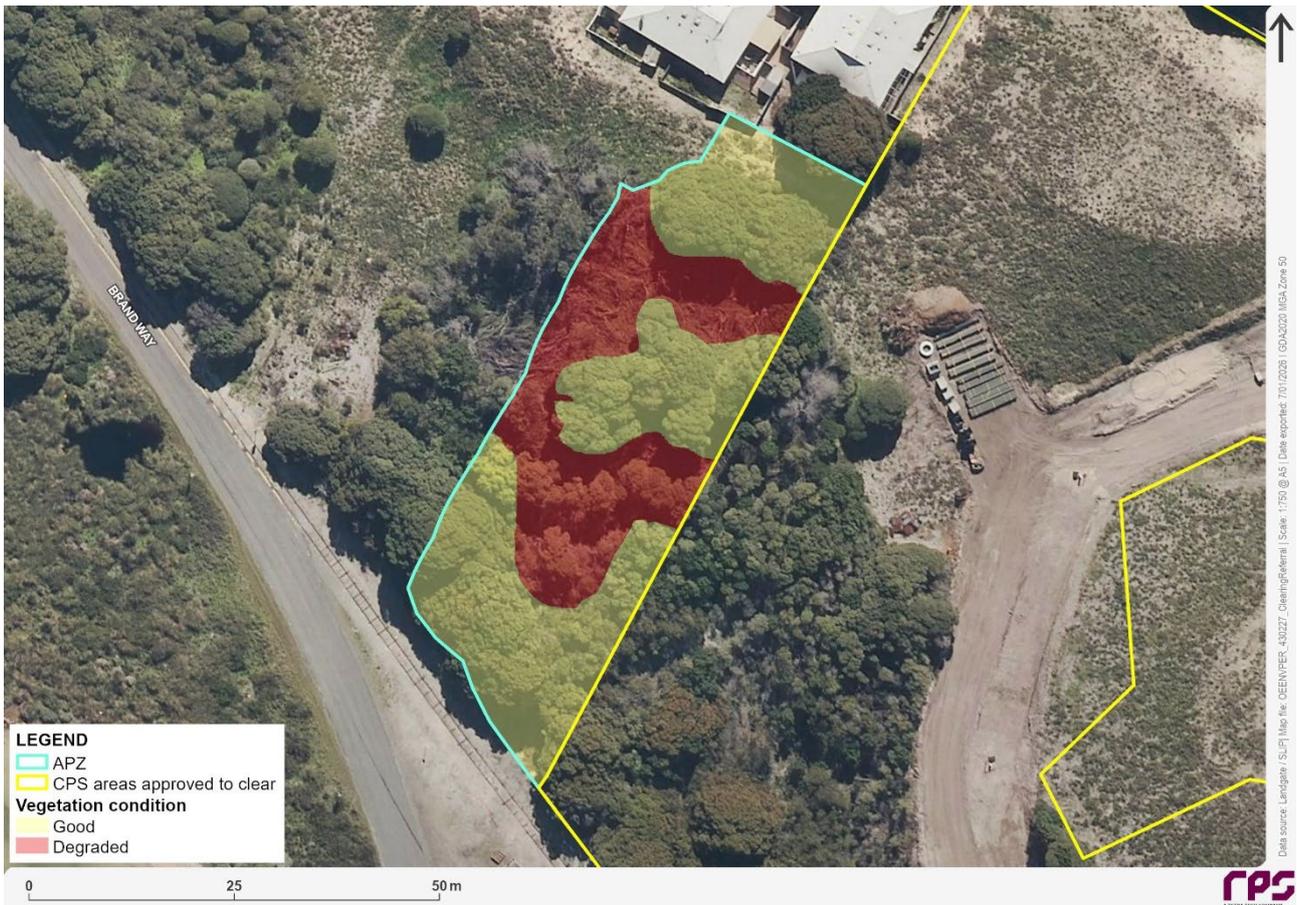
Figure 10: Vegetation condition within the APZ

RPS assessed the vegetation within the APZ as ranging from Good to Degraded as shown in Figure 10.

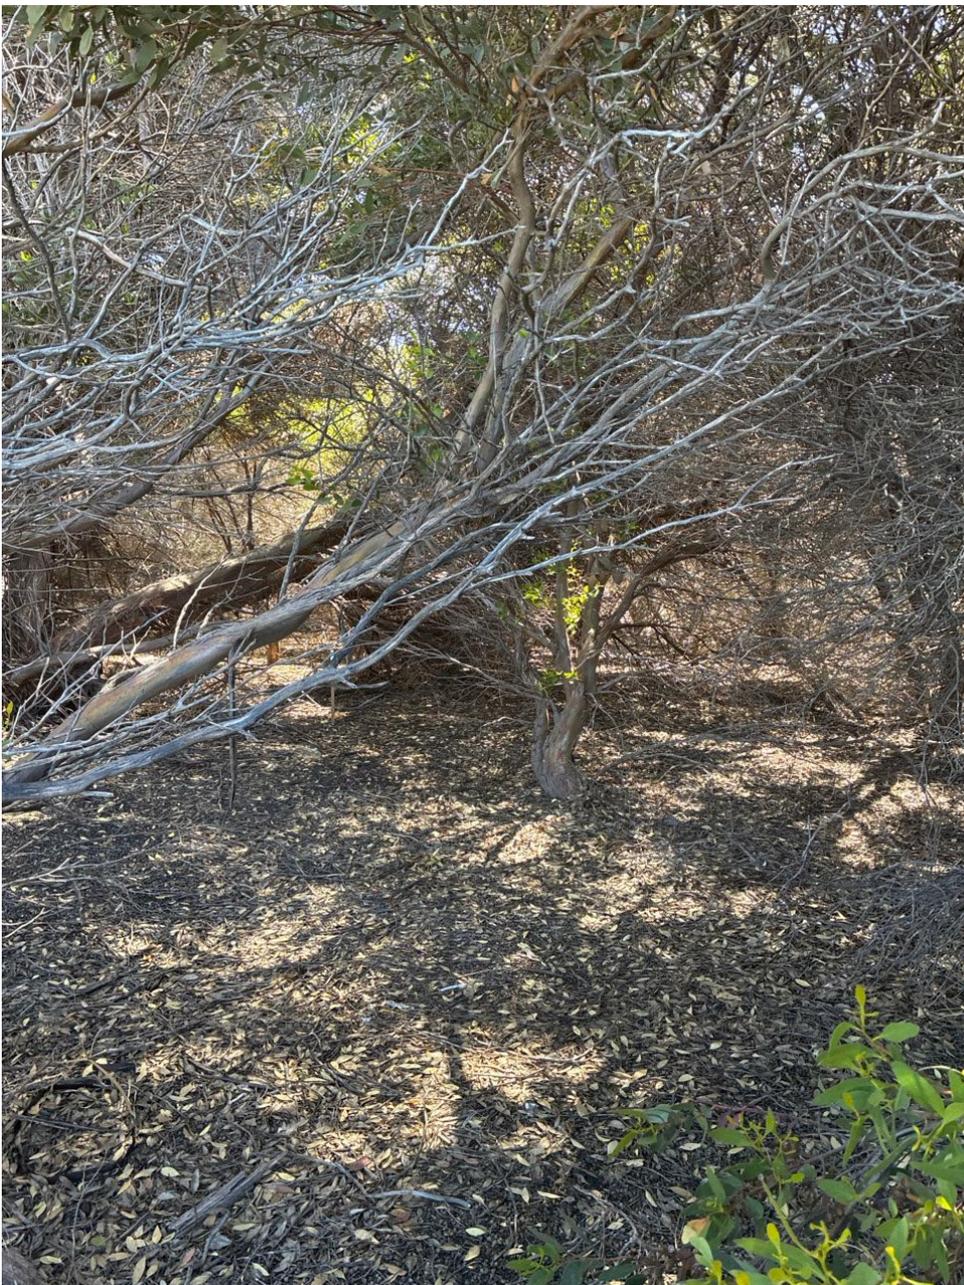
Plate 2: Lack of understorey within woodland vegetation type

No understorey species were present within the APZ, as shown in Plate 2.

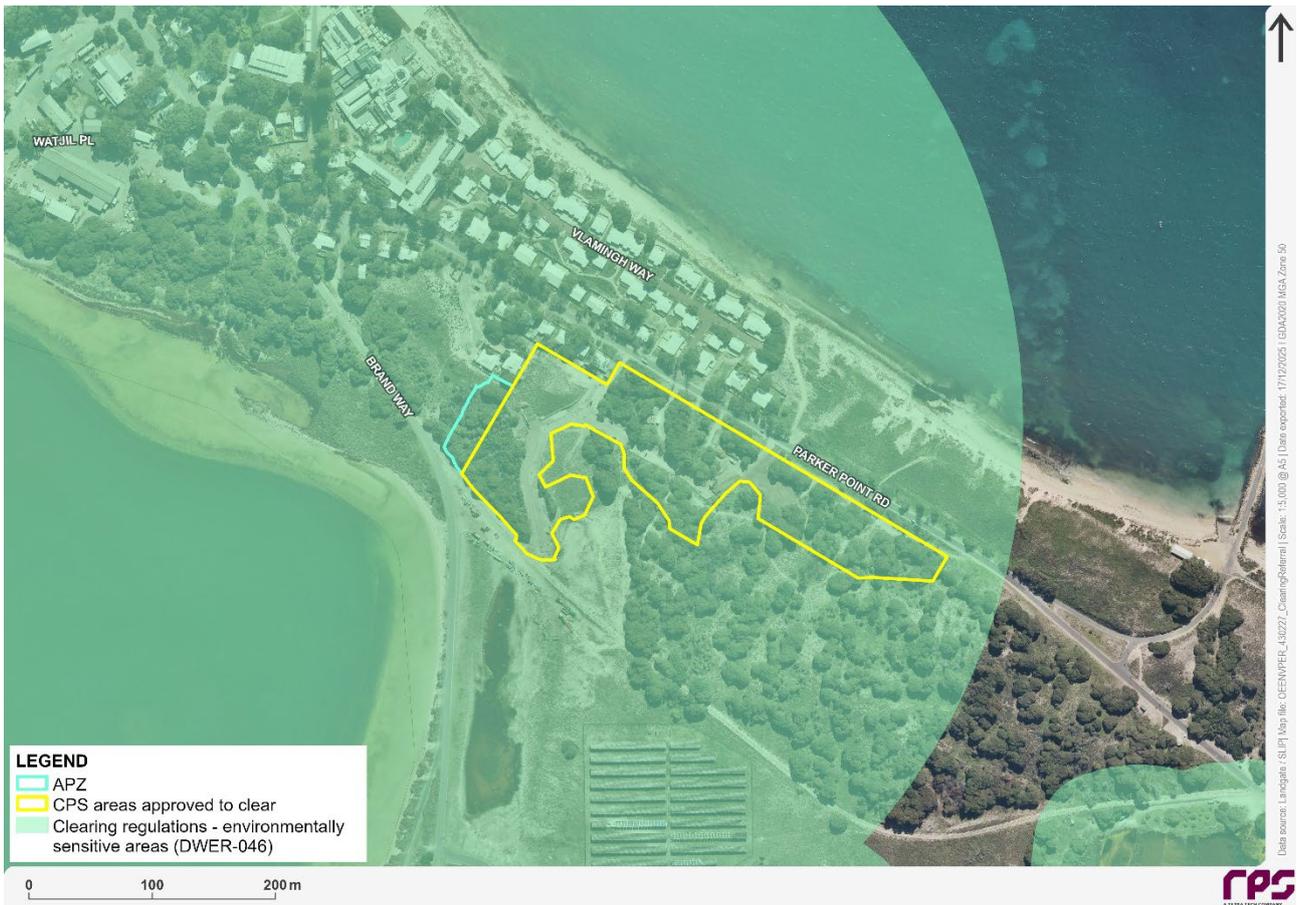
Figure 11: Environmentally sensitive areas (buffered)

The entirety of the APZ is located within the buffered extents of ESAs, ESAs mapped over the APZ are associated with:

- the TEC *Callitris preissii* (or *Melaleuca lanceolata*) forests and woodlands of the Swan Coastal Plain (floristic community type 30a as originally described by Gibson et. al. 1994), as shown in Figure 11, and
- Government House Lake which is part of the Rottneest Island Lakes (WA089) which is listed under the Directory of Important Wetlands in Australia.

Principle (h) – Native vegetation should not be cleared if the clearing of the vegetation is likely to have an impact	<p>The APZ is mapped within the buffered area of an ESA (Figure 11).</p> <p>The ESA associated with the TEC encompasses the APZ. As discussed under Principle (d), RPS considers that vegetation maintenance within the APZ will not result in the removal of vegetation</p>	Clearing of vegetation within the proposed APZ is

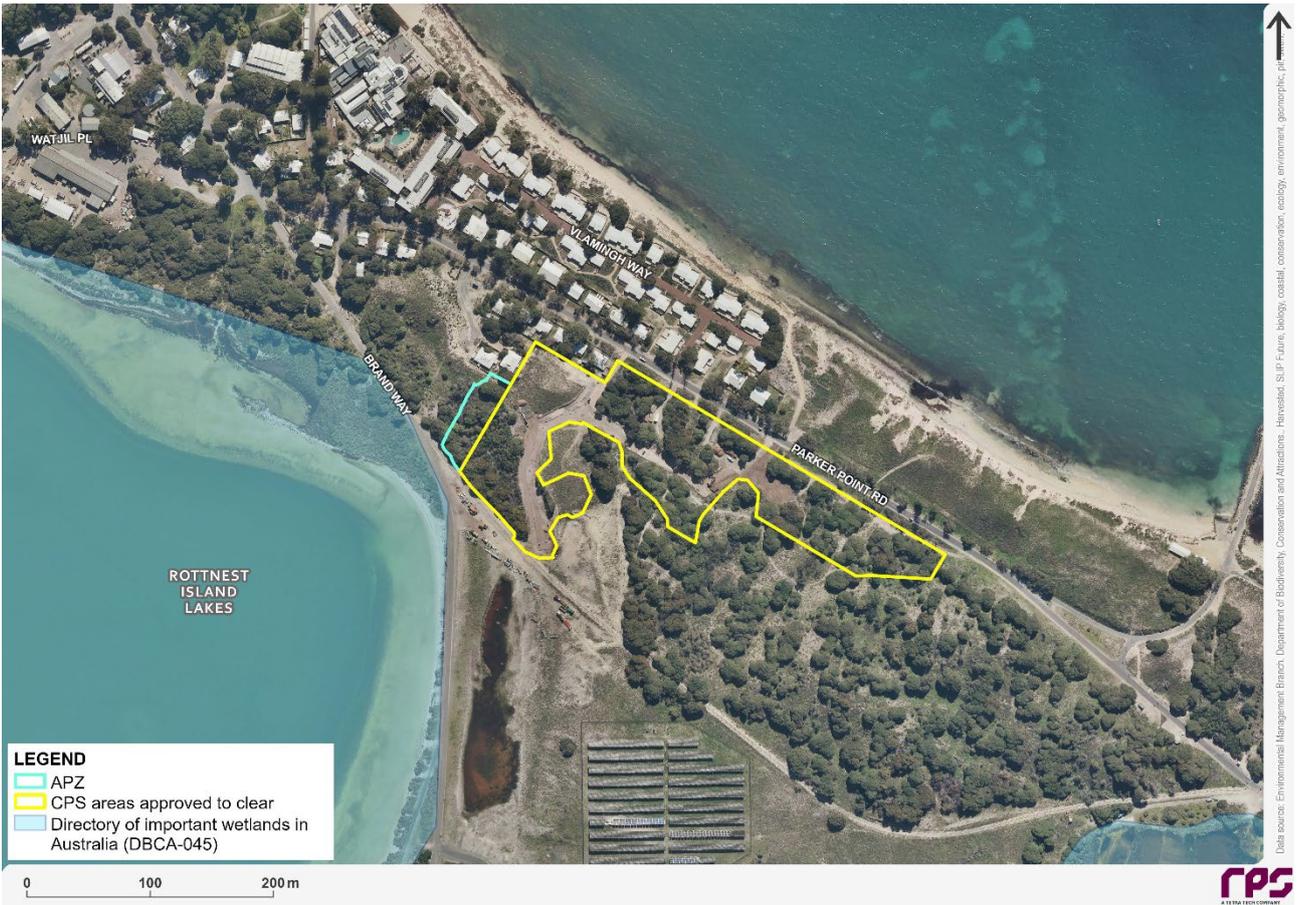
Figure 12: Surface water

There are no surface water features within the APZ. However, the APZ is located adjacent to the mapped boundary of Government House Lake which is part of the Rottnest Island Lakes (WA089) which is listed under the Directory of Important Wetlands in Australia. The APZ (at its nearest point) and Government House Lake are separated by Brand Way, a historical railway track and minor vegetation (Figure 12).

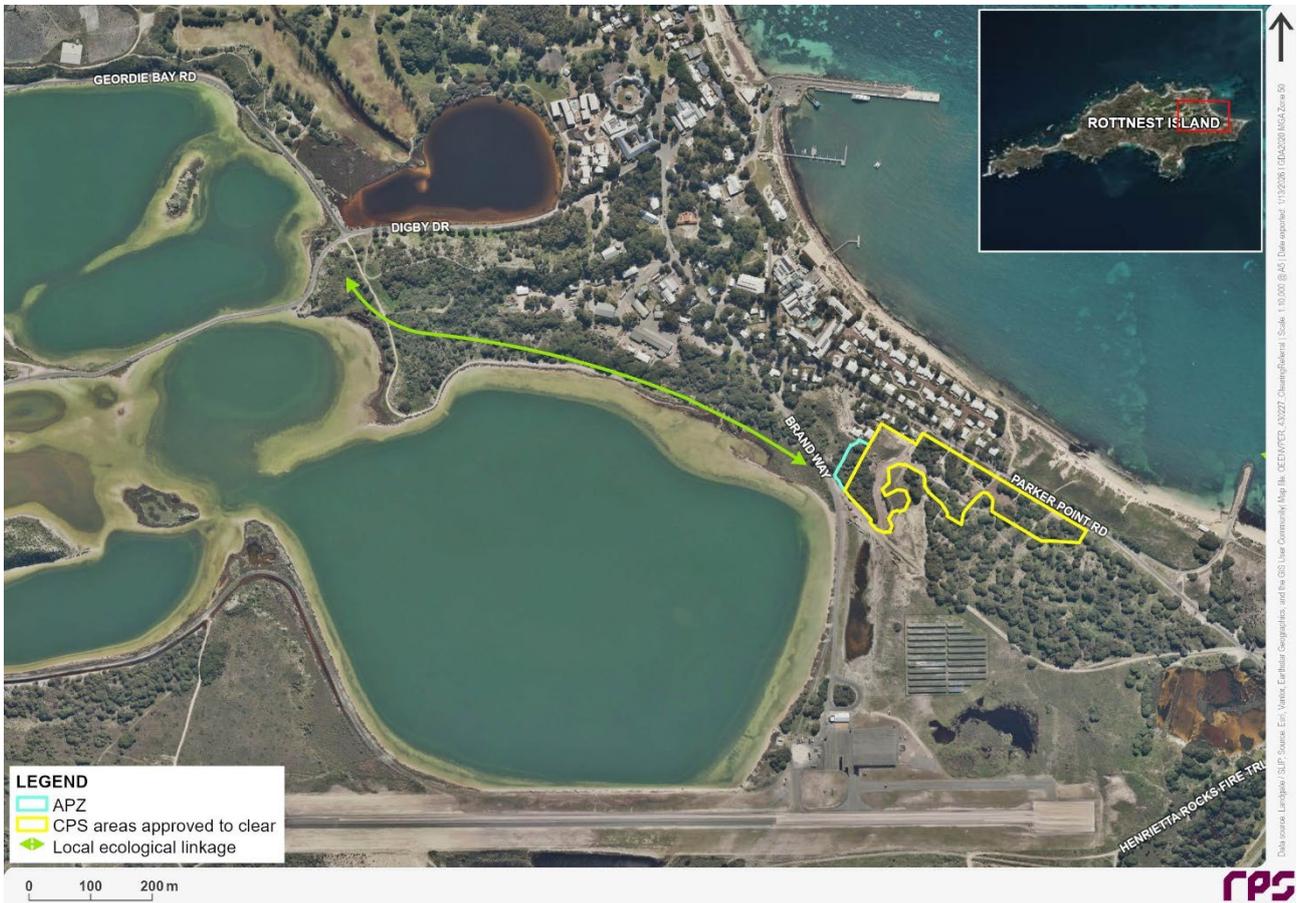
Figure 13: Local ecological linkage

Vegetation to the west of Brand Way comprises vegetation forming a local ecological linkage, connecting Government House Lake, Pearse Lake and Herschel Lake (Figure 13). Although separated from this linkage by Brand Way, there may be some movement between the vegetation within the APZ and this linkage.

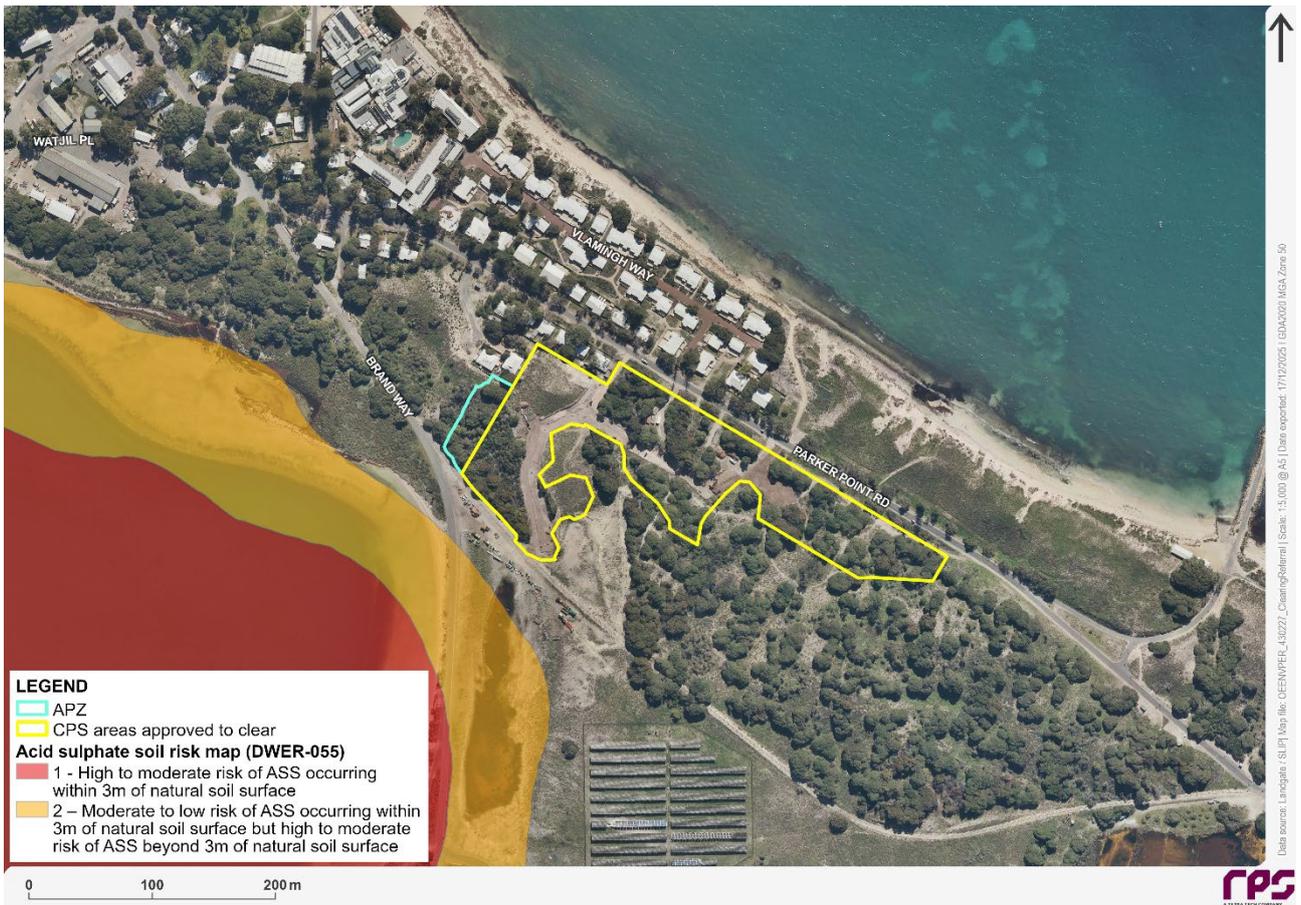
Figure 14: Acid sulfate soils risk mapping

A review of DWER’s ASS mapping indicates that the APZ is not at risk of ASS occurring within 3 m of the natural soil surface or deeper (Figure 14). An area of moderate to low risk of ASS occurring within 3 m of the natural soil surface is mapped <100 m south of the APZ (Figure 14). The ASS risk is associated with wetlands, however as the site is underlain with calcareous sands (refer Section 3.3), there is no risk of ASS at the site.

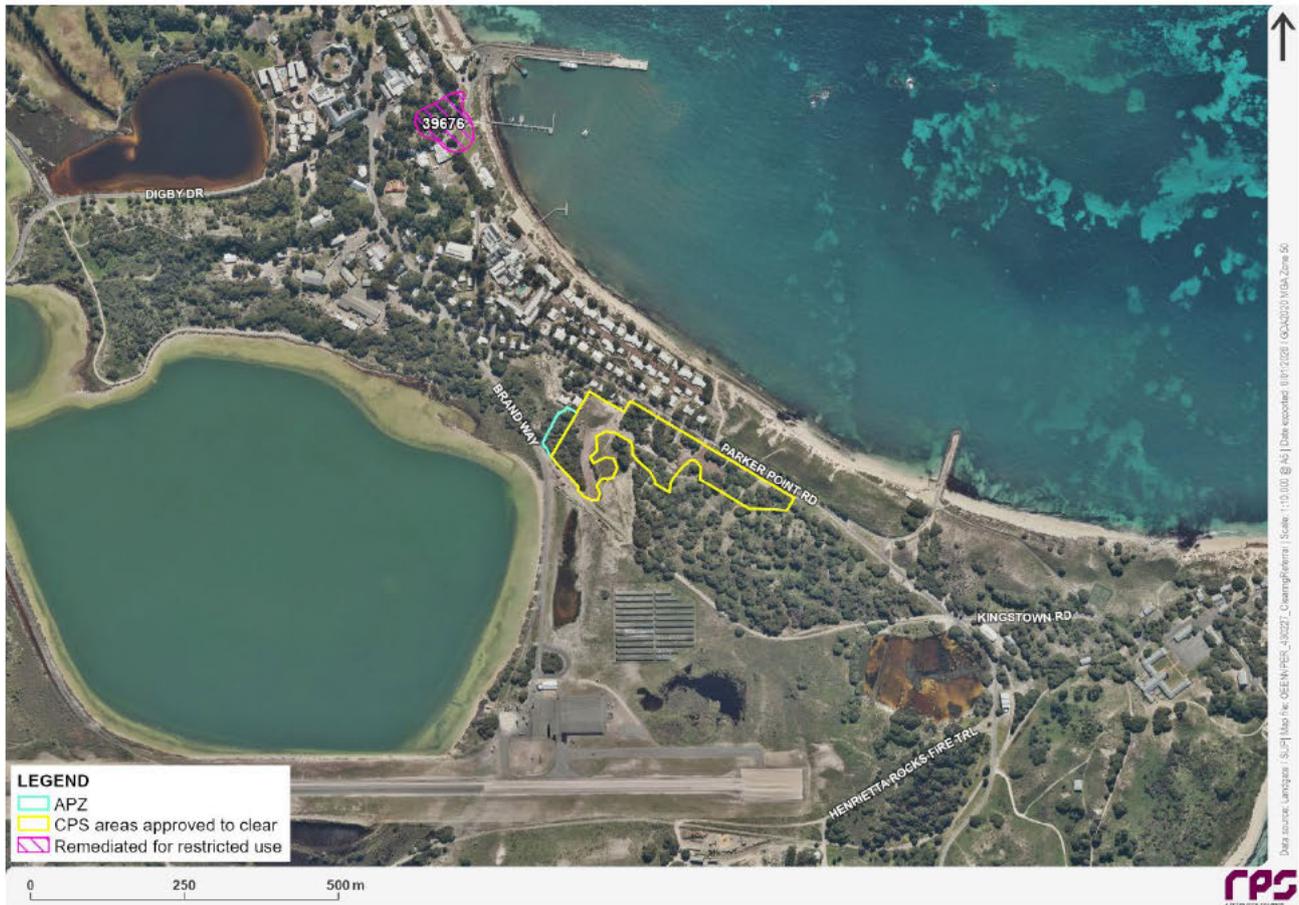
Figure 15: Contaminated sites mapping

One registered contaminated site is located within 2 km of the APZ (Figure 15). The information pertaining to the classification of this site is provided Table 5. The Basic Summary of Records associated with this parcel of land has been provided in Appendix C. The registered contaminated site will have no impact on the APZ due to the significant separation distance and associated natural attenuation.

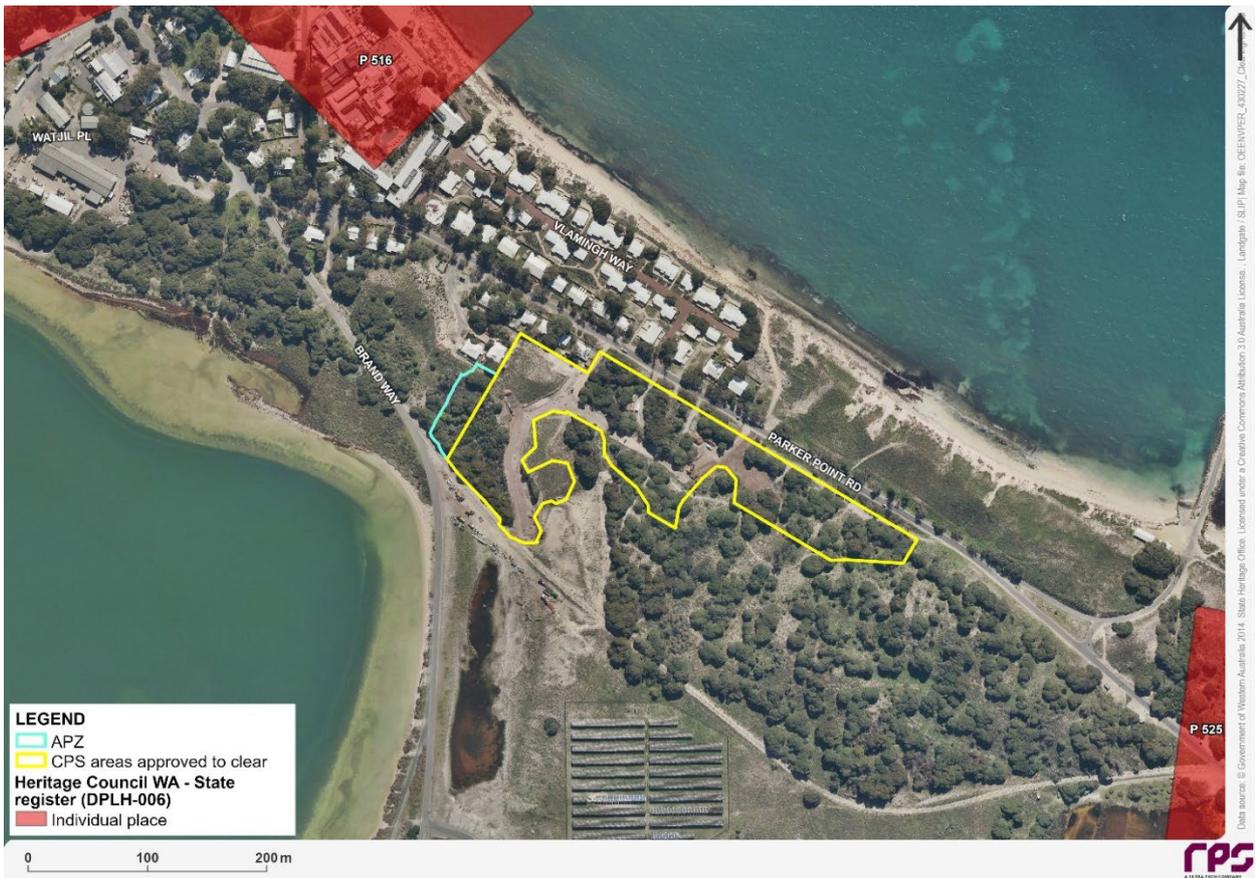
Figure 17: European heritage mapping

A search of the Heritage Council’s inHerit database did not identify any heritage places within (or adjacent to) the APZ that would be impacted by the proposed vegetation maintenance. The closest historic heritage place to the APZ is Heritage Place number 516 (Thompson Bay Settlement, Wadjemup / Rottneest Island), located approximately 0.20 km north-west of the APZ (Figure 17).

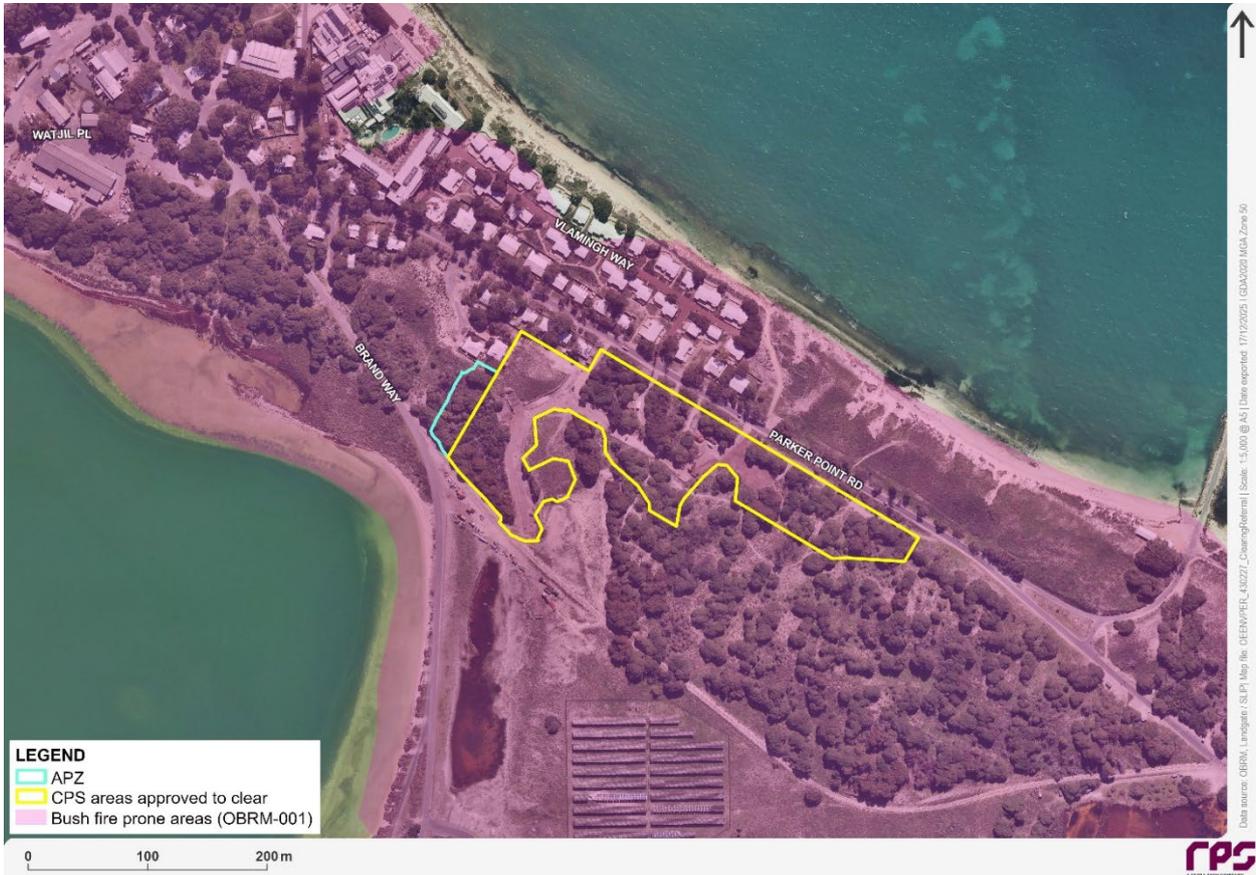
Figure 18: Bushfire prone areas mapping

A search of the Department of Fire and Emergency Services’ Map of Bushfire Prone Area identified that the APZ falls within a Bushfire Prone Area (Figure 18).
