CLEARING REFERRAL SUPPORTING DOCUMENTATION

Samphire Staff Accommodation, Bushfire Asset Protection Zone

604-OEENPER-430227
19 January 2026
Rev 0

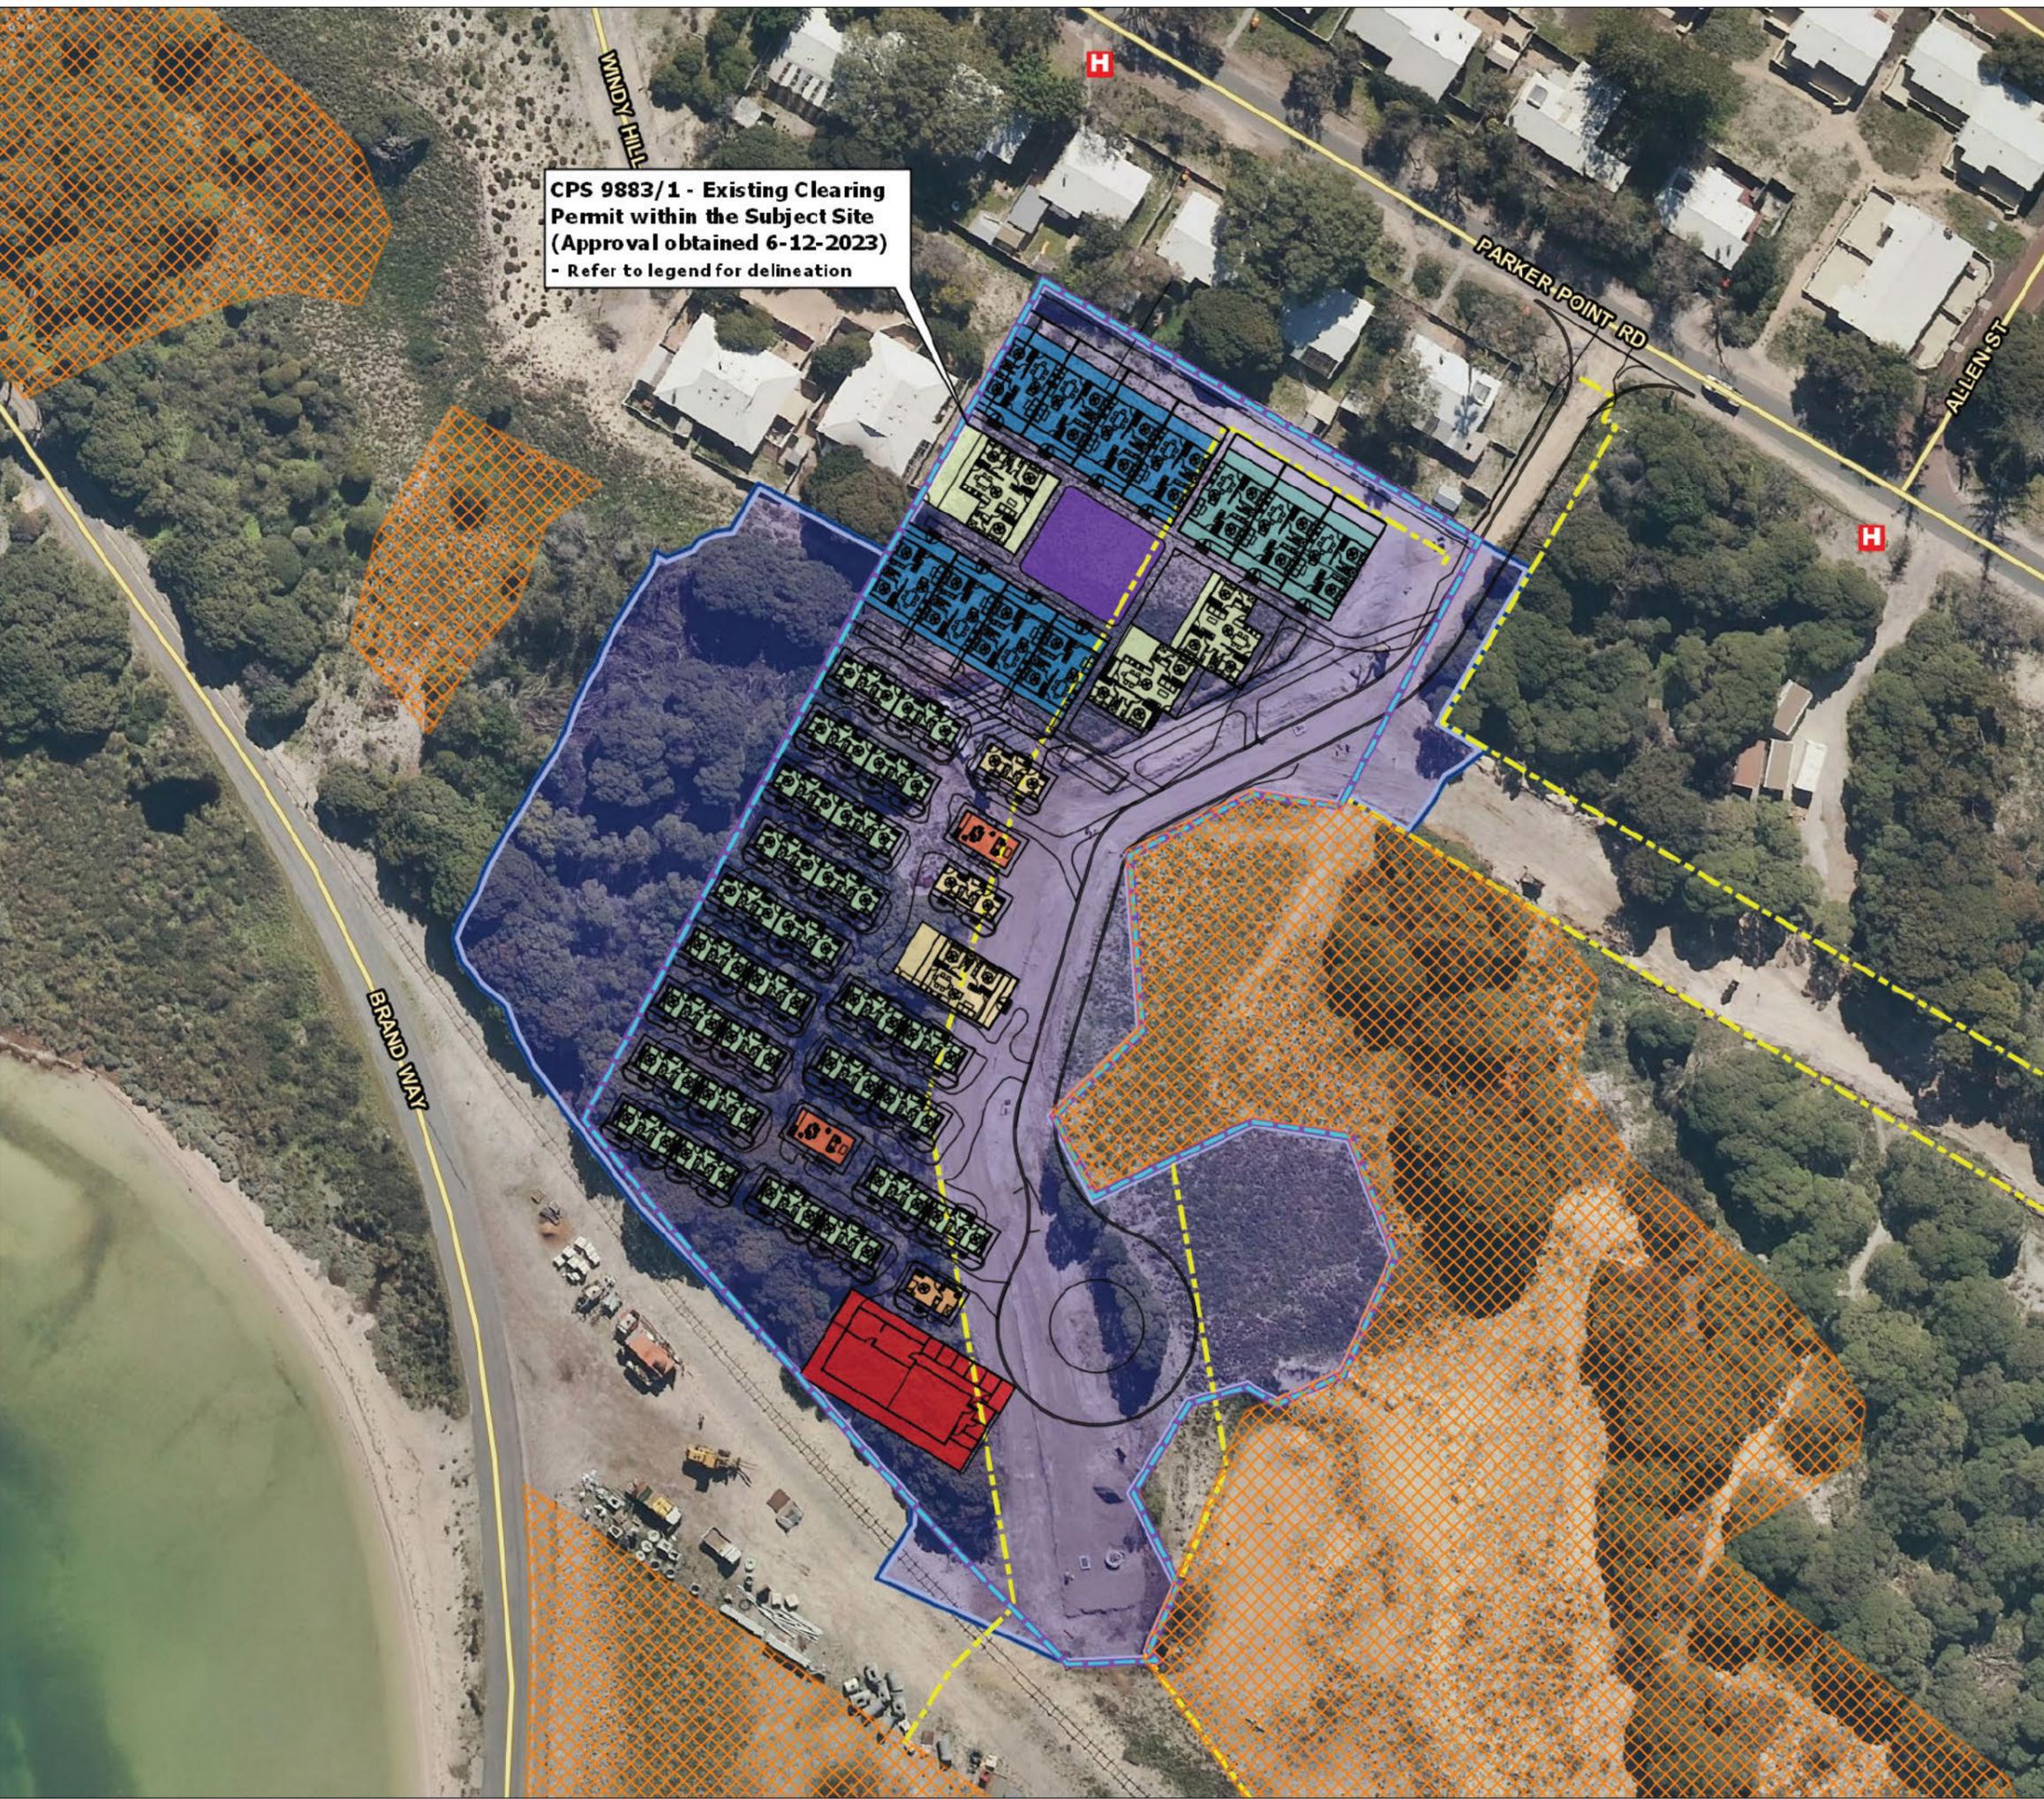
CPS 9883/1 - Existing Clearing Permit within the Subject Site (Approval obtained 6-12-2023)
 - Refer to legend for delineation

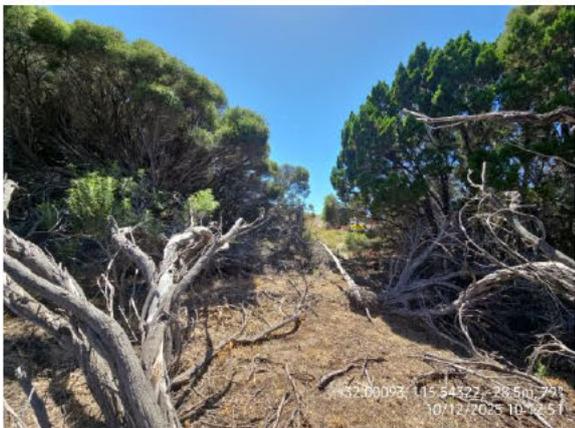
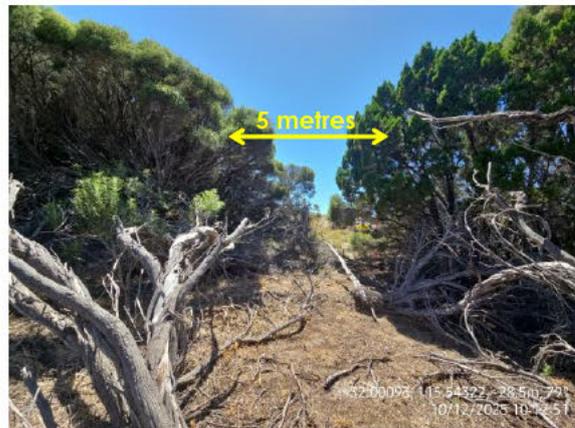
PHOTO ID: 1

APZ- VEGETATION CELL 1

CANOPY SEPARATION

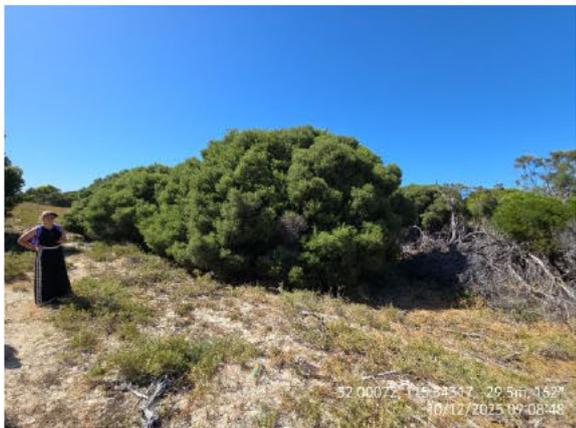
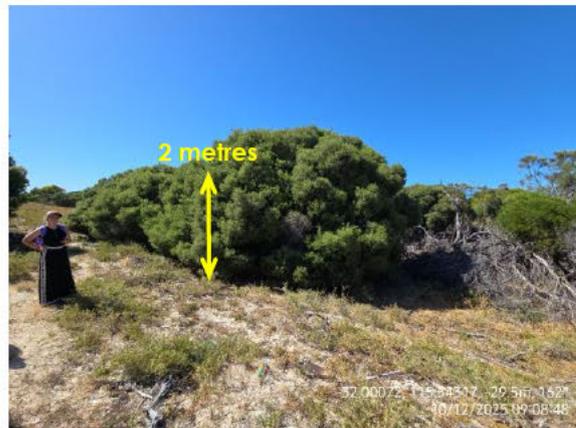
PHOTO ID: 3

UNDERSTOREY

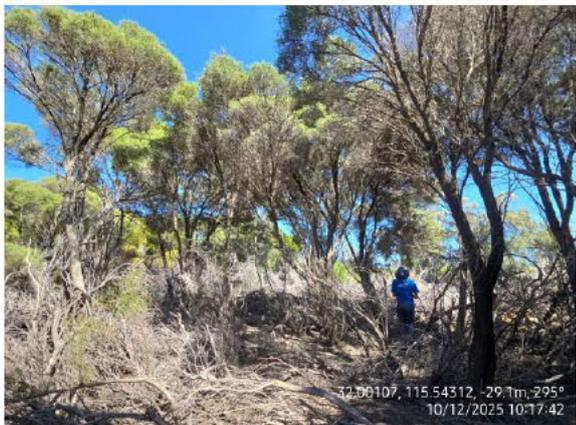
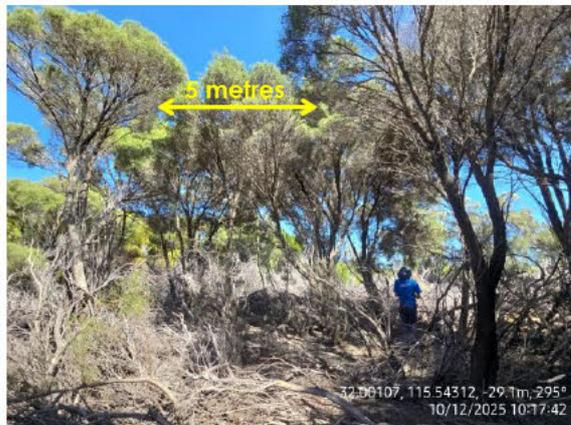
PHOTO ID: 1

CANOPY SEPARATION

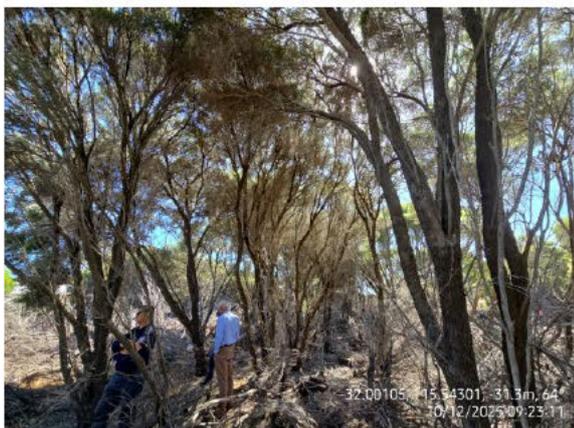
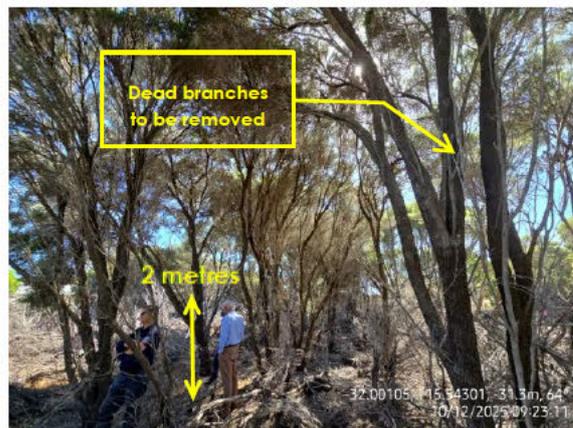
PHOTO ID: 4

UNDERSTOREY

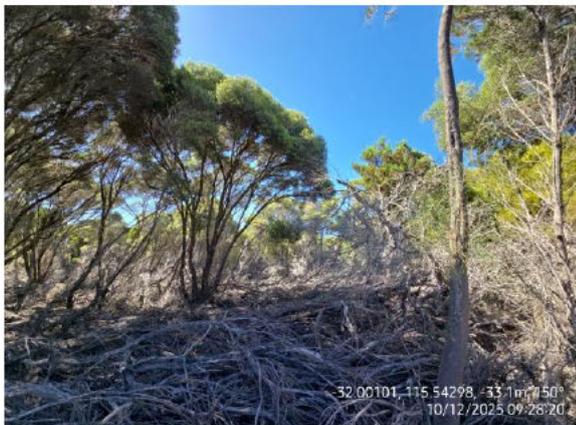
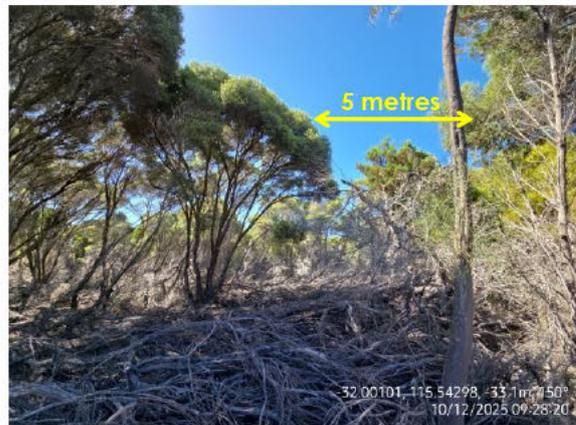
PHOTO ID: 1

CANOPY SEPARATION

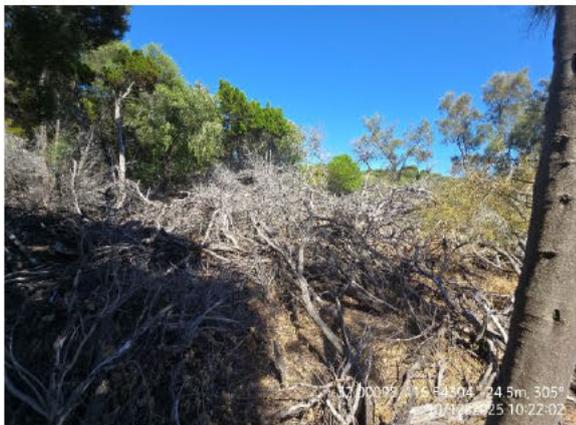
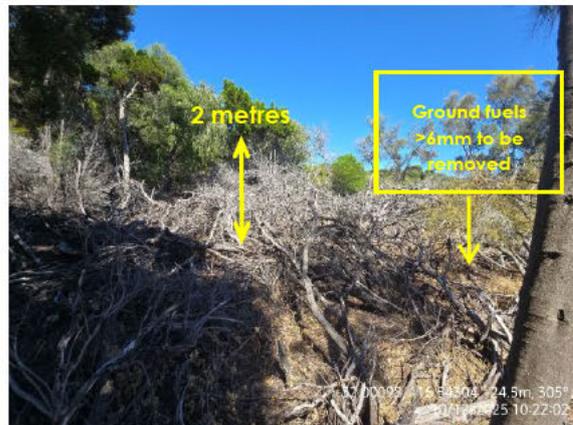
PHOTO ID: 2

UNDERSTOREY

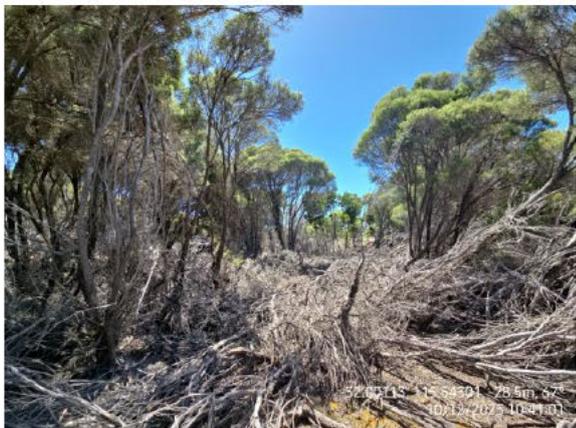
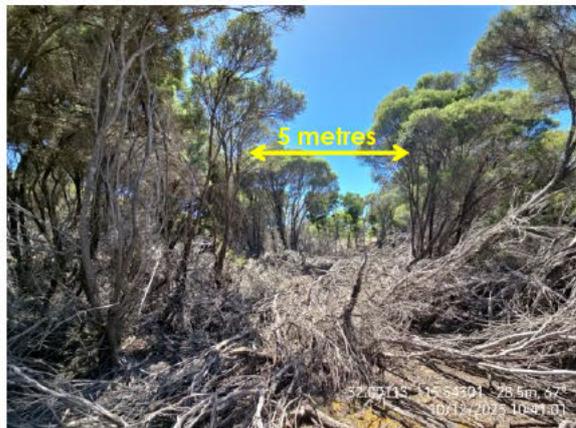
PHOTO ID: 1

CANOPY SEPARATION

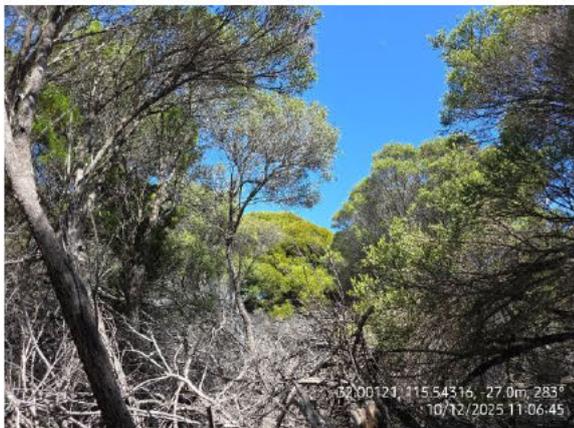
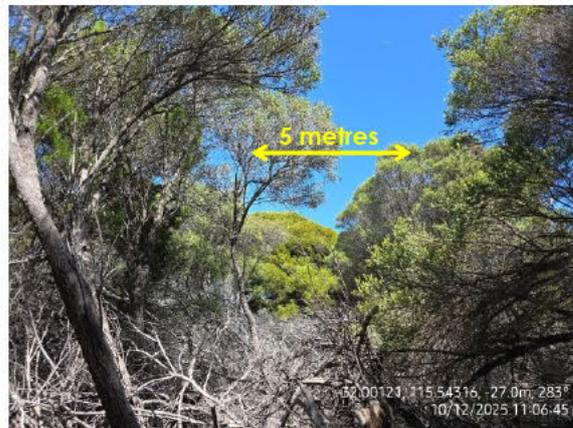
PHOTO ID: 3

CANOPY SEPARATION

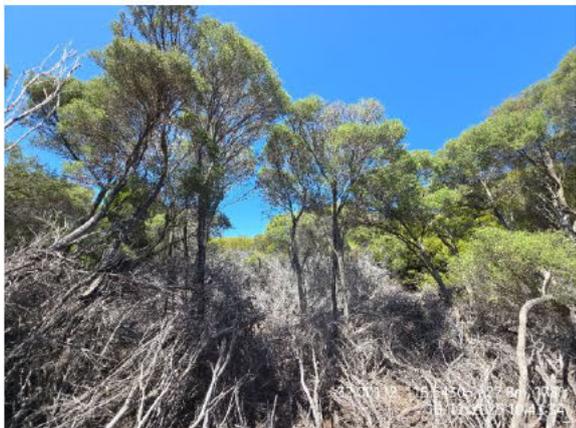
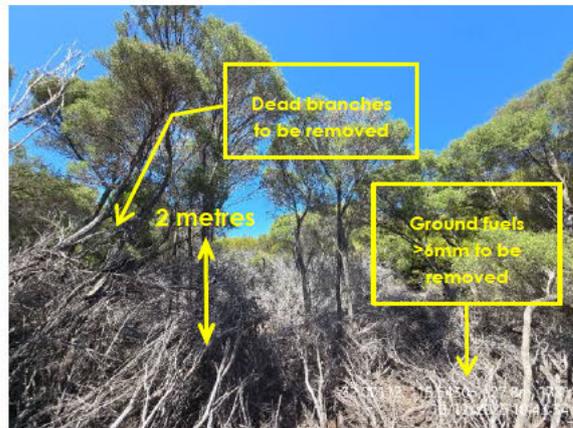
PHOTO ID: 4

UNDERSTOREY

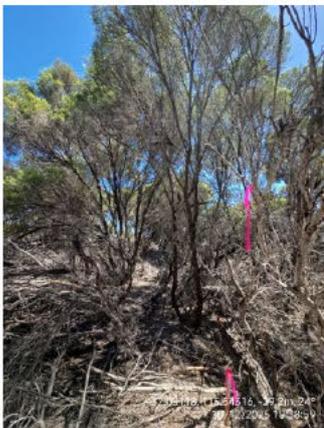
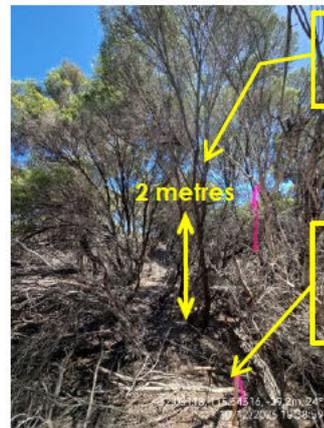
PHOTO ID: 6

UNDERSTOREY

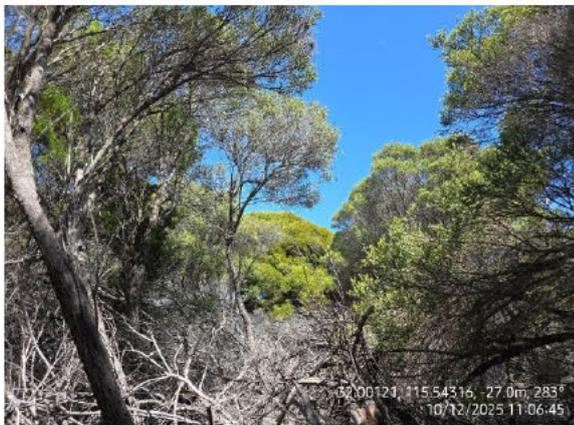
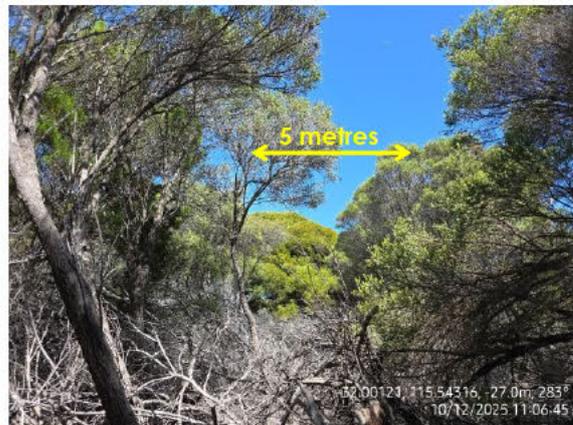
PHOTO ID: 1

CANOPY SEPARATION

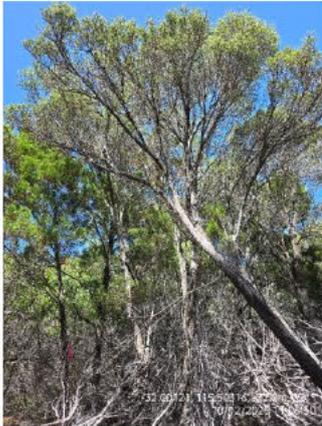
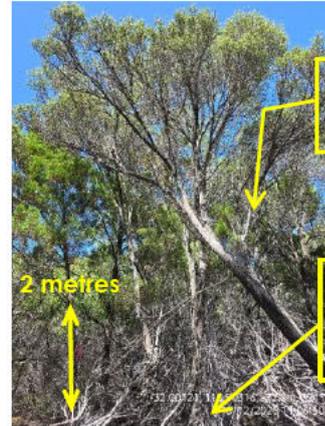
PHOTO ID: 2

UNDERSTOREY

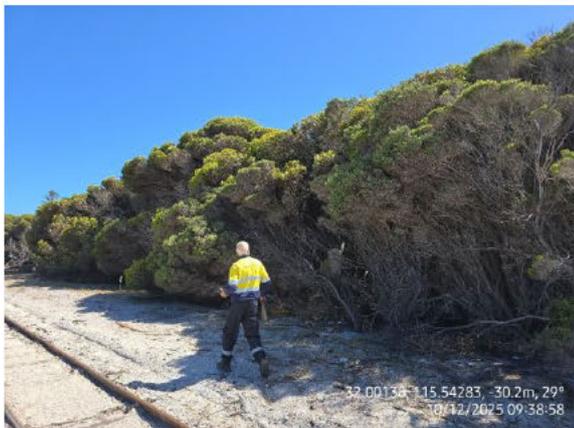
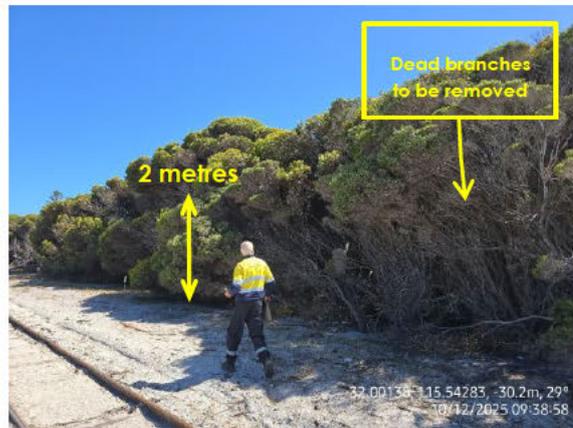
PHOTO ID: 1

UNDERSTOREY

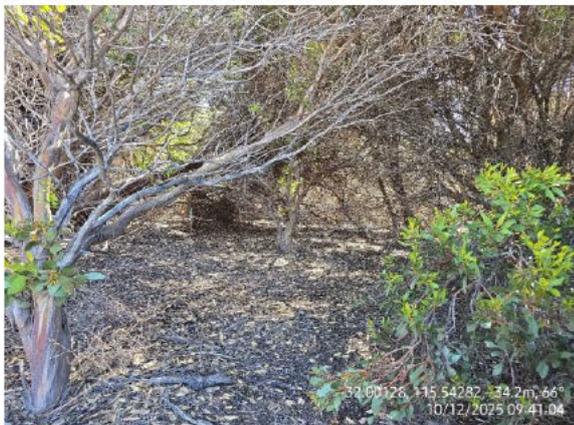
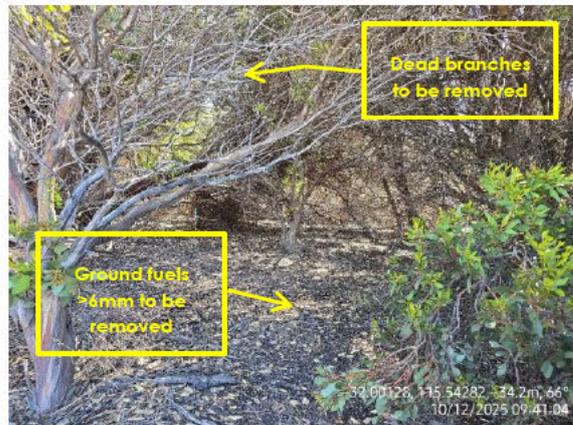
PHOTO ID: 3

UNDERSTOREY

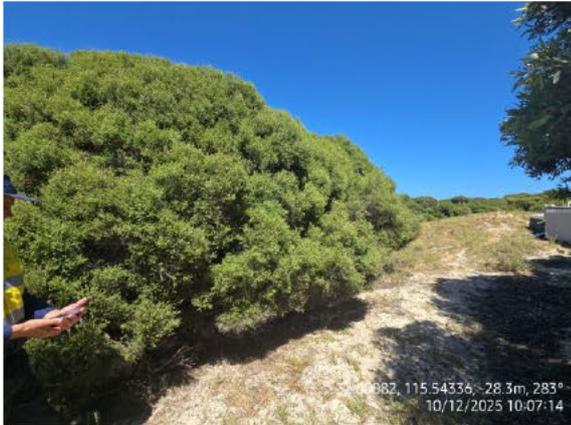
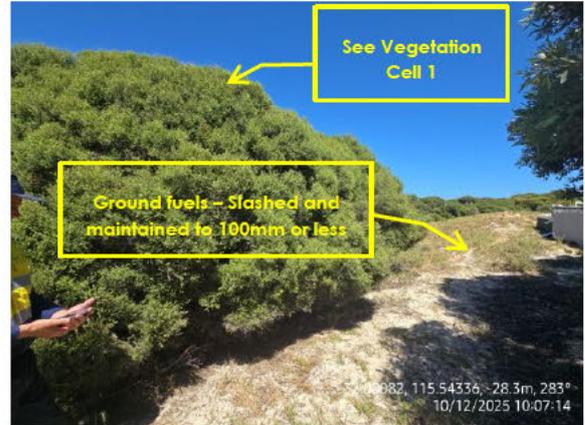
PHOTO ID: 1

- Ground fuels – To be slashed and maintained to 100mm or less.

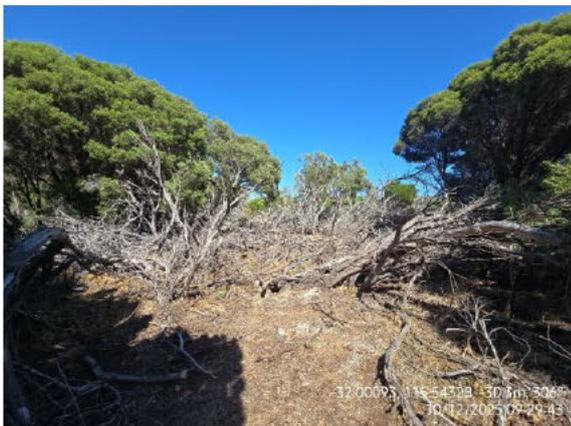
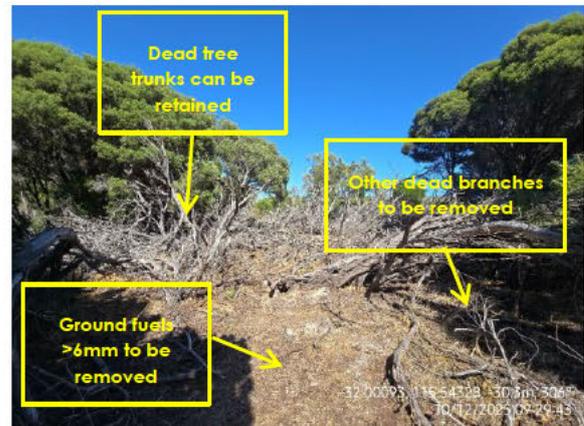
PHOTO ID: 4

- Ground fuels exceeding 6mm are to be removed.
- Dead tree trunks with branches exceeding 25mm (course/heavy fuel) can be retained for habitat.
- Large logs can be removed for the purposes of APZ implementation but can be placed back in the area for habitat.
- Other dead branches are to be removed.

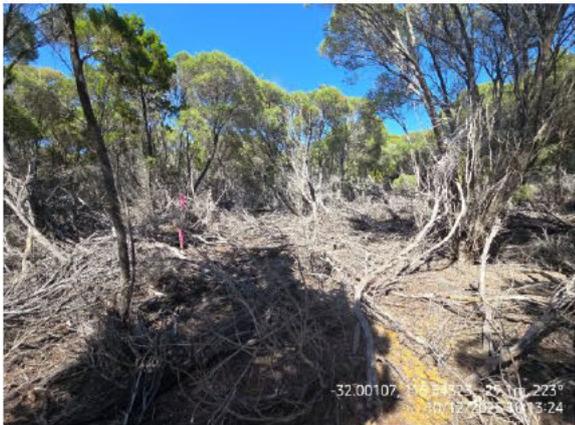
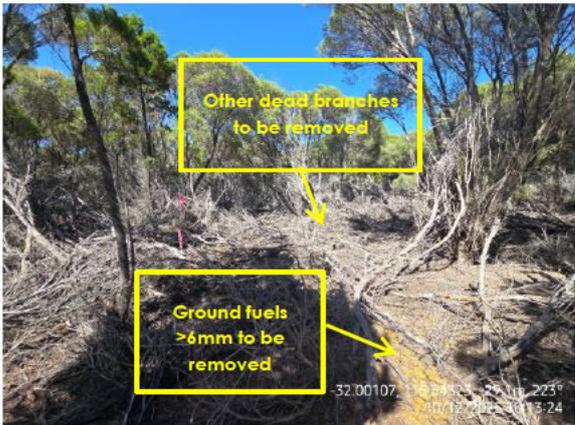
PHOTO ID: 5	PHOTO ID: 5 – Mark-up
WORKS REQUIRED →	<ul style="list-style-type: none"> ➤ Ground fuels exceeding 6mm are to be removed. ➤ Other dead branches are to be removed.

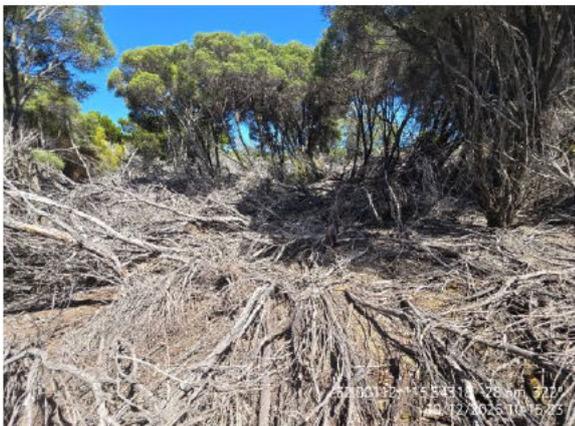
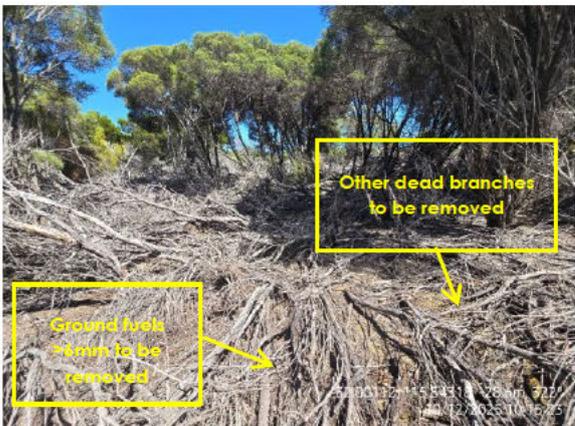
PHOTO ID: 6	PHOTO ID: 6 – Mark-up
WORKS REQUIRED →	<ul style="list-style-type: none"> ➤ Ground fuels exceeding 6mm are to be removed. ➤ Other dead branches are to be removed.

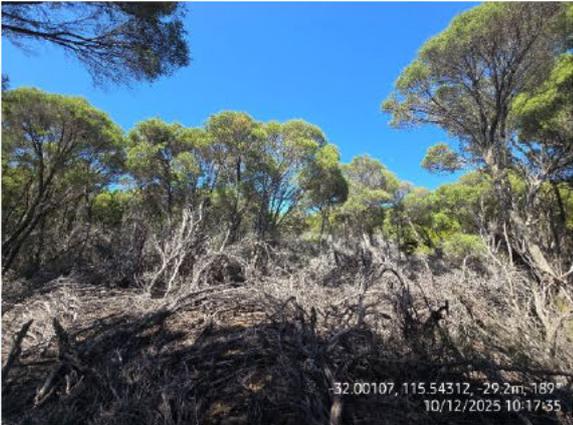
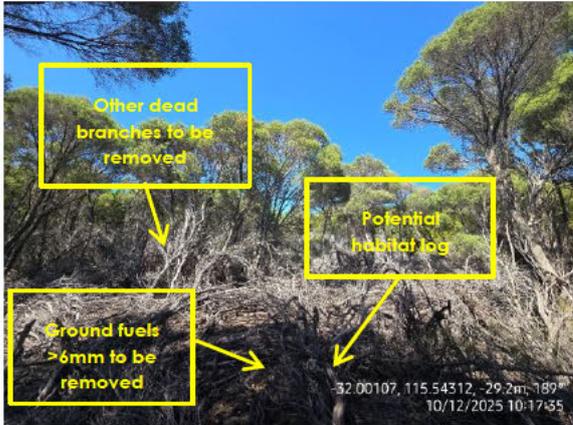
PHOTO ID: 7	PHOTO ID: 7 – Mark-up
WORKS REQUIRED ➔	<ul style="list-style-type: none"> ➤ Ground fuels exceeding 6mm are to be removed. ➤ Large logs can be removed for the purposes of APZ implementation but can be placed back in the area for habitat. ➤ Other dead branches are to be removed.

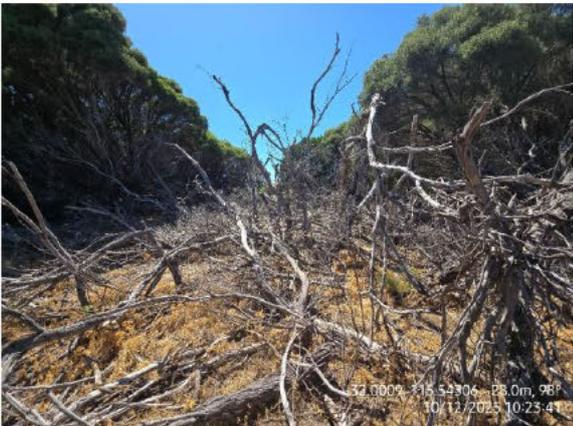
PHOTO ID: 8	PHOTO ID: 8 – Mark-up
WORKS REQUIRED ➔	<ul style="list-style-type: none"> ➤ Ground fuels exceeding 6mm are to be removed. ➤ Dead tree trunks with branches exceeding 25mm (course/heavy fuel) can be retained for habitat. ➤ Other dead branches are to be removed.

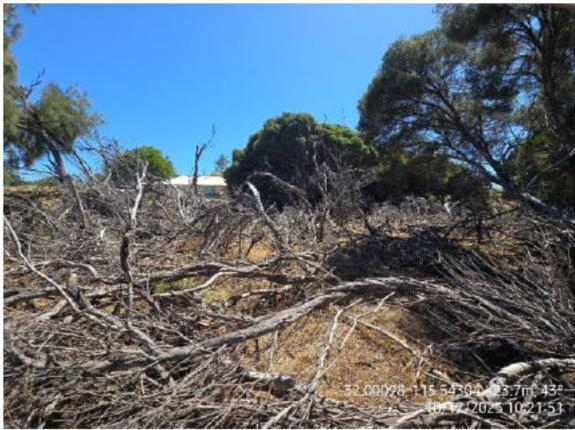
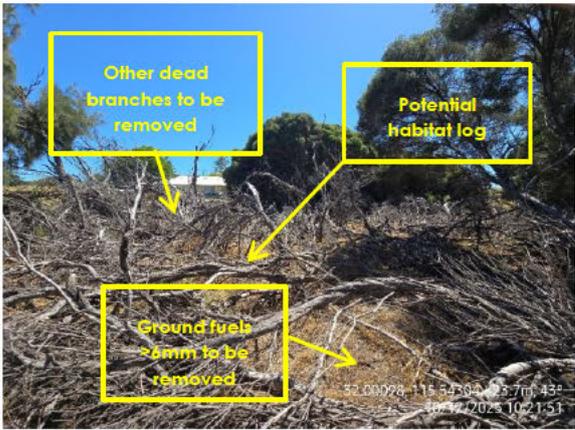
PHOTO ID: 9	PHOTO ID: 9 – Mark-up
WORKS REQUIRED ➔	<ul style="list-style-type: none"> ➤ Ground fuels exceeding 6mm are to be removed. ➤ Large logs can be removed for the purposes of APZ implementation but can be placed back in the area for habitat. ➤ Other dead branches are to be removed.

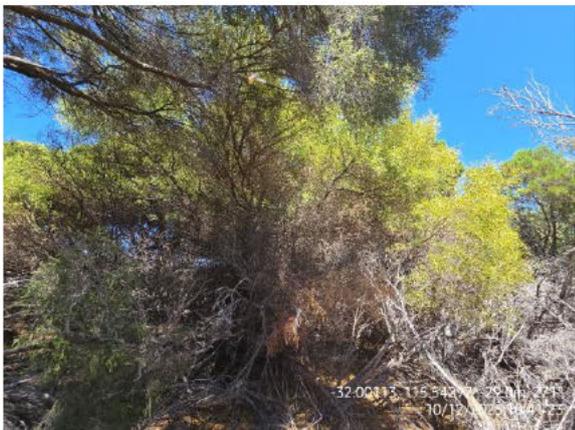
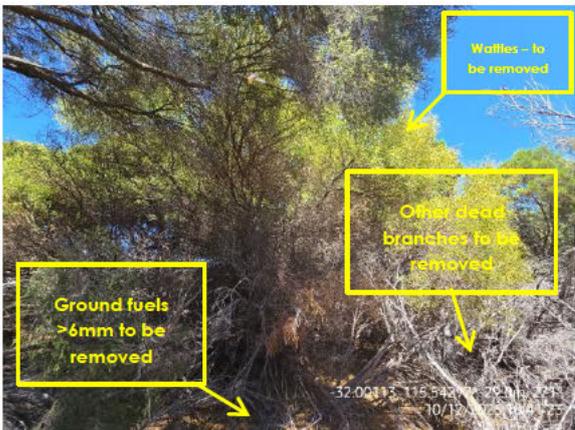
PHOTO ID: 10	PHOTO ID: 10 – Mark-up
WORKS REQUIRED ➔	<ul style="list-style-type: none"> ➤ Wattles to be removed. ➤ Ground fuels exceeding 6mm are to be removed. ➤ Other dead branches are to be removed.

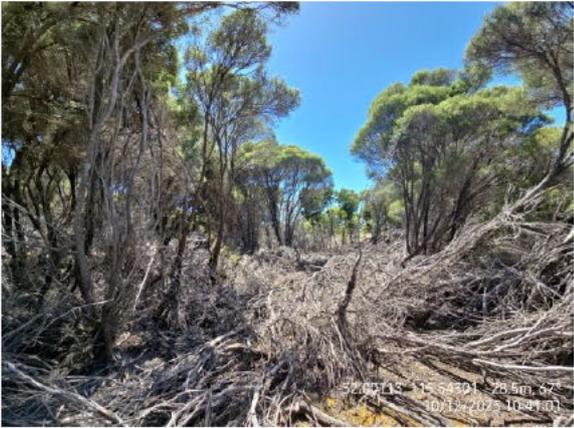
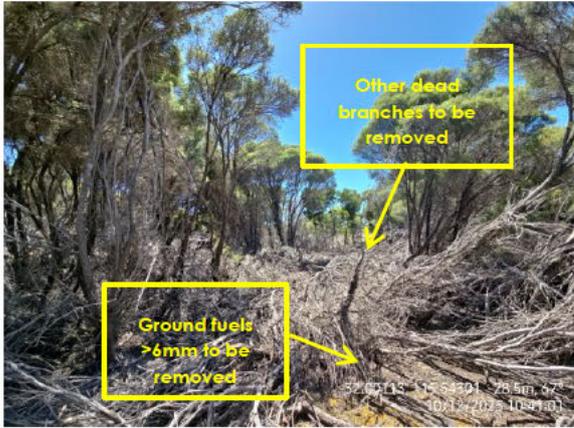
<p>PHOTO ID: 11</p>	<p>PHOTO ID: 11 – Mark-up</p>
<p>WORKS REQUIRED ➔</p>	<ul style="list-style-type: none"> ➤ Ground fuels exceeding 6mm are to be removed. ➤ Other dead branches are to be removed.

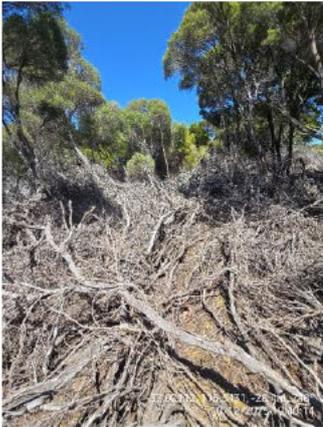
<p>PHOTO ID: 12</p>	<p>PHOTO ID: 12 – Mark-up</p>
<p>WORKS REQUIRED ➔</p>	<ul style="list-style-type: none"> ➤ Ground fuels exceeding 6mm are to be removed. ➤ Large logs can be removed for the purposes of APZ implementation but can be placed back in the area for habitat. ➤ Other dead branches are to be removed.

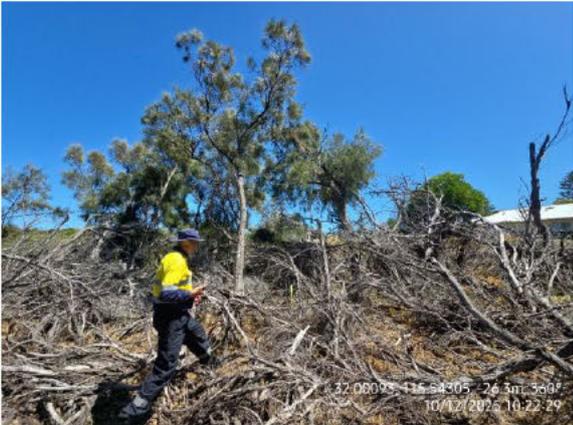
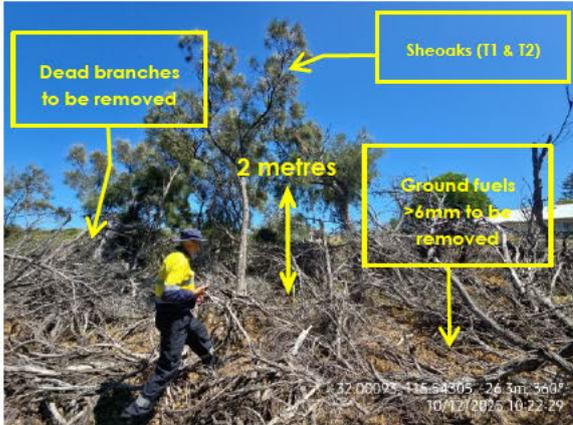
PHOTO ID: 1	PHOTO ID: 1 – Mark-up
WORKS REQUIRED ➡	<ul style="list-style-type: none"> ➤ Significant Trees (T1 & T2 – Sheoaks) to be under-pruned to a height of two (2) metres above the ground. ➤ Dead branches are to be removed. ➤ Ground fuels exceeding 6mm are to be removed.

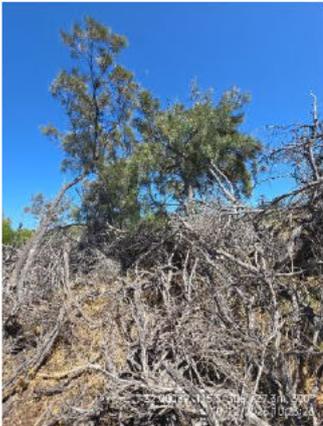
PHOTO ID: 2	PHOTO ID: 2 – Mark-up
WORKS REQUIRED ➡	<ul style="list-style-type: none"> ➤ Significant Trees (T1 & T2 – Sheoaks) to be under-pruned to a height of two (2) metres above the ground. ➤ Dead branches are to be removed. ➤ Ground fuels exceeding 6mm are to be removed.

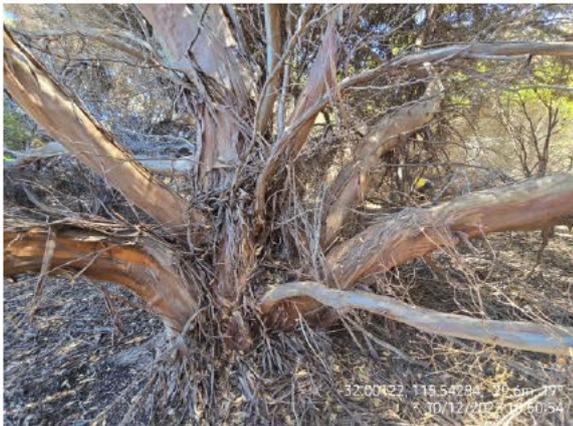
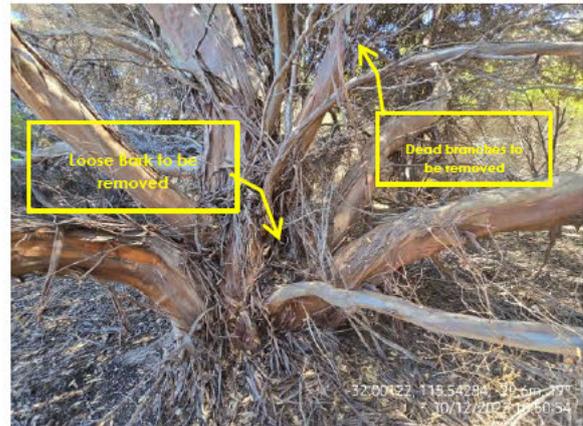
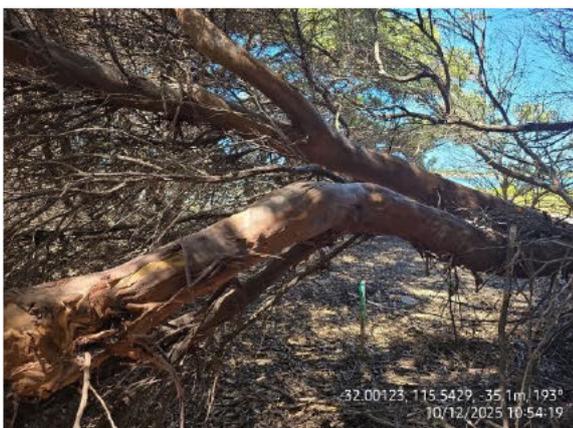
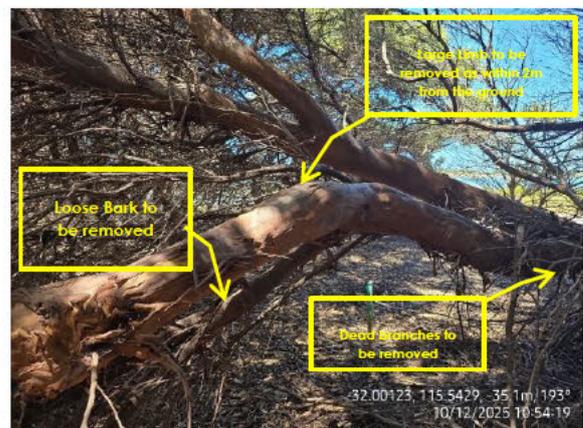
T16 Supplementary Photos (Not included on map)

- Significant Tree (T16 – Coastal Moort) to be underpruned to a height of two (2) metres above the ground.
- Dead branches are to be removed.
- Loose (Candle Stick Bark) to be removed.
- Ground fuels exceeding 6mm are to be removed.

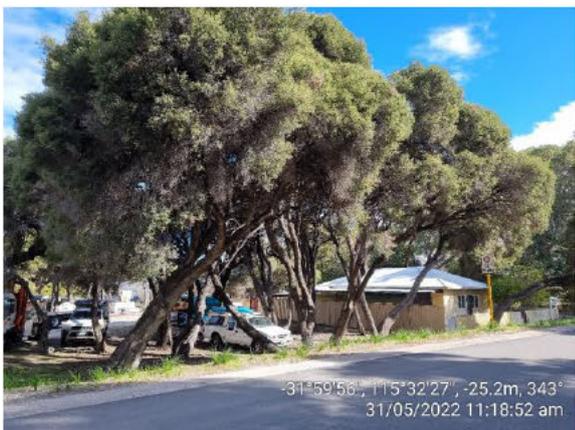
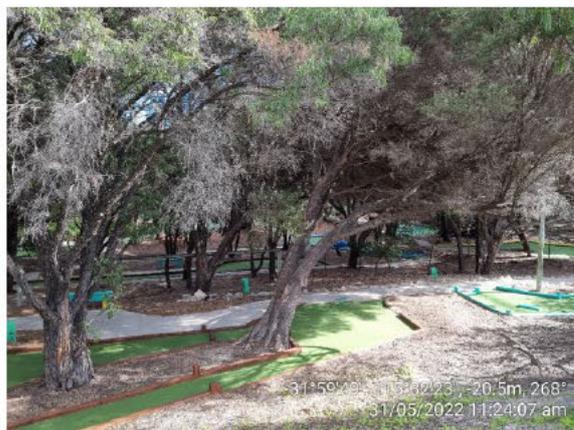
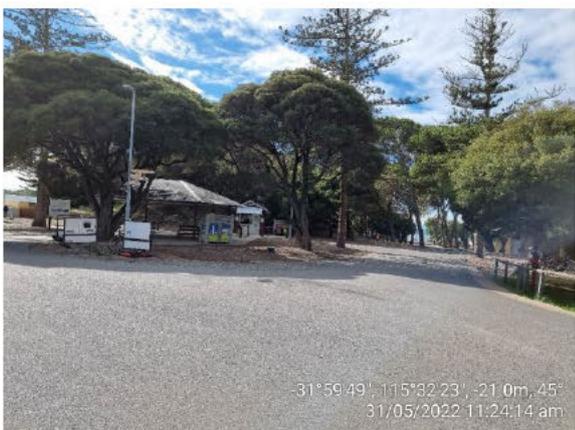
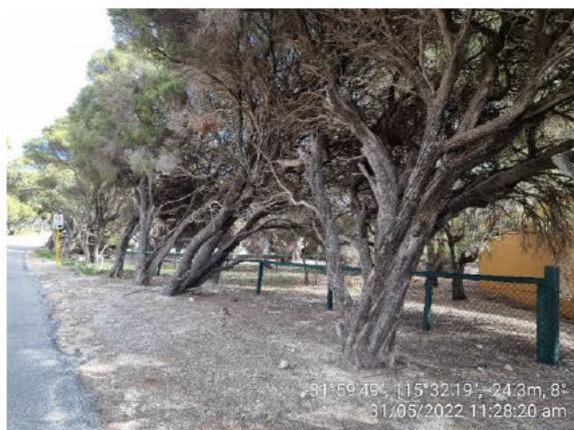
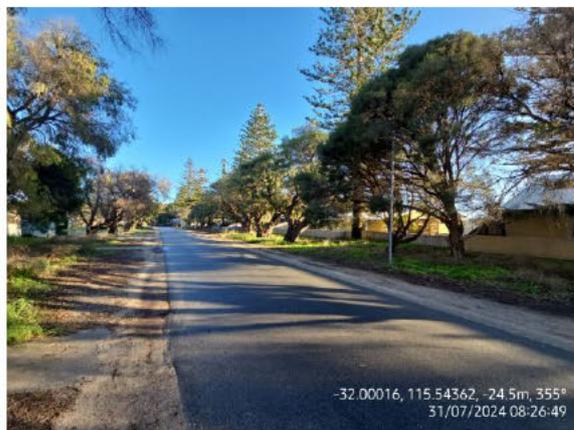
Existing, managed conditions on Rottnest Island – Vegetation excludable under s2.2.3.2 of AS3959-2018

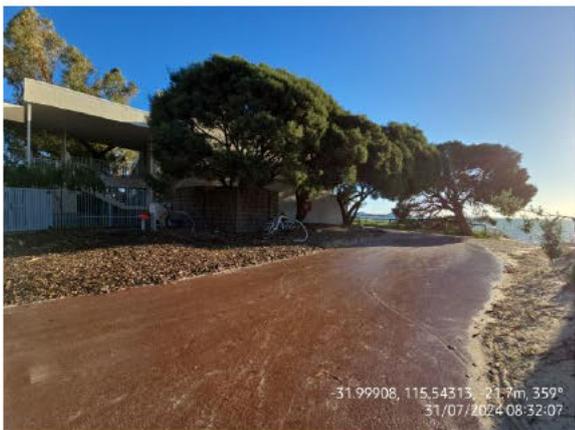
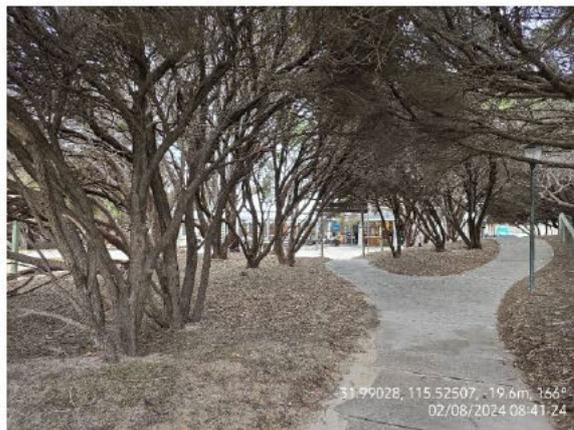
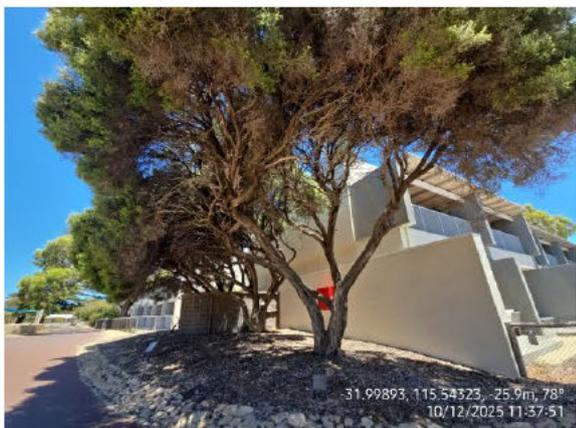
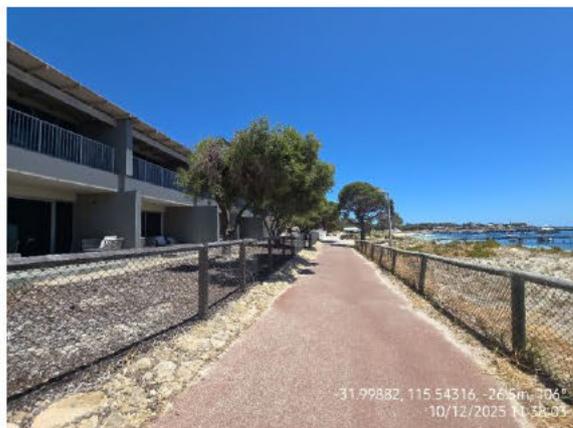
Existing, managed conditions on Rottnest Island – Vegetation excludable under s2.2.3.2 of AS3959-2018
