Surrounds of East Perth Power Station (EPPS)

Vegetation Condition Survey

CW1200027

Prepared for
Development WA

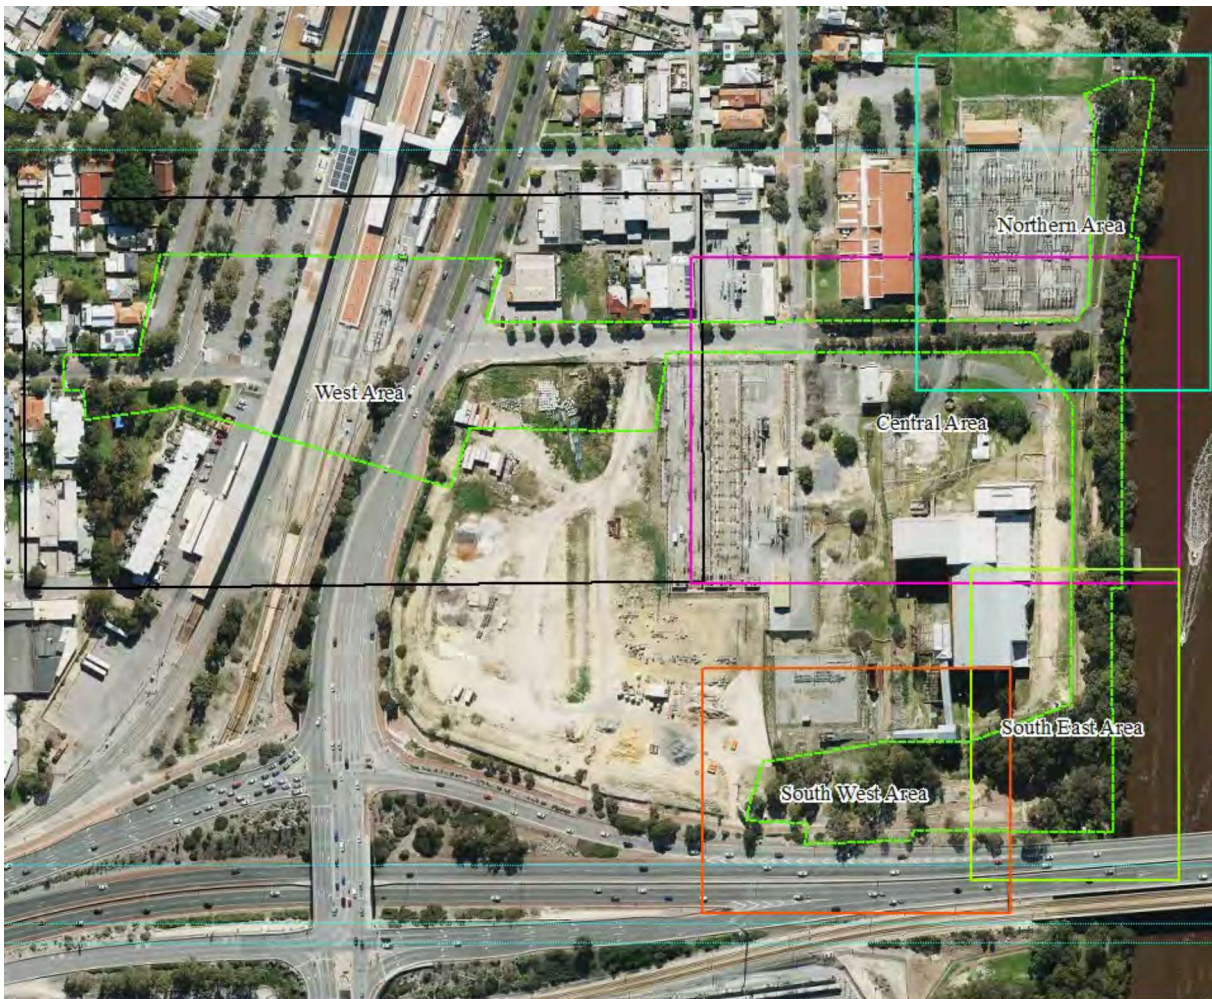
Figure 4-1 Zone Breakdown

The survey Area has been broken down into 5 zones to provide better clarity of results. These zones are South West, South East, Central, Northern and Western. The below **Figure 4-1** and **Figure 1.1 Appendix B** outlines the zone breakup.

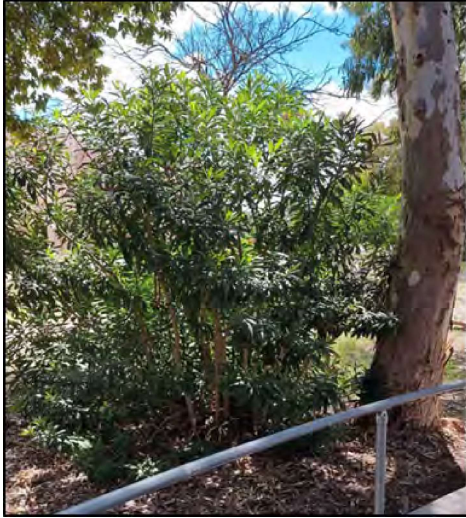
Figure 4-4 Predicted WP Impact tree – Survey 8

Survey ID	Species	Within ESA	Health	Height (m)	DBH
8	Nerium oleander (Oleander)	Yes	Healthy	3	100_200mm
9	Eucalyptus camaldulensis (River Gum)	Yes	Healthy	17	300_400mm

On review of predicted works to this area, the main impact would occur to the northern part of this zone. Half of the SE area falls within the ESA, with the ESA encompassing the area from the Swan River West until survey point 234. The double trench for the 132kV underground line is planned to enter this zone from the North and directly impacting the vegetation adjacent to the footpath. The trench is proposed to continue along the existing footpath parallel to the revegetated area before turning West and following the line of the footpath towards Lot 602. The below table (Table 4-4) outlines the vegetation that will be affected by this planned construction.

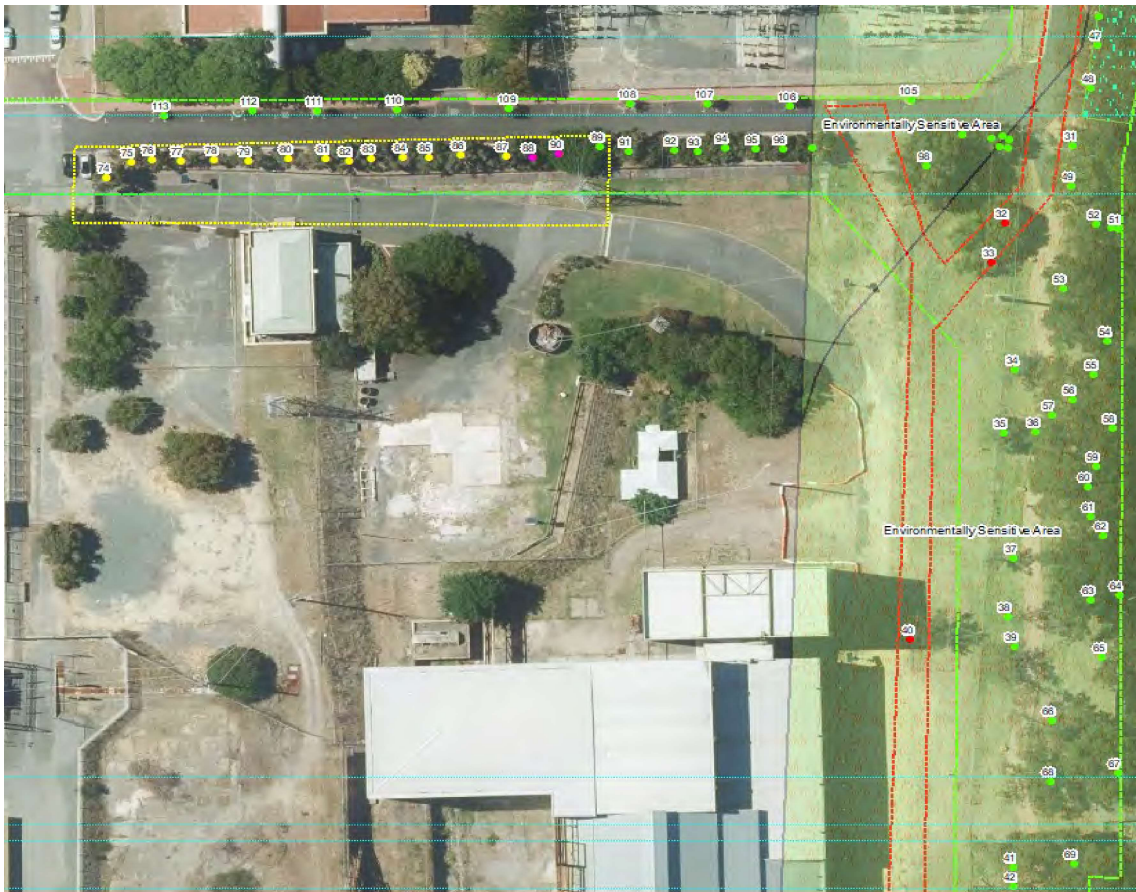
Figure 4-6 Central Area

The Central Area is Bordered to the North by the Northern Area and Western Power Sub Station, South by the South Eastern Area and EPPS, West by the Western Area and East by the Swan River. A more detailed map can be found at **Appendix D Fig 1.3**.

The Survey area for this zone incorporated both the North and South sides of Summers St and also the Eastern side of Summers St once it heads North. The Swan River Buffer vegetation was audited right to the edge of the river between an area 50m North up Summers St and down to the existing jetty near Survey ID 67. The remaining surveys were conducted on the scattered vegetation throughout the shire managed foreshore outside the direct Swan River buffer zone.

The Survey area running North/South along the Swan River was predominately made up of remnant and planted native vegetation (*Eucalyptus sp*, *Casuarina sp*, *Acasia sp*). The section of fenced area just North of the Summer St corner has been revegetated and contains larger established Eucalypts and Casuarinas, with also a large population of smaller native shrubs including; *Melaleuca armillaris*, *Acasia pulchella* (*Prickely Moses*) and *Melaleuca alternifolia* (*Tea Tree*).

The area running East and West along Summers St, was void of remnant vegetation and had been shire planted with predominately *Melaleuca quinquenervia* (*Broad Leafed Paperbark*) and *Lophostemon confertus* (*Box Tree*). There was a small area within the NE corner of EPPS where there were some self-seeded native species of Casuarina and Eucalypts at their sapling stage.

On review of predicted works to this area, the main impact would occur to the central part of this zone. There are proposed Western Power and ATCO ground works throughout the North and East of the EPPS compound. The new proposed 132kV underground line is intended to travel South down Summers St and then enter the EPPS compound in the NE corner. The two cleared areas are to be utilised to minimise the effect on the surrounding vegetation. The below table (**Table 4-5**) outlines the possible impact the Western Power works will have to individual vegetation within this area.

From review of the ATCO proposed PRS relocation and alteration works, the new HP gas pipeline being installed at the Northern boundary of the EPPS may impact on some of the existing vegetation surveyed. The plan shows that the groundwork will be carried out in a section of cleared land North within the EPPS compound directly South on an existing line of planted *Melaleuca quinquenervia* (*Broad Leafed Paperbark*) trees. Between the survey 74 – 87 the works will be conducted via horizontal boring at a depth of 900mm, there may be some affect to the root structure but these trees are expected to survive. Trees located at survey locations 88 and 90 will be directly affected by ground works and may need to be removed. The tables below (**Table 4-6 and Table 4-7**) outline which surveyed vegetation has the potential to be impacted by the proposed ATCO gas works:

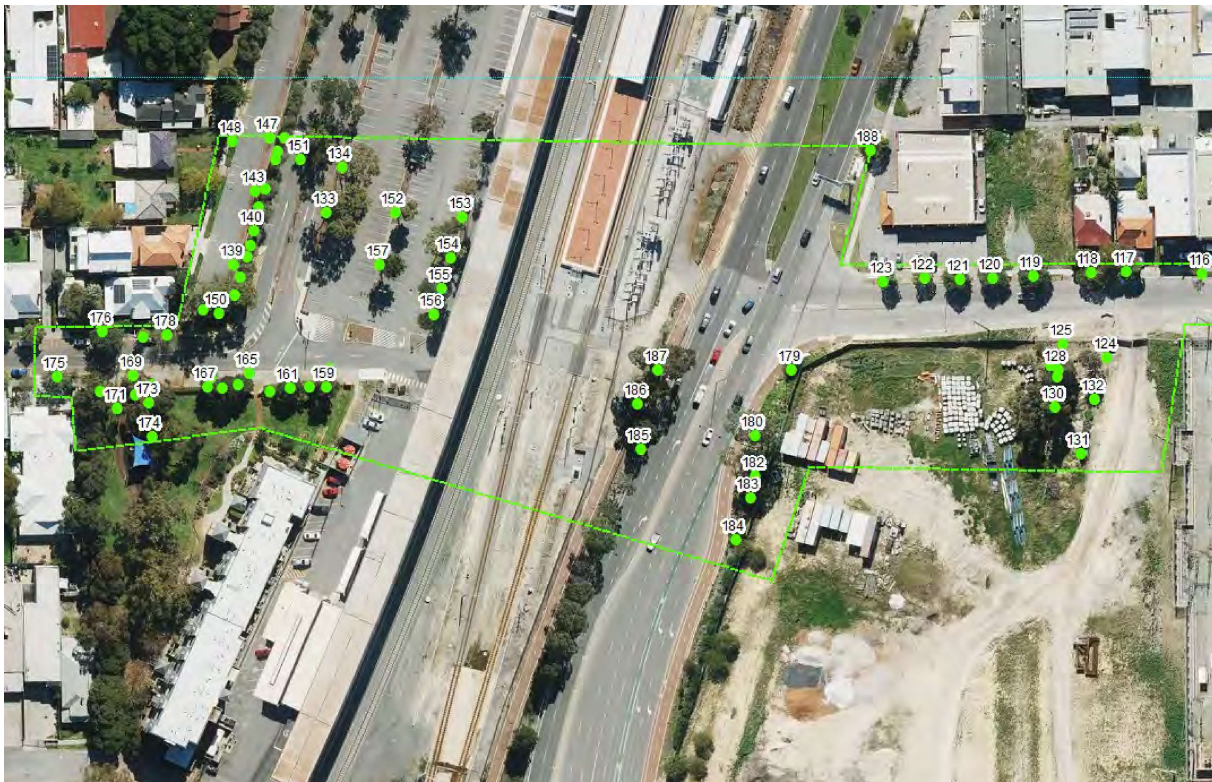
Figure 4-8 Western Area

The Western Area is the largest of the 5 zones and runs the remainder of Summers St on the Eastern boundary, crosses East Parade and continues down Summers St and concludes adjacent to Norwood Park on the West. This area encompasses around 5000m² of the East Perth Train Station carpark to the North and ceases at the TransWA coach depot to the South. A more detailed map can be viewed in **Appendix F Figure 1.5**.

This area was predominately populated with shire planted non-endemic and endemic WA species such as *Angophora costata* (Smooth Barked Apple) and *Melaleuca viminalis* (Weeping Bottlebrush). Remnant *Eucalyptus camaldulensis* (River Gum) were identified scattered throughout the shire areas. Summers St on the East contained planted *Lophostemon confertus* (Box Tree) along its Northern border. Additional Species were identified throughout the area and can be viewed in **Appendix I**.

Currently there is no planned Western Power work occurring in this area. No Impact predicted.

Currently there is no planned ATCO works within the Western area. No Impact predicted.

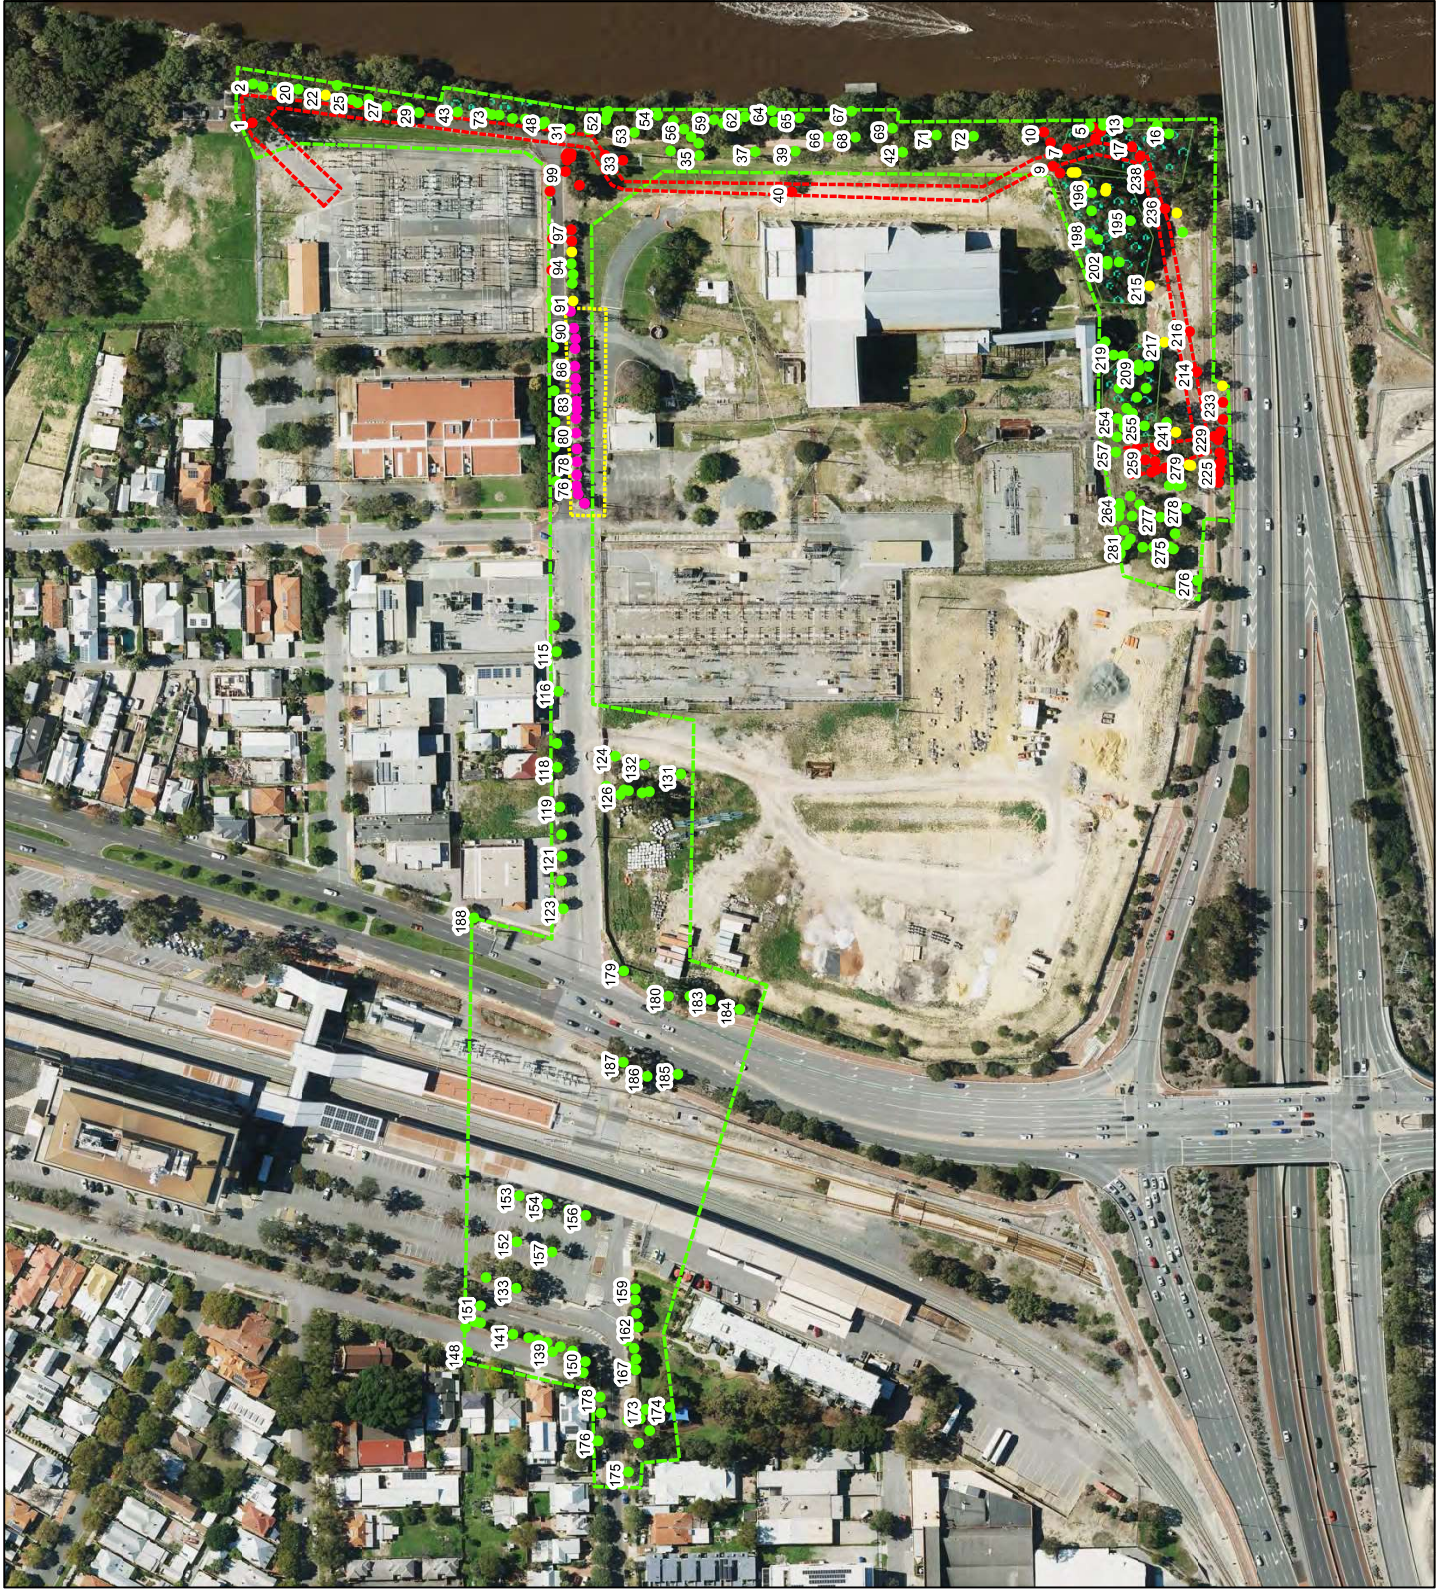
Figure 1 – Vegetation Survey Locations

Cardno was engaged by Development WA (“the Client”) to conduct a vegetation condition survey (“the assessment”) of an area of land labelled as Veg Survey Area. This area contains several land parcels with multiple owners (“the Site”) and presented in **Figure 1, Appendix A**.

The scope and methodology for the vegetation mapping was generally conducted in accordance as detailed in **Table 3-1**. The assessment locations are presented in **Figure 1, Appendix A**.
