December 20, 2024

**RE: Initial assessment of trees in area for potential facility; Potters Gorge Wellington
Dam National Park**

4. Summary of Key Findings

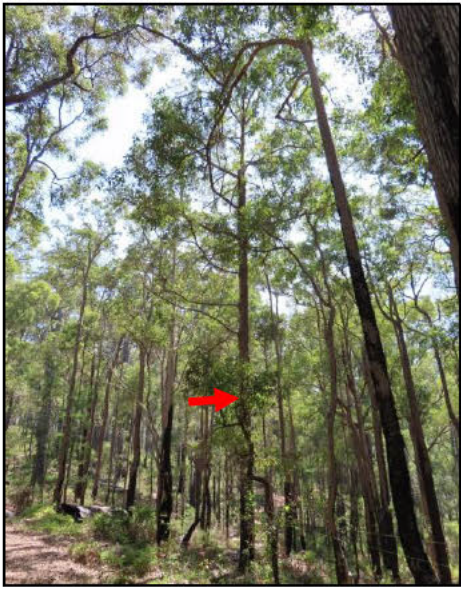
Good tree. Canopy slightly sparse. Remaining leaf still good condition. Leggy form	Suitable, but lower half only
647	Yellow/ Blue C3	Marri (<i>Corymbia calophylla</i>)	23	49	Good	Good

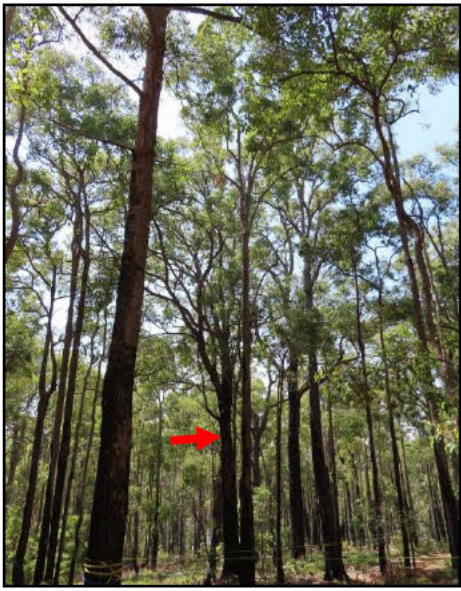
Good tree. Canopy slightly sparse. Remaining leaf still good condition. Leggy form	Suitable, but lower half only
648	Yellow C4	Jarrah (<i>Eucalyptus marginata</i>)	27	67	Good	Acceptable

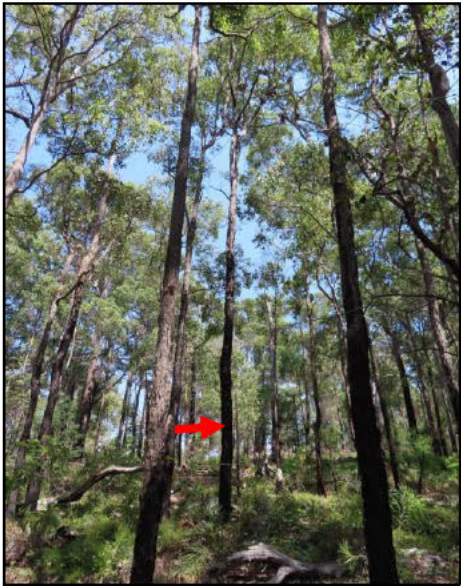
Ok smaller tree. Leggy form	Just suitable; lower quarter only though
654	Yellow C7	Jarrah (<i>Eucalyptus marginata</i>)	12	26	Good	Acceptable

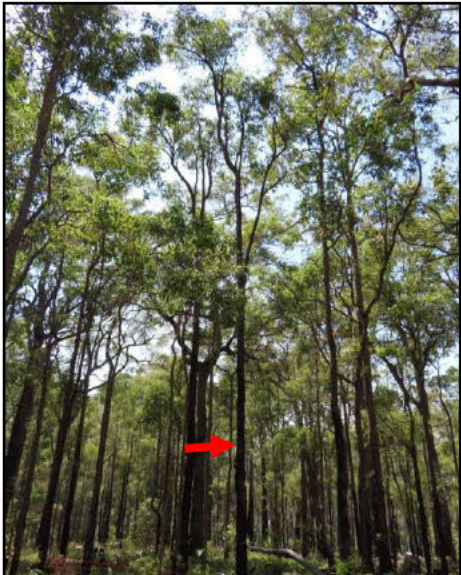
Ok smaller tree. Leggy form	Just suitable; lower quarter only though

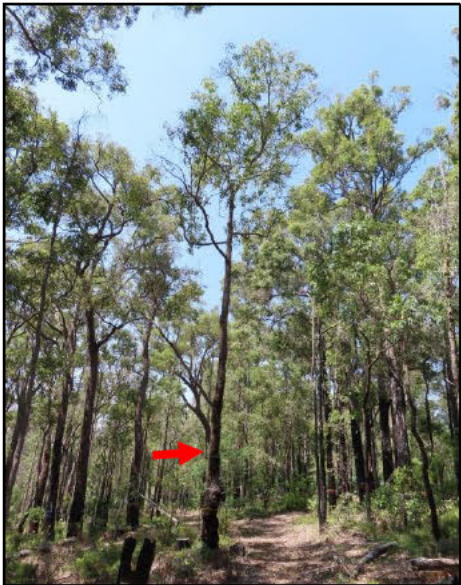
Ok tree. Canopy slightly sparse. Remaining leaf still good condition	Just suitable; lower quarter only though
657	Yellow C5	Marri (<i>Corymbia calophylla</i>)	18	37	Fair	Good

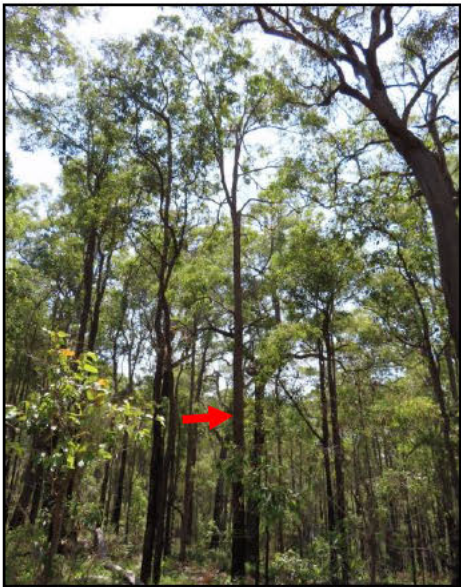
Ok tree. Canopy slightly sparse. Remaining leaf still good condition	Suitable, but lower third only
658	Blue G6	Jarrah (<i>Eucalyptus marginata</i>)	23	64	Good	Good

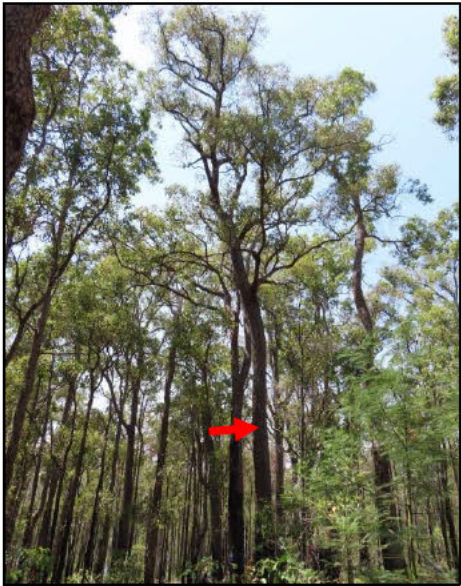
Large mature tree. Canopy slightly sparse. Remaining leaf still good condition. Area of decay lower main stem but not of any major concerns at this time	Suitable, but lower half only

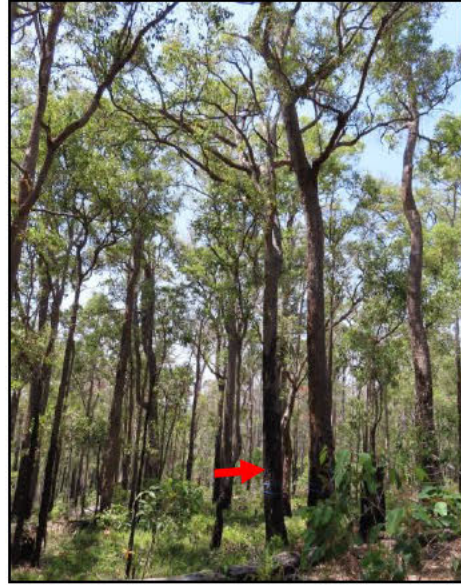
Large mature tree. Canopy slightly sparse. Remaining leaf still good condition. Effectively forms the one canopy with the adjacent tree	Suitable, but lower half only

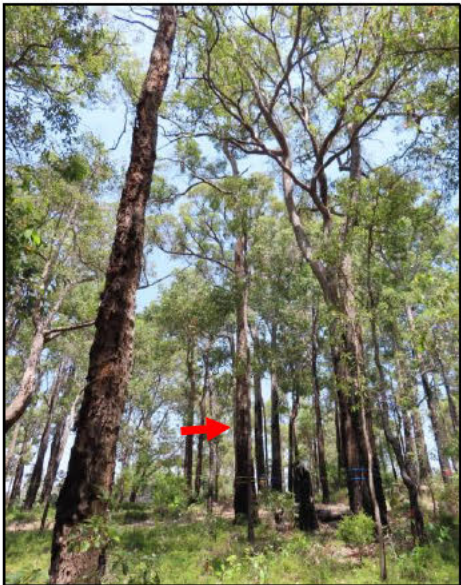
Large mature tree. Canopy slightly sparse. Remaining leaf still good condition. Leggy from with no lower canopy	Suitable, but lower half only
661	Red D9	Jarrah (<i>Eucalyptus marginata</i>)	14	28	Good	Good

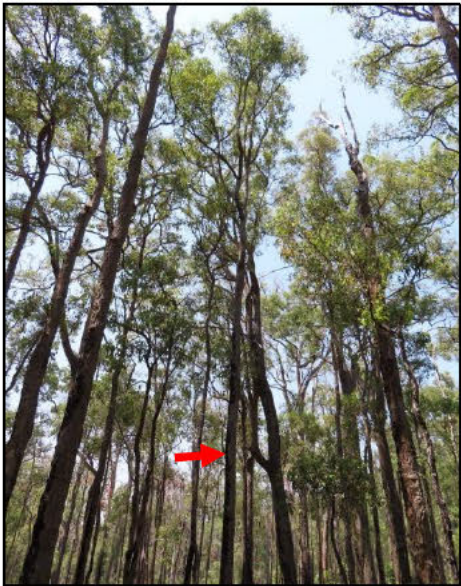
Ok tree. Leggy from with no lower canopy	Just suitable, but lower third only
662	Red D8	Jarrah (<i>Eucalyptus marginata</i>)	22	58	Good	Questionable

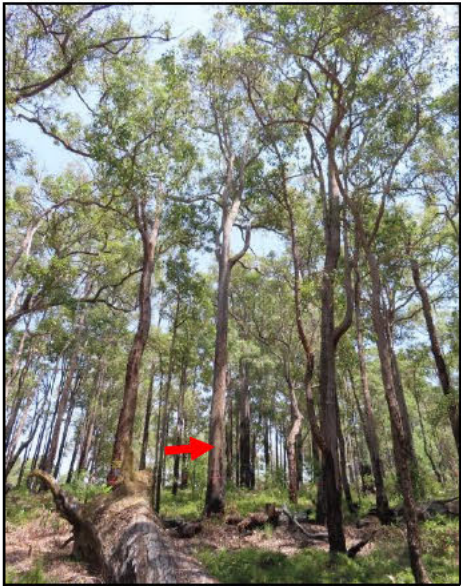
Large mature tree	Suitable; up to around half of its height

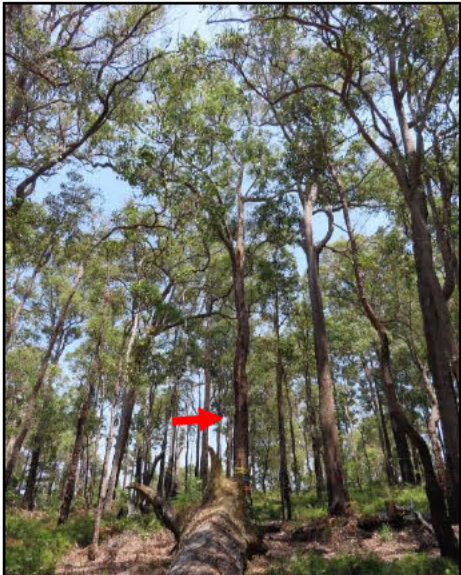
Large mature tree. Canopy slightly sparse. Remaining leaf still good condition	Suitable; up to around half of its height

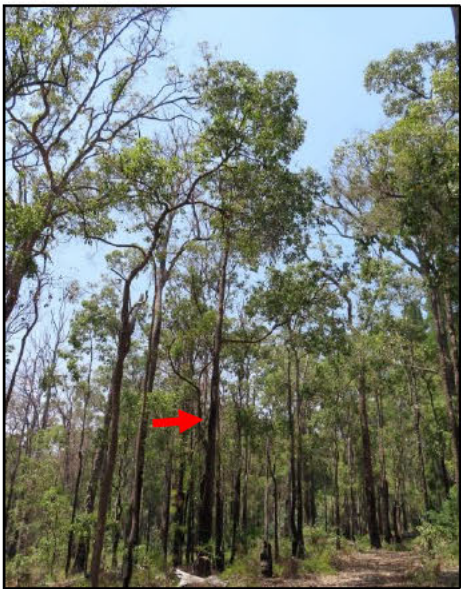
Good smaller tree	Suitable, but lower quarter only
666	Red H5	Marri (<i>Corymbia calophylla</i>)	20	40	Fair	Questionable

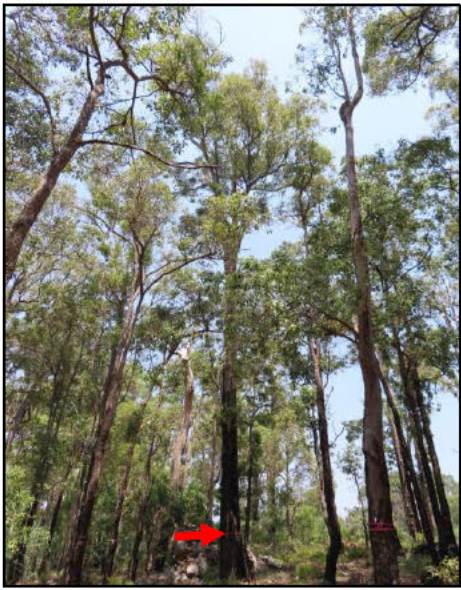
Large mature tree. Good tree. Area of decay lower main stem but not of any major concerns at this time	Suitable; up to around half of its height
668	Red H3	Jarrah (<i>Eucalyptus marginata</i>)	15	45	Good	Good

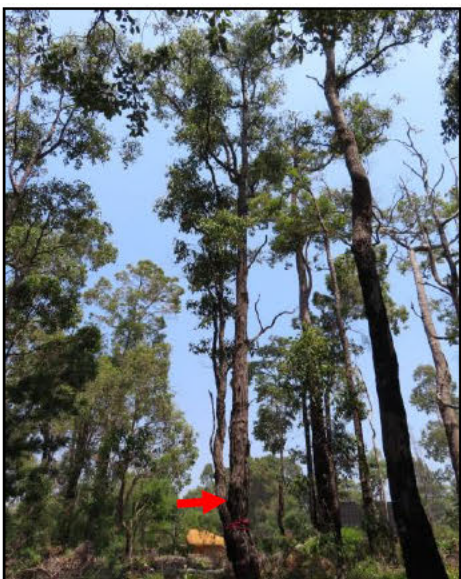
Good tree. Area of decay lower main stem but not of any major concerns at this time	Suitable, but lower third only

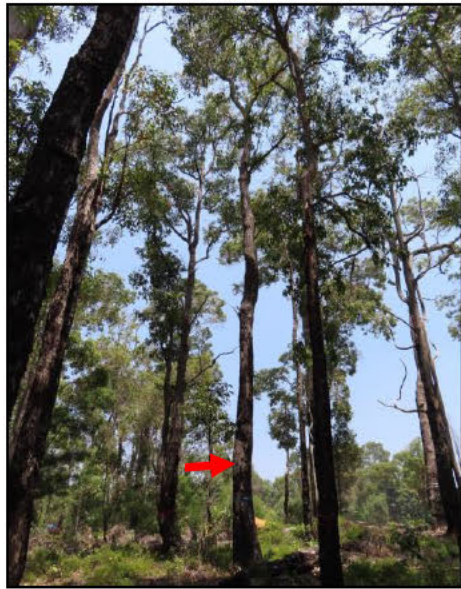
Good tree. Canopy slightly sparse. Remaining leaf still good condition	Suitable, but lower half only
670	Red H6	Marri (<i>Corymbia calophylla</i>)	15	28	Good	Good

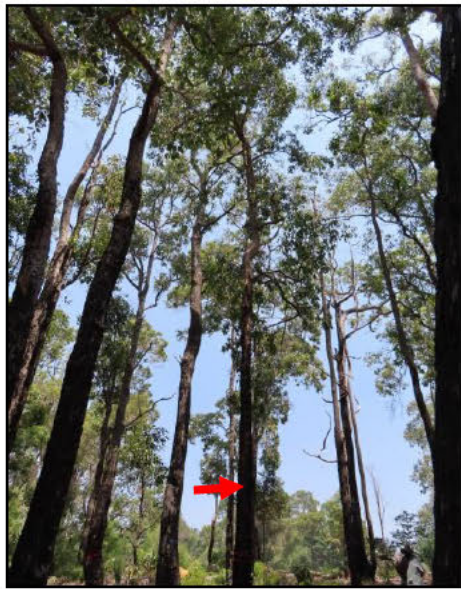
Good tree. Area of decay lower main stem but not of any major concerns at this time	Suitable, but lower third only
671	Red H7	Jarrah (<i>Eucalyptus marginata</i>)	18	41	Fair	Good

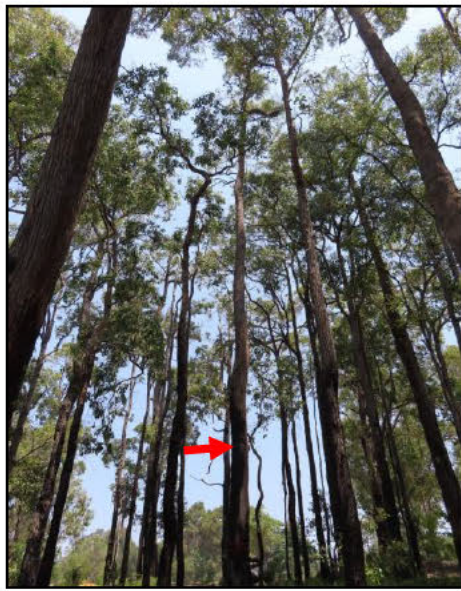
Ok tree. Very leggy form with no lower canopy. Canopy slightly sparse. Remaining leaf still good condition	Suitable, but lower third only
672	Blue/ Yellow D5	Marri (<i>Corymbia calophylla</i>)	22	59	Good	Good

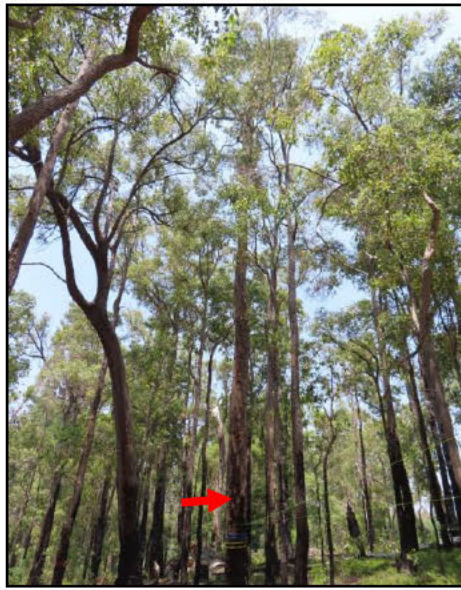
Large mature tree	Suitable, but lower half only
673	Blue/ Yellow D6	Marri (<i>Corymbia calophylla</i>)	24	62	Good	Good

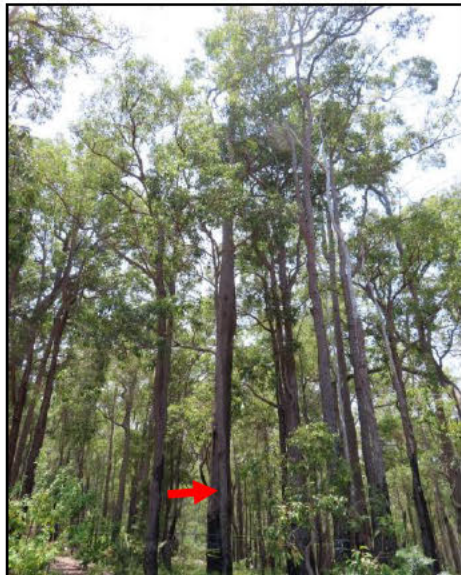
Large mature tree	Suitable; up to around half of its height

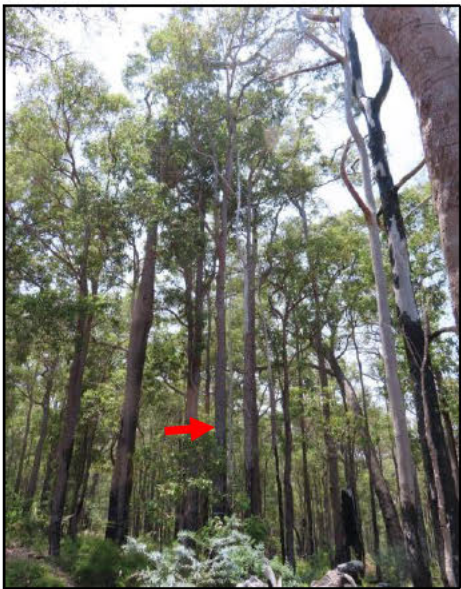
Ok tree. Very leggy form with no lower canopy	Suitable, but lower half only
675	White F3	Marri (<i>Corymbia calophylla</i>)	21	65	Fair	Questionable

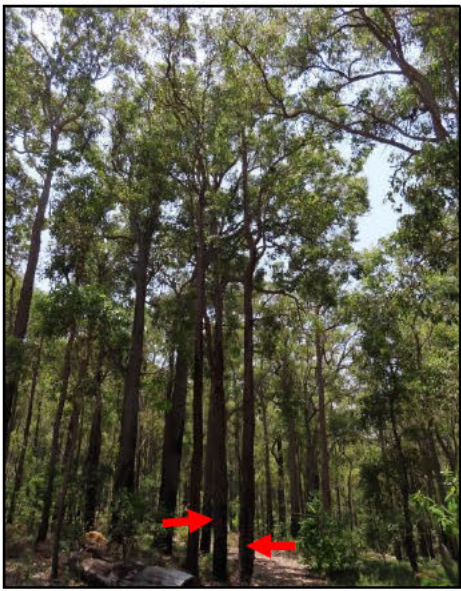
Good tree. Might be two trees but equally may be the same tree	Suitable, but lower quarter only
677	Red/ Blue/ Yellow D1	Jarrah (<i>Eucalyptus marginata</i>)	20	64	Good	Acceptable

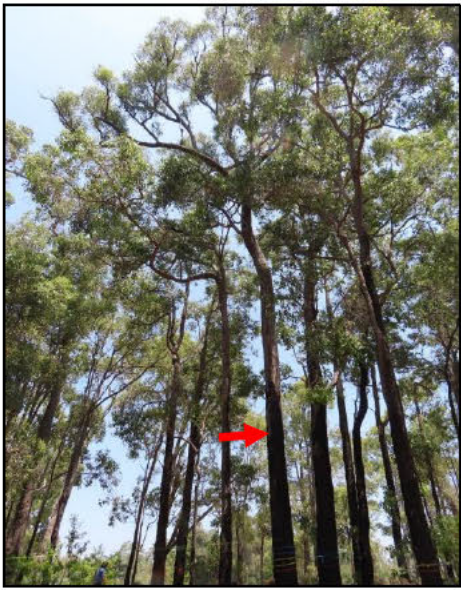
Large mature tree. Good tree. Effectively forms the one canopy with the adjacent tree	Suitable; up to around half of its height

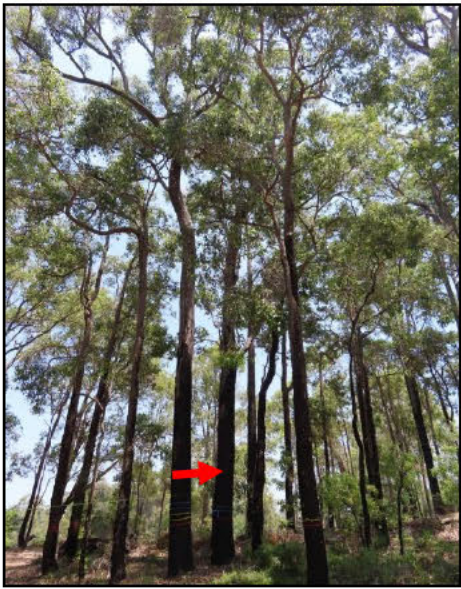
Large mature tree. Good tree. Effectively forms the one canopy with the adjacent tree	Suitable; up to around half of its height

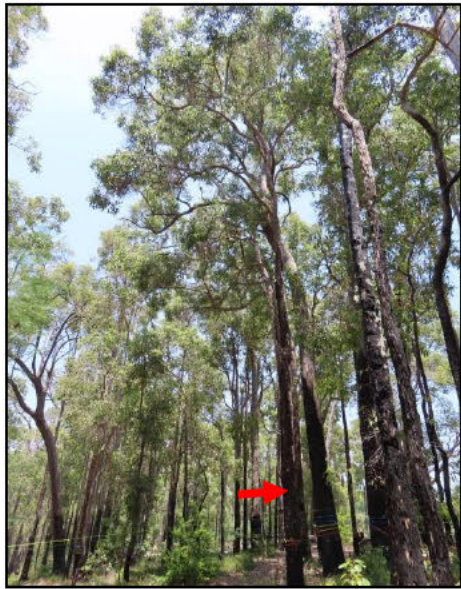
Good tree	Suitable; up to around half of its height
680	Red/ Yellow B6	Jarrah (<i>Eucalyptus marginata</i>)	22	57	Good	Acceptable

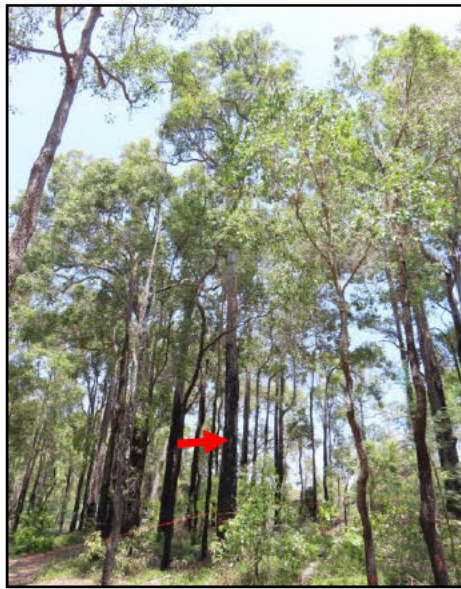
Large mature tree. Good tree. Area of decay lower main stem but not of any major concerns at this time	Suitable; up to around half of its height
681	White I1	Marri (<i>Corymbia calophylla</i>)	9	17	Good	Acceptable

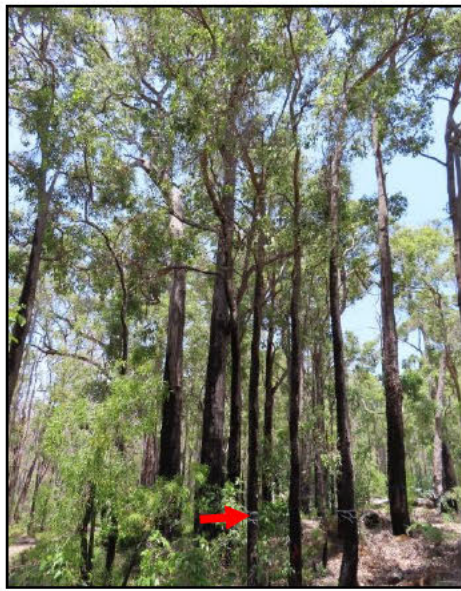
Ok smaller tree	Just suitable, but lower quarter only
682	White I2	Marri (<i>Corymbia calophylla</i>)	11	21	Good	Acceptable

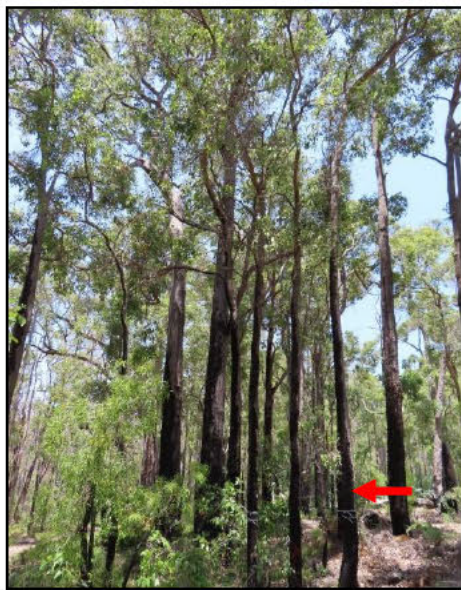
Ok smaller tree	Suitable, but lower quarter only
683	Blue E3A	Marri (<i>Corymbia calophylla</i>)	20	44	Good	Good

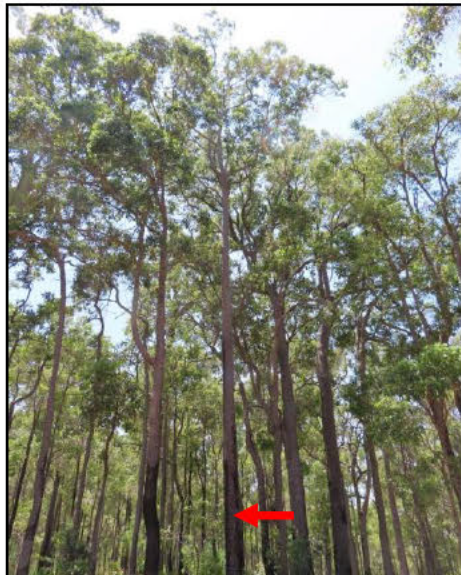
Good tree. Leggy form with no lower canopy	Suitable, but lower quarter only

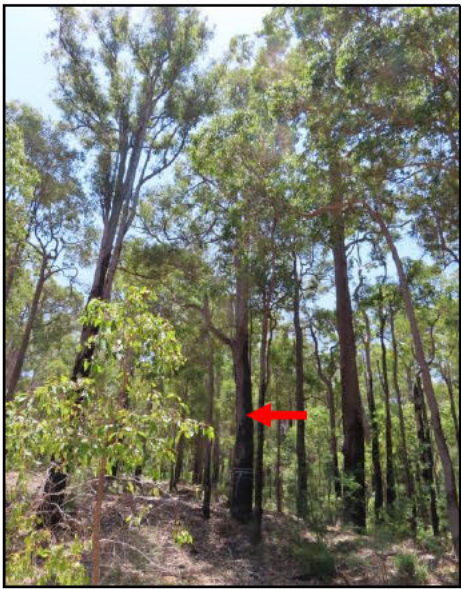
Large mature tree. Good tree	Suitable; up to 2/3rd height
686	Blue/ White F2	Jarrah (<i>Eucalyptus marginata</i>)	24	58	Good	Good

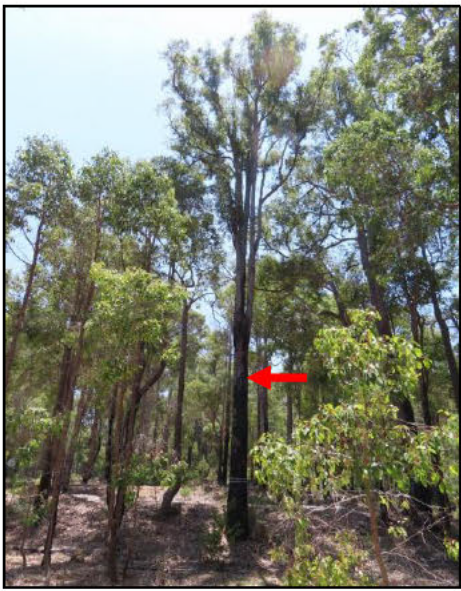
Large mature tree. Good tree	Suitable, but lower half only
687	Green G8	Marri (<i>Corymbia calophylla</i>)	12	25	Good	Good

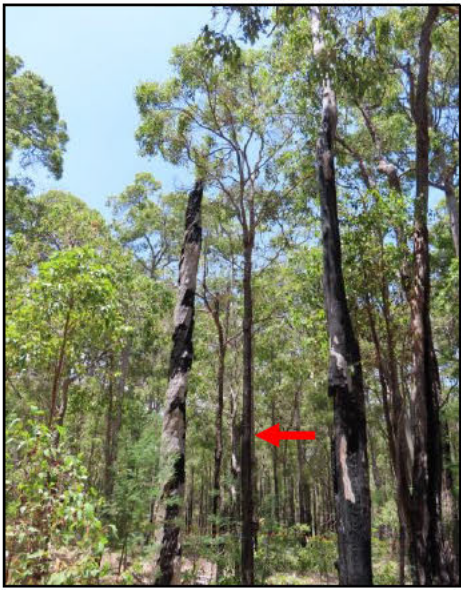
Good smaller tree	Suitable, but lower quarter only
688	Blue A17	Jarrah (<i>Eucalyptus marginata</i>)	23	59	Good	Good

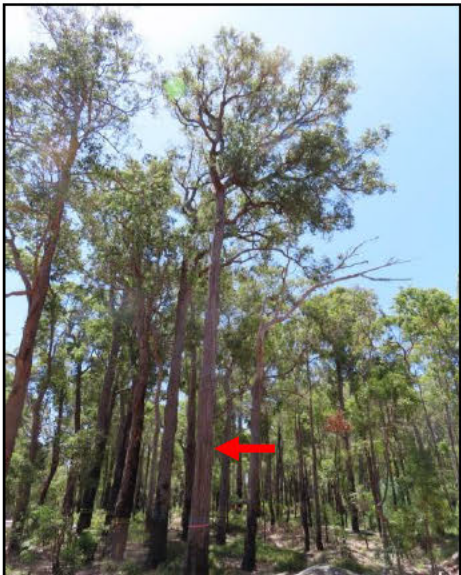
Large mature tree. Good tree	Suitable; up to 2/3rd height

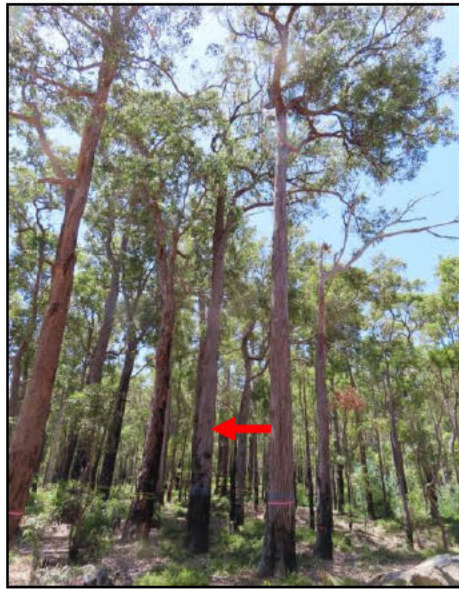
Large mature tree. Good tree. Canopy slightly sparse. Remaining leaf still good condition	Suitable; up to 2/3rd height
690	Yellow A15	Marri (<i>Corymbia calophylla</i>)	22	66	Good	Good

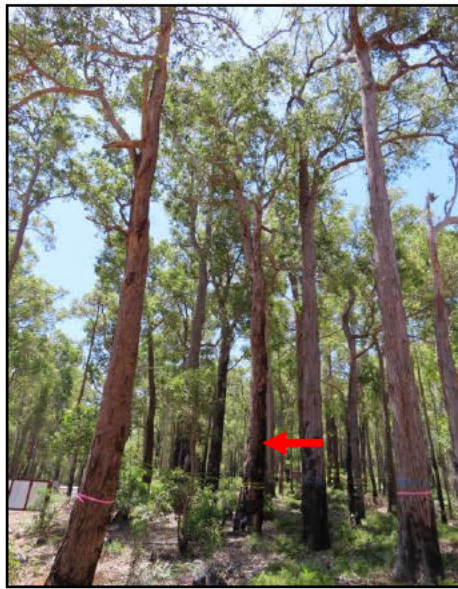
Large mature tree. Good tree. Area of decay lower main stem but not of any major concerns at this time	Suitable; up to 2/3rd height
691	Yellow A14	Jarrah (<i>Eucalyptus marginata</i>)	16	39	Good	Good

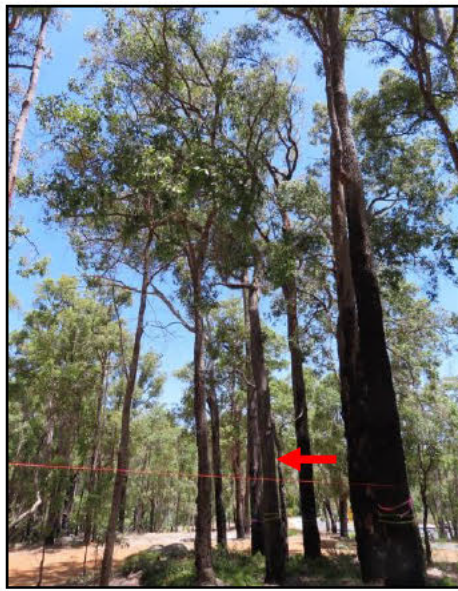
Good tree	Suitable, but lower half only
692	Yellow A12	Jarrah (<i>Eucalyptus marginata</i>)	28	60	Good	Good

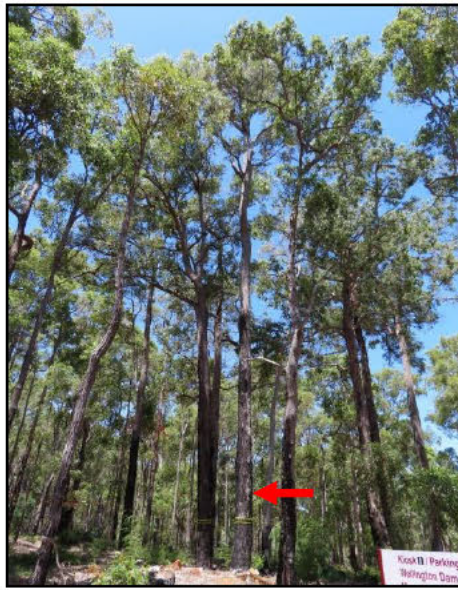
Large mature tree. Good tree. Effectively forms the one canopy with the adjacent tree	Suitable; up to around half of its height
693	Yellow A13	Jarrah (<i>Eucalyptus marginata</i>)	26	52	Good	Good

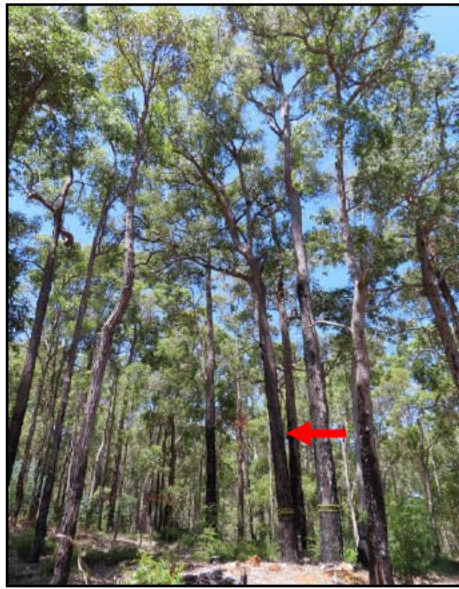
Large mature tree. Good tree. Effectively forms the one canopy with the adjacent tree	Suitable; up to around half of its height

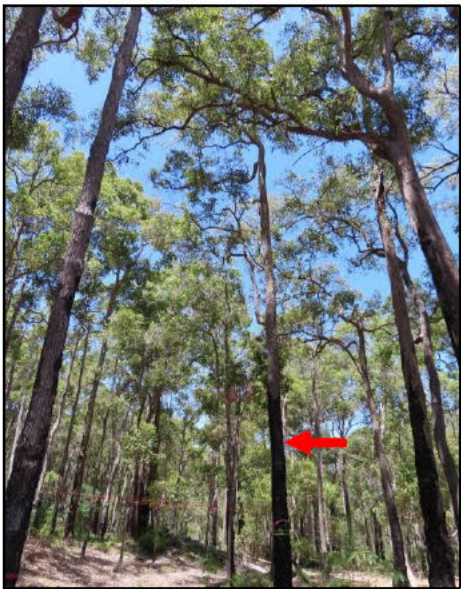
Large mature tree. Good tree. Leggy canopy form	Suitable, but lower half only
695	Red A11	Jarrah (<i>Eucalyptus marginata</i>)	15	22	Good	Good

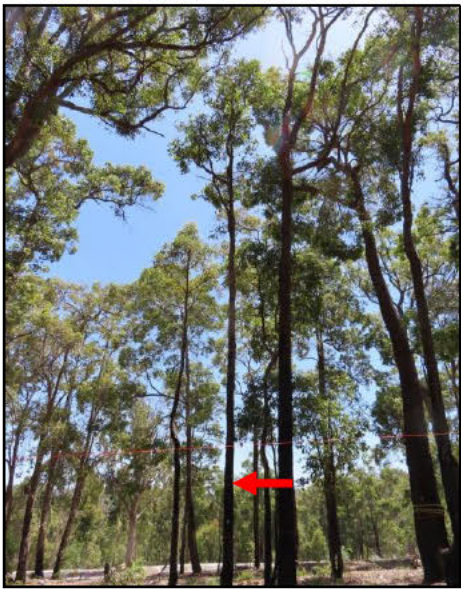
Ok smaller tree. Leggy canopy form	Suitable, but lower quarter only
696	Red A10	Jarrah (<i>Eucalyptus marginata</i>)	20	34	Good	Good

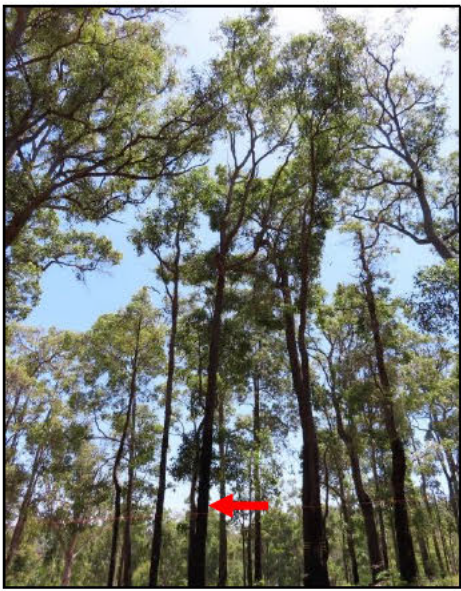
Ok smaller tree. Leggy canopy form	Suitable, but lower quarter only
697	Red/ Yellow A6	Marri (<i>Corymbia calophylla</i>)	21	69	Fair	Good

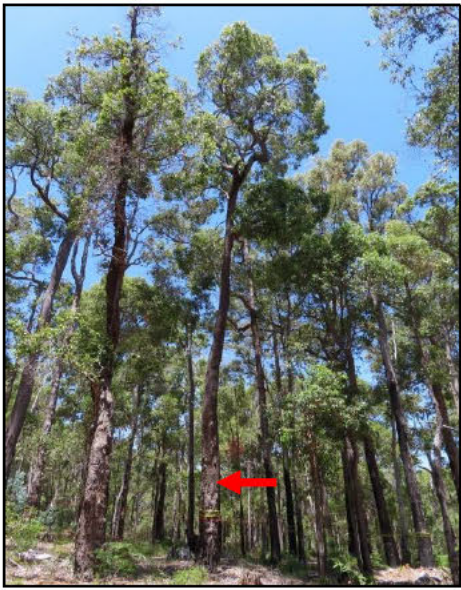
Large mature tree. Canopy slightly sparse. Remaining leaf still good condition. Some larger deadwood in its canopy	Suitable, but lower third only
698	Red A9	Jarrah (<i>Eucalyptus marginata</i>)	23	59	Good	Good

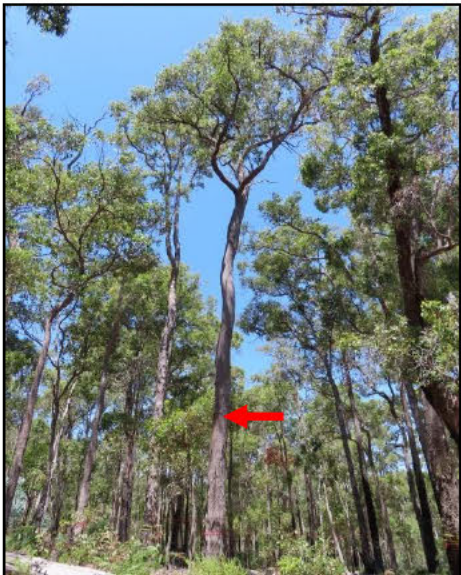
Large mature tree. Leggy form with no lower branch structures	Suitable; up to around half of its height

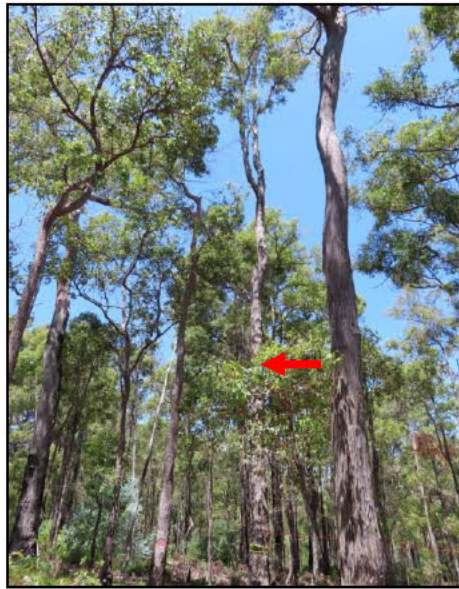
Tree Tag #	Tape Ref	Species	Approx. Height (metres)	DBH (cm)	Health	Structure	Image	Comments	Suitability
699	Yellow A5	Jarrah (<i>Eucalyptus marginata</i>)	23	52	Fair	Good

Large mature tree. Canopy slightly sparse. Remaining leaf still good condition. Leggy form with no lower branch structures	Suitable; up to around half of its height
700	Red A8	Marri (<i>Corymbia calophylla</i>)	14	37	Fair	Good

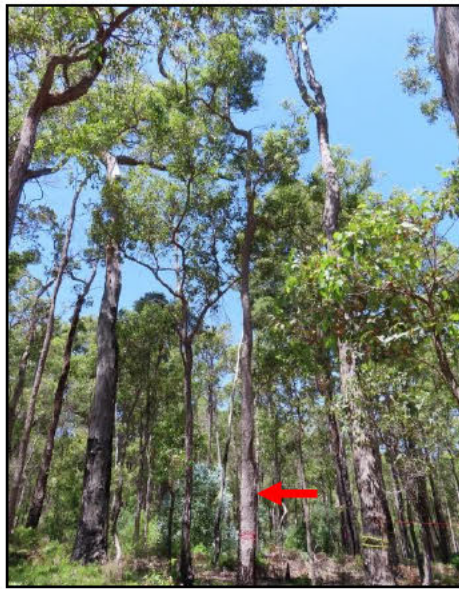
Ok tree. Canopy slightly sparse. Remaining leaf still good condition. Leggy form with no lower branch structures	Suitable, but lower third only
840	Yellow A4	Marri (<i>Corymbia calophylla</i>)	14	30	Good	Good

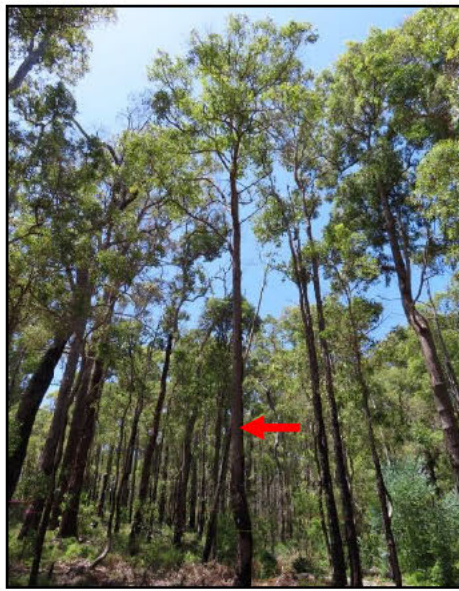
Ok tree. Canopy slightly sparse. Remaining leaf still good condition. Leggy form with no lower branch structures	Suitable, but lower third only
841	Yellow A3	Jarrah (<i>Eucalyptus marginata</i>)	23	50	Good	Good

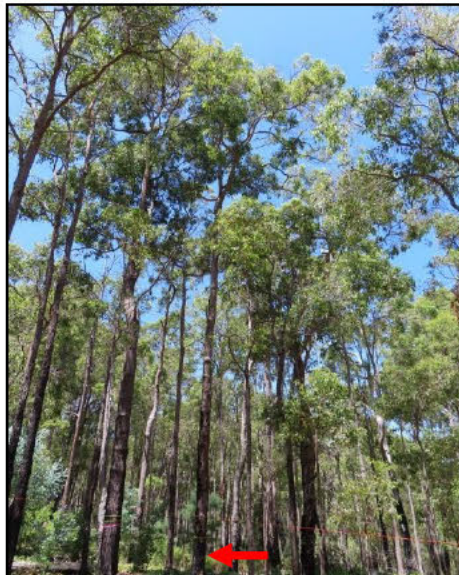
842	Yellow A2	Marri (<i>Corymbia calophylla</i>)	16	39	Good	Good

Good tree. Leggy form with no lower branch structures. Effectively forms the one canopy with the adjacent tree	Suitable, but lower third only

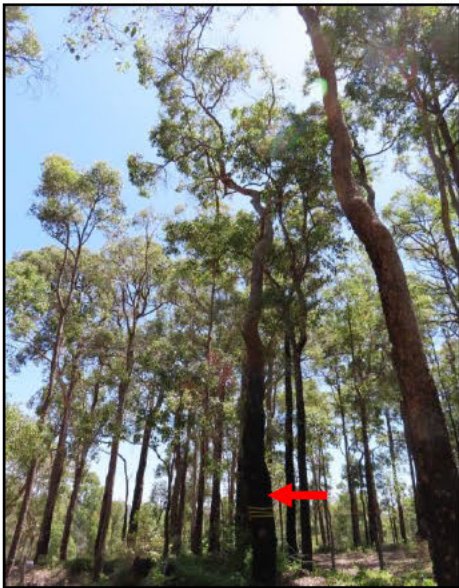
Tree Tag #	Tape Ref	Species	Approx. Height (metres)	DBH (cm)	Health	Structure	Image	Comments	Suitability
843	Yellow A1	Marri (<i>Corymbia calophylla</i>)	15	46	Fair	Good

Ok tree. Canopy slightly sparse. Remaining leaf still good condition	Suitable, but lower third only
844	Green A18	Jarrah (<i>Eucalyptus marginata</i>)	13	21	Good	Good	 	Good smaller tree. Leggy form	Suitable, but lower quarter only
