Tree Protection Plan (TPP) and Tree Protection Specifications (TPS)

Prepared for Christopher & Jessica Coles
95 Paini Way, Jandabup WA 6077
City of Wanneroo

Prepared by Rowan Barkey – Consulting Arborist (AQF Level 5, *Dip. Arboriculture*)
Sorbus Arbor Consulting | ABN 98 356 184 454
Date: 13 November 2025

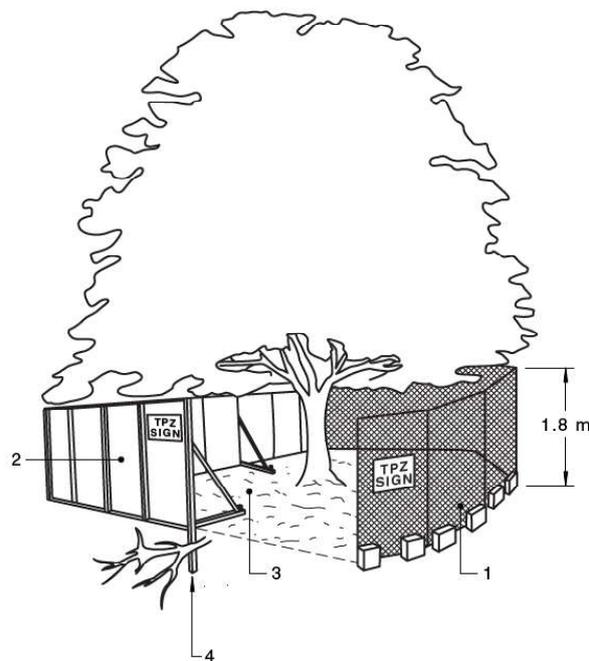
Figure 4 — Protective fences

Figure 4 indicates an example of protective fences.

Signs identifying the TPZ should be placed around the edge of the TPZ and be visible from within the development site, as shown in Figure 4. The lettering on the sign should conform to AS 1319. Appendix C provides an example of a suitable TPZ sign.
