Arboricultural Report - Balcatta Recycling Centre

December 13, 2024
Total Tree Count:
145

Brief

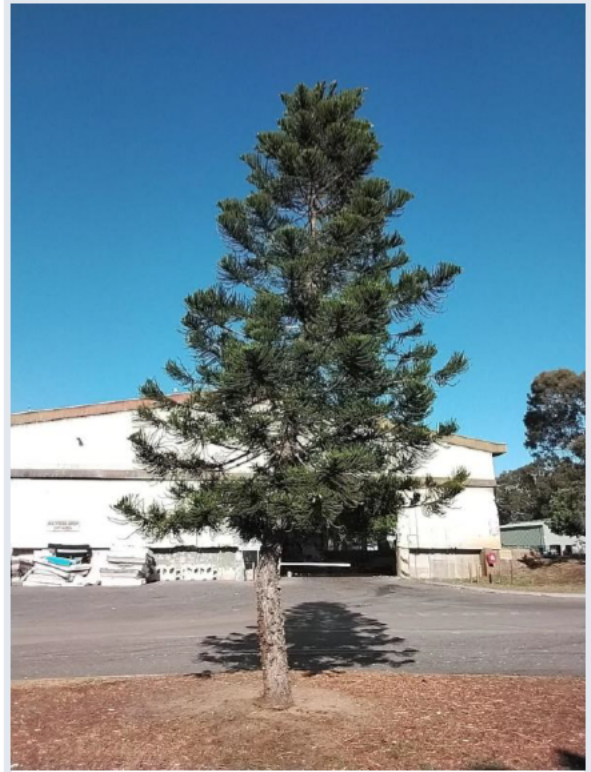
Norfolk Island Pine Tree ID #4

Latin Name:	Araucaria heterophylla
Latitude:	-31.864081163955
Longitude:	115.8190912088
Tree Height (Estimated) [m]:	7.3
Canopy Spread [m]:	3
DBH [cm]:	27
Health:	Good
Structure:	Good
Problems:	
Notes:	
Priority:	None
Tree Work:	No Works
Observation Comments:	Slight bend in trunk
Tree Protection Zone (TPZ) [m]:	3.24
Structural Root Zone (SRZ) [m]:	2.05
Useful Life Expectancy:	40+ years
Retention Value:	High
Risk of Harm Number:	Not applicable

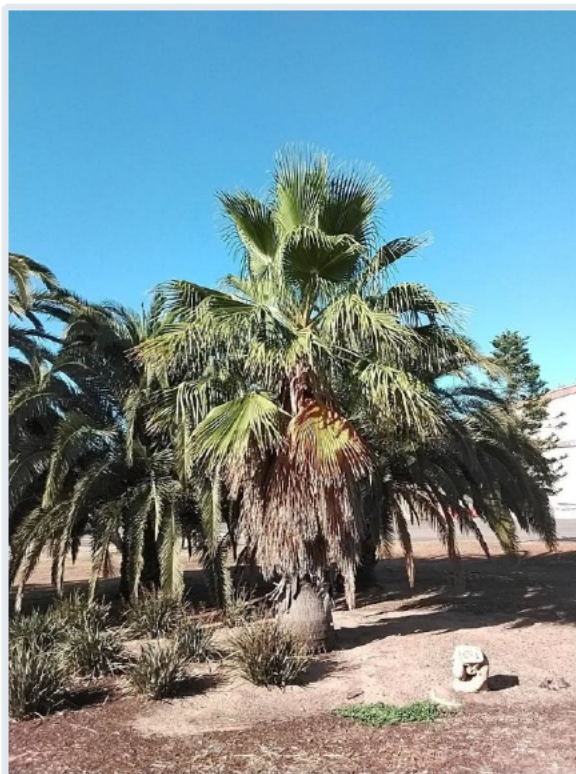
Thread Palm, Fan Palm Tree ID #5

Health: Good

Structure: Good

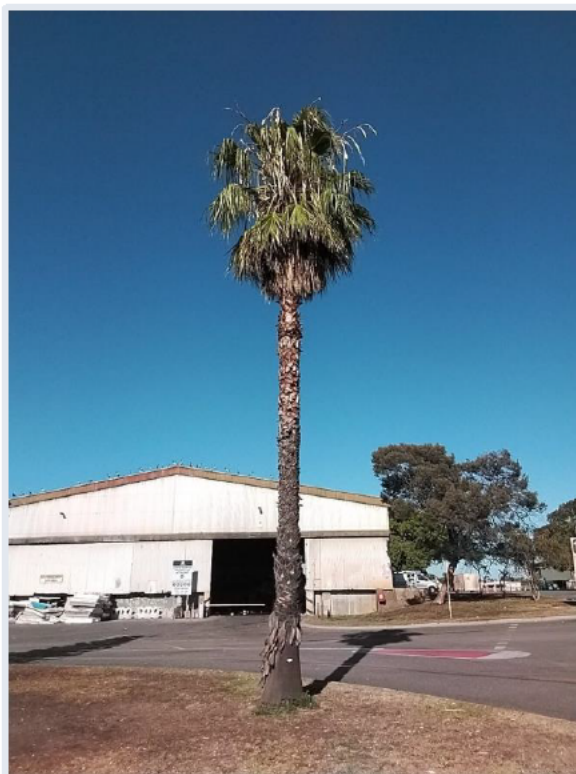
Thread Palm, Fan Palm Tree ID #6

Health: Fair

Structure: Good

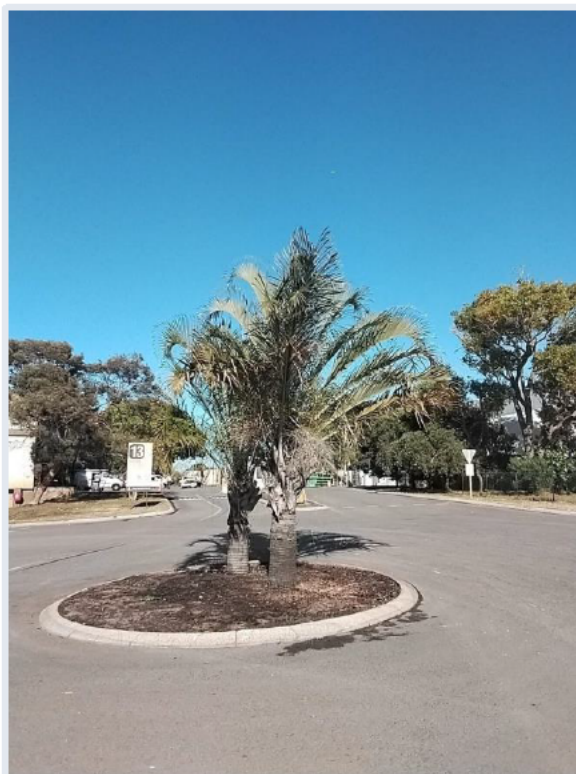
Triangle Palm Tree ID #7

Latin Name:	Dypsis decaryi
Latitude:	-31.863808485994
Longitude:	115.81920401792
Tree Height (Estimated) [m]:	4.6
Canopy Spread [m]:	4
DBH [cm]:	41
Health:	Fair
Structure:	Good
Problems:	
Notes:	
Priority:	None
Tree Work:	No Works
Observation Comments:	
Tree Protection Zone (TPZ) [m]:	4.92
Structural Root Zone (SRZ) [m]:	2.32
Useful Life Expectancy:	40+ years
Retention Value:	High
Risk of Harm Number:	Not applicable

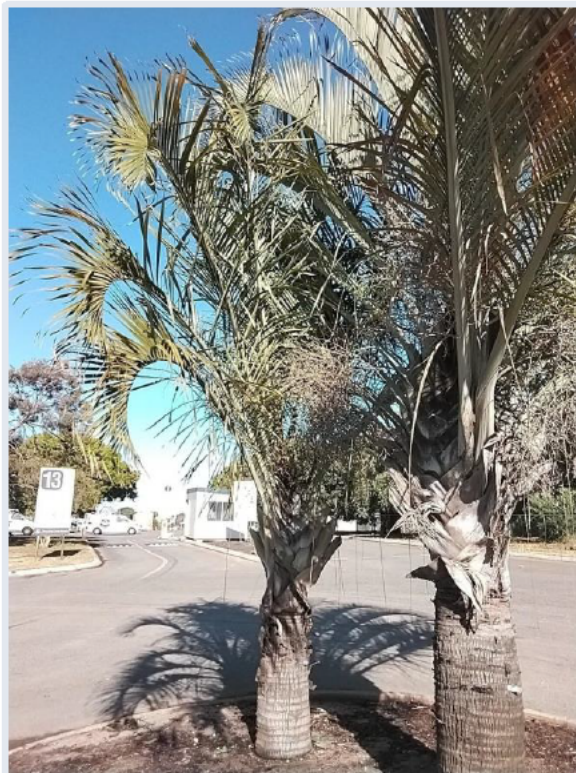
Triangle Palm Tree ID #8

Latin Name:	Dypsis decaryi
Latitude:	-31.863828285713
Longitude:	115.8191755418
Tree Height (Estimated) [m]:	4.1
Canopy Spread [m]:	3
DBH [cm]:	38
Health:	Fair
Structure:	Good
Problems:	
Notes:	
Priority:	None
Tree Work:	No Works
Observation Comments:	
Tree Protection Zone (TPZ) [m]:	4.56
Structural Root Zone (SRZ) [m]:	2.23
Useful Life Expectancy:	20-40 years
Retention Value:	High
Risk of Harm Number:	Not applicable

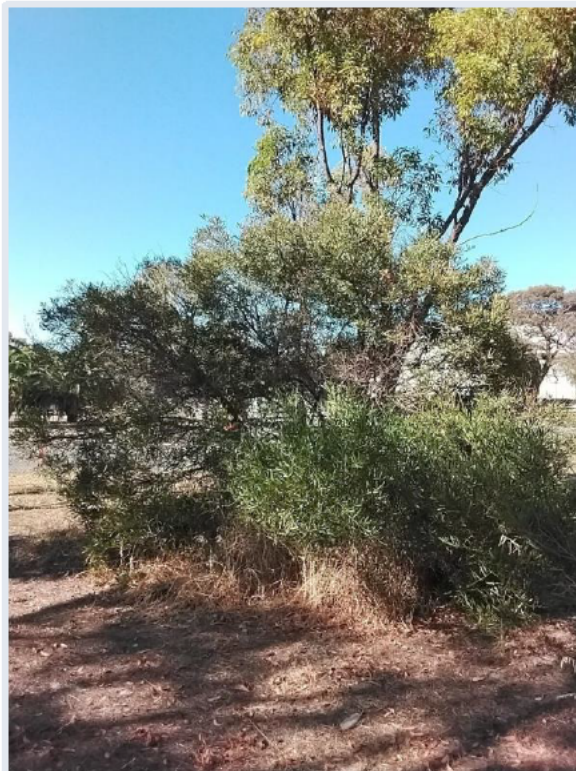
Latin Name:	Acacia longifolia
Latitude:	-31.863595737921
Longitude:	115.81925001767
Tree Height (Estimated) [m]:	5
Canopy Spread [m]:	7.5
DBH [cm]:	17.32
Health:	Good
Structure:	Poor
Problems:	Deadwood minor <50, Low Growth, Multi Crown leaders
Notes:	
Priority:	None
Tree Work:	No Works
Observation Comments:	
Tree Protection Zone (TPZ) [m]:	2.08
Structural Root Zone (SRZ) [m]:	2
Useful Life Expectancy:	6-10 years
Retention Value:	Medium
Risk of Harm Number:	Not applicable

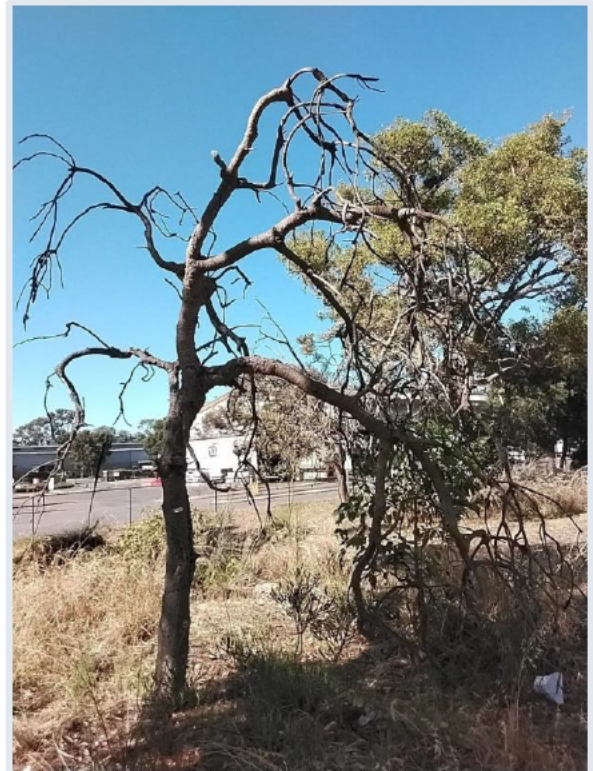
Latin Name:	Banksia species
Latitude:	-31.863539660545
Longitude:	115.81917335088
Tree Height (Estimated) [m]:	4.1
Canopy Spread [m]:	0
DBH [cm]:	19
Health:	Dead
Structure:	Fair
Problems:	Deadwood major >50
Notes:	
Priority:	Low
Tree Work:	Remove Tree
Observation Comments:	
Tree Protection Zone (TPZ) [m]:	2.28
Structural Root Zone (SRZ) [m]:	1.72
Useful Life Expectancy:	0 years
Retention Value:	Low
Risk of Harm Number:	Not applicable

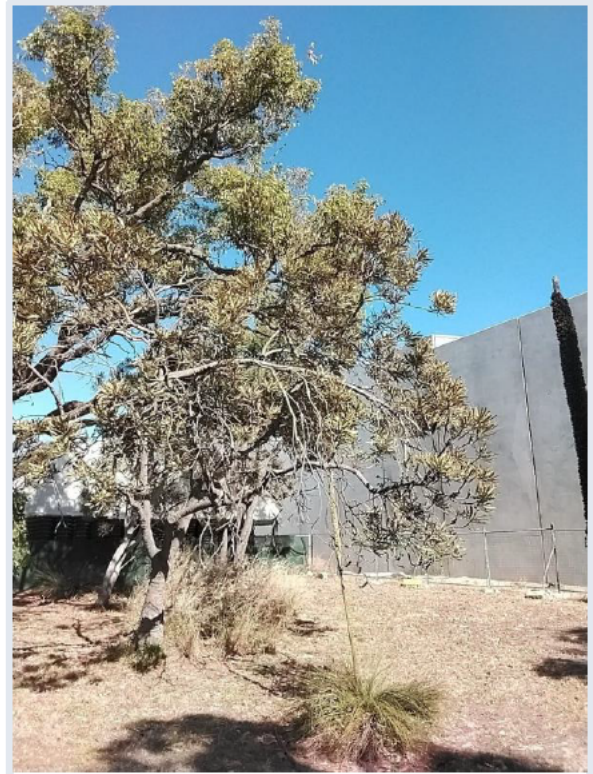
Silver Banksia Tree ID #22

Latin Name:	Banksia marginata
Latitude:	-31.863605969873
Longitude:	115.81908682729
Tree Height (Estimated) [m]:	6.7
Canopy Spread [m]:	6
DBH [cm]:	25
Health:	Fair
Structure:	Fair
Problems:	Deadwood minor <50, Multi Crown leaders
Notes:	
Priority:	None
Tree Work:	No Works
Observation Comments:	
Tree Protection Zone (TPZ) [m]:	3
Structural Root Zone (SRZ) [m]:	1.97
Useful Life Expectancy:	6-10 years
Retention Value:	High
Risk of Harm Number:	Not applicable

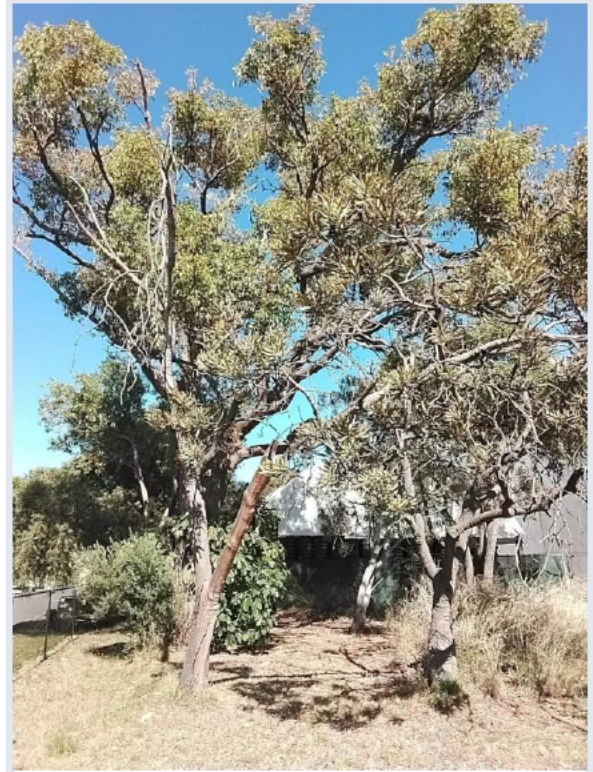
Banksia Tree ID #23

Latin Name:	Banksia species
Latitude:	-31.863649024433
Longitude:	115.81906820825
Tree Height (Estimated) [m]:	7
Canopy Spread [m]:	0
DBH [cm]:	34
Health:	Dead
Structure:	Fair
Problems:	Deadwood major >50
Notes:	
Priority:	Low
Tree Work:	Remove Tree
Observation Comments:	
Tree Protection Zone (TPZ) [m]:	4.08
Structural Root Zone (SRZ) [m]:	2.2
Useful Life Expectancy:	0 years
Retention Value:	Low
Risk of Harm Number:	Not applicable

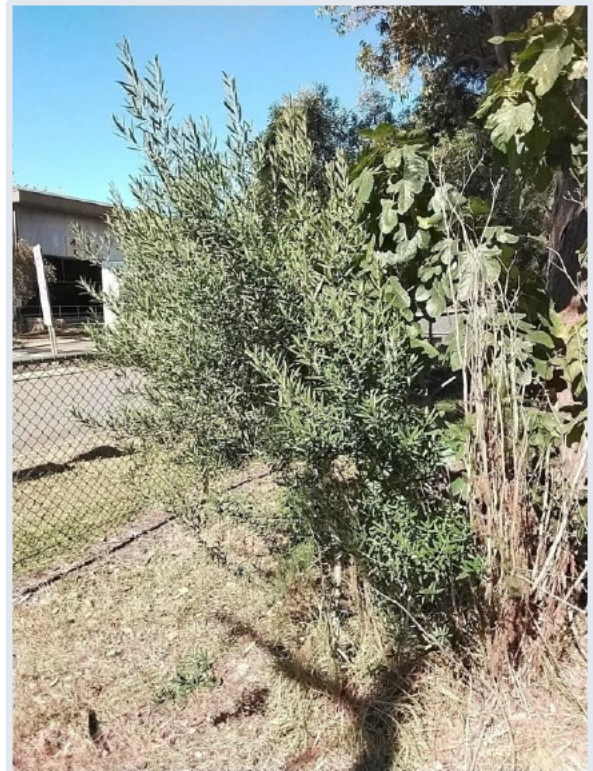
Olive tree Tree ID #25

Latin Name:	Olea europaea
Latitude:	-31.863648625703
Longitude:	115.81901344639
Tree Height (Estimated) [m]:	2
Canopy Spread [m]:	1.5
DBH [cm]:	8
Health:	Good
Structure:	Good
Problems:	Multi Crown leaders
Notes:	
Priority:	None
Tree Work:	No Works
Observation Comments:	
Tree Protection Zone (TPZ) [m]:	2
Structural Root Zone (SRZ) [m]:	1.26
Useful Life Expectancy:	20-40 years
Retention Value:	Medium
Risk of Harm Number:	Not applicable

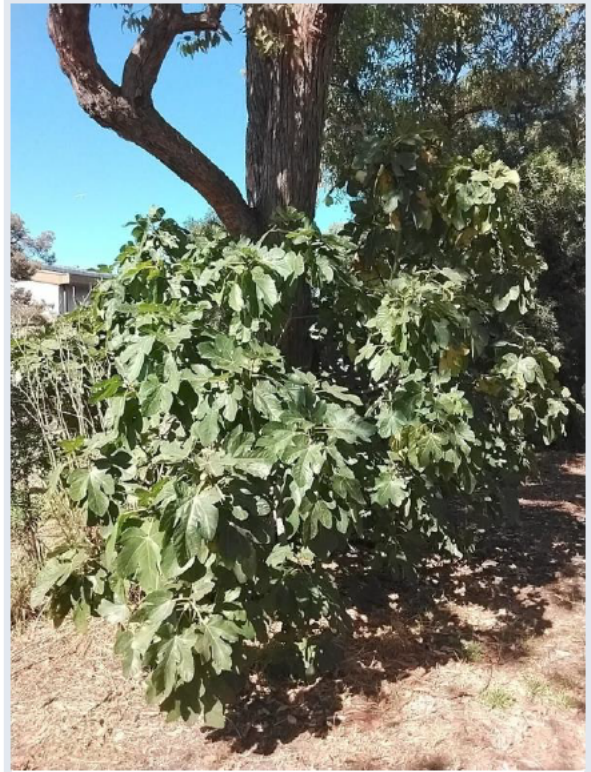
Domestic Fig Tree ID #26

Latin Name:	Ficus carica
Latitude:	-31.863624706456
Longitude:	115.8190254939
Tree Height (Estimated) [m]:	3
Canopy Spread [m]:	3.5
DBH [cm]:	8
Health:	Good
Structure:	Fair
Problems:	Multi Crown leaders
Notes:	
Priority:	None
Tree Work:	No Works
Observation Comments:	
Tree Protection Zone (TPZ) [m]:	2
Structural Root Zone (SRZ) [m]:	1.26
Useful Life Expectancy:	11-20 years
Retention Value:	Low
Risk of Harm Number:	Not applicable

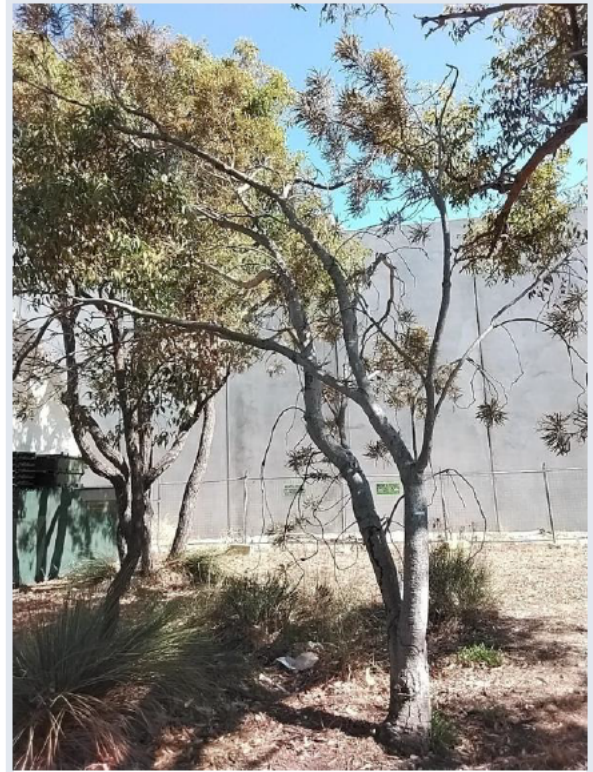
Candle Banksia Tree ID #27

Latin Name:	Banksia attenuata
Latitude:	-31.863598926926
Longitude:	115.8189860654
Tree Height (Estimated) [m]:	6.8
Canopy Spread [m]:	6
DBH [cm]:	27
Health:	Fair
Structure:	Fair
Problems:	Codominant Stem, Deadwood minor <50, Leaning
Notes:	
Priority:	None
Tree Work:	No Works
Observation Comments:	
Tree Protection Zone (TPZ) [m]:	3.24
Structural Root Zone (SRZ) [m]:	1.97
Useful Life Expectancy:	6-10 years
Retention Value:	High
Risk of Harm Number:	Not applicable

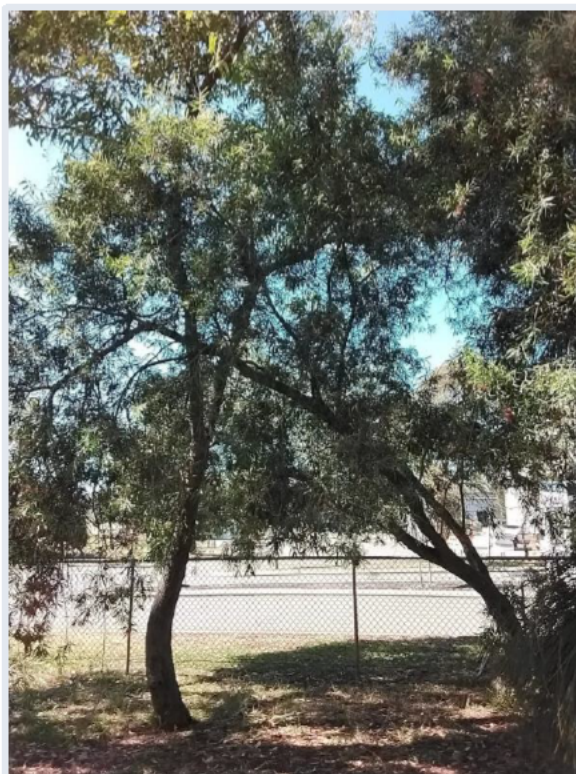
kings park special Tree ID #31

Latin Name:	Callistemon Kings Park Special
Latitude:	-31.863655801412
Longitude:	115.81889077982
Tree Height (Estimated) [m]:	5.3
Canopy Spread [m]:	4.5
DBH [cm]:	21
Health:	Good
Structure:	Poor
Problems:	Codominant Stem, Epicormic growth, Leaning
Notes:	
Priority:	None
Tree Work:	No Works
Observation Comments:	
Tree Protection Zone (TPZ) [m]:	2.52
Structural Root Zone (SRZ) [m]:	1.94
Useful Life Expectancy:	6-10 years
Retention Value:	Medium
Risk of Harm Number:	Not applicable

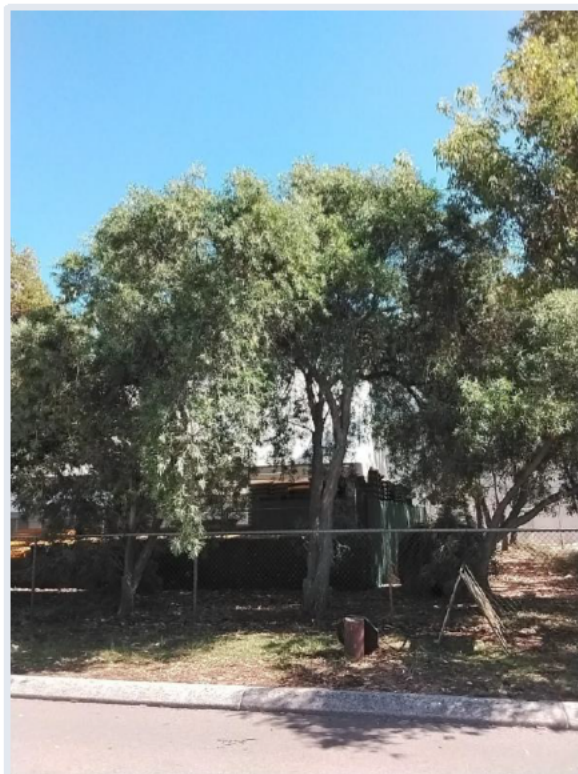
kings park special Tree ID #32

Latin Name:	Callistemon Kings Park Special
Latitude:	-31.863648891338
Longitude:	115.81883382757
Tree Height (Estimated) [m]:	7.1
Canopy Spread [m]:	5
DBH [cm]:	26.17
Health:	Good
Structure:	Fair
Problems:	Epicormic growth, Included bark, Multi Crown leaders
Notes:	
Priority:	None
Tree Work:	No Works
Observation Comments:	
Tree Protection Zone (TPZ) [m]:	3.14
Structural Root Zone (SRZ) [m]:	2.23
Useful Life Expectancy:	6-10 years
Retention Value:	Medium
Risk of Harm Number:	Not applicable

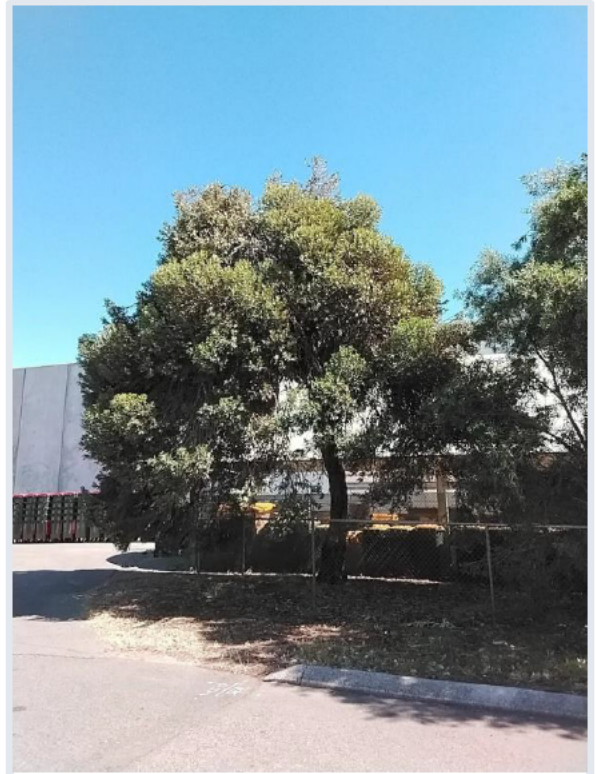
Coastal Moort Tree ID #34

Latin Name:	Eucalyptus utilis
Latitude:	-31.863656598506
Longitude:	115.81878080363
Tree Height (Estimated) [m]:	8
Canopy Spread [m]:	8
DBH [cm]:	35
Health:	Good
Structure:	Fair
Problems:	Hollow, Deadwood minor <50, Epicormic growth, Low Growth
Notes:	
Priority:	Low
Tree Work:	Canopy lift
Observation Comments:	
Tree Protection Zone (TPZ) [m]:	4.2
Structural Root Zone (SRZ) [m]:	2.51
Useful Life Expectancy:	20-40 years
Retention Value:	High
Risk of Harm Number:	Not applicable

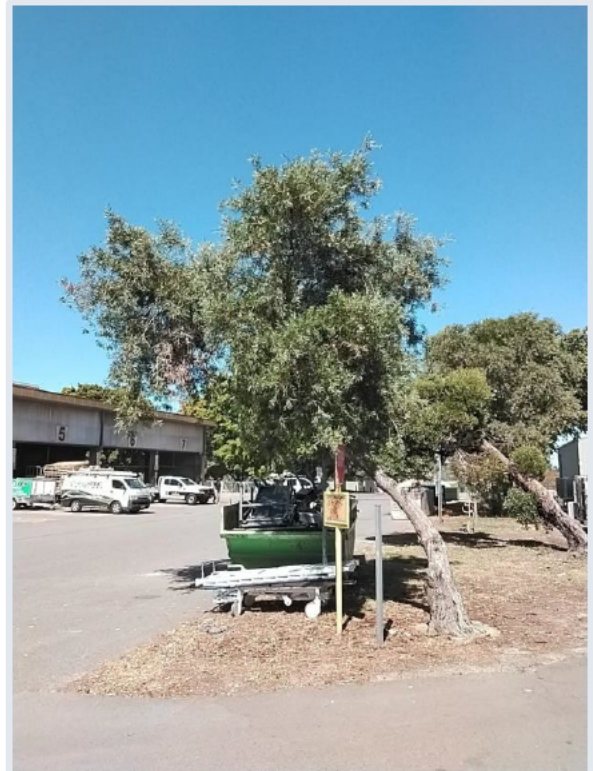
kings park special Tree ID #35

Latin Name:	Callistemon Kings Park Special
Latitude:	-31.863647660334
Longitude:	115.81867717729
Tree Height (Estimated) [m]:	5.2
Canopy Spread [m]:	4
DBH [cm]:	22
Health:	Good
Structure:	Fair
Problems:	Leaning
Notes:	
Priority:	None
Tree Work:	No Works
Observation Comments:	
Tree Protection Zone (TPZ) [m]:	2.64
Structural Root Zone (SRZ) [m]:	2.02
Useful Life Expectancy:	6-10 years
Retention Value:	Medium
Risk of Harm Number:	Not applicable

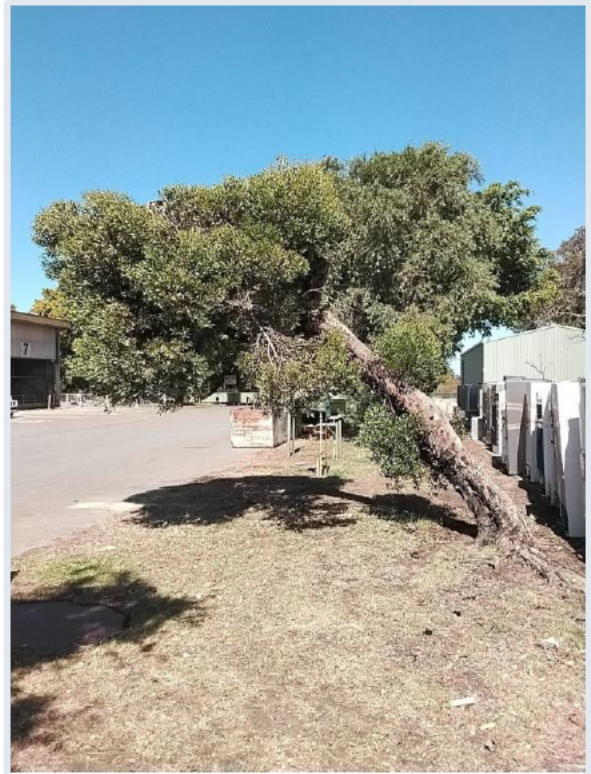
Coastal Moort Tree ID #36

Latin Name:	Eucalyptus utilis
Latitude:	-31.863652577056
Longitude:	115.81859722506
Tree Height (Estimated) [m]:	4
Canopy Spread [m]:	3.5
DBH [cm]:	35
Health:	Good
Structure:	Poor
Problems:	Hollow, Epicormic growth, Leaning, Surface roots
Notes:	
Priority:	None
Tree Work:	No Works
Observation Comments:	
Tree Protection Zone (TPZ) [m]:	4.2
Structural Root Zone (SRZ) [m]:	2.55
Useful Life Expectancy:	6 - 10 years
Retention Value:	Low
Risk of Harm Number:	Not applicable

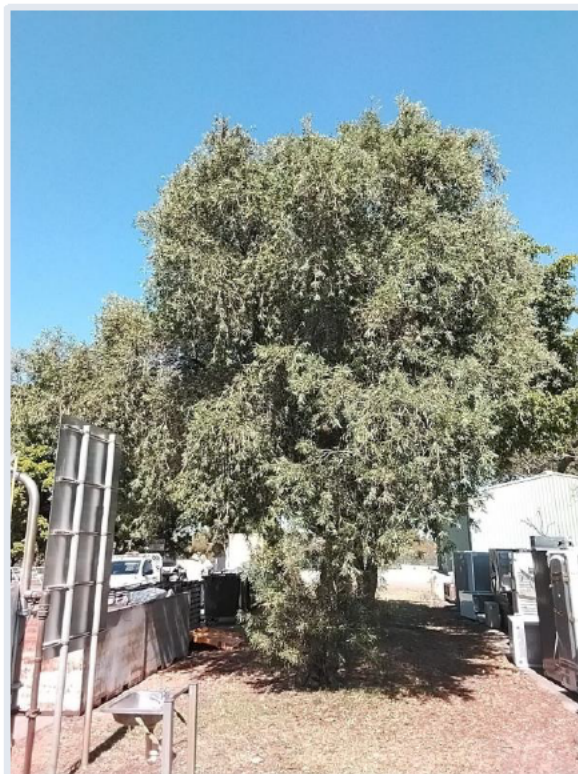
kings park special Tree ID #37

Latin Name:	Callistemon Kings Park Special
Latitude:	-31.863649122019
Longitude:	115.8184877015
Tree Height (Estimated) [m]:	8.3
Canopy Spread [m]:	7
DBH [cm]:	42.43
Health:	Good
Structure:	Fair
Problems:	Codominant Stem, Epicormic growth, Leaning, Surface roots
Notes:	
Priority:	None
Tree Work:	No Works
Observation Comments:	
Tree Protection Zone (TPZ) [m]:	5.09
Structural Root Zone (SRZ) [m]:	2.67
Useful Life Expectancy:	6-10 years
Retention Value:	Medium
Risk of Harm Number:	Not applicable

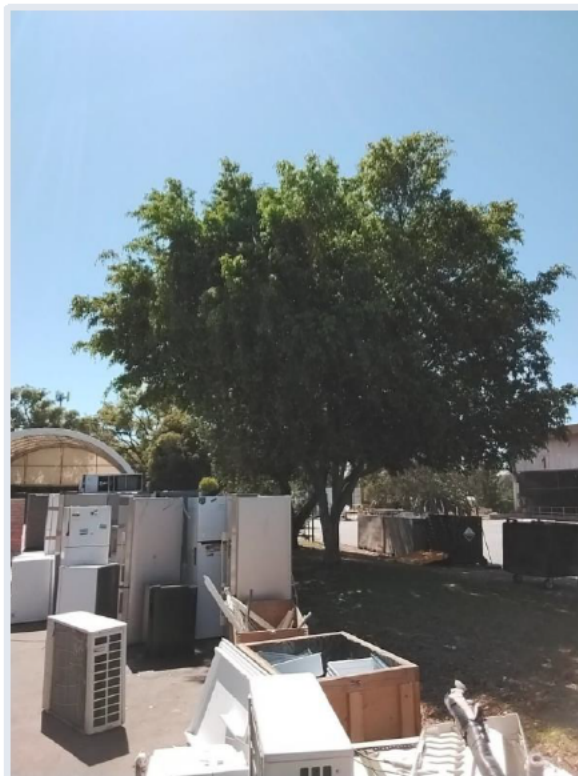
Weeping Fig Tree ID #38

Latin Name:	Ficus benjamina
Latitude:	-31.863642876464
Longitude:	115.81841979687
Tree Height (Estimated) [m]:	8.9
Canopy Spread [m]:	7.5
DBH [cm]:	52
Health:	Good
Structure:	Good
Problems:	Included bark, Surface roots, Multi Crown leaders
Notes:	
Priority:	None
Tree Work:	No Works
Observation Comments:	
Tree Protection Zone (TPZ) [m]:	6.24
Structural Root Zone (SRZ) [m]:	2.67
Useful Life Expectancy:	40+ years
Retention Value:	High
Risk of Harm Number:	Not applicable

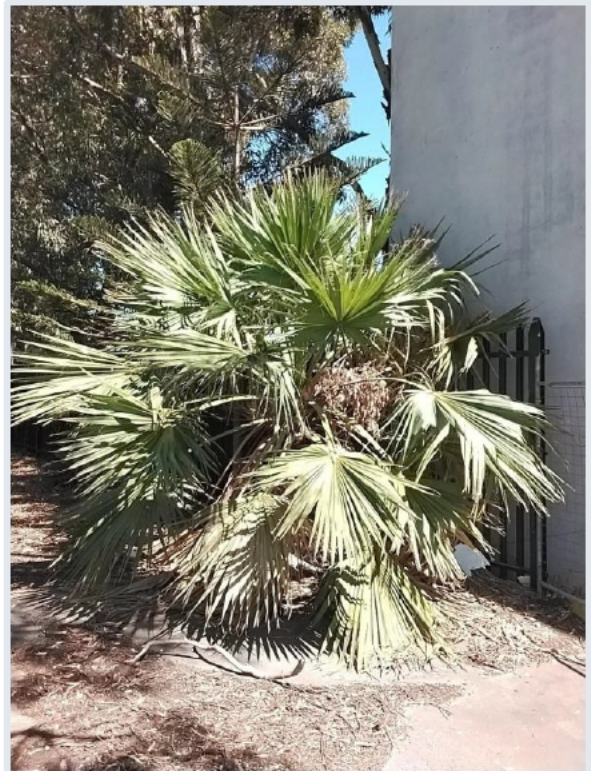
Latin Name:	Washingtonia robusta
Latitude:	-31.863500158407
Longitude:	115.81820951158
Tree Height (Estimated) [m]:	3.5
Canopy Spread [m]:	4
DBH [cm]:	45
Health:	Good
Structure:	Good
Problems:	
Notes:	
Priority:	None
Tree Work:	No Works
Observation Comments:	
Tree Protection Zone (TPZ) [m]:	5.4
Structural Root Zone (SRZ) [m]:	2.47
Useful Life Expectancy:	11-20 years
Retention Value:	Low
Risk of Harm Number:	Not applicable

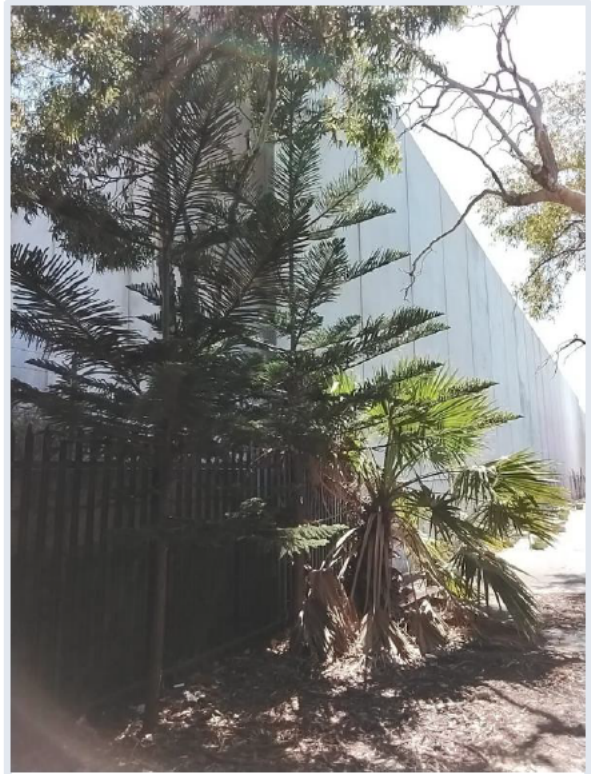
Thread Palm, Fan Palm Tree ID #42

Latin Name:	Washingtonia robusta
Latitude:	-31.8634929826
Longitude:	115.81818541635
Tree Height (Estimated) [m]:	5.5
Canopy Spread [m]:	2
DBH [cm]:	9
Health:	Good
Structure:	Good
Problems:	
Notes:	
Priority:	None
Tree Work:	No Works
Observation Comments:	
Tree Protection Zone (TPZ) [m]:	2
Structural Root Zone (SRZ) [m]:	1.36
Useful Life Expectancy:	40+ years
Retention Value:	Medium
Risk of Harm Number:	Not applicable

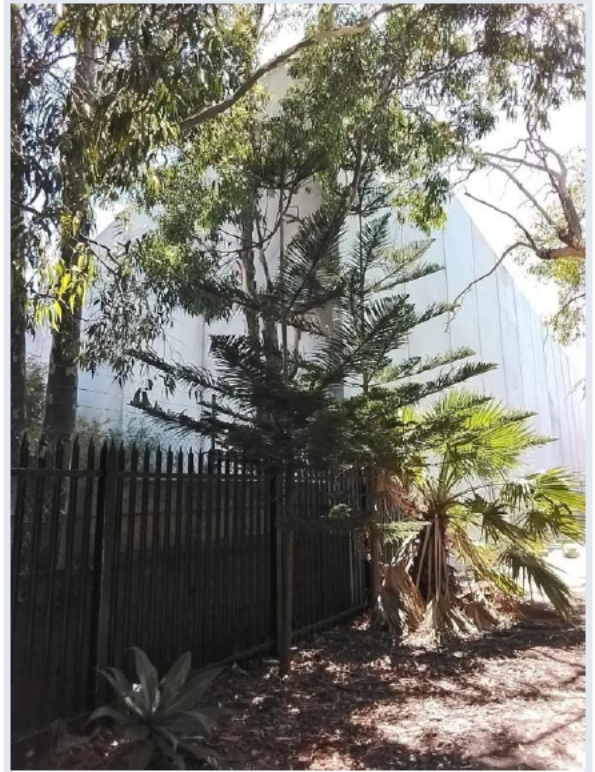
Spotted Gum Tree ID #43

Latin Name:	Washingtonia robusta
Latitude:	-31.863494178565
Longitude:	115.81814489259
Tree Height (Estimated) [m]:	5.5
Canopy Spread [m]:	2
DBH [cm]:	9
Health:	Good
Structure:	Good
Problems:	
Notes:	
Priority:	None
Tree Work:	No Works
Observation Comments:	
Tree Protection Zone (TPZ) [m]:	2
Structural Root Zone (SRZ) [m]:	1.36
Useful Life Expectancy:	40+ years
Retention Value:	Medium
Risk of Harm Number:	Not applicable

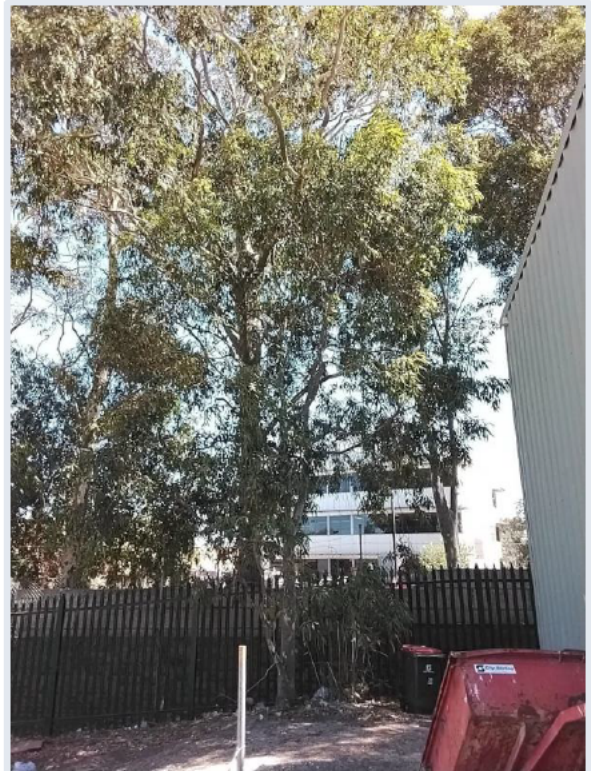
Hill's Fig Tree ID #44

Latin Name:	Corymbia maculata
Latitude:	-31.863500955642
Longitude:	115.81797622635
Tree Height (Estimated) [m]:	8
Canopy Spread [m]:	5
DBH [cm]:	21
Health:	Good
Structure:	Good
Problems:	Codominant Stem
Notes:	
Priority:	None
Tree Work:	No Works
Observation Comments:	
Tree Protection Zone (TPZ) [m]:	2.52
Structural Root Zone (SRZ) [m]:	2.02
Useful Life Expectancy:	40+ years
Retention Value:	High
Risk of Harm Number:	Not applicable

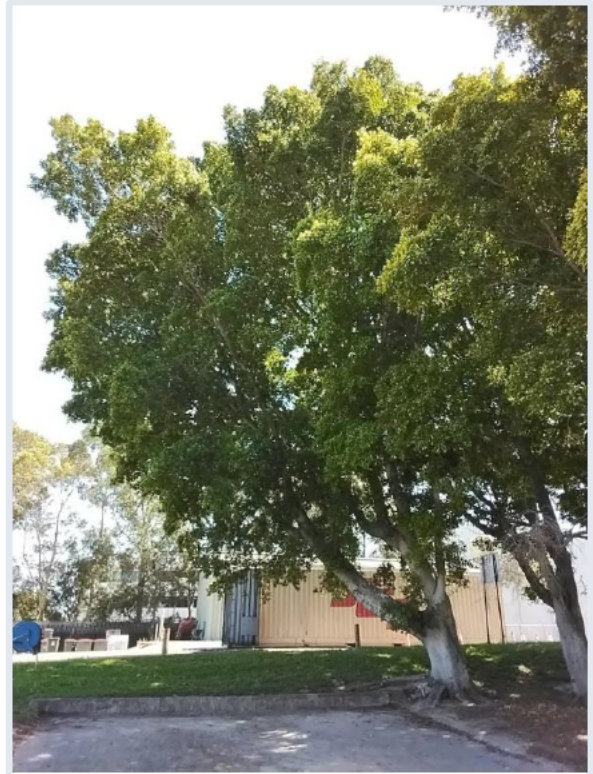
Hill's Fig Tree ID #45

Latin Name:	Ficus hillii
Latitude:	-31.863819538609
Longitude:	115.81795737204
Tree Height (Estimated) [m]:	17
Canopy Spread [m]:	14
DBH [cm]:	75
Health:	Good
Structure:	Fair
Problems:	Codominant Stem, Deadwood minor <50, Surface roots
Notes:	
Priority:	None
Tree Work:	No Works
Observation Comments:	
Tree Protection Zone (TPZ) [m]:	9
Structural Root Zone (SRZ) [m]:	3.21
Useful Life Expectancy:	40+ years
Retention Value:	High
Risk of Harm Number:	Not applicable

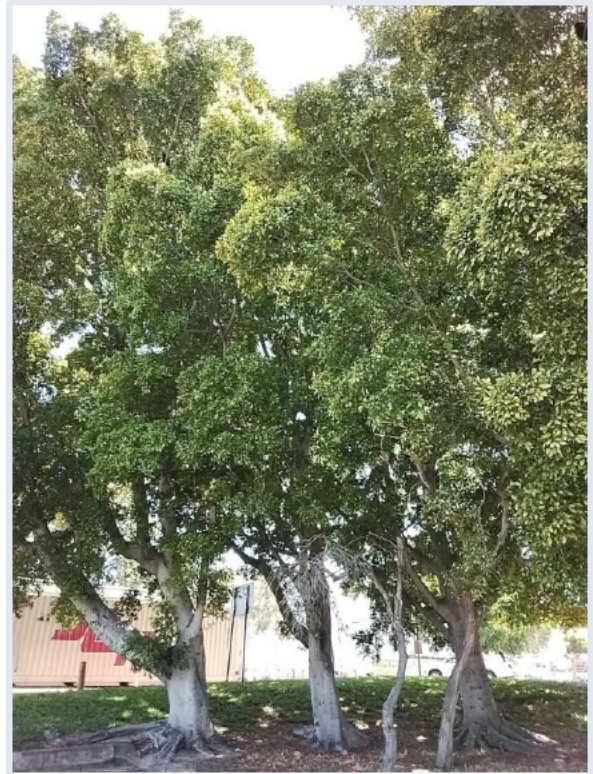
Hill's Fig Tree ID #46

Latin Name:	Ficus hillii
Latitude:	-31.863814488958
Longitude:	115.81803075261
Tree Height (Estimated) [m]:	17
Canopy Spread [m]:	9
DBH [cm]:	63
Health:	Good
Structure:	Fair
Problems:	Deadwood minor <50, Epicormic growth, Surface roots
Notes:	
Priority:	None
Tree Work:	No Works
Observation Comments:	
Tree Protection Zone (TPZ) [m]:	7.56
Structural Root Zone (SRZ) [m]:	2.97
Useful Life Expectancy:	40+ years
Retention Value:	High
Risk of Harm Number:	Not applicable

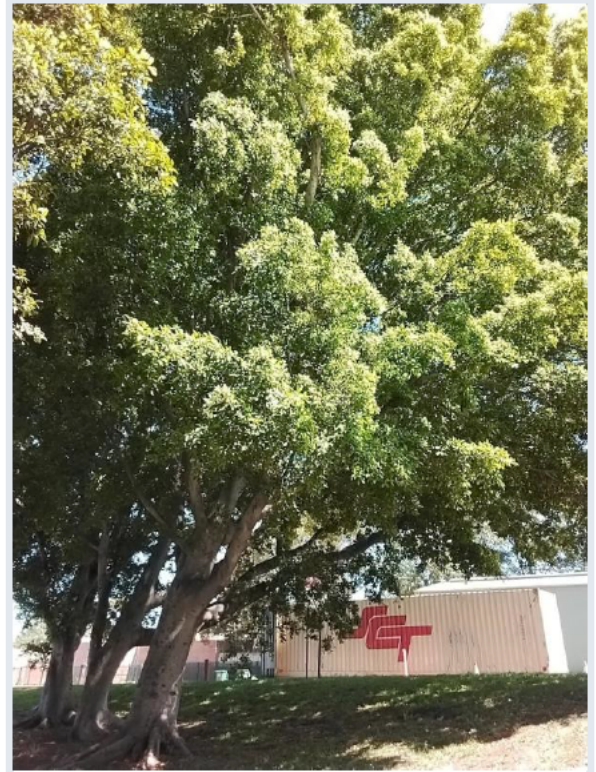
Unknown tree species Tree ID #47

Latin Name:	Ficus hillii
Latitude:	-31.863825651143
Longitude:	115.81811180005
Tree Height (Estimated) [m]:	17
Canopy Spread [m]:	16
DBH [cm]:	68
Health:	Good
Structure:	Fair
Problems:	Deadwood minor <50, Epicormic growth, Surface roots, Multi Crown leaders
Notes:	
Priority:	None
Tree Work:	No Works
Observation Comments:	
Tree Protection Zone (TPZ) [m]:	8.16
Structural Root Zone (SRZ) [m]:	3.51
Useful Life Expectancy:	40+ years
Retention Value:	High
Risk of Harm Number:	Not applicable

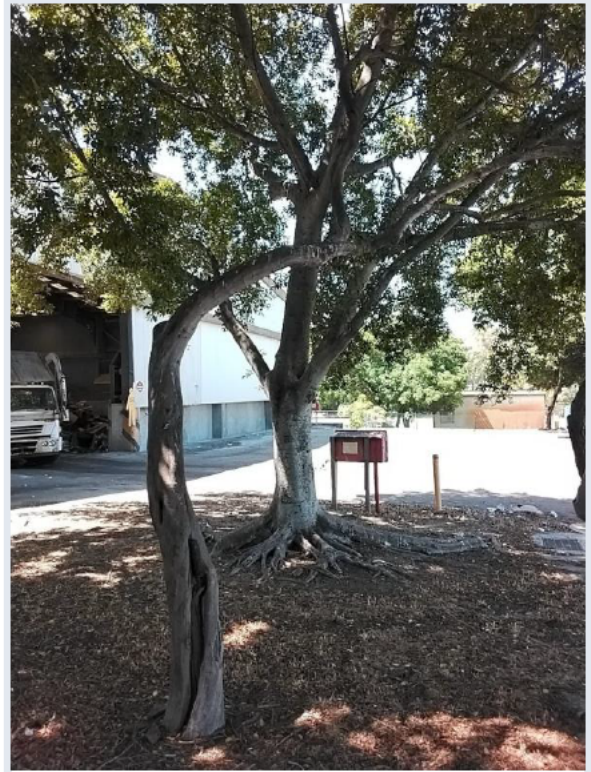
Unknown tree species Tree ID #48

Latin Name:	Unknown species
Latitude:	-31.86385196212
Longitude:	115.81807456206
Tree Height (Estimated) [m]:	6
Canopy Spread [m]:	0
DBH [cm]:	21
Health:	Dead
Structure:	Fair
Problems:	Deadwood major >50
Notes:	
Priority:	Low
Tree Work:	Remove Tree
Observation Comments:	
Tree Protection Zone (TPZ) [m]:	2.52
Structural Root Zone (SRZ) [m]:	1.82
Useful Life Expectancy:	0 years
Retention Value:	Low
Risk of Harm Number:	Not applicable

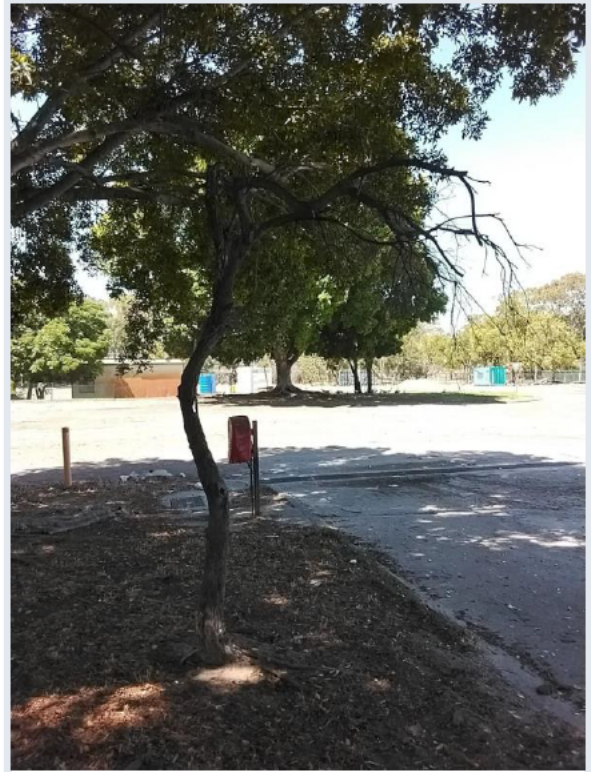
Hill's Fig Tree ID #49

Latin Name:	Unknown species
Latitude:	-31.863863390092
Longitude:	115.81802746689
Tree Height (Estimated) [m]:	3
Canopy Spread [m]:	0
DBH [cm]:	13
Health:	Dead
Structure:	Fair
Problems:	Deadwood major >50
Notes:	
Priority:	Low
Tree Work:	Remove Tree
Observation Comments:	
Tree Protection Zone (TPZ) [m]:	2
Structural Root Zone (SRZ) [m]:	1.53
Useful Life Expectancy:	0 years
Retention Value:	Low
Risk of Harm Number:	Not applicable

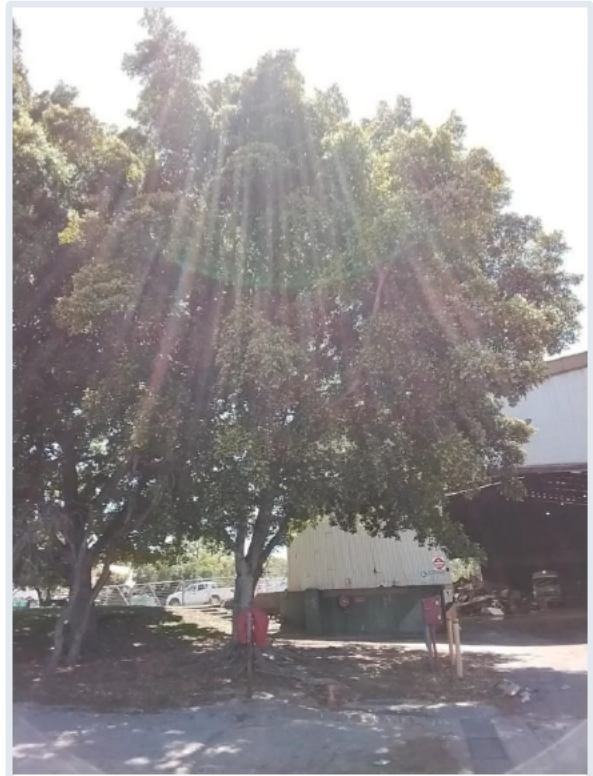
Broadleaf Paperbark Tree ID #50

Latin Name:	Ficus hillii
Latitude:	-31.86390830487
Longitude:	115.81806689532
Tree Height (Estimated) [m]:	16
Canopy Spread [m]:	15
DBH [cm]:	49
Health:	Good
Structure:	Fair
Problems:	Deadwood minor <50, Epicormic growth, Surface roots, Multi Crown leaders
Notes:	
Priority:	None
Tree Work:	No Works
Observation Comments:	
Tree Protection Zone (TPZ) [m]:	5.88
Structural Root Zone (SRZ) [m]:	3.6
Useful Life Expectancy:	40+ years
Retention Value:	High
Risk of Harm Number:	Not applicable

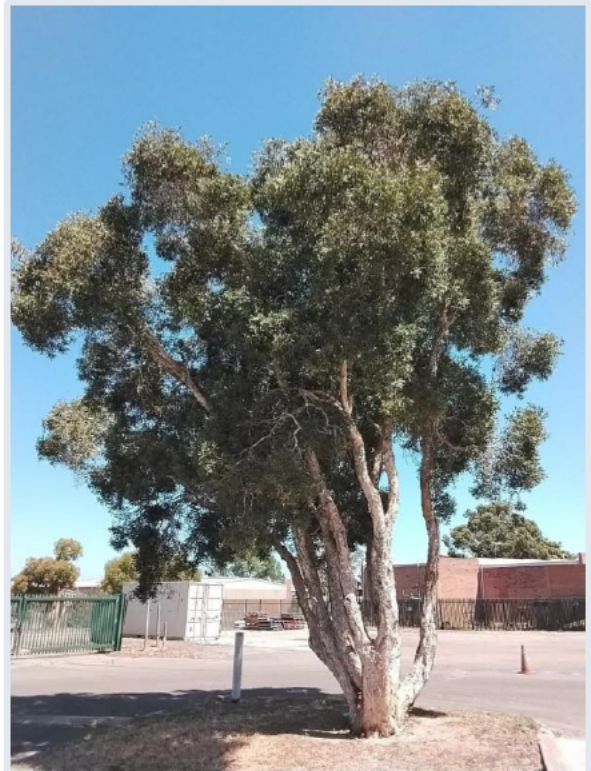
Marri Tree ID #51

Latin Name:	Melaleuca quinquenervia
Latitude:	-31.863837876349
Longitude:	115.8176671344
Tree Height (Estimated) [m]:	9
Canopy Spread [m]:	7
DBH [cm]:	64.4
Health:	Good
Structure:	Fair
Problems:	Deadwood minor <50, Epicormic growth, Included bark, Surface roots, Multi Crown leaders
Notes:	
Priority:	None
Tree Work:	No Works
Observation Comments:	
Tree Protection Zone (TPZ) [m]:	7.73
Structural Root Zone (SRZ) [m]:	3.06
Useful Life Expectancy:	20-40 years
Retention Value:	High
Risk of Harm Number:	Not applicable

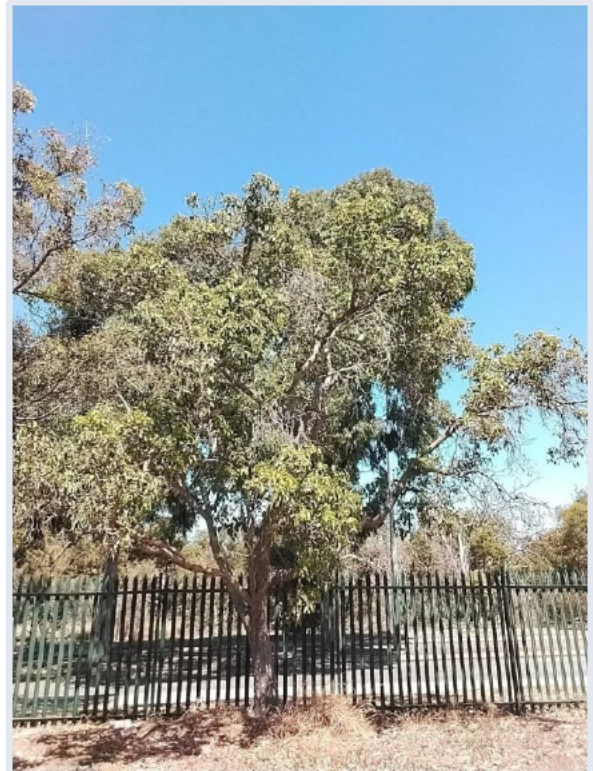
Unknown tree species Tree ID #52

Latin Name:	Corymbia calophylla
Latitude:	-31.864123709629
Longitude:	115.81739661126
Tree Height (Estimated) [m]:	8.2
Canopy Spread [m]:	7
DBH [cm]:	35
Health:	Fair
Structure:	Fair
Problems:	Deadwood minor <50, Epicormic growth, Multi Crown leaders
Notes:	
Priority:	None
Tree Work:	No Works
Observation Comments:	
Tree Protection Zone (TPZ) [m]:	4.2
Structural Root Zone (SRZ) [m]:	2.23
Useful Life Expectancy:	20-40 years
Retention Value:	High
Risk of Harm Number:	Not applicable

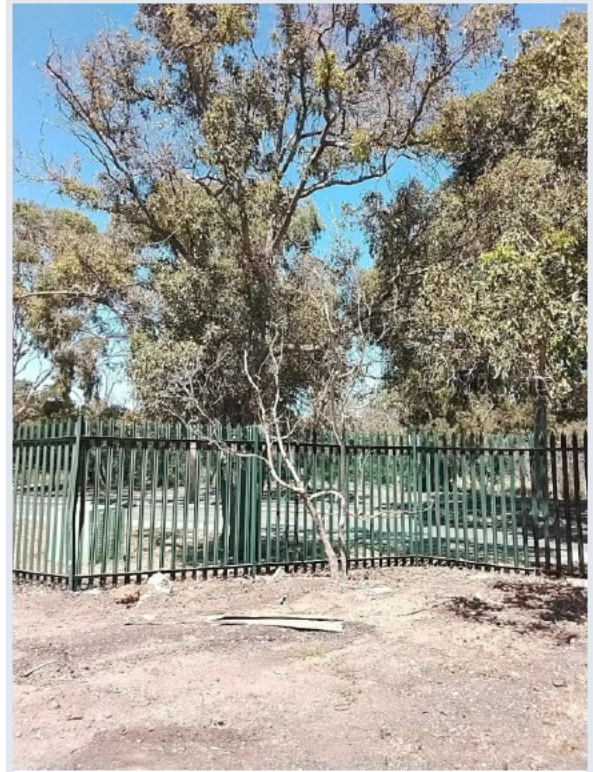
Unknown tree species Tree ID #53

Latin Name:	Unknown species
Latitude:	-31.864170068985
Longitude:	115.81740992458
Tree Height (Estimated) [m]:	5
Canopy Spread [m]:	0
DBH [cm]:	15
Health:	Dead
Structure:	Fair
Problems:	Deadwood major >50
Notes:	
Priority:	Low
Tree Work:	Remove Tree
Observation Comments:	
Tree Protection Zone (TPZ) [m]:	2
Structural Root Zone (SRZ) [m]:	1.68
Useful Life Expectancy:	0 years
Retention Value:	Low
Risk of Harm Number:	Not applicable

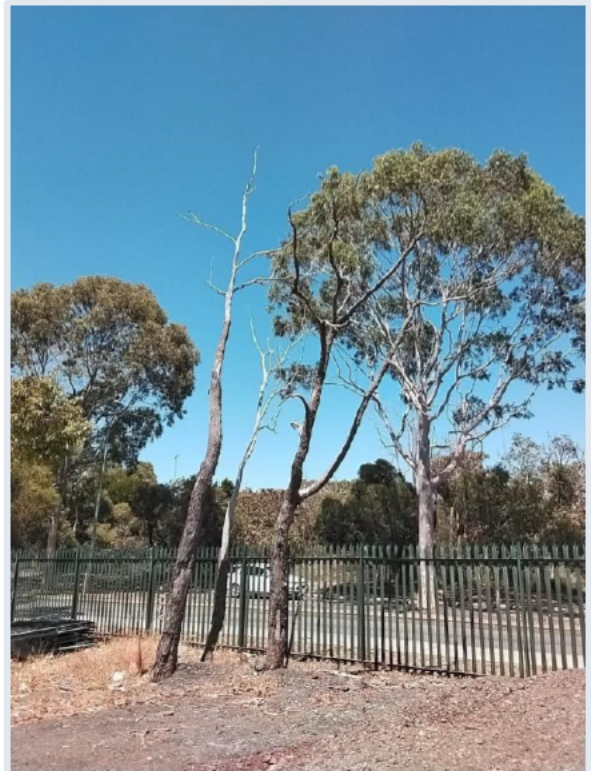
Jarrah Tree ID #54

Latin Name:	Unknown species
Latitude:	-31.864428925915
Longitude:	115.81741430552
Tree Height (Estimated) [m]:	8
Canopy Spread [m]:	0
DBH [cm]:	30
Health:	Dead
Structure:	Fair
Problems:	Deadwood major >50
Notes:	
Priority:	Low
Tree Work:	Remove Tree
Observation Comments:	3 dead trees
Tree Protection Zone (TPZ) [m]:	3.6
Structural Root Zone (SRZ) [m]:	2.25
Useful Life Expectancy:	0 years
Retention Value:	Low
Risk of Harm Number:	Not applicable

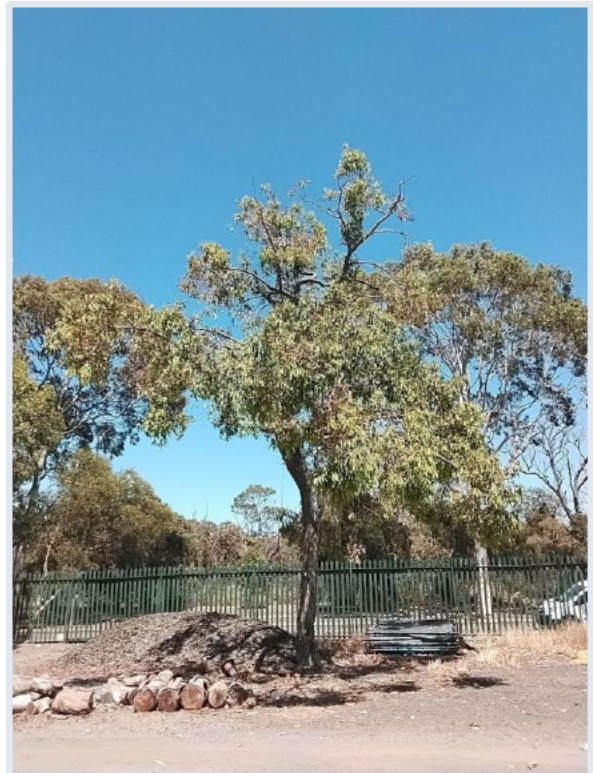
Jarraah Tree ID #55

Latin Name:	Eucalyptus marginata
Latitude:	-31.864504536449
Longitude:	115.8174362102
Tree Height (Estimated) [m]:	9.5
Canopy Spread [m]:	8
DBH [cm]:	37
Health:	Fair
Structure:	Fair
Problems:	Deadwood minor <50, Bark wound
Notes:	
Priority:	None
Tree Work:	No Works
Observation Comments:	
Tree Protection Zone (TPZ) [m]:	4.44
Structural Root Zone (SRZ) [m]:	2.3
Useful Life Expectancy:	40+ years
Retention Value:	High
Risk of Harm Number:	Not applicable

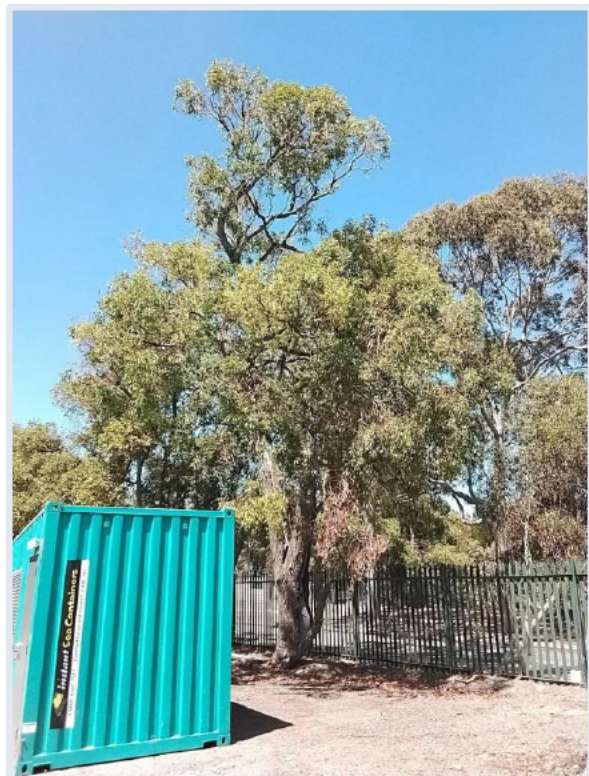
Jarrah Tree ID #56

Problems: Codominant Stem,
Deadwood major >50,
Decay, Deadwood
minor <50, Fire
damage, Bark wound,
Secondary stem

Tree Work: Remove major
deadwood

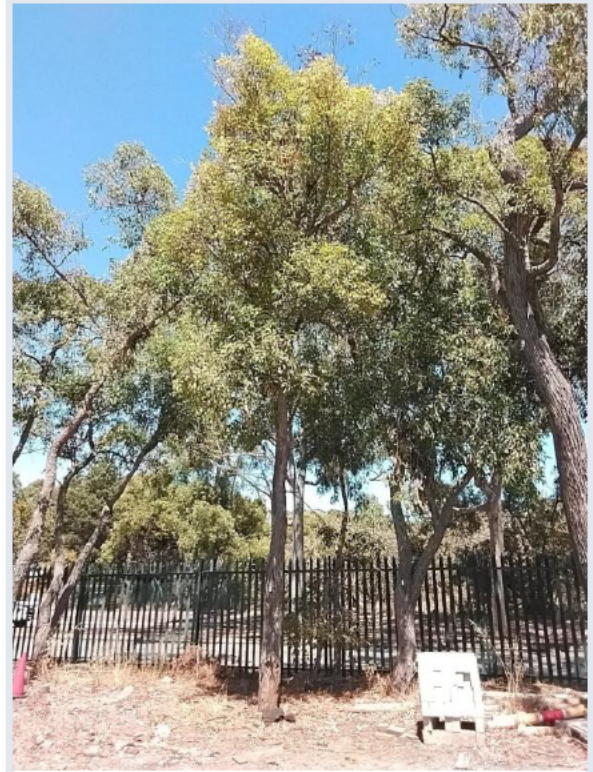
Jarraah Tree ID #59

Problems: Codominant Stem

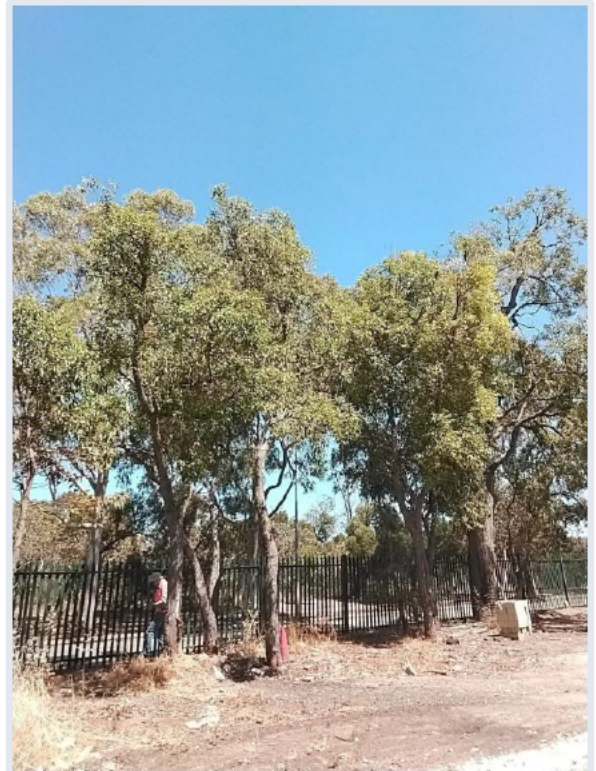
Jarrah Tree ID #60

Problems: Leaning

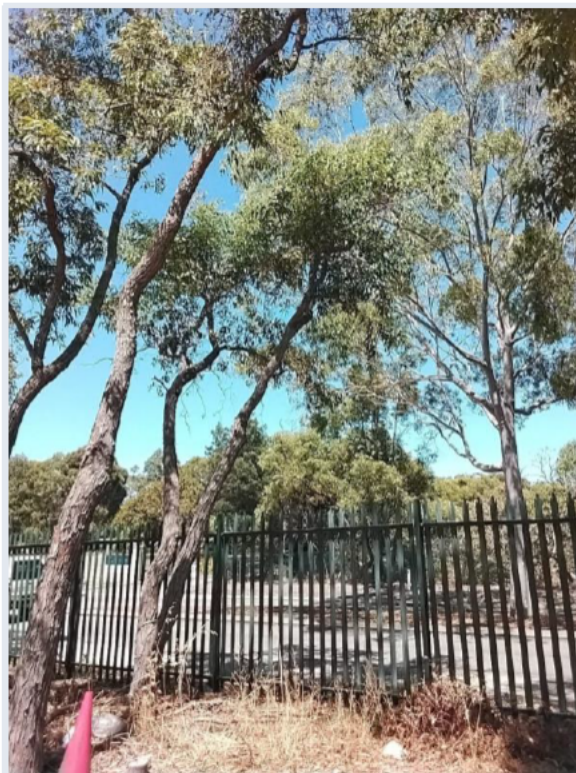
Jarraah Tree ID #61

Problems: Codominant Stem,
Leaning

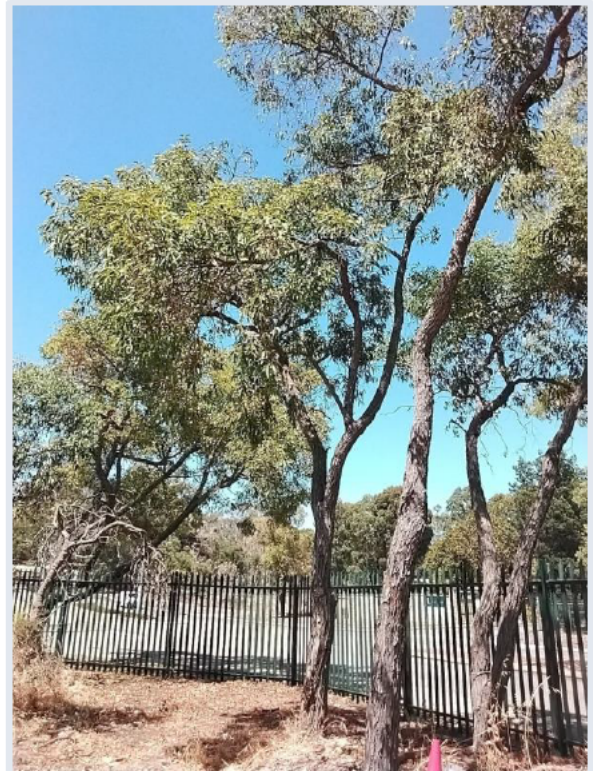
Jarrah Tree ID #62

Latin Name:	Eucalyptus marginata
Latitude:	-31.864833820097
Longitude:	115.81745263852
Tree Height (Estimated) [m]:	10.5
Canopy Spread [m]:	5
DBH [cm]:	25
Health:	Good
Structure:	Fair
Problems:	Codominant Stem
Notes:	
Priority:	None
Tree Work:	No Works
Observation Comments:	
Tree Protection Zone (TPZ) [m]:	3
Structural Root Zone (SRZ) [m]:	2.05
Useful Life Expectancy:	40+ years
Retention Value:	High
Risk of Harm Number:	Not applicable

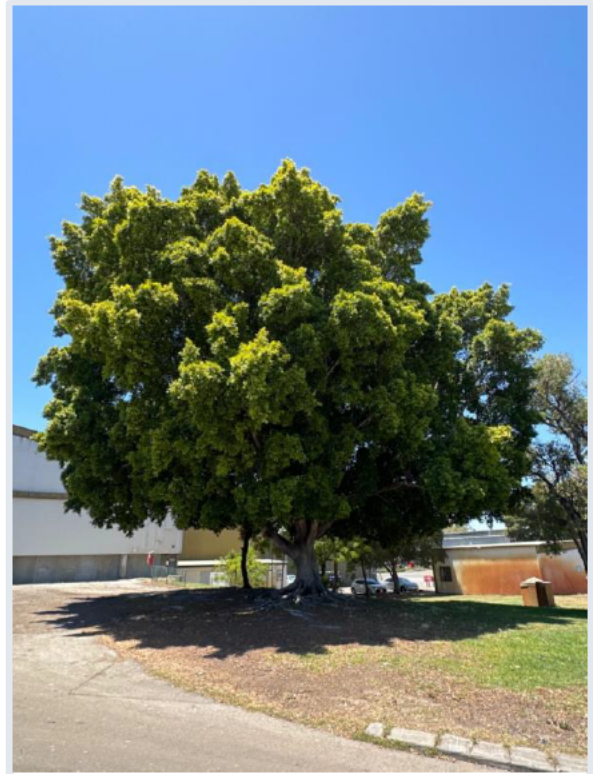
Swamp Mallee Tree ID #64

Latin Name:	Ficus hillii
Latitude:	-31.864186440701
Longitude:	115.81795360466
Tree Height (Estimated) [m]:	24.5
Canopy Spread [m]:	16
DBH [cm]:	89
Health:	Good
Structure:	Fair
Problems:	Deadwood minor <50, Epicormic growth, Surface roots, Multi Crown leaders
Notes:	
Priority:	None
Tree Work:	No Works
Observation Comments:	
Tree Protection Zone (TPZ) [m]:	10.68
Structural Root Zone (SRZ) [m]:	3.63
Useful Life Expectancy:	40+ years
Retention Value:	High
Risk of Harm Number:	Not applicable
