Arboricultural Report - Balcatta Recycling Centre

December 13, 2024
Total Tree Count:
145

Brief

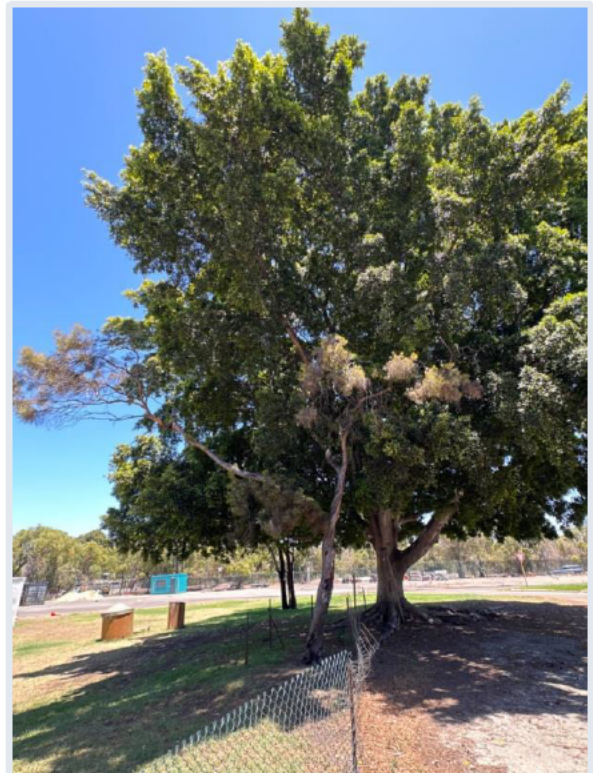
Jarraah Tree ID #65

Latin Name:	Eucalyptus spathulata
Latitude:	-31.864187579703
Longitude:	115.81801998934
Tree Height (Estimated) [m]:	6.5
Canopy Spread [m]:	5.5
DBH [cm]:	26
Health:	Fair
Structure:	Fair
Problems:	Surface roots, Suppressed canopy, Bark wound
Notes:	
Priority:	None
Tree Work:	No Works
Observation Comments:	
Tree Protection Zone (TPZ) [m]:	3.12
Structural Root Zone (SRZ) [m]:	2.13
Useful Life Expectancy:	11-20 years
Retention Value:	Medium
Risk of Harm Number:	Not applicable

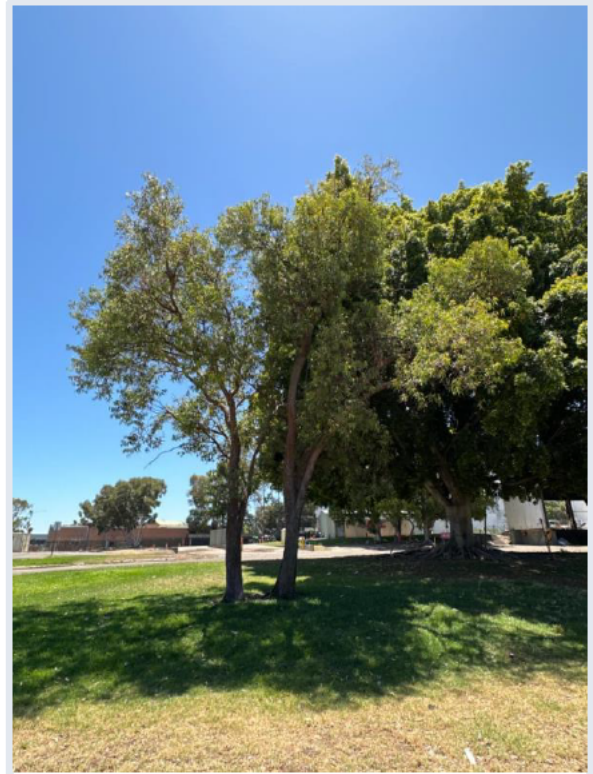
Cape Lilac, White Cedar Tree ID #66

Latin Name:	Eucalyptus marginata
Latitude:	-31.864242251807
Longitude:	115.81787045618
Tree Height (Estimated) [m]:	9.8
Canopy Spread [m]:	6
DBH [cm]:	50.99
Health:	Good
Structure:	Fair
Problems:	Deadwood minor <50, Multi Crown leaders
Notes:	
Priority:	None
Tree Work:	No Works
Observation Comments:	
Tree Protection Zone (TPZ) [m]:	6.12
Structural Root Zone (SRZ) [m]:	3.68
Useful Life Expectancy:	40+ years
Retention Value:	High
Risk of Harm Number:	Not applicable

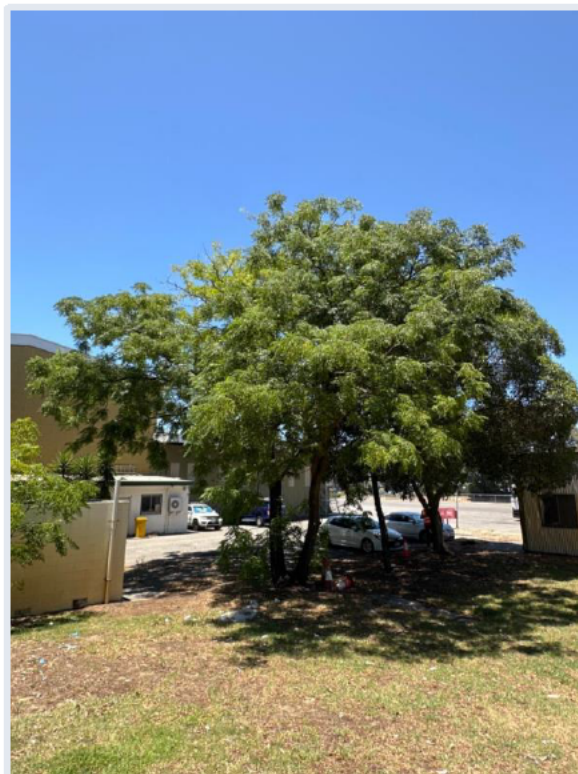
Norfolk Island Pine Tree ID #67

Latin Name:	Melia azedarach
Latitude:	-31.8643219819
Longitude:	115.81813500877
Tree Height (Estimated) [m]:	12.1
Canopy Spread [m]:	13
DBH [cm]:	60.83
Health:	Good
Structure:	Fair
Problems:	Deadwood minor <50, Epicormic growth, Basal bifurcation, Surface roots, Twin Stem
Notes:	Remove basal epicormic growth
Priority:	Low
Tree Work:	Remove epicormic growth, Other (Describe Below)
Observation Comments:	
Tree Protection Zone (TPZ) [m]:	7.3
Structural Root Zone (SRZ) [m]:	3.63
Useful Life Expectancy:	20-40 years
Retention Value:	High
Risk of Harm Number:	Not applicable

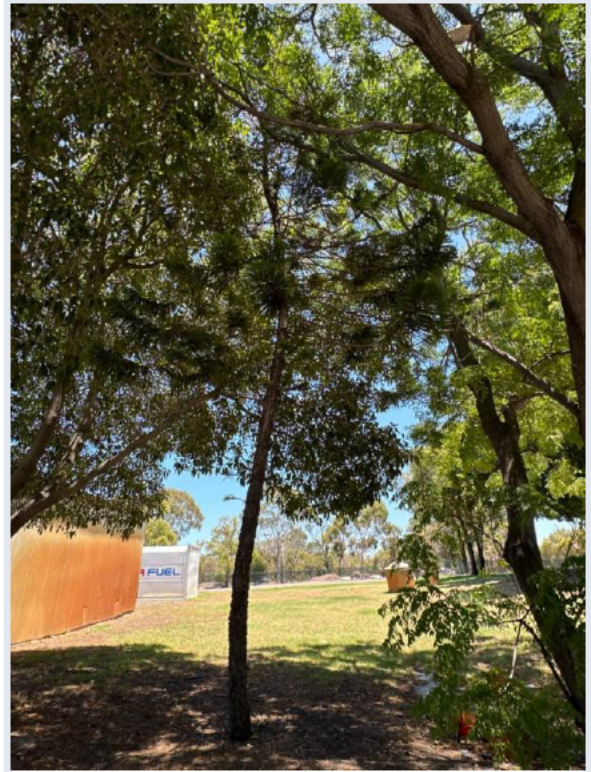
Port Jackson Fig Tree ID #68

Latin Name:	Araucaria heterophylla
Latitude:	-31.864350456917
Longitude:	115.81814506705
Tree Height (Estimated) [m]:	12.2
Canopy Spread [m]:	2
DBH [cm]:	21
Health:	Fair
Structure:	Fair
Problems:	Suppressed canopy
Notes:	
Priority:	None
Tree Work:	No Works
Observation Comments:	
Tree Protection Zone (TPZ) [m]:	2.52
Structural Root Zone (SRZ) [m]:	1.85
Useful Life Expectancy:	11-20 years
Retention Value:	Medium
Risk of Harm Number:	Not applicable

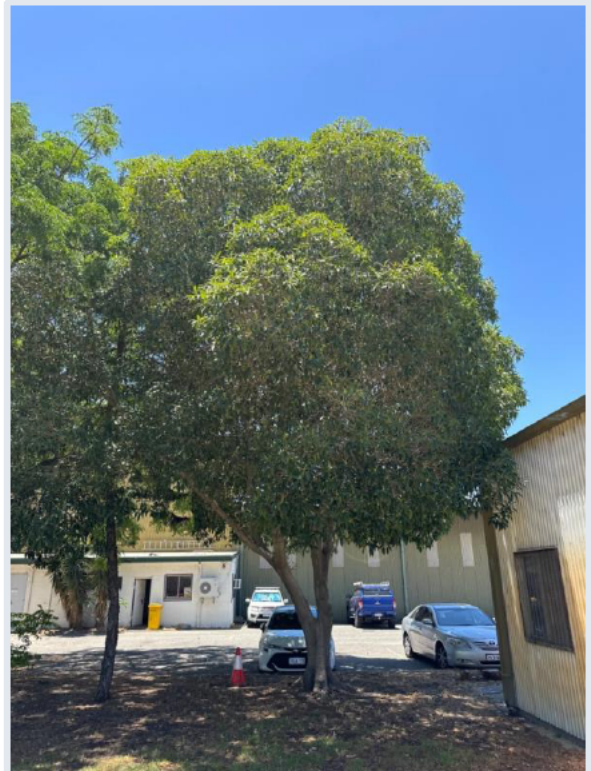
Banksia Tree ID #69

Latin Name:	Ficus rubiginosa
Latitude:	-31.864381209925
Longitude:	115.81814707871
Tree Height (Estimated) [m]:	12.3
Canopy Spread [m]:	10
DBH [cm]:	55
Health:	Good
Structure:	Fair
Problems:	Codominant Stem, Surface roots
Notes:	
Priority:	None
Tree Work:	No Works
Observation Comments:	
Tree Protection Zone (TPZ) [m]:	6.6
Structural Root Zone (SRZ) [m]:	2.76
Useful Life Expectancy:	40+ years
Retention Value:	High
Risk of Harm Number:	Not applicable

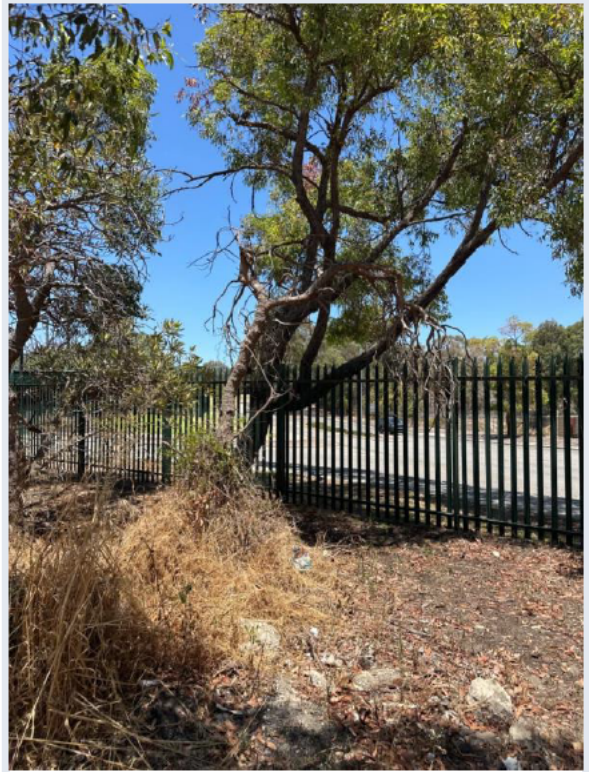
Candle Banksia Tree ID #70

Latin Name:	Banksia species
Latitude:	-31.864875439023
Longitude:	115.81747905253
Tree Height (Estimated) [m]:	3.5
Canopy Spread [m]:	0
DBH [cm]:	17
Health:	Dead
Structure:	Fair
Problems:	Deadwood major >50
Notes:	
Priority:	Low
Tree Work:	Remove Tree
Observation Comments:	
Tree Protection Zone (TPZ) [m]:	2.04
Structural Root Zone (SRZ) [m]:	1.68
Useful Life Expectancy:	0 years
Retention Value:	Low
Risk of Harm Number:	Not applicable

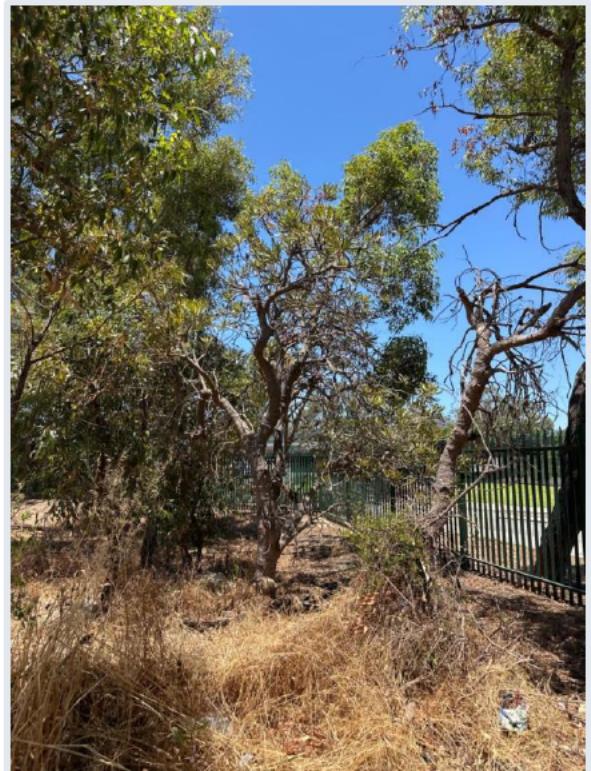
Jarraah Tree ID #71

Latin Name:	Eucalyptus marginata
Latitude:	-31.864807099357
Longitude:	115.81754342554
Tree Height (Estimated) [m]:	3.7
Canopy Spread [m]:	1.5
DBH [cm]:	12
Health:	Good
Structure:	Fair
Problems:	
Notes:	
Priority:	None
Tree Work:	No Works
Observation Comments:	
Tree Protection Zone (TPZ) [m]:	2
Structural Root Zone (SRZ) [m]:	1.4
Useful Life Expectancy:	40+ years
Retention Value:	High
Risk of Harm Number:	Not applicable

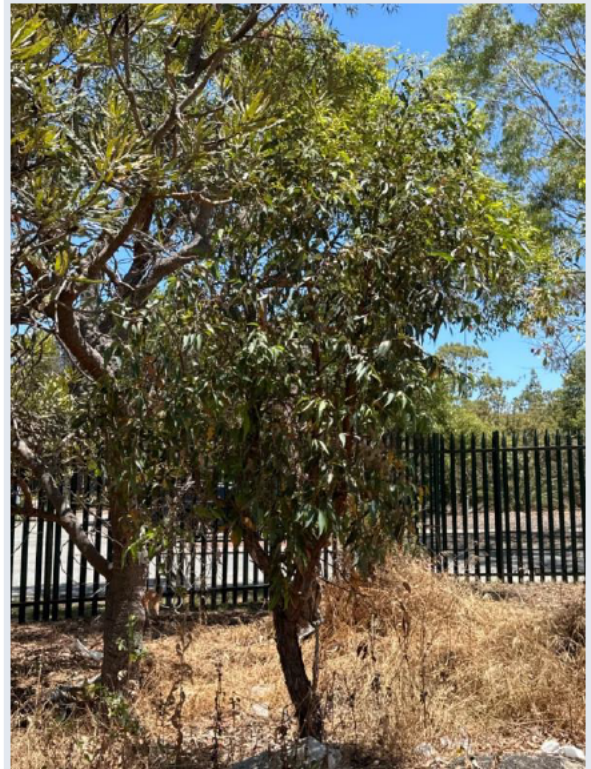
Jarraah Tree ID #72

Latin Name:	Eucalyptus marginata
Latitude:	-31.864838991207
Longitude:	115.81757561205
Tree Height (Estimated) [m]:	6.8
Canopy Spread [m]:	1.3
DBH [cm]:	12
Health:	Fair
Structure:	Fair
Problems:	
Notes:	
Priority:	None
Tree Work:	No Works
Observation Comments:	
Tree Protection Zone (TPZ) [m]:	2
Structural Root Zone (SRZ) [m]:	1.45
Useful Life Expectancy:	40+ years
Retention Value:	High
Risk of Harm Number:	Not applicable

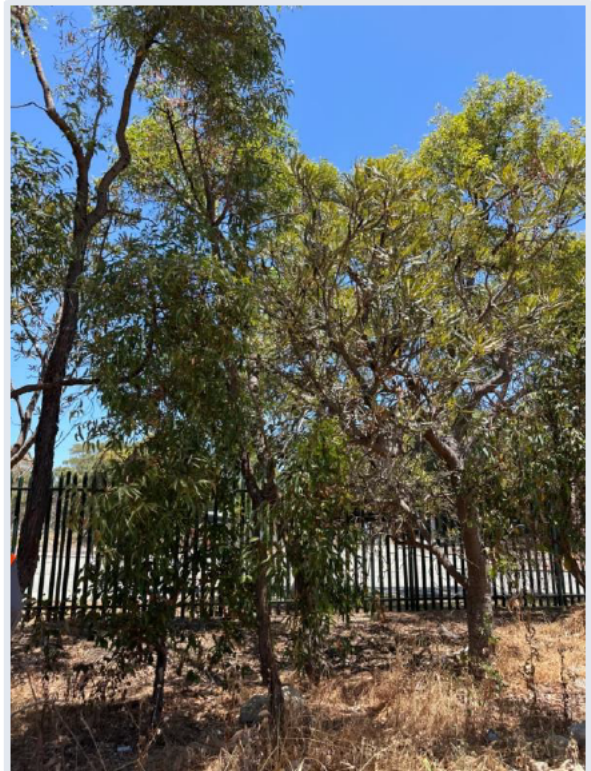
Jarraah Tree ID #73

Latin Name:	Eucalyptus marginata
Latitude:	-31.864850381151
Longitude:	115.81759572862
Tree Height (Estimated) [m]:	2.3
Canopy Spread [m]:	1
DBH [cm]:	10
Health:	Good
Structure:	Fair
Problems:	
Notes:	
Priority:	None
Tree Work:	No Works
Observation Comments:	
Tree Protection Zone (TPZ) [m]:	2
Structural Root Zone (SRZ) [m]:	1.36
Useful Life Expectancy:	40+ years
Retention Value:	Medium
Risk of Harm Number:	Not applicable

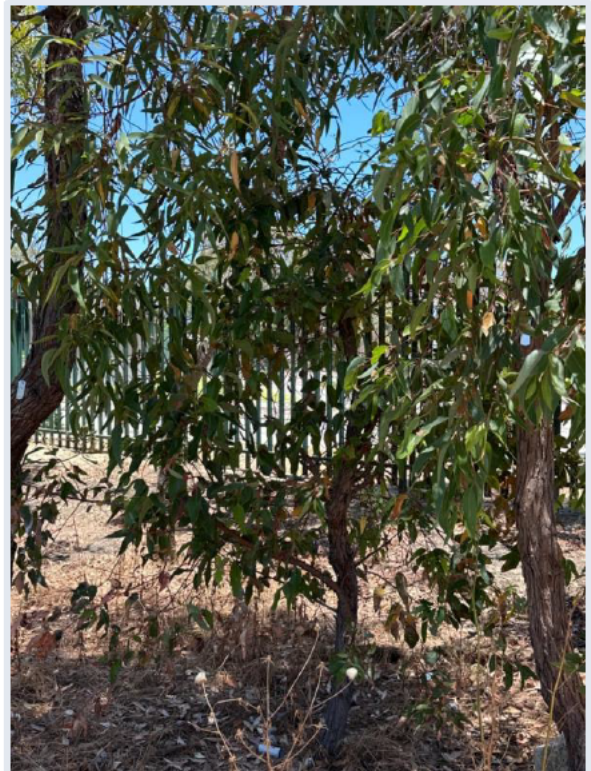
Jarraah Tree ID #74

Latin Name:	Eucalyptus marginata
Latitude:	-31.864882272986
Longitude:	115.81761182187
Tree Height (Estimated) [m]:	7
Canopy Spread [m]:	4
DBH [cm]:	23
Health:	Good
Structure:	Fair
Problems:	Codominant Stem
Notes:	
Priority:	None
Tree Work:	No Works
Observation Comments:	
Tree Protection Zone (TPZ) [m]:	2.76
Structural Root Zone (SRZ) [m]:	1.82
Useful Life Expectancy:	40+ years
Retention Value:	Medium
Risk of Harm Number:	Not applicable

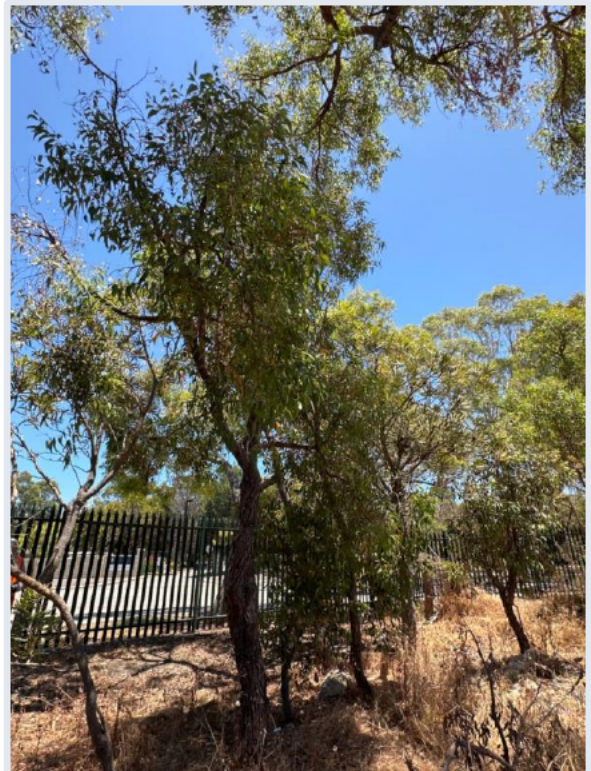
Jarraah Tree ID #75

Latin Name:	Eucalyptus marginata
Latitude:	-31.864891384937
Longitude:	115.81755683659
Tree Height (Estimated) [m]:	10.4
Canopy Spread [m]:	5
DBH [cm]:	19
Health:	Good
Structure:	Fair
Problems:	
Notes:	
Priority:	None
Tree Work:	No Works
Observation Comments:	
Tree Protection Zone (TPZ) [m]:	2.28
Structural Root Zone (SRZ) [m]:	1.82
Useful Life Expectancy:	40+ years
Retention Value:	High
Risk of Harm Number:	Not applicable

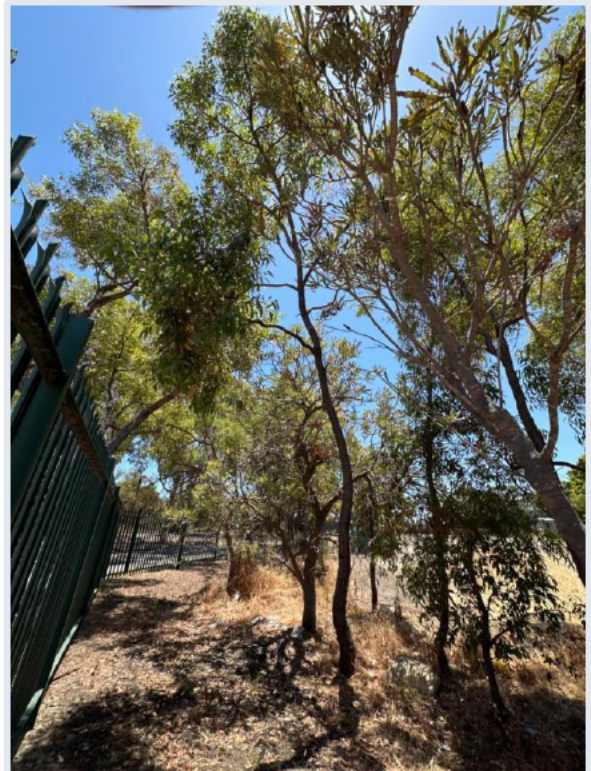
Firewood Banksia Tree ID #76

Latin Name:	Banksia menziesii
Latitude:	-31.864890245943
Longitude:	115.81767485378
Tree Height (Estimated) [m]:	7.2
Canopy Spread [m]:	2.5
DBH [cm]:	18
Health:	Good
Structure:	Fair
Problems:	
Notes:	
Priority:	None
Tree Work:	No Works
Observation Comments:	
Tree Protection Zone (TPZ) [m]:	2.16
Structural Root Zone (SRZ) [m]:	1.75
Useful Life Expectancy:	11-20 years
Retention Value:	High
Risk of Harm Number:	Not applicable

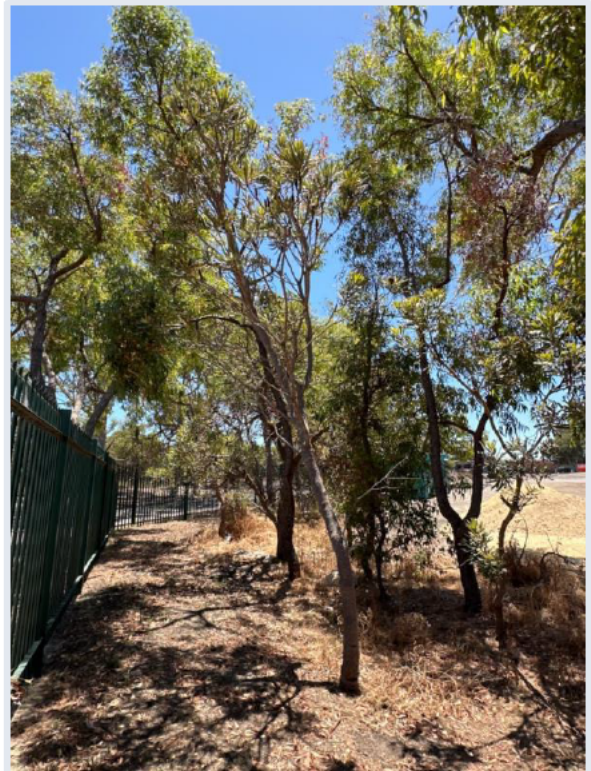
Candle Banksia Tree ID #77

Latin Name:	Banksia attenuata
Latitude:	-31.864864049082
Longitude:	115.8176802182
Tree Height (Estimated) [m]:	3.9
Canopy Spread [m]:	1.5
DBH [cm]:	6
Health:	Good
Structure:	Fair
Problems:	
Notes:	
Priority:	None
Tree Work:	No Works
Observation Comments:	
Tree Protection Zone (TPZ) [m]:	2
Structural Root Zone (SRZ) [m]:	1.26
Useful Life Expectancy:	11-20 years
Retention Value:	Medium
Risk of Harm Number:	Not applicable

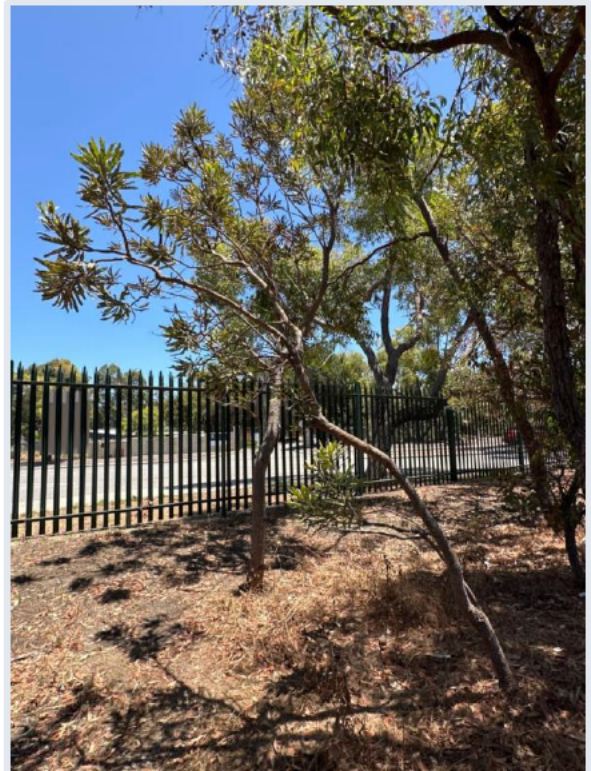
Jarraah Tree ID #78

Latin Name:	Eucalyptus marginata
Latitude:	-31.864816211316
Longitude:	115.81760511635
Tree Height (Estimated) [m]:	11
Canopy Spread [m]:	0
DBH [cm]:	63
Health:	Dead
Structure:	Fair
Problems:	Deadwood major >50
Notes:	
Priority:	Low
Tree Work:	Remove Tree
Observation Comments:	
Tree Protection Zone (TPZ) [m]:	7.56
Structural Root Zone (SRZ) [m]:	2.85
Useful Life Expectancy:	0 years
Retention Value:	Low
Risk of Harm Number:	Not applicable

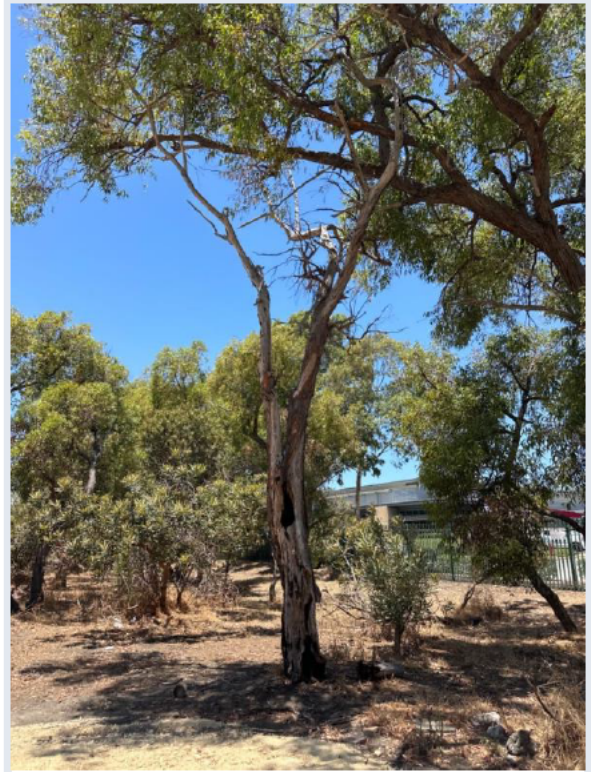
Jarrah Tree ID #79

Health: Good

Structure: Poor

Problems: Deadwood major >50,
Hollow, Basal decay,
Leaning, Multi Crown
leaders

Observation
Comments: 3 stems

Tree Work: No Works

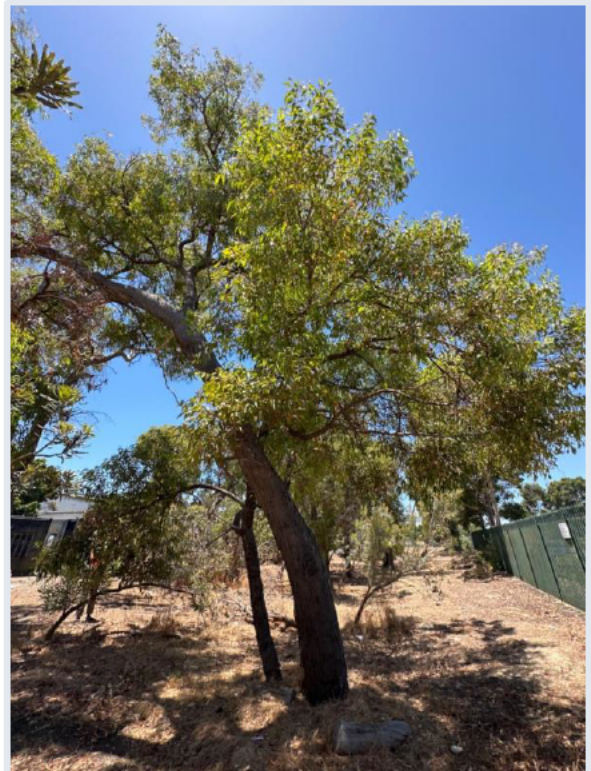
Candle Banksia Tree ID #80

Latin Name:	Banksia attenuata
Latitude:	-31.864801404383
Longitude:	115.81768692372
Tree Height (Estimated) [m]:	2.4
Canopy Spread [m]:	1
DBH [cm]:	8
Health:	Fair
Structure:	Very poor
Problems:	
Notes:	
Priority:	None
Tree Work:	No Works
Observation Comments:	
Tree Protection Zone (TPZ) [m]:	2
Structural Root Zone (SRZ) [m]:	1.26
Useful Life Expectancy:	1-5 years
Retention Value:	Low
Risk of Harm Number:	Not applicable

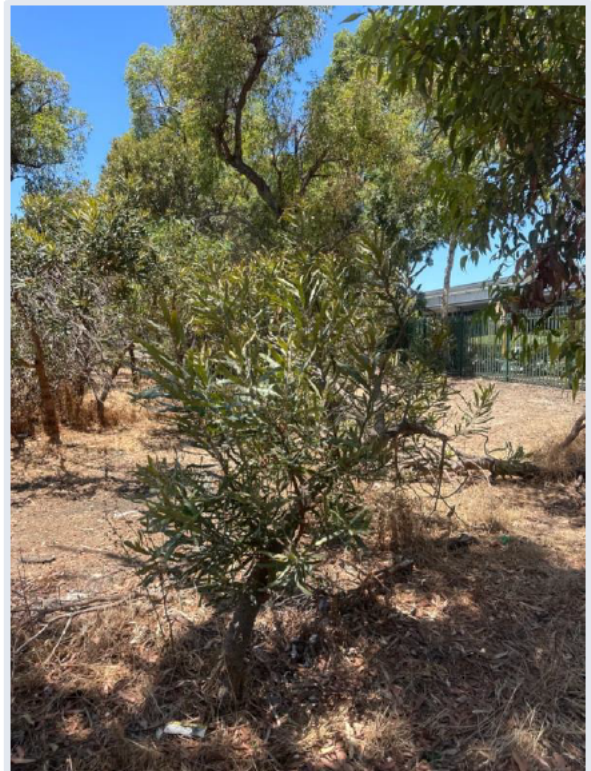
Candle Banksia Tree ID #81

Latin Name:	Banksia attenuata
Latitude:	-31.864848103163
Longitude:	115.81772313355
Tree Height (Estimated) [m]:	2.8
Canopy Spread [m]:	2
DBH [cm]:	8
Health:	Fair
Structure:	Poor
Problems:	Leaning
Notes:	
Priority:	None
Tree Work:	No Works
Observation Comments:	
Tree Protection Zone (TPZ) [m]:	2
Structural Root Zone (SRZ) [m]:	1.26
Useful Life Expectancy:	6-10 years
Retention Value:	Low
Risk of Harm Number:	Not applicable

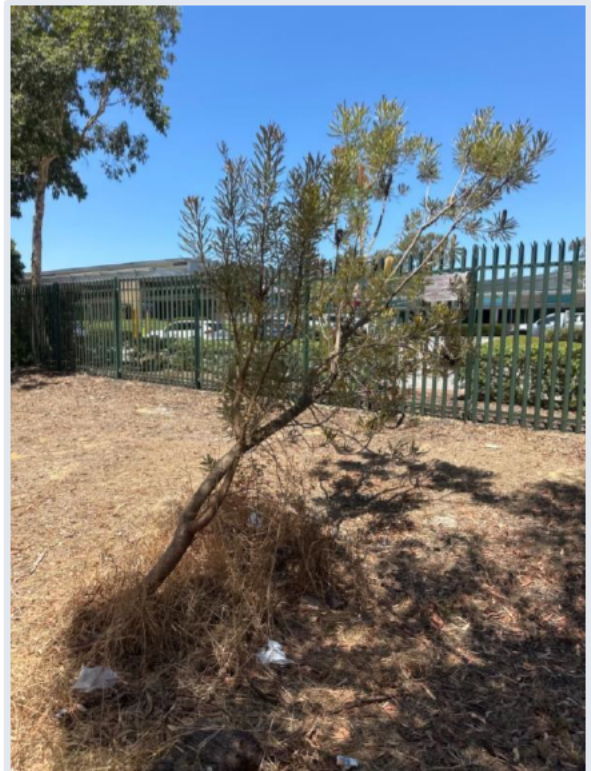
Jarraah Tree ID #82

Latin Name:	Eucalyptus marginata
Latitude:	-31.864820767294
Longitude:	115.81773386238
Tree Height (Estimated) [m]:	10.1
Canopy Spread [m]:	4
DBH [cm]:	30
Health:	Good
Structure:	Fair
Problems:	Deadwood minor <50, Epicormic growth, Leaning
Notes:	
Priority:	None
Tree Work:	No Works
Observation Comments:	
Tree Protection Zone (TPZ) [m]:	3.6
Structural Root Zone (SRZ) [m]:	2.2
Useful Life Expectancy:	40+ years
Retention Value:	High
Risk of Harm Number:	Not applicable

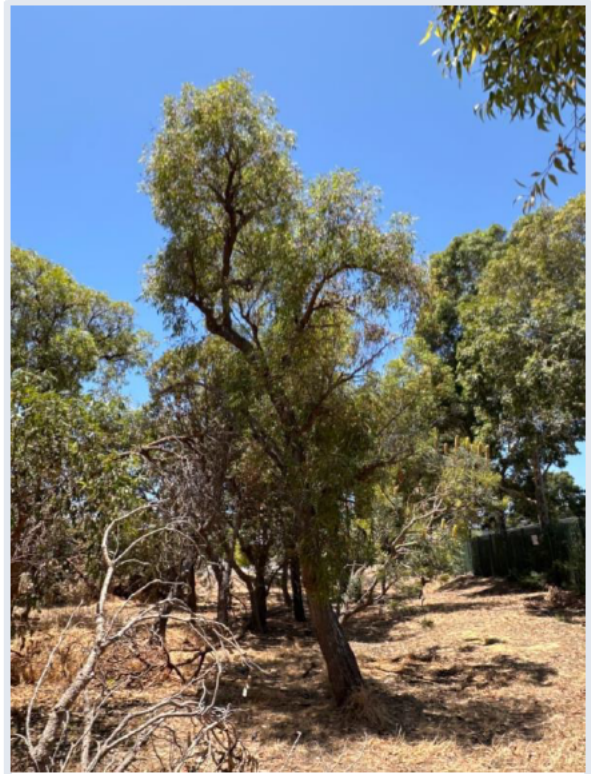
Candle Banksia Tree ID #83

Latin Name:	Banksia attenuata
Latitude:	-31.864777485487
Longitude:	115.81772983907
Tree Height (Estimated) [m]:	4
Canopy Spread [m]:	5
DBH [cm]:	12
Health:	Good
Structure:	Fair
Problems:	Codominant Stem, Leaning
Notes:	
Priority:	None
Tree Work:	No Works
Observation Comments:	
Tree Protection Zone (TPZ) [m]:	2
Structural Root Zone (SRZ) [m]:	1.49
Useful Life Expectancy:	11-20 years
Retention Value:	Medium
Risk of Harm Number:	Not applicable

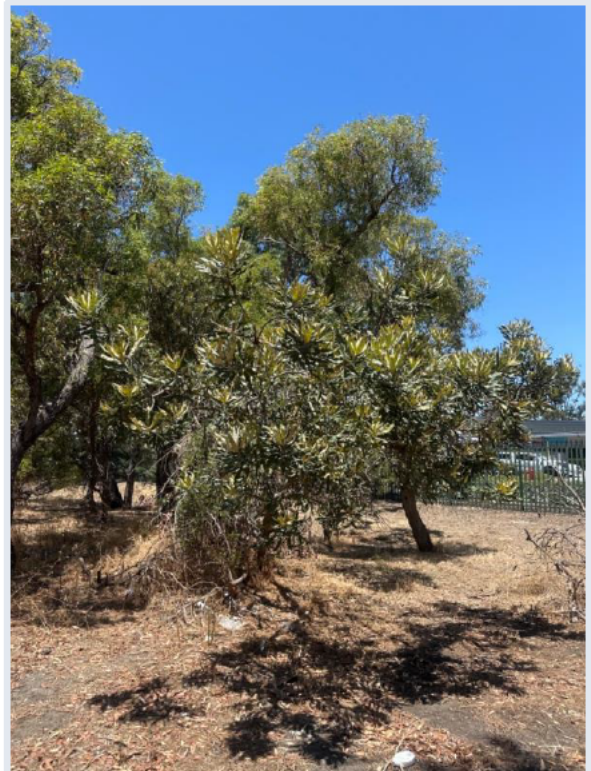
Jarraah Tree ID #84

Health: Good

Structure: Fair

Problems: Hollow, Deadwood
minor <50, Epicormic
growth, Basal
bifurcation, Leaning

Tree Work: No Works

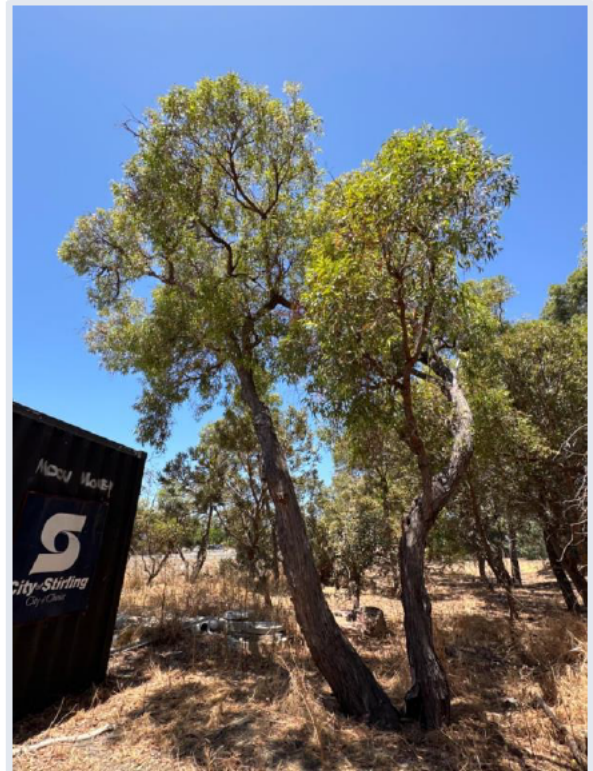
Banksia Tree ID #85

Latin Name:	Banksia species
Latitude:	-31.864833296235
Longitude:	115.81776739
Tree Height (Estimated) [m]:	4.5
Canopy Spread [m]:	0
DBH [cm]:	24
Health:	Dead
Structure:	Fair
Problems:	Deadwood major >50
Notes:	
Priority:	Low
Tree Work:	Remove Tree
Observation Comments:	2 dead banksias
Tree Protection Zone (TPZ) [m]:	2.88
Structural Root Zone (SRZ) [m]:	1.94
Useful Life Expectancy:	0 years
Retention Value:	Low
Risk of Harm Number:	Not applicable

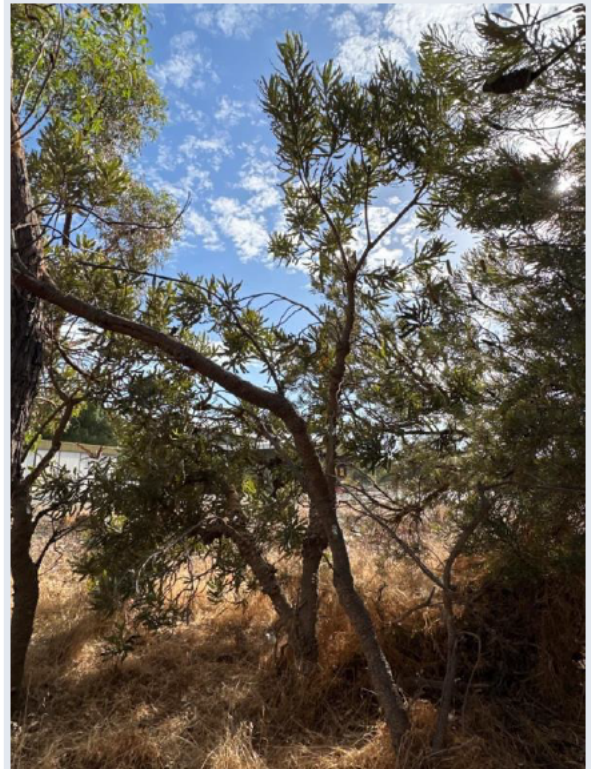
Jarraah Tree ID #86

Latin Name:	Eucalyptus marginata
Latitude:	-31.864879994998
Longitude:	115.81774190901
Tree Height (Estimated) [m]:	3
Canopy Spread [m]:	2
DBH [cm]:	8
Health:	Good
Structure:	Fair
Problems:	Hollow, Epicormic growth, Leaning
Notes:	
Priority:	None
Tree Work:	No Works
Observation Comments:	
Tree Protection Zone (TPZ) [m]:	2
Structural Root Zone (SRZ) [m]:	1.26
Useful Life Expectancy:	40+ years
Retention Value:	Medium
Risk of Harm Number:	Not applicable

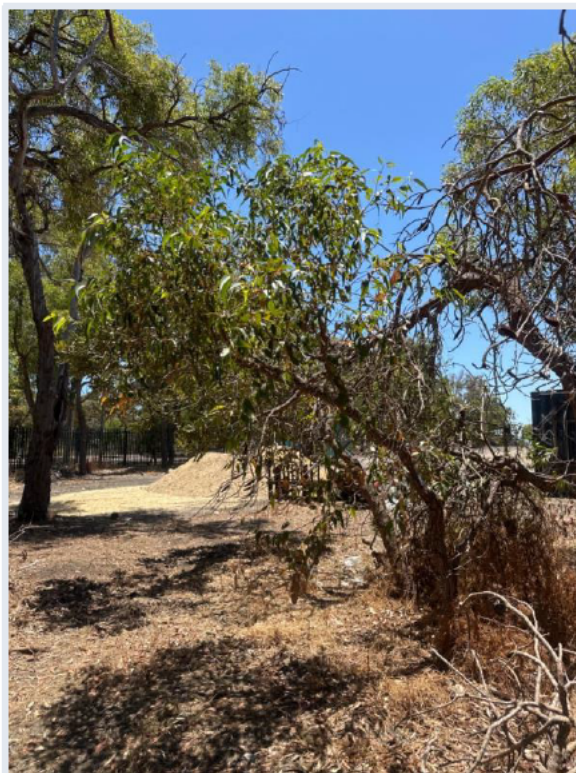
Candle Banksia Tree ID #87

Latin Name:	Banksia attenuata
Latitude:	-31.864864049082
Longitude:	115.81775800226
Tree Height (Estimated) [m]:	3.5
Canopy Spread [m]:	2.5
DBH [cm]:	13
Health:	Good
Structure:	Fair
Problems:	Leaning
Notes:	
Priority:	None
Tree Work:	No Works
Observation Comments:	
Tree Protection Zone (TPZ) [m]:	2
Structural Root Zone (SRZ) [m]:	1.68
Useful Life Expectancy:	6-10 years
Retention Value:	Low
Risk of Harm Number:	Not applicable

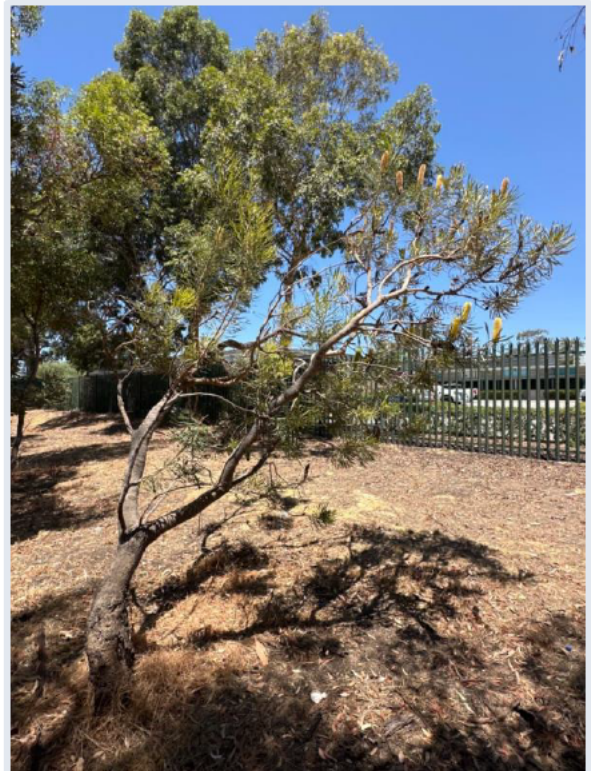
Yellow Gum Tree ID #88

Latin Name:	Eucalyptus leucoxylon
Latitude:	-31.863654308995
Longitude:	115.81735593753
Tree Height (Estimated) [m]:	5.8
Canopy Spread [m]:	5
DBH [cm]:	22.5
Health:	Good
Structure:	Fair
Problems:	Codominant Stem
Notes:	
Priority:	None
Tree Work:	No Works
Observation Comments:	
Tree Protection Zone (TPZ) [m]:	2.7
Structural Root Zone (SRZ) [m]:	1.91
Useful Life Expectancy:	11-20 years
Retention Value:	High
Risk of Harm Number:	Not applicable

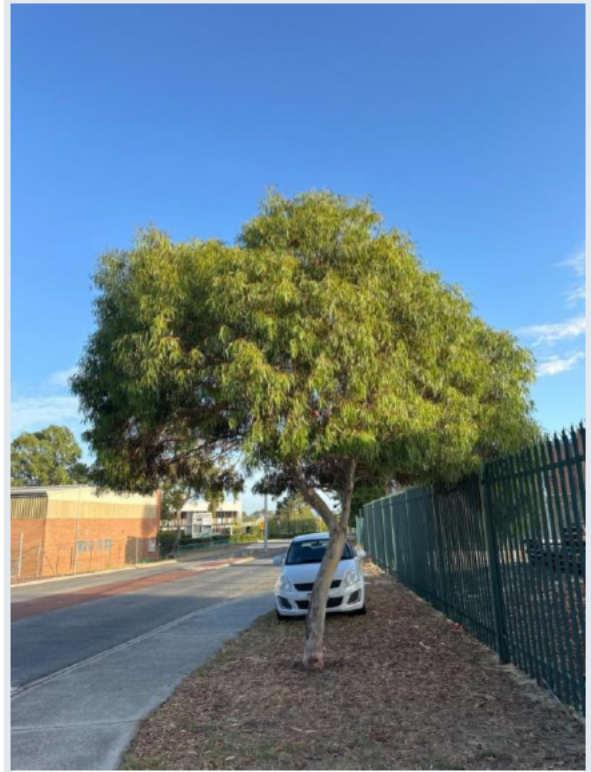
Yellow Gum Tree ID #89

Latin Name:	Eucalyptus leucoxylon
Latitude:	-31.863962979941
Longitude:	115.81735258477
Tree Height (Estimated) [m]:	6.2
Canopy Spread [m]:	6
DBH [cm]:	25
Health:	Good
Structure:	Fair
Problems:	Codominant Stem
Notes:	
Priority:	Low
Tree Work:	Canopy lift
Observation Comments:	
Tree Protection Zone (TPZ) [m]:	3
Structural Root Zone (SRZ) [m]:	1.95
Useful Life Expectancy:	11-20 years
Retention Value:	High
Risk of Harm Number:	Not applicable

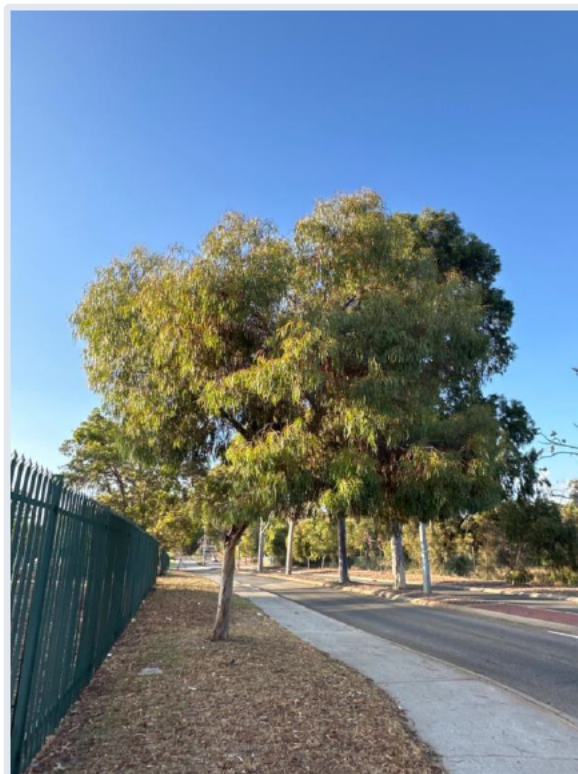
Marri Tree ID #90

Latin Name:	Corymbia calophylla
Latitude:	-31.864206726747
Longitude:	115.81739617067
Tree Height (Estimated) [m]:	11.2
Canopy Spread [m]:	8
DBH [cm]:	47.23
Health:	Fair
Structure:	Fair
Problems:	Codominant Stem, Deadwood minor <50, Epicormic growth, Secondary stem
Notes:	
Priority:	None
Tree Work:	No Works
Observation Comments:	
Tree Protection Zone (TPZ) [m]:	5.67
Structural Root Zone (SRZ) [m]:	3.06
Useful Life Expectancy:	11-20 years
Retention Value:	High
Risk of Harm Number:	Not applicable

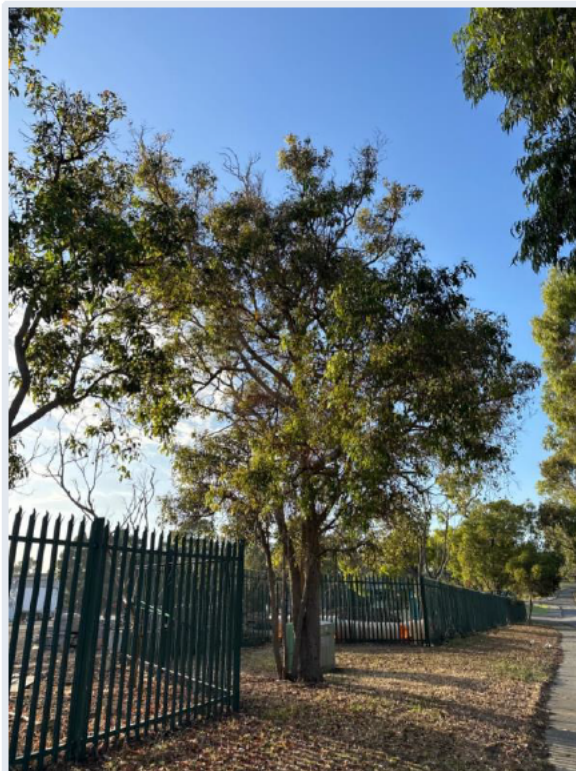
Yellow Gum Tree ID #91

Latin Name:	Eucalyptus leucoxylon
Latitude:	-31.864490689674
Longitude:	115.81735022451
Tree Height (Estimated) [m]:	6.5
Canopy Spread [m]:	4
DBH [cm]:	17.5
Health:	Good
Structure:	Fair
Problems:	Codominant Stem
Notes:	
Priority:	None
Tree Work:	No Works
Observation Comments:	
Tree Protection Zone (TPZ) [m]:	2.1
Structural Root Zone (SRZ) [m]:	1.7
Useful Life Expectancy:	11-20 years
Retention Value:	High
Risk of Harm Number:	Not applicable

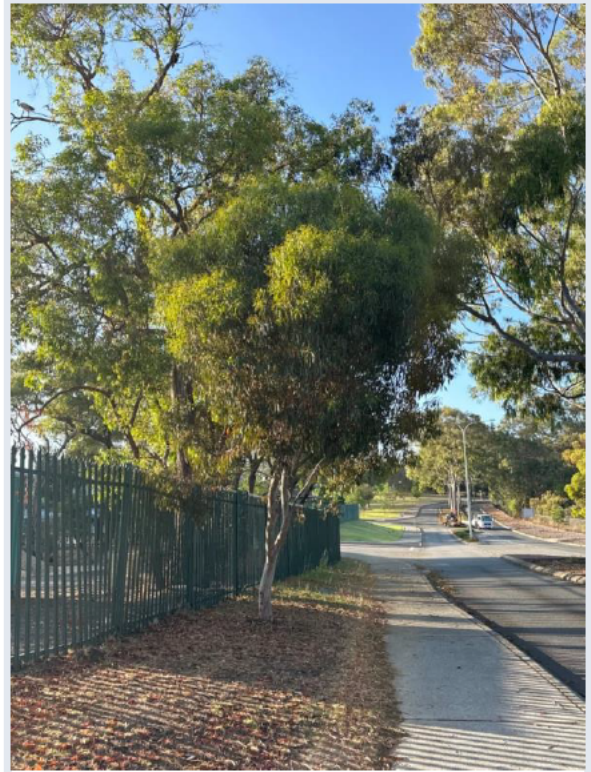
Jarraah Tree ID #92

Latin Name:	Eucalyptus marginata
Latitude:	-31.864845123739
Longitude:	115.81740800751
Tree Height (Estimated) [m]:	6.5
Canopy Spread [m]:	4
DBH [cm]:	47
Health:	Good
Structure:	Fair
Problems:	Codominant Stem, Deadwood minor <50, Included bark, Leaning
Notes:	
Priority:	None
Tree Work:	No Works
Observation Comments:	
Tree Protection Zone (TPZ) [m]:	5.64
Structural Root Zone (SRZ) [m]:	2.45
Useful Life Expectancy:	11-20 years
Retention Value:	High
Risk of Harm Number:	Not applicable

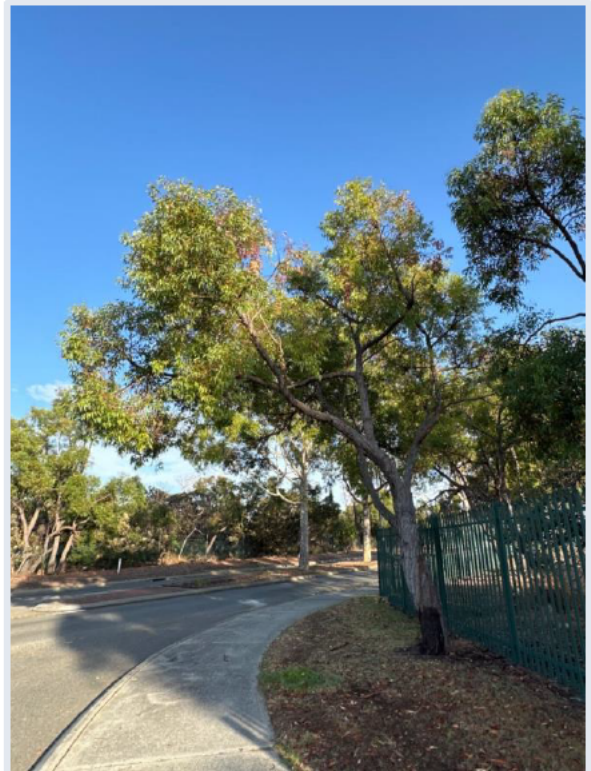
Lemon Scented Gum Tree ID #93

Latin Name:	Corymbia citriodora
Latitude:	-31.864706166321
Longitude:	115.81726719153
Tree Height (Estimated) [m]:	18
Canopy Spread [m]:	16
DBH [cm]:	56
Health:	Good
Structure:	Fair
Problems:	Codominant Stem
Notes:	
Priority:	None
Tree Work:	No Works
Observation Comments:	
Tree Protection Zone (TPZ) [m]:	6.72
Structural Root Zone (SRZ) [m]:	2.81
Useful Life Expectancy:	40+ years
Retention Value:	Very high
Risk of Harm Number:	Not applicable

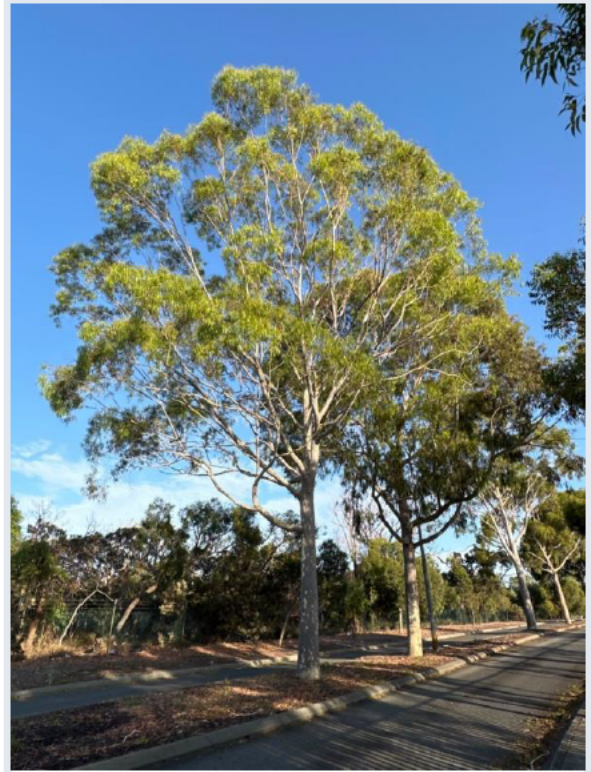
Lemon Scented Gum Tree ID #94

Latin Name:	Corymbia citriodora
Latitude:	-31.864623019568
Longitude:	115.81727590871
Tree Height (Estimated) [m]:	20.6
Canopy Spread [m]:	16
DBH [cm]:	52
Health:	Good
Structure:	Fair
Problems:	
Notes:	
Priority:	None
Tree Work:	No Works
Observation Comments:	
Tree Protection Zone (TPZ) [m]:	6.24
Structural Root Zone (SRZ) [m]:	2.65
Useful Life Expectancy:	40+ years
Retention Value:	Very high
Risk of Harm Number:	Not applicable

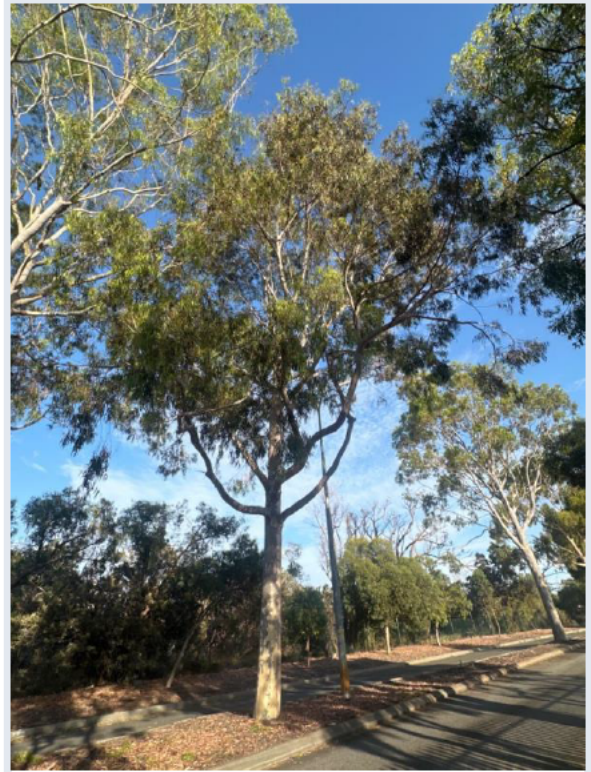
Lemon Scented Gum Tree ID #95

Latin Name:	Corymbia citriodora
Latitude:	-31.864445335847
Longitude:	115.81725981546
Tree Height (Estimated) [m]:	19.2
Canopy Spread [m]:	12
DBH [cm]:	59
Health:	Good
Structure:	Fair
Problems:	Deadwood major >50, Infrastructure damage kerb
Notes:	
Priority:	None
Tree Work:	No Works
Observation Comments:	
Tree Protection Zone (TPZ) [m]:	7.08
Structural Root Zone (SRZ) [m]:	2.9
Useful Life Expectancy:	40+ years
Retention Value:	Very high
Risk of Harm Number:	Not applicable

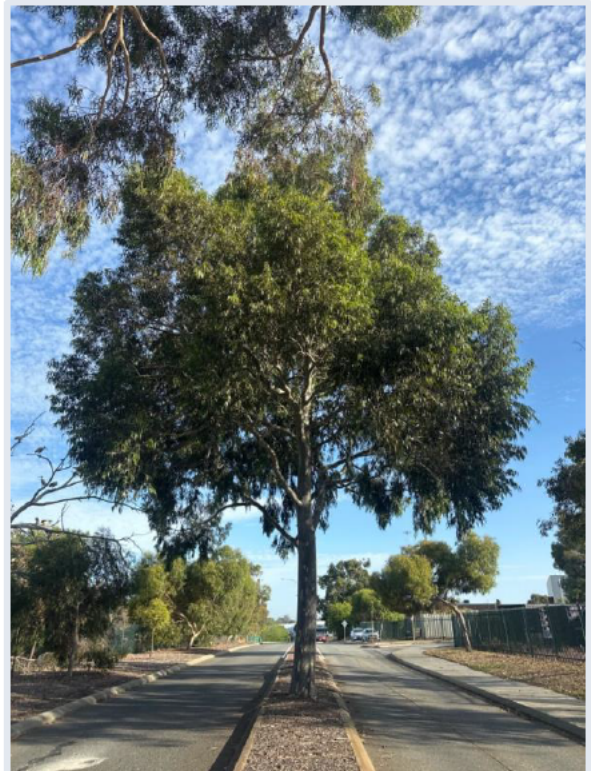
Spotted Gum Tree ID #98

Latin Name:	Corymbia maculata
Latitude:	-31.864054658255
Longitude:	115.81725981546
Tree Height (Estimated) [m]:	17.4
Canopy Spread [m]:	13
DBH [cm]:	56
Health:	Good
Structure:	Fair
Problems:	
Notes:	
Priority:	None
Tree Work:	No Works
Observation Comments:	
Tree Protection Zone (TPZ) [m]:	6.72
Structural Root Zone (SRZ) [m]:	2.76
Useful Life Expectancy:	40+ years
Retention Value:	Very high
Risk of Harm Number:	Not applicable

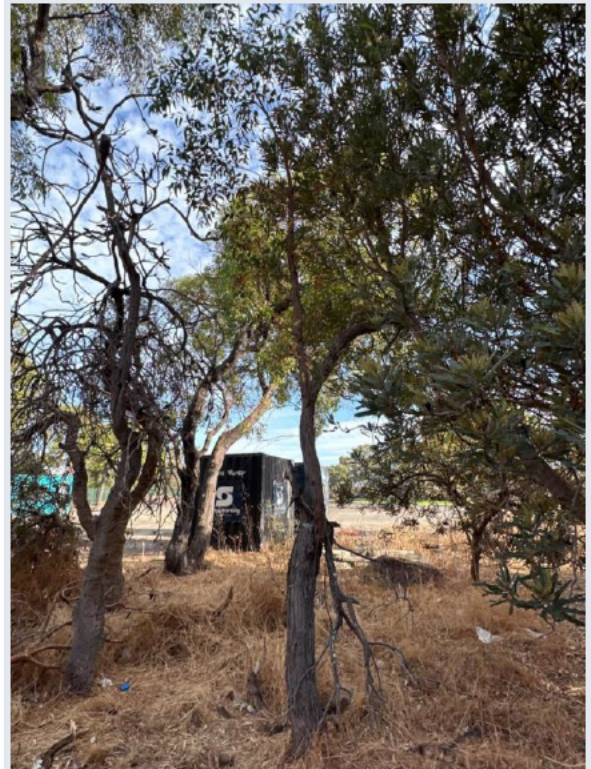
Jarraah Tree ID #102

Latin Name:	Eucalyptus marginata
Latitude:	-31.864887967956
Longitude:	115.81778750656
Tree Height (Estimated) [m]:	6.1
Canopy Spread [m]:	3
DBH [cm]:	24
Health:	Good
Structure:	Poor
Problems:	Epicormic growth
Notes:	
Priority:	None
Tree Work:	No Works
Observation Comments:	
Tree Protection Zone (TPZ) [m]:	2.88
Structural Root Zone (SRZ) [m]:	2
Useful Life Expectancy:	40+ years
Retention Value:	Medium
Risk of Harm Number:	Not applicable

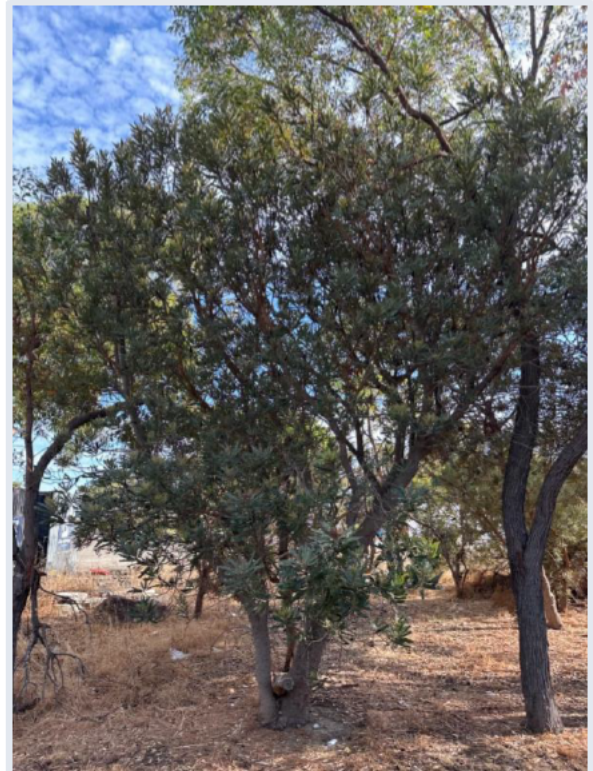
Firewood Banksia Tree ID #103

Latin Name:	Banksia menziesii
Latitude:	-31.864890245943
Longitude:	115.81786529062
Tree Height (Estimated) [m]:	7.4
Canopy Spread [m]:	8
DBH [cm]:	32.45
Health:	Good
Structure:	Fair
Problems:	Secondary stem
Notes:	
Priority:	None
Tree Work:	No Works
Observation Comments:	
Tree Protection Zone (TPZ) [m]:	3.89
Structural Root Zone (SRZ) [m]:	2.57
Useful Life Expectancy:	11-20 years
Retention Value:	High
Risk of Harm Number:	Not applicable

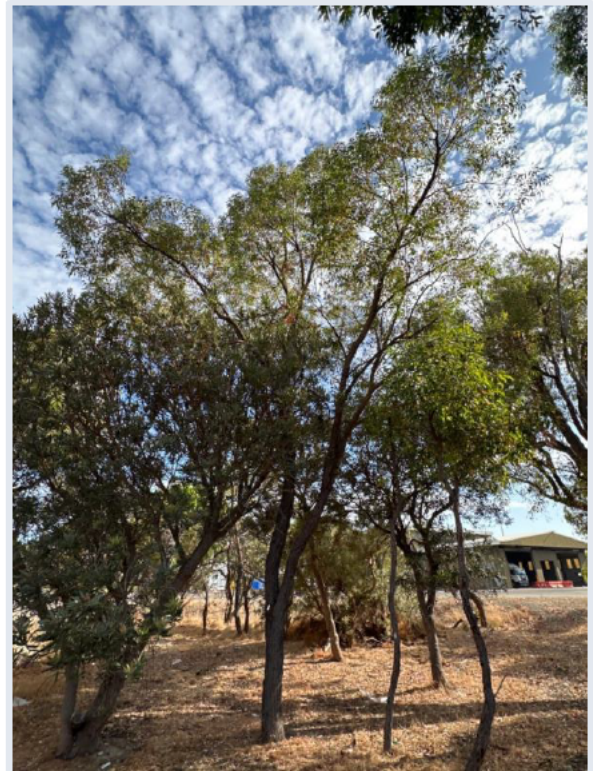
Jarraah Tree ID #107

Latin Name:	Eucalyptus marginata
Latitude:	-31.864853798134
Longitude:	115.81786797283
Tree Height (Estimated) [m]:	10.1
Canopy Spread [m]:	7
DBH [cm]:	30
Health:	Good
Structure:	Fair
Problems:	Codominant Stem
Notes:	
Priority:	None
Tree Work:	No Works
Observation Comments:	
Tree Protection Zone (TPZ) [m]:	3.6
Structural Root Zone (SRZ) [m]:	2.1
Useful Life Expectancy:	40+ years
Retention Value:	Very high
Risk of Harm Number:	Not applicable

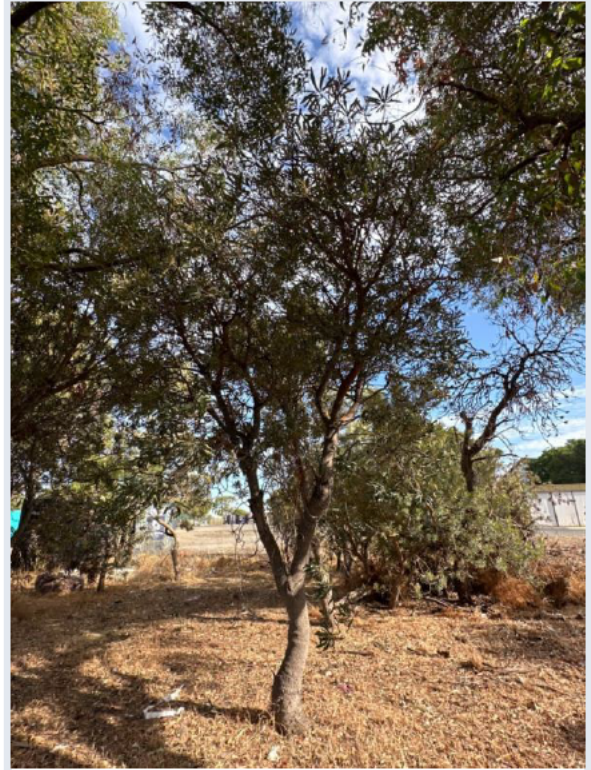
Firewood Banksia Tree ID #110

Latin Name:	Banksia menziesii
Latitude:	-31.864843547185
Longitude:	115.81780628203
Tree Height (Estimated) [m]:	6.7
Canopy Spread [m]:	4.5
DBH [cm]:	26
Health:	Good
Structure:	Good
Problems:	Codominant Stem
Notes:	
Priority:	None
Tree Work:	No Works
Observation Comments:	
Tree Protection Zone (TPZ) [m]:	3.12
Structural Root Zone (SRZ) [m]:	2.02
Useful Life Expectancy:	11-20 years
Retention Value:	High
Risk of Harm Number:	Not applicable

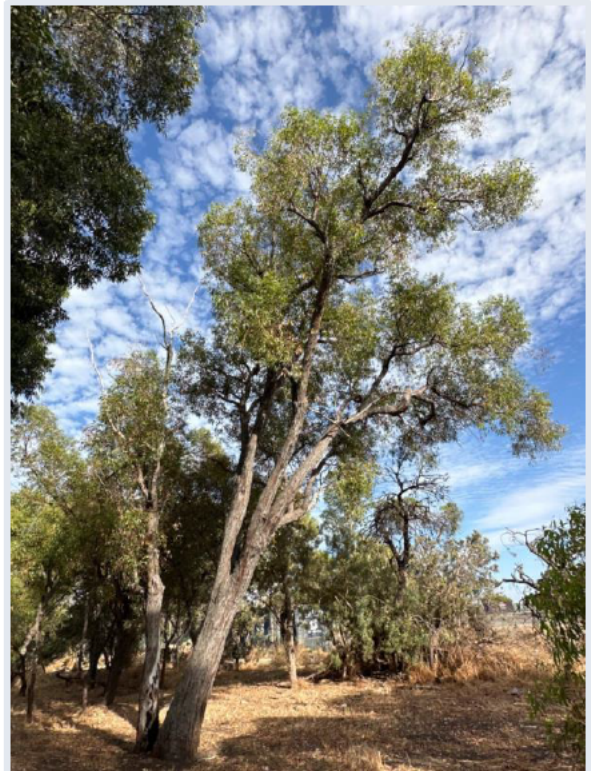
Jarraah Tree ID #111

Health: Fair

Structure: Fair

Problems: Codominant Stem,
Deadwood major >50,
Hanging branch, Basal
decay, Deadwood
minor <50, Epicormic
growth, Leaning, Fire
damage, Secondary
stem

Priority: Low

Tree Work: Remove hanger

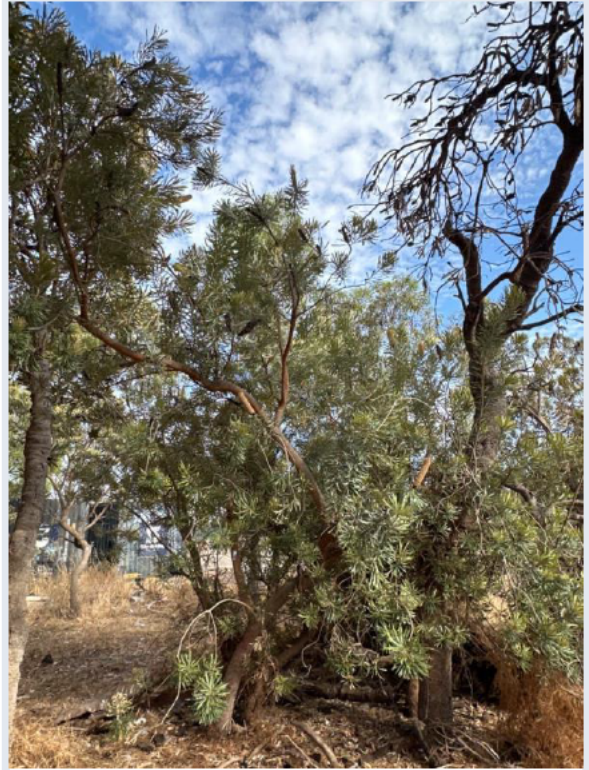
Candle Banksia Tree ID #113

Latin Name:	Banksia attenuata
Latitude:	-31.864816211316
Longitude:	115.81781969307
Tree Height (Estimated) [m]:	5
Canopy Spread [m]:	2.5
DBH [cm]:	17.2
Health:	Good
Structure:	Fair
Problems:	Secondary stem
Notes:	
Priority:	None
Tree Work:	No Works
Observation Comments:	
Tree Protection Zone (TPZ) [m]:	2.06
Structural Root Zone (SRZ) [m]:	1.57
Useful Life Expectancy:	6-10 years
Retention Value:	Medium
Risk of Harm Number:	Not applicable

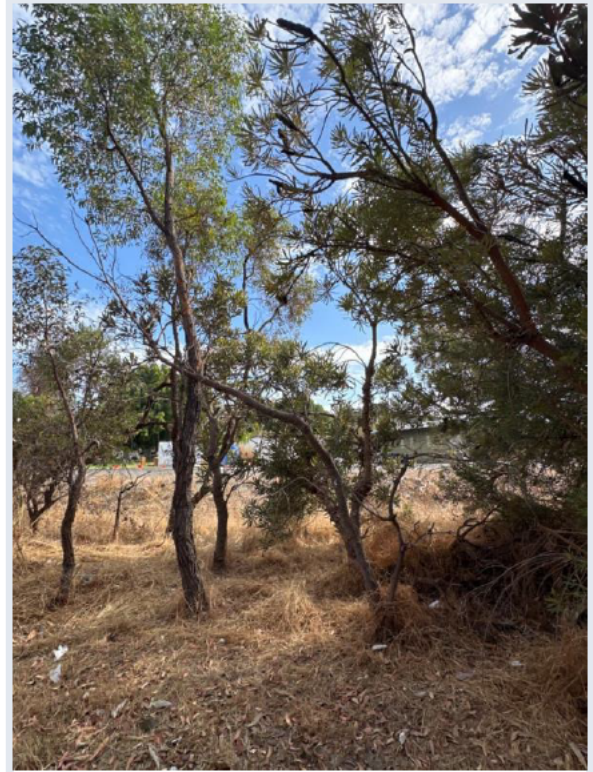
Banksia Tree ID #115

Latin Name:	Banksia species
Latitude:	-31.864785458453
Longitude:	115.81778884767
Tree Height (Estimated) [m]:	4
Canopy Spread [m]:	0
DBH [cm]:	8
Health:	Dead
Structure:	Fair
Problems:	Deadwood major >50
Notes:	
Priority:	Low
Tree Work:	Remove Tree
Observation Comments:	
Tree Protection Zone (TPZ) [m]:	2
Structural Root Zone (SRZ) [m]:	1.36
Useful Life Expectancy:	0 years
Retention Value:	Low
Risk of Harm Number:	Not applicable
