Arboricultural Report - Balcatta Recycling Centre

December 13, 2024
Total Tree Count:
145

Brief

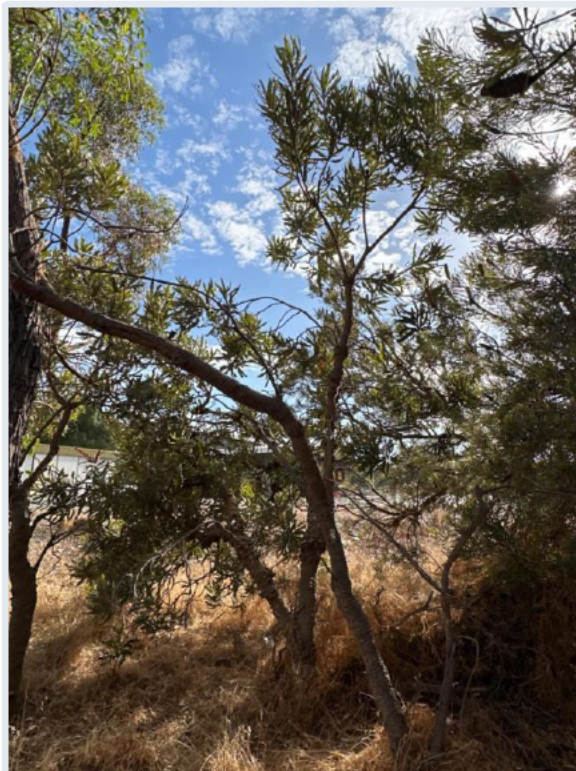
Candle Banksia Tree ID #116

Problems: Codominant Stem

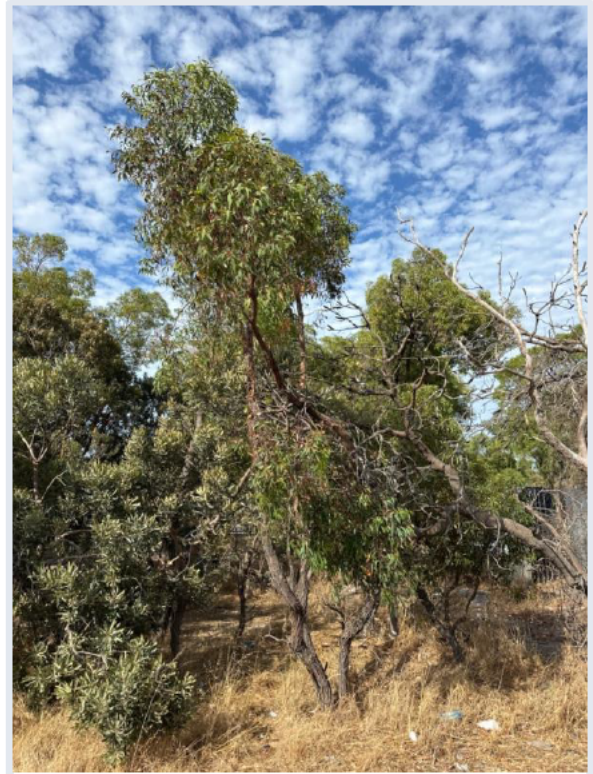
Jarraah Tree ID #120

Latin Name:	Eucalyptus marginata
Latitude:	-31.864729647675
Longitude:	115.81775934337
Tree Height (Estimated) [m]:	8.3
Canopy Spread [m]:	3
DBH [cm]:	23.15
Health:	Good
Structure:	Fair
Problems:	Multi Crown leaders
Notes:	
Priority:	None
Tree Work:	No Works
Observation Comments:	
Tree Protection Zone (TPZ) [m]:	2.78
Structural Root Zone (SRZ) [m]:	1.88
Useful Life Expectancy:	40+ years
Retention Value:	High
Risk of Harm Number:	Not applicable

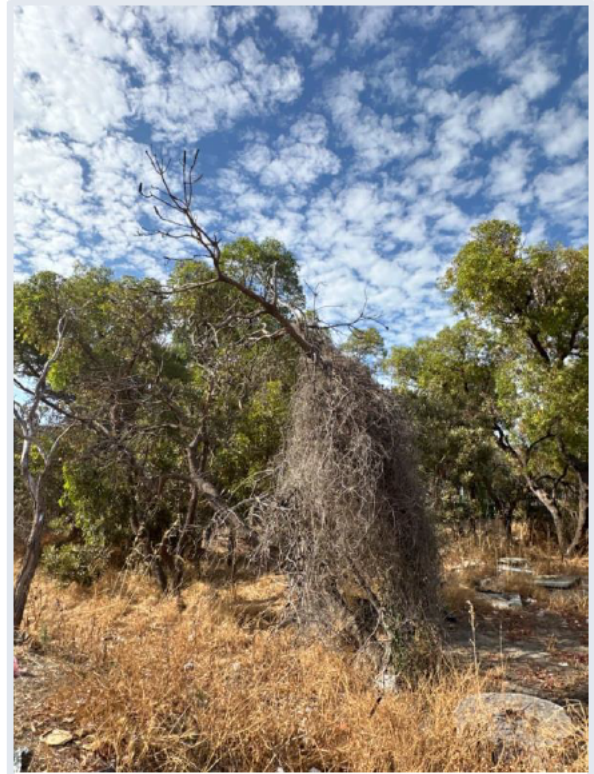
Banksia Tree ID #122

Latin Name:	Banksia species
Latitude:	-31.864734203659
Longitude:	115.81780494092
Tree Height (Estimated) [m]:	6
Canopy Spread [m]:	0
DBH [cm]:	35.38
Health:	Dead
Structure:	Fair
Problems:	Deadwood major >50
Notes:	
Priority:	Low
Tree Work:	Remove Tree
Observation Comments:	
Tree Protection Zone (TPZ) [m]:	4.25
Structural Root Zone (SRZ) [m]:	2.05
Useful Life Expectancy:	0 years
Retention Value:	Low
Risk of Harm Number:	Not applicable

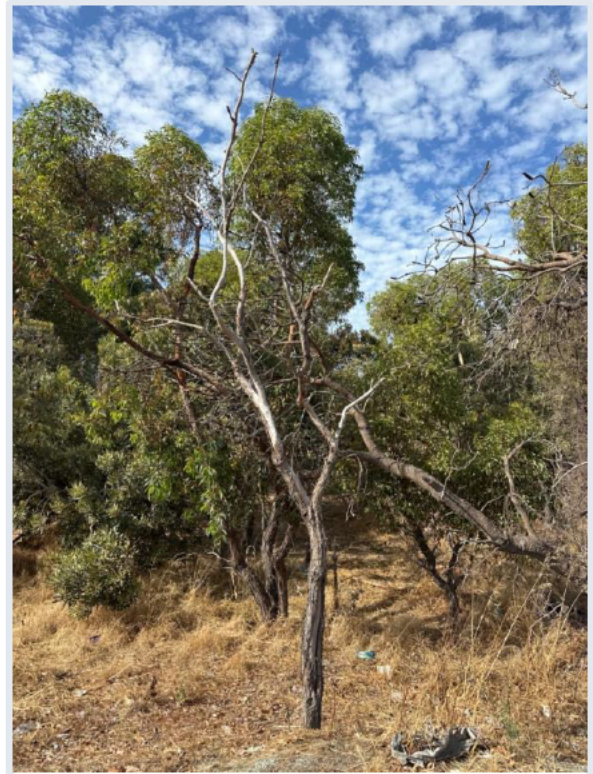
Jarrah Tree ID #123

Latin Name:	Eucalyptus marginata
Latitude:	-31.864763817543
Longitude:	115.81783846853
Tree Height (Estimated) [m]:	5
Canopy Spread [m]:	0
DBH [cm]:	14
Health:	Dead
Structure:	Fair
Problems:	Deadwood major >50
Notes:	
Priority:	Low
Tree Work:	Remove Tree
Observation Comments:	
Tree Protection Zone (TPZ) [m]:	2
Structural Root Zone (SRZ) [m]:	1.49
Useful Life Expectancy:	0 years
Retention Value:	Low
Risk of Harm Number:	Not applicable

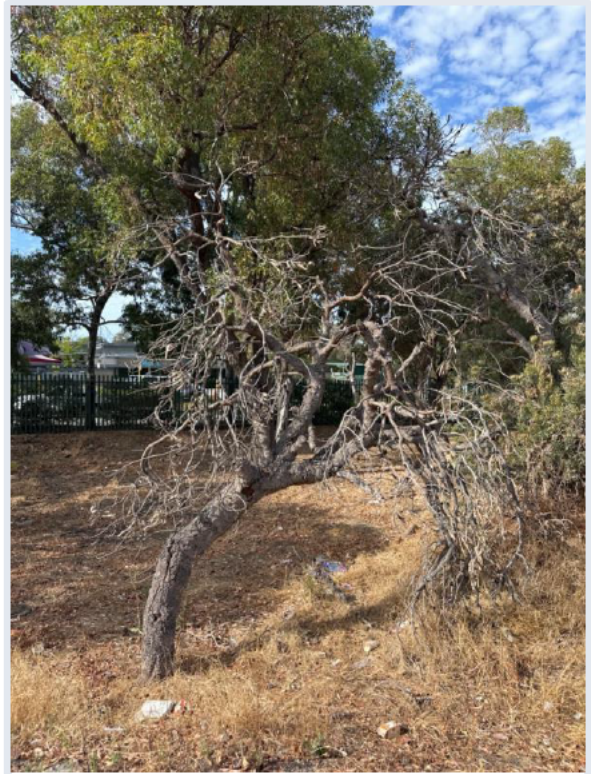
Jarraah Tree ID #124

Latin Name:	Eucalyptus marginata
Latitude:	-31.864845825174
Longitude:	115.8179162526
Tree Height (Estimated) [m]:	5
Canopy Spread [m]:	0
DBH [cm]:	36
Health:	Dead
Structure:	Fair
Problems:	Deadwood major >50
Notes:	
Priority:	Low
Tree Work:	Remove Tree
Observation Comments:	
Tree Protection Zone (TPZ) [m]:	4.32
Structural Root Zone (SRZ) [m]:	2.05
Useful Life Expectancy:	0 years
Retention Value:	Low
Risk of Harm Number:	Not applicable

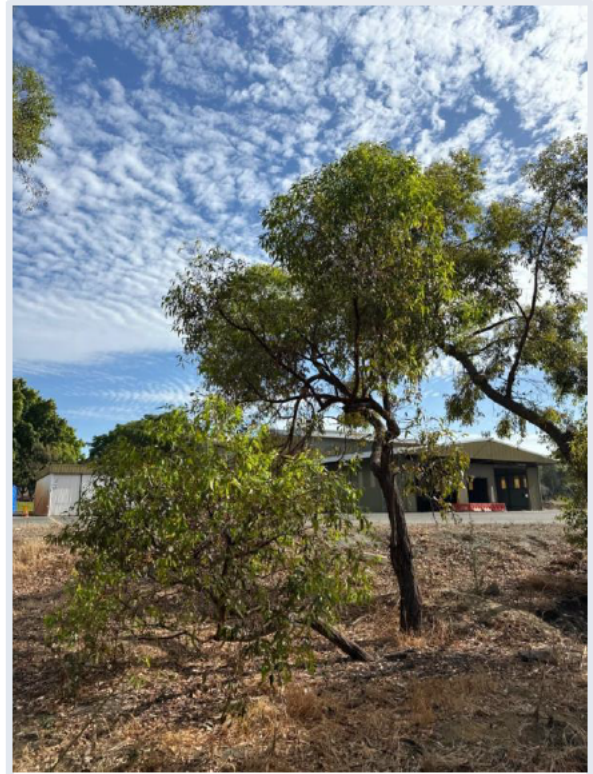
Jarraah Tree ID #125

Latin Name:	Eucalyptus marginata
Latitude:	-31.864860632099
Longitude:	115.81784249185
Tree Height (Estimated) [m]:	6.8
Canopy Spread [m]:	10.5
DBH [cm]:	26.93
Health:	Good
Structure:	Poor
Problems:	Secondary stem
Notes:	
Priority:	None
Tree Work:	No Works
Observation Comments:	
Tree Protection Zone (TPZ) [m]:	3.23
Structural Root Zone (SRZ) [m]:	2
Useful Life Expectancy:	40+ years
Retention Value:	High
Risk of Harm Number:	Not applicable

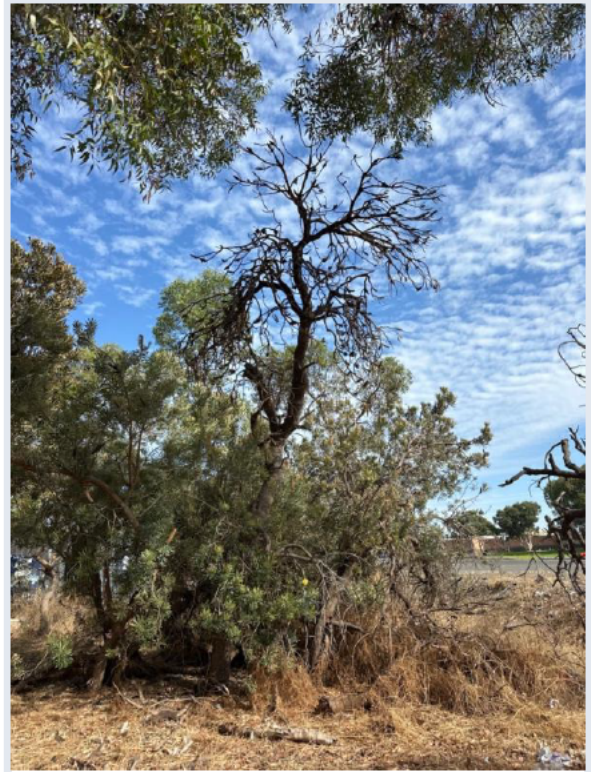
Banksia Tree ID #126

Latin Name:	Banksia species
Latitude:	-31.864821906289
Longitude:	115.81792966364
Tree Height (Estimated) [m]:	8
Canopy Spread [m]:	0
DBH [cm]:	20
Health:	Dead
Structure:	Poor
Problems:	Deadwood major >50
Notes:	
Priority:	Low
Tree Work:	Remove Tree
Observation Comments:	
Tree Protection Zone (TPZ) [m]:	2.4
Structural Root Zone (SRZ) [m]:	2.02
Useful Life Expectancy:	0 years
Retention Value:	Low
Risk of Harm Number:	Not applicable

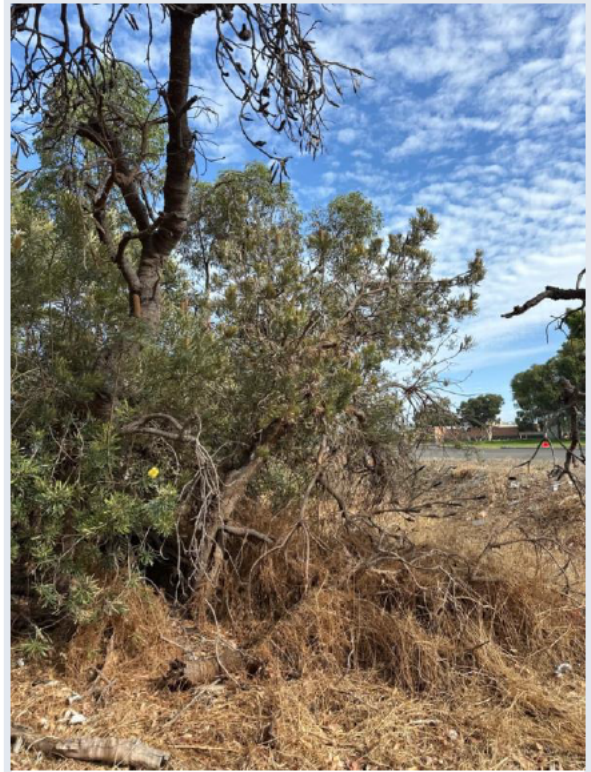
Candle Banksia Tree ID #127

Latin Name:	Banksia attenuata
Latitude:	-31.864824184278
Longitude:	115.81787199615
Tree Height (Estimated) [m]:	4.1
Canopy Spread [m]:	2
DBH [cm]:	23
Health:	Fair
Structure:	Poor
Problems:	
Notes:	
Priority:	None
Tree Work:	No Works
Observation Comments:	
Tree Protection Zone (TPZ) [m]:	2.76
Structural Root Zone (SRZ) [m]:	1.88
Useful Life Expectancy:	11-20 years
Retention Value:	Medium
Risk of Harm Number:	Not applicable

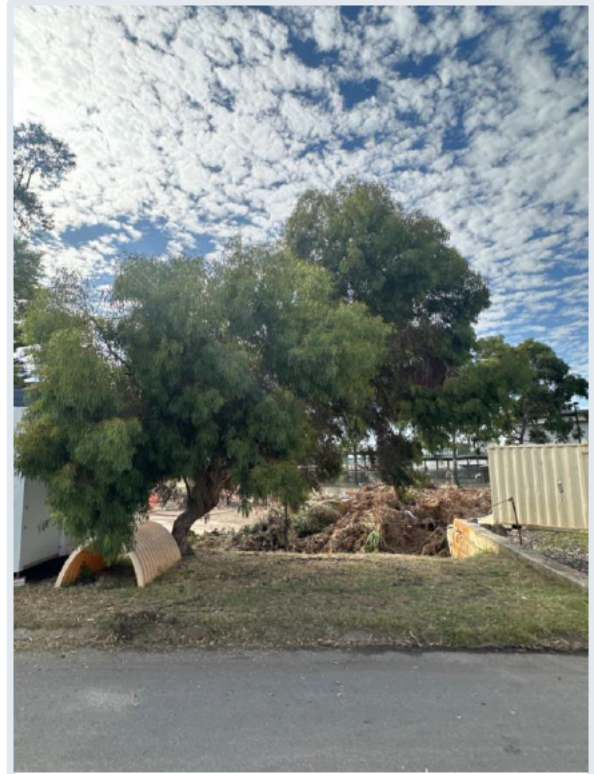
Latin Name:	Eucalyptus leucoxylon
Latitude:	-31.864672153702
Longitude:	115.81919333904
Tree Height (Estimated) [m]:	8.7
Canopy Spread [m]:	9.5
DBH [cm]:	33
Health:	Good
Structure:	Poor
Problems:	Codominant Stem, Epicormic growth, Leaning
Notes:	
Priority:	Low
Tree Work:	Canopy lift
Observation Comments:	
Tree Protection Zone (TPZ) [m]:	3.96
Structural Root Zone (SRZ) [m]:	2.49
Useful Life Expectancy:	20-40 years
Retention Value:	High
Risk of Harm Number:	Not applicable

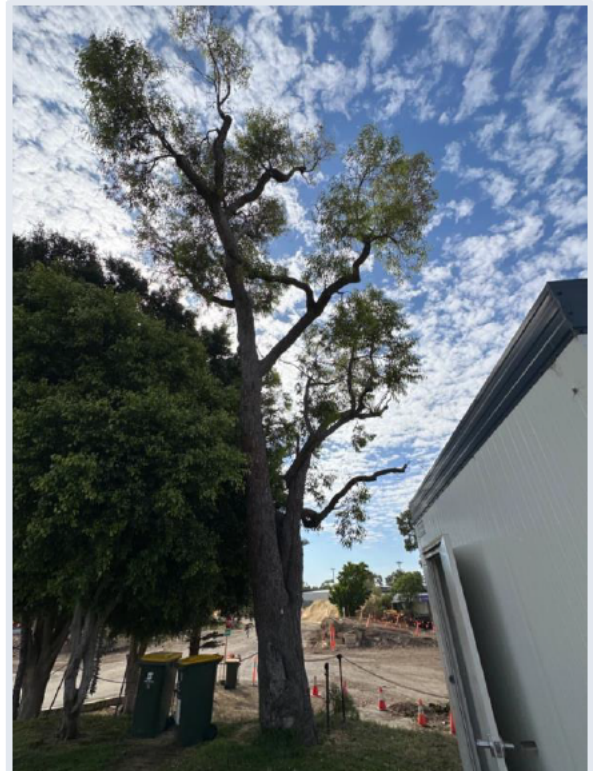
Jarraah Tree ID #130

Problems: Codominant Stem, Basal decay, Deadwood minor <50, Epicormic growth

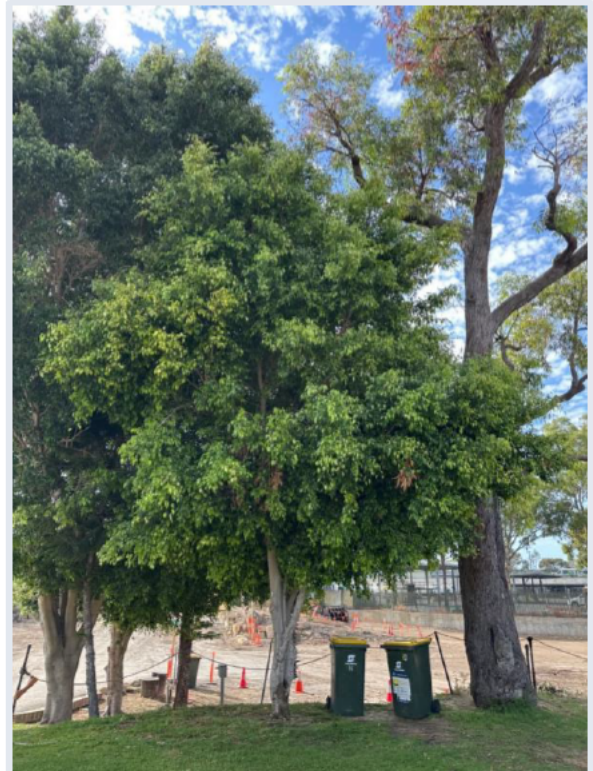
Weeping Fig Tree ID #131

Latin Name:	Ficus benjamina
Latitude:	-31.864651651762
Longitude:	115.819359636
Tree Height (Estimated) [m]:	7.5
Canopy Spread [m]:	6
DBH [cm]:	27.8
Health:	Good
Structure:	Fair
Problems:	Codominant Stem
Notes:	
Priority:	None
Tree Work:	No Works
Observation Comments:	
Tree Protection Zone (TPZ) [m]:	3.34
Structural Root Zone (SRZ) [m]:	2
Useful Life Expectancy:	40+ years
Retention Value:	High
Risk of Harm Number:	Not applicable

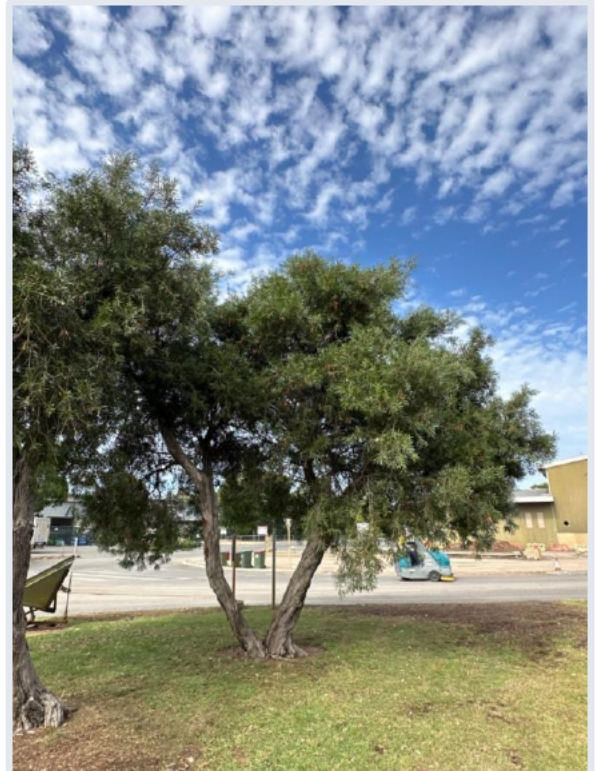
kings park special Tree ID #133

Latin Name:	Callistemon Kings Park Special
Latitude:	-31.864370929327
Longitude:	115.81927714884
Tree Height (Estimated) [m]:	5.3
Canopy Spread [m]:	6
DBH [cm]:	35.81
Health:	Good
Structure:	Fair
Problems:	Basal bifurcation
Notes:	
Priority:	None
Tree Work:	No Works
Observation Comments:	
Tree Protection Zone (TPZ) [m]:	4.3
Structural Root Zone (SRZ) [m]:	2.74
Useful Life Expectancy:	6-10 years
Retention Value:	Medium
Risk of Harm Number:	Not applicable

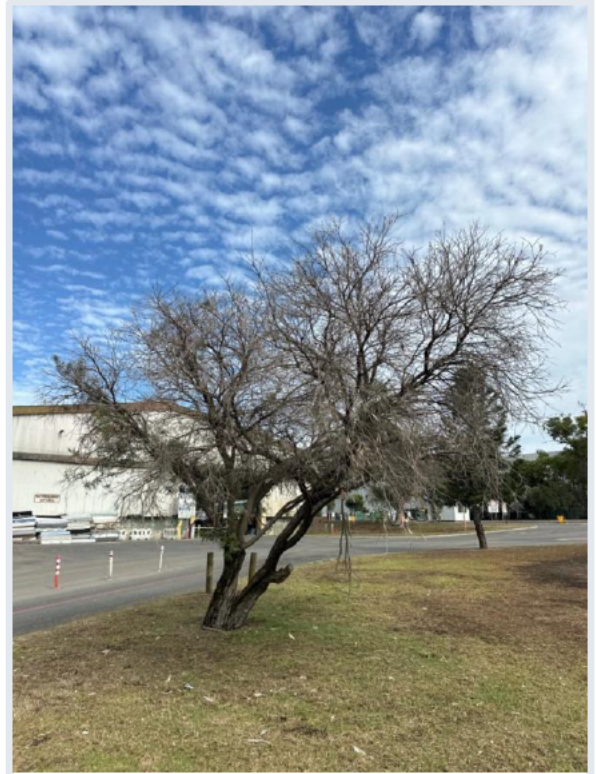
kings park special Tree ID #134

Latin Name:	Callistemon Kings Park Special
Latitude:	-31.864236527201
Longitude:	115.819176566
Tree Height (Estimated) [m]:	5.2
Canopy Spread [m]:	0
DBH [cm]:	32.45
Health:	Dead
Structure:	Fair
Problems:	Deadwood major >50
Notes:	
Priority:	Low
Tree Work:	Remove Tree
Observation Comments:	
Tree Protection Zone (TPZ) [m]:	3.89
Structural Root Zone (SRZ) [m]:	2.69
Useful Life Expectancy:	0 years
Retention Value:	Low
Risk of Harm Number:	Not applicable

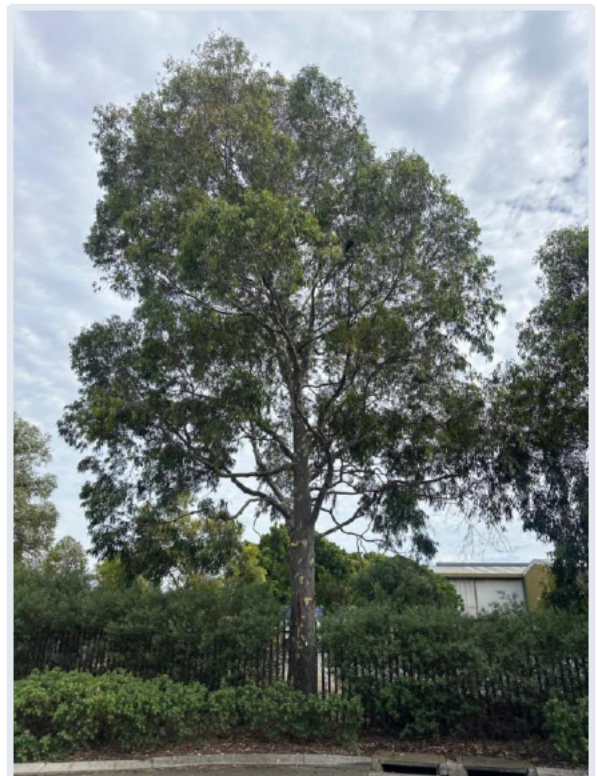
Spotted Gum Tree ID #135

Latin Name:	Corymbia maculata
Latitude:	-31.864984206589
Longitude:	115.81806183051
Tree Height (Estimated) [m]:	19.2
Canopy Spread [m]:	11
DBH [cm]:	59
Health:	Good
Structure:	Fair
Problems:	Deadwood minor <50
Notes:	
Priority:	None
Tree Work:	No Works
Observation Comments:	
Tree Protection Zone (TPZ) [m]:	7.08
Structural Root Zone (SRZ) [m]:	2.95
Useful Life Expectancy:	40+ years
Retention Value:	Very high
Risk of Harm Number:	Not applicable

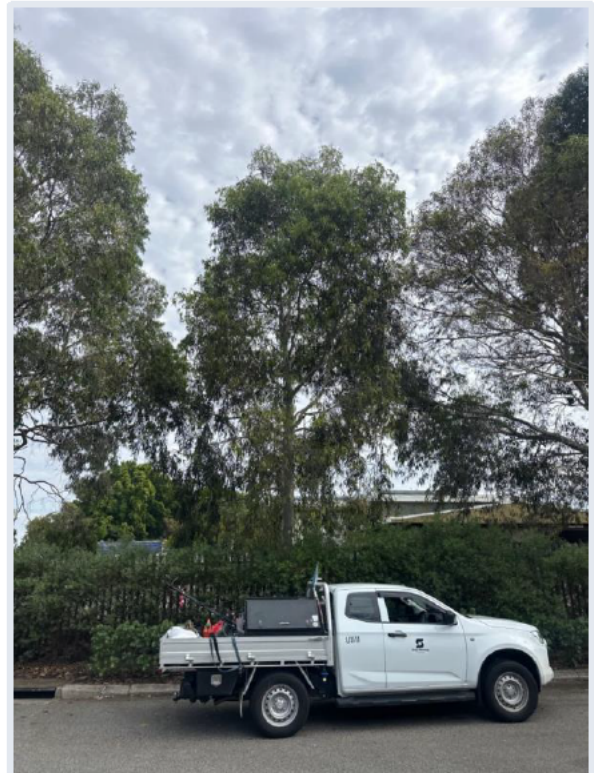
Spotted Gum Tree ID #136

Latin Name:	Corymbia maculata
Latitude:	-31.864996735507
Longitude:	115.81816040169
Tree Height (Estimated) [m]:	10.9
Canopy Spread [m]:	4.5
DBH [cm]:	27
Health:	Good
Structure:	Fair
Problems:	Deadwood minor <50
Notes:	
Priority:	None
Tree Work:	No Works
Observation Comments:	
Tree Protection Zone (TPZ) [m]:	3.24
Structural Root Zone (SRZ) [m]:	2.08
Useful Life Expectancy:	40+ years
Retention Value:	Very high
Risk of Harm Number:	Not applicable

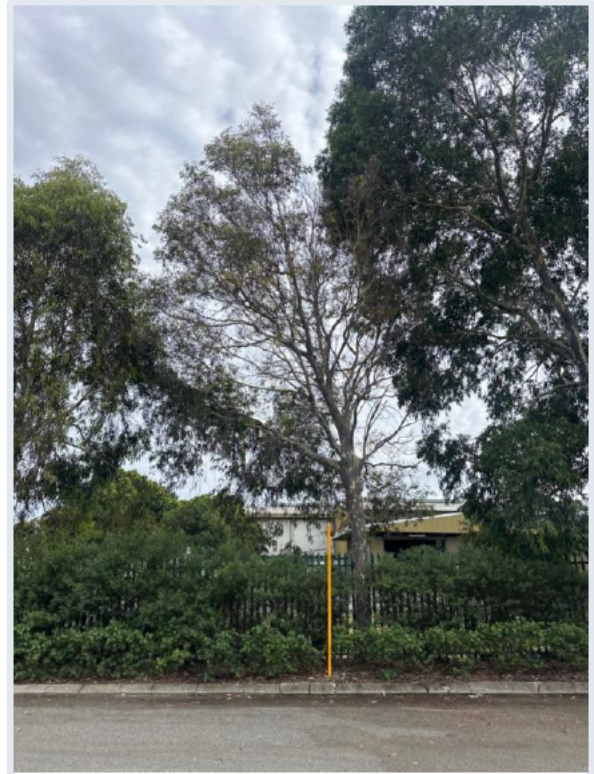
Spotted Gum Tree ID #137

Latin Name:	Corymbia maculata
Latitude:	-31.86500243047
Longitude:	115.81824422072
Tree Height (Estimated) [m]:	12.5
Canopy Spread [m]:	5.5
DBH [cm]:	36
Health:	Fair
Structure:	Fair
Problems:	Deadwood minor <50, Canopy thinning evident
Notes:	
Priority:	None
Tree Work:	No Works
Observation Comments:	
Tree Protection Zone (TPZ) [m]:	4.32
Structural Root Zone (SRZ) [m]:	2.37
Useful Life Expectancy:	40+ years
Retention Value:	High
Risk of Harm Number:	Not applicable

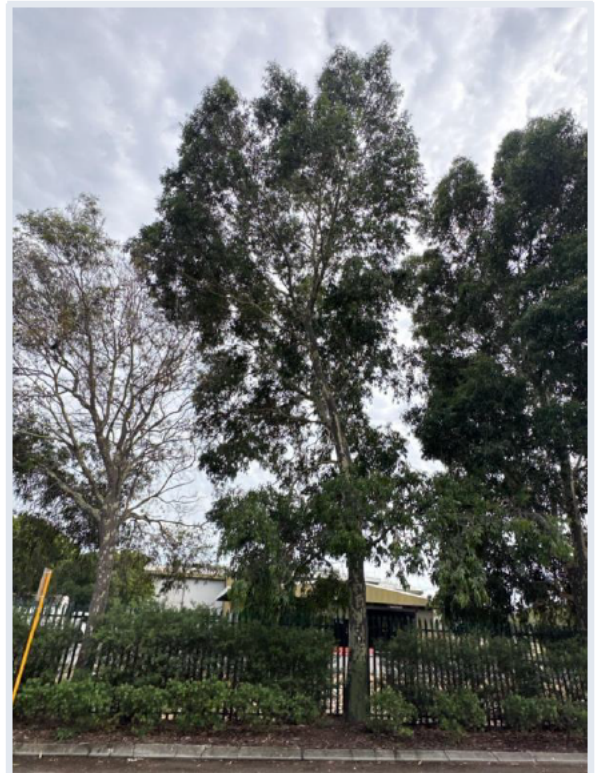
Spotted Gum Tree ID #138

Latin Name:	Corymbia maculata
Latitude:	-31.865008125432
Longitude:	115.8183132876
Tree Height (Estimated) [m]:	18.6
Canopy Spread [m]:	7.5
DBH [cm]:	47
Health:	Good
Structure:	Fair
Problems:	Codominant Stem, Low Growth
Notes:	
Priority:	None
Tree Work:	No Works
Observation Comments:	
Tree Protection Zone (TPZ) [m]:	5.64
Structural Root Zone (SRZ) [m]:	2.63
Useful Life Expectancy:	40+ years
Retention Value:	Very high
Risk of Harm Number:	Not applicable

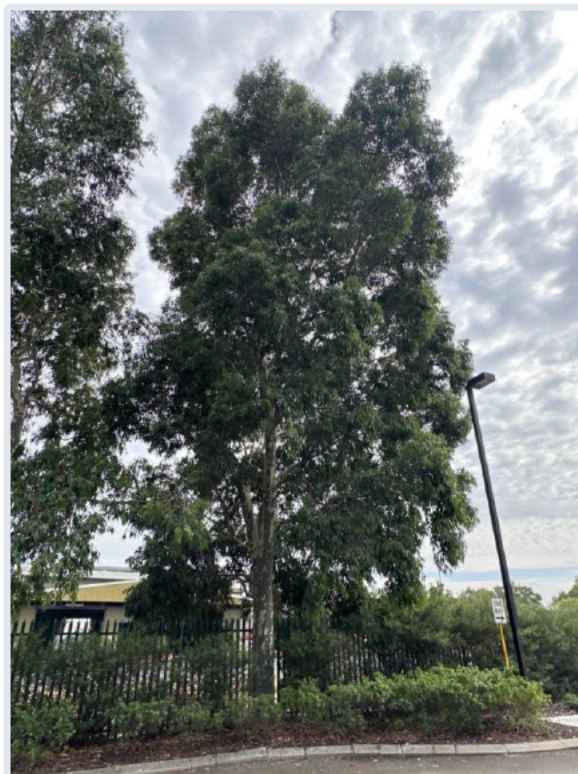
Spotted Gum Tree ID #139

Latin Name:	Corymbia maculata
Latitude:	-31.865010403416
Longitude:	115.81837833117
Tree Height (Estimated) [m]:	18.8
Canopy Spread [m]:	10
DBH [cm]:	45
Health:	Good
Structure:	Fair
Problems:	Codominant Stem
Notes:	
Priority:	None
Tree Work:	No Works
Observation Comments:	
Tree Protection Zone (TPZ) [m]:	5.4
Structural Root Zone (SRZ) [m]:	2.65
Useful Life Expectancy:	40+ years
Retention Value:	Very high
Risk of Harm Number:	Not applicable

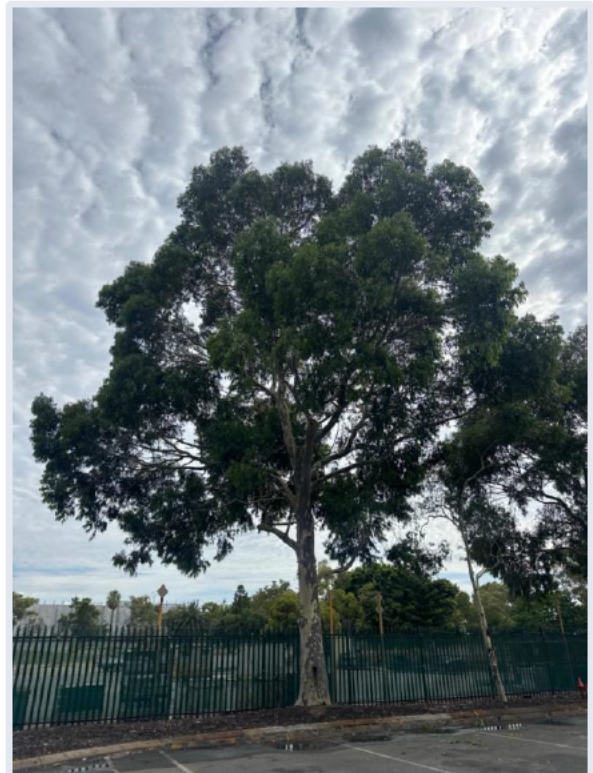
Spotted Gum Tree ID #140

Latin Name:	Corymbia maculata
Latitude:	-31.865047990156
Longitude:	115.81891867864
Tree Height (Estimated) [m]:	18.7
Canopy Spread [m]:	13.5
DBH [cm]:	64
Health:	Good
Structure:	Fair
Problems:	Multi Crown leaders
Notes:	
Priority:	None
Tree Work:	No Works
Observation Comments:	
Tree Protection Zone (TPZ) [m]:	7.68
Structural Root Zone (SRZ) [m]:	3
Useful Life Expectancy:	40+ years
Retention Value:	Very high
Risk of Harm Number:	Not applicable

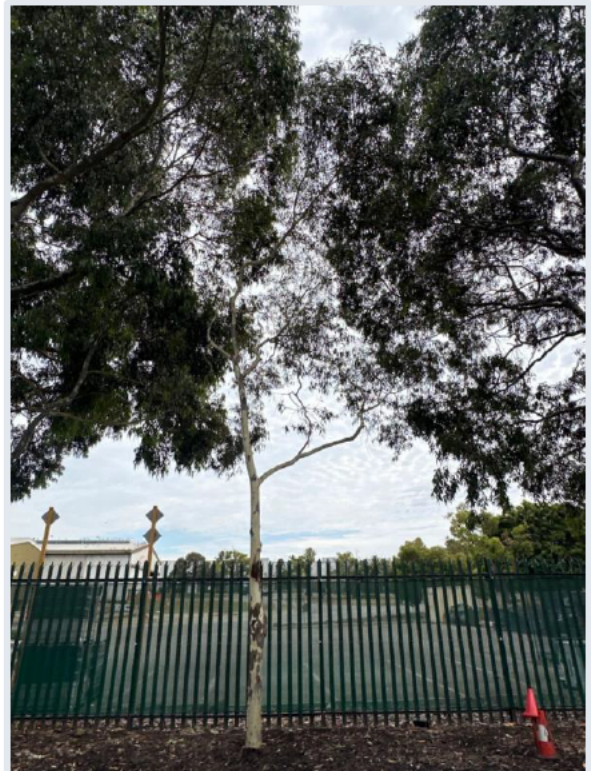
Spotted Gum Tree ID #141

Latin Name:	Corymbia maculata
Latitude:	-31.865050268139
Longitude:	115.81902529645
Tree Height (Estimated) [m]:	8.7
Canopy Spread [m]:	3.5
DBH [cm]:	21
Health:	Fair
Structure:	Fair
Problems:	Bark wound
Notes:	
Priority:	None
Tree Work:	No Works
Observation Comments:	
Tree Protection Zone (TPZ) [m]:	2.52
Structural Root Zone (SRZ) [m]:	1.75
Useful Life Expectancy:	40+ years
Retention Value:	High
Risk of Harm Number:	Not applicable

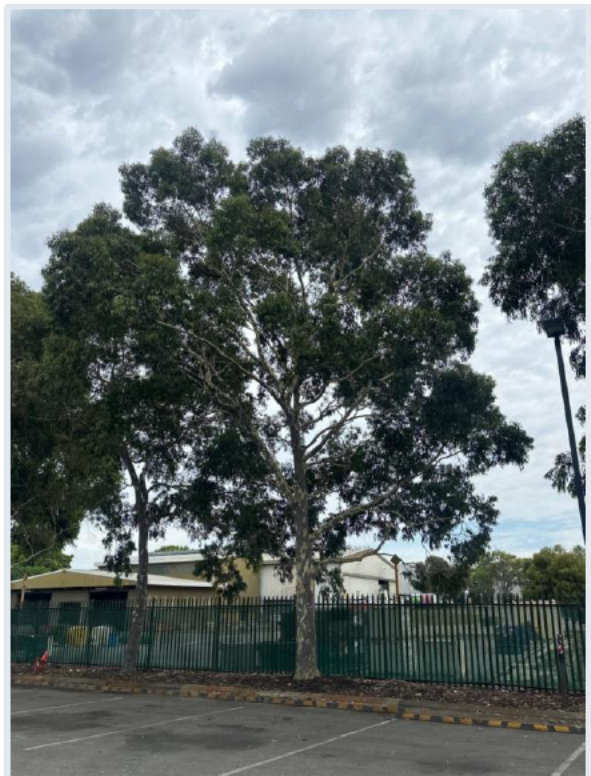
Spotted Gum Tree ID #143

Latin Name:	Corymbia maculata
Latitude:	-31.865051407131
Longitude:	115.81916477132
Tree Height (Estimated) [m]:	15.1
Canopy Spread [m]:	10
DBH [cm]:	49
Health:	Good
Structure:	Fair
Problems:	Codominant Stem, Deadwood minor <50
Notes:	
Priority:	None
Tree Work:	No Works
Observation Comments:	
Tree Protection Zone (TPZ) [m]:	5.88
Structural Root Zone (SRZ) [m]:	2.65
Useful Life Expectancy:	40+ years
Retention Value:	Very high
Risk of Harm Number:	Not applicable

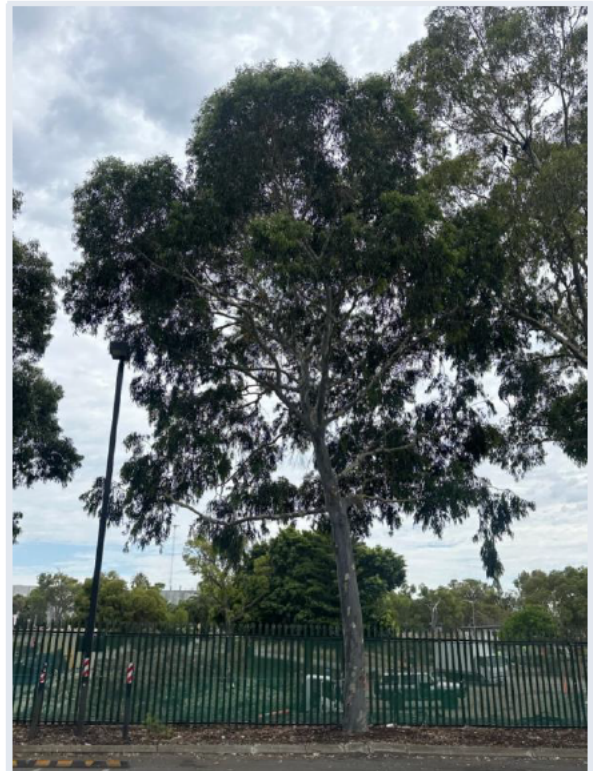
Spotted Gum Tree ID #144

Latin Name:	Corymbia maculata
Latitude:	-31.865067353015
Longitude:	115.81924724924
Tree Height (Estimated) [m]:	14.8
Canopy Spread [m]:	9
DBH [cm]:	45
Health:	Good
Structure:	Fair
Problems:	Codominant Stem, Deadwood minor <50
Notes:	
Priority:	None
Tree Work:	No Works
Observation Comments:	
Tree Protection Zone (TPZ) [m]:	5.4
Structural Root Zone (SRZ) [m]:	2.53
Useful Life Expectancy:	40+ years
Retention Value:	Very high
Risk of Harm Number:	Not applicable
