# City of Wanneroo Assets Structural Assessment

## Coastal Assets

City Of Wanneroo

30 July 2021

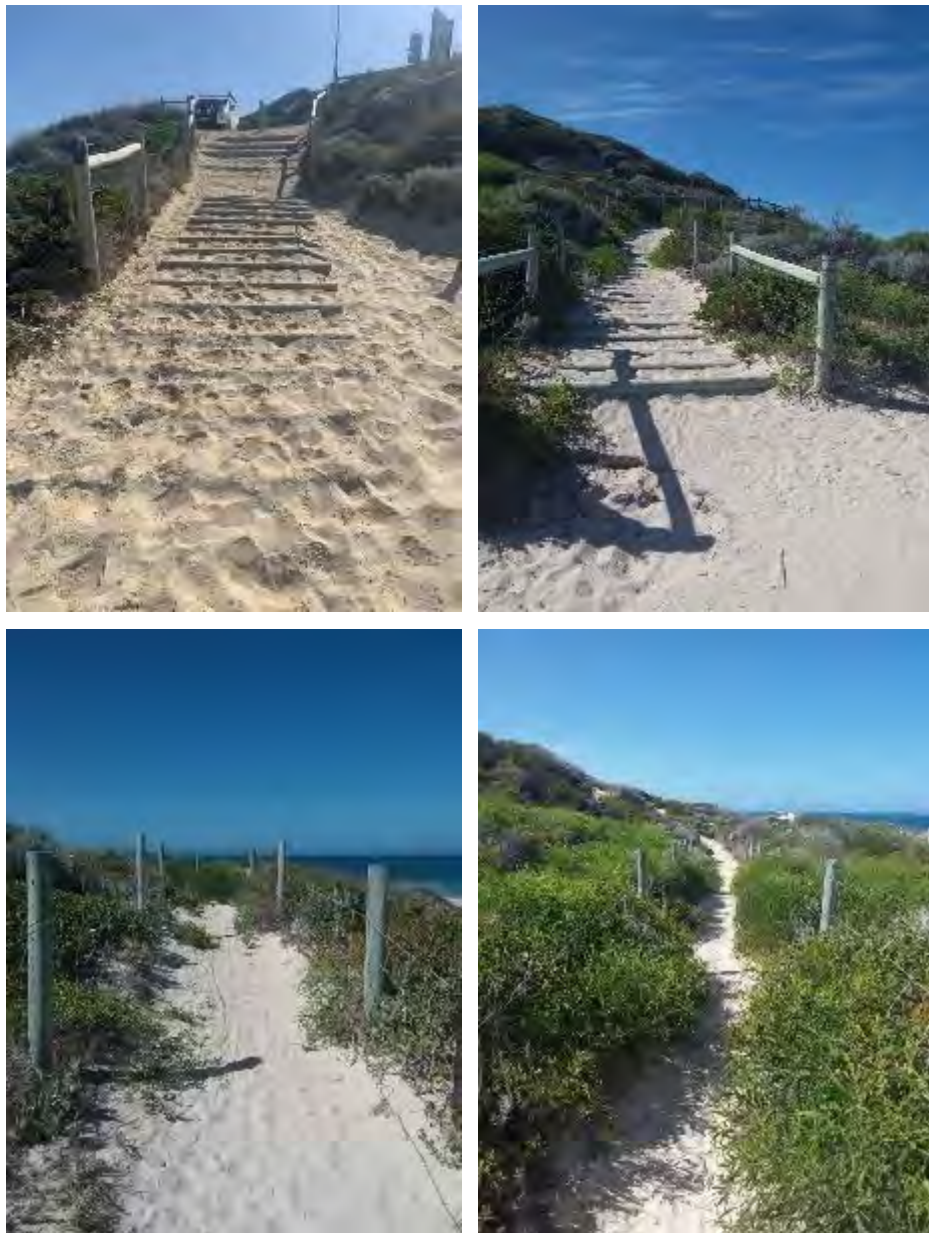
Figure 3.3 C2 Assets

Site C2 provides beach access at The Spot, accessed from Two Rocks Road. No drawings were available/provided to GHD, hence the age of the structure is not known. The site consists of set of timber sleeper style stairs, a coastal lookout and a sand path. The coastal lookout and sand path are bordered by steel mesh and timber post fence which has been considered as 1 asset for this site. The fencing comprises of coated steel mesh transitioning into plain steel square mesh wire. An asphalt surface links the three paths together. Refer Figure 3.3 for general photos of the structures. The inspection was completed from ground level, the battery limits of the inspection are shown in Figure 3.4. The assets within site C2 were generally found to be in adequate condition with routine maintenance generally required within 5 years.

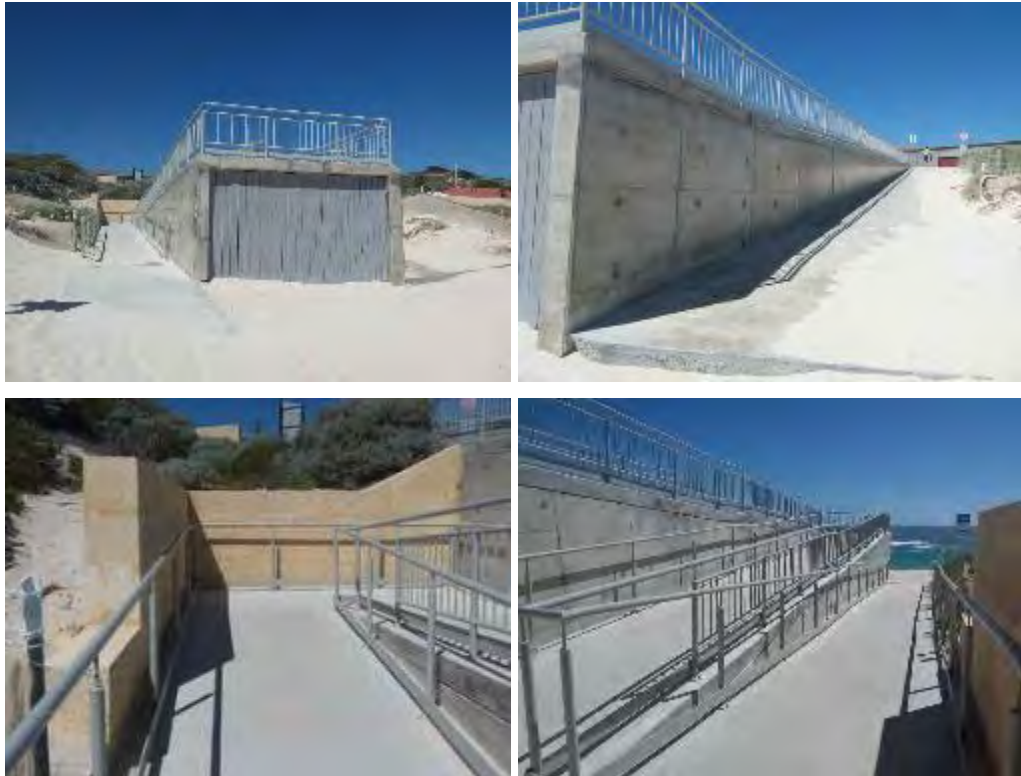
Figure 3.11 C6 Assets

Site C6 provides access to the beach via a disabled access ramp and concrete vehicle ramp at the Yanchep Surf Life Saving Club on Brazier Road, Yanchep. Based on provided information the vehicle and disabled access ramps were constructed circa 2018. Both ramps comprise of concrete base, with the disabled access ramp supported by concrete walls and a coated steel balustrade along the length of the ramp on both sides. The Northern side of the disabled access ramp has a limestone retaining wall. Refer Figure 3.11 for general photos of the structures. The inspection was completed from ground level, the battery limits of the inspection are shown in Figure 3.12. The assets within site C6 were found to be in good condition with only minor maintenance required.

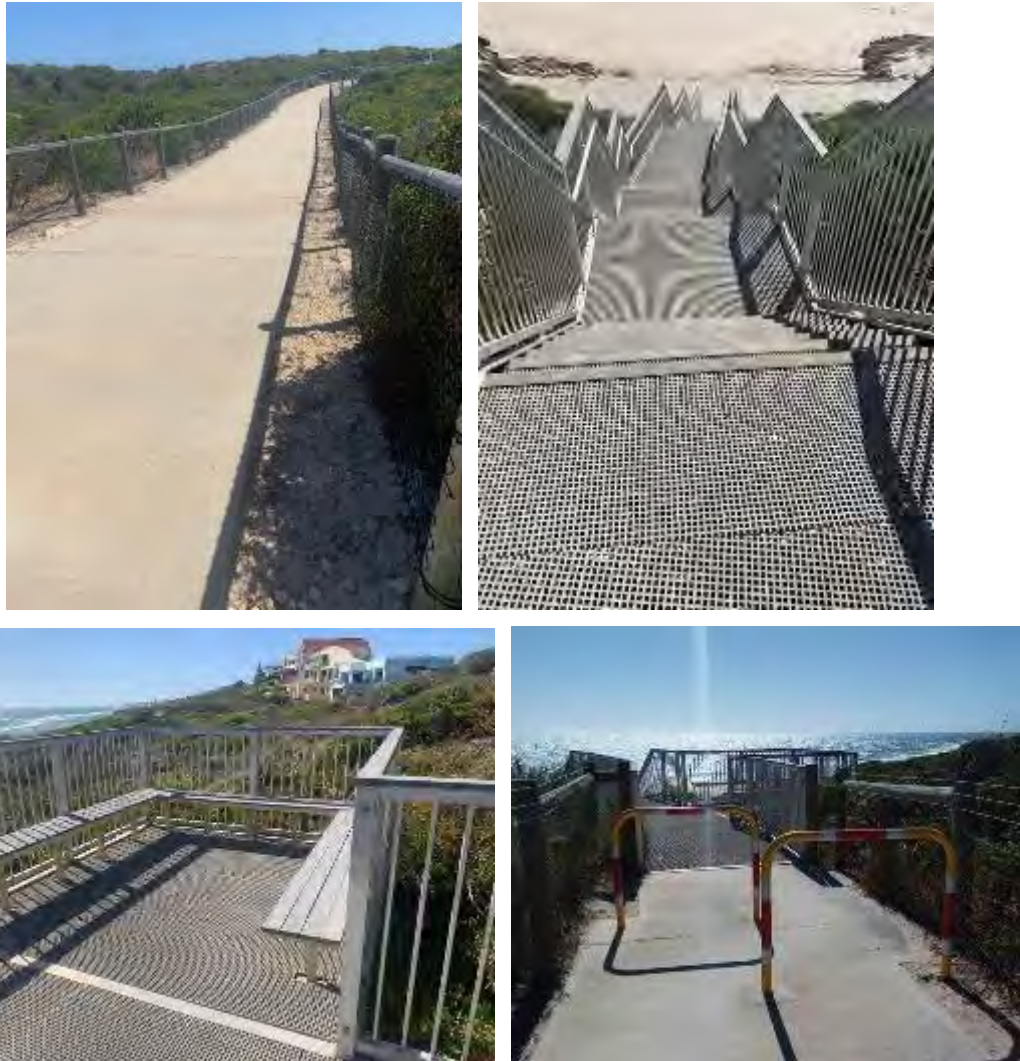
Figure 3.15 C8 Assets

Site C8 provides beach access via a long concrete path, leading to a staircase and lookout, located off Brazier road on the Foreshore Reserve. Based on provided information the concrete path, staircase and lookout were constructed circa 2015. The Staircase and lookout are made of composite fibre mesh with steel supports. The concrete path has timber fencing on each side along the full the length of the path until reaching the platform. Refer Figure 3.15 for general photos of the structures. The inspection was completed from ground level, the battery limits of the inspection are shown in Figure 3.16. The assets within site C8 were found to be in good condition with only minor maintenance required.

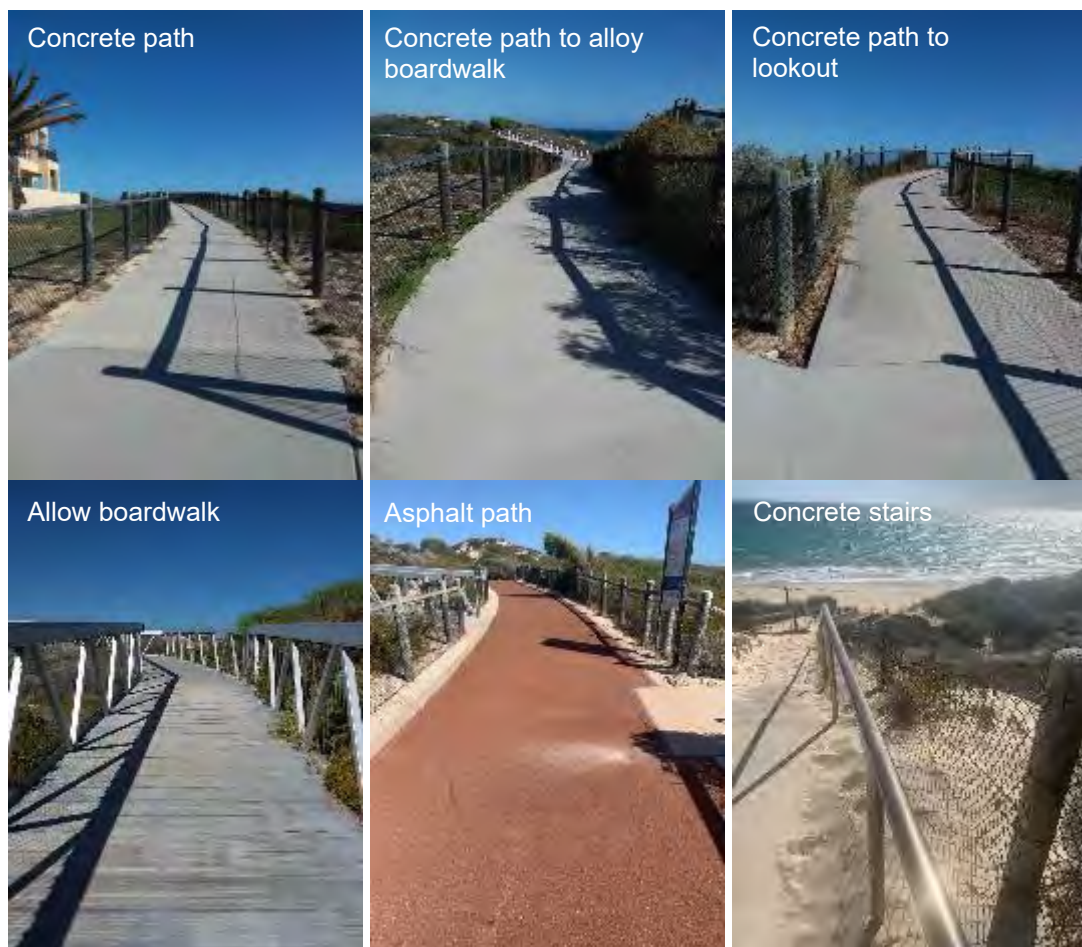
Figure 3.17 C9 Assets

Site C9 forms part of a walking trail between Compass Circle and Foreshore Vista, in Yanchep. Based on provided information the assets were constructed circa 2009. The site consists of a concrete path from the Compass Circle entry which branches into two sections, the first leading to an elevated alloy boardwalk and the second leading to an ocean lookout with benches. A red asphalt path is provided at the entry point from Foreshore Vista which leads to the other side of the alloy boardwalk and a set of concrete stairs which provides access to the beach. Mesh fencing is provided along both sides of the asphalt path and surrounds the ocean lookout. Refer Figure 3.17 for general photos of the structures. The inspection was completed from ground level, the battery limits of the inspection are shown in Figure 3.18. The assets within site C9 were found to be in good condition with a few maintenance requirements.

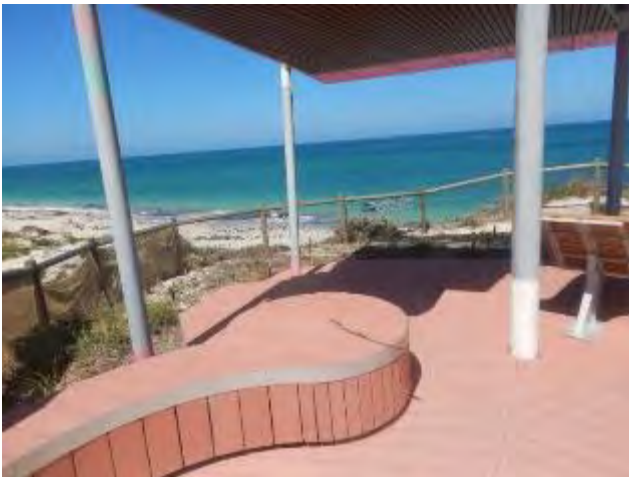
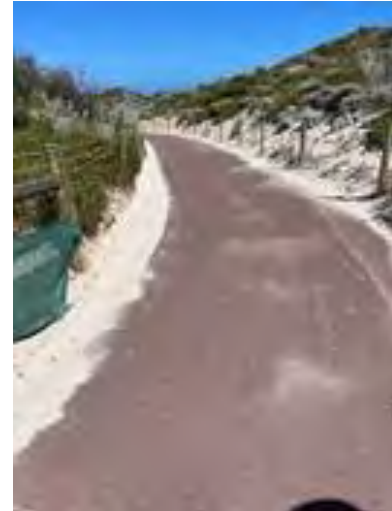
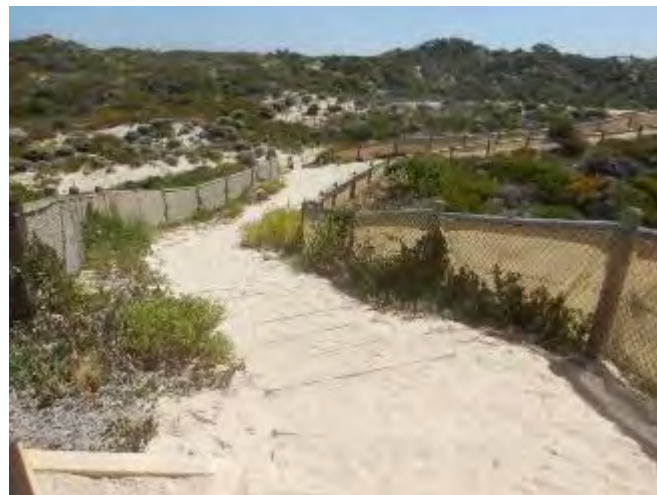
Figure 3.25 C13 Assets

Site C13 provides a sheltered coastal lookout with bench seats atop a staircase, and vehicle access to the beach located at the Alkimos Surf Life Saving Club, off Marginella Boulevard. No drawings were available/provided to GHD, hence the age of the structure is not known. The fence that borders the lookout and paths to the beach and carpark is comprised of timber posts and railing with a steel mesh fencing and cloth. The lookout comprises of timber decking with steel columns supporting timber / FRP roofing. The vehicle access ramp comprises of asphalt base slab. Refer Figure 3.25 for general photos of the structures. The inspection was completed from ground level, the battery limits of the inspection are shown in Figure 3.26. The assets within site C13 were found to be in good condition with the exception of a pothole located at the base of the access ramp which requires immediate remediation and a number of items which require maintenance with 5 years.

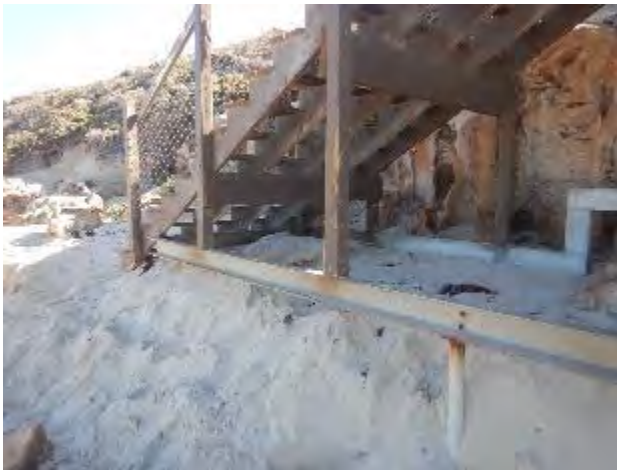
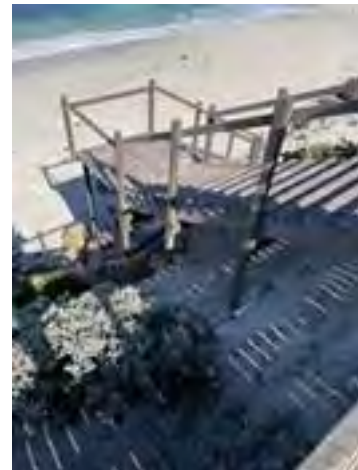
Figure 3.29 C15 Assets

Site C15 provides beach access via a timber staircase, just North of the Jindalee Foreshore. Based on provided information the staircase was constructed circa 2015. This asset comprises of timber decking / boardwalk, timber handrailing with steel cord-strand balustrade and a timber staircase founded on concrete footings. Refer Figure 3.29 for general photos of the structures. The inspection was completed from ground level, the battery limits of the inspection are shown in Figure 3.30. The assets within site C15 were found to be in adequate condition. The footings embedded in limestone bedrock require further detailed investigation and a number of assets require maintenance within 1 – 2 years.

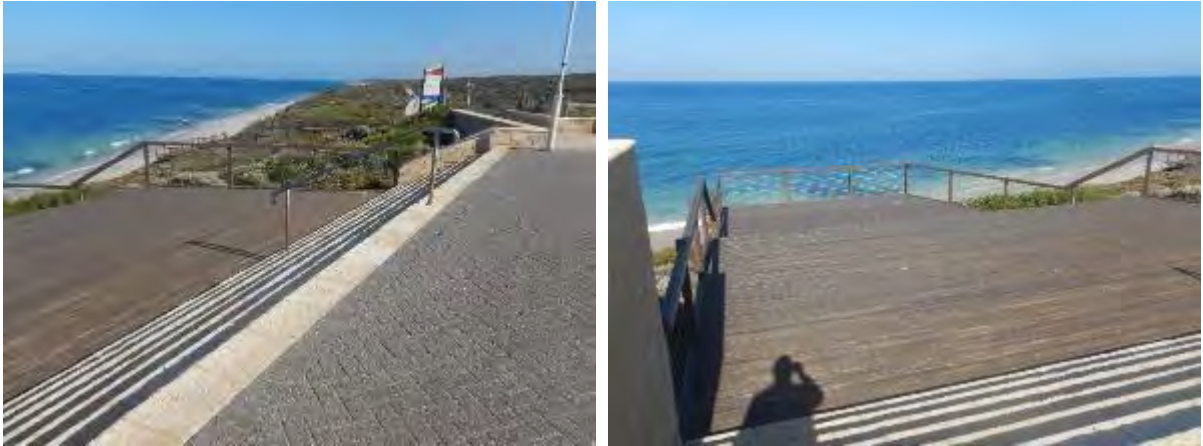
Figure 3.31 C16 Assets

Site C16 consists of a coastal lookout with steps along the Jindalee Foreshore just south of the Jindalee Beach Shack. Based on provided information the lookout was constructed circa 2010. The lookout is a timber structure with two platform levels separated by a set of timber steps. A timber and steel cord-strand balustrade borders the lookout. The platforms are accessed via limestone steps with limestone retaining walls at both ends. Refer Figure 3.31 for general photos of the structures. The inspection was limited to platform level and the view from the adjacent path, the battery limits of the inspection are shown in Figure 3.32. The assets within site C16 were found to be in good condition with the exception of one damaged timber plank which requires replacement within 6 months.

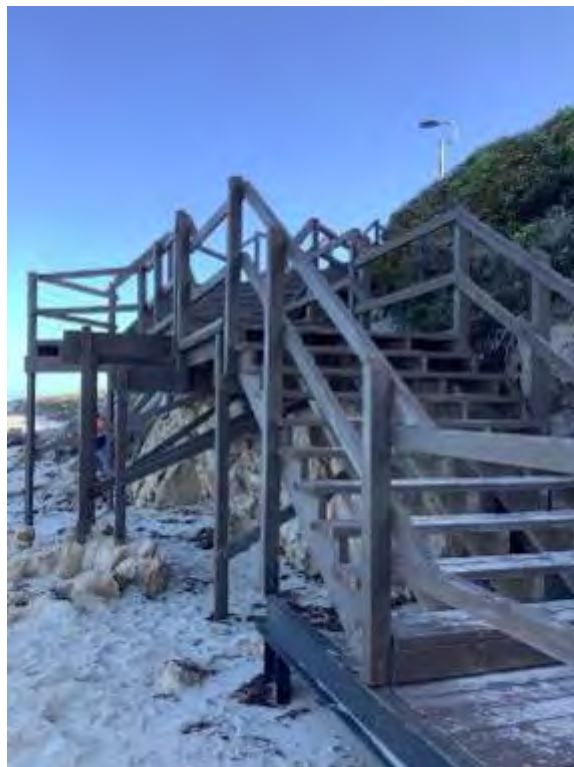
Figure 3.35 C18 Assets

Site C18 provides beach access via a staircase from the Jindalee Foreshore roughly 50 m south of the Jindalee Beach Shack. Based on provided information the staircase was constructed circa 2009. Majority of the structure is timber, with steel mounts at the base of the structure into the limestone bedrock. A steel mounting frame is provided at the base of the staircase on the beach to support the bottom landing. The stairs have a timber and steel chord handrail (both sides) for most of the length, except the last set of stairs between the bottom and second landing. Refer Figure 3.35 for general photos of the structures. The inspection was completed from ground level, the battery limits of the inspection are shown in Figure 3.36. Site C18 was found to be in good condition with exception to the supports and footings which require urgent and significant maintenance.

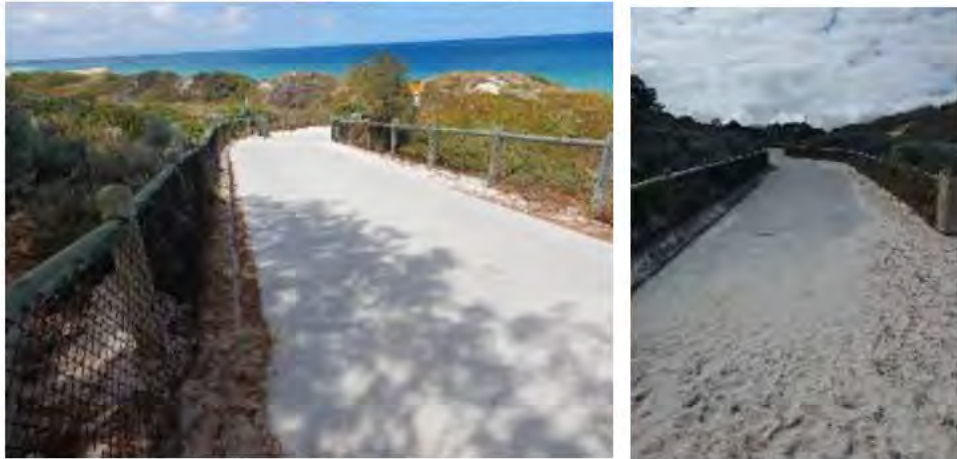
Figure 3.43 C22 Assets

Site C22 provides vehicular access to the beach via a concrete path from a car park off the corner of Ocean Drive and Camira Way, in Quinns Rocks. Based on provided information the vehicle access ramp was constructed circa 2012. The site consists of a concrete vehicle access ramp which is boarded by timber and coated steel wire mesh fence along both sides for the full length. Three steel removable bollards are provided at the access point from the car park. Refer Figure 3.43 for general photos of the structures. The inspection was completed from ground level, the battery limits of the inspection are shown in Figure 3.44. The assets within site C22 were found to be in good condition, with the exception of a number of localised items which require maintenance..

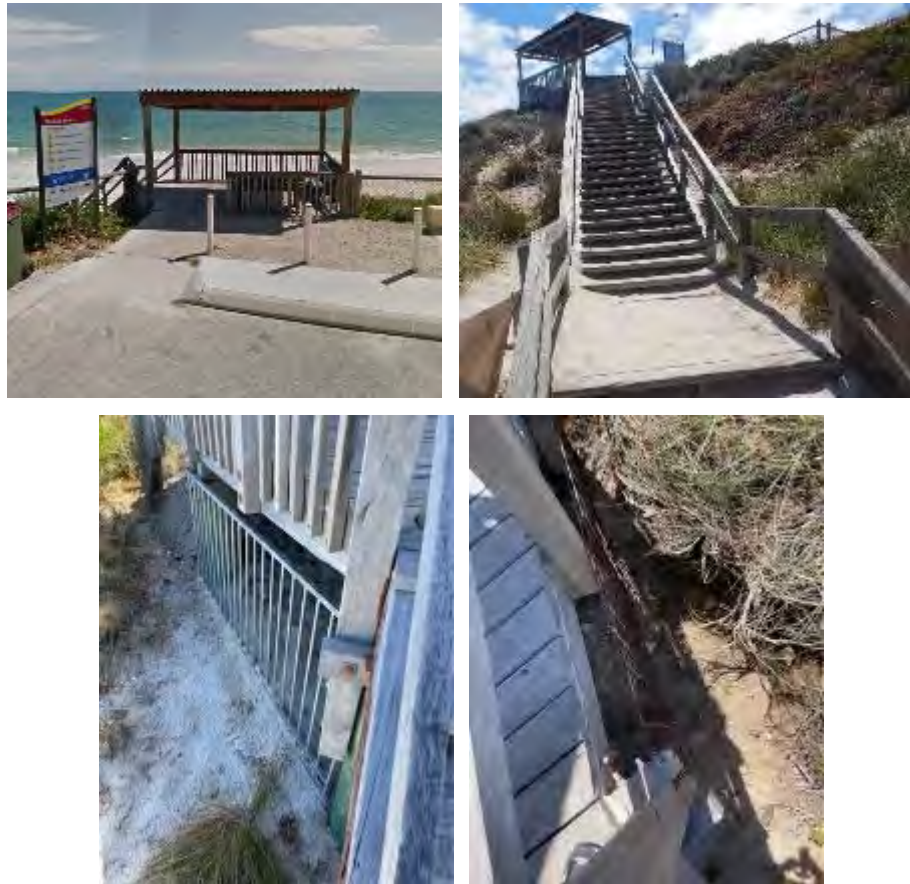
Figure 3.45 C23 Assets

Site C23 provides a coastal lookout and beach access via a staircase from the car park at the corner of Ocean Drive and Mary Street, in Quinns Rocks. No drawings were available/provided to GHD, hence the age of the structure is not known. The coastal lookout comprises of timber decking and supports and a steel corrugated roof supported with timber columns and timber purlins and rafters. The lookout is connected to the adjacent timber staircase which descends to the beach. Access under the lookout structure has been limited with a combination of typical balustrade panels, square steel mesh and steel wire mesh (i.e. chicken wire). Refer Figure 3.45 for general photos of the structures. The inspection was completed from ground level, the battery limits of the inspection are shown in Figure 3.46. The assets within site C23 were found to be in poor condition with a number of items requiring maintenance within 6 months.

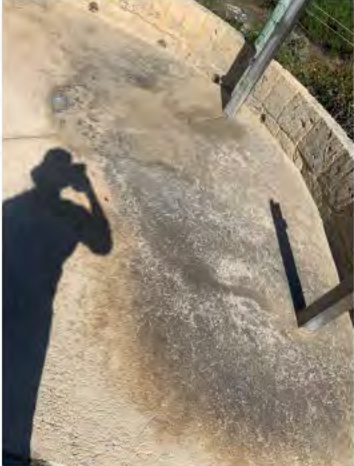
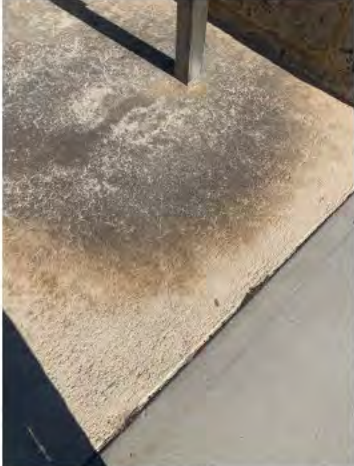
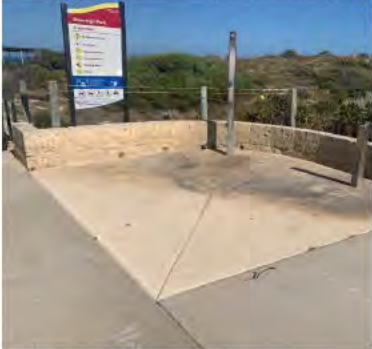
Monitor at next inspection

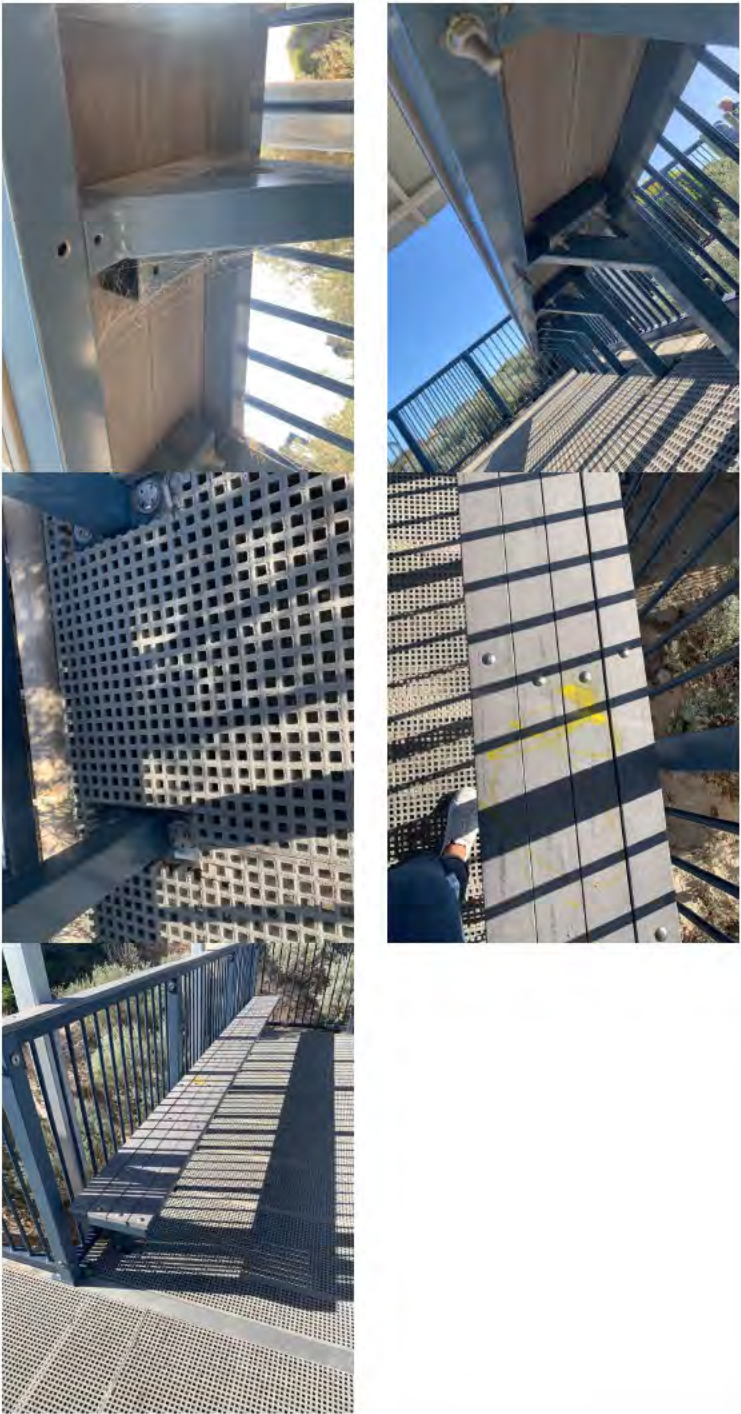
<b>Site No.</b>	C1
<b>Site Name/ Location</b>	North Two Rocks Foreshore
<b>Date</b>	25/02/2021
<b>Time</b>	08:38 (8 GMT)
<b>Item Number</b>	13
<b>Costal Asset Type</b>	Lookout
<b>Element</b>	Lookouts
<b>Sub-element</b>	Column
<b>Material Type</b>	Galvanised Steel
<b>2021 Observed Defects (Steel)</b>	No visible defects
<b>Defect Description</b>	Minor wear and tear on SHS observed.
<b>Quantity of Defects</b>	18m
<b>Condition Rating (0- 10)</b>	3
<b>Health and Safety Concern (Y/N)</b>	No
<b>Consequence of Failure</b>	4
<b>Likelihood of Failure within next 5 years</b>	1
<b>Risk Rating</b>	4
<b>Overall Rating (CR X RR)</b>	12
<b>Maintenance Recommendation</b>	Monitor and reinspect at next scheduled inspection.
<b>Maintenance Timeframe</b>	Greater than 5 years

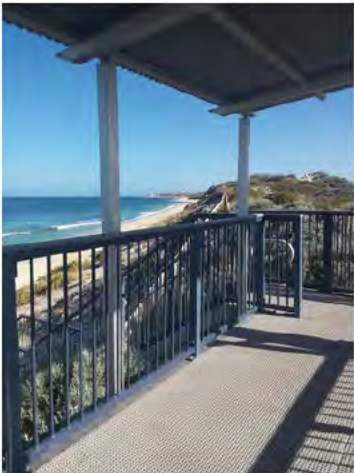
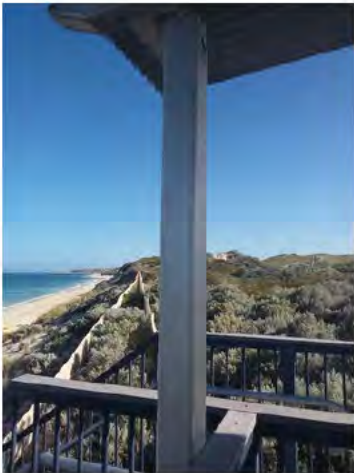
<b>Site No.</b>	C1
<b>Site Name/ Location</b>	North Two Rocks Foreshore
<b>Date</b>	25/02/2021
<b>Time</b>	08:29 (8 GMT)
<b>Item Number</b>	14
<b>Costal Asset Type</b>	Lookout
<b>Sub-element (Decking and Supports)</b>	Support beams
<b>Material Type</b>	Galvanised Steel
<b>2021 Observed Defects (Steel)</b>	Other
<b>Defect Description</b>	Generally good condition. southern beam installed lower than others .
<b>Condition Rating (0- 10)</b>	4
<b>Health and Safety Concern (Y/N)</b>	No
<b>Consequence of Failure</b>	4
<b>Likelihood of Failure within next 5 years</b>	1
<b>Risk Rating</b>	4
<b>Overall Rating (CR X RR)</b>	16
<b>Maintenance Recommendation</b>	Monitor and reinspect at next scheduled inspection.
<b>Maintenance Timeframe</b>	Greater than 5 years

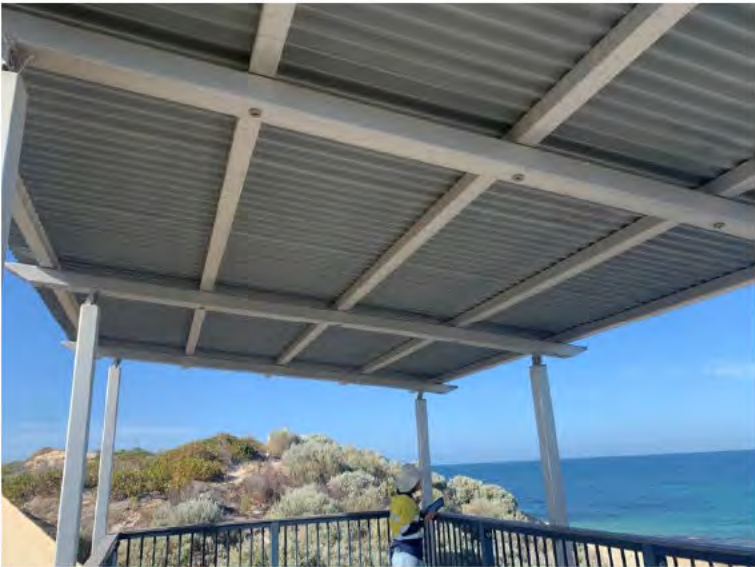
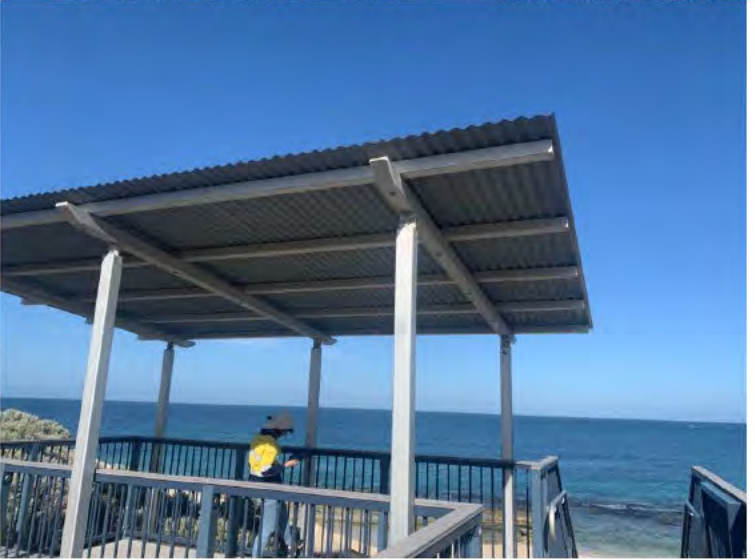
<b>Site No.</b>	C1
<b>Site Name/ Location</b>	North Two Rocks Foreshore
<b>Date</b>	25/02/2021
<b>Time</b>	08:33 (8 GMT)
<b>Item Number</b>	16
<b>Costal Asset Type</b>	Lookout
<b>Sub-element</b>	Roof connection
<b>Material Type</b>	Stainless Steel
<b>2021 Observed Defects (Steel)</b>	Tea Staining
<b>Defect Description</b>	Generally good condition with minor tea staining observed
<b>Condition Rating (0- 10)</b>	2
<b>Health and Safety Concern (Y/N)</b>	No
<b>Consequence of Failure</b>	3
<b>Likelihood of Failure within next 5 years</b>	1
<b>Risk Rating</b>	3
<b>Overall Rating (CR X RR)</b>	6
<b>Maintenance Recommendation</b>	Monitor and reinspect at next scheduled inspection
<b>Maintenance Timeframe</b>	Greater than 5 years

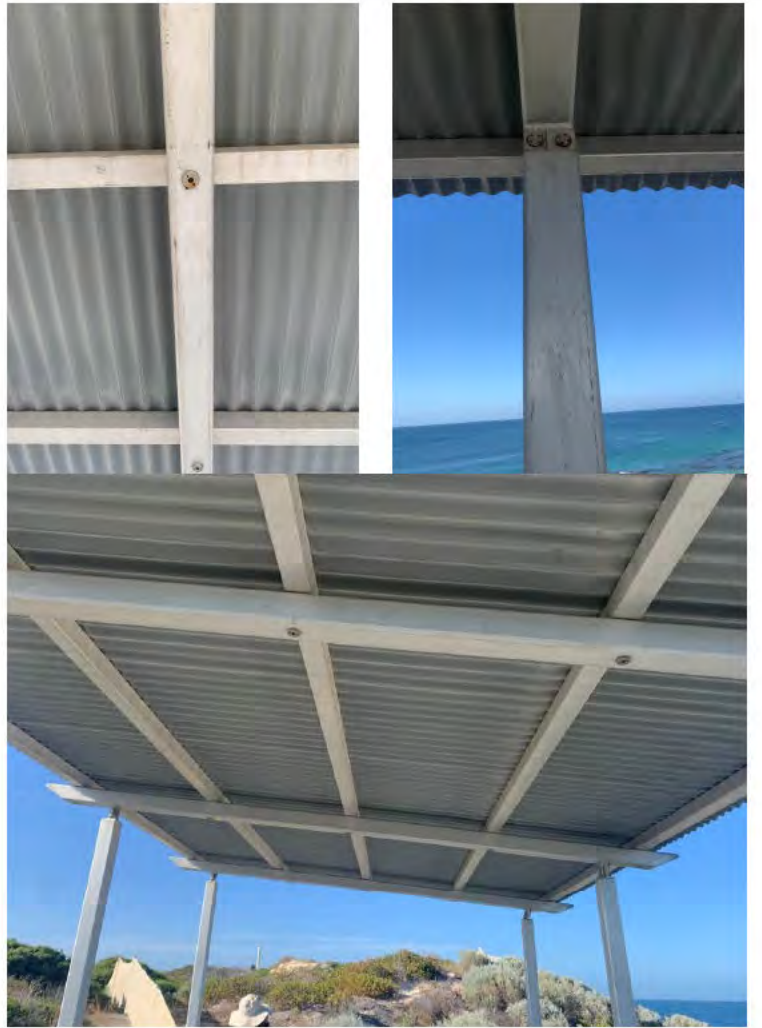
<b>Site No.</b>	C1
<b>Site Name/ Location</b>	North Two Rocks Foreshore
<b>Date</b>	25/02/2021
<b>Time</b>	08:40 (8 GMT)
<b>Item Number</b>	17
<b>Costal Asset Type</b>	Lookout
<b>Element</b>	Roof sheeting
<b>Material Type</b>	Colourbond
<b>2021 Observed Defects (Steel)</b>	No visible defects observed
<b>Condition Rating (0- 10)</b>	3
<b>Health and Safety Concern (Y/N)</b>	No
<b>Consequence of Failure</b>	3
<b>Likelihood of Failure within next 5 years</b>	1
<b>Risk Rating</b>	3
<b>Overall Rating (CR X RR)</b>	9
<b>Maintenance Recommendation</b>	Monitor and reinspect at next scheduled inspection. Consider using alternate inspection methods to inspect top of roof (i.e drones)
<b>Maintenance Timeframe</b>	Greater than 5 years

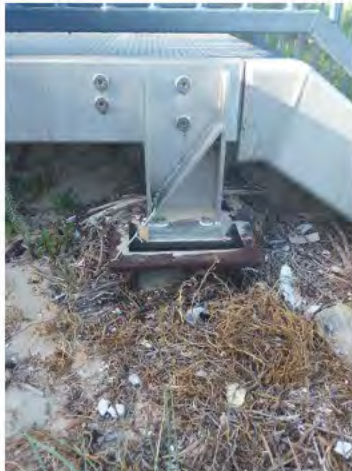
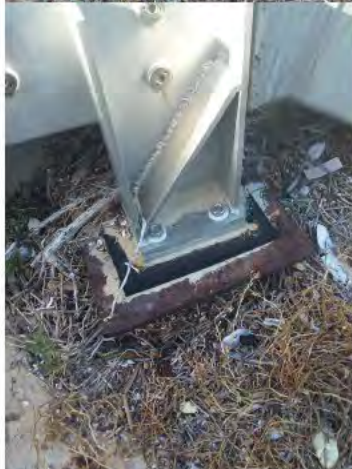
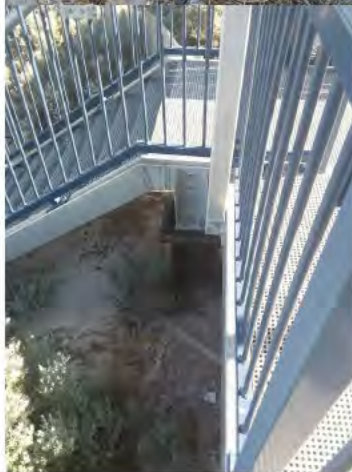
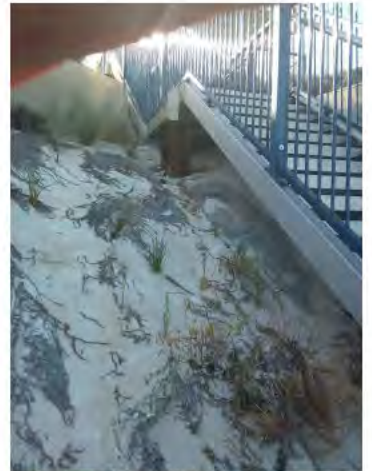
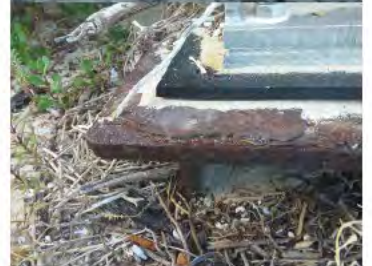
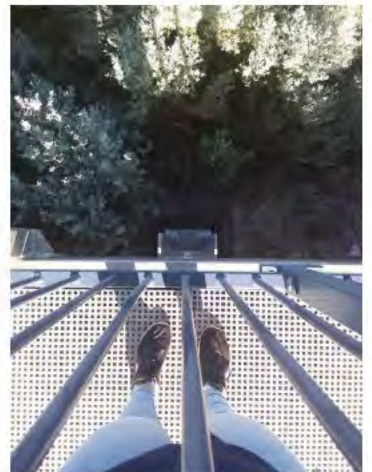
<b>Site No.</b>	C1
<b>Site Name/ Location</b>	North Two Rocks Foreshore
<b>Date</b>	25/02/2021
<b>Time</b>	08:02 (8 GMT)
<b>Item Number</b>	19
<b>Costal Asset Type</b>	Stairs
<b>Element</b>	Stairs
<b>Sub-element</b>	stringers, tread supports and support stubs
<b>Material Type</b>	Galvanised Steel
<b>2021 Observed Defects (Steel)</b>	Cracking or other signs of distress at welds
<b>Defect Description</b>	Generally good condition. North western support stub at bottom landing has stiffener. Southern side of stairs had build up of sand was unable to be inspected. Generally welds appeared to be of poor workmanship.
<b>Quantity of Defects</b>	70m of stringers, 6x support stubs at approx. 400mm height
<b>Condition Rating (0- 10)</b>	4
<b>Health and Safety Concern (Y/N)</b>	No
<b>Consequence of Failure</b>	4
<b>Likelihood of Failure within next 5 years</b>	2
<b>Risk Rating</b>	8
<b>Overall Rating (CR X RR)</b>	32
<b>Maintenance Recommendation</b>	Monitor and reinspect at next scheduled inspection.

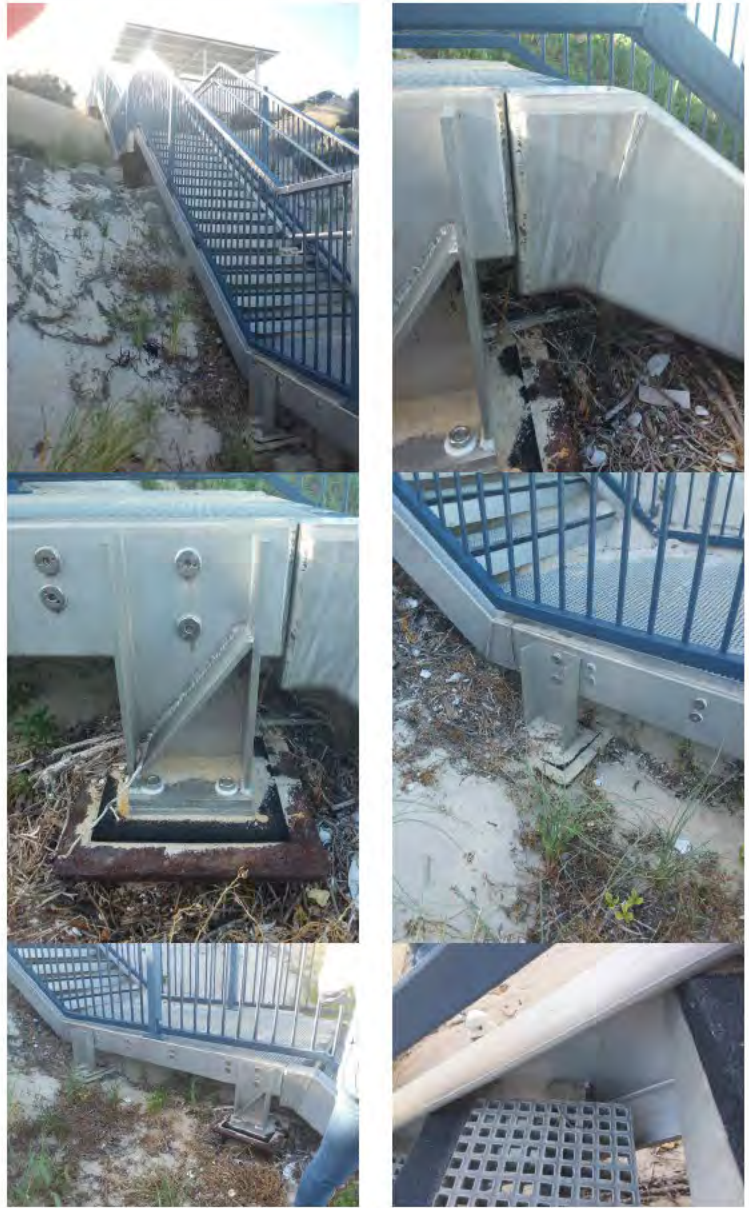
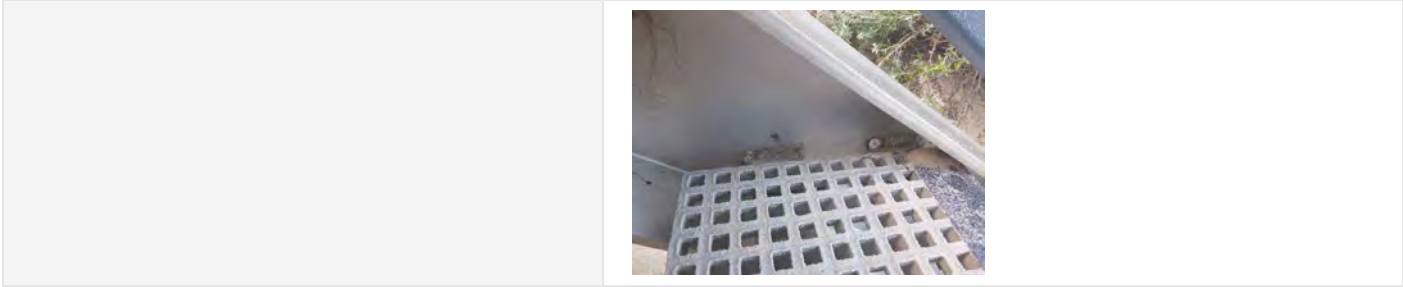
<b>Site No.</b>	C1
<b>Site Name/ Location</b>	North Two Rocks Foreshore
<b>Date</b>	25/02/2021
<b>Time</b>	07:56 (8 GMT)
<b>Item Number</b>	20
<b>Costal Asset Type</b>	Stairs
<b>Element</b>	Stairs
<b>Sub-element (Stairs and Landing)</b>	Treads
<b>Sub-element</b>	including landings
<b>Material Type</b>	FRP
<b>2021 Observed Defects (FRP)</b>	Noticeable build-up of debris, No visible defects
<b>Defect Description</b>	Generally good condition. Sand build up in areas, with the bottom of the stairs being buried.
<b>Quantity of Defects</b>	37 steps, 4m2 landing
<b>Condition Rating (0- 10)</b>	3
<b>Health and Safety Concern (Y/N)</b>	No
<b>Consequence of Failure</b>	3
<b>Likelihood of Failure within next 5 years</b>	2
<b>Risk Rating</b>	6
<b>Overall Rating (CR X RR)</b>	18
<b>Maintenance Recommendation</b>	Monitor and reinspect at next scheduled inspection.
<b>Maintenance Timeframe</b>	Greater than 5 years

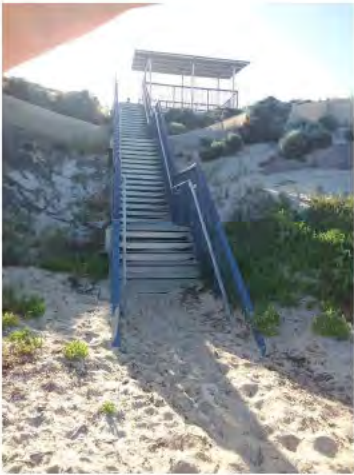
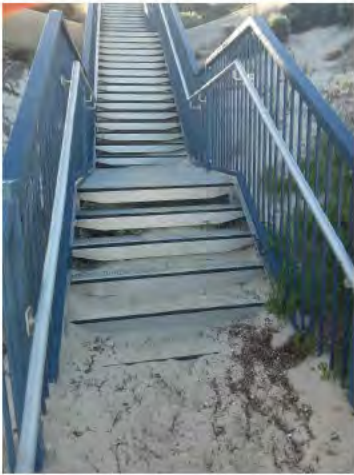
<b>Site No.</b>	C1
<b>Site Name/ Location</b>	North Two Rocks Foreshore
<b>Date</b>	25/02/2021
<b>Time</b>	08:24 (8 GMT)
<b>Item Number</b>	21
<b>Costal Asset Type</b>	Stairs
<b>Sub-element</b>	Balustrade Post (Localised)
<b>Material Type</b>	Coated Steel
<b>2021 Observed Defects (Steel)</b>	Corrosion with section loss
<b>Defect Description</b>	Corrosion and coating loss with section loss was observed. Most likely due to poor weld quality.
<b>Quantity of Defects</b>	1 post effected
<b>Condition Rating (0- 10)</b>	7
<b>Health and Safety Concern (Y/N)</b>	No
<b>Consequence of Failure</b>	2
<b>Likelihood of Failure within next 5 years</b>	3
<b>Risk Rating</b>	6
<b>Overall Rating (CR X RR)</b>	42
<b>Maintenance Recommendation</b>	Remove corrosion product and apply protective coating.
<b>Maintenance Timeframe</b>	Within 1-2 years

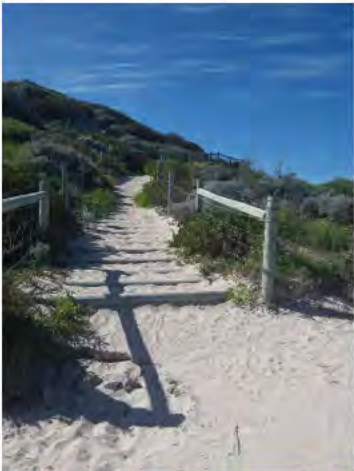
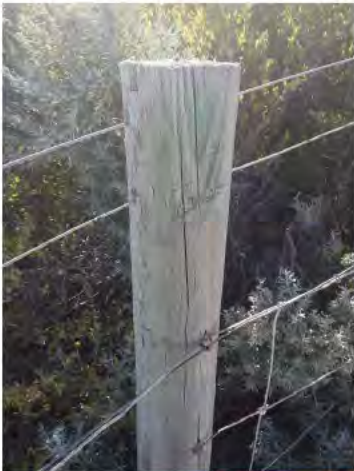
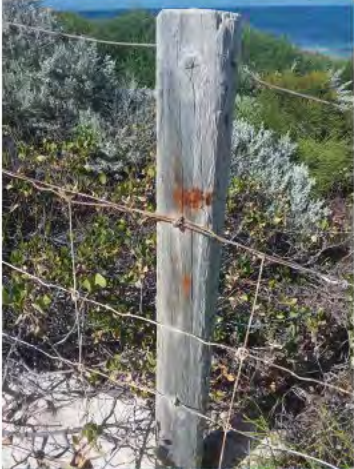
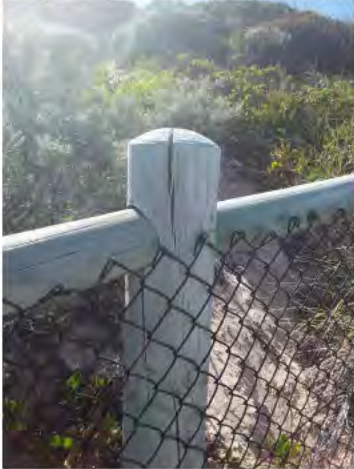
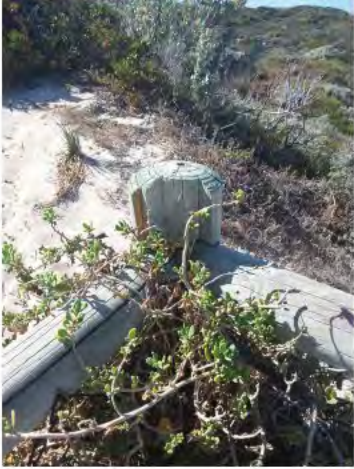
<b>Site No.</b>	C2
<b>Site Name/ Location</b>	South Two Rocks Foreshore
<b>Date</b>	25/02/2021
<b>Time</b>	09:31 (8 GMT)
<b>Item Number</b>	6
<b>Costal Asset Type</b>	Fencing
<b>Sub-element (Fencing)</b>	Timber posts
<b>Material Type</b>	Timber
<b>2021 Observed Defects (Timber)</b>	Split timber
<b>Defect Description</b>	Generally good condition with timber splitting observed to be typical throughout. Inspection limited due to significant vegetation growth.
<b>Quantity of Defects</b>	84 posts
<b>Condition Rating (0- 10)</b>	4
<b>Health and Safety Concern (Y/N)</b>	No
<b>Consequence of Failure</b>	4
<b>Likelihood of Failure within next 5 years</b>	2
<b>Risk Rating</b>	8
<b>Overall Rating (CR X RR)</b>	32
<b>Maintenance Recommendation</b>	Monitor and reinspect at next scheduled inspection.
<b>Maintenance timeframe</b>	Greater than 5 years

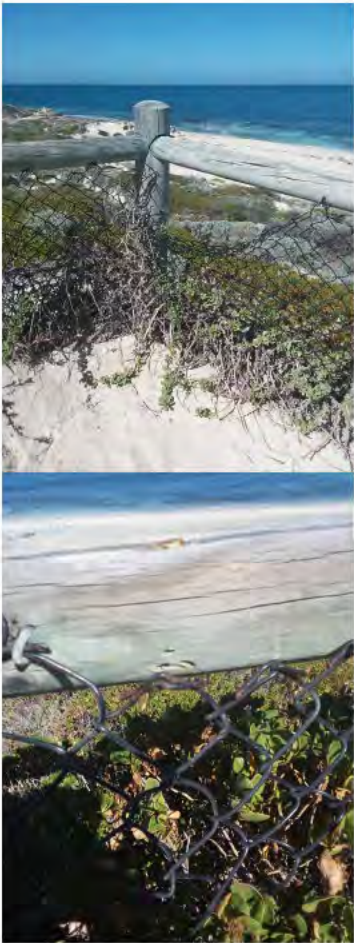
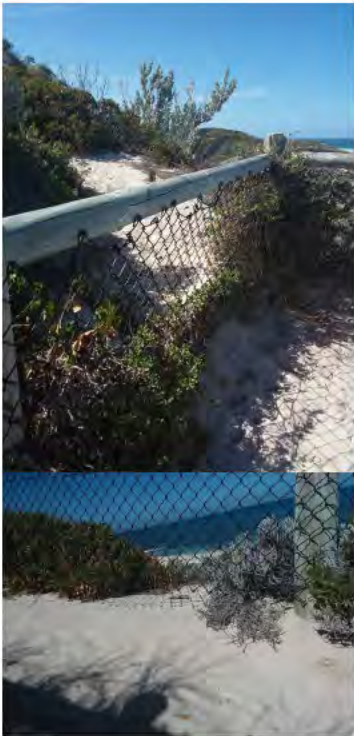
<b>Site No.</b>	C2
<b>Site Name/ Location</b>	South Two Rocks Foreshore
<b>Date</b>	25/02/2021
<b>Time</b>	09:42 (8 GMT)
<b>Item Number</b>	7
<b>Costal Asset Type</b>	Fencing
<b>Sub-element (Fencing)</b>	Mesh
<b>Material Type</b>	Coated Steel
<b>2021 Observed Defects (Steel)</b>	Coating loss
<b>Defect Description</b>	Mesh observed to have localised areas of coating loss, as well as the mesh not being fixed to the rail properly (prominent in the south west corner).
<b>Quantity of Defects</b>	50m2
<b>Condition Rating (0- 10)</b>	6
<b>Health and Safety Concern (Y/N)</b>	No
<b>Consequence of Failure</b>	2
<b>Likelihood of Failure within next 5 years</b>	3
<b>Risk Rating</b>	6
<b>Overall Rating (CR X RR)</b>	36
<b>Maintenance Recommendation</b>	Reinstate mesh connection to the railing. Replace heavily corroded fence areas.
<b>Maintenance Timeframe</b>	Within 1-2 years

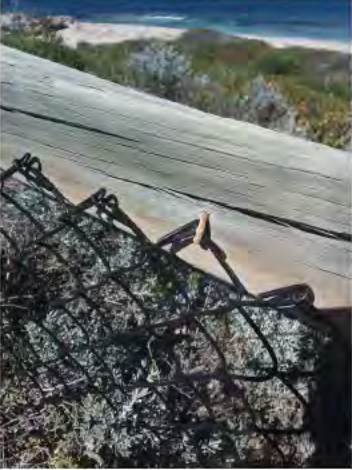
<b>Site No.</b>	C2
<b>Site Name/ Location</b>	South Two Rocks Foreshore
<b>Date</b>	25/02/2021
<b>Time</b>	09:47 (8 GMT)
<b>Item Number</b>	8
<b>Costal Asset Type</b>	Fencing
<b>Sub-element (Fencing)</b>	Mesh staples
<b>Material Type</b>	Coated Steel
<b>2021 Observed Defects (Steel)</b>	Surface corrosion
<b>Defect Description</b>	Typical widespread corrosion to staples.
<b>Condition Rating (0- 10)</b>	6
<b>Health and Safety Concern (Y/N)</b>	No
<b>Consequence of Failure</b>	1
<b>Likelihood of Failure within next 5 years</b>	2
<b>Risk Rating</b>	2
<b>Overall Rating (CR X RR)</b>	12
<b>Maintenance Recommendation</b>	Replace heavily corroded staples
<b>Maintenance Timeframe</b>	Within 5 years

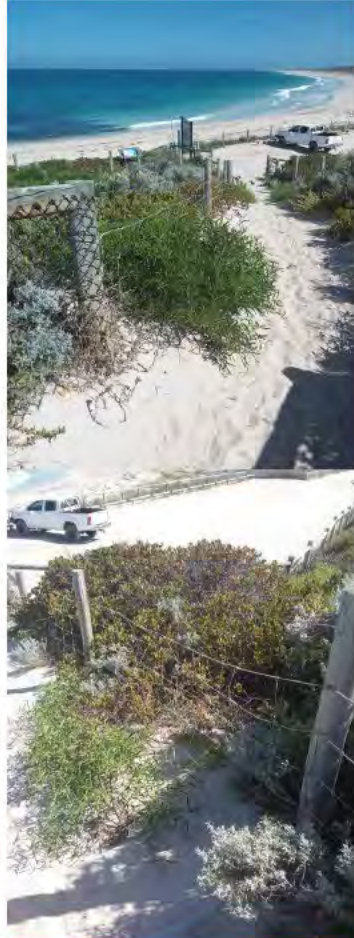
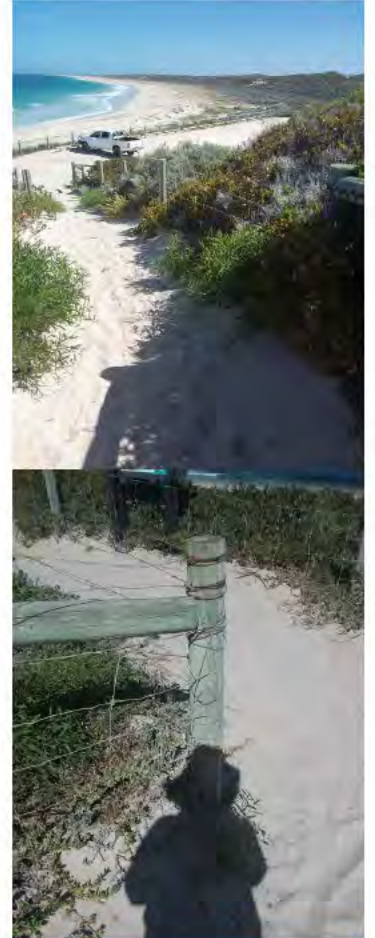
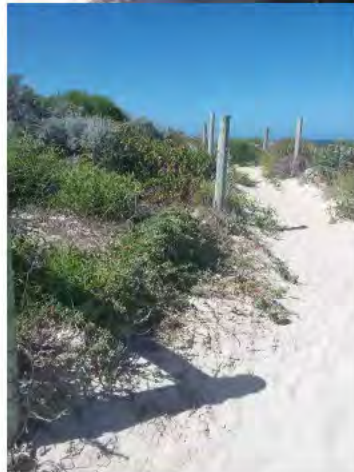
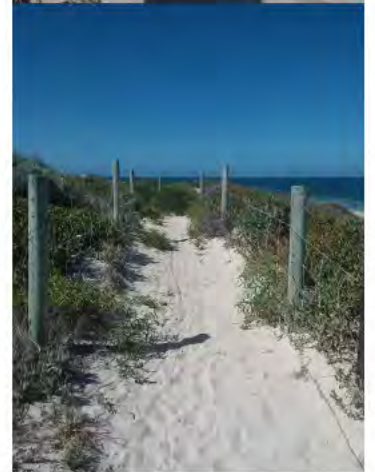
<b>Site No.</b>	C2
<b>Site Name/ Location</b>	South Two Rocks Foreshore
<b>Date</b>	25/02/2021
<b>Time</b>	09:50 (8 GMT)
<b>Item Number</b>	9
<b>Costal Asset Type</b>	Fencing
<b>Sub-element (Fencing)</b>	Mesh
<b>Sub-element</b>	including strainer wires
<b>Material Type</b>	Steel
<b>2021 Observed Defects (Steel)</b>	Surface corrosion, Failed
<b>Defect Description</b>	Strainer wire failed on western edge of top fence. Mesh typically loose.
<b>Quantity of Defects</b>	216m <sup>2</sup>
<b>Condition Rating (0- 10)</b>	6
<b>Health and Safety Concern (Y/N)</b>	No
<b>Consequence of Failure</b>	2
<b>Likelihood of Failure within next 5 years</b>	3
<b>Risk Rating</b>	6
<b>Overall Rating (CR X RR)</b>	36
<b>Maintenance Recommendation</b>	Replace or tighten failed or loose strainer wires.
<b>Maintenance Timeframe</b>	Within 5 years

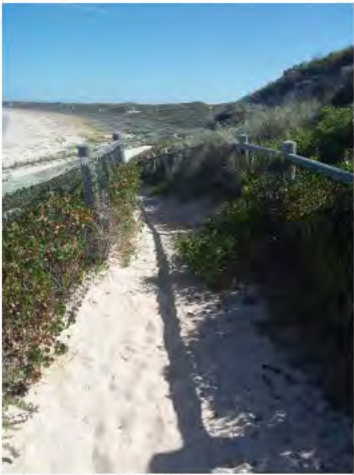
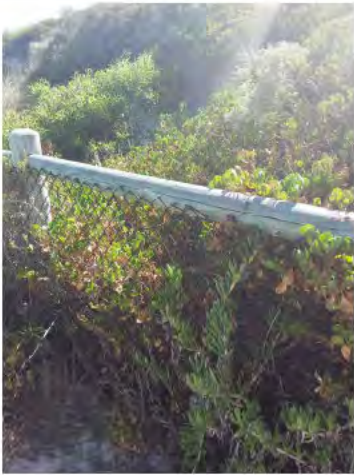
<b>Site No.</b>	C2
<b>Site Name/ Location</b>	South Two Rocks Foreshore
<b>Date</b>	25/02/2021
<b>Time</b>	09:38 (8 GMT)
<b>Item Number</b>	10
<b>Costal Asset Type</b>	Fencing
<b>Sub-element (Fencing)</b>	Timber rail
<b>Material Type</b>	Timber
<b>2021 Observed Defects (Timber)</b>	Split timber
<b>Defect Description</b>	Generally good condition with timber splitting observed to be typical throughout. Note: railing and post type changes at approx. 18m from southern edge
<b>Quantity of Defects</b>	52m
<b>Condition Rating (0- 10)</b>	4
<b>Health and Safety Concern (Y/N)</b>	No
<b>Consequence of Failure</b>	4
<b>Likelihood of Failure within next 5 years</b>	2
<b>Risk Rating</b>	8
<b>Overall Rating (CR X RR)</b>	32
<b>Maintenance Recommendation</b>	Monitor and reinspect at next scheduled inspection.
<b>Maintenance timeframe</b>	Greater than 5 years

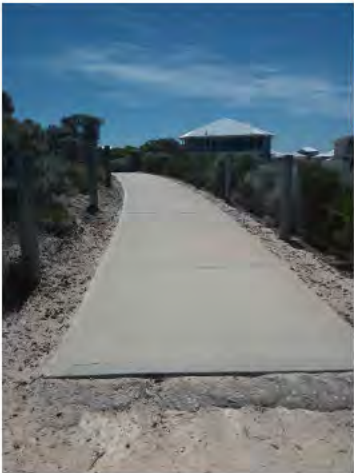
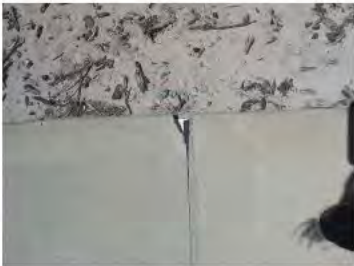
<b>Site No.</b>	C3
<b>Site Name/ Location</b>	North Yanchep Foreshore
<b>Date</b>	25/02/2021
<b>Time</b>	11:38 (8 GMT)
<b>Item Number</b>	1
<b>Costal Asset Type</b>	Concrete path
<b>Material Type</b>	Reinforced Concrete
<b>2021 Observed Defects (Reinforced Concrete)</b>	Cracking
<b>Defect Description</b>	Generally good condition with minor damage to the corner at control joint.
<b>Quantity of Defects</b>	33m2
<b>Condition Rating (0- 10)</b>	3
<b>Health and Safety Concern (Y/N)</b>	No
<b>Consequence of Failure</b>	2
<b>Likelihood of Failure within next 5 years</b>	1
<b>Risk Rating</b>	2
<b>Overall Rating (CR X RR)</b>	6
<b>Maintenance Recommendation</b>	Monitor and reinspect at next scheduled inspection.
<b>Maintenance Timeframe</b>	Greater than 5 years

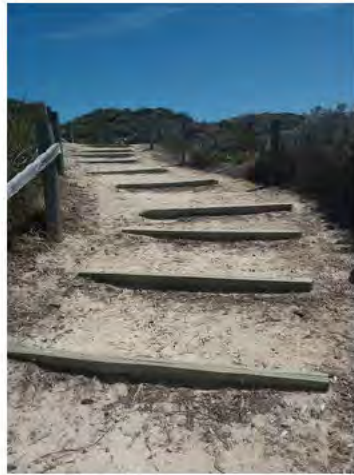
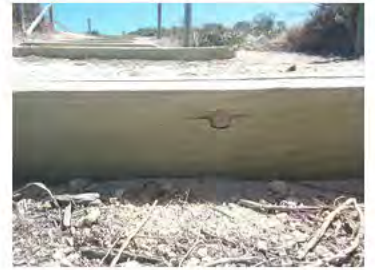
<b>Site No.</b>	C4
<b>Site Name/ Location</b>	North Yanchep Foreshore
<b>Date</b>	25/02/2021
<b>Time</b>	11:12 (8 GMT)
<b>Item Number</b>	2
<b>Costal Asset Type</b>	Stairs
<b>Sub-element (Stairs and Landing)</b>	Timber sleepers
<b>Material Type</b>	Timber
<b>2021 Observed Defects (Timber)</b>	No visible defects
<b>Defect Description</b>	No visible defects were observed
<b>Condition Rating (0- 10)</b>	2
<b>Health and Safety Concern (Y/N)</b>	No
<b>Consequence of Failure</b>	2
<b>Likelihood of Failure within next 5 years</b>	2
<b>Risk Rating</b>	4
<b>Overall Rating (CR X RR)</b>	8
<b>Maintenance Recommendation</b>	Monitor and reinspect at next scheduled inspection.
<b>Maintenance Timeframe</b>	Greater than 5 years
