# City of Wanneroo Assets Structural Assessment

## Coastal Assets

City Of Wanneroo

30 July 2021

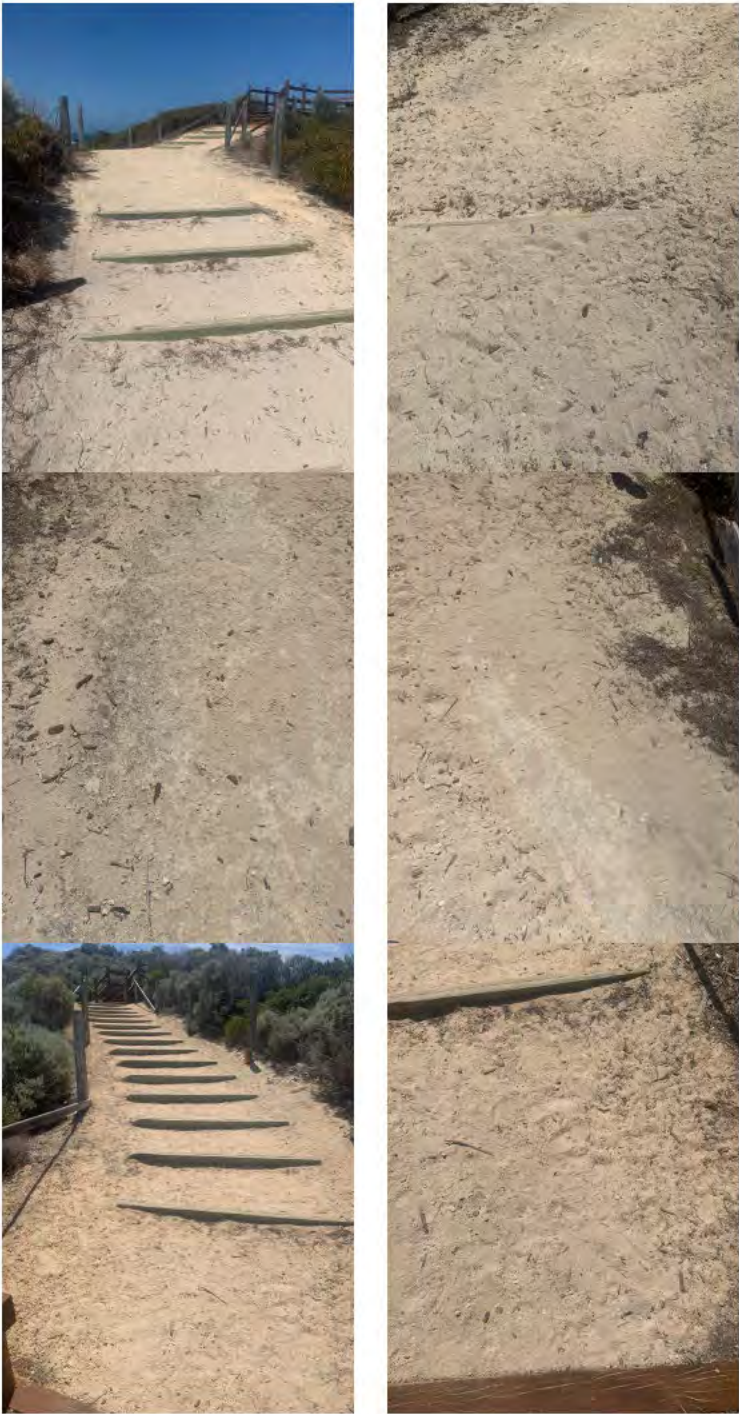
<b>Site No.</b>	C3
<b>Site Name/ Location</b>	North Yanchep Foreshore
<b>Date</b>	25/02/2021
<b>Time</b>	11:25 (8 GMT)
<b>Item Number</b>	3
<b>Costal Asset Type</b>	Other
<b>Asset Type</b>	Boardwalk / stairs
<b>Element</b>	Surface
<b>Sub-element</b>	Concrete steps
<b>Material Type</b>	Limestone
<b>Defect Description</b>	Generally good condition with some minor erosion observed to be typical.
<b>Quantity of Defects</b>	3m Wide x 77m
<b>Condition Rating (0- 10)</b>	4
<b>Health and Safety Concern (Y/N)</b>	No
<b>Consequence of Failure</b>	2
<b>Likelihood of Failure within next 5 years</b>	1
<b>Risk Rating</b>	2
<b>Overall Rating (CR X RR)</b>	8
<b>Maintenance Recommendation</b>	Monitor and reinspect at next scheduled inspection.
<b>Maintenance Timeframe</b>	Greater than 5 years

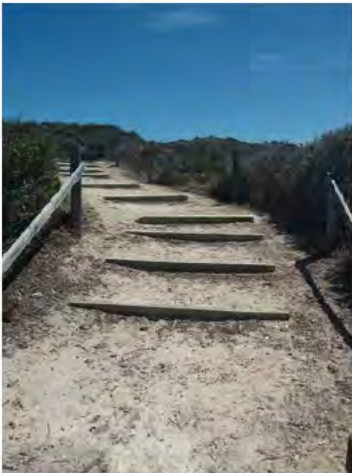
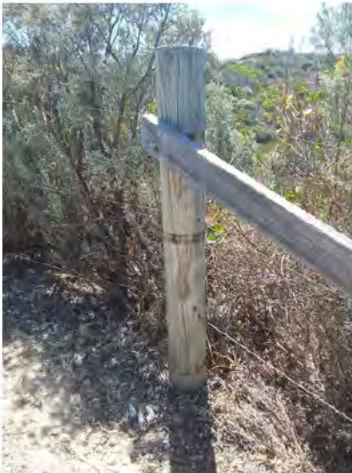
Site No.	C4
Site Name/ Location	North Yanchep Foreshore
Date	25/02/2021
Time	11:07 (8 GMT)
Item Number	4
Costal Asset Type	Fencing
Element	Fencing
Sub-element (Fencing)	Timber posts
Material Type	Timber
2021 Observed Defects (Timber)	Split timber
Defect Description	Generally good condition with minor timber splitting observed to be typical throughout.
Quantity of Defects	10 posts
Condition Rating (0- 10)	3
Health and Safety Concern (Y/N)	No
Consequence of Failure	2
Likelihood of Failure within next 5 years	2
Risk Rating	4
Overall Rating (CR X RR)	12
Maintenance Recommendation	Monitor and reinspect at next scheduled inspection.
Maintenance Timeframe	Greater than 5 years

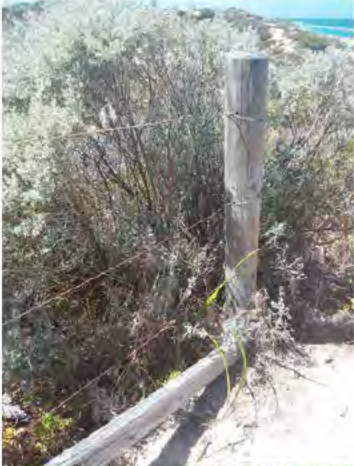
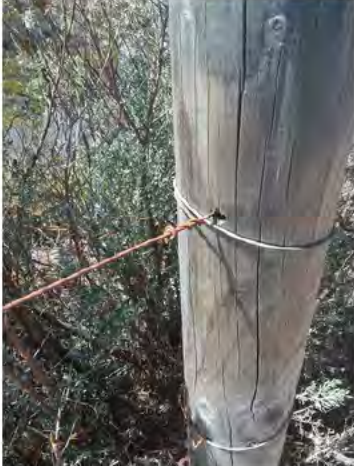
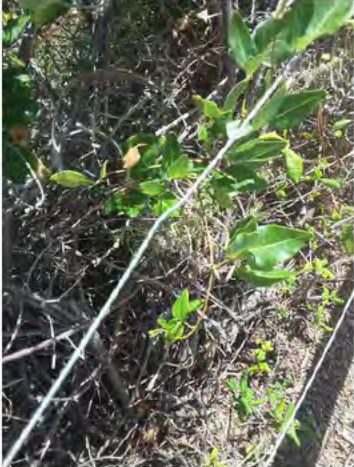
<b>Site No.</b>	C4
<b>Site Name/ Location</b>	North Yanchep Foreshore
<b>Date</b>	25/02/2021
<b>Time</b>	11:09 (8 GMT)
<b>Item Number</b>	5
<b>Costal Asset Type</b>	Fencing
<b>Sub-element (Fencing)</b>	Mesh strainer wires
<b>Sub-element</b>	strainer wires no mesh
<b>Material Type</b>	Steel
<b>2021 Observed Defects (Steel)</b>	Surface corrosion, Deformation.
<b>Defect Description</b>	Surface corrosion was observed to be typical throughout. Localised areas of deformed wires were also observed.
<b>Quantity of Defects</b>	144m
<b>Condition Rating (0- 10)</b>	6
<b>Health and Safety Concern (Y/N)</b>	No
<b>Consequence of Failure</b>	2
<b>Likelihood of Failure within next 5 years</b>	3
<b>Risk Rating</b>	6
<b>Overall Rating (CR X RR)</b>	36
<b>Maintenance Recommendation</b>	Replace heavily corroded or deformed strainer wires.
<b>Maintenance Timeframe</b>	Within 5 years

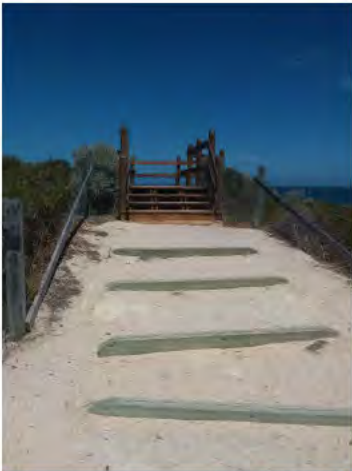
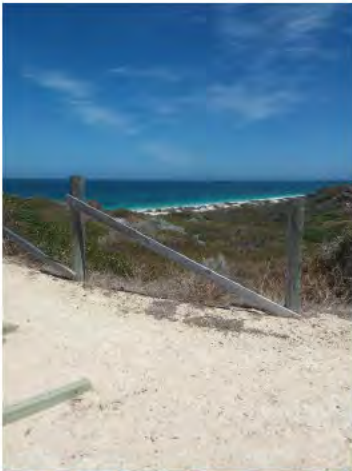
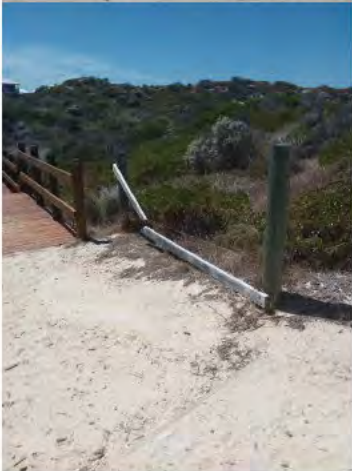
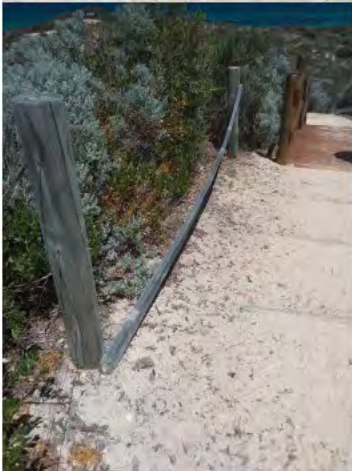
<b>Site No.</b>	C3
<b>Site Name/ Location</b>	North Yanchep Foreshore
<b>Date</b>	25/02/2021
<b>Time</b>	11:26 (8 GMT)
<b>Item Number</b>	6
<b>Costal Asset Type</b>	Fencing
<b>Sub-element (Fencing)</b>	Timber members
<b>Sub-element</b>	Bracing
<b>Material Type</b>	Timber
<b>2021 Observed Defects (Timber)</b>	Failed
<b>Defect Description</b>	Failed bracing and bowed bracing.
<b>Quantity of Defects</b>	39m
<b>Condition Rating (0- 10)</b>	8
<b>Health and Safety Concern (Y/N)</b>	No
<b>Consequence of Failure</b>	2
<b>Likelihood of Failure within next 5 years</b>	5
<b>Risk Rating</b>	10
<b>Overall Rating (CR X RR)</b>	80
<b>Maintenance Recommendation</b>	Replace bracing.
<b>Maintenance Timeframe</b>	Within 6 months.

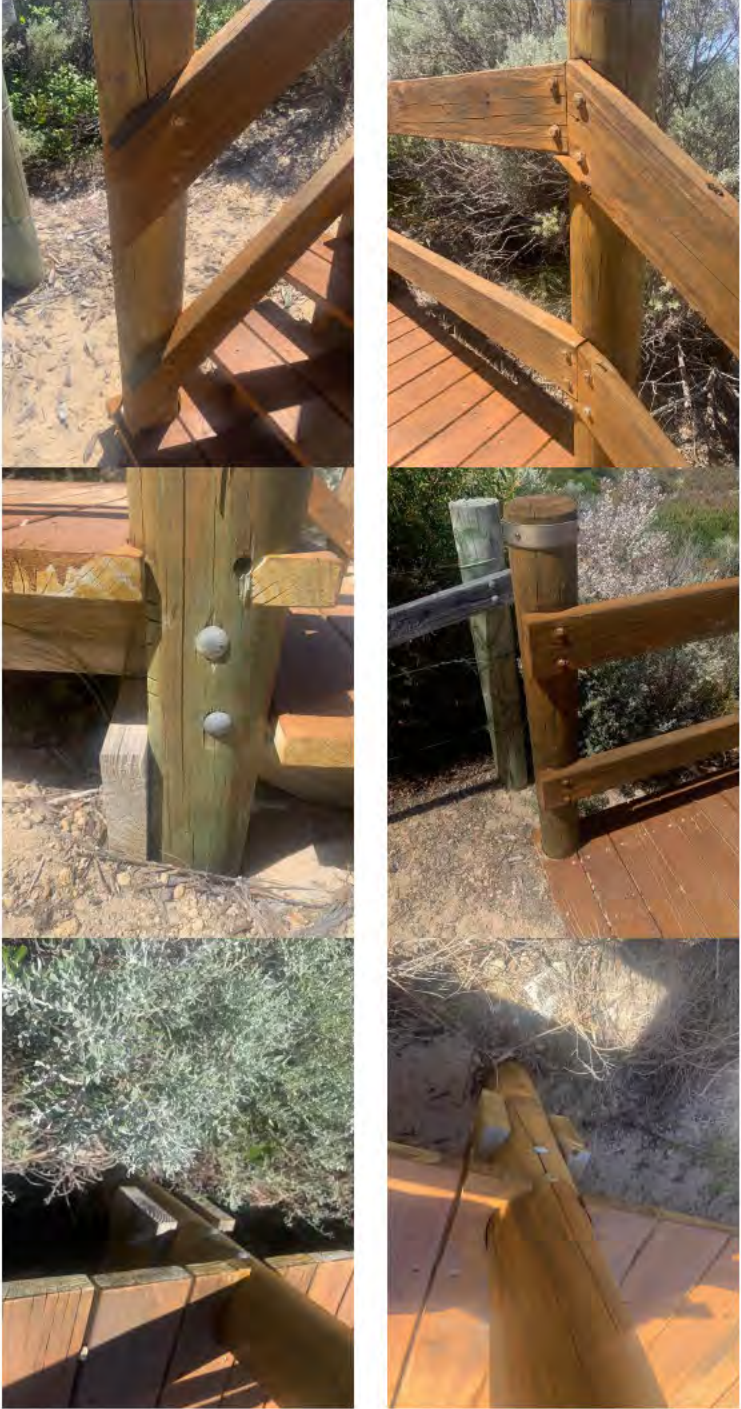
<b>Site No.</b>	C3
<b>Site Name/ Location</b>	North Yanchep Foreshore
<b>Date</b>	25/02/2021
<b>Time</b>	11:17 (8 GMT)
<b>Item Number</b>	15
<b>Asset Type</b>	Boardwalk / stairs
<b>Element</b>	Supports
<b>Sub-element</b>	Connections
<b>Material Type</b>	Galvanised Steel
<b>2021 Observed Defects (Steel)</b>	Surface corrosion
<b>Defect description</b>	Generally good condition, minor surface corrosion observed.
<b>Condition Rating (0- 10)</b>	3
<b>Health and Safety Concern (Y/N)</b>	No
<b>Consequence of Failure</b>	3
<b>Likelihood of Failure within next 5 years</b>	1
<b>Risk Rating</b>	3
<b>Overall Rating (CR X RR)</b>	9
<b>Maintenance Recommendation</b>	Monitor and reinspect at next scheduled inspection.
<b>Maintenance Timeframe</b>	Greater than 5 years

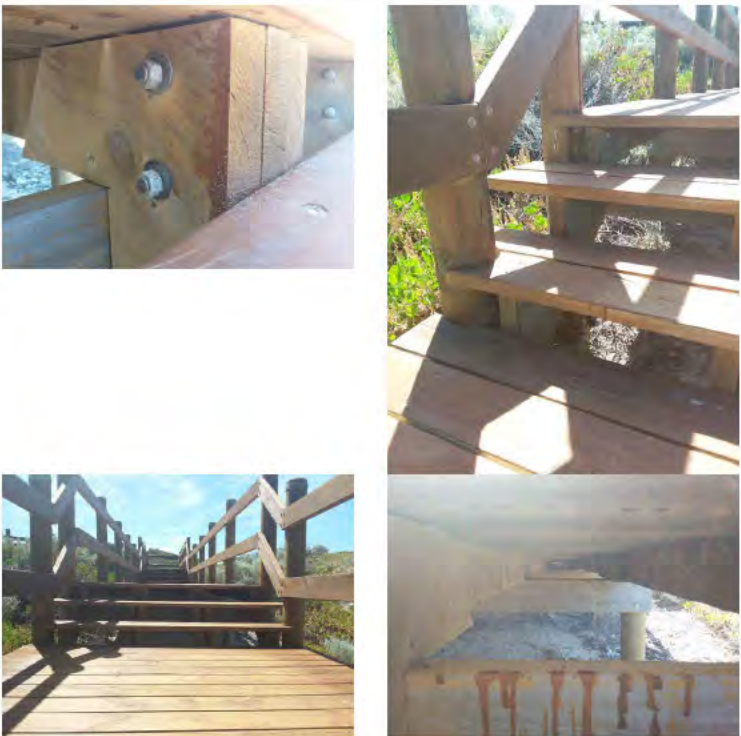
<b>Site No.</b>	C4
<b>Site Name/ Location</b>	North Yanchep Foreshore
<b>Date</b>	25/02/2021
<b>Time</b>	10:46 (8 GMT)
<b>Item Number</b>	16
<b>Costal Asset Type</b>	Stairs
<b>Element</b>	Stairs
<b>Sub-element (Stairs and Landing)</b>	Timber support beam
<b>Sub-element</b>	support beam for treads and landings
<b>Material Type</b>	Timber, Steel
<b>2021 Observed Defects (Timber)</b>	No visible defects were observed.
<b>2021 Observed Defects (Steel)</b>	Surface corrosion
<b>Defect Description</b>	No visible defects were observed to timber members. Connections observed to contain minor surface corrosion.
<b>Quantity of Defects</b>	180m across width of stairs, 224m along length of stairs/boardwalk
<b>Condition Rating (0- 10)</b>	4
<b>Health and Safety Concern (Y/N)</b>	No
<b>Consequence of Failure</b>	3
<b>Likelihood of Failure within next 5 years</b>	2
<b>Risk Rating</b>	6
<b>Overall Rating (CR X RR)</b>	24
<b>Maintenance Recommendation</b>	Monitor and reinspect at next scheduled inspection

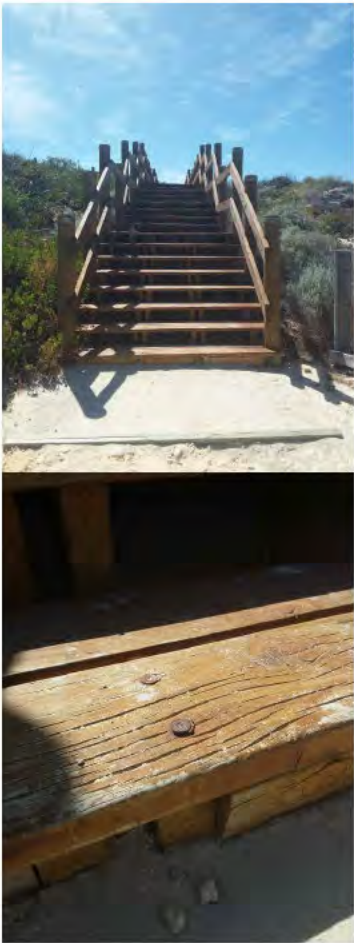
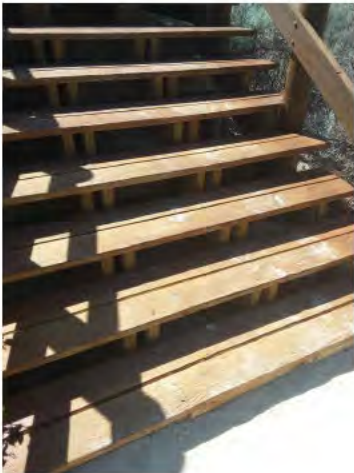
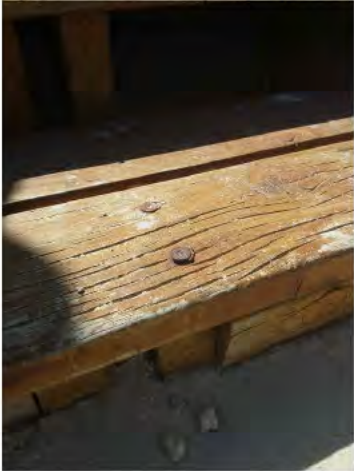
<b>Site No.</b>	C4
<b>Site Name/ Location</b>	North Yanchep Foreshore
<b>Date</b>	25/02/2021
<b>Time</b>	10:36 (8 GMT)
<b>Item Number</b>	17
<b>Costal Asset Type</b>	Stairs
<b>Sub-element (Stairs and Landing)</b>	Timber sleepers
<b>Sub-element (Decking and Supports)</b>	Deck planks
<b>Material Type</b>	Timber
<b>2021 Observed Defects (Timber)</b>	General damage, Split timber, Other
<b>Defect Description</b>	Generally good condition with minor timber splitting and coating loss observed to be typical. A number of bolts were raised from tread level.
<b>Quantity of Defects</b>	112m2
<b>Condition Rating (0- 10)</b>	3
<b>Health and Safety Concern (Y/N)</b>	No
<b>Consequence of Failure</b>	3
<b>Likelihood of Failure within next 5 years</b>	2
<b>Risk Rating</b>	6
<b>Overall Rating (CR X RR)</b>	30
<b>Maintenance Recommendation</b>	Recoat timber members which contain significant coating loss of timber splitting. Fix or replace raised bolts.

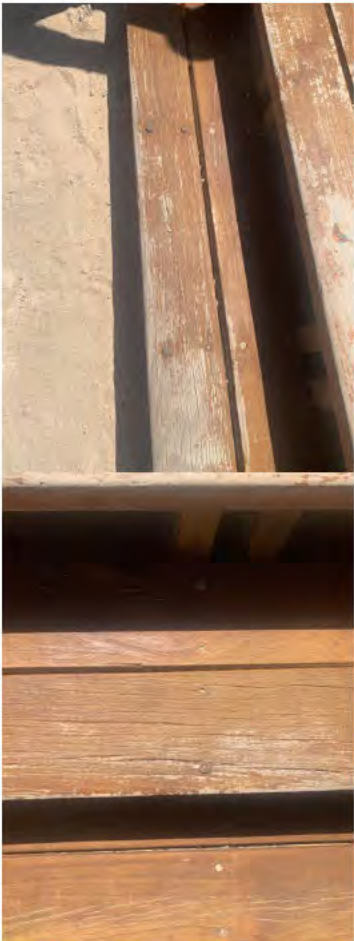
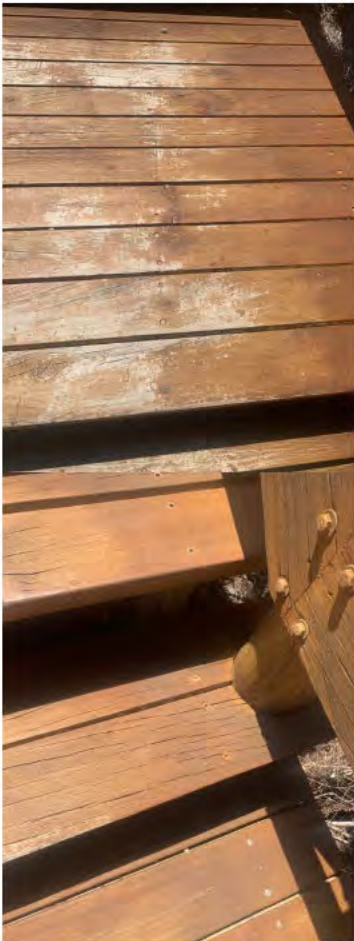
<b>Site No.</b>	C3
<b>Site Name/ Location</b>	North Yanchep Foreshore
<b>Date</b>	25/02/2021
<b>Time</b>	11:14 (8 GMT)
<b>Item Number</b>	19
<b>Asset Type</b>	Boardwalk / stairs
<b>Element</b>	Decking
<b>Sub-element (Decking and Supports)</b>	Decking screws
<b>Material Type</b>	Galvanised Steel
<b>2021 Observed Defects (Steel)</b>	Surface corrosion, Other
<b>Defect Description</b>	Generally good condition with minor surface corrosion observed to be typical and some screws in localised areas observed to not be sitting flush.
<b>Condition Rating (0- 10)</b>	5
<b>Health and Safety Concern (Y/N)</b>	No
<b>Consequence of Failure</b>	2
<b>Likelihood of Failure within next 5 years</b>	3
<b>Risk Rating</b>	6
<b>Overall Rating (CR X RR)</b>	30
<b>Maintenance Recommendation</b>	Replace heavily corroded screws and localised replacement of screws which aren't flush.
<b>Maintenance Timeframe</b>	Within 5 years

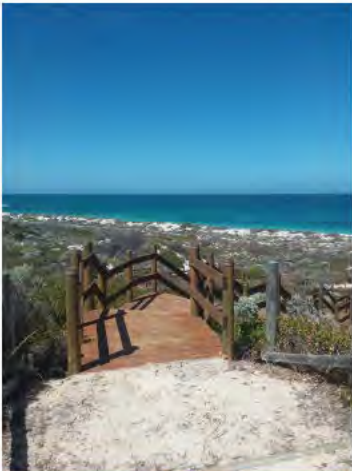
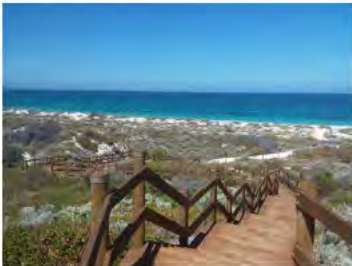
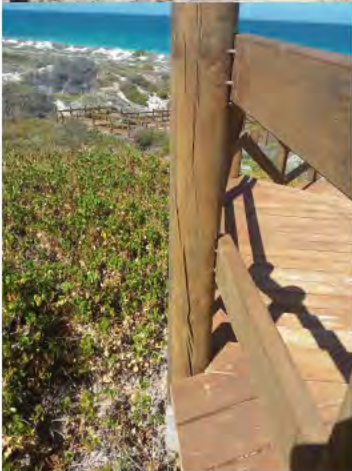
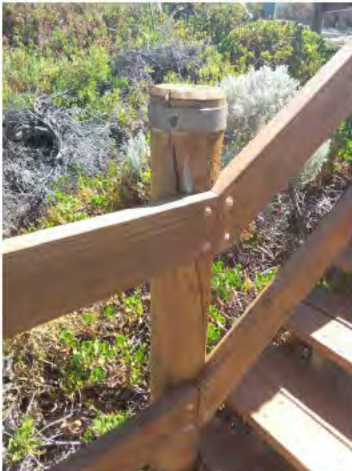
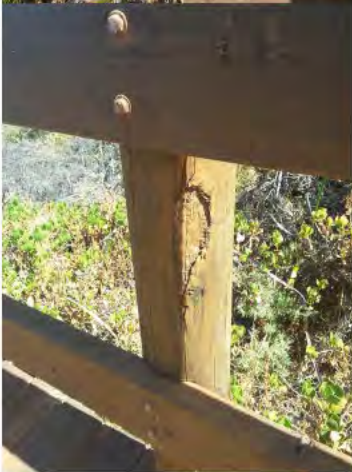
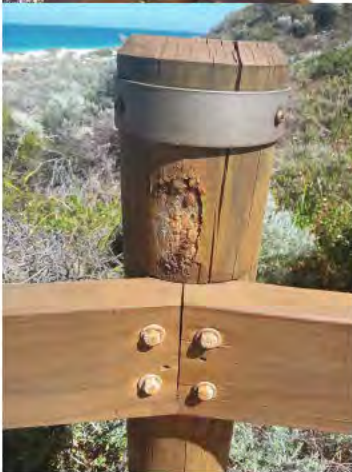
<b>Site No.</b>	C4
<b>Site Name/ Location</b>	North Yanchep Foreshore
<b>Date</b>	25/02/2021
<b>Time</b>	10:25 (8 GMT)
<b>Item Number</b>	20
<b>Costal Asset Type</b>	Stairs
<b>Sub-element (Stairs and Landing)</b>	Timber posts
<b>Material Type</b>	Timber
<b>2021 Observed Defects (Timber)</b>	Split timber, Rotted timber
<b>Defect Description</b>	Localised rot to 2 No. timber posts.
<b>Quantity of Defects</b>	112
<b>Condition Rating (0- 10)</b>	4
<b>Health and Safety Concern (Y/N)</b>	No
<b>Consequence of Failure</b>	3
<b>Likelihood of Failure within next 5 years</b>	2
<b>Risk Rating</b>	6
<b>Overall Rating (CR X RR)</b>	24
<b>Maintenance Recommendation</b>	Monitor and reinspect at next scheduled inspection
<b>Maintenance Timeframe</b>	Greater than 5 years

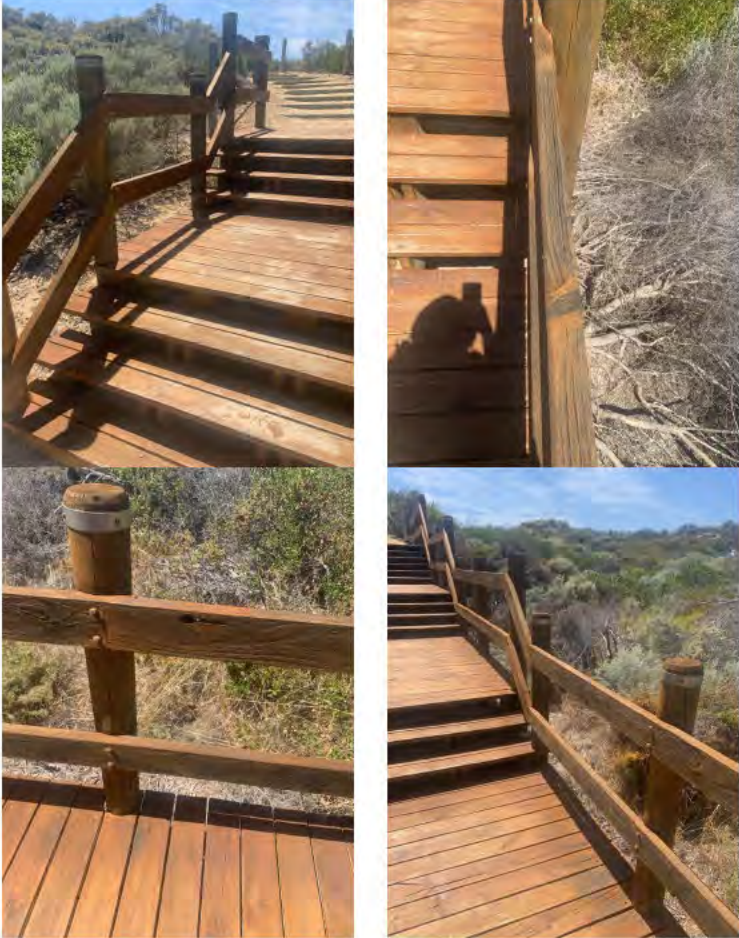
<b>Site No.</b>	C3
<b>Site Name/ Location</b>	North Yanchep Foreshore
<b>Date</b>	25/02/2021
<b>Time</b>	11:03 (8 GMT)
<b>Item Number</b>	22
<b>Asset Type</b>	Boardwalk / stairs
<b>Element</b>	Handrails
<b>Material Type</b>	Timber
<b>2021 Observed Defects (Timber)</b>	Split timber, General damage
<b>Defect Description</b>	Generally good condition with some minor deterioration and split timber observed.
<b>Quantity of Defects</b>	Boardwalk 4x span Stairs 4x span
<b>Condition Rating (0- 10)</b>	4
<b>Health and Safety Concern (Y/N)</b>	No
<b>Consequence of Failure</b>	3
<b>Likelihood of Failure within next 5 years</b>	1
<b>Risk Rating</b>	3
<b>Overall Rating (CR X RR)</b>	12
<b>Maintenance Recommendation</b>	Monitor and reinspect at next scheduled inspection
<b>Maintenance Timeframe</b>	Greater than 5 years

Monitor at next inspection and oil at regular intervals

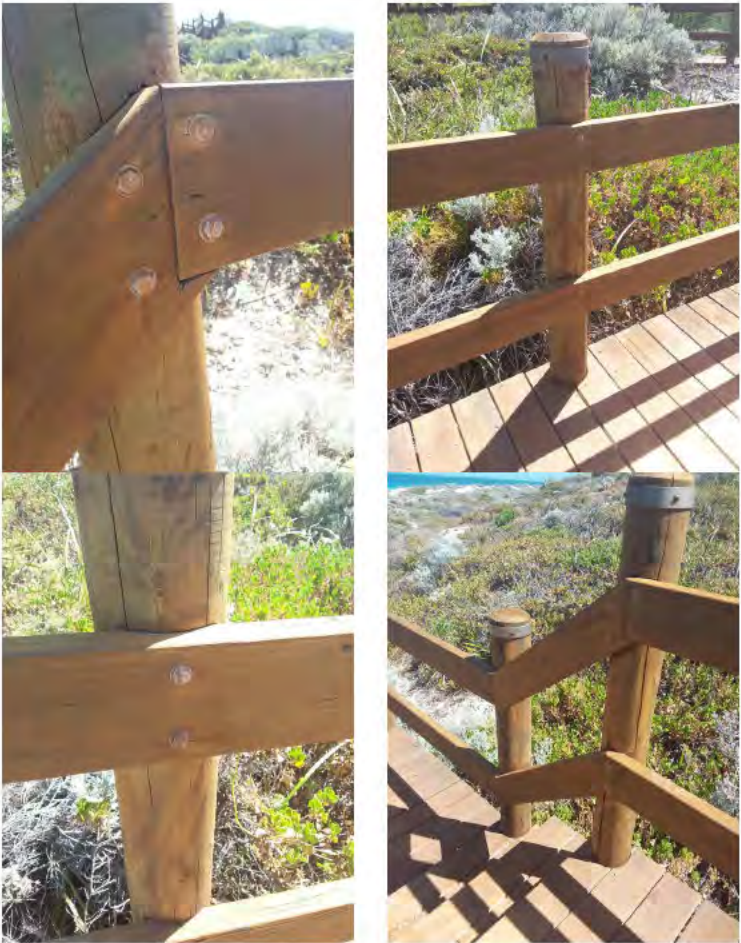
<b>Site No.</b>	C4
<b>Site Name/ Location</b>	North Yanchep Foreshore
<b>Date</b>	25/02/2021
<b>Time</b>	10:43 (8 GMT)
<b>Item Number</b>	22
<b>Costal Asset Type</b>	Stairs
<b>Element</b>	Handrails
<b>Sub-element (Handrails)</b>	Bolts
<b>Material Type</b>	Steel
<b>2021 Observed Defects (Steel)</b>	Surface corrosion
<b>Defect Description</b>	Generally good condition with surface corrosion observed to be typical throughout.
<b>Condition Rating (0- 10)</b>	3
<b>Health and Safety Concern (Y/N)</b>	No
<b>Consequence of Failure</b>	3
<b>Likelihood of Failure within next 5 years</b>	1
<b>Risk Rating</b>	3
<b>Overall Rating (CR X RR)</b>	9
<b>Maintenance Recommendation</b>	Monitor and reinspect at next scheduled inspection
<b>Maintenance Timeframe</b>	Greater than 5 years

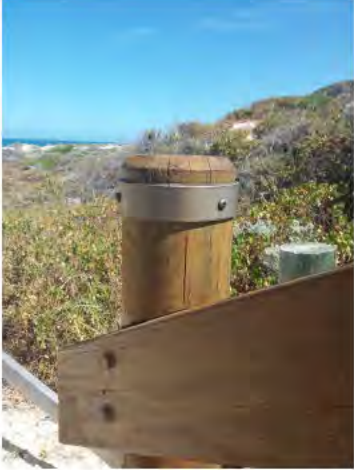
<b>Site No.</b>	C4
<b>Site Name/ Location</b>	North Yanchep Foreshore
<b>Date</b>	25/02/2021
<b>Time</b>	10:34 (8 GMT)
<b>Item Number</b>	23
<b>Costal Asset Type</b>	Stairs
<b>Sub-element</b>	Steel banding
<b>Material Type</b>	Steel
<b>2021 Observed Defects (Steel)</b>	Surface corrosion
<b>Defect Description</b>	typical
<b>Condition Rating (0- 10)</b>	3
<b>Health and Safety Concern (Y/N)</b>	No
<b>Consequence of Failure</b>	1
<b>Likelihood of Failure within next 5 years</b>	2
<b>Risk Rating</b>	2
<b>Overall Rating (CR X RR)</b>	6
<b>Maintenance Recommendation</b>	Monitor and reinspect at next scheduled inspection
<b>Maintenance Timeframe</b>	Greater than 5 years

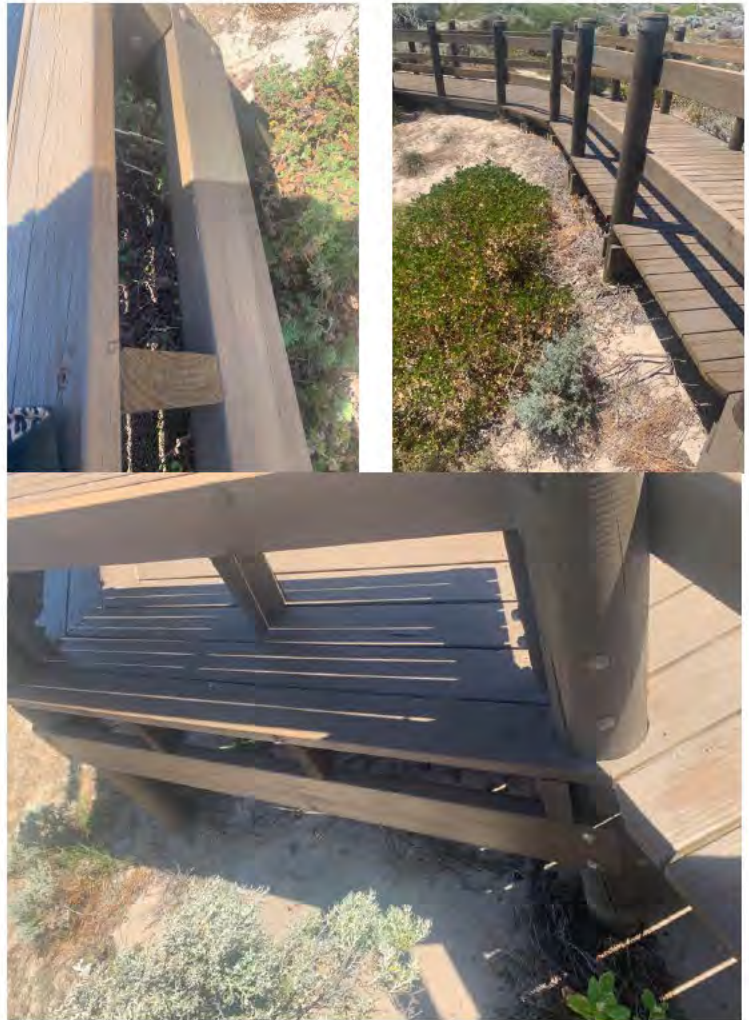
Site No.	C4
Site Name/ Location	North Yanchep Foreshore
Date	25/02/2021
Time	11:51 (8 GMT)
Item Number	1
Costal Asset Type	Boardwalk to elevated look out
Element	Supports
Sub-element	Beams
Material Type	Timber
2021 Observed Defects (Timber)	General damage, Split timber
Defect Description	Minor damage and timber splitting observed.
Condition Rating (0- 10)	3
Health and Safety Concern (Y/N)	No
Consequence of Failure	3
Likelihood of Failure within next 5 years	1
Risk Rating	3
Overall Rating (CR X RR)	9
Maintenance Recommendation	Monitor and reinspect at next scheduled inspection
Maintenance Timeframe	Greater than 5 years

Monitor at next inspection, oil at regular intervals

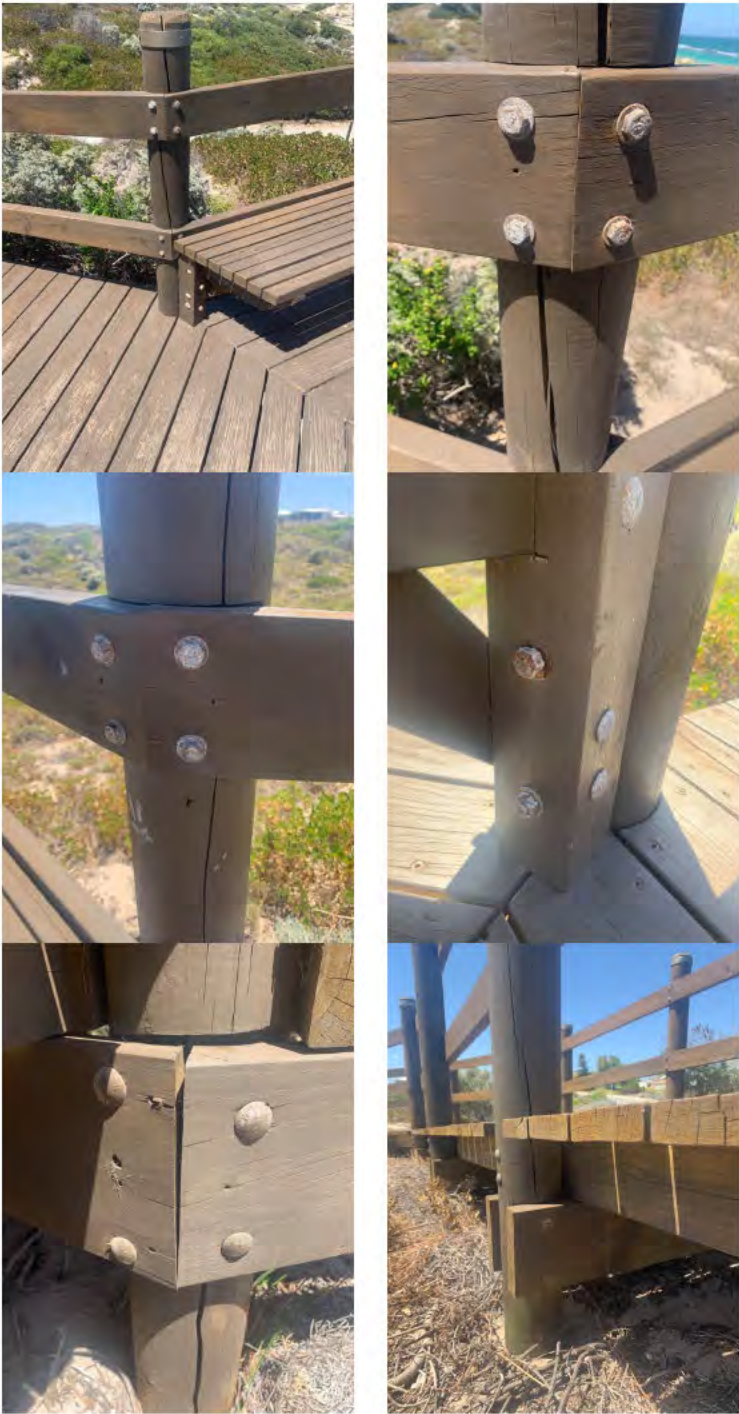
Site No.	C4
Site Name/ Location	North Yanchep Foreshore
Date	25/02/2021
Time	11:57 (8 GMT)
Item Number	2
Costal Asset Type	Boardwalk to elevated look out
Element	Supports
Sub-element	Connections
Material Type	Galvanised Steel
2021 Observed Defects (Steel)	Surface corrosion, Coating loss
Defect Description	Typical minor surface corrosion to connections.
Condition Rating (0- 10)	4
Health and Safety Concern (Y/N)	No
Consequence of Failure	2
Likelihood of Failure within next 5 years	2
Risk Rating	4
Overall Rating (CR X RR)	16
Maintenance Recommendation	Monitor and reinspect at next scheduled inspection.
Maintenance Timeframe	Greater than 5 years

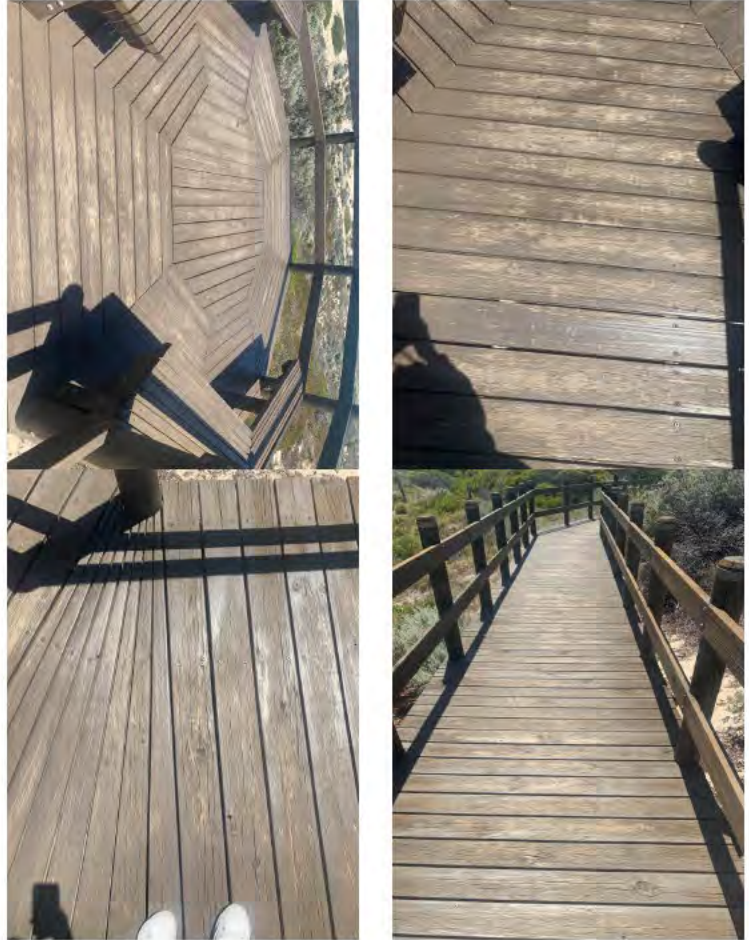
<b>Site No.</b>	C4
<b>Site Name/ Location</b>	North Yanchep Foreshore
<b>Date</b>	25/02/2021
<b>Time</b>	11:48 (8 GMT)
<b>Item Number</b>	3
<b>Costal Asset Type</b>	Boardwalk to elevated look out
<b>Element</b>	Decking
<b>Sub-element (Decking and Supports)</b>	Deck planks
<b>Material Type</b>	Timber
<b>2021 Observed Defects (Timber)</b>	General damage, Split timber
<b>Defect Description</b>	Minor damage and timber splitting was observed.
<b>Condition Rating (0- 10)</b>	3
<b>Health and Safety Concern (Y/N)</b>	No
<b>Consequence of Failure</b>	3
<b>Likelihood of Failure within next 5 years</b>	1
<b>Risk Rating</b>	3
<b>Overall Rating (CR X RR)</b>	9
<b>Maintenance Recommendation</b>	Monitor and reinspect at next scheduled inspection
<b>Maintenance Timeframe</b>	Greater than 5 years

Monitor at next inspection, oil at regular intervals

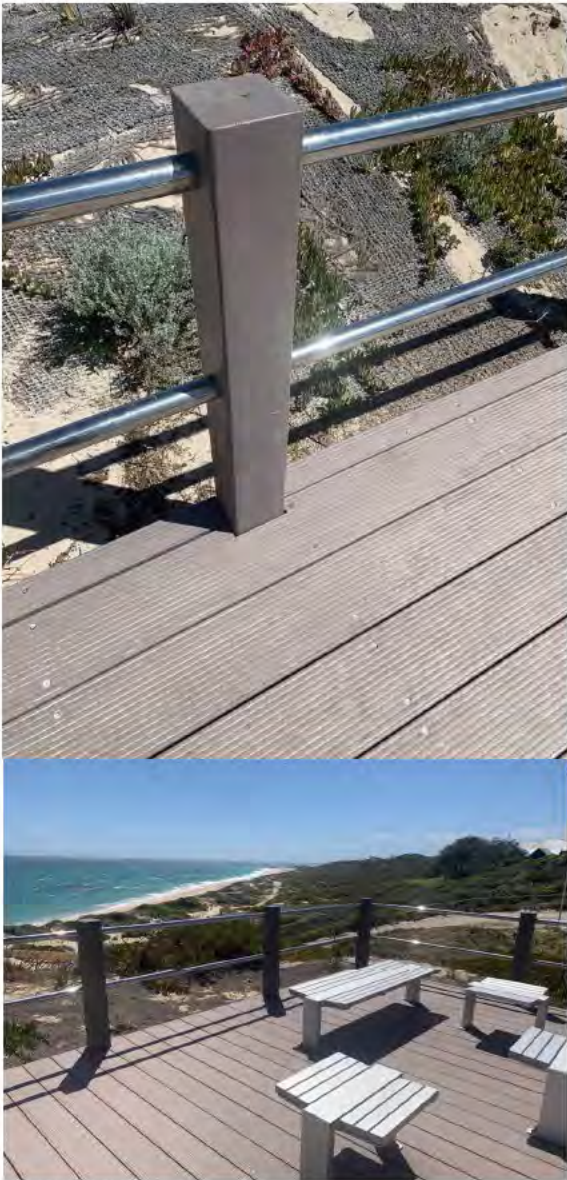
<b>Site No.</b>	C5
<b>Site Name/ Location</b>	Old Yanchep Surf Life Saving Club
<b>Date</b>	25/02/2021
<b>Time</b>	14:09 (8 GMT)
<b>Item Number</b>	5
<b>Costal Asset Type</b>	Lookout
<b>Element</b>	Handrails
<b>Sub-element</b>	Ballustrade post
<b>Material Type</b>	Composite Material
<b>Defect Description</b>	No visible defects were observed.
<b>Quantity of Defects</b>	8 posts 1m tall
<b>Condition Rating (0- 10)</b>	3
<b>Health and Safety Concern (Y/N)</b>	No
<b>Consequence of Failure</b>	2
<b>Likelihood of Failure within next 5 years</b>	1
<b>Risk Rating</b>	2
<b>Overall Rating (CR X RR)</b>	6
<b>Maintenance Recommendation</b>	Monitor and reinspect at next scheduled inspection.
<b>Maintenance Timeframe</b>	Greater than 5 years

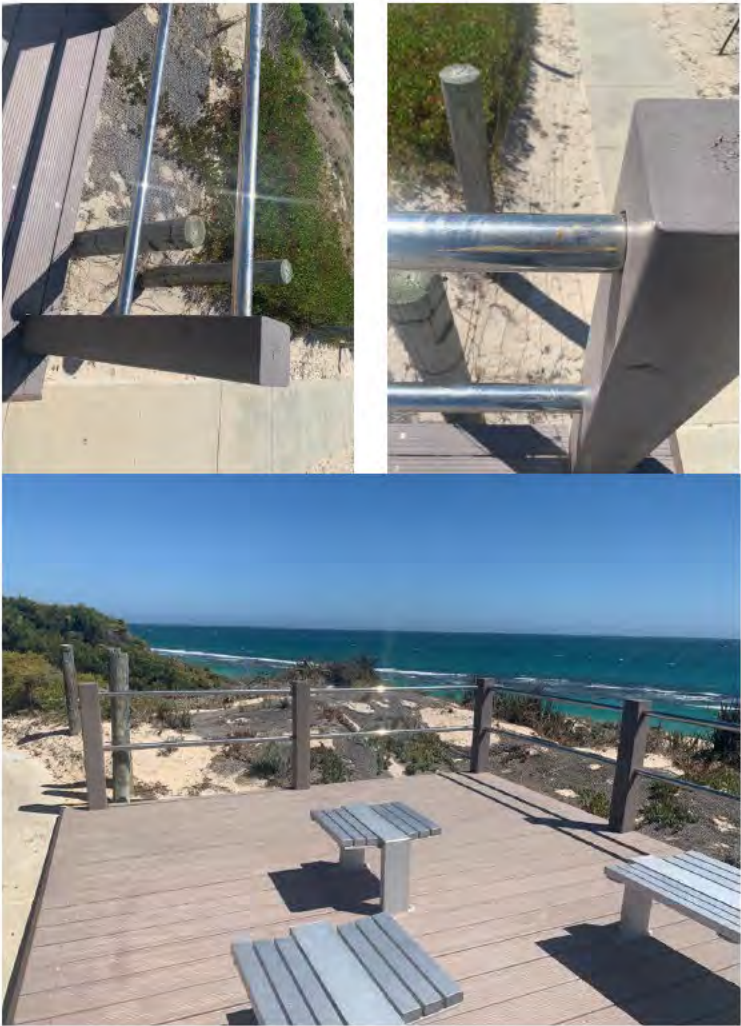
<b>Site No.</b>	C5
<b>Site Name/ Location</b>	Old Yanchep Surf Life Saving Club
<b>Date</b>	25/02/2021
<b>Time</b>	14:11 (8 GMT)
<b>Item Number</b>	6
<b>Costal Asset Type</b>	Lookout
<b>Element</b>	Handrails
<b>Material Type</b>	Stainless Steel
<b>2021 Observed Defects (Steel)</b>	Tea staining
<b>Defect Description</b>	Minor tea staining observed.
<b>Quantity of Defects</b>	26m total
<b>Condition Rating (0- 10)</b>	4
<b>Health and Safety Concern (Y/N)</b>	No
<b>Consequence of Failure</b>	2
<b>Likelihood of Failure within next 5 years</b>	1
<b>Risk Rating</b>	2
<b>Overall Rating (CR X RR)</b>	8
<b>Maintenance Recommendation</b>	Monitor and reinspect at next scheduled inspection.
<b>Maintenance Timeframe</b>	Greater than 5 years

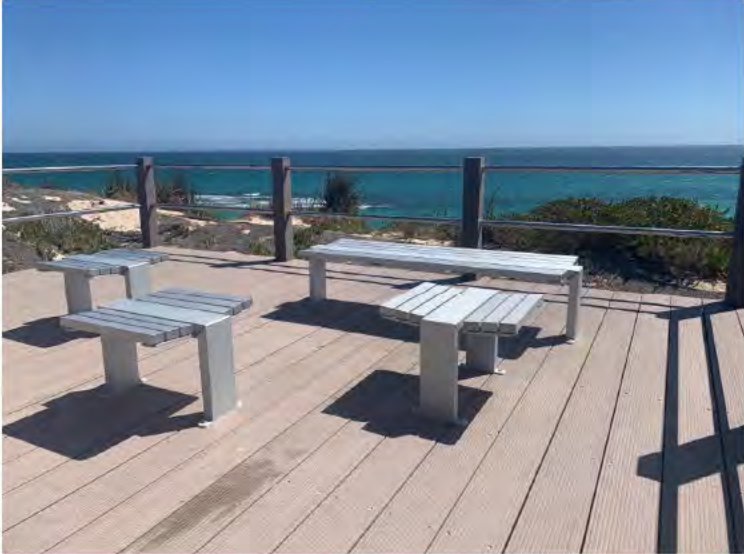
<b>Site No.</b>	C5
<b>Site Name/ Location</b>	Old Yanchep Surf Life Saving Club
<b>Date</b>	25/02/2021
<b>Time</b>	14:13 (8 GMT)
<b>Item Number</b>	7
<b>Costal Asset Type</b>	Lookout
<b>Element</b>	Bench
<b>Material Type</b>	Composite Material, Stainless Steel
<b>2021 Observed Defects (Steel)</b>	No visible defects were observed.
<b>Quantity of Defects</b>	3 small, 1 long
<b>Condition Rating (0- 10)</b>	2
<b>Health and Safety Concern (Y/N)</b>	No
<b>Consequence of Failure</b>	2
<b>Likelihood of Failure within next 5 years</b>	1
<b>Risk Rating</b>	2
<b>Overall Rating (CR X RR)</b>	4
<b>Maintenance Recommendation</b>	Monitor and reinspect at next scheduled inspection.
<b>Maintenance Timeframe</b>	Greater than 5 years

Plastic seats, SS connections

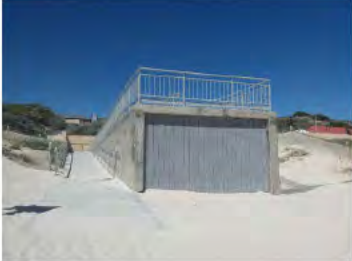
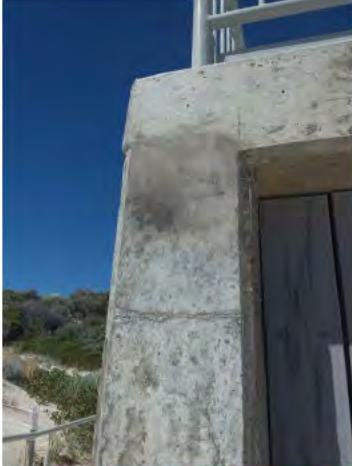
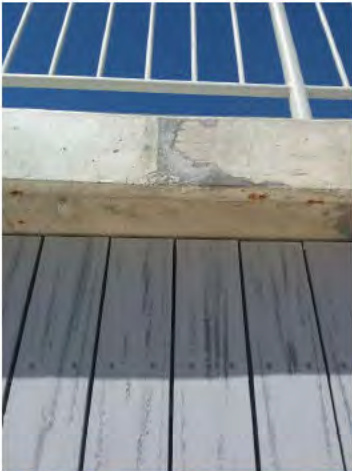
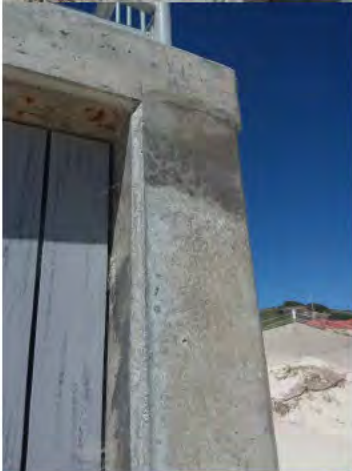
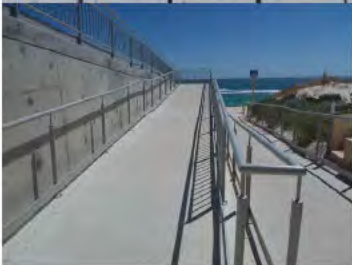
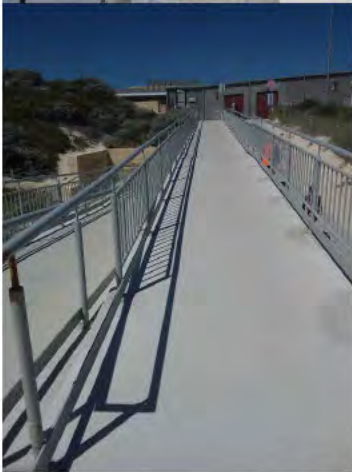
<b>Site No.</b>	C6
<b>Site Name/ Location</b>	Yanchep Surf Life Saving Club
<b>Date</b>	25/02/2021
<b>Time</b>	14:05 (8 GMT)
<b>Item Number</b>	1
<b>Costal Asset Type</b>	Disabled Access Ramp
<b>Sub-element (Foundations)</b>	Base slab
<b>Material Type</b>	Reinforced Concrete
<b>2021 Observed Defects (Reinforced Concrete)</b>	Crack, Noticeable prior concrete repairs
<b>Defect Description</b>	Surface cracks observed to be typical to surface slab. Prior concrete repairs to slab edge facing the ocean above the storage area.
<b>Quantity of Defects</b>	135m <sup>2</sup>
<b>Condition Rating (0- 10)</b>	3
<b>Health and Safety Concern (Y/N)</b>	No
<b>Consequence of Failure</b>	3
<b>Likelihood of Failure within next 5 years</b>	1
<b>Risk Rating</b>	3
<b>Overall Rating (CR X RR)</b>	9
<b>Maintenance Recommendation</b>	Monitor and reinspect at next scheduled inspection.
<b>Maintenance Timeframe</b>	Greater than 5 years

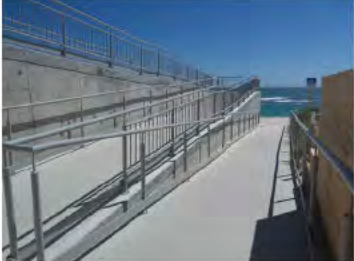
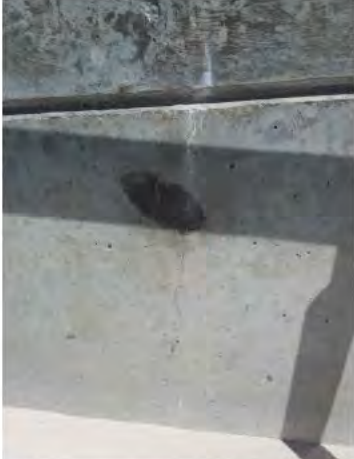
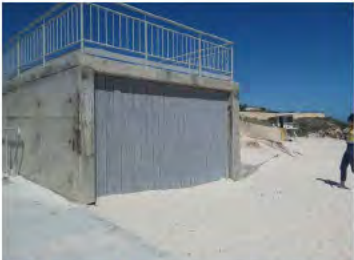
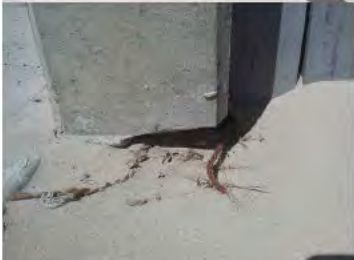
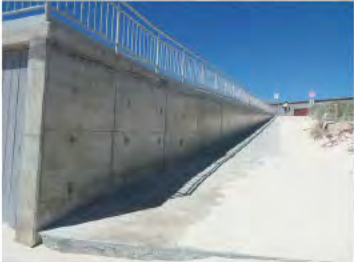
<b>Site No.</b>	C6
<b>Site Name/ Location</b>	Yanchep Surf Life Saving Club
<b>Date</b>	25/02/2021
<b>Time</b>	14:13 (8 GMT)
<b>Item Number</b>	2
<b>Costal Asset Type</b>	Disabled Access Ramp
<b>Element</b>	Walls
<b>Material Type</b>	Reinforced Concrete
<b>2021 Observed Defects (Reinforced Concrete)</b>	Noticeable prior concrete repairs, Erosion
<b>Defect Description</b>	Generally good condition. With noticeable prior concrete repairs to edge facing ocean above storage area. Some minor erosion at base near storage area observed.
<b>Quantity of Defects</b>	60m approx 3m max high along ramp
<b>Condition Rating (0- 10)</b>	3
<b>Health and Safety Concern (Y/N)</b>	No
<b>Consequence of Failure</b>	3
<b>Likelihood of Failure within next 5 years</b>	1
<b>Risk Rating</b>	3
<b>Overall Rating (CR X RR)</b>	9
<b>Maintenance Recommendation</b>	Monitor and reinspect at next scheduled inspection.
<b>Maintenance Timeframe</b>	Greater than 5 years

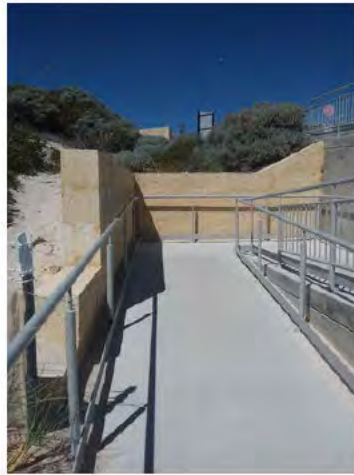
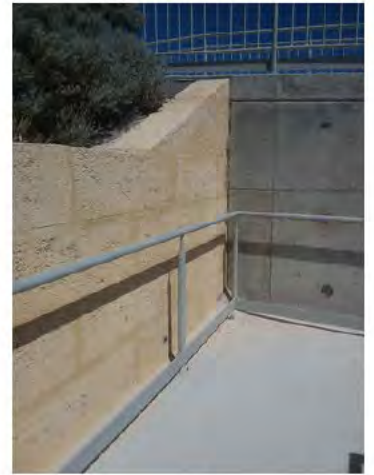
<b>Site No.</b>	C6
<b>Site Name/ Location</b>	Yanchep Surf Life Saving Club
<b>Date</b>	25/02/2021
<b>Time</b>	14:22 (8 GMT)
<b>Item Number</b>	3
<b>Costal Asset Type</b>	Retaining wall
<b>Material Type</b>	Limestone
<b>Condition Rating (0- 10)</b>	2
<b>Health and Safety Concern (Y/N)</b>	No
<b>Consequence of Failure</b>	2
<b>Likelihood of Failure within next 5 years</b>	1
<b>Risk Rating</b>	2
<b>Overall Rating (CR X RR)</b>	4
<b>Maintenance Recommendation</b>	Monitor and reinspect at next scheduled inspection.
<b>Maintenance Timeframe</b>	Greater than 5 years

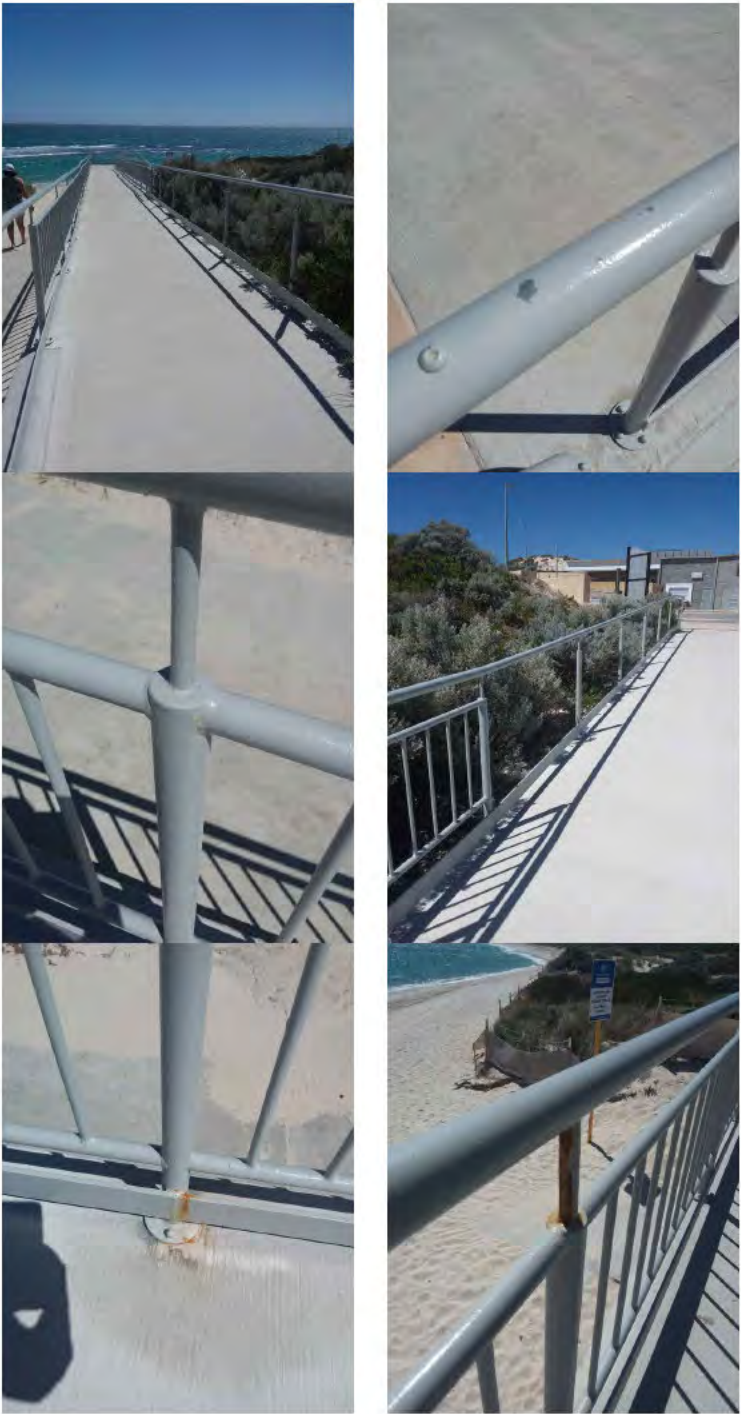
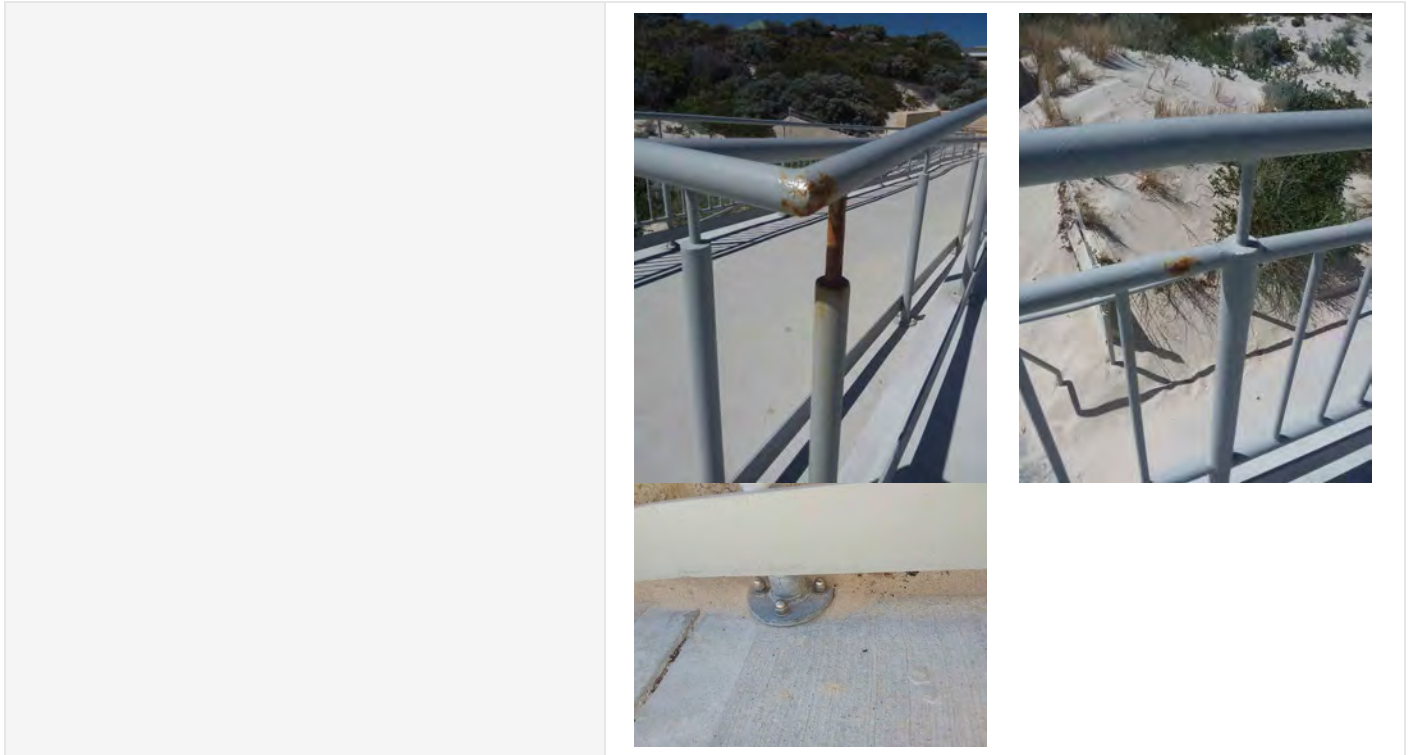
Site No.	C6
Site Name/ Location	Yanchep Surf Life Saving Club
Date	25/02/2021
Time	14:16 (8 GMT)
Item Number	4
Costal Asset Type	Ramp disabled beach access
Element	Balustrade (All Components)
Material Type	Coated Steel
2021 Observed Defects (Steel)	Surface corrosion, Rust staining
Defect Description	Generally good condition. Vertical rails missing for 6 panels on Northern side, and 1 panel on Southern side at ramp entry. Local coating loss, surface corrosion and rust staining observed. Inconsistent fixings used with some screws being stainless steel and some general steel.
Quantity of Defects	170m
Condition Rating (0- 10)	5
Health and Safety Concern (Y/N)	No
Consequence of Failure	3
Likelihood of Failure within next 5 years	2
Risk Rating	6
Overall Rating (CR X RR)	30
Maintenance Recommendation	Localised abrasive cleaning and application of protective coating.
Maintenance Timeframe	Within 5 years

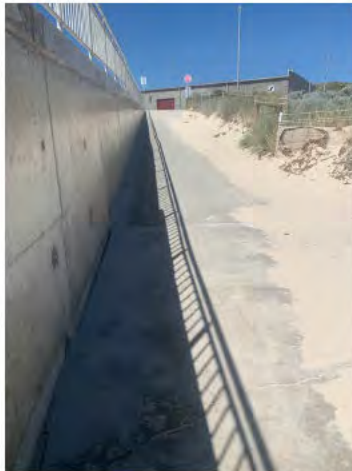
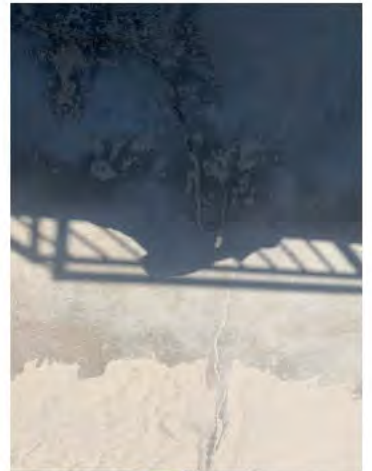
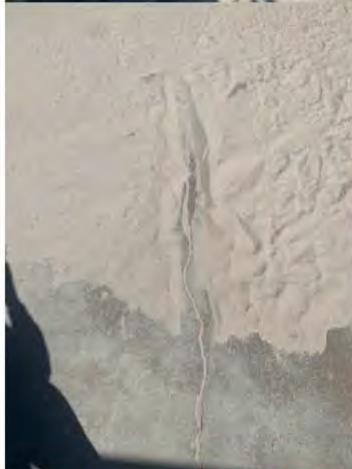
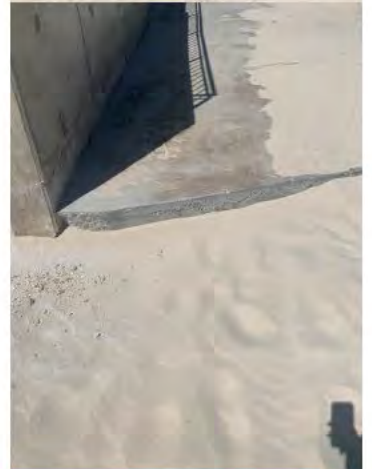
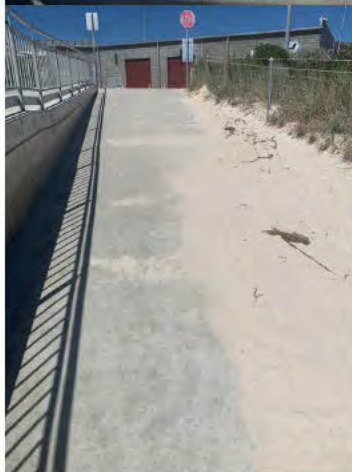
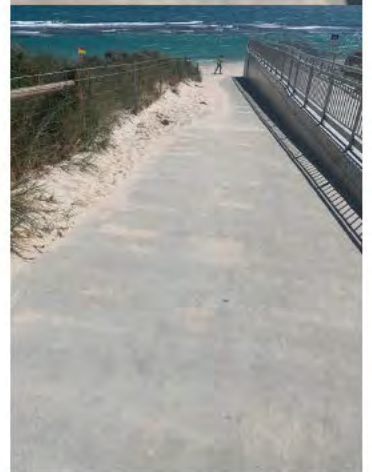
<b>Site No.</b>	C6
<b>Site Name/ Location</b>	Yanchep Surf Life Saving Club
<b>Date</b>	25/02/2021
<b>Time</b>	14:23 (8 GMT)
<b>Item Number</b>	5
<b>Costal Asset Type</b>	Concrete vehicle access ramp
<b>Element</b>	Surface
<b>Material Type</b>	Reinforced Concrete
<b>2021 Observed Defects (Reinforced Concrete)</b>	Crack
<b>Defect Description</b>	Typical cracking in concrete.
<b>Quantity of Defects</b>	111m2 concrete
<b>Condition Rating (0- 10)</b>	4
<b>Health and Safety Concern (Y/N)</b>	No
<b>Consequence of Failure</b>	2
<b>Likelihood of Failure within next 5 years</b>	1
<b>Risk Rating</b>	2
<b>Overall Rating (CR X RR)</b>	8
<b>Maintenance Recommendation</b>	Monitor and reinspect at next scheduled inspection.
<b>Maintenance Timeframe</b>	Greater than 5 years

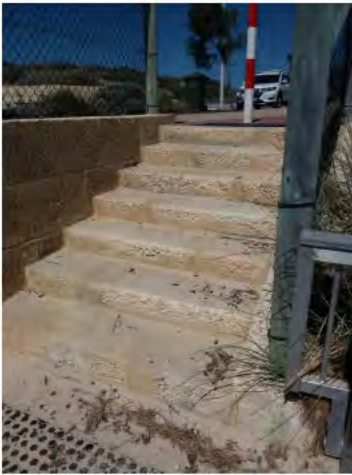
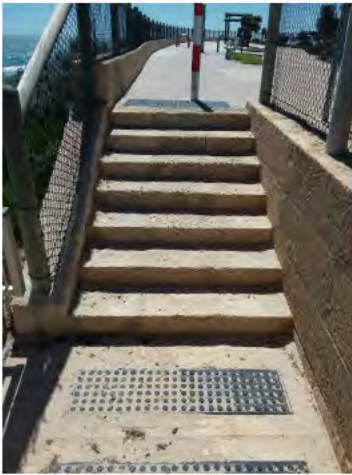
<b>Site No.</b>	C7
<b>Site Name/ Location</b>	Newman Park (North)
<b>Date</b>	25/02/2021
<b>Time</b>	14:37 (8 GMT)
<b>Item Number</b>	1
<b>Costal Asset Type</b>	Stairs
<b>Material Type</b>	Limestone
<b>Defect Description</b>	Grout observed to be in good condition. Minor erosion on steps.
<b>Quantity of Defects</b>	14 step, 1m wide
<b>Condition Rating (0- 10)</b>	4
<b>Health and Safety Concern (Y/N)</b>	No
<b>Consequence of Failure</b>	3
<b>Likelihood of Failure within next 5 years</b>	1
<b>Risk Rating</b>	3
<b>Overall Rating (CR X RR)</b>	12
<b>Maintenance Recommendation</b>	Monitor and reinspect at next scheduled inspection.
<b>Maintenance Timeframe</b>	Within 5 years
