# City of Wanneroo Assets Structural Assessment

## Coastal Assets

City Of Wanneroo

30 July 2021

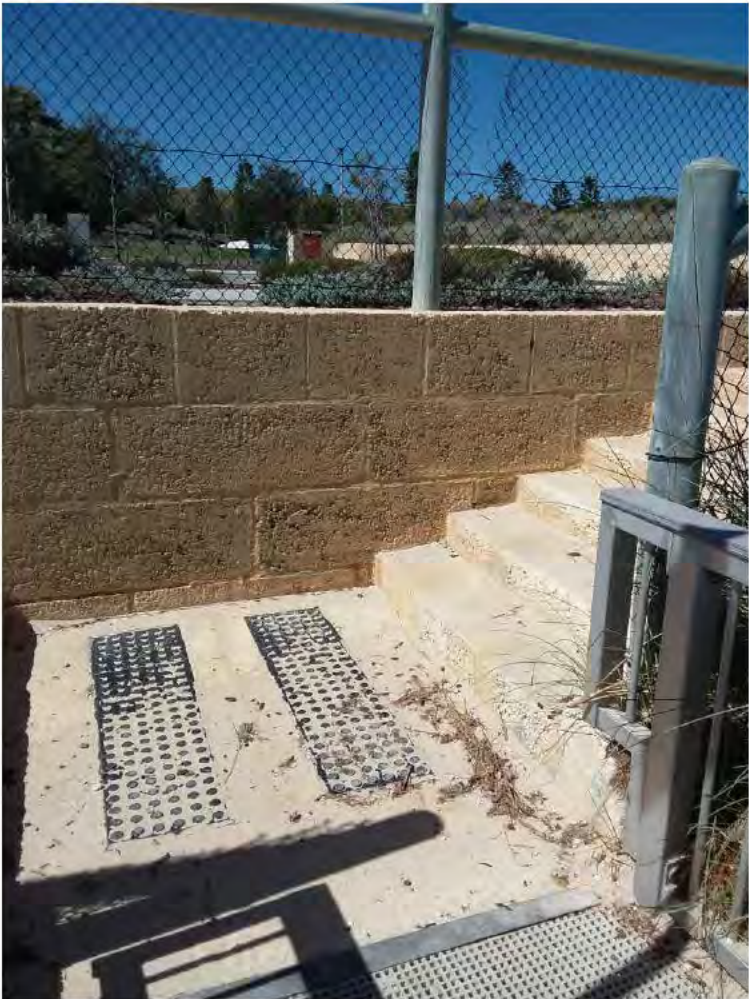
<b>Site No.</b>	C7
<b>Site Name/ Location</b>	Newman Park (North)
<b>Date</b>	25/02/2021
<b>Time</b>	14:39 (8 GMT)
<b>Item Number</b>	2
<b>Costal Asset Type</b>	Retaining wall
<b>Material Type</b>	Limestone
<b>Defect Description</b>	Grout observed to be in good condition. Minor erosion to blocks.
<b>Quantity of Defects</b>	6m x avg 1m
<b>Condition Rating (0- 10)</b>	4
<b>Health and Safety Concern (Y/N)</b>	No
<b>Consequence of Failure</b>	3
<b>Likelihood of Failure within next 5 years</b>	2
<b>Risk Rating</b>	3
<b>Overall Rating (CR X RR)</b>	12
<b>Maintenance Recommendation</b>	Monitor and reinspect at next scheduled inspection.
<b>Maintenance Timeframe</b>	Greater than 5 years

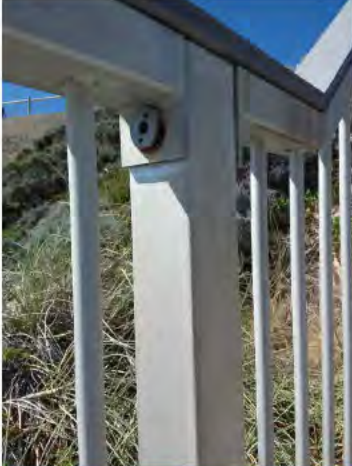
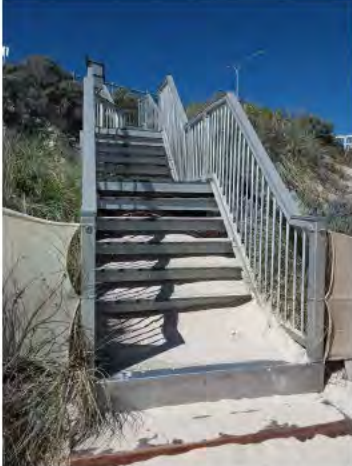
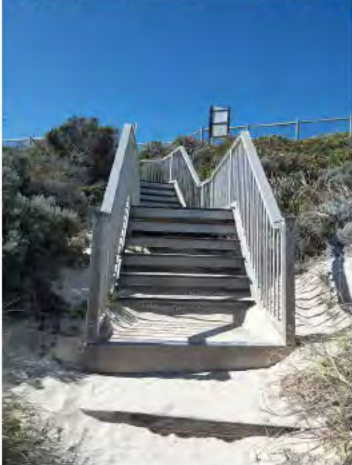
<b>Site No.</b>	C7
<b>Site Name/ Location</b>	Newman Park (North)
<b>Date</b>	25/02/2021
<b>Time</b>	14:48 (8 GMT)
<b>Item Number</b>	8
<b>Costal Asset Type</b>	Stairs
<b>Element</b>	Balustrade
<b>Material Type</b>	FRP
<b>2021 Observed Defects (FRP)</b>	Minor corrosion
<b>Defect Description</b>	Generally good condition. Minor corrosion to fasteners.
<b>Quantity of Defects</b>	56m
<b>Condition Rating (0- 10)</b>	3
<b>Health and Safety Concern (Y/N)</b>	No
<b>Consequence of Failure</b>	3
<b>Likelihood of Failure within next 5 years</b>	1
<b>Risk Rating</b>	3
<b>Overall Rating (CR X RR)</b>	9
<b>Maintenance Recommendation</b>	Monitor and reinspect at next scheduled inspection.
<b>Maintenance Timeframe</b>	Greater than 5 years

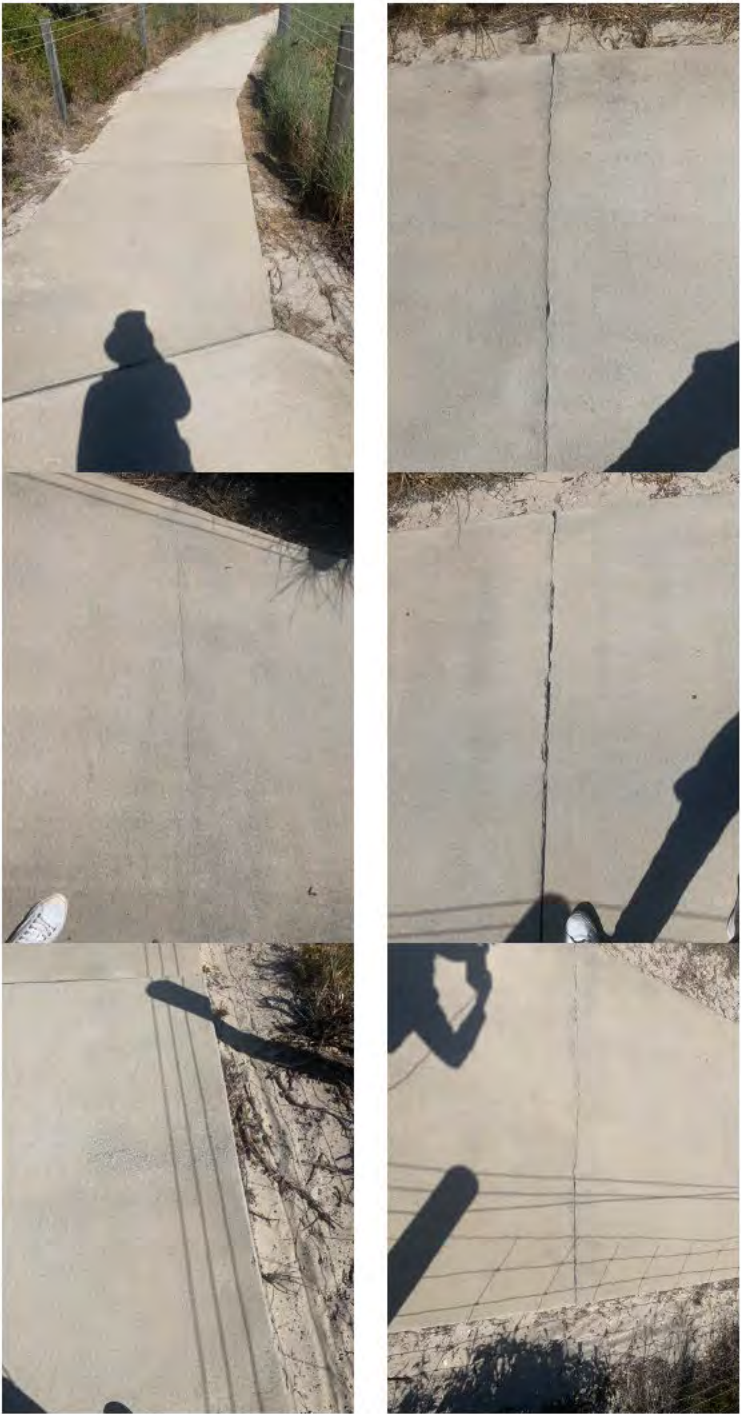
<b>Site No.</b>	C8
<b>Site Name/ Location</b>	South Yanchep Foreshore
<b>Date</b>	25/02/2021
<b>Time</b>	15:25 (8 GMT)
<b>Item Number</b>	1
<b>Costal Asset Type</b>	Concrete path
<b>Element</b>	Surface
<b>Material Type</b>	Reinforced Concrete
<b>2021 Observed Defects (Reinforced Concrete)</b>	Spalling, Crack
<b>Defect Description</b>	Spalling/cracking with minor deterioration at joints were observed.
<b>Quantity of Defects</b>	140m <sup>2</sup>
<b>Condition Rating (0- 10)</b>	3
<b>Health and Safety Concern (Y/N)</b>	No
<b>Consequence of Failure</b>	2
<b>Likelihood of Failure within next 5 years</b>	2
<b>Risk Rating</b>	4
<b>Overall Rating (CR X RR)</b>	12
<b>Maintenance Recommendation</b>	Monitor and reinspect at next scheduled inspection.
<b>Maintenance Timeframe</b>	Greater than 5 years

<b>Other Comments/Inspection Limitations</b>	Monitor at next inspection repair if becomes a trip hazards

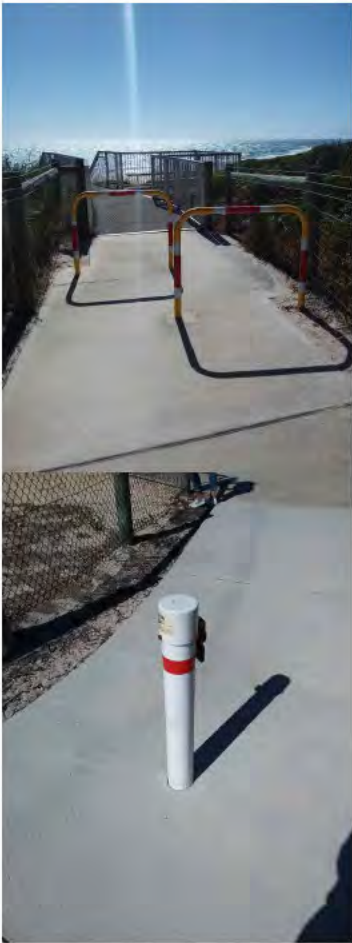
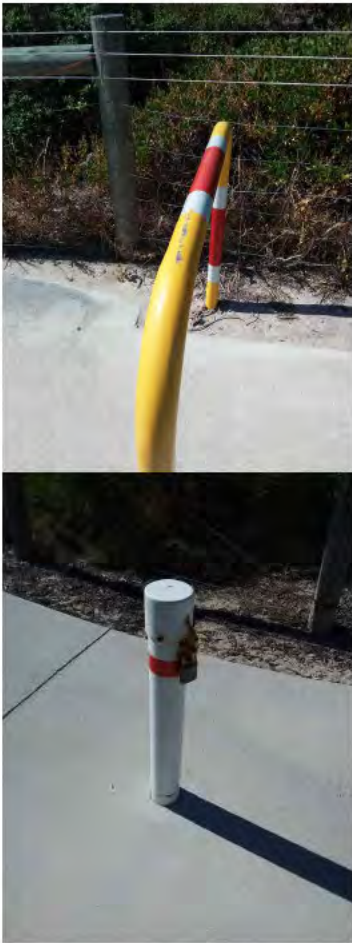
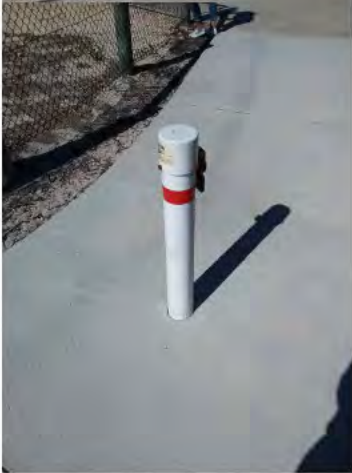
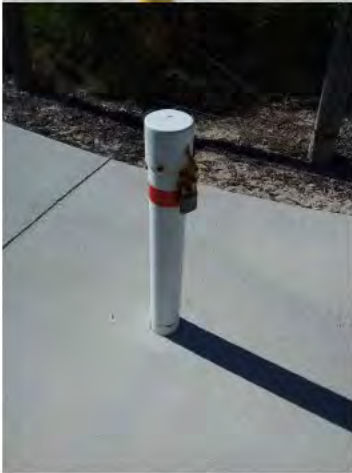
<b>Site No.</b>	C8
<b>Site Name/ Location</b>	South Yanchep Foreshore
<b>Date</b>	25/02/2021
<b>Time</b>	15:26 (8 GMT)
<b>Item Number</b>	2
<b>Costal Asset Type</b>	Bollards / Gate
<b>Material Type</b>	Coated Steel
<b>2021 Observed Defects (Steel)</b>	Surface corrosion
<b>Defect Description</b>	Coating and reflective tape deterioration typica. Surface corrosion to fixings.
<b>Condition Rating (0- 10)</b>	5
<b>Health and Safety Concern (Y/N)</b>	No
<b>Consequence of Failure</b>	2
<b>Likelihood of Failure within next 5 years</b>	2
<b>Risk Rating</b>	4
<b>Overall Rating (CR X RR)</b>	20
<b>Maintenance Recommendation</b>	Monitor and reinspect at next scheduled inspection.
<b>Maintenance Timeframe</b>	Greater than 5 years

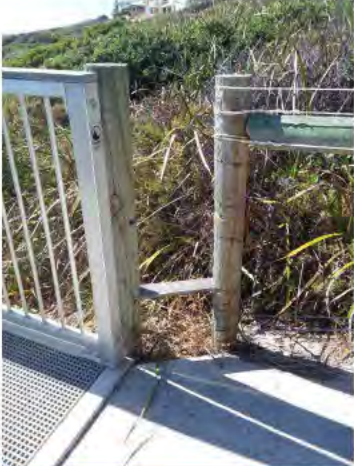
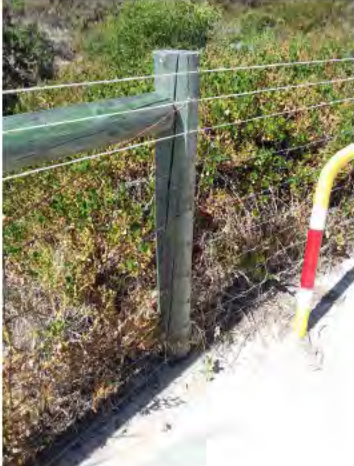
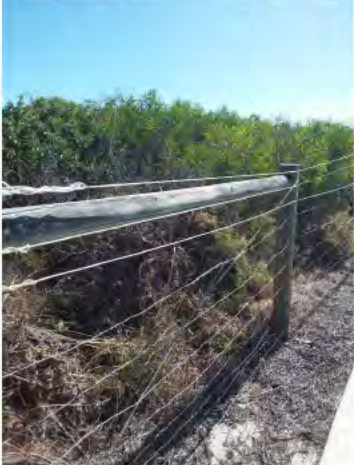
<b>Site No.</b>	C8
<b>Site Name/ Location</b>	South Yanchep Foreshore
<b>Date</b>	25/02/2021
<b>Time</b>	15:21 (8 GMT)
<b>Item Number</b>	3
<b>Coastal Asset Type</b>	Concrete Path
<b>Element</b>	Fencing
<b>Sub-element (Fencing)</b>	Timber posts and railing
<b>Material Type</b>	Timber
<b>2021 Observed Defects (Timber)</b>	Split timber
<b>Defect Description</b>	Minor timber splitting was observed
<b>Quantity of Defects</b>	50. 16m of railing at each end bay
<b>Condition Rating (0- 10)</b>	3
<b>Health and Safety Concern (Y/N)</b>	No
<b>Consequence of Failure</b>	2
<b>Likelihood of Failure within next 5 years</b>	2
<b>Risk Rating</b>	4
<b>Overall Rating (CR X RR)</b>	12
<b>Maintenance Recommendation</b>	Monitor and reinspect at next scheduled inspection.
<b>Maintenance Timeframe</b>	Greater than 5 years

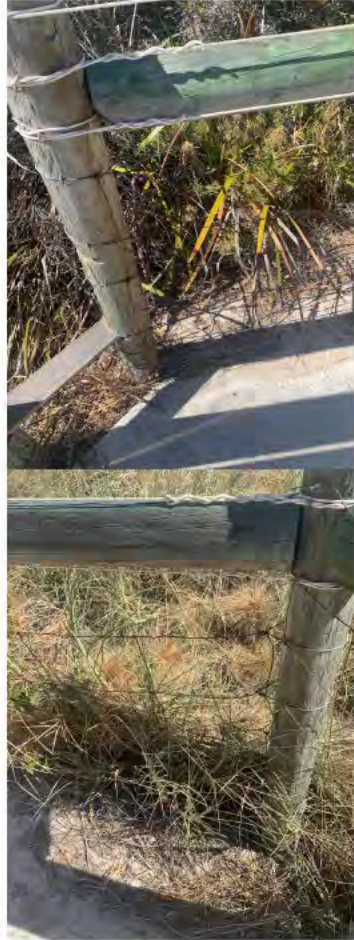
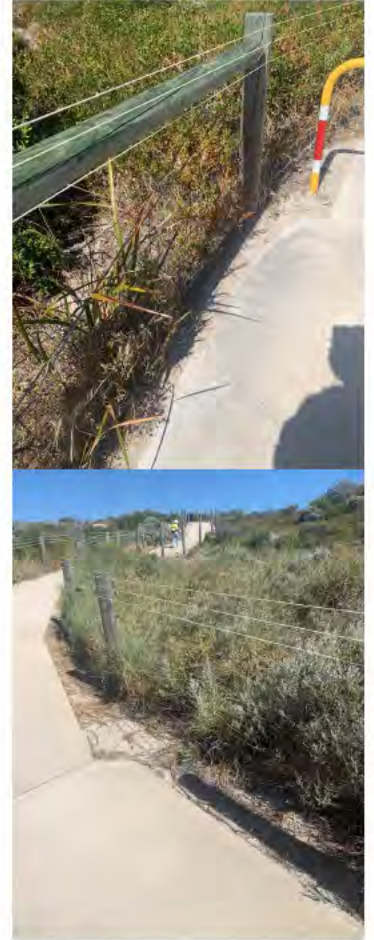
<b>Site No.</b>	C8
<b>Site Name/ Location</b>	South Yanchep Foreshore
<b>Date</b>	25/02/2021
<b>Time</b>	15:17 (8 GMT)
<b>Item Number</b>	4
<b>Costal Asset Type</b>	Concrete path
<b>Element</b>	Fencing
<b>Sub-element (Fencing)</b>	Mesh
<b>Sub-element</b>	Mesh and staples
<b>Material Type</b>	Steel
<b>2021 Observed Defects (Steel)</b>	Corrosion with section loss observed to be typical throughout.
<b>Quantity of Defects</b>	140m x 0.5
<b>Condition Rating (0- 10)</b>	5
<b>Health and Safety Concern (Y/N)</b>	No
<b>Consequence of Failure</b>	2
<b>Likelihood of Failure within next 5 years</b>	4
<b>Risk Rating</b>	8
<b>Overall Rating (CR X RR)</b>	40
<b>Maintenance Recommendation</b>	Replace heavily corroded sections of mesh or staples.
<b>Maintenance Timeframe</b>	Within 5 years

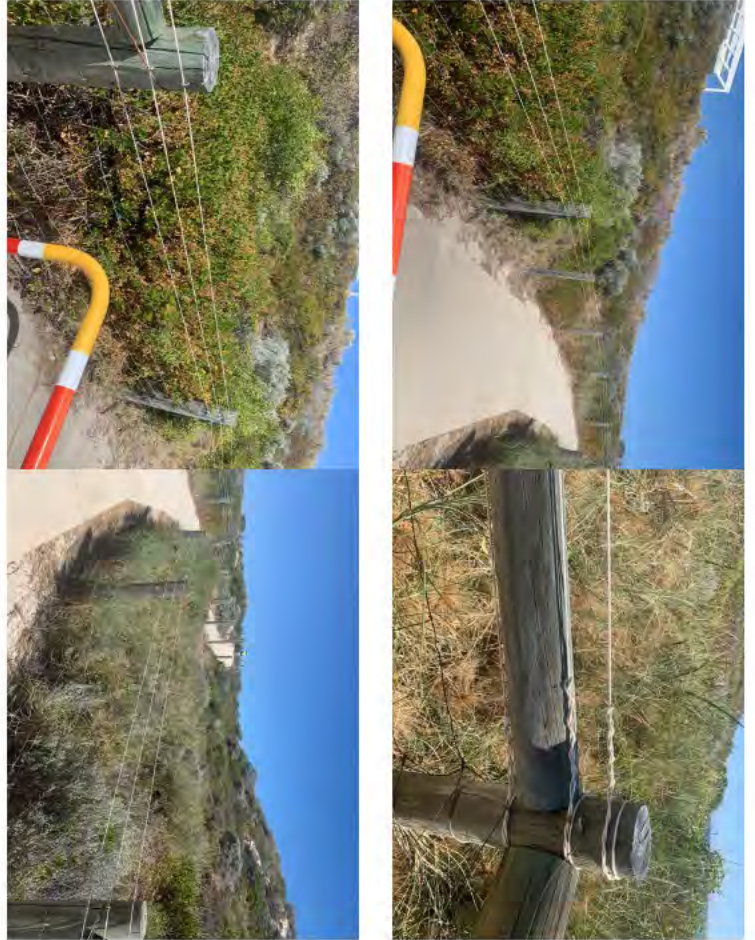
<b>Site No.</b>	C8
<b>Site Name/ Location</b>	South Yanchep Foreshore
<b>Date</b>	25/02/2021
<b>Time</b>	15:23 (8 GMT)
<b>Item Number</b>	13
<b>Costal Asset Type</b>	Concrete path
<b>Element</b>	Fencing
<b>Sub-element (Fencing)</b>	Mesh strainer wires
<b>Material Type</b>	Coated Steel
<b>2021 Observed Defects (Steel)</b>	No visible defects were observed
<b>Quantity of Defects</b>	6x70m
<b>Condition Rating (0- 10)</b>	2
<b>Health and Safety Concern (Y/N)</b>	No
<b>Consequence of Failure</b>	1
<b>Likelihood of Failure within next 5 years</b>	1
<b>Risk Rating</b>	2
<b>Overall Rating (CR X RR)</b>	4
<b>Maintenance Recommendation</b>	Monitor and reinspect at next scheduled inspection.
<b>Maintenance Timeframe</b>	Greater than 5 years

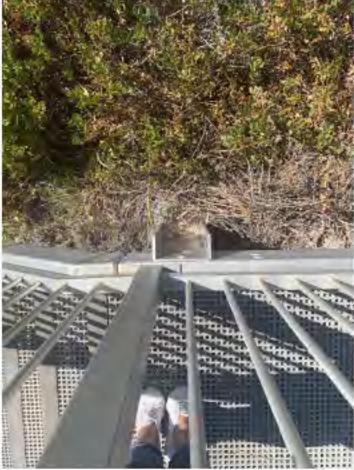
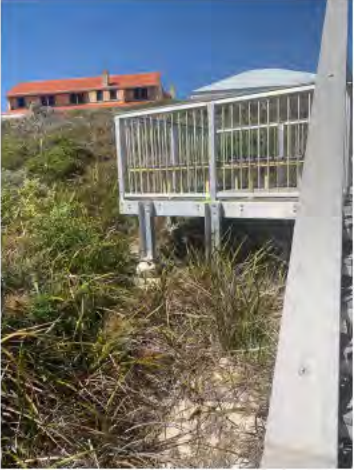
Site No.	C8
Site Name/ Location	South Yanchep Foreshore
Date	25/02/2021
Time	14:50 (8 GMT)
Item Number	7
Costal Asset Type	Other
Asset Type	Stairs / lookout
Element	Supports
Sub-element	Columns
Material Type	Stainless Steel
2021 Observed Defects (Steel)	No visible defects were observed
Quantity of Defects	29 visible
Condition Rating (0- 10)	2
Health and Safety Concern (Y/N)	No
Consequence of Failure	3
Likelihood of Failure within next 5 years	1
Risk Rating	3
Overall Rating (CR X RR)	6
Maintenance Recommendation	Monitor and reinspect at next scheduled inspection.
Maintenance Timeframe	Greater than 5 years

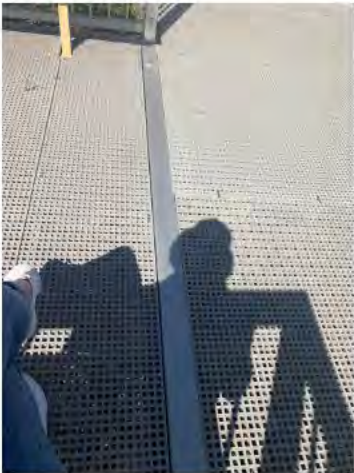
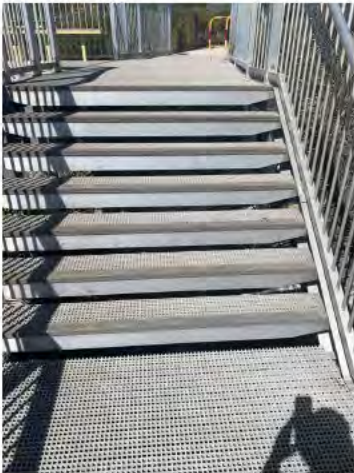
<b>Site No.</b>	C8
<b>Site Name/ Location</b>	South Yanchep Foreshore
<b>Date</b>	25/02/2021
<b>Time</b>	14:58 (8 GMT)
<b>Item Number</b>	8
<b>Asset Type</b>	Stairs / lookout
<b>Element</b>	Supports
<b>Sub-element</b>	Grid mesh support beams
<b>Material Type</b>	Stainless Steel
<b>2021 Observed Defects (Steel)</b>	No visible defects were observed
<b>Quantity of Defects</b>	40x1.5 surface area for grid mesh (including stair planks)
<b>Condition Rating (0- 10)</b>	2
<b>Health and Safety Concern (Y/N)</b>	No
<b>Consequence of Failure</b>	3
<b>Likelihood of Failure within next 5 years</b>	1
<b>Risk Rating</b>	3
<b>Overall Rating (CR X RR)</b>	6
<b>Maintenance Recommendation</b>	Monitor and reinspect at next scheduled inspection.
<b>Maintenance Timeframe</b>	Greater than 5 years

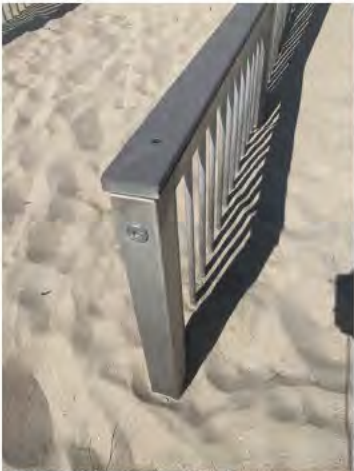
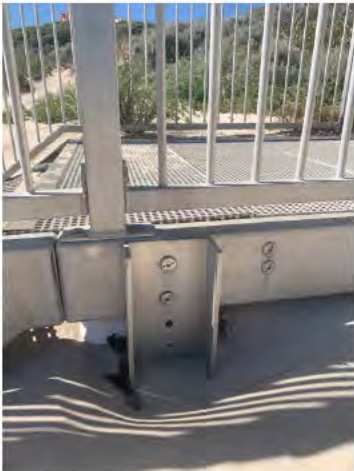
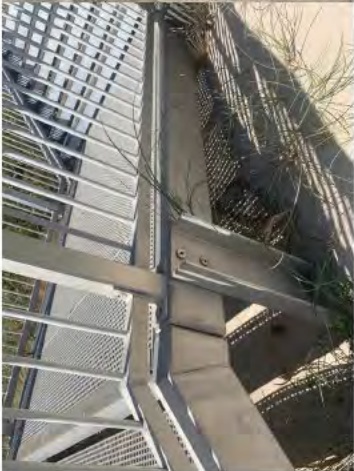
<b>Site No.</b>	C8
<b>Site Name/ Location</b>	South Yanchep Foreshore
<b>Date</b>	25/02/2021
<b>Time</b>	15:12 (8 GMT)
<b>Item Number</b>	9
<b>Asset Type</b>	Lookout / Stairs
<b>Element</b>	Supports
<b>Sub-element</b>	Support stair connections
<b>Material Type</b>	Stainless Steel
<b>2021 Observed Defects (Steel)</b>	No visible defects were observed
<b>Condition Rating (0- 10)</b>	2
<b>Health and Safety Concern (Y/N)</b>	No
<b>Consequence of Failure</b>	3
<b>Likelihood of Failure within next 5 years</b>	1
<b>Risk Rating</b>	3
<b>Overall Rating (CR X RR)</b>	6
<b>Maintenance Recommendation</b>	Monitor and reinspect at next scheduled inspection.
<b>Maintenance Timeframe</b>	Greater than 5 years

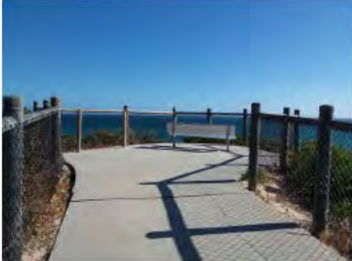
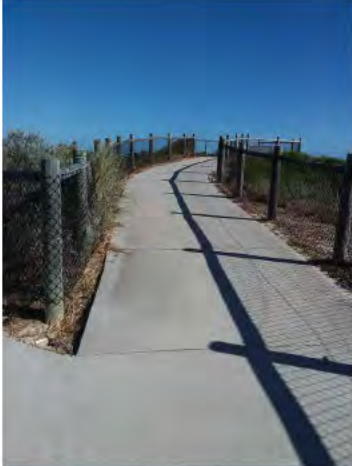
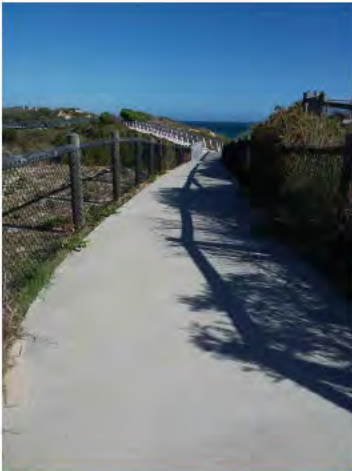
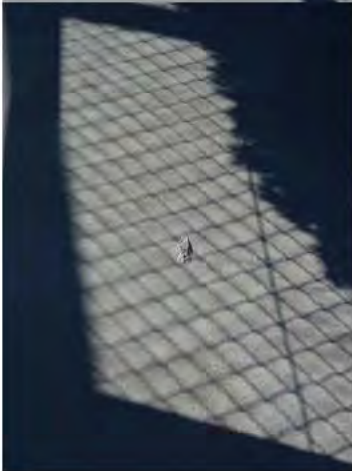
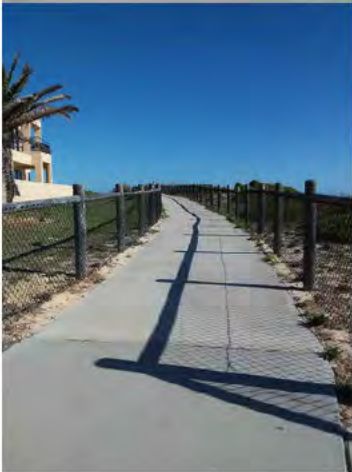
<b>Site No.</b>	C9
<b>Site Name/ Location</b>	South Yanchep Foreshore
<b>Date</b>	25/02/2021
<b>Time</b>	16:17 (8 GMT)
<b>Item Number</b>	2
<b>Costal Asset Type</b>	Concrete path
<b>Element</b>	Fencing
<b>Sub-element (Fencing)</b>	Timber posts
<b>Material Type</b>	Timber
<b>2021 Observed Defects (Timber)</b>	Minor timber splitting was observed to be typical throughout.
<b>Quantity of Defects</b>	1.2m high x 96 posts
<b>Condition Rating (0- 10)</b>	3
<b>Health and Safety Concern (Y/N)</b>	No
<b>Consequence of Failure</b>	2
<b>Likelihood of Failure within next 5 years</b>	2
<b>Risk Rating</b>	4
<b>Overall Rating (CR X RR)</b>	12
<b>Maintenance Recommendation</b>	Monitor and reinspect at next scheduled inspection.
<b>Maintenance Timeframe</b>	Greater than 5 years

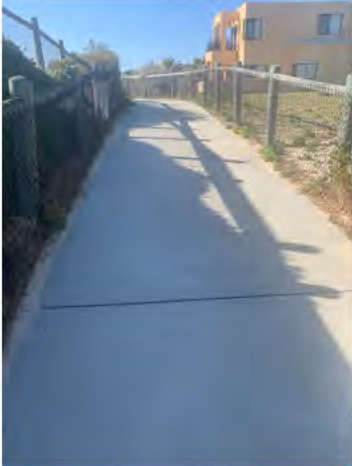
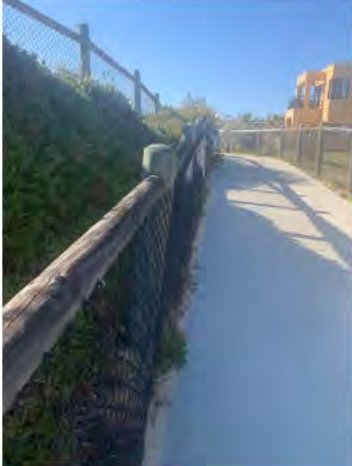
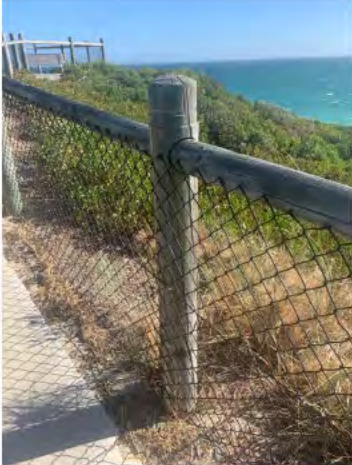
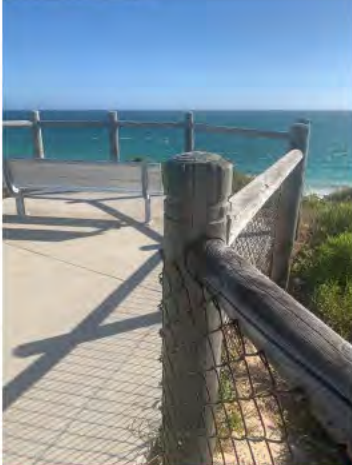
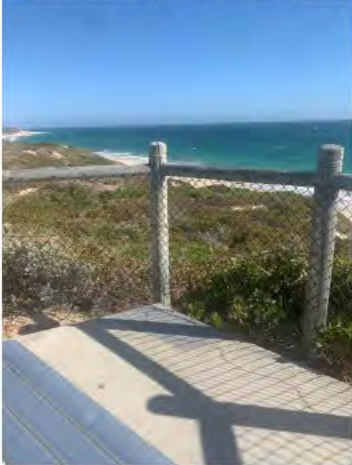
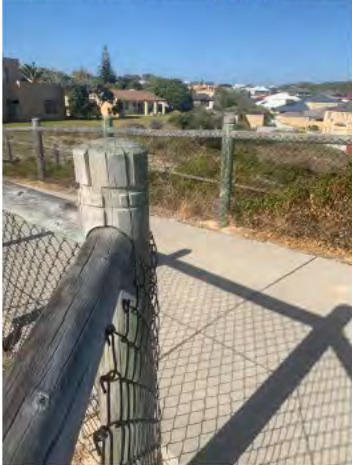
<b>Site No.</b>	C9
<b>Site Name/ Location</b>	South Yanchep Foreshore
<b>Date</b>	25/02/2021
<b>Time</b>	16:12 (8 GMT)
<b>Item Number</b>	3
<b>Costal Asset Type</b>	Lookout
<b>Element</b>	Fencing
<b>Sub-element (Fencing)</b>	Mesh
<b>Material Type</b>	Coated Steel
<b>Defect Description</b>	Typically, good condition. Mesh observed to not be secured well to top rail at the lookout. Strainer wire in the same area is loose.
<b>Quantity of Defects</b>	210m2
<b>Condition Rating (0- 10)</b>	5
<b>Health and Safety Concern (Y/N)</b>	No
<b>Consequence of Failure</b>	2
<b>Likelihood of Failure within next 5 years</b>	3
<b>Risk Rating</b>	6
<b>Overall Rating (CR X RR)</b>	30
<b>Maintenance Recommendation</b>	Fix mesh to the top rail.
<b>Maintenance Timeframe</b>	Within 1-2 years

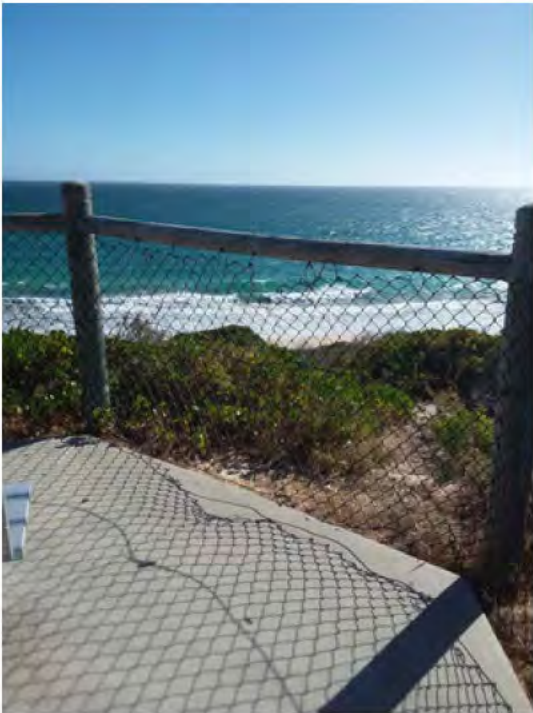
<b>Site No.</b>	C9
<b>Site Name/ Location</b>	South Yanchep Foreshore
<b>Date</b>	25/02/2021
<b>Time</b>	16:18 (8 GMT)
<b>Item Number</b>	4
<b>Costal Asset Type</b>	Fencing
<b>Sub-element (Fencing)</b>	Mesh staples
<b>Material Type</b>	Steel
<b>2021 Observed Defects (Steel)</b>	Surface corrosion
<b>Condition Rating (0- 10)</b>	3
<b>Health and Safety Concern (Y/N)</b>	No
<b>Consequence of Failure</b>	1
<b>Likelihood of Failure within next 5 years</b>	3
<b>Risk Rating</b>	3
<b>Overall Rating (CR X RR)</b>	9
<b>Maintenance Recommendation</b>	Monitor and reinspect at next scheduled inspection.
<b>Maintenance Timeframe</b>	Greater than 5 years

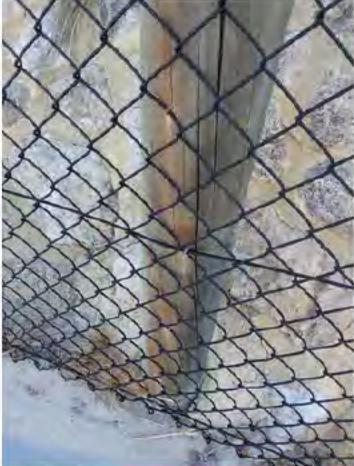
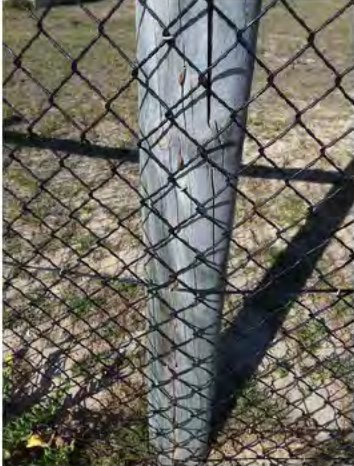
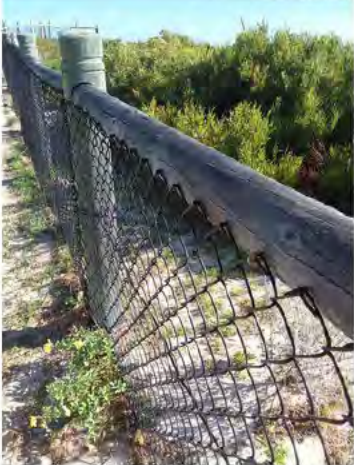
<b>Site No.</b>	C9
<b>Site Name/ Location</b>	South Yanchep Foreshore
<b>Date</b>	25/02/2021
<b>Time</b>	16:14 (8 GMT)
<b>Item Number</b>	5
<b>Costal Asset Type</b>	Concrete path
<b>Element</b>	Fencing
<b>Sub-element (Fencing)</b>	Timber rail
<b>Material Type</b>	Timber
<b>2021 Observed Defects (Timber)</b>	Split timber, General damage
<b>Defect Description</b>	Moderate timber splitting was observed to be typical throughout.
<b>Quantity of Defects</b>	210 linear m
<b>Condition Rating (0- 10)</b>	6
<b>Health and Safety Concern (Y/N)</b>	No
<b>Consequence of Failure</b>	2
<b>Likelihood of Failure within next 5 years</b>	4
<b>Risk Rating</b>	8
<b>Overall Rating (CR X RR)</b>	48
<b>Maintenance Recommendation</b>	Monitor and reinspect at next scheduled inspection.
<b>Maintenance Timeframe</b>	Greater than 5 years

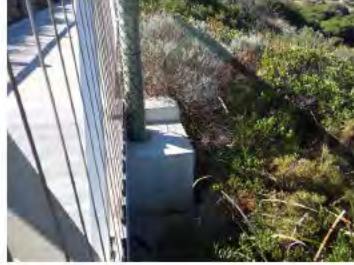
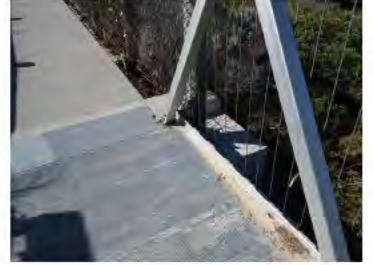
<b>Site No.</b>	C9
<b>Site Name/ Location</b>	South Yanchep Foreshore
<b>Date</b>	25/02/2021
<b>Time</b>	15:46 (8 GMT)
<b>Item Number</b>	7
<b>Costal Asset Type</b>	Alloy boardwalk
<b>Sub-element (Decking and Supports)</b>	Deck planks
<b>Material Type</b>	Aluminum
<b>2021 Observed Defects (Steel)</b>	Blistering/peeling, Noticeable build-up of debris
<b>Defect Description</b>	Cap plates are typically in good condition. Decking observed to contain some coating degradation and flaking.
<b>Quantity of Defects</b>	280m <sup>2</sup>
<b>Condition Rating (0- 10)</b>	3
<b>Health and Safety Concern (Y/N)</b>	No
<b>Consequence of Failure</b>	4
<b>Likelihood of Failure within next 5 years</b>	2
<b>Risk Rating</b>	8
<b>Overall Rating (CR X RR)</b>	24
<b>Maintenance Recommendation</b>	Monitor and reinspect at next scheduled inspection.
<b>Maintenance Timeframe</b>	Greater than 5 years

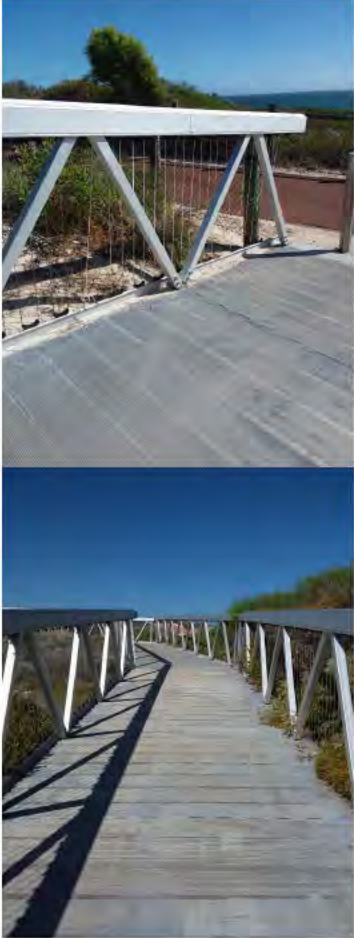
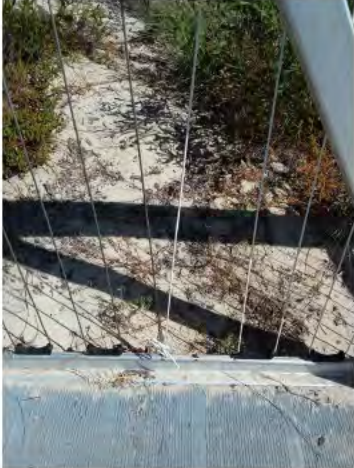
<b>Site No.</b>	C9
<b>Site Name/ Location</b>	South Yanchep Foreshore
<b>Date</b>	25/02/2021
<b>Time</b>	15:40 (8 GMT)
<b>Item Number</b>	10
<b>Costal Asset Type</b>	Alloy boardwalk
<b>Sub-element</b>	Cable (Localised Failure)
<b>Material Type</b>	Steel
<b>2021 Observed Defects (Steel)</b>	Cable has failed in localised area.
<b>Condition Rating (0- 10)</b>	9
<b>Health and Safety Concern (Y/N)</b>	No
<b>Consequence of Failure</b>	2
<b>Likelihood of Failure within next 5 years</b>	5
<b>Risk Rating</b>	10
<b>Overall Rating (CR X RR)</b>	90
<b>Maintenance Recommendation</b>	Replace failed cable wires.
<b>Maintenance Timeframe</b>	Within 1-2 years

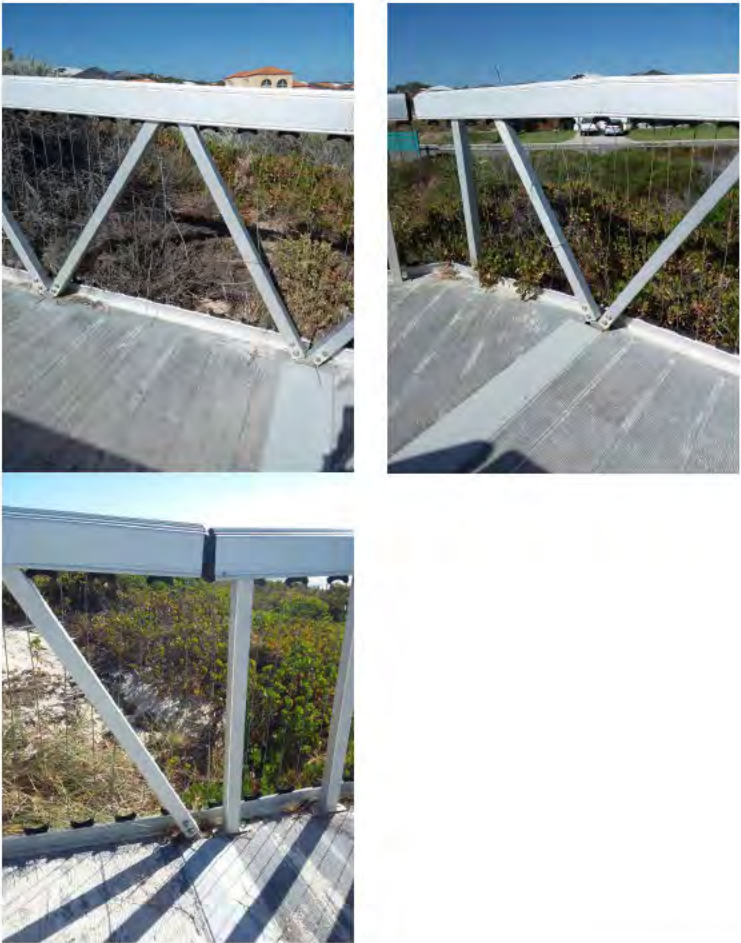
<b>Site No.</b>	C9
<b>Site Name/ Location</b>	South Yanchep Foreshore
<b>Date</b>	25/02/2021
<b>Time</b>	15:45 (8 GMT)
<b>Item Number</b>	11
<b>Costal Asset Type</b>	Alloy boardwalk
<b>Sub-element (Handrails)</b>	Top rail and Bracing
<b>Material Type</b>	Aluminum
<b>2021 Observed Defects (Steel)</b>	Impact/mechanical damage
<b>Defect Description</b>	Localised impact damage, general wear and tear. One connection bolt missing, but not of concern.
<b>Quantity of Defects</b>	256m
<b>Condition Rating (0- 10)</b>	4
<b>Health and Safety Concern (Y/N)</b>	No
<b>Consequence of Failure</b>	3
<b>Likelihood of Failure within next 5 years</b>	2
<b>Risk Rating</b>	6
<b>Overall Rating (CR X RR)</b>	24
<b>Maintenance Recommendation</b>	Monitor and reinspect at next scheduled inspection.
<b>Maintenance Timeframe</b>	Greater than 5 years

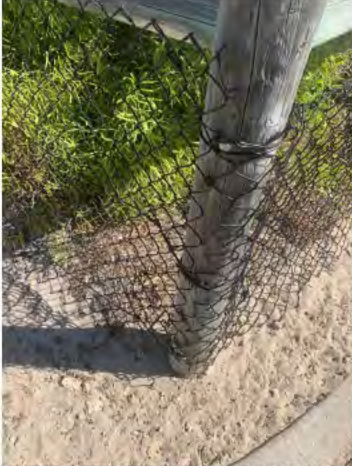
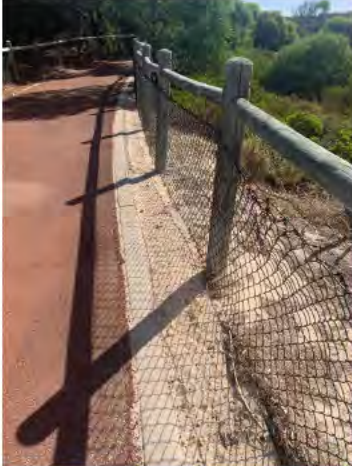
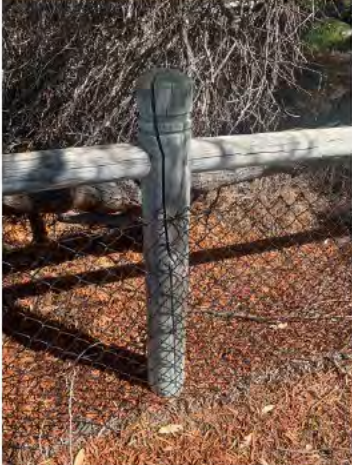
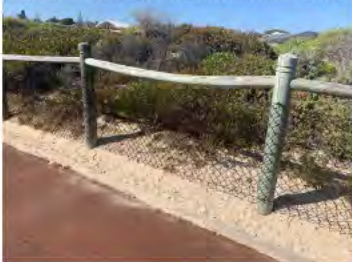
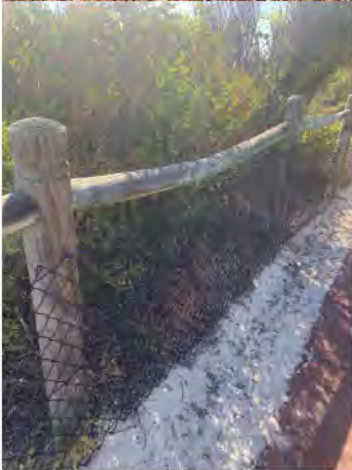
<b>Site No.</b>	C9
<b>Site Name/ Location</b>	South Yanchep Foreshore
<b>Date</b>	25/02/2021
<b>Time</b>	15:53 (8 GMT)
<b>Item Number</b>	15
<b>Costal Asset Type</b>	Asphalt path
<b>Element</b>	Fencing
<b>Sub-element (Fencing)</b>	Timber rail
<b>Material Type</b>	Timber
<b>2021 Observed Defects (Timber)</b>	General damage, Split timber, Rotted timber, Deformation
<b>Defect Description</b>	Localised warping of railing observed. Typical minor splits and rot in timber.
<b>Quantity of Defects</b>	216m of top rails
<b>Condition Rating (0- 10)</b>	4
<b>Health and Safety Concern (Y/N)</b>	No
<b>Consequence of Failure</b>	2
<b>Likelihood of Failure within next 5 years</b>	3
<b>Risk Rating</b>	6
<b>Overall Rating (CR X RR)</b>	24
<b>Maintenance Recommendation</b>	Replace split, rotten, and deformed rails
<b>Maintenance Timeframe</b>	Within 5 years

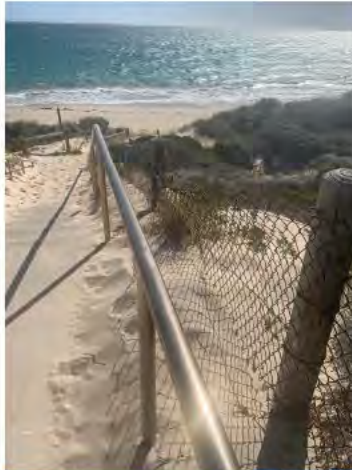
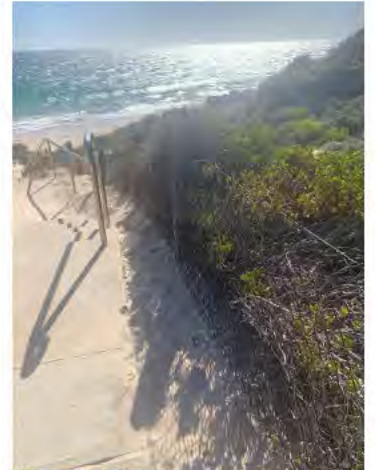
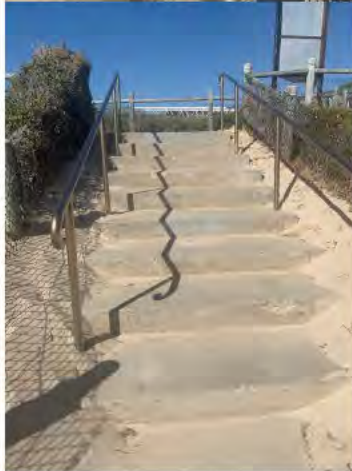
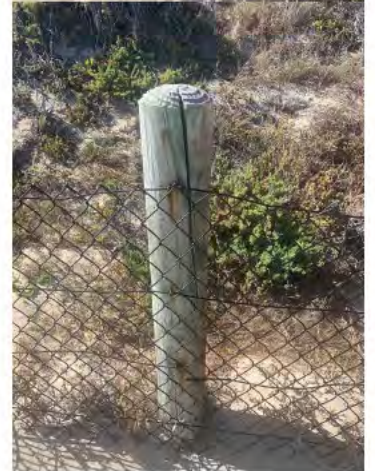
<b>Site No.</b>	C9
<b>Site Name/ Location</b>	South Yanchep Foreshore
<b>Date</b>	25/02/2021
<b>Time</b>	15:55 (8 GMT)
<b>Item Number</b>	18
<b>Costal Asset Type</b>	Stairs
<b>Element</b>	Fencing
<b>Sub-element (Fencing)</b>	Mesh
<b>Sub-element</b>	Mesh and staples
<b>Material Type</b>	Coated Steel, Steel
<b>2021 Observed Defects (Steel)</b>	Corrosion with section loss, Other
<b>Defect Description</b>	Some areas of corrosion with section loss were observed. Mesh was not tight in some areas.
<b>Quantity of Defects</b>	40m x 4strainer wires x2
<b>Condition Rating (0- 10)</b>	6
<b>Health and Safety Concern (Y/N)</b>	No
<b>Consequence of Failure</b>	2
<b>Likelihood of Failure within next 5 years</b>	3
<b>Risk Rating</b>	6
<b>Overall Rating (CR X RR)</b>	36
<b>Maintenance Recommendation</b>	Replace heavily corroded mesh areas or staples. Tighten loose mesh.

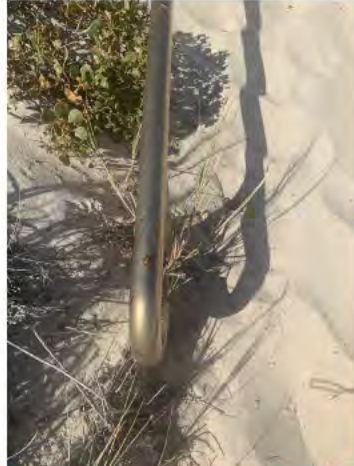
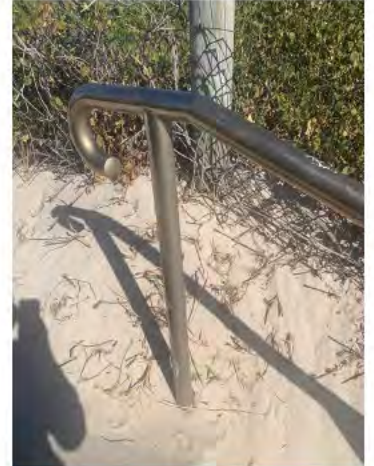
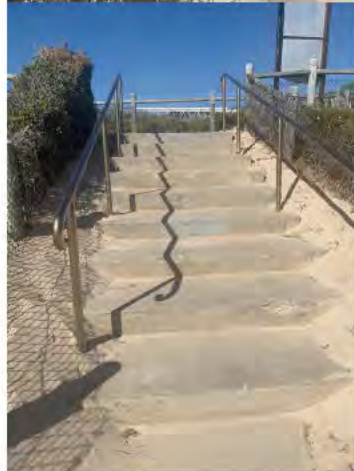
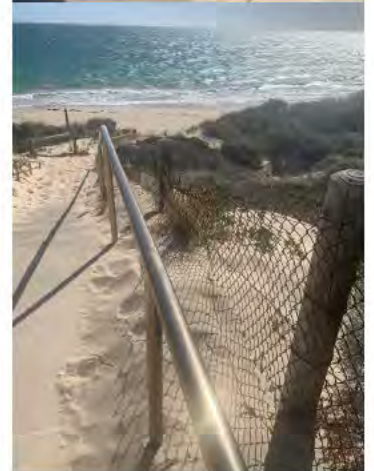
<b>Site No.</b>	C9
<b>Site Name/ Location</b>	South Yanchep Foreshore
<b>Date</b>	25/02/2021
<b>Time</b>	16:02 (8 GMT)
<b>Item Number</b>	19
<b>Costal Asset Type</b>	Stairs
<b>Element</b>	Handrails
<b>Material Type</b>	Stainless Steel
<b>2021 Observed Defects (Steel)</b>	Tea Staining
<b>Defect Description</b>	Minor tea staining was observed.
<b>Quantity of Defects</b>	16x2 + 28 = total liner m of handrail
<b>Condition Rating (0- 10)</b>	3
<b>Health and Safety Concern (Y/N)</b>	No
<b>Consequence of Failure</b>	3
<b>Likelihood of Failure within next 5 years</b>	1
<b>Risk Rating</b>	3
<b>Overall Rating (CR X RR)</b>	9
<b>Maintenance Recommendation</b>	Monitor and reinspect at next scheduled inspection.
<b>Maintenance Timeframe</b>	Greater than 5 years

Monitor at next inspection

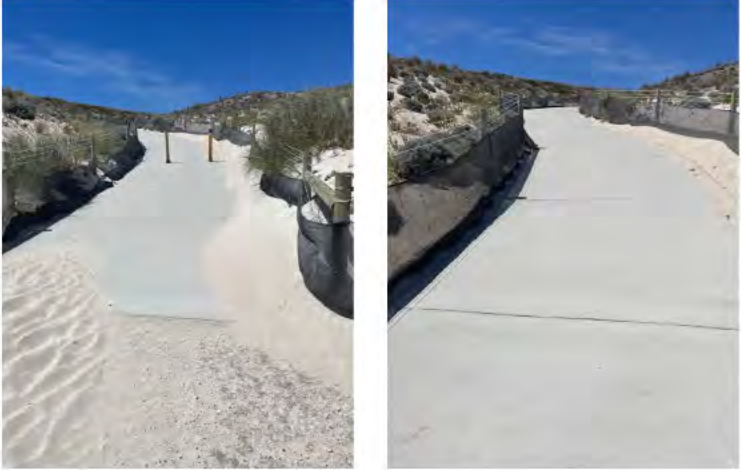
<b>Site No.</b>	C10
<b>Site Name/ Location</b>	Eglinton Foreshore
<b>Date</b>	25/02/2021
<b>Time</b>	13:03 (8 GMT)
<b>Item Number</b>	1
<b>Costal Asset Type</b>	Vehicle access ramp
<b>Element</b>	Foundation
<b>Sub-element (Foundations)</b>	Concrete Paver
<b>Material Type</b>	Reinforced Concrete
<b>2021 Observed Defects (Reinforced Concrete)</b>	No visible defects observed. Inspection limited as bottom of path buried in sand.
<b>Quantity of Defects</b>	Approx 4m wide x 80m long
<b>Condition Rating (0- 10)</b>	2
<b>Health and Safety Concern (Y/N)</b>	No
<b>Consequence of Failure</b>	3
<b>Likelihood of Failure within next 5 years</b>	1
<b>Risk Rating</b>	3
<b>Overall Rating (CR X RR)</b>	6
<b>Maintenance Recommendation</b>	Monitor and reinspect at next scheduled inspection.
<b>Maintenance Timeframe</b>	Greater than 5 years

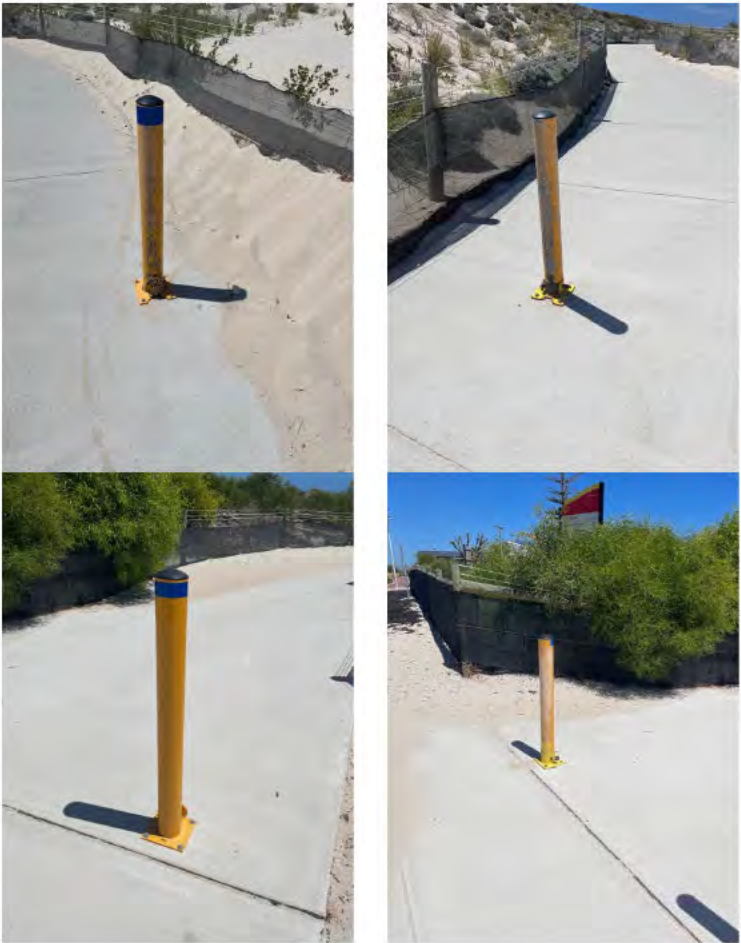
<b>Site No.</b>	C10
<b>Site Name/ Location</b>	Eglinton Foreshore
<b>Date</b>	25/02/2021
<b>Time</b>	13:07 (8 GMT)
<b>Item Number</b>	2
<b>Costal Asset Type</b>	Bollards
<b>Element</b>	Bollards
<b>Sub-element (Bollards)</b>	Bollards
<b>Material Type</b>	Coated Steel
<b>2021 Observed Defects (Steel)</b>	Surface corrosion, Coating loss
<b>Defect Description</b>	Surface corrosion and coating loss observed to three bollards. Top north bollard observed to be in good condition.
<b>Quantity of Defects</b>	4 no bollards, top north bollard good condition
<b>Condition Rating (0- 10)</b>	5
<b>Health and Safety Concern (Y/N)</b>	No
<b>Consequence of Failure</b>	2
<b>Likelihood of Failure within next 5 years</b>	2
<b>Risk Rating</b>	4
<b>Overall Rating (CR X RR)</b>	20
<b>Maintenance Recommendation</b>	Monitor and reinspect at next scheduled inspection.
<b>Maintenance Timeframe</b>	Greater than 5 years

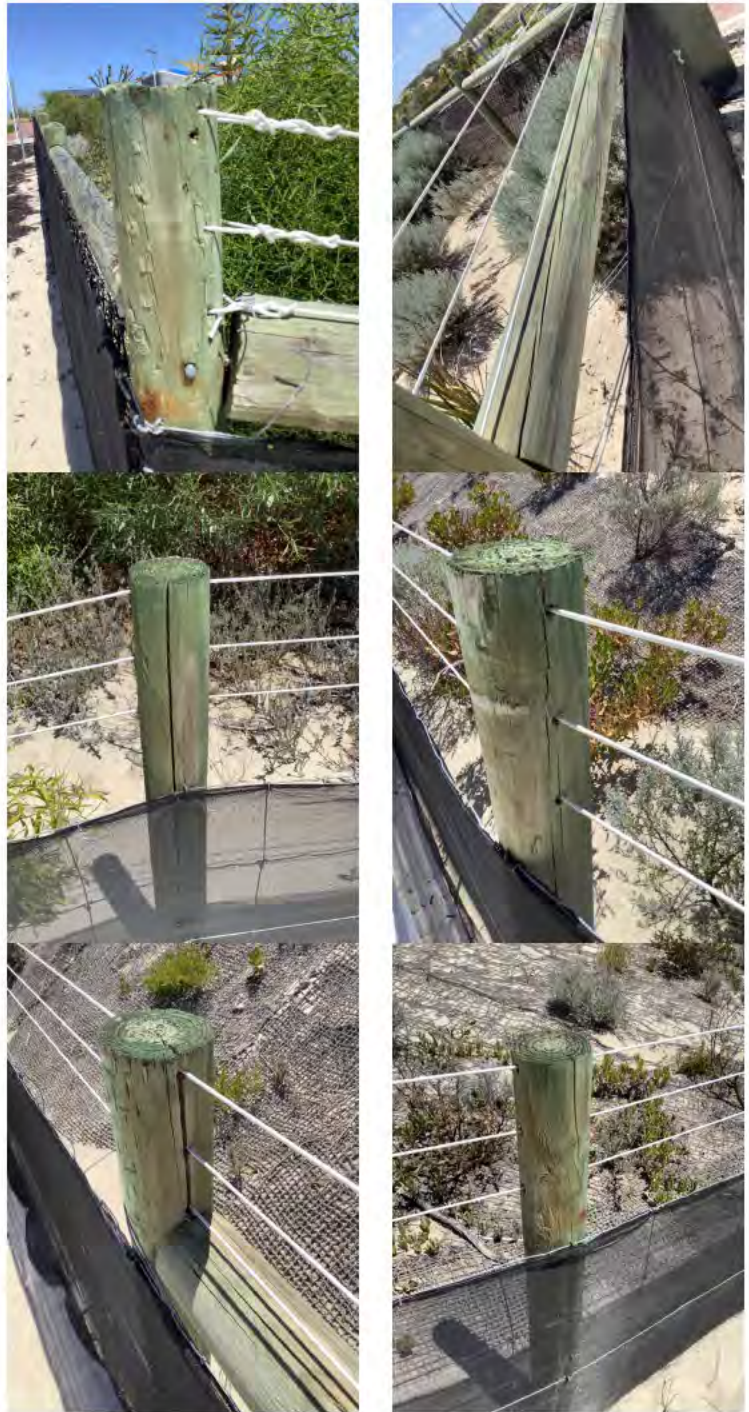
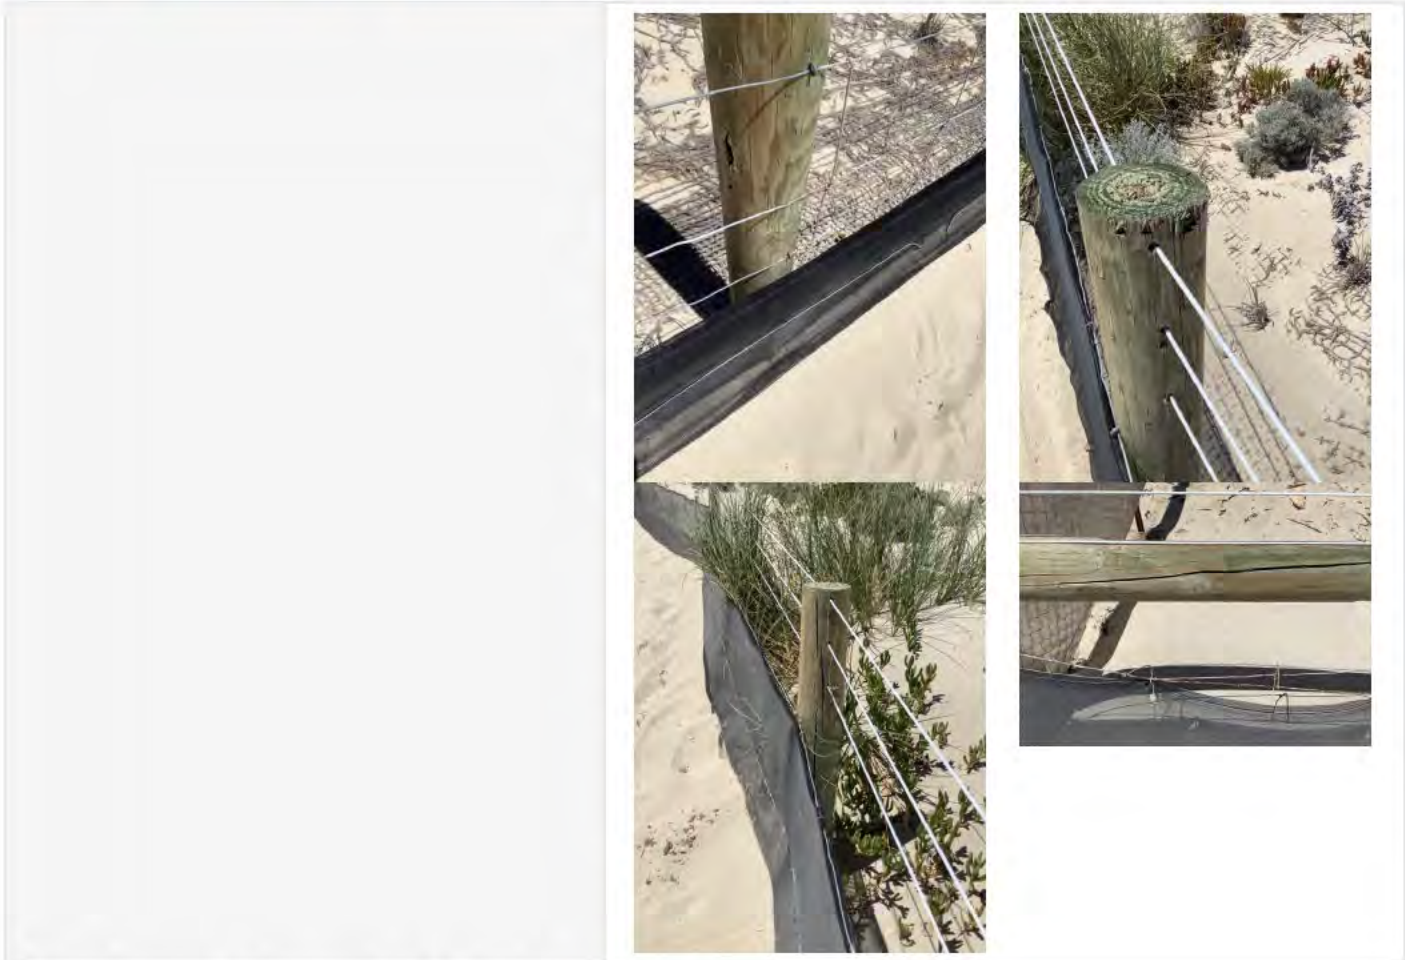
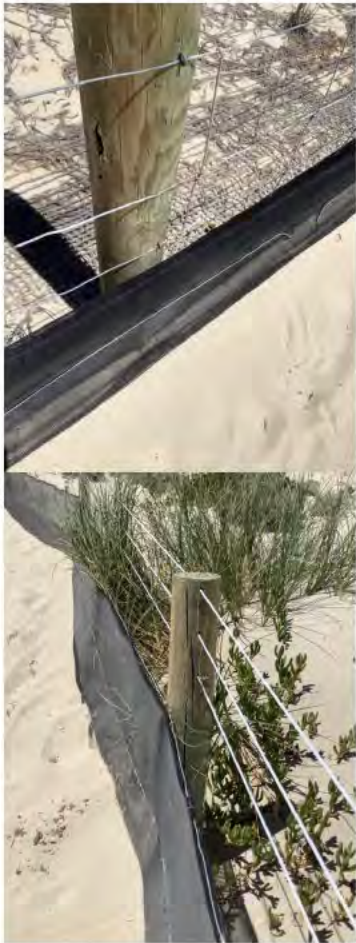
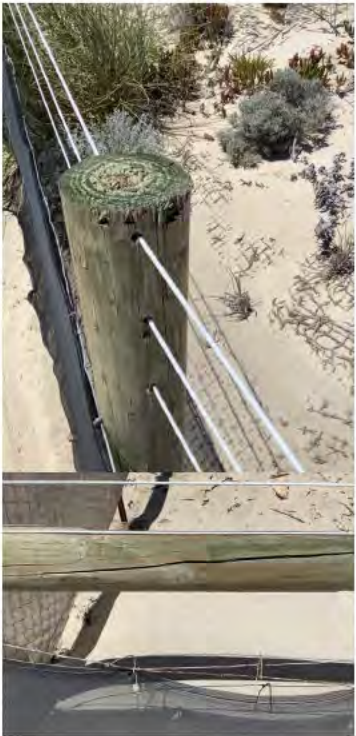
<b>Site No.</b>	C10
<b>Site Name/ Location</b>	Eglinton Foreshore
<b>Date</b>	25/02/2021
<b>Time</b>	13:02 (8 GMT)
<b>Item Number</b>	3
<b>Costal Asset Type</b>	Concrete vehicle access ramp
<b>Element</b>	Fencing
<b>Sub-element (Fencing)</b>	Timber members
<b>Material Type</b>	Timber
<b>2021 Observed Defects (Timber)</b>	Split timber
<b>Defect Description</b>	Timber splitting observed to be typical throughout
<b>Condition Rating (0- 10)</b>	4
<b>Health and Safety Concern (Y/N)</b>	No
<b>Consequence of Failure</b>	1
<b>Likelihood of Failure within next 5 years</b>	3
<b>Risk Rating</b>	3
<b>Overall Rating (CR X RR)</b>	12
<b>Maintenance Recommendation</b>	Monitor and reinspect at next scheduled inspection.
<b>Maintenance Timeframe</b>	Greater than 5 years

80m x 2

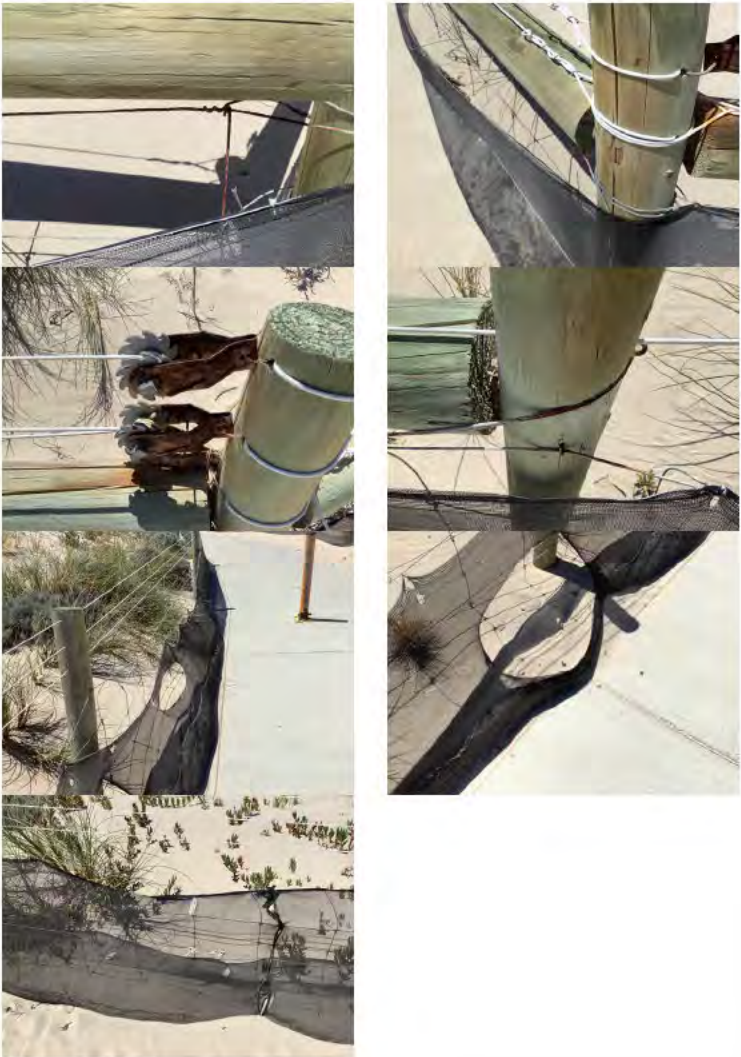
<b>Site No.</b>	C10
<b>Site Name/ Location</b>	Eglinton Foreshore
<b>Date</b>	25/02/2021
<b>Time</b>	13:06 (8 GMT)
<b>Item Number</b>	4
<b>Costal Asset Type</b>	Concrete vehicle access ramp
<b>Element</b>	Fencing
<b>Sub-element (Fencing)</b>	Mesh
<b>Material Type</b>	Galvanised Steel
<b>2021 Observed Defects (Steel)</b>	Coating loss, Rust staining
<b>Defect Description</b>	Coating loss and rust staining observed to be typical throughout. Some areas of fence observed to be deformed.
<b>Condition Rating (0- 10)</b>	5
<b>Health and Safety Concern (Y/N)</b>	No
<b>Consequence of Failure</b>	1
<b>Likelihood of Failure within next 5 years</b>	4
<b>Risk Rating</b>	4
<b>Overall Rating (CR X RR)</b>	20
<b>Maintenance Recommendation</b>	Replace heavily corroded or heavily deformed areas of fencing.
<b>Maintenance Timeframe</b>	Within 5 years

Mesh and staples
