# City of Wanneroo Assets Structural Assessment

## Coastal Assets

City Of Wanneroo

30 July 2021

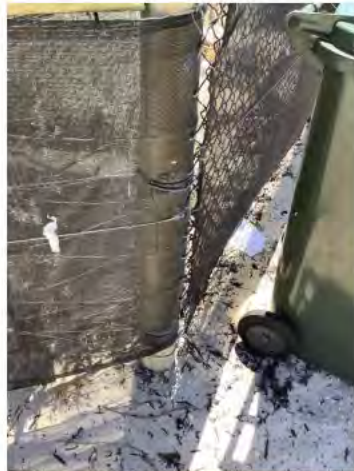
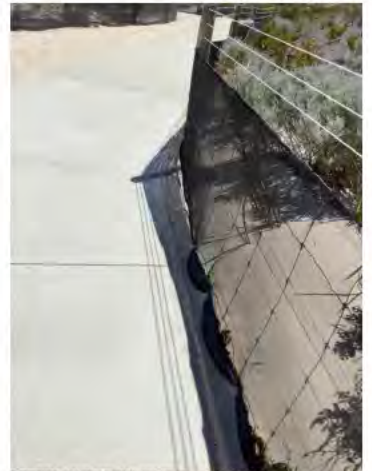
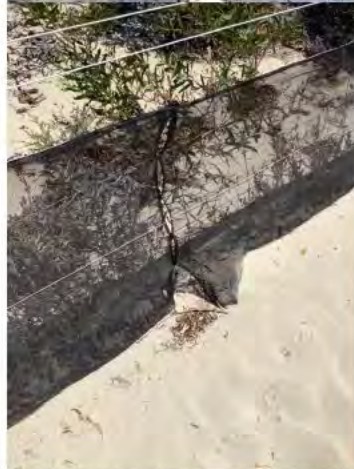
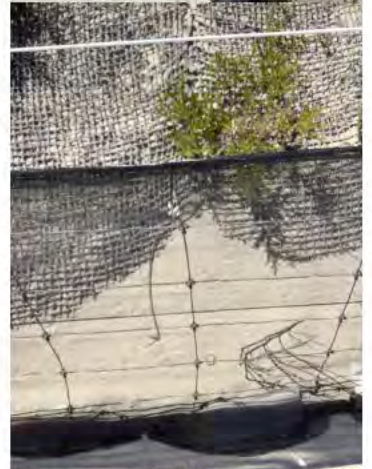
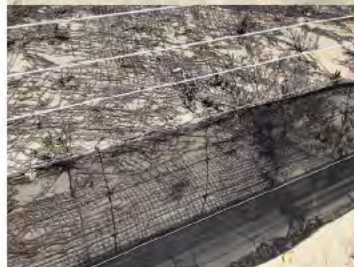
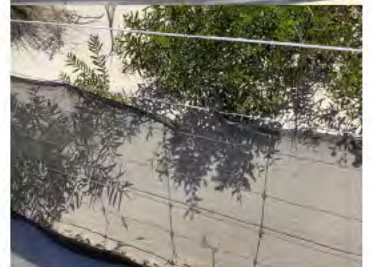
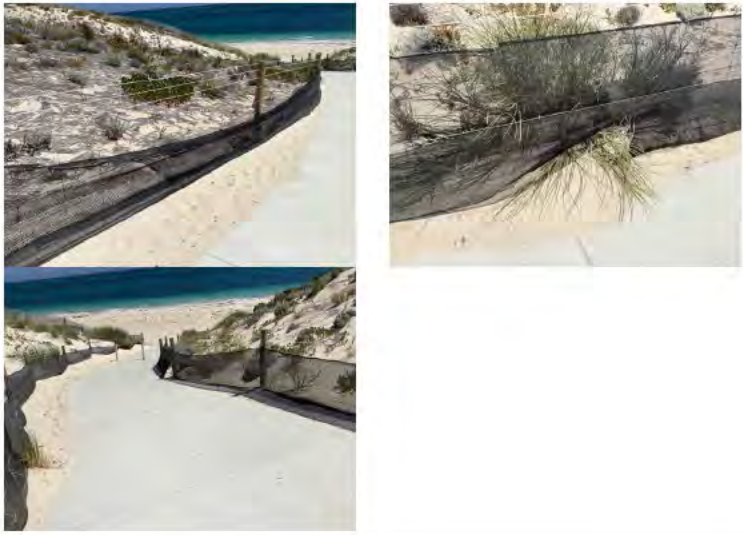
<b>Site No.</b>	C10
<b>Site Name/ Location</b>	Eglinton Foreshore
<b>Date</b>	25/02/2021
<b>Time</b>	13:09 (8 GMT)
<b>Item Number</b>	5
<b>Costal Asset Type</b>	Concrete vehicle access ramp
<b>Element</b>	Fencing
<b>Material Type (Other)</b>	Cloth
<b>Defect Description</b>	Some tears and disconnected areas observed.
<b>Condition Rating (0- 10)</b>	5
<b>Health and Safety Concern (Y/N)</b>	No
<b>Consequence of Failure</b>	1
<b>Likelihood of Failure within next 5 years</b>	4
<b>Risk Rating</b>	4
<b>Overall Rating (CR X RR)</b>	20
<b>Maintenance Recommendation</b>	Replace/patch-up torn areas and reinstate disconnected areas.
<b>Maintenance Timeframe</b>	Within 5 years

<p><b>Other Comments/Inspection Limitations</b></p>	<p>Mesh cloth</p>

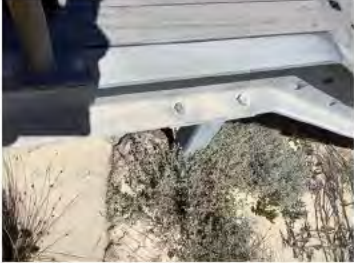
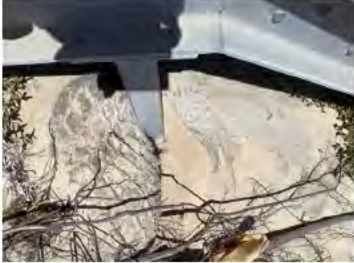
<b>Site No.</b>	C11
<b>Site Name/ Location</b>	Amberton Beach Foreshore South
<b>Date</b>	25/02/2021
<b>Time</b>	13:20 (8 GMT)
<b>Item Number</b>	1
<b>Costal Asset Type</b>	Stairs
<b>Element</b>	Supports
<b>Sub-element</b>	Columns
<b>Material Type</b>	Galvanised Steel
<b>2021 Observed Defects (Steel)</b>	Coating loss, Rust staining
<b>Defect Description</b>	Coating loss and rust staining were observed to be typical. Inspection limited due to access.
<b>Condition Rating (0- 10)</b>	4
<b>Health and Safety Concern (Y/N)</b>	No
<b>Consequence of Failure</b>	4
<b>Likelihood of Failure within next 5 years</b>	1
<b>Risk Rating</b>	4
<b>Overall Rating (CR X RR)</b>	16
<b>Maintenance Recommendation</b>	Monitor and reinspect at next scheduled inspection.
<b>Maintenance Timeframe</b>	Greater than 5 years

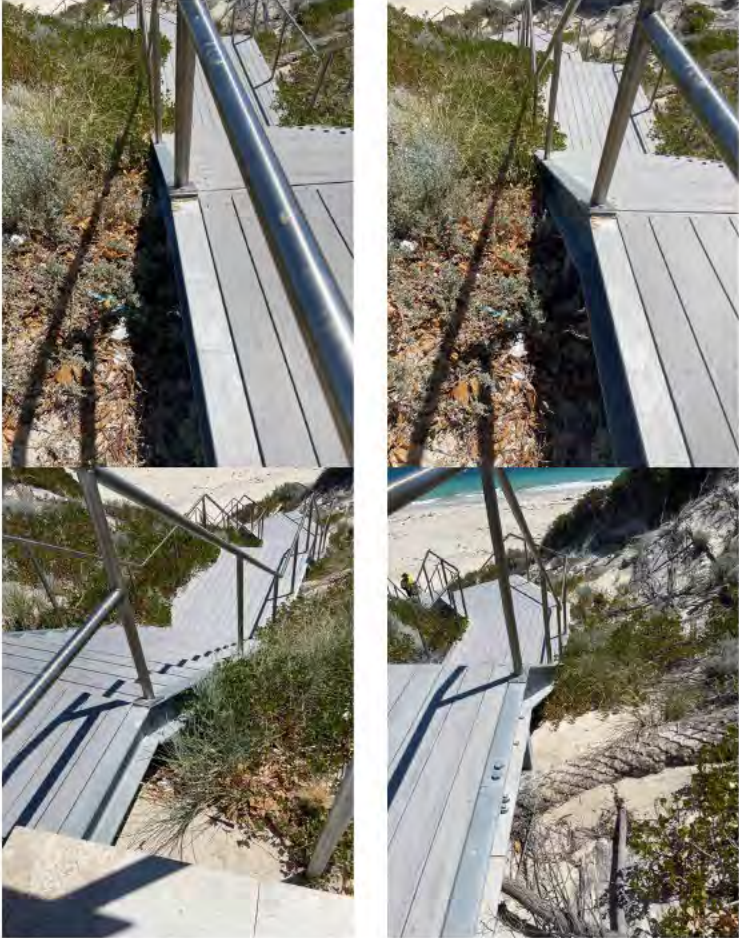
<b>Site No.</b>	C11
<b>Site Name/ Location</b>	Amberton Beach Foreshore South
<b>Date</b>	25/02/2021
<b>Time</b>	13:17 (8 GMT)
<b>Item Number</b>	2
<b>Costal Asset Type</b>	Stairs
<b>Sub-element (Stairs and Landing)</b>	Stringers and Supports
<b>Material Type</b>	Galvanised Steel
<b>2021 Observed Defects (Steel)</b>	Surface corrosion
<b>Defect Description</b>	Generally good condition with minor corrosion observed at welds.
<b>Condition Rating (0- 10)</b>	3
<b>Health and Safety Concern (Y/N)</b>	No
<b>Consequence of Failure</b>	3
<b>Likelihood of Failure within next 5 years</b>	1
<b>Risk Rating</b>	3
<b>Overall Rating (CR X RR)</b>	9
<b>Maintenance Recommendation</b>	Monitor and reinspect at next scheduled inspection.
<b>Maintenance Timeframe</b>	Greater than 5 years

Inspected from top of stairs, no access to embankments

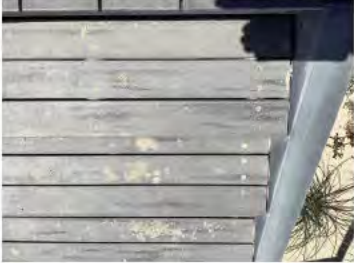
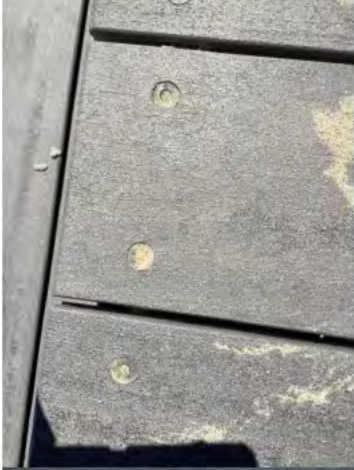
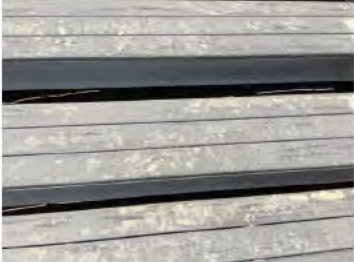
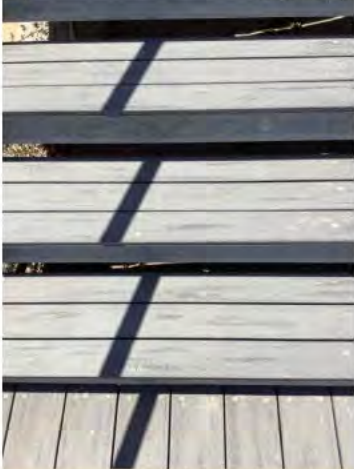
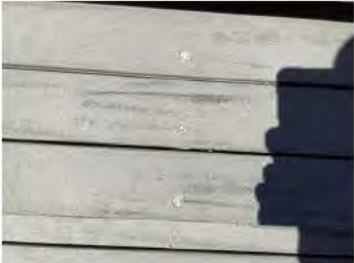
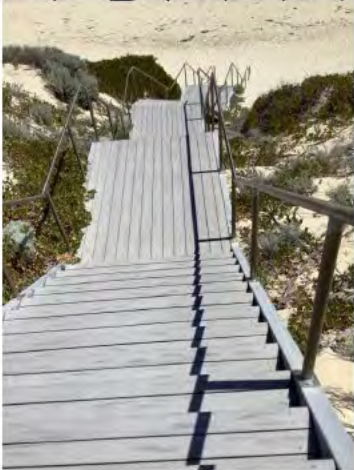
<b>Site No.</b>	C11
<b>Site Name/ Location</b>	Amberton Beach Foreshore South
<b>Date</b>	25/02/2021
<b>Time</b>	13:16 (8 GMT)
<b>Item Number</b>	3
<b>Costal Asset Type</b>	Stairs
<b>Element</b>	Decking
<b>Material Type</b>	Composite Material
<b>Defect Description</b>	Some minor coating loss and one small crack observed.
<b>Condition Rating (0- 10)</b>	3
<b>Health and Safety Concern (Y/N)</b>	No
<b>Consequence of Failure</b>	3
<b>Likelihood of Failure within next 5 years</b>	1
<b>Risk Rating</b>	3
<b>Overall Rating (CR X RR)</b>	9
<b>Maintenance Recommendation</b>	Monitor and reinspect at next scheduled inspection.
<b>Maintenance Timeframe</b>	Greater than 5 years

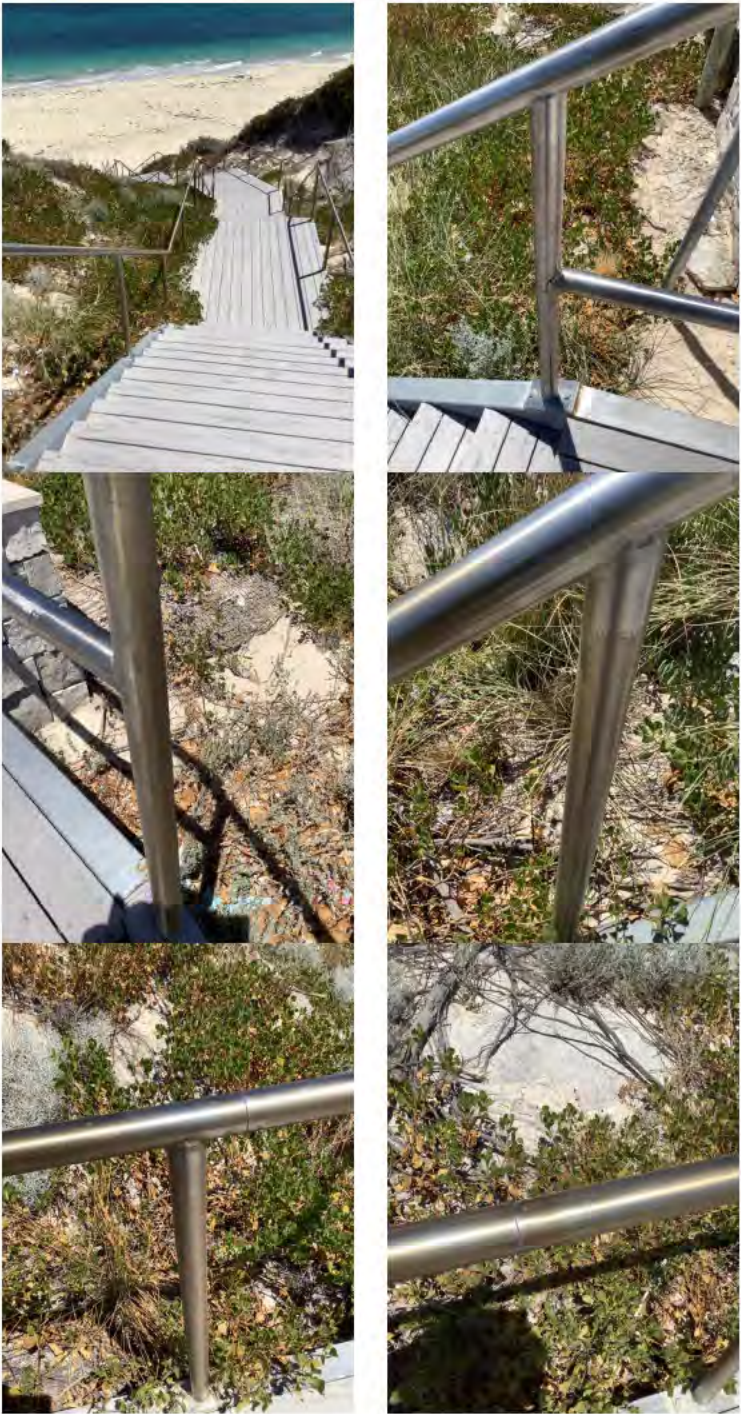
<b>Site No.</b>	C11
<b>Site Name/ Location</b>	Amberton Beach Foreshore South
<b>Date</b>	25/02/2021
<b>Time</b>	13:13 (8 GMT)
<b>Item Number</b>	4
<b>Costal Asset Type</b>	Stairs
<b>Element</b>	Handrails
<b>Material Type</b>	Stainless Steel
<b>2021 Observed Defects (Steel)</b>	Tea Staining
<b>Defect Description</b>	Generally good condition with tea staining observed to be typical throughout.
<b>Condition Rating (0- 10)</b>	2
<b>Health and Safety Concern (Y/N)</b>	No
<b>Consequence of Failure</b>	2
<b>Likelihood of Failure within next 5 years</b>	1
<b>Risk Rating</b>	2
<b>Overall Rating (CR X RR)</b>	4
<b>Maintenance Recommendation</b>	Monitor and reinspect at next scheduled inspection.
<b>Maintenance Timeframe</b>	Greater than 5 years

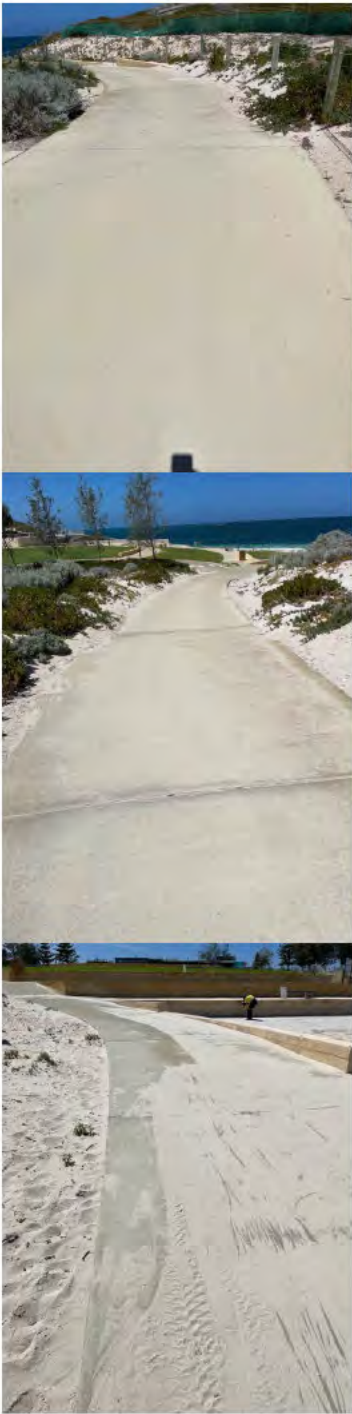
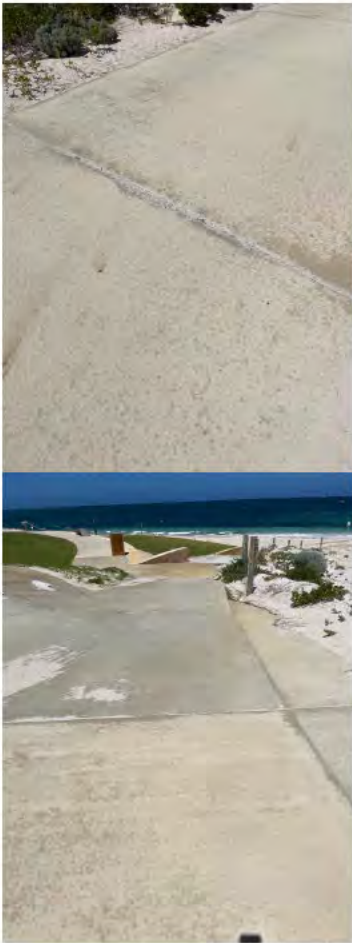
<b>Site No.</b>	C12
<b>Site Name/ Location</b>	Waterfront Park
<b>Date</b>	25/02/2021
<b>Time</b>	11:17 (8 GMT)
<b>Item Number</b>	1
<b>Costal Asset Type</b>	Vehicle access ramp
<b>Element</b>	Foundation
<b>Sub-element (Foundations)</b>	Base slab
<b>Material Type</b>	Reinforced Concrete
<b>2021 Observed Defects (Reinforced Concrete)</b>	Crack, Spalling
<b>Defect Description</b>	Generally good condition with minor spalling and cracking observed at the joints.
<b>Quantity of Defects</b>	3m x 120
<b>Condition Rating (0- 10)</b>	3
<b>Health and Safety Concern (Y/N)</b>	No
<b>Consequence of Failure</b>	3
<b>Likelihood of Failure within next 5 years</b>	1
<b>Risk Rating</b>	3
<b>Overall Rating (CR X RR)</b>	9
<b>Maintenance Recommendation</b>	Monitor and reinspect at next scheduled inspection.
<b>Maintenance Timeframe</b>	Greater than 5 years

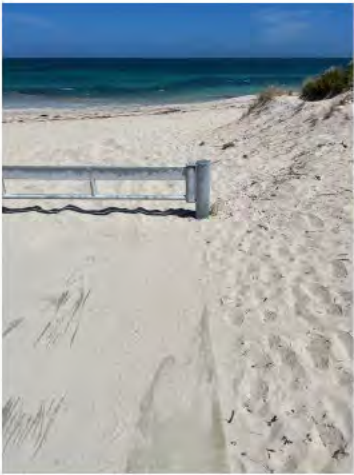
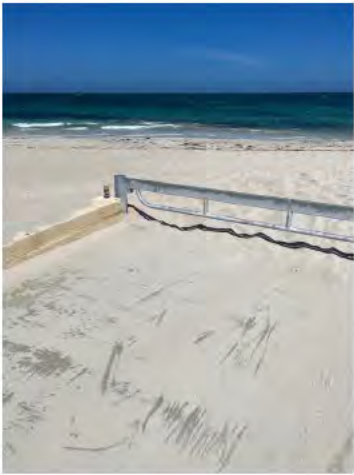
<b>Site No.</b>	C12
<b>Site Name/ Location</b>	Waterfront Park
<b>Date</b>	25/02/2021
<b>Time</b>	11:32 (8 GMT)
<b>Item Number</b>	2
<b>Costal Asset Type</b>	Vehicle access ramp
<b>Element</b>	Boom gate
<b>Material Type</b>	Galvanised Steel
<b>2021 Observed Defects (Steel)</b>	Coating loss
<b>Defect Description</b>	Generally good condition with minor coating loss observed to be typical on the top and bottom of the gate.
<b>Condition Rating (0- 10)</b>	4
<b>Health and Safety Concern (Y/N)</b>	No
<b>Consequence of Failure</b>	2
<b>Likelihood of Failure within next 5 years</b>	2
<b>Risk Rating</b>	4
<b>Overall Rating (CR X RR)</b>	16
<b>Maintenance Recommendation</b>	Monitor and reinspect at next scheduled inspection.
<b>Maintenance Timeframe</b>	Greater than 5 years

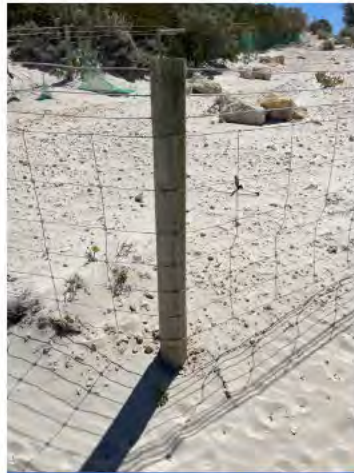
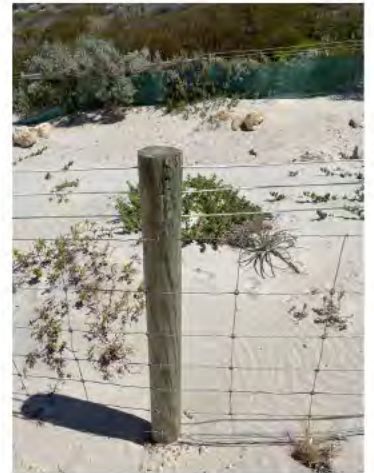
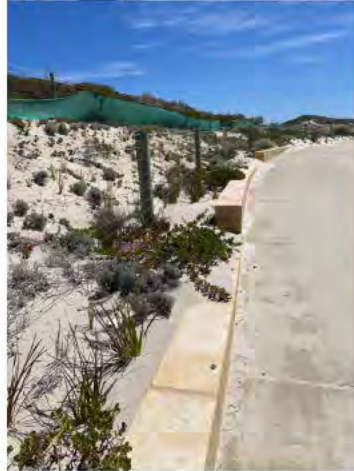
<b>Site No.</b>	C12
<b>Site Name/ Location</b>	Waterfront Park
<b>Date</b>	25/02/2021
<b>Time</b>	11:21 (8 GMT)
<b>Item Number</b>	3
<b>Costal Asset Type</b>	Fencing
<b>Element</b>	Fencing
<b>Sub-element (Fencing)</b>	Timber posts
<b>Material Type</b>	Timber
<b>2021 Observed Defects (Timber)</b>	Split timber
<b>Defect Description</b>	Generally good condition with minor timber splitting observed.
<b>Quantity of Defects</b>	Approx 60 posts
<b>Condition Rating (0- 10)</b>	4
<b>Health and Safety Concern (Y/N)</b>	No
<b>Consequence of Failure</b>	2
<b>Likelihood of Failure within next 5 years</b>	1
<b>Risk Rating</b>	2
<b>Overall Rating (CR X RR)</b>	8
<b>Maintenance Recommendation</b>	Monitor and reinspect at next scheduled inspection.
<b>Maintenance Timeframe</b>	Greater than 5 years

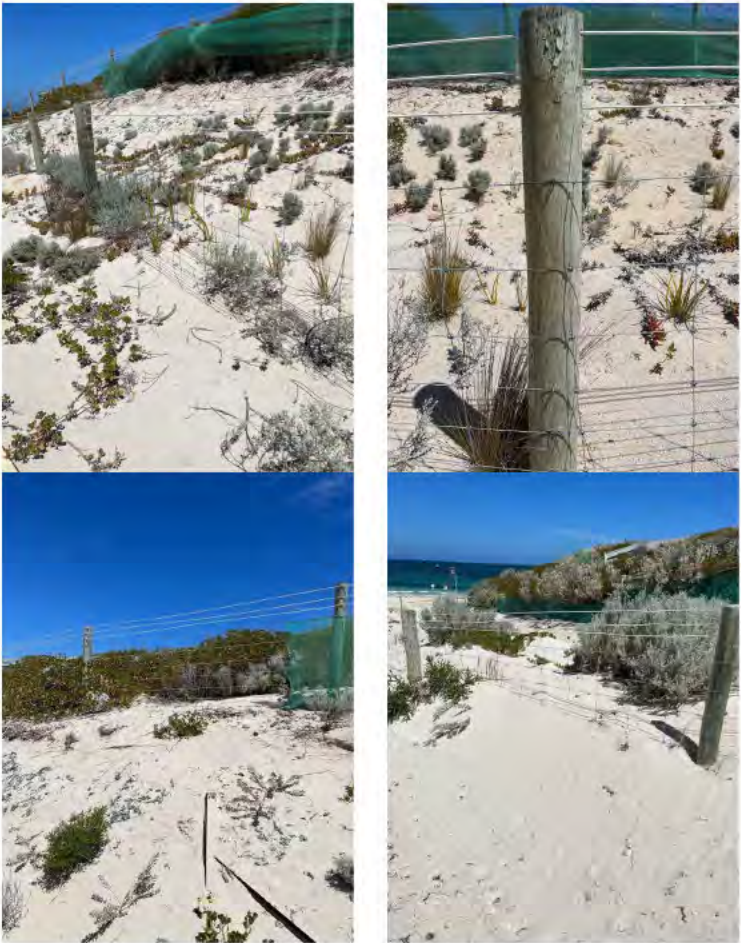
<b>Site No.</b>	C12
<b>Site Name/ Location</b>	Waterfront Park
<b>Date</b>	25/02/2021
<b>Time</b>	11:25 (8 GMT)
<b>Item Number</b>	4
<b>Costal Asset Type</b>	Fencing
<b>Element</b>	Fencing
<b>Sub-element (Fencing)</b>	Mesh & Staples
<b>Material Type</b>	Galvanised Steel
<b>2021 Observed Defects (Steel)</b>	Surface corrosion
<b>Defect Description</b>	Generally good condition. Minor surface corrosion was observed at localised areas. The corrosion was observed to be more predominant on the northern fence. Deformation due to sand build up was also observed.
<b>Condition Rating (0- 10)</b>	4
<b>Health and Safety Concern (Y/N)</b>	No
<b>Consequence of Failure</b>	2
<b>Likelihood of Failure within next 5 years</b>	2
<b>Risk Rating</b>	4
<b>Overall Rating (CR X RR)</b>	16
<b>Maintenance Recommendation</b>	Monitor and reinspect at next scheduled inspection.
<b>Maintenance Timeframe</b>	Greater than 5 years

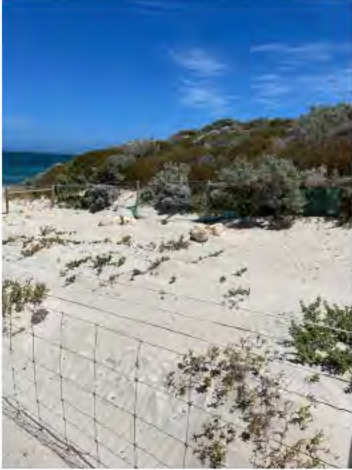
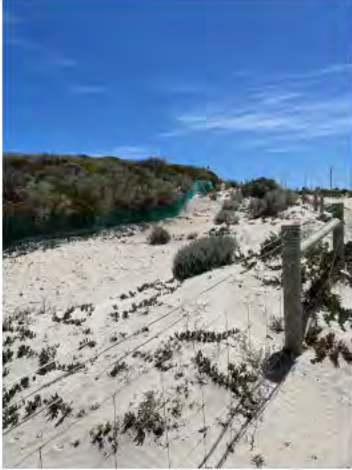
Site No.	C12
Site Name/ Location	Waterfront Park
Date	25/02/2021
Time	11:30 (8 GMT)
Item Number	5
Costal Asset Type	Fencing
Element	Fencing
Sub-element (Fencing)	Windbreak fencing - Shade cloth
Material Type	Geofabric
Defect Description	Cloth observed to be deteriorated and failed at base of northern fence. Cloth noticed to be typically loose throughout.
Condition Rating (0- 10)	7
Health and Safety Concern (Y/N)	No
Consequence of Failure	2
Likelihood of Failure within next 5 years	4
Risk Rating	8
Overall Rating (CR X RR)	56
Maintenance Recommendation	Replace full length of cloth.
Maintenance Timeframe	Within 1-2 years

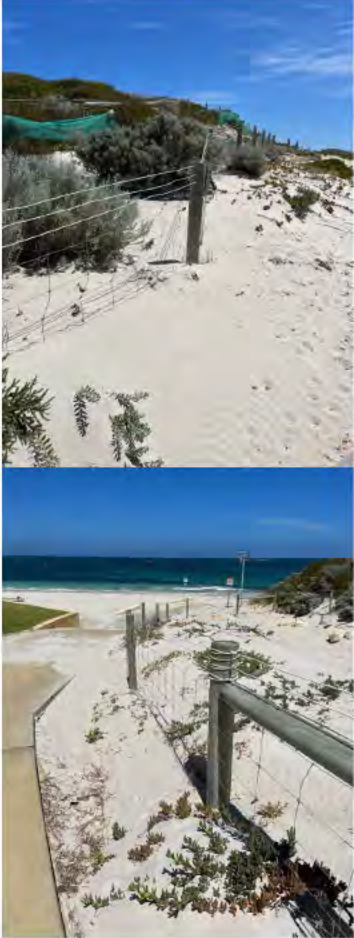
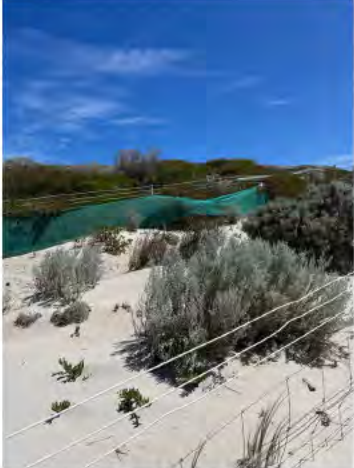
<b>Site No.</b>	C12
<b>Site Name/ Location</b>	Waterfront Park
<b>Date</b>	25/02/2021
<b>Time</b>	11:28 (8 GMT)
<b>Item Number</b>	6
<b>Costal Asset Type</b>	Fencing
<b>Element</b>	Fencing
<b>Sub-element (Fencing)</b>	Strainer wires above mesh
<b>Material Type</b>	Coated Steel
<b>2021 Observed Defects (Steel)</b>	Impact/mechanical damage
<b>Defect Description</b>	Generally good condition with localised areas of loose wire observed (most likely due to overgrown vegetation).
<b>Condition Rating (0- 10)</b>	3
<b>Health and Safety Concern (Y/N)</b>	No
<b>Consequence of Failure</b>	2
<b>Likelihood of Failure within next 5 years</b>	2
<b>Risk Rating</b>	4
<b>Overall Rating (CR X RR)</b>	12
<b>Maintenance Recommendation</b>	Monitor and reinspect at next scheduled inspection.
<b>Maintenance Timeframe</b>	Greater than 5 years

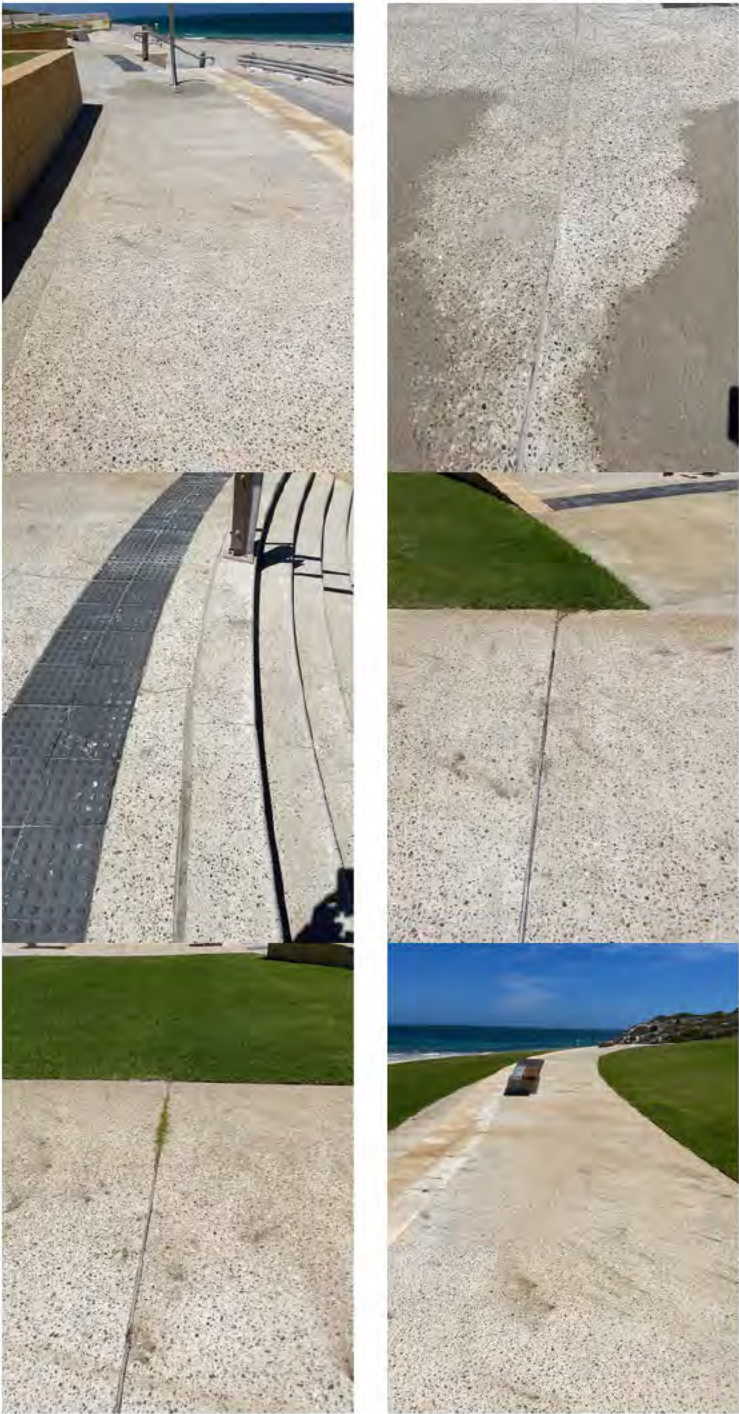
<b>Site No.</b>	C12
<b>Site Name/ Location</b>	Waterfront Park
<b>Date</b>	25/02/2021
<b>Time</b>	11:37 (8 GMT)
<b>Item Number</b>	7
<b>Costal Asset Type</b>	Concrete path
<b>Element</b>	Path
<b>Sub-element</b>	Concrete path
<b>Material Type (Other)</b>	Concrete (Exposed aggregate concrete finish)
<b>Defect Description</b>	Generally good condition. Minor deterioration of joint sealant at wall interface was observed to be typical along with some localised areas of join sealant failure. Minor cracking at southern most staircase was also observed.
<b>Condition Rating (0- 10)</b>	3
<b>Health and Safety Concern (Y/N)</b>	No
<b>Consequence of Failure</b>	3
<b>Likelihood of Failure within next 5 years</b>	1
<b>Risk Rating</b>	3
<b>Overall Rating (CR X RR)</b>	9
<b>Maintenance Recommendation</b>	Monitor and reinspect at next scheduled inspection.
<b>Maintenance Timeframe</b>	Greater than 5 years

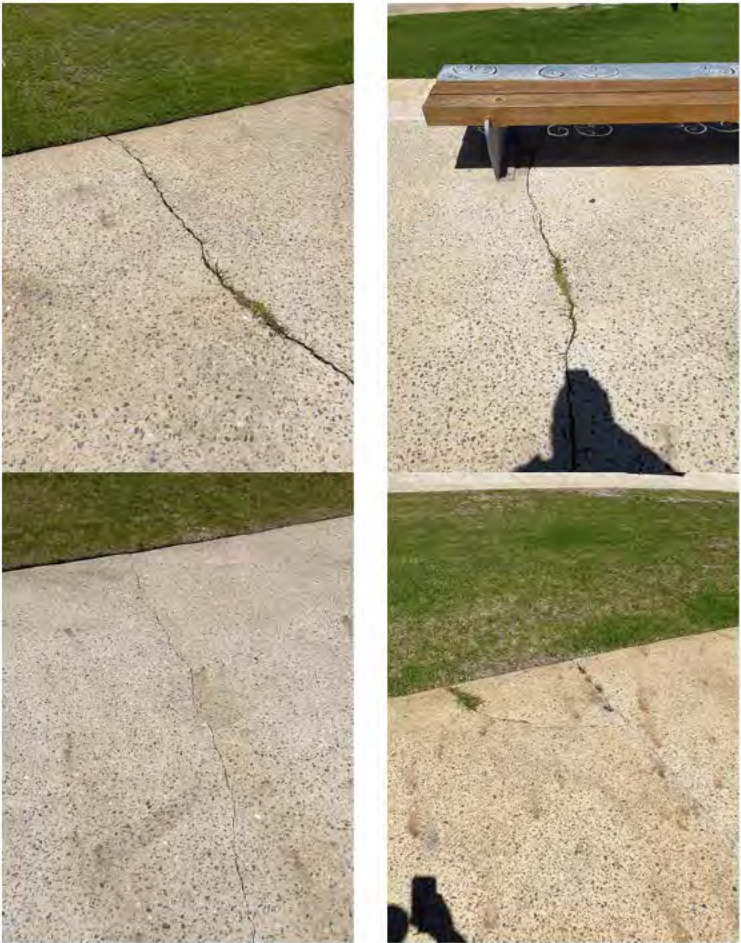
Site No.	C12
Site Name/ Location	Waterfront Park
Date	25/02/2021
Time	11:44 (8 GMT)
Item Number	8
Costal Asset Type	Concrete path
Element	Path
Material Type (Other)	Concrete
Defect Description	Heavy crack on adjacent southern most bench on level three was observed.
Quantity of Defects	2m long crack by 10mm wide
Defect Location	South end of path lv3 North end lv3
Condition Rating (0- 10)	7
Health and Safety Concern (Y/N)	No
Consequence of Failure	2
Likelihood of Failure within next 5 years	4
Risk Rating	8
Overall Rating (CR X RR)	56
Maintenance Recommendation	Conventional concrete repair
Maintenance Timeframe	Within 1-2 years

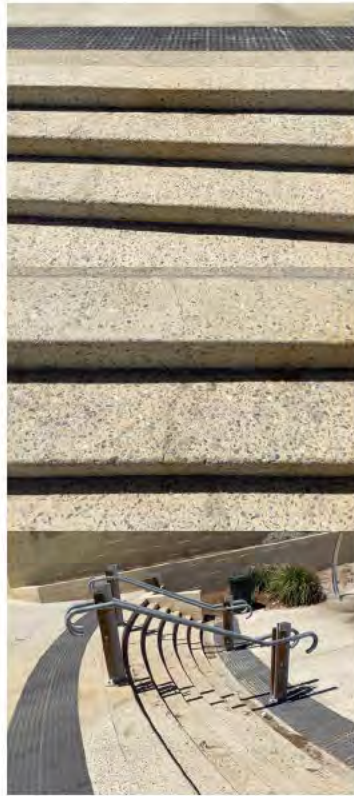
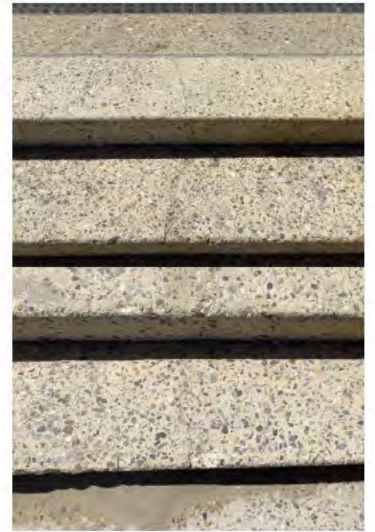
Site No.	C12
Site Name/ Location	Waterfront Park
Date	25/02/2021
Time	11:40 (8 GMT)
Item Number	9
Costal Asset Type	Stairs
Element	Staircase
Material Type (Other)	Exposed aggregate finished concrete
Defect Description	Generally good condition. The south side stairwell was observed to possess some discoloration, minor cracking and one small chip.
Condition Rating (0- 10)	2
Health and Safety Concern (Y/N)	No
Consequence of Failure	3
Likelihood of Failure within next 5 years	2
Risk Rating	6
Overall Rating (CR X RR)	12
Maintenance Recommendation	Monitor and reinspect at next scheduled inspection.
Maintenance Timeframe	Greater than 5 years

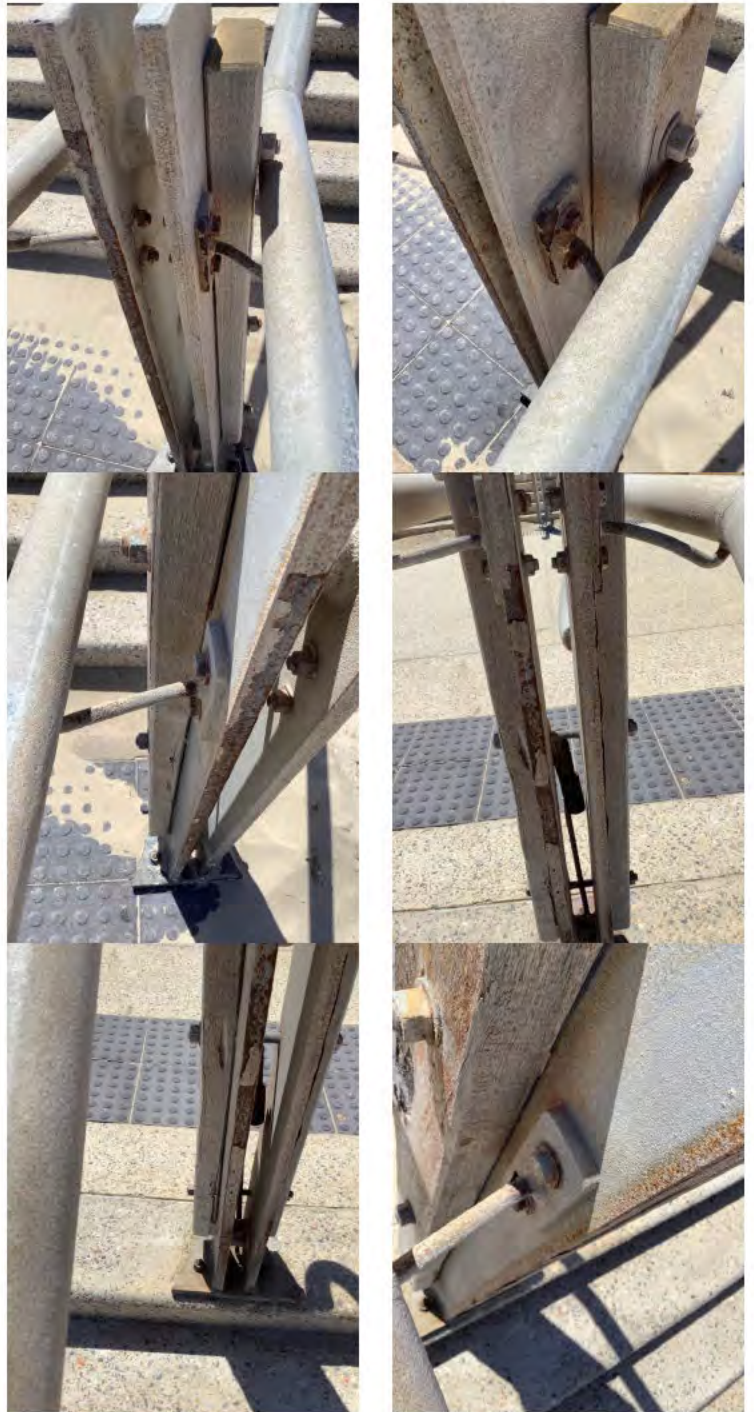
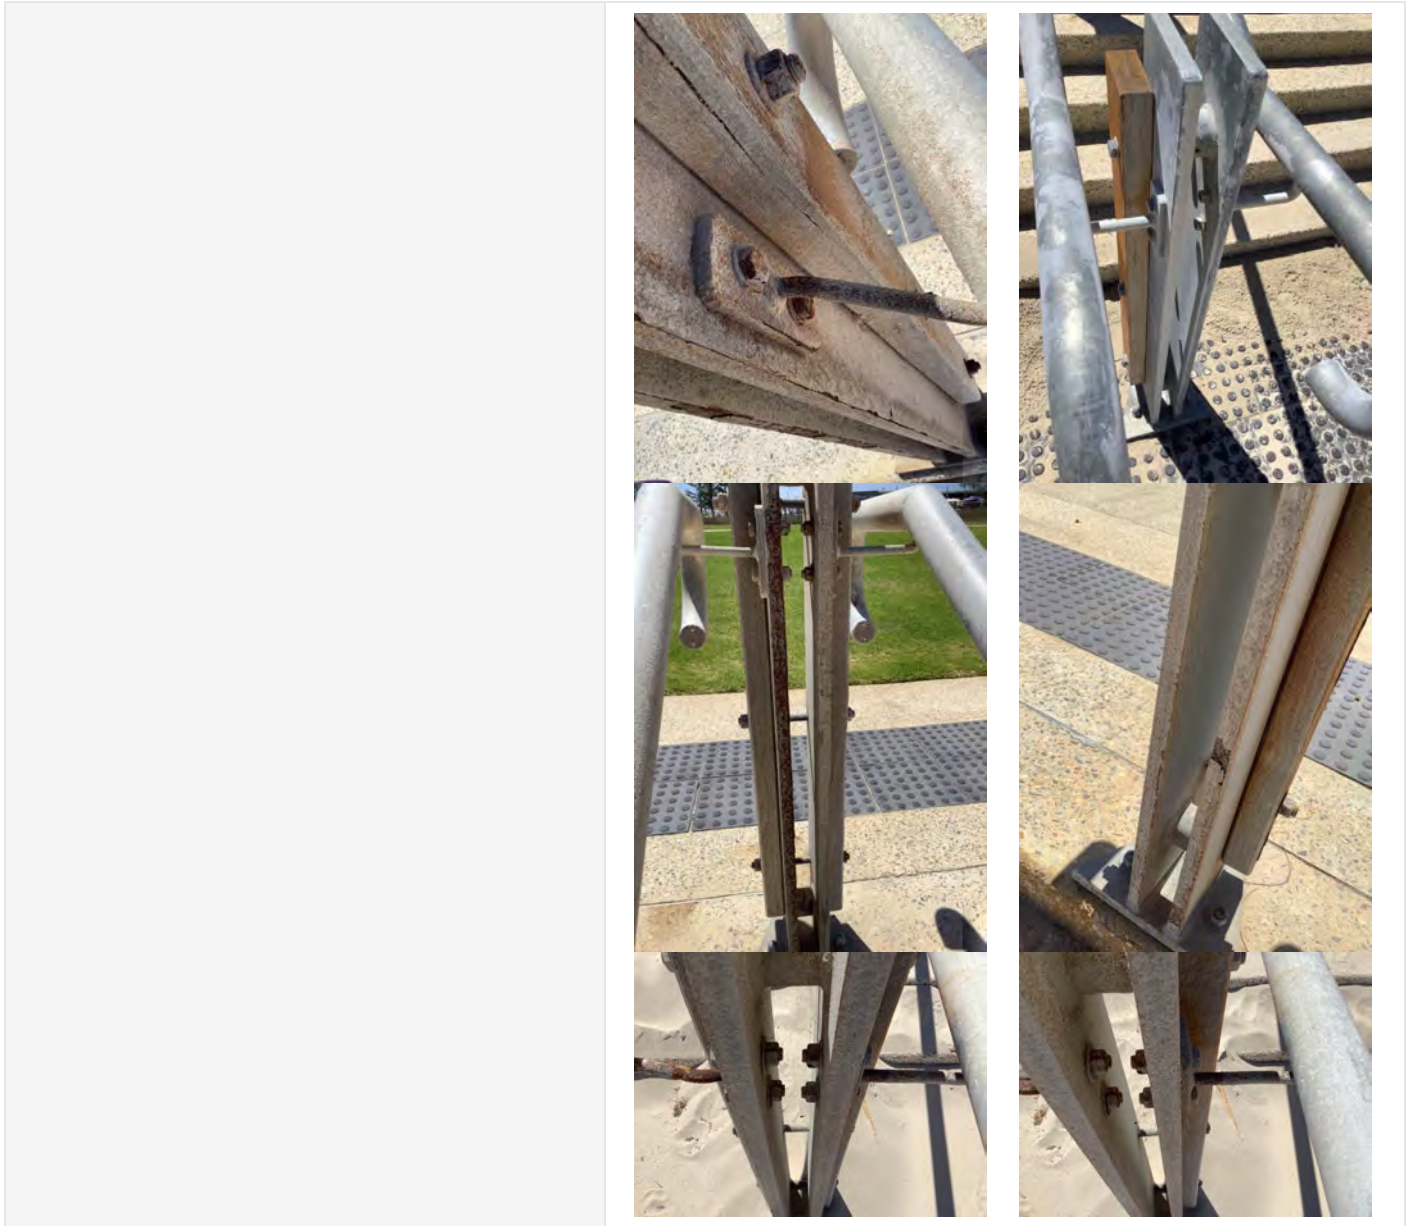
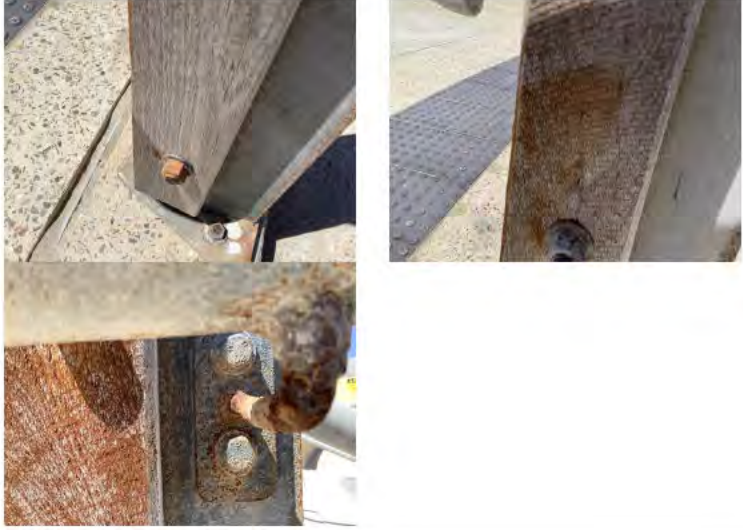
<b>Site No.</b>	C12
<b>Site Name/ Location</b>	Waterfront Park
<b>Date</b>	25/02/2021
<b>Time</b>	11:30 (8 GMT)
<b>Item Number</b>	10
<b>Costal Asset Type</b>	Stairs
<b>Element</b>	Handrails
<b>Sub-element (Handrails)</b>	Posts
<b>Material Type</b>	Galvanised Steel
<b>2021 Observed Defects (Steel)</b>	Coating loss, Rust staining, Surface corrosion
<b>Defect Description</b>	Surface corrosion, coating loss and rust staining were typical throughout on posts and connections. These were observed to be more prominent on the ocean side of the posts.
<b>Condition Rating (0- 10)</b>	7
<b>Health and Safety Concern (Y/N)</b>	No
<b>Consequence of Failure</b>	2
<b>Likelihood of Failure within next 5 years</b>	4
<b>Risk Rating</b>	8
<b>Overall Rating (CR X RR)</b>	56
<b>Maintenance Recommendation</b>	Replace heavily corroded posts and fixings.
<b>Maintenance Timeframe</b>	Within 5 years

<b>Other Comments/Inspection Limitations</b>	All c12 steel posts and connections

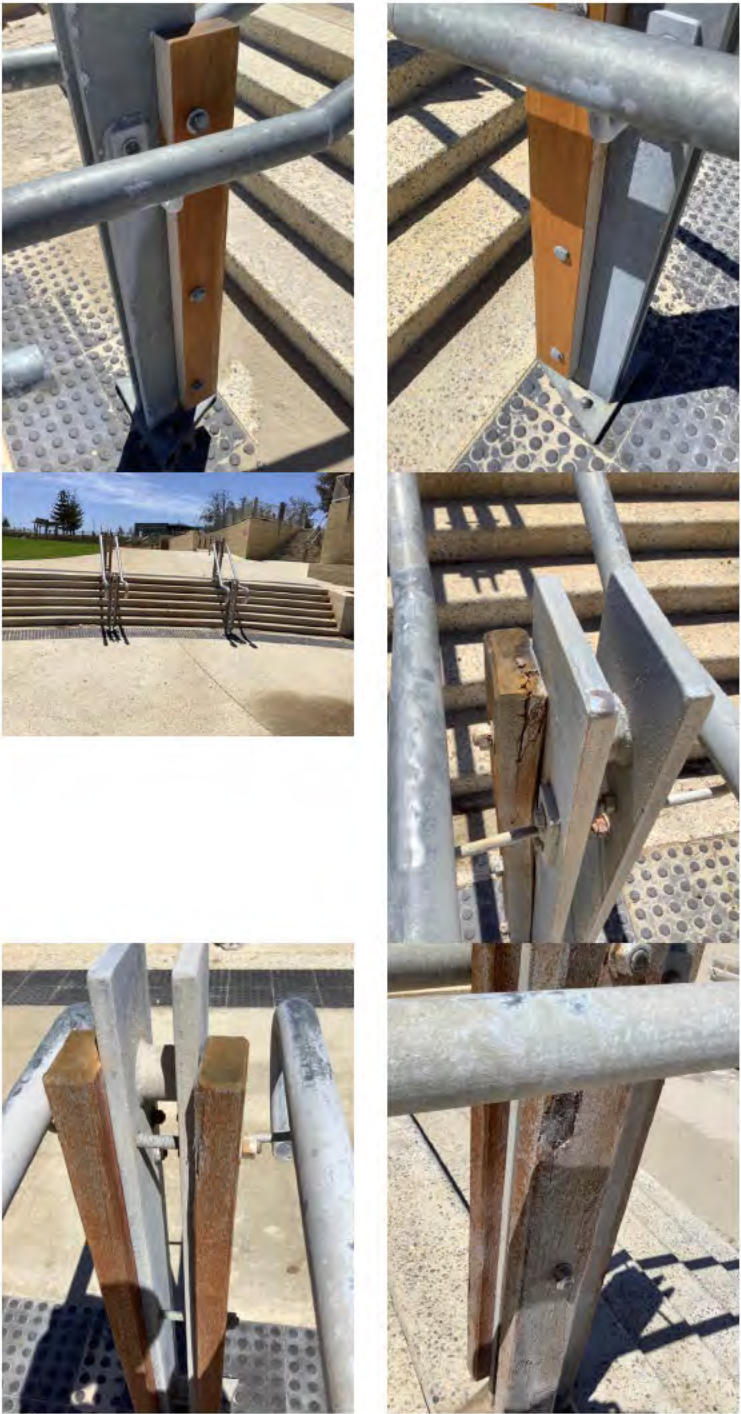
<b>Site No.</b>	C12
<b>Site Name/ Location</b>	Waterfront Park
<b>Date</b>	25/02/2021
<b>Time</b>	11:26 (8 GMT)
<b>Item Number</b>	11
<b>Costal Asset Type</b>	Stairs
<b>Element</b>	Handrails
<b>Sub-element (Fencing)</b>	Timber members
<b>Material Type</b>	Timber
<b>2021 Observed Defects (Timber)</b>	Split timber
<b>Defect Description</b>	Generally good condition. Coating loss was observed to be typical throughout. Some members were also observed to contain split timber.
<b>Condition Rating (0- 10)</b>	3
<b>Health and Safety Concern (Y/N)</b>	No
<b>Consequence of Failure</b>	1
<b>Likelihood of Failure within next 5 years</b>	2
<b>Risk Rating</b>	2
<b>Overall Rating (CR X RR)</b>	6
<b>Maintenance Recommendation</b>	Monitor and reinspect at next scheduled inspection.
<b>Maintenance Timeframe</b>	Greater than 5 years

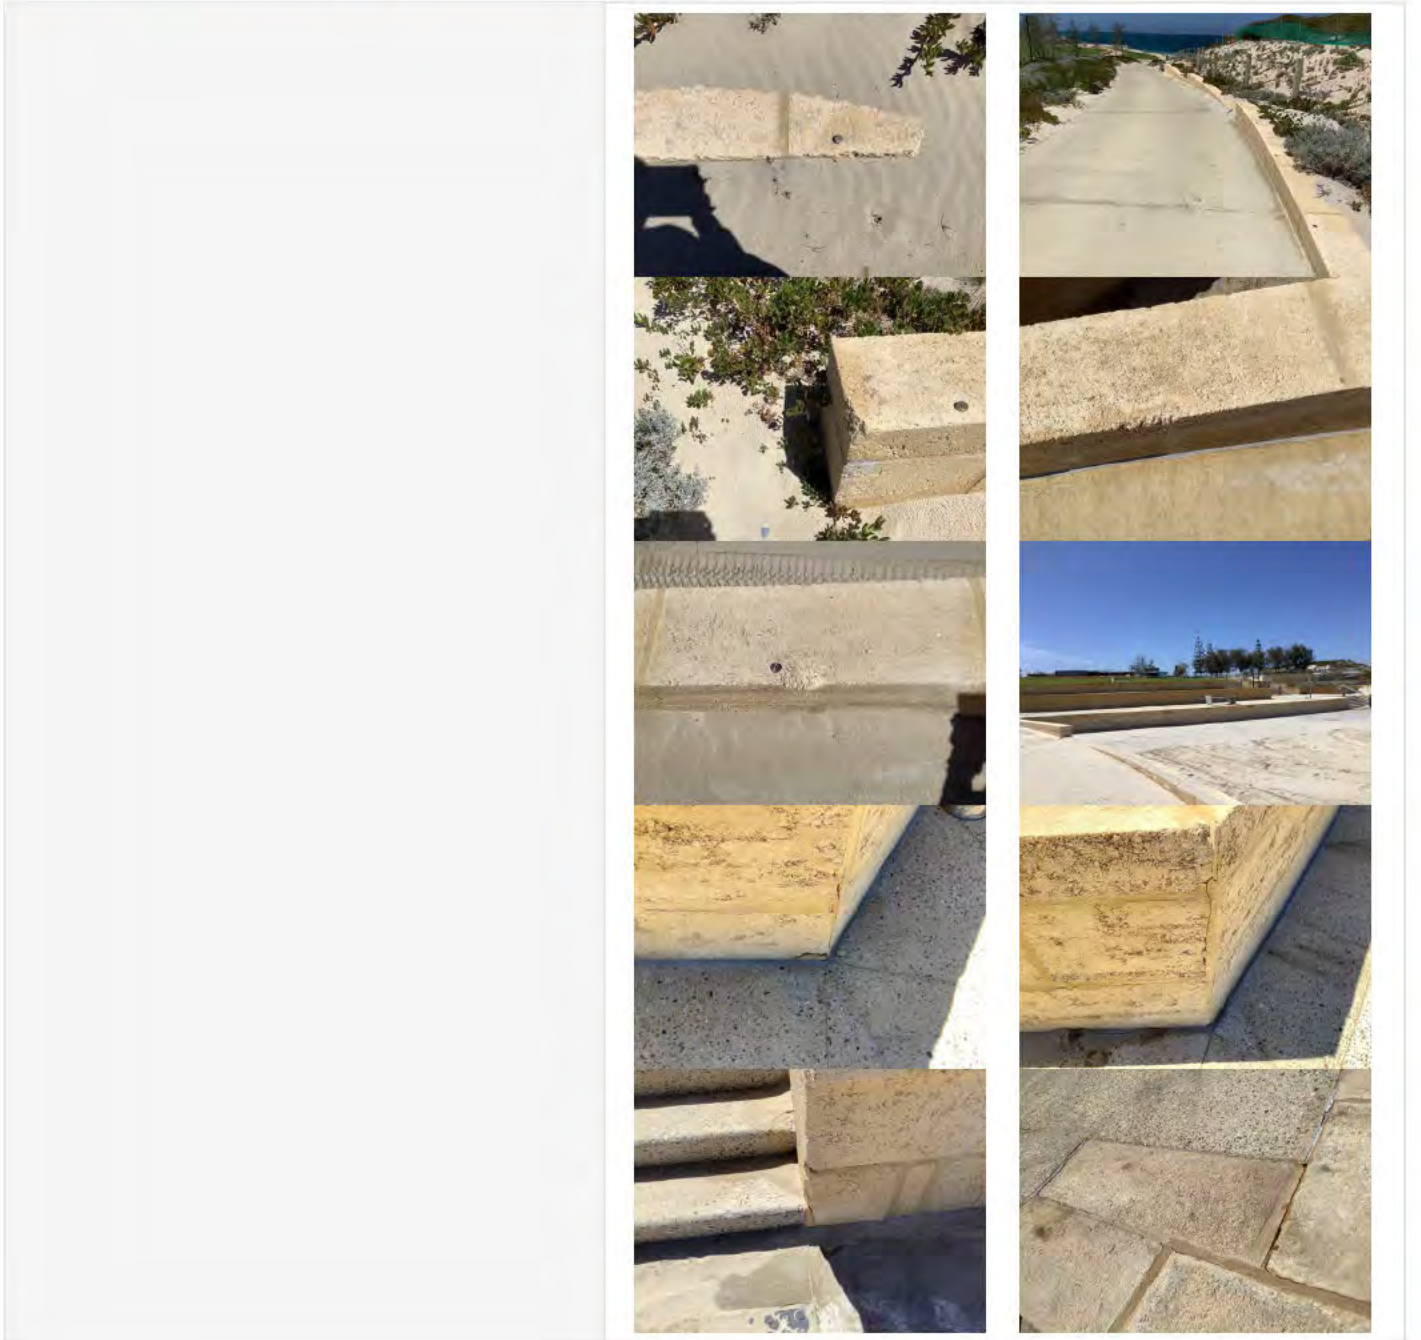
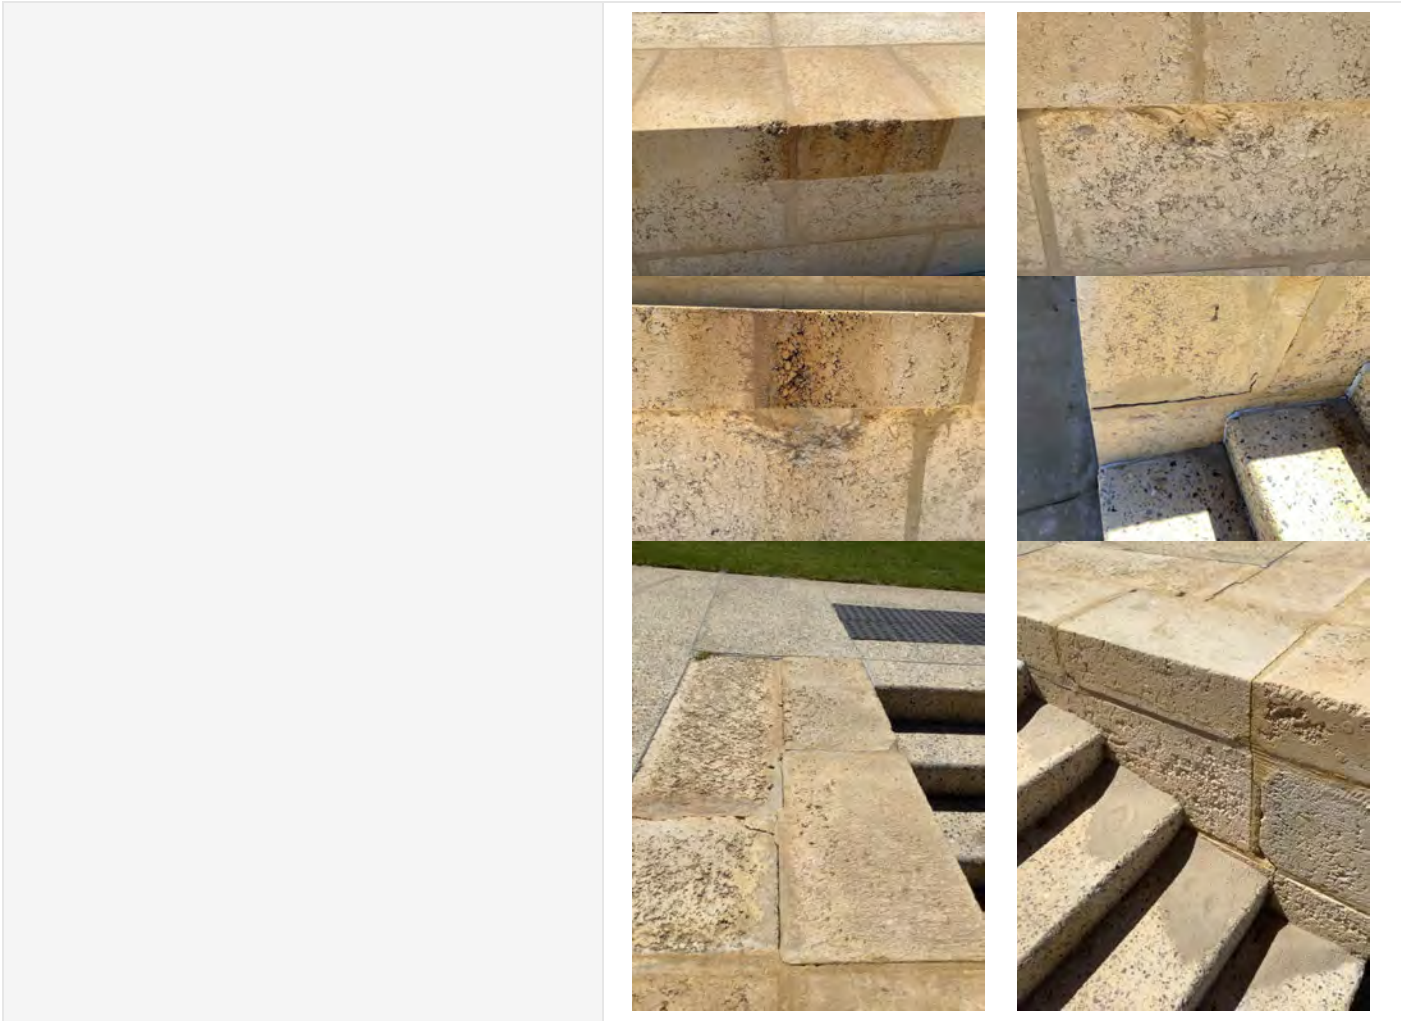
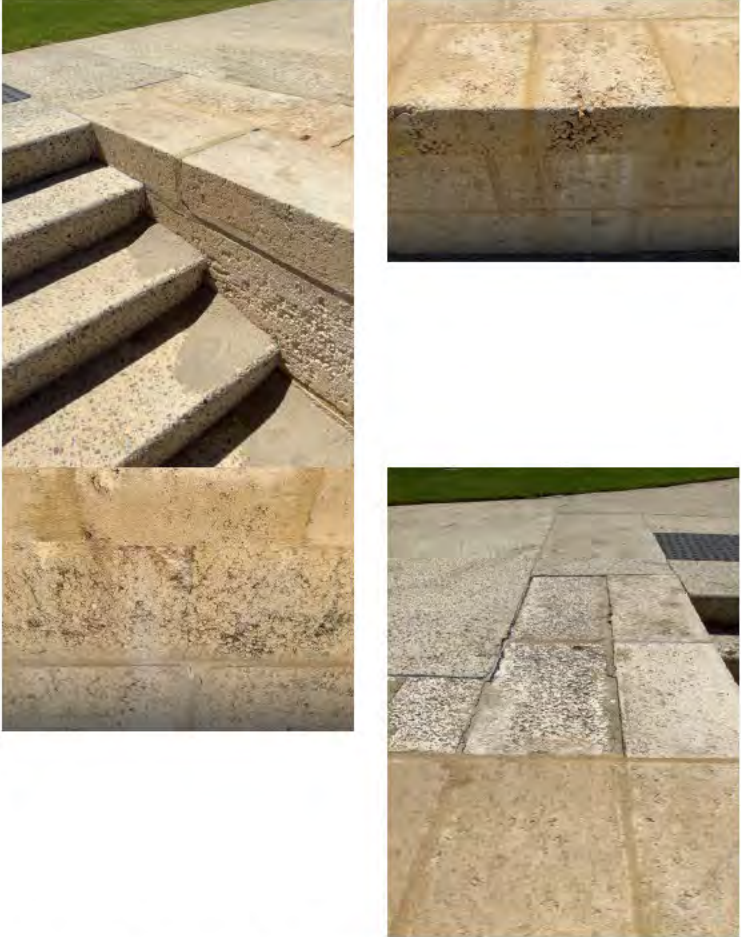
<p><b>Other Comments/Inspection Limitations</b></p>	<p>Retaining walls across all c12</p>

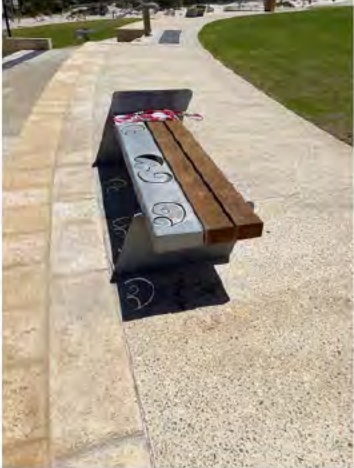
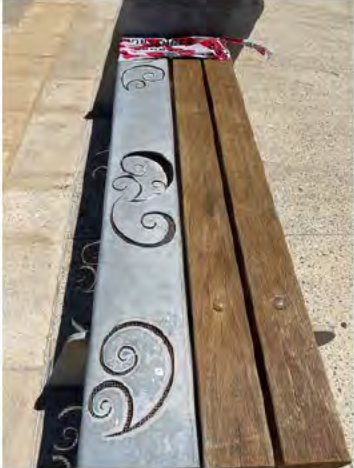
Remaining benches generally in good condition

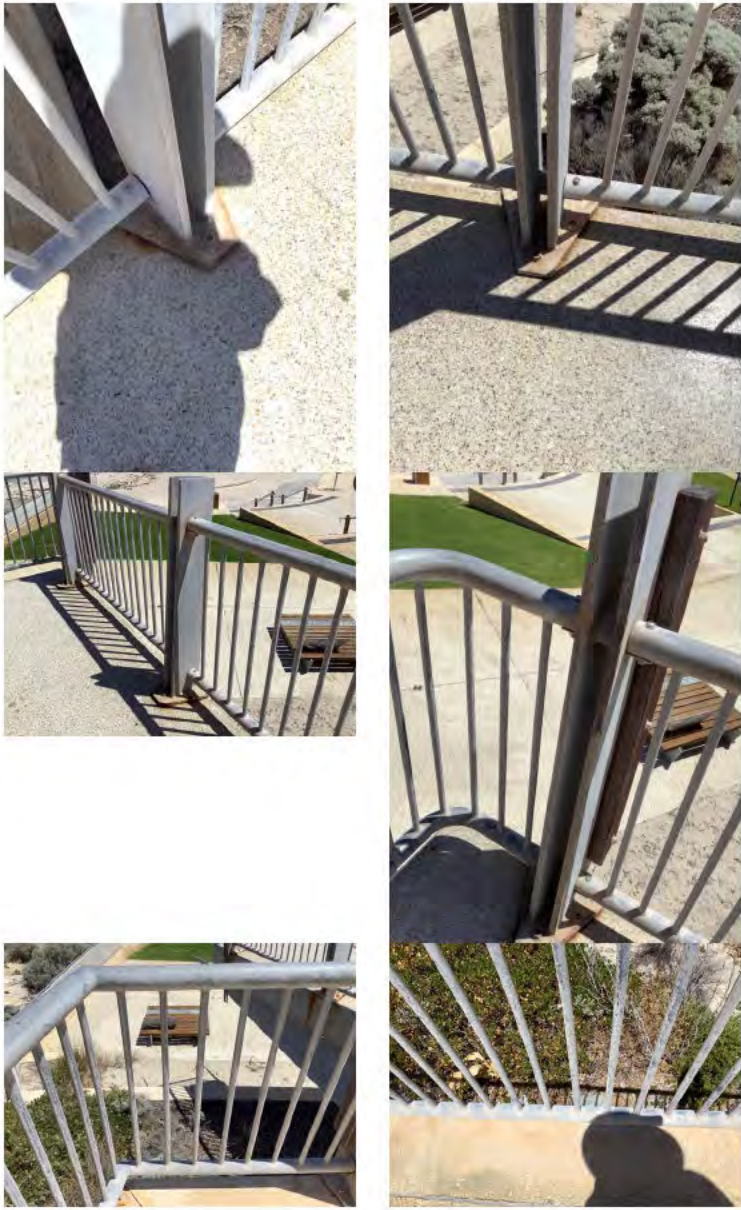
<b>Site No.</b>	C12
<b>Site Name/ Location</b>	Waterfront Park
<b>Date</b>	25/02/2021
<b>Time</b>	11:54 (8 GMT)
<b>Item Number</b>	16
<b>Costal Asset Type</b>	Lookout
<b>Element</b>	Handrails
<b>Material Type</b>	Galvanised Steel
<b>2021 Observed Defects (Steel)</b>	Surface corrosion, Coating loss
<b>Defect Description</b>	Generally good condition with minor surface corrosion and coating loss observed to be typical throughout.
<b>Condition Rating (0- 10)</b>	3
<b>Health and Safety Concern (Y/N)</b>	No
<b>Consequence of Failure</b>	3
<b>Likelihood of Failure within next 5 years</b>	2
<b>Risk Rating</b>	6
<b>Overall Rating (CR X RR)</b>	18
<b>Maintenance Recommendation</b>	Monitor and reinspect at next scheduled inspection.
<b>Maintenance Timeframe</b>	Greater than 5 years
