# City of Wanneroo Assets Structural Assessment

## Coastal Assets

City Of Wanneroo

30 July 2021

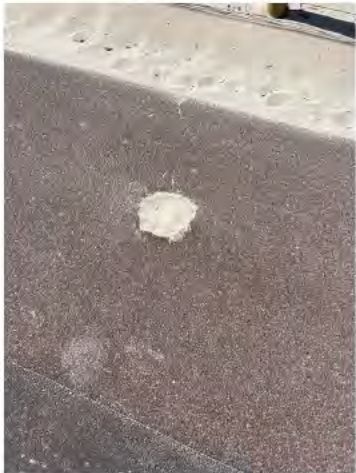
<b>Site No.</b>	C13
<b>Site Name/ Location</b>	Alkimos Beach
<b>Date</b>	25/02/2021
<b>Time</b>	10:14 (8 GMT)
<b>Item Number</b>	1
<b>Costal Asset Type</b>	Vehicle access ramp
<b>Element</b>	Foundation
<b>Sub-element (Foundations)</b>	Base slab
<b>Material Type</b>	Asphalt
<b>Defect Description</b>	An asphalt pothole was observed (1.8 m from bottom of ramp)
<b>Defect Location</b>	18m from base of ramp
<b>Condition Rating (0- 10)</b>	5
<b>Health and Safety Concern (Y/N)</b>	Yes
<b>Consequence of Failure</b>	3
<b>Likelihood of Failure within next 5 years</b>	4
<b>Risk Rating</b>	12
<b>Overall Rating (CR X RR)</b>	60
<b>Maintenance Recommendation</b>	Fill in pothole.
<b>Maintenance Timeframe</b>	Immediately

Pothole trip hazard

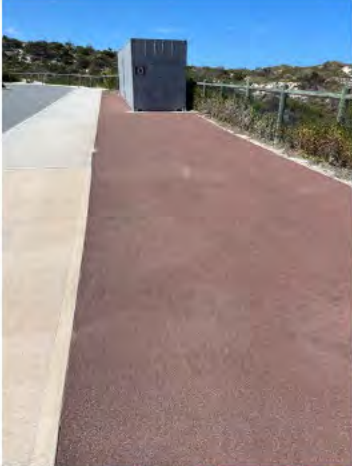
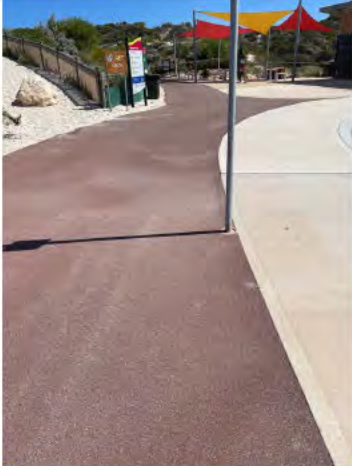
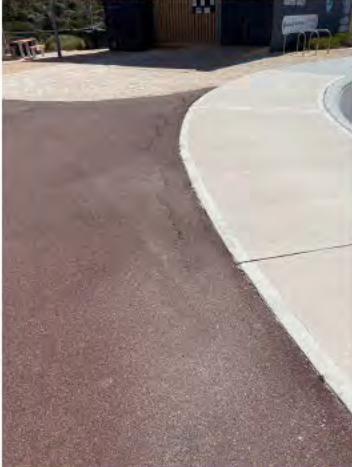
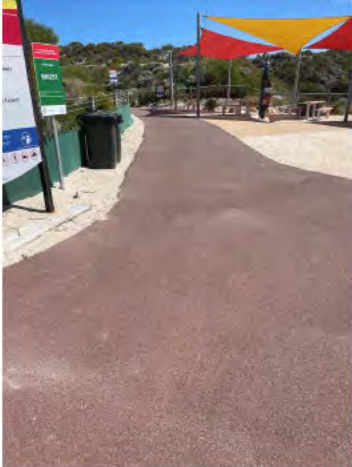
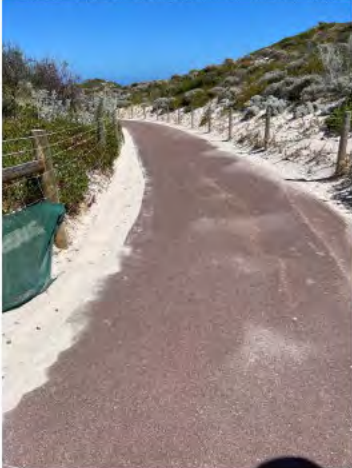
<b>Site No.</b>	C13
<b>Site Name/ Location</b>	Alkimos Beach
<b>Date</b>	25/02/2021
<b>Time</b>	10:17 (8 GMT)
<b>Item Number</b>	2
<b>Costal Asset Type</b>	Vehicle access ramp
<b>Element</b>	Foundation
<b>Sub-element (Foundations)</b>	Base slab
<b>Material Type</b>	Asphalt
<b>Defect Description</b>	Generally good condition with some cracking observed adjacent to the footpath.
<b>Quantity of Defects</b>	3m x approx 180m
<b>Condition Rating (0- 10)</b>	3
<b>Health and Safety Concern (Y/N)</b>	No
<b>Consequence of Failure</b>	3
<b>Likelihood of Failure within next 5 years</b>	1
<b>Risk Rating</b>	3
<b>Overall Rating (CR X RR)</b>	9
<b>Maintenance Recommendation</b>	Monitor and reinspect at next scheduled inspection.
<b>Maintenance Timeframe</b>	Greater than 5 years

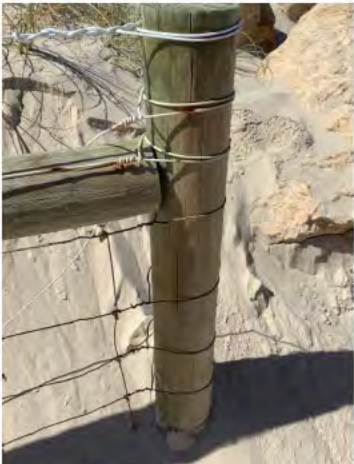
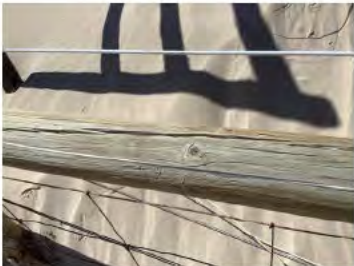
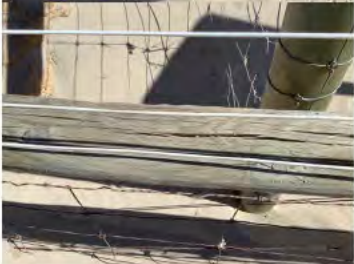
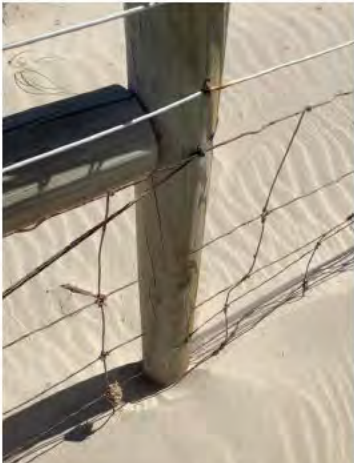
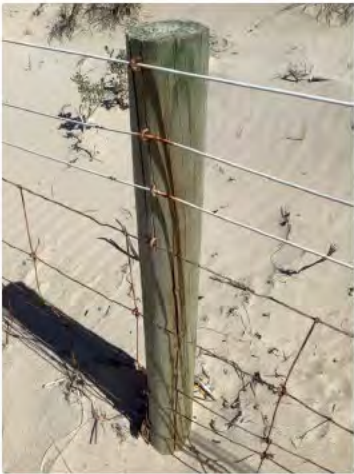
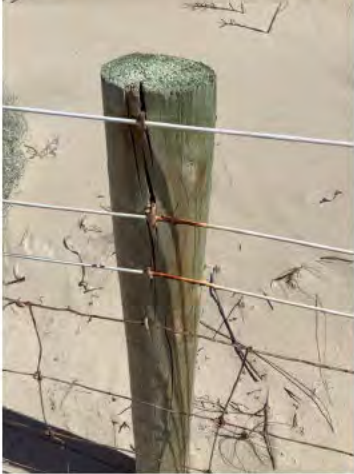
<b>Site No.</b>	C13
<b>Site Name/ Location</b>	Alkimos Beach
<b>Date</b>	25/02/2021
<b>Time</b>	10:13 (8 GMT)
<b>Item Number</b>	3
<b>Costal Asset Type</b>	Concrete vehicle access ramp
<b>Element</b>	Fencing
<b>Sub-element (Fencing)</b>	Posts
<b>Material Type</b>	Timber
<b>2021 Observed Defects (Timber)</b>	Salt kill, Split timber
<b>Defect Description</b>	Salt kill and split timber was observed to be typical throughout.
<b>Condition Rating (0- 10)</b>	5
<b>Health and Safety Concern (Y/N)</b>	No
<b>Consequence of Failure</b>	1
<b>Likelihood of Failure within next 5 years</b>	3
<b>Risk Rating</b>	3
<b>Overall Rating (CR X RR)</b>	15
<b>Maintenance Recommendation</b>	Monitor and reinspect at next scheduled inspection.
<b>Maintenance Timeframe</b>	Greater than 5 years

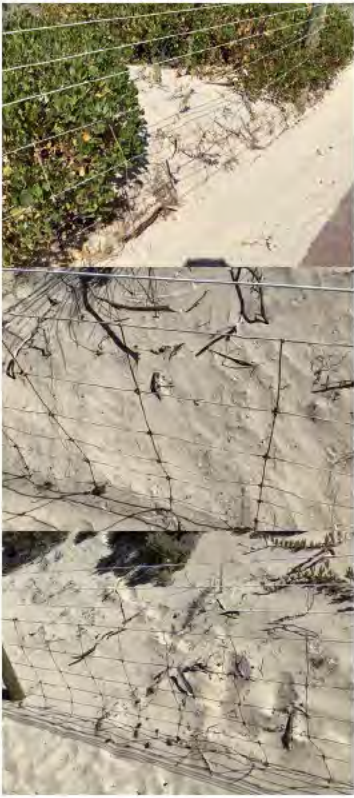
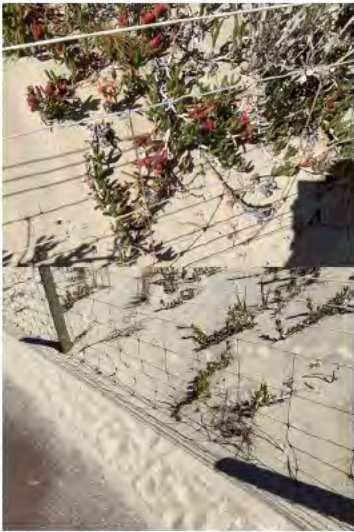
<b>Site No.</b>	C13
<b>Site Name/ Location</b>	Alkimos Beach
<b>Date</b>	25/02/2021
<b>Time</b>	10:16 (8 GMT)
<b>Item Number</b>	4
<b>Costal Asset Type</b>	Concrete vehicle access ramp
<b>Element</b>	Fencing
<b>Sub-element (Fencing)</b>	Mesh
<b>Material Type</b>	Galvanised Steel
<b>2021 Observed Defects (Steel)</b>	Localised impact damage, typical widespread corrosion.
<b>Condition Rating (0- 10)</b>	5
<b>Health and Safety Concern (Y/N)</b>	No
<b>Consequence of Failure</b>	1
<b>Likelihood of Failure within next 5 years</b>	3
<b>Risk Rating</b>	3
<b>Overall Rating (CR X RR)</b>	15
<b>Maintenance Recommendation</b>	Replace damaged and heavily rusted sections
<b>Maintenance Timeframe</b>	Within 5 years

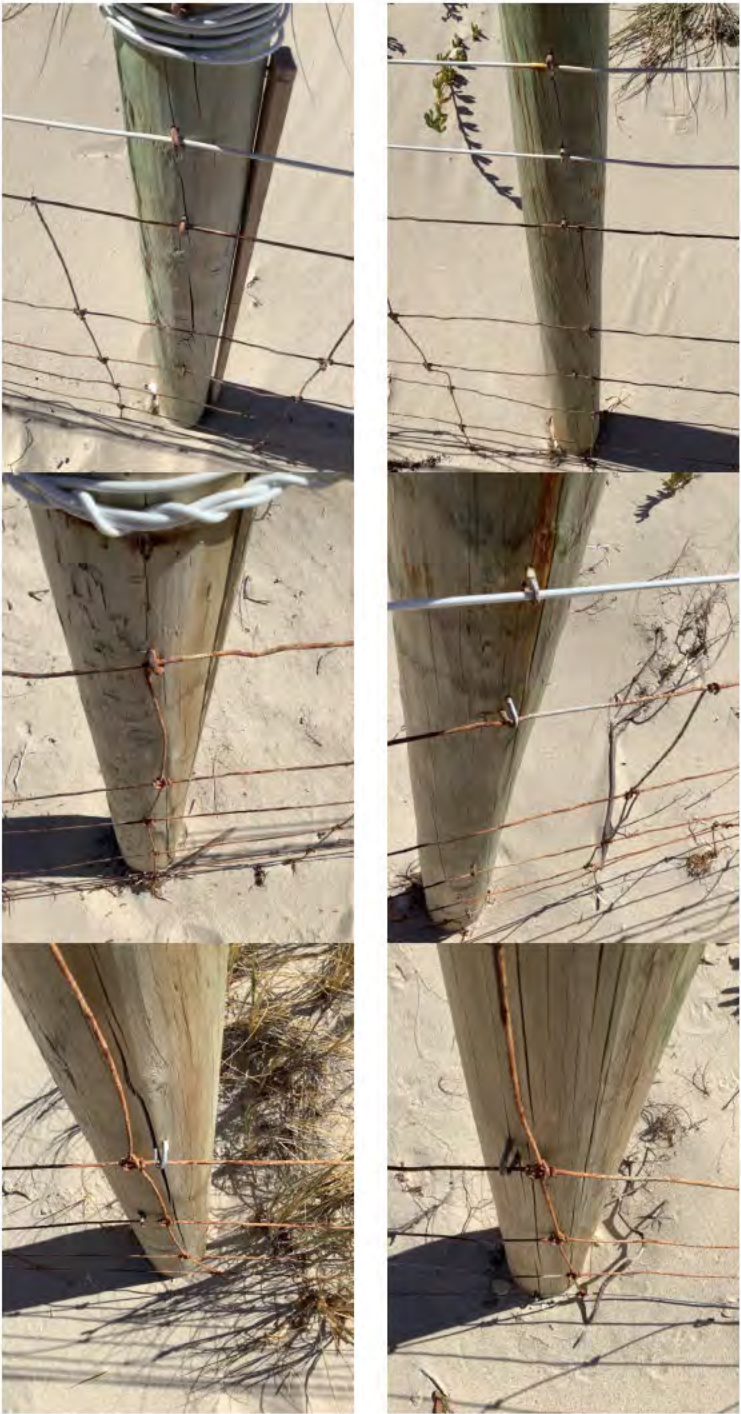
<b>Site No.</b>	C13
<b>Site Name/ Location</b>	Alkimos Beach
<b>Date</b>	25/02/2021
<b>Time</b>	10:18 (8 GMT)
<b>Item Number</b>	5
<b>Costal Asset Type</b>	Concrete vehicle access ramp
<b>Element</b>	Fencing
<b>Sub-element (Fencing)</b>	Mesh staples
<b>Material Type</b>	Galvanised Steel
<b>2021 Observed Defects (Steel)</b>	Rust staining, Coating loss
<b>Defect Description</b>	Typical surface corrosion. A number of loose and missing staples were also observed.
<b>Condition Rating (0- 10)</b>	4
<b>Health and Safety Concern (Y/N)</b>	No
<b>Consequence of Failure</b>	1
<b>Likelihood of Failure within next 5 years</b>	3
<b>Risk Rating</b>	3
<b>Overall Rating (CR X RR)</b>	12
<b>Maintenance Recommendation</b>	Replace Missing, and heavily rusted staples
<b>Maintenance Timeframe</b>	Within 5 years

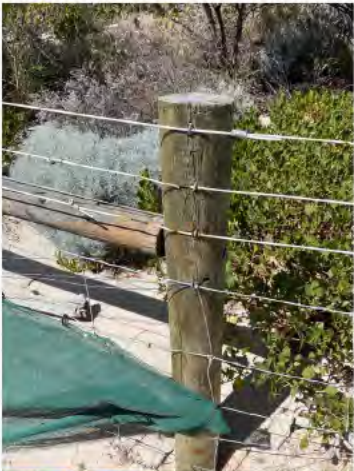
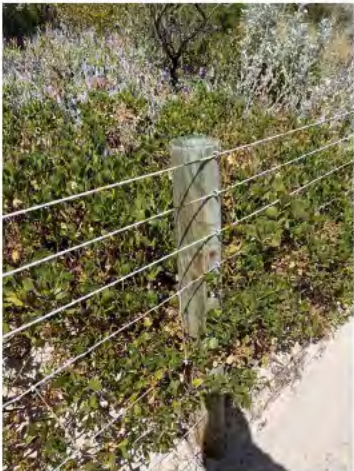
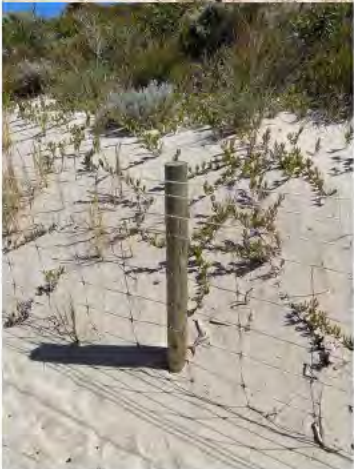
<b>Site No.</b>	C13
<b>Site Name/ Location</b>	Alkimos Beach
<b>Date</b>	25/02/2021
<b>Time</b>	10:27 (8 GMT)
<b>Item Number</b>	6
<b>Costal Asset Type</b>	Vehicle access ramp
<b>Element</b>	Fencing
<b>Sub-element (Fencing)</b>	Strainer wires above mesh
<b>Material Type</b>	Coated Steel
<b>2021 Observed Defects (Steel)</b>	Surface corrosion
<b>Defect Description</b>	Generally good condition with some minor corrosion observed at localised areas. A loose wire was also observed on the north side halfway down the ramp (due to missing staples).
<b>Condition Rating (0- 10)</b>	4
<b>Health and Safety Concern (Y/N)</b>	No
<b>Consequence of Failure</b>	2
<b>Likelihood of Failure within next 5 years</b>	3
<b>Risk Rating</b>	6
<b>Overall Rating (CR X RR)</b>	24
<b>Maintenance Recommendation</b>	Monitor and reinspect at next scheduled inspection.
<b>Maintenance Timeframe</b>	Greater than 5 years

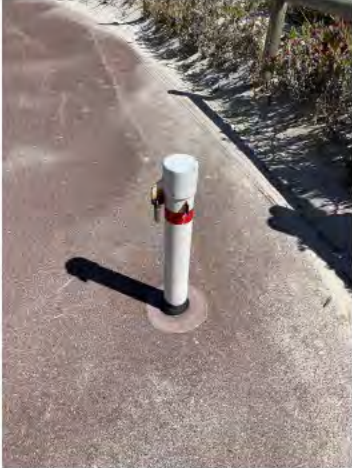
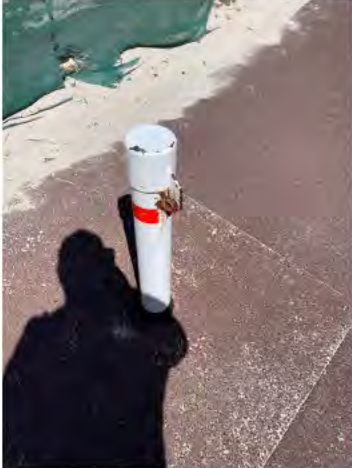
<b>Site No.</b>	C13
<b>Site Name/ Location</b>	Alkimos Beach
<b>Date</b>	25/02/2021
<b>Time</b>	10:22 (8 GMT)
<b>Item Number</b>	7
<b>Costal Asset Type</b>	Vehicle access ramp
<b>Element</b>	Bollards
<b>Sub-element (Bollards)</b>	Bollards
<b>Material Type</b>	Coated Steel
<b>2021 Observed Defects (Steel)</b>	Surface corrosion
<b>Defect Description</b>	Surface corrosion was observed around the lock bracket. The bollard was observed to be missing its lock.
<b>Condition Rating (0- 10)</b>	5
<b>Health and Safety Concern (Y/N)</b>	No
<b>Consequence of Failure</b>	2
<b>Likelihood of Failure within next 5 years</b>	1
<b>Risk Rating</b>	2
<b>Overall Rating (CR X RR)</b>	10
<b>Maintenance Recommendation</b>	Replace lock if required by COW
<b>Maintenance Timeframe</b>	Immediately

Replace lock if required by cow

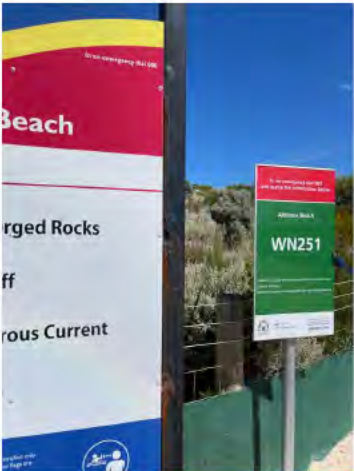
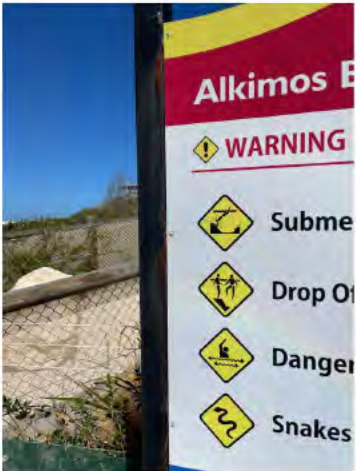
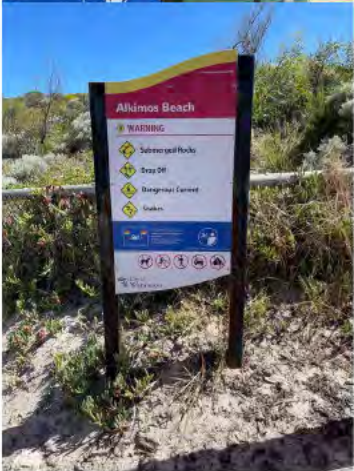
<b>Site No.</b>	C13
<b>Site Name/ Location</b>	Alkimos Beach
<b>Date</b>	25/02/2021
<b>Time</b>	10:25 (8 GMT)
<b>Item Number</b>	8
<b>Costal Asset Type</b>	Vehicle access ramp
<b>Element</b>	Sign
<b>Material Type</b>	Coated Steel
<b>2021 Observed Defects (Steel)</b>	Surface corrosion, Corrosion with section loss
<b>Defect Description</b>	Some surface corrosion with apparent section loss to the signs at the top of the ramp was observed
<b>Condition Rating (0- 10)</b>	6
<b>Health and Safety Concern (Y/N)</b>	No
<b>Consequence of Failure</b>	3
<b>Likelihood of Failure within next 5 years</b>	3
<b>Risk Rating</b>	9
<b>Overall Rating (CR X RR)</b>	54
<b>Maintenance Recommendation</b>	Blast clean heavily corroded areas. Add coating if over areas with section loss after blast cleaning.
<b>Maintenance Timeframe</b>	Within 1-2 years

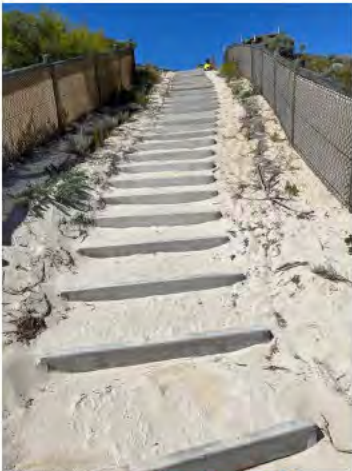
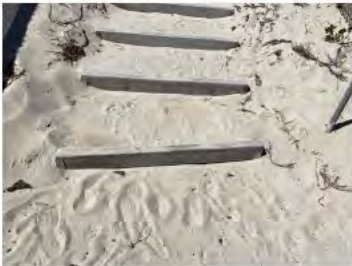
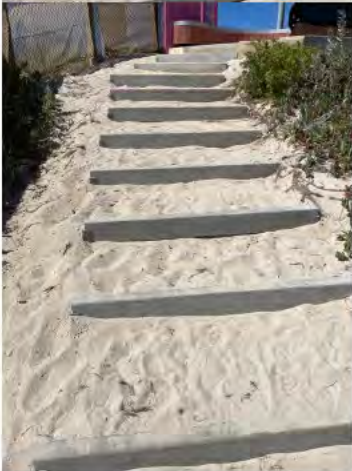
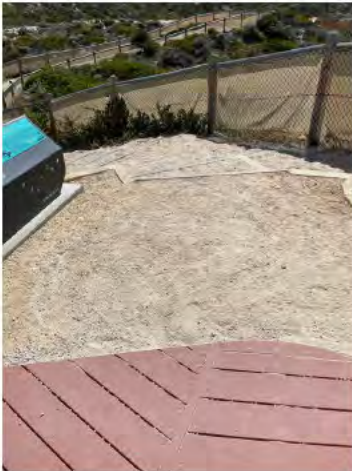
<b>Site No.</b>	C13
<b>Site Name/ Location</b>	Alkimos Beach
<b>Date</b>	25/02/2021
<b>Time</b>	10:31 (8 GMT)
<b>Item Number</b>	9
<b>Costal Asset Type</b>	Stairs
<b>Element</b>	Stairs
<b>Sub-element (Stairs and Landing)</b>	Stair treads
<b>Material Type</b>	Reinforced Concrete
<b>2021 Observed Defects (Reinforced Concrete)</b>	No visible defects were observed
<b>Defect Description</b>	Concrete beach stairs, with steel brackets
<b>Quantity of Defects</b>	55 treads approx 1m long
<b>Condition Rating (0- 10)</b>	2
<b>Health and Safety Concern (Y/N)</b>	No
<b>Consequence of Failure</b>	3
<b>Likelihood of Failure within next 5 years</b>	1
<b>Risk Rating</b>	3
<b>Overall Rating (CR X RR)</b>	6
<b>Maintenance Recommendation</b>	Monitor and reinspect at next scheduled inspection.
<b>Maintenance Timeframe</b>	Greater than 5 years

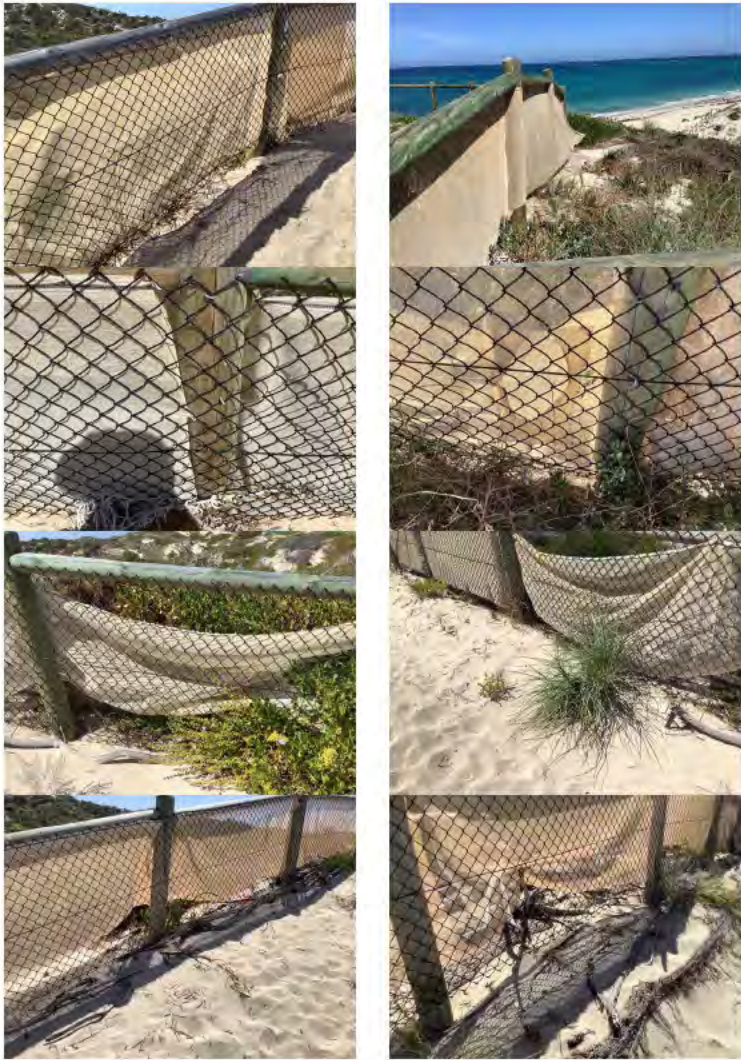
<b>Site No.</b>	C13
<b>Site Name/ Location</b>	Alkimos Beach
<b>Date</b>	25/02/2021
<b>Time</b>	10:32 (8 GMT)
<b>Item Number</b>	12
<b>Costal Asset Type</b>	Stairs and Lookout
<b>Element</b>	Fencing
<b>Sub-element (Fencing)</b>	Windbreak fencing - Shade cloth
<b>Material Type (Other)</b>	Fabric
<b>Defect Description</b>	Some areas with holes and tears were noticed. There were observed to be parts with detached or loose sections (this was more common on the sand path leading to the carpark from the lookout)
<b>Condition Rating (0- 10)</b>	6
<b>Health and Safety Concern (Y/N)</b>	No
<b>Consequence of Failure</b>	1
<b>Likelihood of Failure within next 5 years</b>	5
<b>Risk Rating</b>	5
<b>Overall Rating (CR X RR)</b>	30
<b>Maintenance Recommendation</b>	Replace or reinstate torn and detached sections.
<b>Maintenance Timeframe</b>	Within 5 years

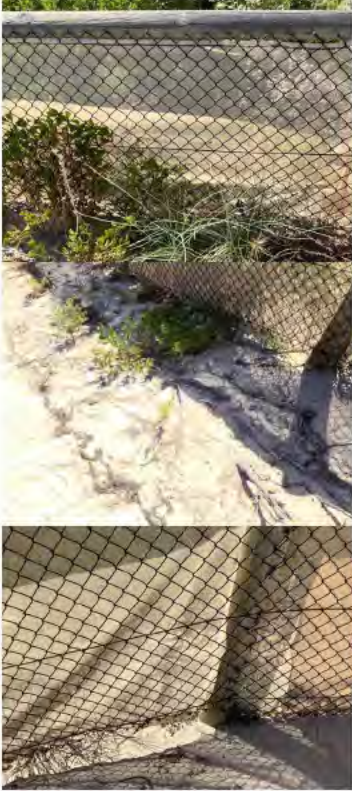
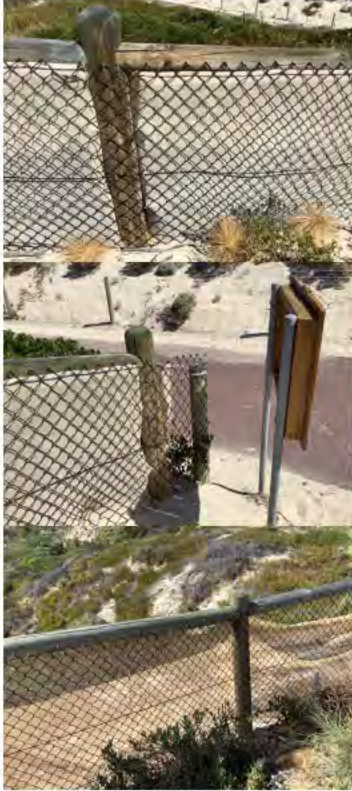
<b>Site No.</b>	C13
<b>Site Name/ Location</b>	Alkimos Beach
<b>Date</b>	25/02/2021
<b>Time</b>	10:37 (8 GMT)
<b>Item Number</b>	13
<b>Costal Asset Type</b>	Stairs
<b>Element</b>	Fencing
<b>Sub-element (Fencing)</b>	Mesh
<b>Material Type</b>	Coated Steel
<b>2021 Observed Defects (Steel)</b>	No visible defects were observed
<b>Condition Rating (0- 10)</b>	2
<b>Health and Safety Concern (Y/N)</b>	No
<b>Consequence of Failure</b>	1
<b>Likelihood of Failure within next 5 years</b>	2
<b>Risk Rating</b>	2
<b>Overall Rating (CR X RR)</b>	4
<b>Maintenance Recommendation</b>	Monitor and reinspect at next scheduled inspection.
<b>Maintenance Timeframe</b>	Greater than 5 years

Mesh and staples

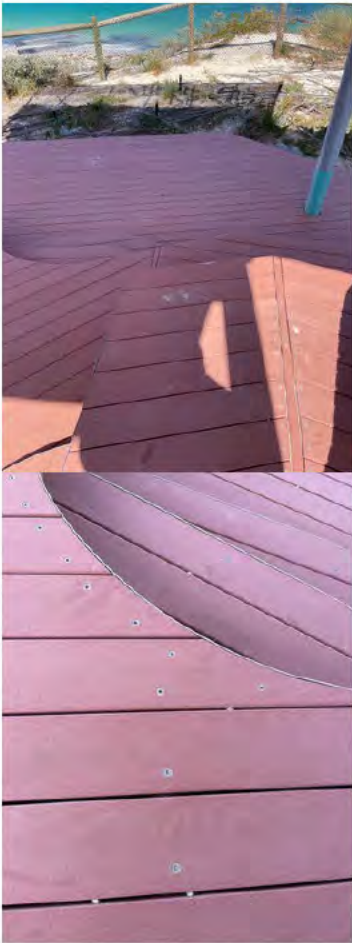
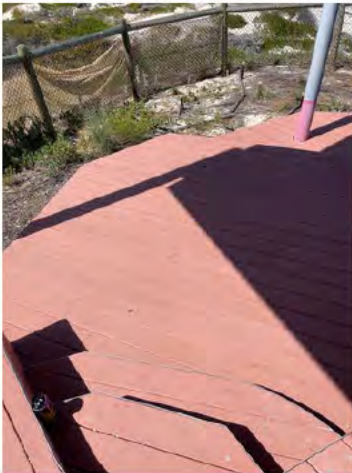
<b>Site No.</b>	C13
<b>Site Name/ Location</b>	Alkimos Beach
<b>Date</b>	25/02/2021
<b>Time</b>	10:39 (8 GMT)
<b>Item Number</b>	14
<b>Costal Asset Type</b>	Lookout
<b>Element</b>	Decking
<b>Sub-element (Decking and Supports)</b>	Deck planks
<b>Material Type</b>	Timber
<b>2021 Observed Defects (Timber)</b>	No visible defects were observed
<b>Defect Description</b>	Pertains to deck planks and connections
<b>Quantity of Defects</b>	Approx 70m2
<b>Condition Rating (0- 10)</b>	2
<b>Health and Safety Concern (Y/N)</b>	No
<b>Consequence of Failure</b>	3
<b>Likelihood of Failure within next 5 years</b>	1
<b>Risk Rating</b>	3
<b>Overall Rating (CR X RR)</b>	6
<b>Maintenance Recommendation</b>	Monitor and reinspect at next scheduled inspection.
<b>Maintenance Timeframe</b>	Greater than 5 years

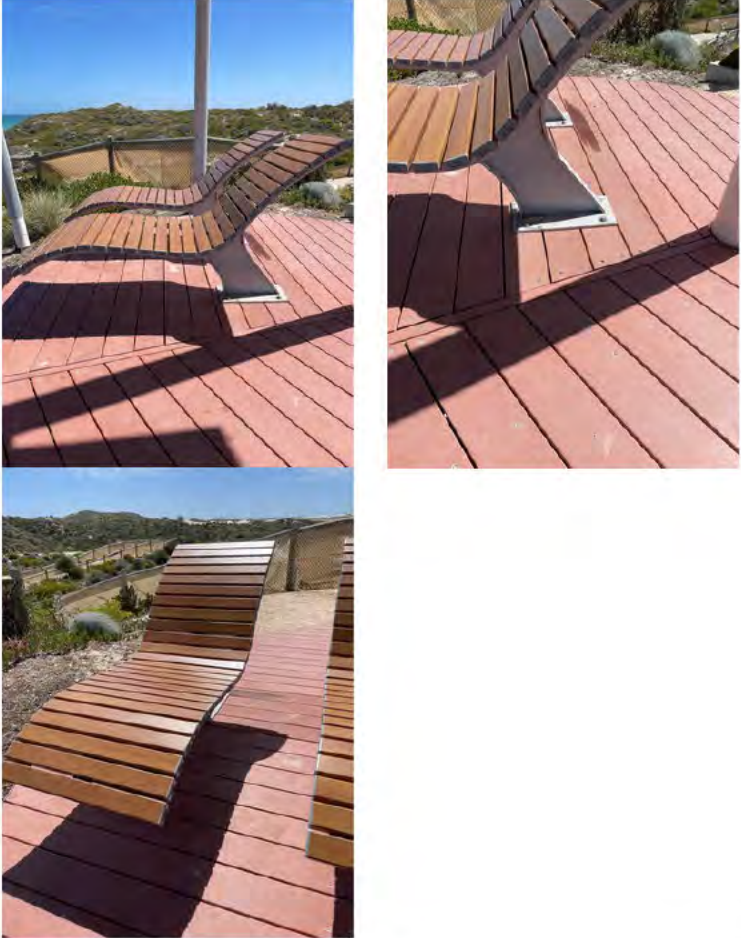
<b>Site No.</b>	C13
<b>Site Name/ Location</b>	Alkimos Beach
<b>Date</b>	25/02/2021
<b>Time</b>	10:41 (8 GMT)
<b>Item Number</b>	15
<b>Costal Asset Type</b>	Lookout
<b>Element</b>	Deck Chairs
<b>Sub-element (Bench)</b>	Steel frame and base plates
<b>Material Type</b>	Timber, Steel
<b>2021 Observed Defects (Timber)</b>	No visible defects were observed
<b>2021 Observed Defects (Steel)</b>	Coating loss
<b>Defect Description</b>	No visible defects were observed on timber sections. Minor coating loss was observed to steel base plates
<b>Quantity of Defects</b>	2 no chairs
<b>Condition Rating (0- 10)</b>	2
<b>Health and Safety Concern (Y/N)</b>	No
<b>Consequence of Failure</b>	2
<b>Likelihood of Failure within next 5 years</b>	1
<b>Risk Rating</b>	2
<b>Overall Rating (CR X RR)</b>	4
<b>Maintenance Recommendation</b>	Monitor and reinspect at next scheduled inspection.
<b>Maintenance Timeframe</b>	Greater than 5 years

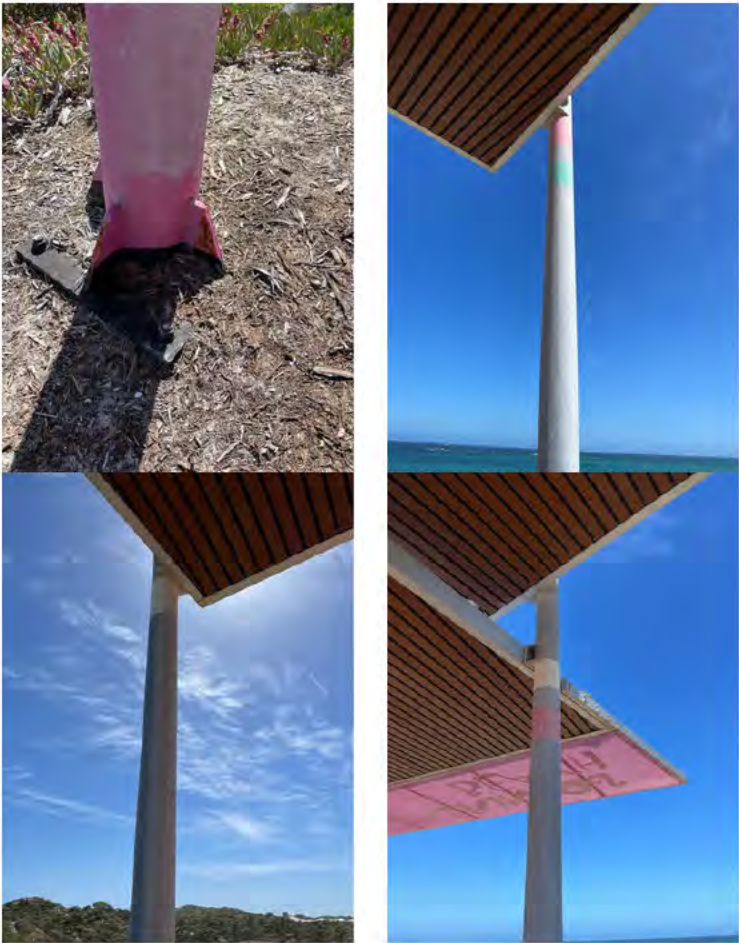
<b>Site No.</b>	C13
<b>Site Name/ Location</b>	Alkimos Beach
<b>Date</b>	25/02/2021
<b>Time</b>	10:43 (8 GMT)
<b>Item Number</b>	16
<b>Costal Asset Type</b>	Lookout
<b>Element</b>	Supports
<b>Sub-element</b>	Columns
<b>Material Type</b>	Galvanised Steel
<b>2021 Observed Defects (Steel)</b>	Surface corrosion
<b>Defect Description</b>	Generally good condition with some minor surface corrosion to the base plates observed, and minor surface corrosion and white rust to the columns also observed.
<b>Quantity of Defects</b>	6 columns approx 2.5m tall
<b>Defect Location</b>	Base plates, towards roof
<b>Condition Rating (0- 10)</b>	3
<b>Health and Safety Concern (Y/N)</b>	No
<b>Consequence of Failure</b>	4
<b>Likelihood of Failure within next 5 years</b>	1
<b>Risk Rating</b>	4
<b>Overall Rating (CR X RR)</b>	12
<b>Maintenance Recommendation</b>	Monitor and reinspect at next scheduled inspection.
<b>Maintenance Timeframe</b>	Greater than 5 years

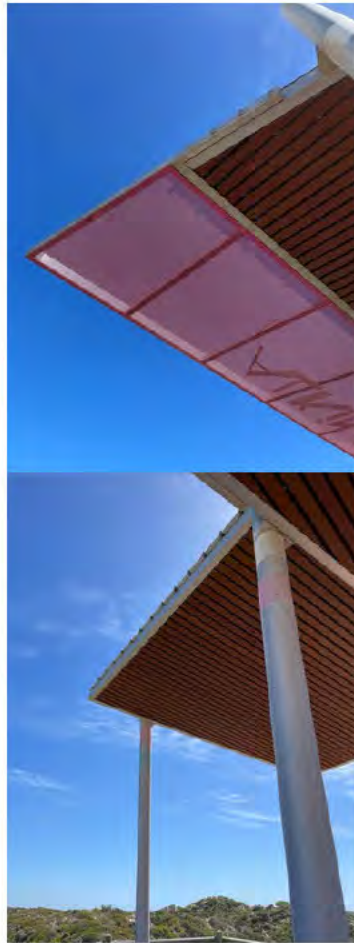
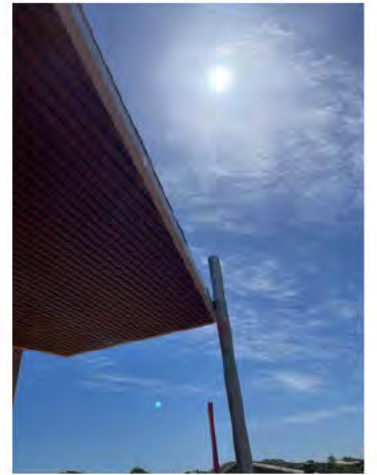
<b>Site No.</b>	C13
<b>Site Name/ Location</b>	Alkimos Beach
<b>Date</b>	25/02/2021
<b>Time</b>	10:48 (8 GMT)
<b>Item Number</b>	17
<b>Costal Asset Type</b>	Lookout
<b>Element</b>	Supports
<b>Sub-element (Decking and Supports)</b>	Support beams
<b>Material Type</b>	Galvanised Steel
<b>2021 Observed Defects (Steel)</b>	No visible defects were observed
<b>Defect Description</b>	Generally good condition
<b>Condition Rating (0- 10)</b>	2
<b>Health and Safety Concern (Y/N)</b>	No
<b>Consequence of Failure</b>	4
<b>Likelihood of Failure within next 5 years</b>	1
<b>Risk Rating</b>	4
<b>Overall Rating (CR X RR)</b>	8
<b>Maintenance Recommendation</b>	Monitor and reinspect at next scheduled inspection.
<b>Maintenance Timeframe</b>	Greater than 5 years

Inspected from lookout ground level, roof sheeting not inspected

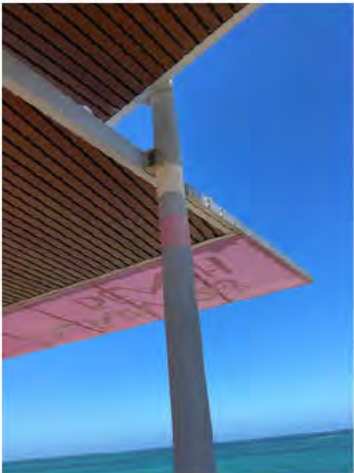
<b>Site No.</b>	C13
<b>Site Name/ Location</b>	Alkimos Beach
<b>Date</b>	25/02/2021
<b>Time</b>	10:46 (8 GMT)
<b>Item Number</b>	18
<b>Costal Asset Type</b>	Lookout
<b>Element</b>	Supports
<b>Sub-element (Decking and Supports)</b>	Steel support bolts
<b>Material Type</b>	Galvanised Steel
<b>2021 Observed Defects (Steel)</b>	No visible defects were observed
<b>Defect Description</b>	Generally good condition, no corrosion identified approx 4 bolts a column
<b>Condition Rating (0- 10)</b>	2
<b>Health and Safety Concern (Y/N)</b>	No
<b>Consequence of Failure</b>	3
<b>Likelihood of Failure within next 5 years</b>	1
<b>Risk Rating</b>	3
<b>Overall Rating (CR X RR)</b>	6
<b>Maintenance Recommendation</b>	Monitor and reinspect at next scheduled inspection.
<b>Maintenance Timeframe</b>	Greater than 5 years

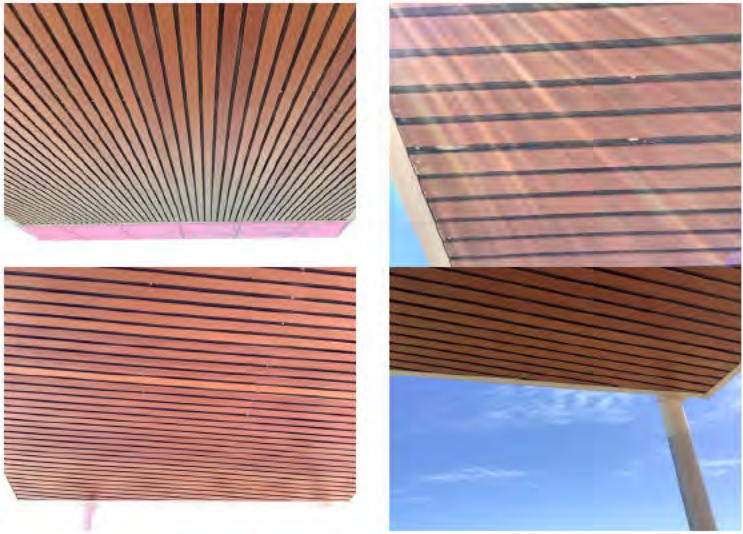
<b>Site No.</b>	C13
<b>Site Name/ Location</b>	Alkimos Beach
<b>Date</b>	25/02/2021
<b>Time</b>	10:45 (8 GMT)
<b>Item Number</b>	19
<b>Costal Asset Type</b>	Lookout
<b>Element</b>	Timber roofing
<b>Material Type</b>	Timber
<b>2021 Observed Defects (Timber)</b>	Crack
<b>Defect Description</b>	One section of the roof contains a small crack No other visible defects were observed
<b>Condition Rating (0- 10)</b>	3
<b>Health and Safety Concern (Y/N)</b>	No
<b>Consequence of Failure</b>	3
<b>Likelihood of Failure within next 5 years</b>	2
<b>Risk Rating</b>	6
<b>Overall Rating (CR X RR)</b>	18
<b>Maintenance Recommendation</b>	Monitor at next inspection
<b>Maintenance Timeframe</b>	Greater than 5 years

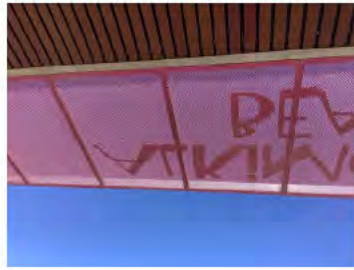
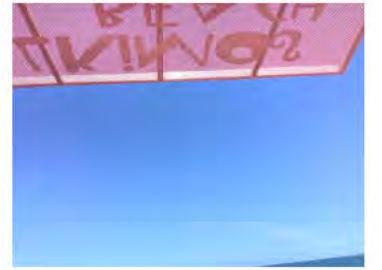
<b>Site No.</b>	C13
<b>Site Name/ Location</b>	Alkimos Beach
<b>Date</b>	25/02/2021
<b>Time</b>	10:48 (8 GMT)
<b>Item Number</b>	20
<b>Costal Asset Type</b>	Lookout
<b>Element</b>	FRP roofing
<b>Material Type</b>	FRP
<b>2021 Observed Defects (FRP)</b>	No visible defects were observed
<b>Condition Rating (0- 10)</b>	2
<b>Health and Safety Concern (Y/N)</b>	No
<b>Consequence of Failure</b>	3
<b>Likelihood of Failure within next 5 years</b>	1
<b>Risk Rating</b>	3
<b>Overall Rating (CR X RR)</b>	6
<b>Maintenance Recommendation</b>	Monitor and reinspect at next scheduled inspection.
<b>Maintenance Timeframe</b>	Greater than 5 years

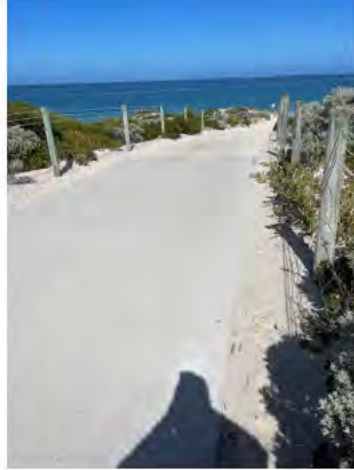
<b>Site No.</b>	C14
<b>Site Name/ Location</b>	Jindalee Foreshore Carpark
<b>Date</b>	25/02/2021
<b>Time</b>	09:41 (8 GMT)
<b>Item Number</b>	1
<b>Costal Asset Type</b>	Vehicle access ramp
<b>Element</b>	Foundation
<b>Sub-element (Foundations)</b>	Base slab
<b>Material Type</b>	Reinforced Concrete
<b>2021 Observed Defects (Reinforced Concrete)</b>	No visible defects were observed
<b>Quantity of Defects</b>	12m long x 2.5m wide refurbished slab in good condition
<b>Defect Location</b>	Top of access way
<b>Condition Rating (0- 10)</b>	2
<b>Health and Safety Concern (Y/N)</b>	No
<b>Consequence of Failure</b>	2
<b>Likelihood of Failure within next 5 years</b>	1
<b>Risk Rating</b>	2
<b>Overall Rating (CR X RR)</b>	4
<b>Maintenance Recommendation</b>	Monitor and reinspect at next scheduled inspection.
<b>Maintenance Timeframe</b>	Greater than 5 years

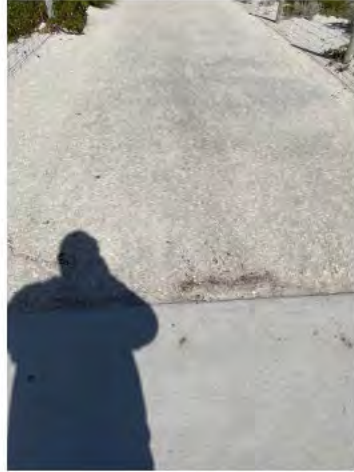
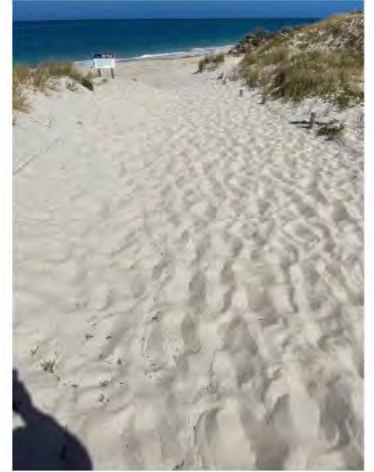
<b>Site No.</b>	C14
<b>Site Name/ Location</b>	Jindalee Foreshore Carpark
<b>Date</b>	25/02/2021
<b>Time</b>	09:43 (8 GMT)
<b>Item Number</b>	2
<b>Costal Asset Type</b>	Vehicle access ramp
<b>Element</b>	Foundation
<b>Sub-element (Foundations)</b>	Base slab
<b>Material Type (Other)</b>	Exposed Aggregate Concrete
<b>Defect Description</b>	No Visible defects were observed. Inspection limited as bottom 20 m of base buried.
<b>Quantity of Defects</b>	Approx 60m by 2.5m wide
<b>Condition Rating (0- 10)</b>	3
<b>Health and Safety Concern (Y/N)</b>	No
<b>Consequence of Failure</b>	2
<b>Likelihood of Failure within next 5 years</b>	1
<b>Risk Rating</b>	2
<b>Overall Rating (CR X RR)</b>	6
<b>Maintenance Recommendation</b>	Monitor and reinspect at next scheduled inspection.
<b>Maintenance Timeframe</b>	Greater than 5 years

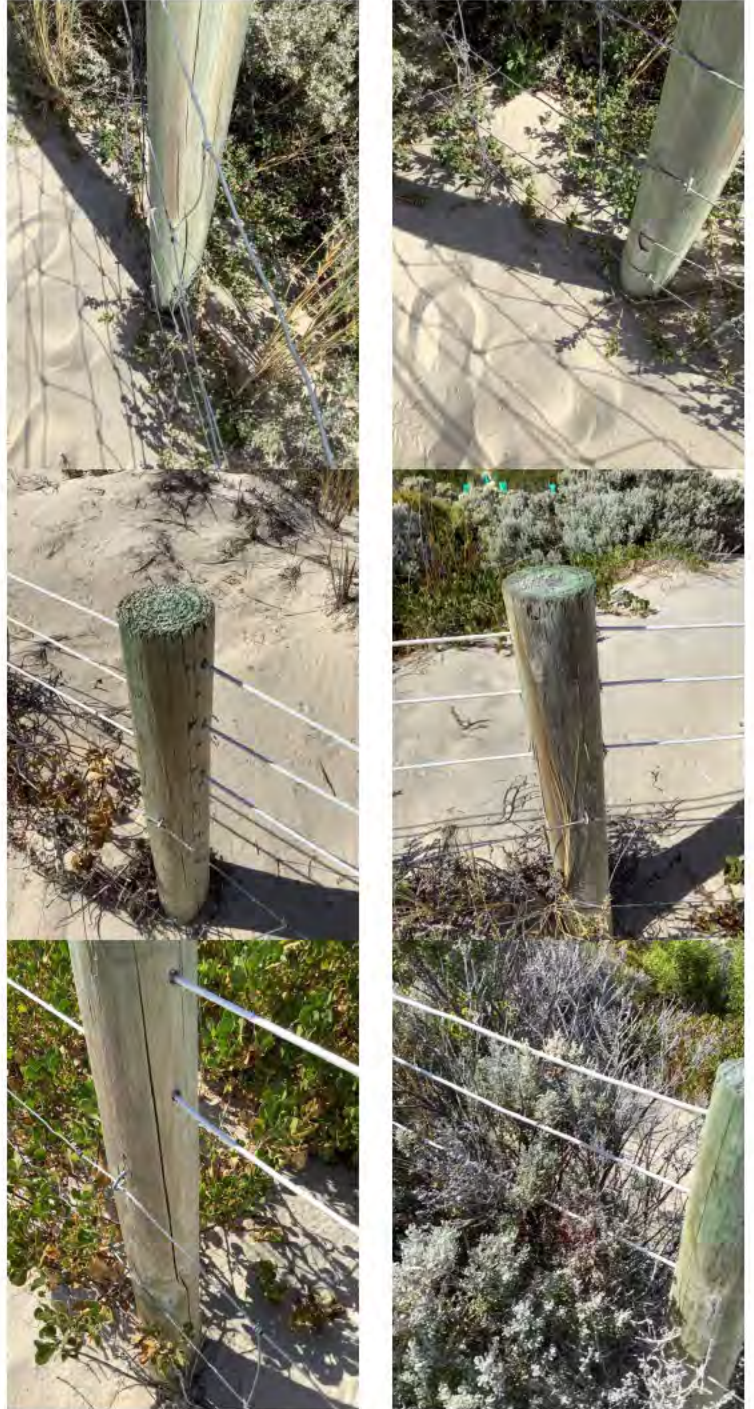
Site No.	C14
Site Name/ Location	Jindalee Foreshore Carpark
Date	25/02/2021
Time	09:36 (8 GMT)
Item Number	3
Costal Asset Type	Concrete vehicle access ramp
Element	Fencing
Sub-element (Fencing)	Timber posts
Material Type	Timber
2021 Observed Defects (Timber)	Split timber, Salt kill
Defect Description	Generally good condition with some timber splitting and salt kill observed.
Condition Rating (0- 10)	3
Health and Safety Concern (Y/N)	No
Consequence of Failure	2
Likelihood of Failure within next 5 years	1
Risk Rating	2
Overall Rating (CR X RR)	8
Maintenance Recommendation	Monitor and reinspect at next scheduled inspection.
Maintenance Timeframe	Greater than 5 years

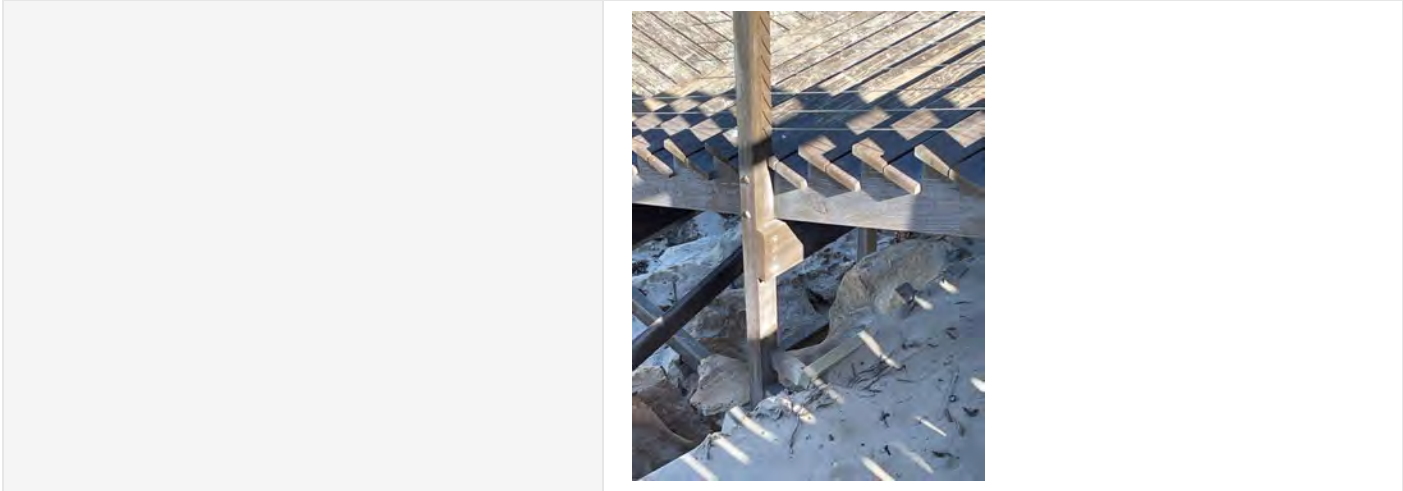
<b>Site No.</b>	C15
<b>Site Name/ Location</b>	Jindalee Foreshore
<b>Date</b>	25/02/2021
<b>Time</b>	09:04 (8 GMT)
<b>Item Number</b>	2
<b>Costal Asset Type</b>	Retaining wall
<b>Element</b>	Retaining Walls
<b>Sub-element (Walls)</b>	Wall
<b>Material Type</b>	Timber, Steel
<b>2021 Observed Defects (Timber)</b>	General damage, Salt kill
<b>2021 Observed Defects (Steel)</b>	Surface corrosion
<b>2021 Observed Defects (General)</b>	Subsidence, sinking, rotation, Foundation damage, Loss of contact with underlying ground surface
<b>Defect Description</b>	Subsidence, sinking, rotation, Foundation damage, Loss of contact with underlying ground surface were all observed. Timber retaining walls have begun to slip and are no longer retaining soil, connections attached are risk of failing. Some corrosion was also noticed on steel sections.
<b>Quantity of Defects</b>	2 no approx 4m long
<b>Defect Location</b>	Below stairs

<b>Condition Rating (0- 10)</b>	8
<b>Health and Safety Concern (Y/N)</b>	No
<b>Consequence of Failure</b>	3
<b>Likelihood of Failure within next 5 years</b>	4

<b>Risk Rating</b>	12
<b>Overall Rating (CR X RR)</b>	96
<b>Maintenance Recommendation</b>	Replace retaining walls.
<b>Maintenance Timeframe</b>	Within 1-2 years
<b>Multi Photo</b>

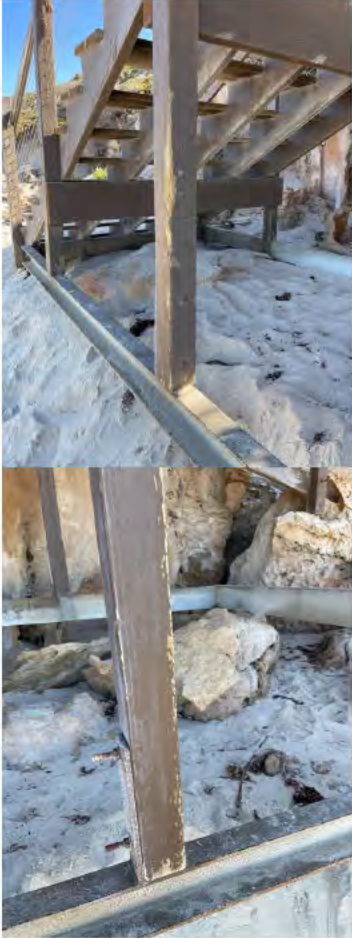
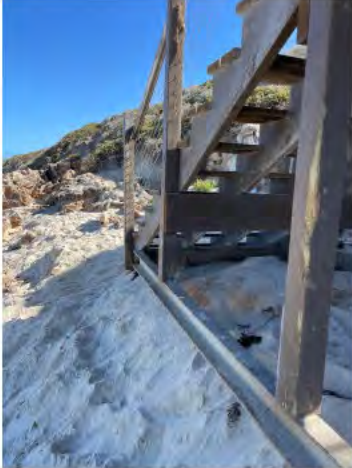
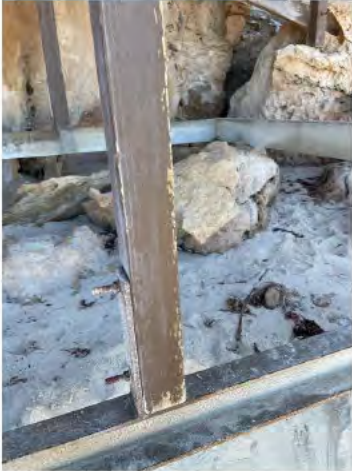
<b>Site No.</b>	C15
<b>Site Name/ Location</b>	Jindalee Foreshore
<b>Date</b>	25/02/2021
<b>Time</b>	09:11 (8 GMT)
<b>Item Number</b>	3
<b>Costal Asset Type</b>	Stairs
<b>Element</b>	Stairs
<b>Sub-element (Stairs and Landing)</b>	Timber posts
<b>Material Type</b>	Timber
<b>2021 Observed Defects (Timber)</b>	Salt kill, fungi attack, and timber splitting were observed to be typical to 5 of the posts, affecting mostly their bases.
<b>Defect Description</b>	Deterioration to base of 5 posts at bottom of stairs
<b>Condition Rating (0- 10)</b>	5
<b>Health and Safety Concern (Y/N)</b>	No
<b>Consequence of Failure</b>	3
<b>Likelihood of Failure within next 5 years</b>	2
<b>Risk Rating</b>	6
<b>Overall Rating (CR X RR)</b>	30
<b>Maintenance Recommendation</b>	Re-coat the 5 damaged timber posts.
<b>Maintenance Timeframe</b>	Within 5 years

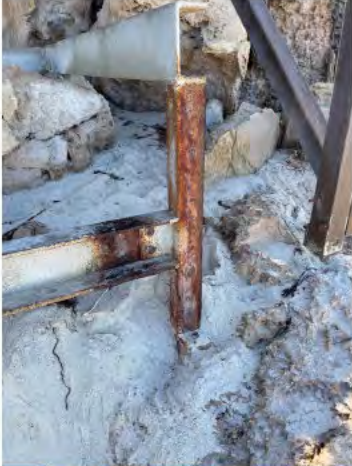
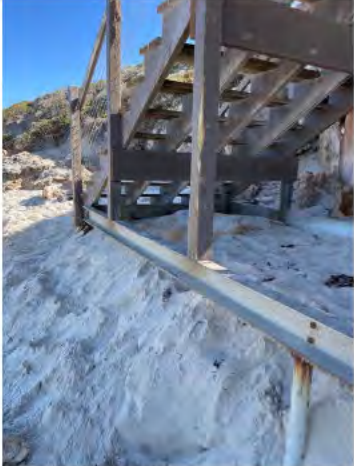
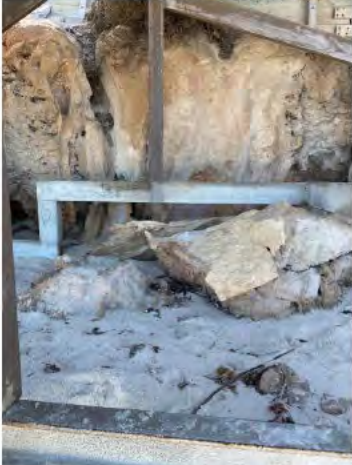
<b>Site No.</b>	C15
<b>Site Name/ Location</b>	Jindalee Foreshore
<b>Date</b>	25/02/2021
<b>Time</b>	09:07 (8 GMT)
<b>Item Number</b>	4
<b>Costal Asset Type</b>	Stairs
<b>Element</b>	Supports
<b>Sub-element (Decking and Supports)</b>	Support beams
<b>Material Type</b>	Steel
<b>2021 Observed Defects (Steel)</b>	Corrosion with section loss, Surface corrosion, Rust staining
<b>Defect Description</b>	Corrosion with section loss, rust staining and surface corrosion were all observed. Corrosion to support beams observed to be mainly on the northern end.
<b>Quantity of Defects</b>	1linear m total approx 10m
<b>Condition Rating (0- 10)</b>	7
<b>Health and Safety Concern (Y/N)</b>	No
<b>Consequence of Failure</b>	3
<b>Likelihood of Failure within next 5 years</b>	3
<b>Risk Rating</b>	9
<b>Overall Rating (CR X RR)</b>	63
<b>Maintenance Recommendation</b>	Abrasive blast clean and apply protective coating. If section loss has occurred replacement of support beams maybe required.

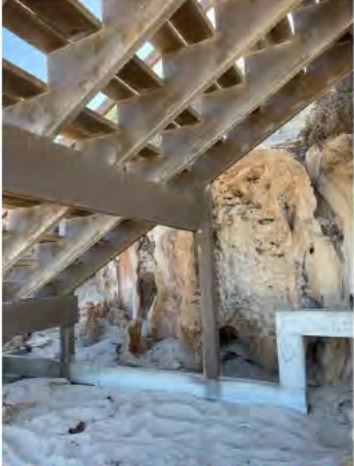
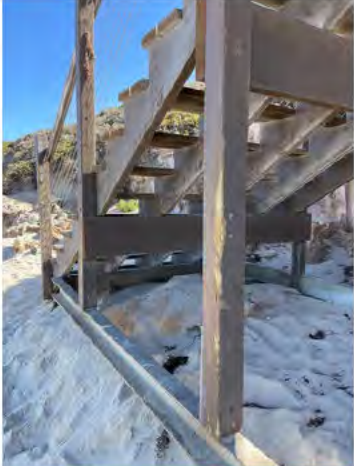
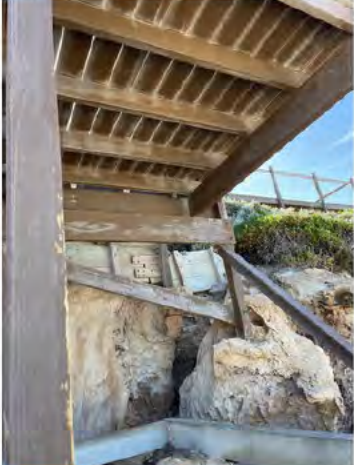
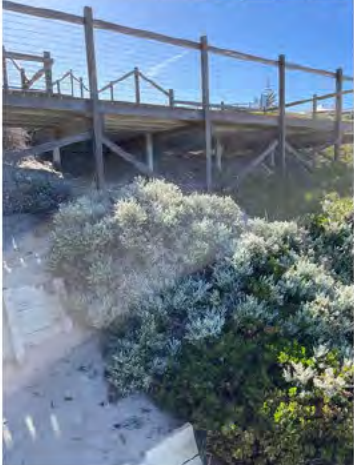
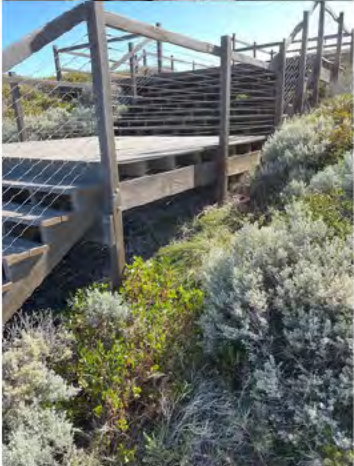
<b>Site No.</b>	C15
<b>Site Name/ Location</b>	Jindalee Foreshore
<b>Date</b>	25/02/2021
<b>Time</b>	09:12 (8 GMT)
<b>Item Number</b>	5
<b>Costal Asset Type</b>	Stairs
<b>Sub-element (Decking and Supports)</b>	Support beams
<b>Material Type</b>	Timber
<b>2021 Observed Defects (Timber)</b>	Split timber
<b>Defect Description</b>	Generally good condition with minor split timber and deterioration observed. Note: Pertains to timber beams and joists
<b>Condition Rating (0- 10)</b>	4
<b>Health and Safety Concern (Y/N)</b>	No
<b>Consequence of Failure</b>	3
<b>Likelihood of Failure within next 5 years</b>	1
<b>Risk Rating</b>	3
<b>Overall Rating (CR X RR)</b>	12
<b>Maintenance Recommendation</b>	Monitor and reinspect at next scheduled inspection.
<b>Maintenance Timeframe</b>	Greater than 5 years

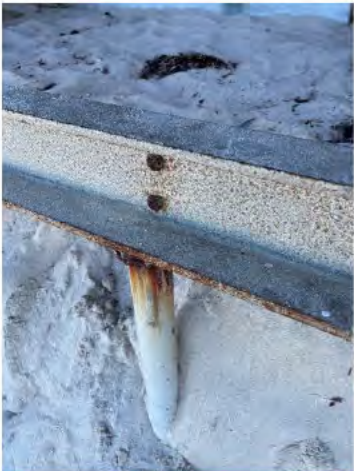
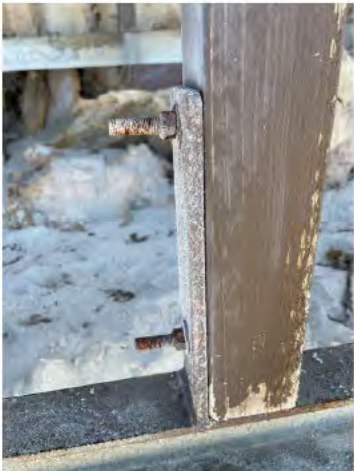
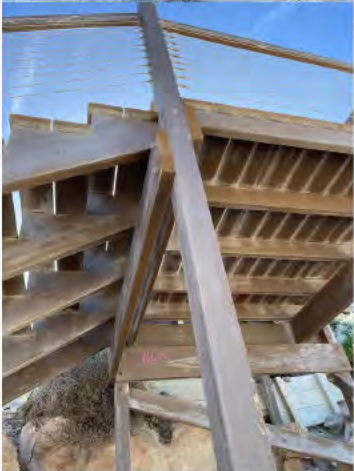
<b>Site No.</b>	C15
<b>Site Name/ Location</b>	Jindalee Foreshore
<b>Date</b>	25/02/2021
<b>Time</b>	09:09 (8 GMT)
<b>Item Number</b>	6
<b>Costal Asset Type</b>	Stairs
<b>Element</b>	Stairs
<b>Sub-element (Stairs and Landing)</b>	Support bolts
<b>Material Type</b>	Steel
<b>2021 Observed Defects (Steel)</b>	Surface corrosion
<b>Defect Description</b>	Moderate to heavy corrosion typical to connection bolts.
<b>Condition Rating (0- 10)</b>	6
<b>Health and Safety Concern (Y/N)</b>	No
<b>Consequence of Failure</b>	2
<b>Likelihood of Failure within next 5 years</b>	3
<b>Risk Rating</b>	6
<b>Overall Rating (CR X RR)</b>	36
<b>Maintenance Recommendation</b>	Replace heavily corroded bolts.
<b>Maintenance Timeframe</b>	Within 5 years

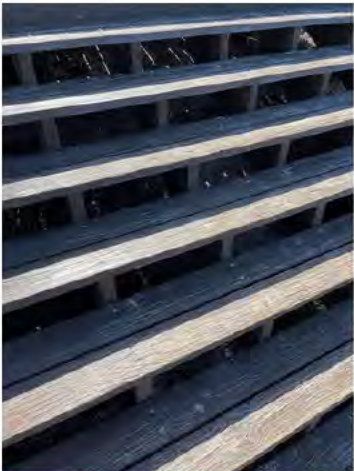
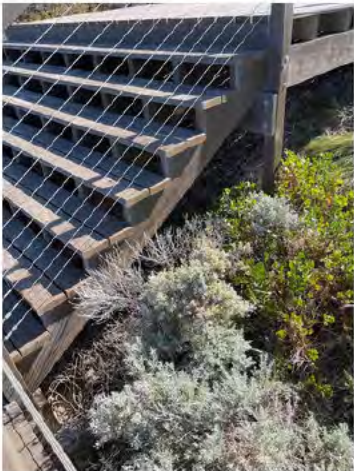
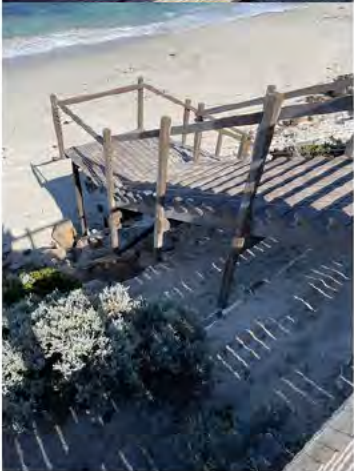
<b>Site No.</b>	C15
<b>Site Name/ Location</b>	Jindalee Foreshore
<b>Date</b>	25/02/2021
<b>Time</b>	09:15 (8 GMT)
<b>Item Number</b>	7
<b>Costal Asset Type</b>	Stairs
<b>Element</b>	Stairs
<b>Sub-element (Stairs and Landing)</b>	Stringers
<b>Material Type</b>	Timber
<b>2021 Observed Defects (Timber)</b>	No visible defects
<b>Defect Description</b>	No visible defects were observed. Note: Inspected from safe vantage points and above stair treads
<b>Condition Rating (0- 10)</b>	4
<b>Health and Safety Concern (Y/N)</b>	No
<b>Consequence of Failure</b>	3
<b>Likelihood of Failure within next 5 years</b>	1
<b>Risk Rating</b>	3
<b>Overall Rating (CR X RR)</b>	12
<b>Maintenance Recommendation</b>	Monitor and reinspect at next scheduled inspection.
<b>Maintenance Timeframe</b>	Greater than 5 years

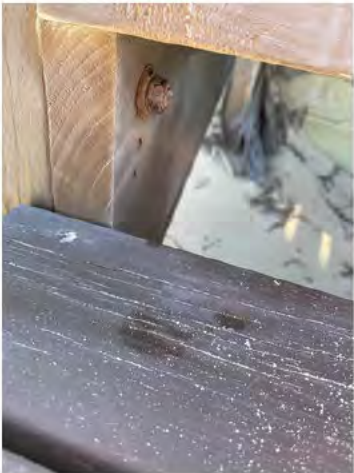
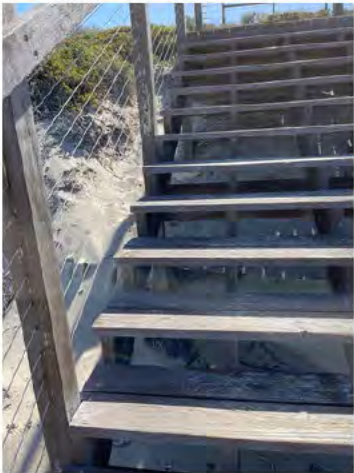
<b>Site No.</b>	C15
<b>Site Name/ Location</b>	Jindalee Foreshore
<b>Date</b>	25/02/2021
<b>Time</b>	09:18 (8 GMT)
<b>Item Number</b>	8
<b>Costal Asset Type</b>	Stairs
<b>Sub-element (Stairs and Landing)</b>	Stringer bolts
<b>Material Type</b>	Steel
<b>2021 Observed Defects (Steel)</b>	Surface corrosion
<b>Defect Description</b>	Moderate to heavy corrosion to the bottom staircase stringer bolts.
<b>Condition Rating (0- 10)</b>	6
<b>Health and Safety Concern (Y/N)</b>	No
<b>Consequence of Failure</b>	2
<b>Likelihood of Failure within next 5 years</b>	3
<b>Risk Rating</b>	6
<b>Overall Rating (CR X RR)</b>	36
<b>Maintenance Recommendation</b>	Replace heavily corroded bolts.
<b>Maintenance Timeframe</b>	Within 5 years
