# City of Wanneroo Assets Structural Assessment

## Coastal Assets

City Of Wanneroo

30 July 2021

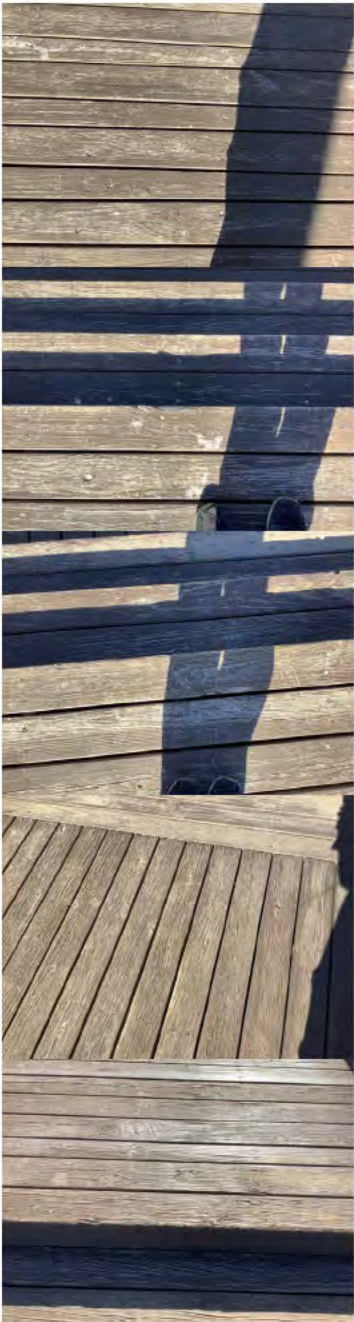
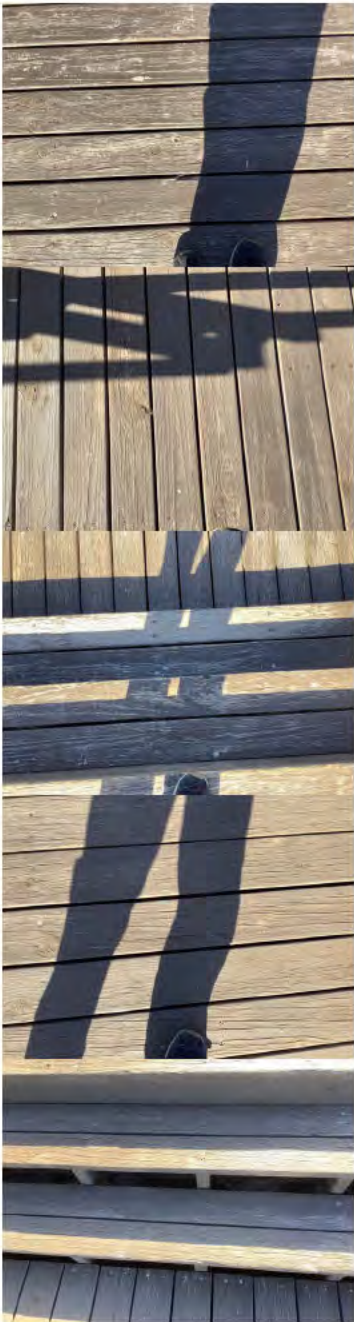
<b>Site No.</b>	C15
<b>Site Name/ Location</b>	Jindalee Foreshore
<b>Date</b>	25/02/2021
<b>Time</b>	08:56 (8 GMT)
<b>Item Number</b>	9
<b>Costal Asset Type</b>	Stairs
<b>Element</b>	Decking
<b>Sub Element</b>	Deck Planks
<b>Material Type</b>	Timber
<b>2021 Observed Defects (Timber)</b>	Split timber, Salt kill
<b>Defect Description</b>	Generally good condition with some minor timber splitting and salt kill observed
<b>Condition Rating (0- 10)</b>	6
<b>Health and Safety Concern (Y/N)</b>	No
<b>Consequence of Failure</b>	3
<b>Likelihood of Failure within next 5 years</b>	3
<b>Risk Rating</b>	9
<b>Overall Rating (CR X RR)</b>	54
<b>Maintenance Recommendation</b>	Monitor and reinspect at next scheduled inspection.
<b>Maintenance Timeframe</b>	Greater than 5 years

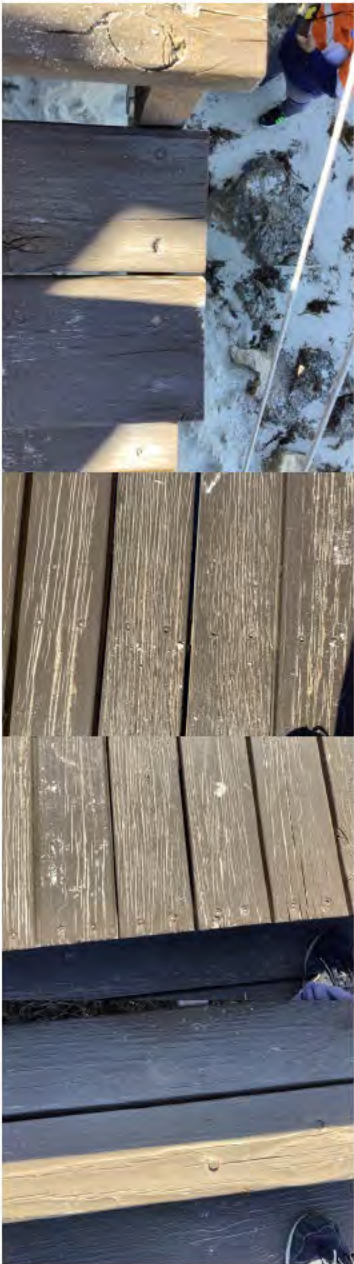
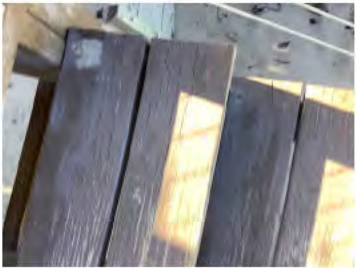
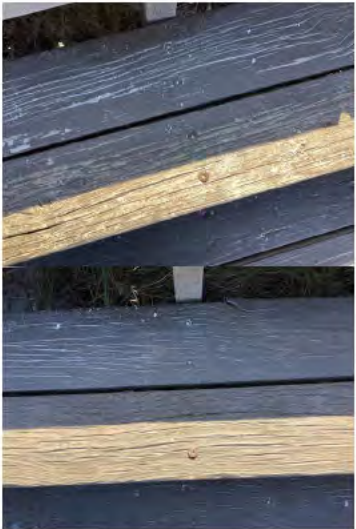
<b>Site No.</b>	C15
<b>Site Name/ Location</b>	Jindalee Foreshore
<b>Date</b>	25/02/2021
<b>Time</b>	09:01 (8 GMT)
<b>Item Number</b>	10
<b>Costal Asset Type</b>	Stairs
<b>Element</b>	Decking Connections
<b>Sub-element (Decking and Supports)</b>	Nails to deck planks
<b>Material Type</b>	Galvanized Steel
<b>2021 Observed Defects (Steel)</b>	Generally good condition with some minor rust staining observed.
<b>Condition Rating (0- 10)</b>	3
<b>Health and Safety Concern (Y/N)</b>	No
<b>Consequence of Failure</b>	2
<b>Likelihood of Failure within next 5 years</b>	2
<b>Risk Rating</b>	4
<b>Overall Rating (CR X RR)</b>	12
<b>Maintenance Recommendation</b>	Monitor and reinspect at next scheduled inspection.
<b>Maintenance Timeframe</b>	Greater than 5 years

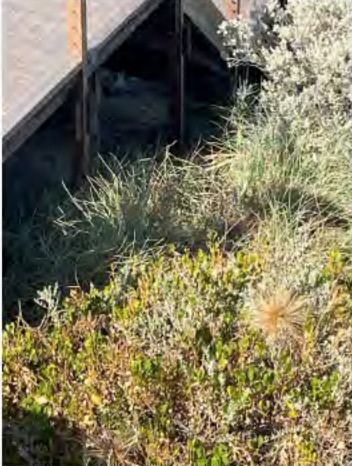
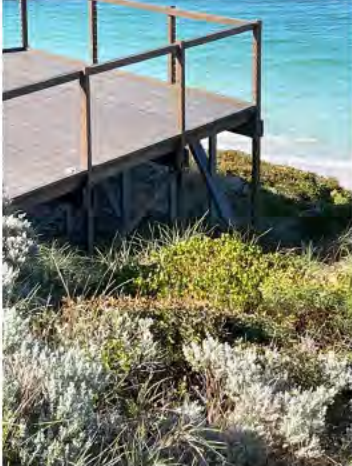
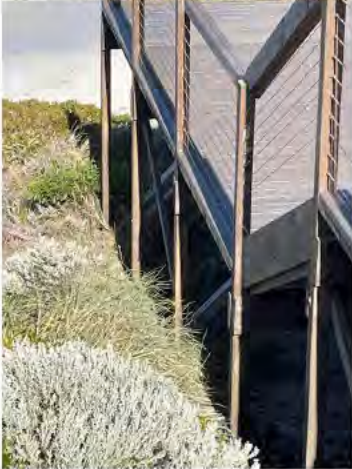
<b>Site No.</b>	C16
<b>Site Name/ Location</b>	Jindalee Foreshore
<b>Date</b>	25/02/2021
<b>Time</b>	08:33 (8 GMT)
<b>Item Number</b>	2
<b>Costal Asset Type</b>	Lookout
<b>Element</b>	Decking
<b>Sub Element</b>	Deck Planks
<b>Material Type</b>	Timber
<b>2021 Observed Defects (Timber)</b>	Split timber
<b>Defect Description</b>	Generally good condition with only minor timber splitting was observed to be typical throughout. Minor chipping on the edges of the stair planks were observed. 8th row from west end has a large crack in it that goes through the connections.
<b>Condition Rating (0- 10)</b>	4
<b>Health and Safety Concern (Y/N)</b>	No
<b>Consequence of Failure</b>	3
<b>Likelihood of Failure within next 5 years</b>	2
<b>Risk Rating</b>	6
<b>Overall Rating (CR X RR)</b>	24
<b>Maintenance Recommendation</b>	Replace damaged plank.
<b>Maintenance Timeframe</b>	Within 6 months

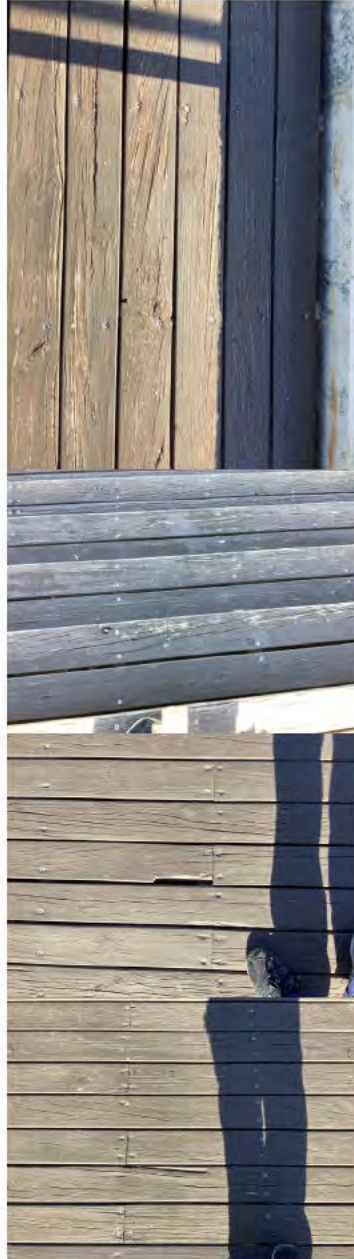
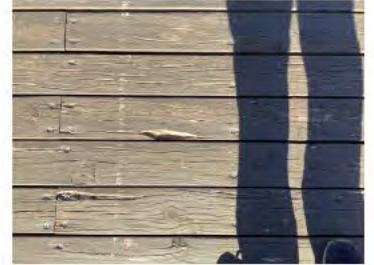
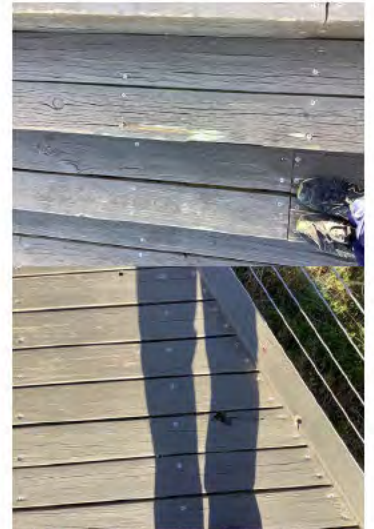
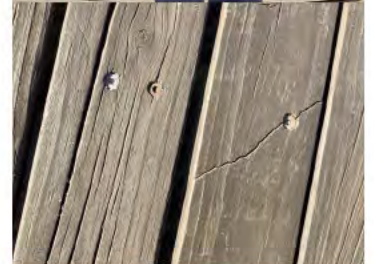
<b>Site No.</b>	C16
<b>Site Name/ Location</b>	Jindalee Foreshore
<b>Date</b>	25/02/2021
<b>Time</b>	08:41 (8 GMT)
<b>Item Number</b>	3
<b>Costal Asset Type</b>	Lookout
<b>Element</b>	Decking
<b>Sub-element (Decking and Supports)</b>	Nails to deck planks
<b>Material Type</b>	Galvanised Steel
<b>2021 Observed Defects (Steel)</b>	No visible defects observed
<b>Condition Rating (0- 10)</b>	2
<b>Health and Safety Concern (Y/N)</b>	No
<b>Consequence of Failure</b>	2
<b>Likelihood of Failure within next 5 years</b>	1
<b>Risk Rating</b>	2
<b>Overall Rating (CR X RR)</b>	4
<b>Maintenance Recommendation</b>	Monitor and reinspect at next scheduled inspection.
<b>Maintenance Timeframe</b>	Greater than 5 years

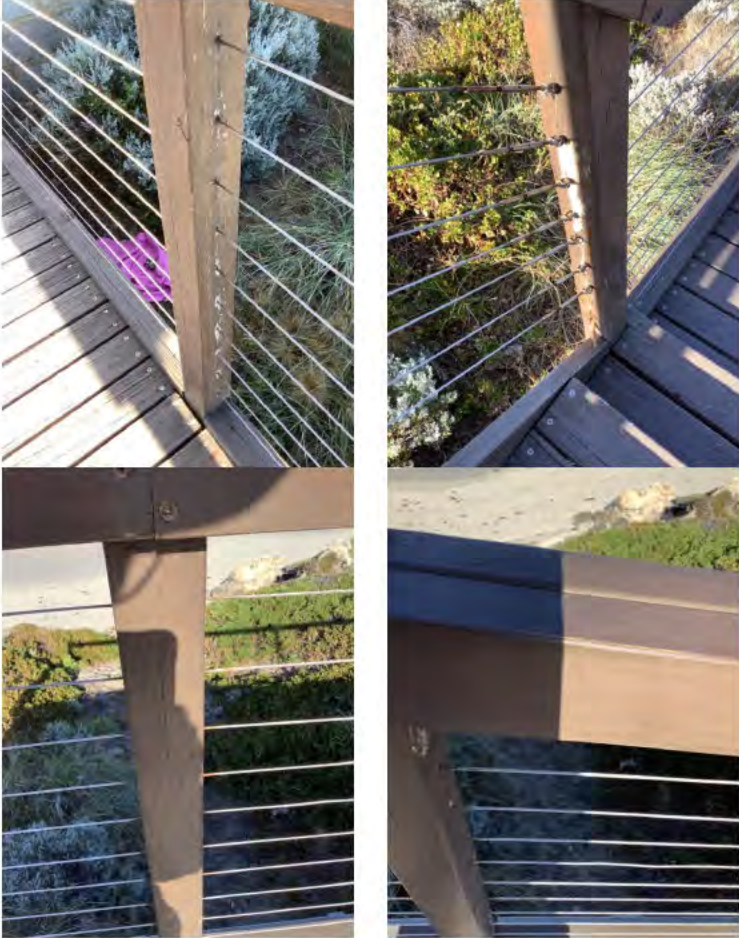
<b>Site No.</b>	C16
<b>Site Name/ Location</b>	Jindalee Foreshore
<b>Date</b>	25/02/2021
<b>Time</b>	08:47 (8 GMT)
<b>Item Number</b>	7
<b>Costal Asset Type</b>	Lookout
<b>Element</b>	Handrails
<b>Sub-element (Handrails)</b>	Connections
<b>Material Type</b>	Galvnised Steel
<b>2021 Observed Defects (Steel)</b>	Generally good condition with minor rust staining observed to be typical throughout.
<b>Condition Rating (0- 10)</b>	3
<b>Health and Safety Concern (Y/N)</b>	No
<b>Consequence of Failure</b>	2
<b>Likelihood of Failure within next 5 years</b>	2
<b>Risk Rating</b>	4
<b>Overall Rating (CR X RR)</b>	12
<b>Maintenance Recommendation</b>	Monitor and reinspect at next scheduled inspection.
<b>Maintenance Timeframe</b>	Greater than 5 years

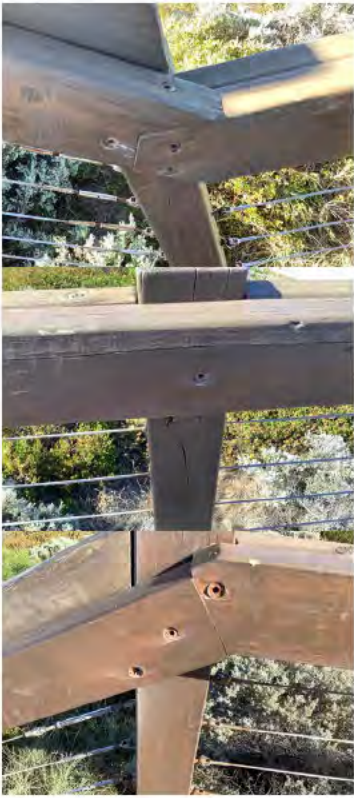
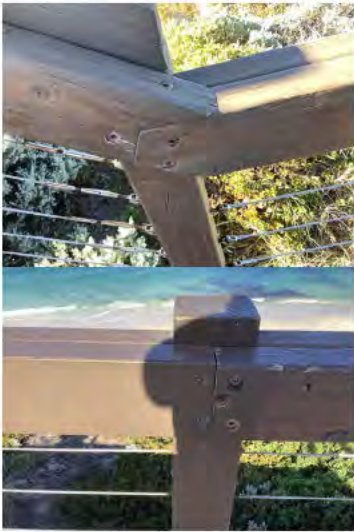
<b>Site No.</b>	C16
<b>Site Name/ Location</b>	Jindalee Foreshore
<b>Date</b>	25/02/2021
<b>Time</b>	08:43 (8 GMT)
<b>Item Number</b>	8
<b>Costal Asset Type</b>	Lookout
<b>Element</b>	Handrails
<b>Sub-element (Handrails)</b>	Mesh strainer wires
<b>Material Type</b>	Stainless Steel
<b>2021 Observed Defects (Steel)</b>	Rust staining, Failed
<b>Defect Description</b>	Generally good condition with minor rust staining observed to be typical on ends. Two wires have failed on one side and one wire is slightly deformed, most likely due to impact damage.
<b>Condition Rating (0- 10)</b>	4
<b>Health and Safety Concern (Y/N)</b>	No
<b>Consequence of Failure</b>	2
<b>Likelihood of Failure within next 5 years</b>	3
<b>Risk Rating</b>	6
<b>Overall Rating (CR X RR)</b>	24
<b>Maintenance Recommendation</b>	Replace damaged and failed wires. Monitor and reinspect the rest at next scheduled inspection.
<b>Maintenance Timeframe</b>	Within 5 years

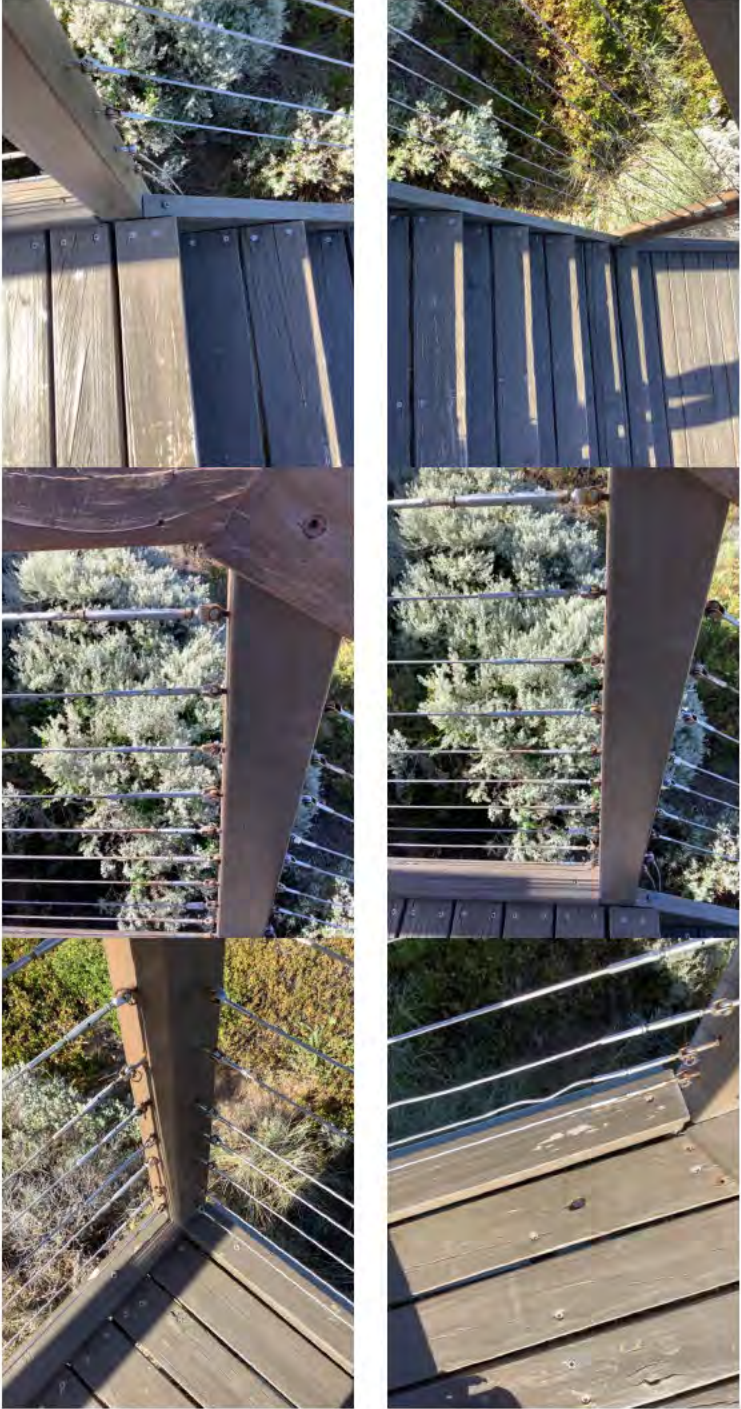
<b>Site No.</b>	C16
<b>Site Name/ Location</b>	Jindalee Foreshore
<b>Date</b>	25/02/2021
<b>Time</b>	08:37 (8 GMT)
<b>Item Number</b>	9
<b>Costal Asset Type</b>	Lookout
<b>Element</b>	Handrails
<b>Sub-element (Handrails)</b>	Handrail
<b>Material Type</b>	Timber
<b>2021 Observed Defects (Timber)</b>	Minor timber splitting was observed to be typical throughout.
<b>Condition Rating (0- 10)</b>	3
<b>Health and Safety Concern (Y/N)</b>	No
<b>Consequence of Failure</b>	3
<b>Likelihood of Failure within next 5 years</b>	2
<b>Risk Rating</b>	6
<b>Overall Rating (CR X RR)</b>	18
<b>Maintenance Recommendation</b>	Monitor and reinspect at next scheduled inspection.
<b>Maintenance Timeframe</b>	Greater than 5 years

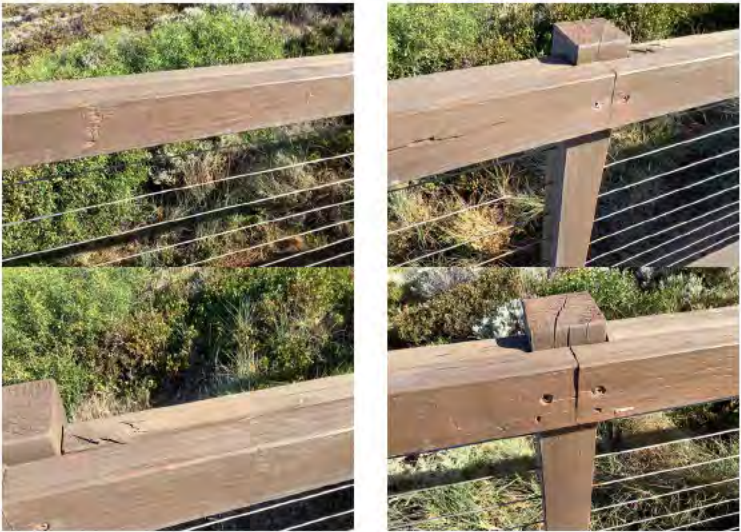
<b>Site No.</b>	C16
<b>Site Name/ Location</b>	Jindalee Foreshore
<b>Date</b>	25/02/2021
<b>Time</b>	08:38 (8 GMT)
<b>Item Number</b>	10
<b>Costal Asset Type</b>	Stairs
<b>Element</b>	Handrails
<b>Sub-element (Handrails)</b>	Handrail
<b>Material Type</b>	Stainless Steel
<b>2021 Observed Defects (Steel)</b>	Rust staining
<b>Defect Description</b>	Generally good condition with some minor tea staining observed.
<b>Quantity of Defects</b>	2m handrail length
<b>Condition Rating (0- 10)</b>	3
<b>Health and Safety Concern (Y/N)</b>	No
<b>Consequence of Failure</b>	2
<b>Likelihood of Failure within next 5 years</b>	1
<b>Risk Rating</b>	2
<b>Overall Rating (CR X RR)</b>	6
<b>Maintenance Recommendation</b>	Monitor and reinspect at next scheduled inspection.
<b>Maintenance Timeframe</b>	Greater than 5 years

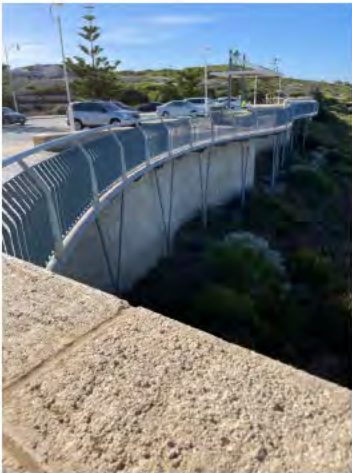
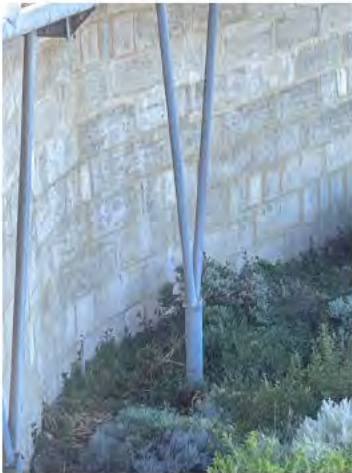
Site No.	C17
Site Name/ Location	Jindalee Foreshore
Date	25/02/2021
Time	08:19 (8 GMT)
Item Number	1
Costal Asset Type	Other
Asset Type	Boardwalk
Element	Supports
Sub-element	Columns
Material Type	Galvanised Steel
2021 Observed Defects (Steel)	Surface corrosion
Defect Description	Minor white rust was observed to be typical throughout
Condition Rating (0- 10)	4
Health and Safety Concern (Y/N)	No
Consequence of Failure	4
Likelihood of Failure within next 5 years	1
Risk Rating	4
Overall Rating (CR X RR)	16
Maintenance Recommendation	Monitor and reinspect at next scheduled inspection.
Maintenance Timeframe	Greater than 5 years

Inspected from safe vantage point on boardwalk

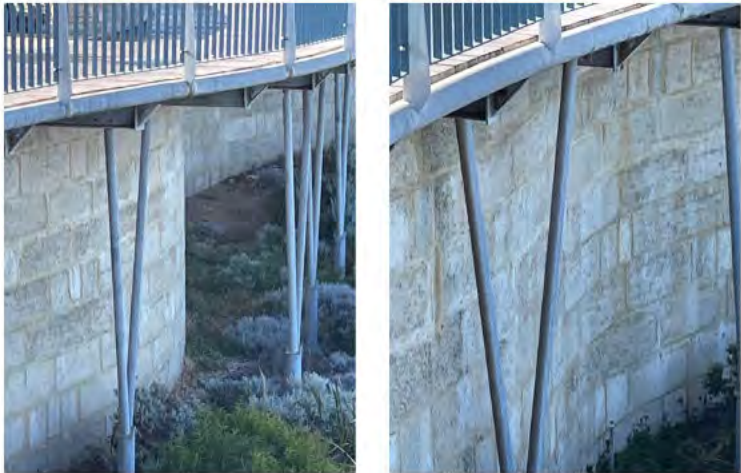
<b>Site No.</b>	C17
<b>Site Name/ Location</b>	Jindalee Foreshore
<b>Date</b>	25/02/2021
<b>Time</b>	08:17 (8 GMT)
<b>Item Number</b>	2
<b>Asset Type</b>	Boardwalk
<b>Element</b>	Supports
<b>Sub-element (Decking and Supports)</b>	Support beams
<b>Material Type</b>	Galvanised Steel
<b>2021 Observed Defects (Steel)</b>	Surface corrosion
<b>Defect Description</b>	Minor white rust was observed.
<b>Quantity of Defects</b>	Beams spaced approx 2m apart along boardwalk
<b>Condition Rating (0- 10)</b>	4
<b>Health and Safety Concern (Y/N)</b>	No
<b>Consequence of Failure</b>	4
<b>Likelihood of Failure within next 5 years</b>	1
<b>Risk Rating</b>	4
<b>Overall Rating (CR X RR)</b>	16
<b>Maintenance Recommendation</b>	Monitor and reinspect at next scheduled inspection.
<b>Maintenance Timeframe</b>	Greater than 5 years

Inspected from safe access point on boardwalk

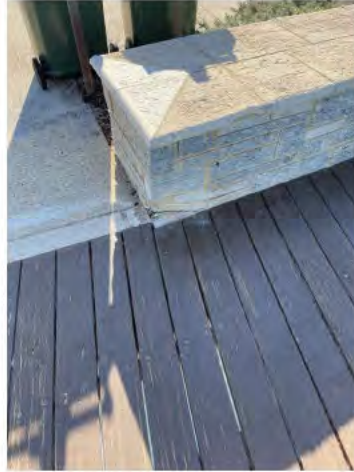
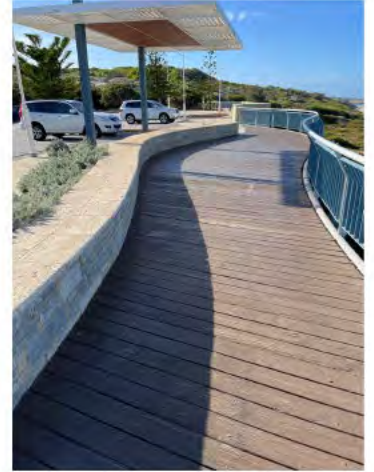
<b>Site No.</b>	C17
<b>Site Name/ Location</b>	Jindalee Foreshore
<b>Date</b>	25/02/2021
<b>Time</b>	08:08 (8 GMT)
<b>Item Number</b>	3
<b>Costal Asset Type</b>	Retaining wall
<b>Element</b>	Wall
<b>Material Type</b>	Limestone
<b>Defect Description</b>	Minor impact damage observed on the corner. Generally good condition. Pertains to southern most retaining wall
<b>Quantity of Defects</b>	20m long 0.5 high 1m wide
<b>Defect Location</b>	Northern corner
<b>Condition Rating (0- 10)</b>	4
<b>Health and Safety Concern (Y/N)</b>	No
<b>Consequence of Failure</b>	2
<b>Likelihood of Failure within next 5 years</b>	2
<b>Risk Rating</b>	4
<b>Overall Rating (CR X RR)</b>	16
<b>Maintenance Recommendation</b>	Repair grout on damaged corner
<b>Maintenance Timeframe</b>	Within 5 years

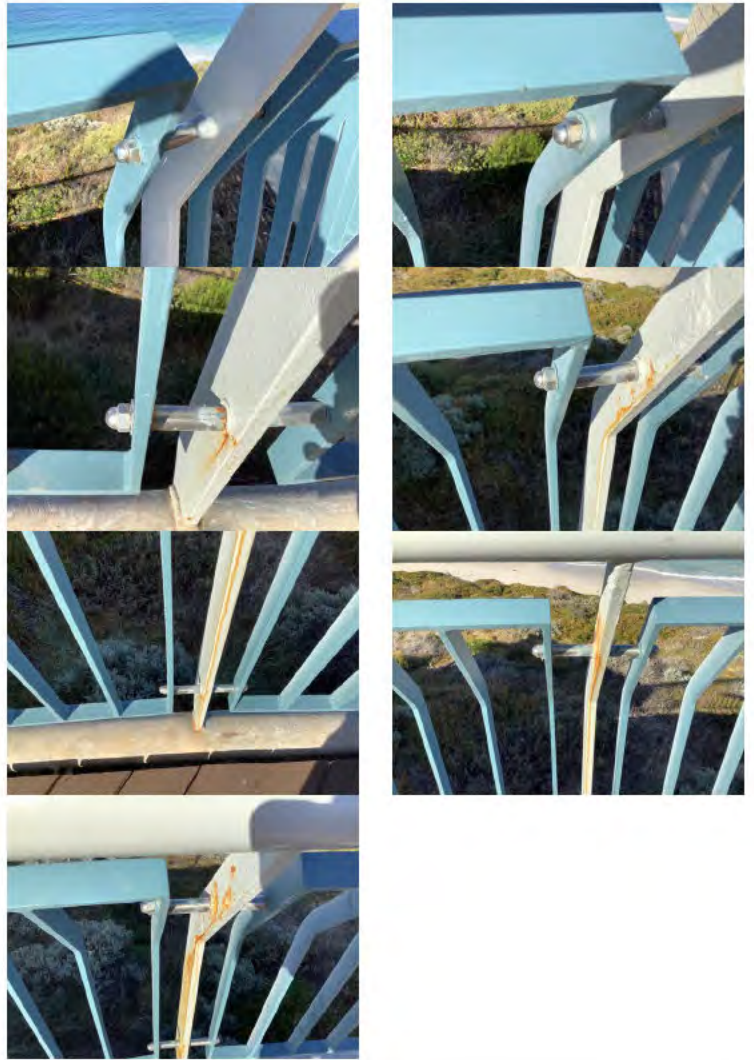
<b>Site No.</b>	C17
<b>Site Name/ Location</b>	Jindalee Foreshore
<b>Date</b>	25/02/2021
<b>Time</b>	08:16 (8 GMT)
<b>Item Number</b>	12
<b>Asset Type</b>	Boardwalk
<b>Sub-element (Handrails)</b>	Handrail
<b>Sub-element</b>	Handrail and fencing
<b>Material Type</b>	Coated Steel
<b>2021 Observed Defects (Steel)</b>	Rust staining
<b>Defect Description</b>	Some rust staining observed mostly on galvanised steel sections
<b>Condition Rating (0- 10)</b>	2
<b>Health and Safety Concern (Y/N)</b>	No
<b>Consequence of Failure</b>	3
<b>Likelihood of Failure within next 5 years</b>	1
<b>Risk Rating</b>	3
<b>Overall Rating (CR X RR)</b>	6
<b>Maintenance Recommendation</b>	Monitor and reinspect at next scheduled inspection.
<b>Maintenance Timeframe</b>	Greater than 5 years

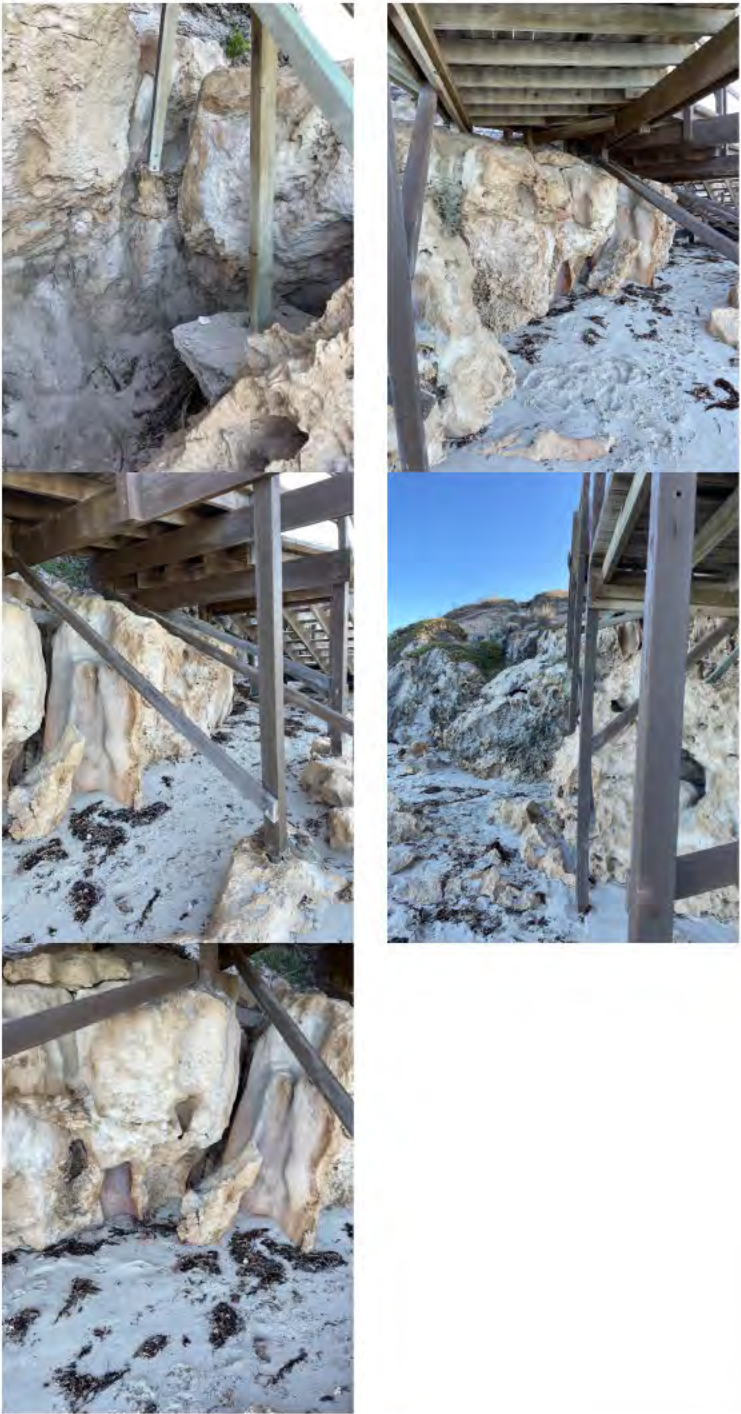
<b>Site No.</b>	C18
<b>Site Name/ Location</b>	Jindalee Foreshore
<b>Date</b>	25/02/2021
<b>Time</b>	07:37 (8 GMT)
<b>Item Number</b>	1
<b>Costal Asset Type</b>	Stairs
<b>Element</b>	Foundation
<b>Sub-element (Foundations)</b>	Footing
<b>Material Type</b>	Limestone
<b>2021 Observed Defects (General)</b>	Foundation damage and loss of contact with underlying ground surface was observed to be typical across the whole embankment
<b>Defect Description</b>	Stairs are founded on limestone which is eroding,
<b>Quantity of Defects</b>	Typical to entire embankment approx 3m high x 20m
<b>Defect Location</b>	Typical embankment
<b>Condition Rating (0- 10)</b>	7
<b>Health and Safety Concern (Y/N)</b>	No
<b>Consequence of Failure</b>	4
<b>Likelihood of Failure within next 5 years</b>	4
<b>Risk Rating</b>	16
<b>Overall Rating (CR X RR)</b>	112
<b>Maintenance Recommendation</b>	Further detailed investigation including geotechnical / structural review of structure.

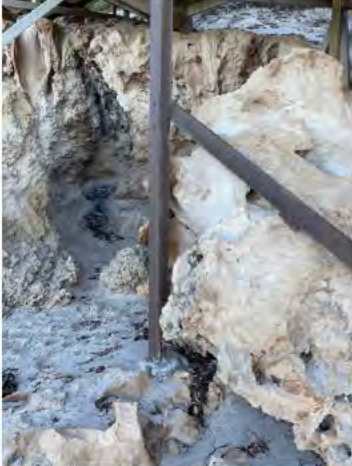
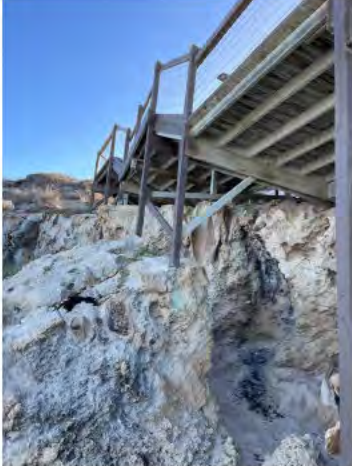
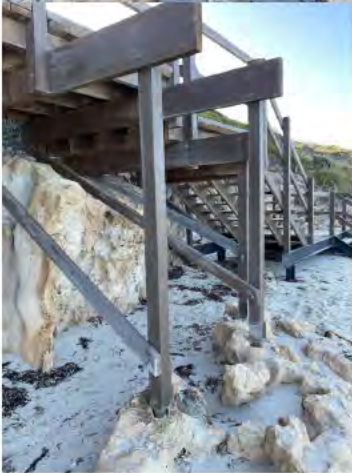
<b>Site No.</b>	C18
<b>Site Name/ Location</b>	Jindalee Foreshore
<b>Date</b>	25/02/2021
<b>Time</b>	07:46 (8 GMT)
<b>Item Number</b>	2
<b>Costal Asset Type</b>	Stairs
<b>Element</b>	Supports
<b>Sub-element (Stairs and Landing)</b>	Timber posts
<b>Material Type</b>	Timber
<b>2021 Observed Defects (Timber)</b>	Split timber
<b>Defect Description</b>	Minor timber splitting was observed
<b>Condition Rating (0- 10)</b>	4
<b>Health and Safety Concern (Y/N)</b>	No
<b>Consequence of Failure</b>	4
<b>Likelihood of Failure within next 5 years</b>	1
<b>Risk Rating</b>	4
<b>Overall Rating (CR X RR)</b>	16
<b>Maintenance Recommendation</b>	Monitor and reinspect at next scheduled inspection.
<b>Maintenance Timeframe</b>	Greater than 5 years

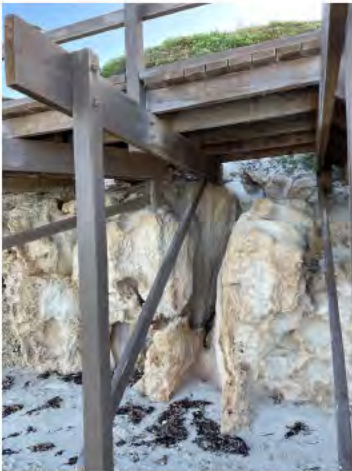
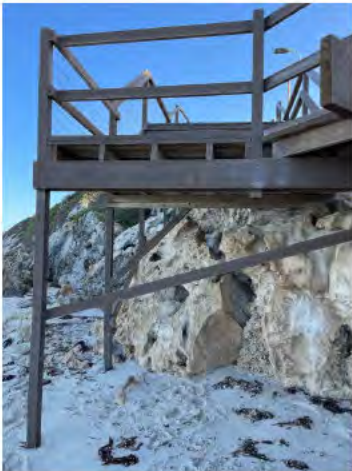
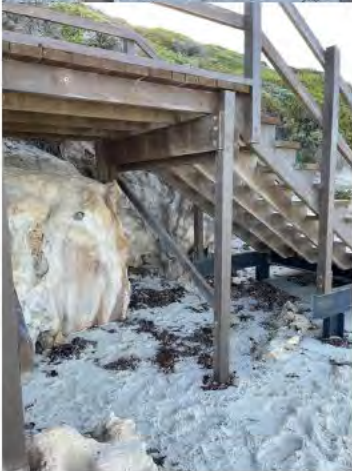
<b>Site No.</b>	C18
<b>Site Name/ Location</b>	Jindalee Foreshore
<b>Date</b>	25/02/2021
<b>Time</b>	07:40 (8 GMT)
<b>Item Number</b>	3
<b>Costal Asset Type</b>	Stairs
<b>Element</b>	Supports
<b>Sub-element (Decking and Supports)</b>	Support beams
<b>Material Type</b>	Timber
<b>2021 Observed Defects (Timber)</b>	No visible defects observed
<b>Defect Description</b>	Support beams generally in good condition
<b>Condition Rating (0- 10)</b>	4
<b>Health and Safety Concern (Y/N)</b>	No
<b>Consequence of Failure</b>	3
<b>Likelihood of Failure within next 5 years</b>	1
<b>Risk Rating</b>	3
<b>Overall Rating (CR X RR)</b>	12
<b>Maintenance Recommendation</b>	Monitor and reinspect at next scheduled inspection.
<b>Maintenance Timeframe</b>	Greater than 5 years

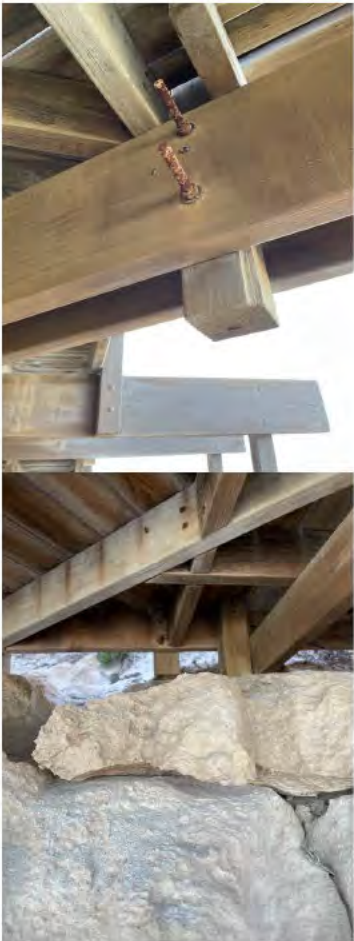
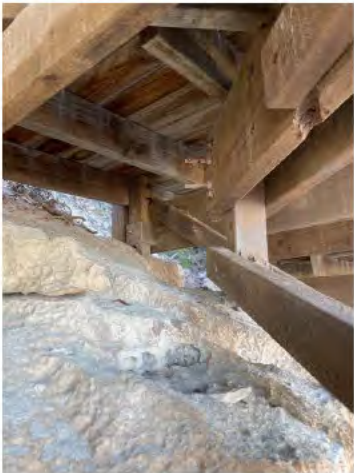
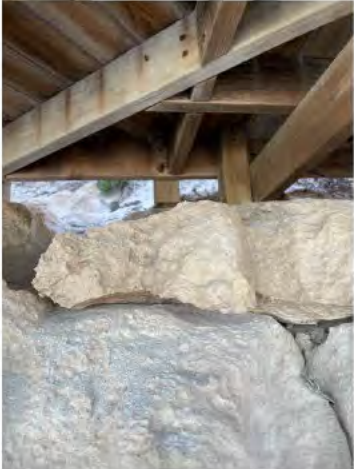
<b>Site No.</b>	C18
<b>Site Name/ Location</b>	Jindalee Foreshore
<b>Date</b>	25/02/2021
<b>Time</b>	07:44 (8 GMT)
<b>Item Number</b>	5
<b>Costal Asset Type</b>	Stairs
<b>Element</b>	Supports
<b>Sub-element (Decking and Supports)</b>	Steel support bolts
<b>Material Type</b>	Steel
<b>2021 Observed Defects (Steel)</b>	Surface corrosion, Rust staining
<b>Defect Description</b>	Surface corrosion was observed to be typical across all connection bolts and screws
<b>Condition Rating (0- 10)</b>	6
<b>Health and Safety Concern (Y/N)</b>	No
<b>Consequence of Failure</b>	3
<b>Likelihood of Failure within next 5 years</b>	3
<b>Risk Rating</b>	9
<b>Overall Rating (CR X RR)</b>	54
<b>Maintenance Recommendation</b>	Replace heavily corroded bolts and screws.
<b>Maintenance Timeframe</b>	Within 5 years

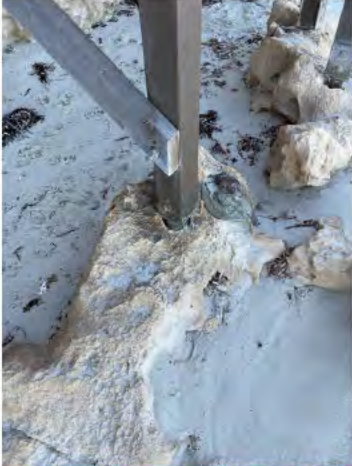
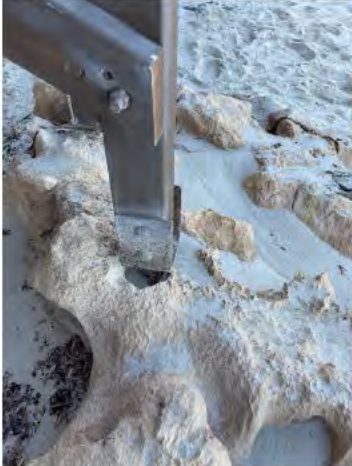
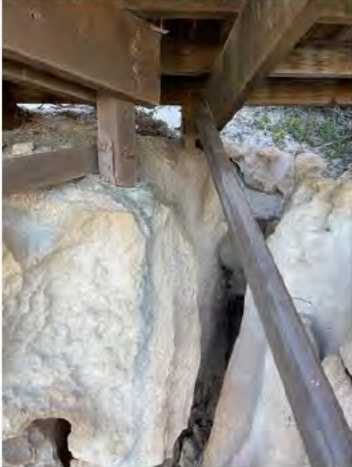
<b>Site No.</b>	C18
<b>Site Name/ Location</b>	Jindalee Foreshore
<b>Date</b>	25/02/2021
<b>Time</b>	07:49 (8 GMT)
<b>Item Number</b>	6
<b>Costal Asset Type</b>	Stairs
<b>Element</b>	Supports
<b>Sub-element (Decking and Supports)</b>	Support beam brackets
<b>Material Type</b>	Steel
<b>2021 Observed Defects (Steel)</b>	Coating loss
<b>Defect Description</b>	Some corrosion has been observed. (pertains to support brackets embedded within limestone, limestone has eroded, and exposed steel is now corroding)
<b>Quantity of Defects</b>	Approx 10 locations
<b>Defect Location</b>	Towards base of stairs
<b>Condition Rating (0- 10)</b>	6
<b>Health and Safety Concern (Y/N)</b>	No
<b>Consequence of Failure</b>	4
<b>Likelihood of Failure within next 5 years</b>	3
<b>Risk Rating</b>	12
<b>Overall Rating (CR X RR)</b>	72
<b>Maintenance Recommendation</b>	Abrasive blast clean and apply protective coating.
<b>Maintenance Timeframe</b>	Within 1-2 years

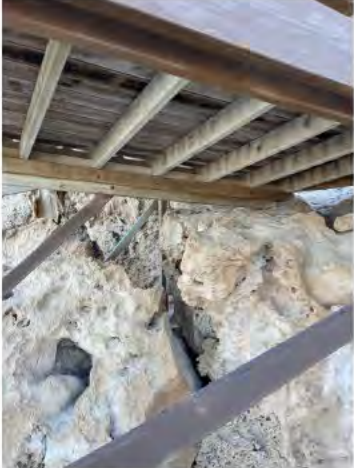
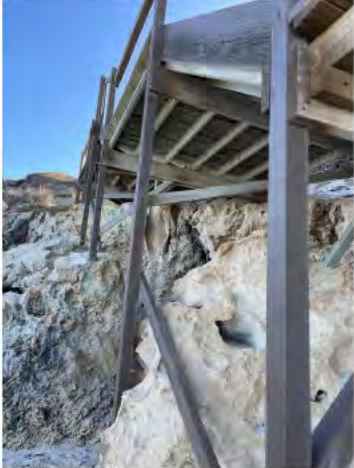
<b>Site No.</b>	C18
<b>Site Name/ Location</b>	Jindalee Foreshore
<b>Date</b>	25/02/2021
<b>Time</b>	07:48 (8 GMT)
<b>Item Number</b>	7
<b>Costal Asset Type</b>	Stairs
<b>Element</b>	Stairs
<b>Sub-element (Decking and Supports)</b>	Joist
<b>Material Type</b>	Timber
<b>2021 Observed Defects (Timber)</b>	Split timber
<b>Defect Description</b>	Minor timber splitting was observed
<b>Condition Rating (0- 10)</b>	4
<b>Health and Safety Concern (Y/N)</b>	No
<b>Consequence of Failure</b>	3
<b>Likelihood of Failure within next 5 years</b>	1
<b>Risk Rating</b>	3
<b>Overall Rating (CR X RR)</b>	12
<b>Maintenance Recommendation</b>	Monitor and reinspect at next scheduled inspection.
<b>Maintenance Timeframe</b>	Greater than 5 years

Appears percentage is pine and ther is jarrah

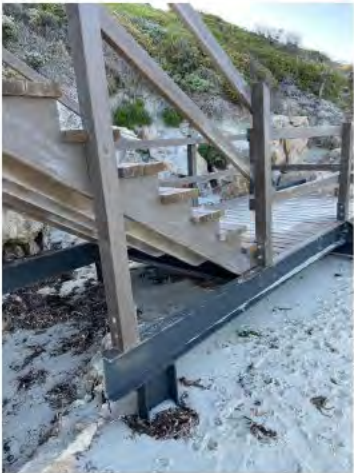
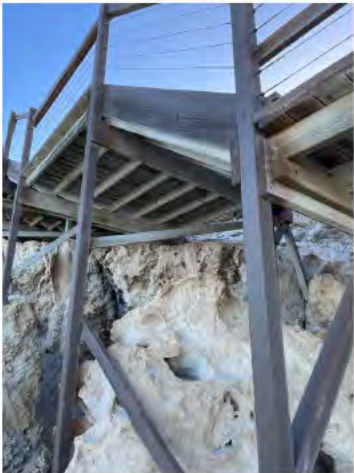
<b>Site No.</b>	C18
<b>Site Name/ Location</b>	Jindalee Foreshore
<b>Date</b>	25/02/2021
<b>Time</b>	07:42 (8 GMT)
<b>Item Number</b>	8
<b>Costal Asset Type</b>	Stairs
<b>Element</b>	Supports
<b>Sub-element (Stairs and Landing)</b>	Stringers
<b>Material Type</b>	Timber
<b>2021 Observed Defects (Timber)</b>	Split timber
<b>Defect Description</b>	Minor timber splitting was observed
<b>Condition Rating (0- 10)</b>	4
<b>Health and Safety Concern (Y/N)</b>	No
<b>Consequence of Failure</b>	3
<b>Likelihood of Failure within next 5 years</b>	1
<b>Risk Rating</b>	3
<b>Overall Rating (CR X RR)</b>	12
<b>Maintenance Recommendation</b>	Monitor and reinspect at next scheduled inspection.
<b>Maintenance Timeframe</b>	Greater than 5 years

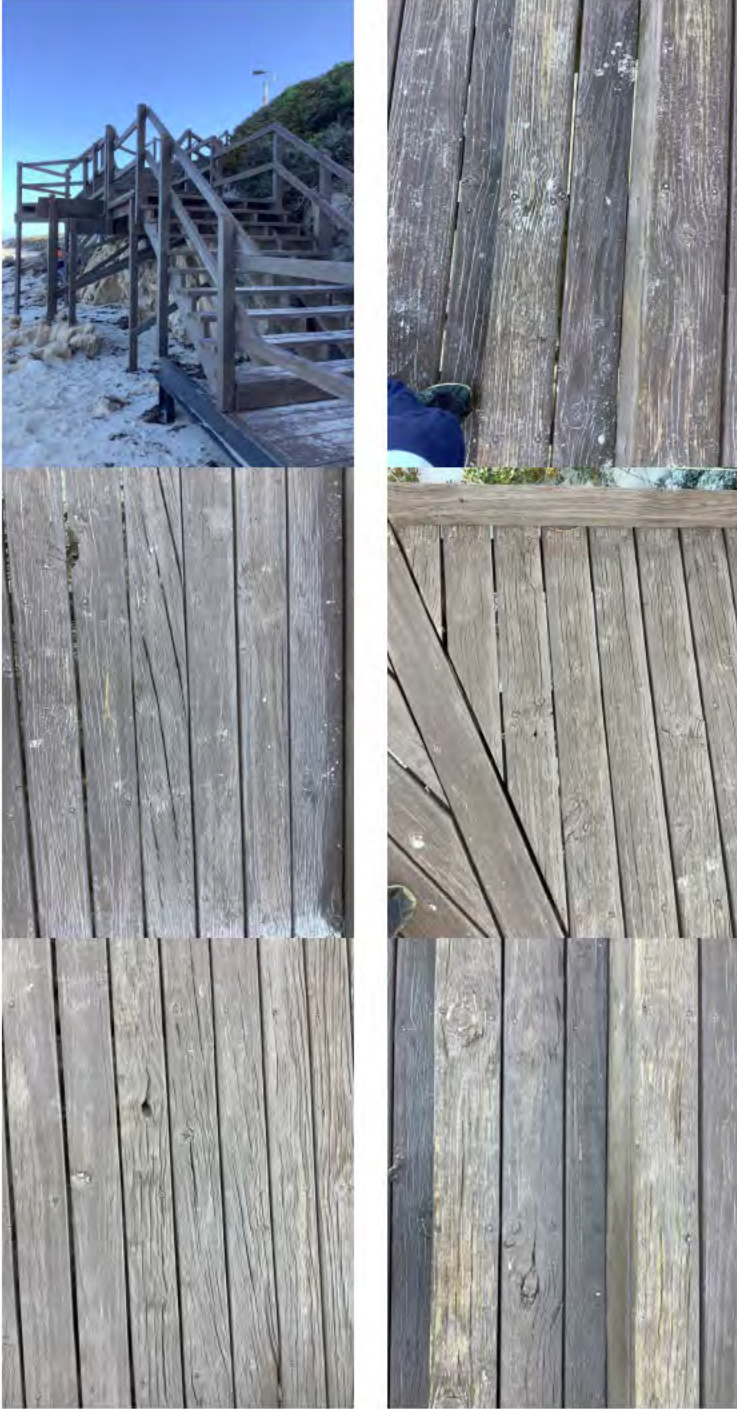
<b>Site No.</b>	C18
<b>Site Name/ Location</b>	Jindalee Foreshore
<b>Date</b>	25/02/2021
<b>Time</b>	07:21 (8 GMT)
<b>Item Number</b>	9
<b>Costal Asset Type</b>	Stairs
<b>Element</b>	Decking
<b>Sub Element</b>	Deck Planks
<b>Material Type</b>	Timber
<b>2021 Observed Defects (Timber)</b>	Split timber
<b>Defect Description</b>	Split timber was observed to be typical across the whole landing. A couple of chips were observed on the staircase planks
<b>Defect Location</b>	Landing and stairs
<b>Condition Rating (0- 10)</b>	4
<b>Health and Safety Concern (Y/N)</b>	No
<b>Consequence of Failure</b>	4
<b>Likelihood of Failure within next 5 years</b>	2
<b>Risk Rating</b>	8
<b>Overall Rating (CR X RR)</b>	32
<b>Maintenance Recommendation</b>	Monitor and reinspect at next scheduled inspection.
<b>Maintenance Timeframe</b>	Greater than 5 years

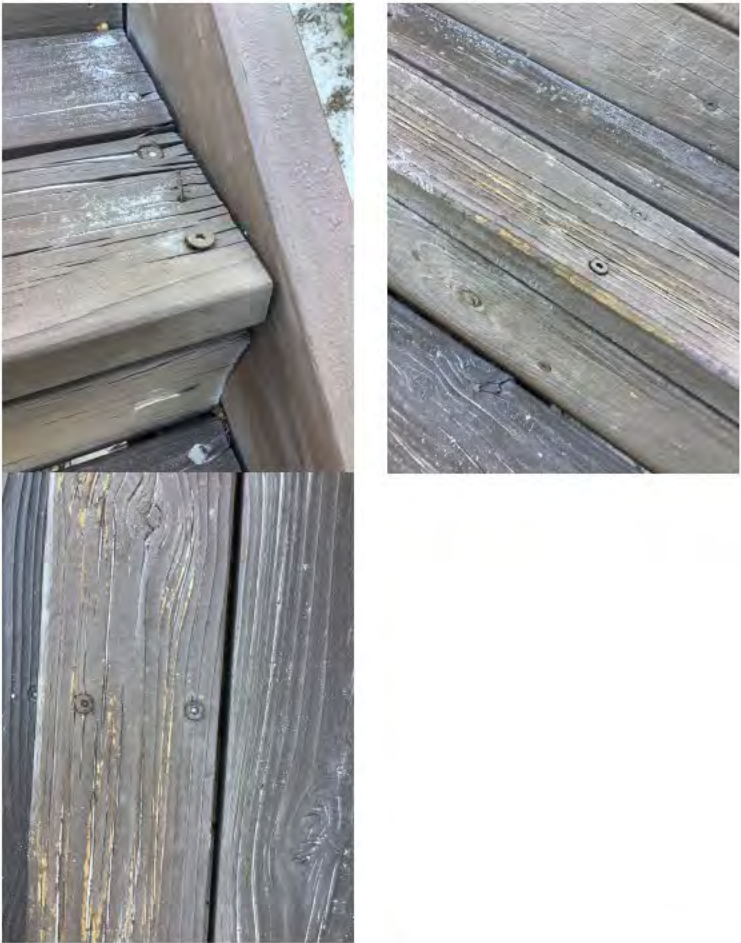
<b>Site No.</b>	C18
<b>Site Name/ Location</b>	Jindalee Foreshore
<b>Date</b>	25/02/2021
<b>Time</b>	07:49 (8 GMT)
<b>Item Number</b>	10
<b>Costal Asset Type</b>	Stairs
<b>Element</b>	Decking
<b>Sub-element (Stairs and Landing)</b>	Connections
<b>Material Type</b>	Steel
<b>2021 Observed Defects (Steel)</b>	Rust staining
<b>Defect Description</b>	Rust staining was observed to be typical throughout One nail observed to be protruding out on the edge of the deck plank. A couple loose connections were also observed
<b>Condition Rating (0- 10)</b>	4
<b>Health and Safety Concern (Y/N)</b>	No
<b>Consequence of Failure</b>	2
<b>Likelihood of Failure within next 5 years</b>	2
<b>Risk Rating</b>	4
<b>Overall Rating (CR X RR)</b>	16
<b>Maintenance Recommendation</b>	Monitor and reinspect at next scheduled inspection.
<b>Maintenance Timeframe</b>	Within 5 years

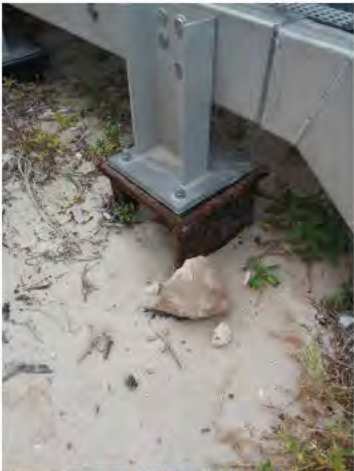
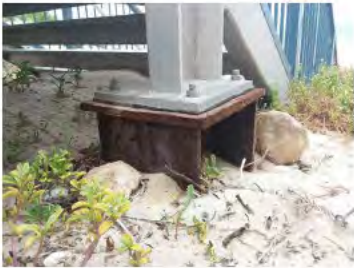
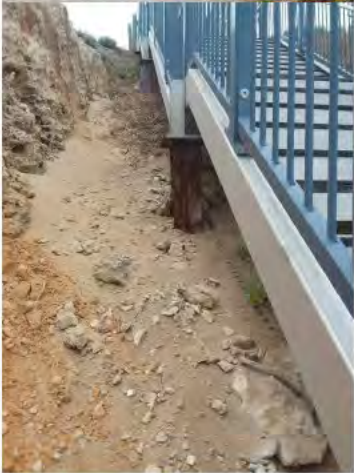
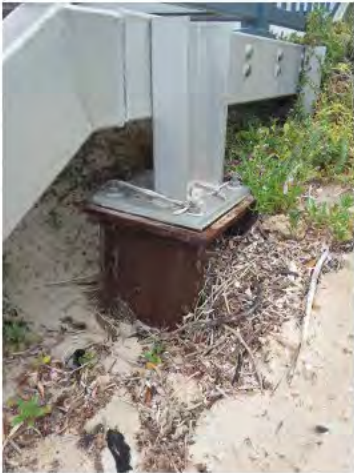
<b>Site No.</b>	C19
<b>Site Name/ Location</b>	North Quinns Rocks Foreshore
<b>Date</b>	09/02/2021
<b>Time</b>	09:36 (8 GMT)
<b>Item Number</b>	8
<b>Costal Asset Type</b>	Stairs
<b>Element</b>	Supports
<b>Sub-element (Stairs and Landing)</b>	Stair support stubs
<b>Sub-element</b>	stair support stubs and stringers
<b>Material Type</b>	Galvanised Steel
<b>2021 Observed Defects (Steel)</b>	Surface corrosion
<b>Defect Description</b>	Generally good condition. With some minor surface corrosion at connection points.
<b>Quantity of Defects</b>	40m (both sides included)
<b>Condition Rating (0- 10)</b>	3
<b>Health and Safety Concern (Y/N)</b>	No
<b>Consequence of Failure</b>	4
<b>Likelihood of Failure within next 5 years</b>	2
<b>Risk Rating</b>	8
<b>Overall Rating (CR X RR)</b>	24
<b>Maintenance Recommendation</b>	Monitor and reinspect at next scheduled inspection.
<b>Maintenance Timeframe</b>	Greater than 5 years

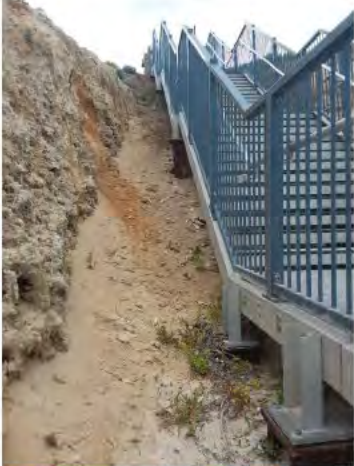
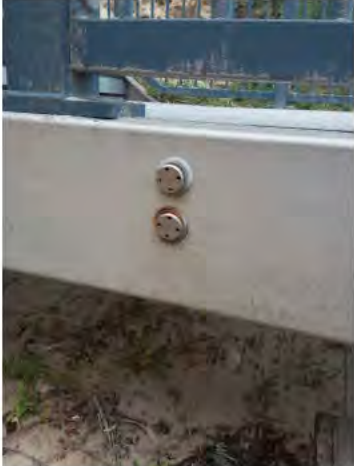
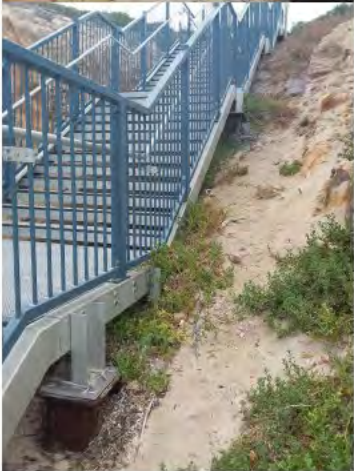
<b>Site No.</b>	C19
<b>Site Name/ Location</b>	North Quinns Rocks Foreshore
<b>Date</b>	09/02/2021
<b>Time</b>	09:29 (8 GMT)
<b>Item Number</b>	9
<b>Costal Asset Type</b>	Stairs
<b>Element</b>	Stairs
<b>Sub-element (Stairs and Landing)</b>	Tread plate, landing platforms and clip connections
<b>Material Type</b>	FRP
<b>2021 Observed Defects (FRP)</b>	No visible defects
<b>Defect Description</b>	No visible defects observed. Inspection limited due to bottom section buried in sand.
<b>Quantity of Defects</b>	52 steps, 3m wide. 20m <sup>2</sup> landing
<b>Condition Rating (0- 10)</b>	2
<b>Health and Safety Concern (Y/N)</b>	No
<b>Consequence of Failure</b>	4
<b>Likelihood of Failure within next 5 years</b>	1
<b>Risk Rating</b>	4
<b>Overall Rating (CR X RR)</b>	8
<b>Maintenance Recommendation</b>	Monitor and reinspect at next scheduled inspection.
<b>Maintenance Timeframe</b>	Greater than 5 years

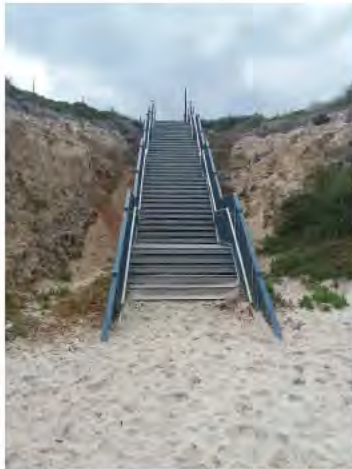
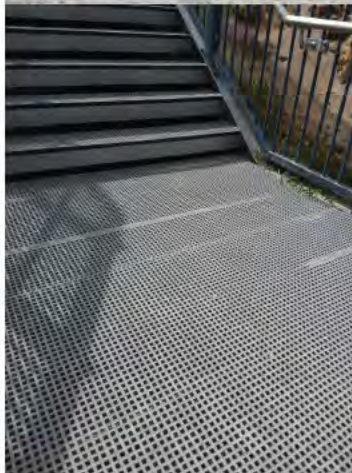
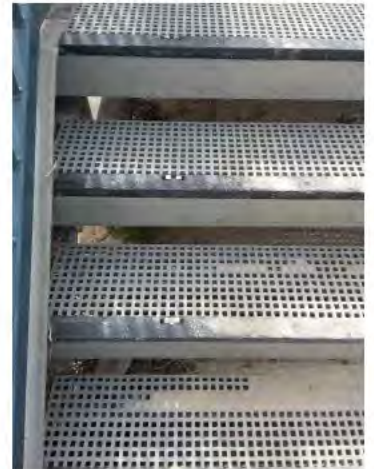
<b>Site No.</b>	C19
<b>Site Name/ Location</b>	North Quinns Rocks Foreshore
<b>Date</b>	09/02/2021
<b>Time</b>	09:45 (8 GMT)
<b>Item Number</b>	10
<b>Costal Asset Type</b>	Stairs
<b>Element</b>	Balustrade
<b>Material Type</b>	Coated Steel
<b>2021 Observed Defects (Steel)</b>	Noticeable build-up of debris, Surface corrosion
<b>Defect Description</b>	Minor surface corrosion at connections, and minor graffiti to paintwork. Bottom of stairs buried in sand.
<b>Quantity of Defects</b>	40m x 1.2 high
<b>Condition Rating (0- 10)</b>	3
<b>Health and Safety Concern (Y/N)</b>	No
<b>Consequence of Failure</b>	3
<b>Likelihood of Failure within next 5 years</b>	2
<b>Risk Rating</b>	6
<b>Overall Rating (CR X RR)</b>	18
<b>Maintenance Recommendation</b>	Monitor and reinspect at next scheduled inspection.
<b>Maintenance Timeframe</b>	Greater than 5 years

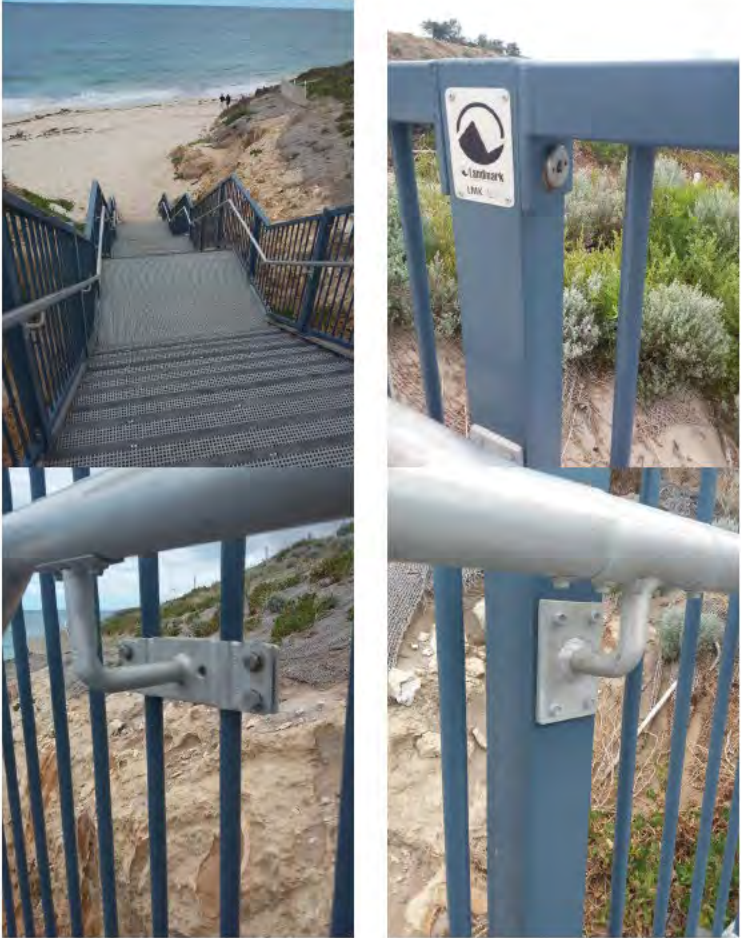
Site No.	C19
Site Name/ Location	North Quinns Rocks Foreshore
Date	09/02/2021
Time	09:50 (8 GMT)
Item Number	11
Costal Asset Type	Stairs
Element	Handrails
Material Type	Galvanised Steel
2021 Observed Defects (Steel)	Surface corrosion
Defect Description	Generally good condition. With some minor surface corrosion at bolts on connections.
Quantity of Defects	40m
Condition Rating (0- 10)	3
Health and Safety Concern (Y/N)	No
Consequence of Failure	2
Likelihood of Failure within next 5 years	2
Risk Rating	4
Overall Rating (CR X RR)	12
Maintenance Recommendation	Monitor and reinspect at next scheduled inspection.
Maintenance Timeframe	Greater than 5 years

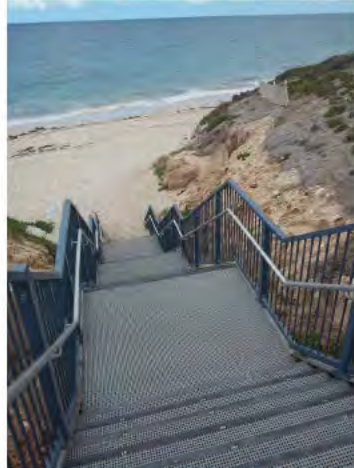
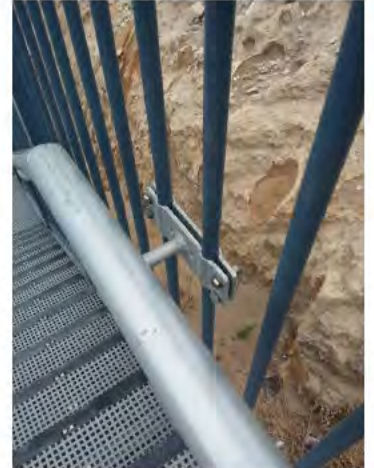
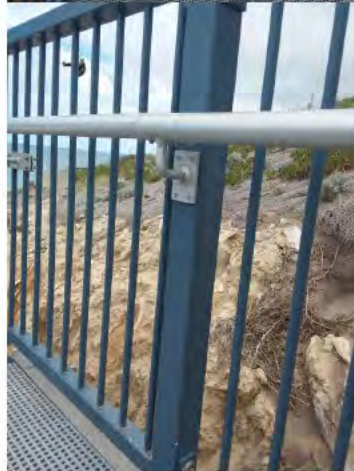
<b>Site No.</b>	C19
<b>Site Name/ Location</b>	North Quinns Rocks Foreshore
<b>Date</b>	09/02/2021
<b>Time</b>	09:52 (8 GMT)
<b>Item Number</b>	12
<b>Costal Asset Type</b>	Stairs
<b>Element</b>	Stairs
<b>Sub-element</b>	Gate
<b>Material Type</b>	Coated Steel
<b>2021 Observed Defects (Steel)</b>	No visible defects
<b>Defect Description</b>	No visible defects observed to gate. Corrosion on chain attaching gate to post found. Some minor graffiti observed.
<b>Condition Rating (0- 10)</b>	3
<b>Health and Safety Concern (Y/N)</b>	No
<b>Consequence of Failure</b>	2
<b>Likelihood of Failure within next 5 years</b>	1
<b>Risk Rating</b>	2
<b>Overall Rating (CR X RR)</b>	6
<b>Maintenance Recommendation</b>	Monitor and reinspect at next scheduled inspection.
<b>Maintenance Timeframe</b>	Greater than 5 years

Corrosion on chain attaching gate to post

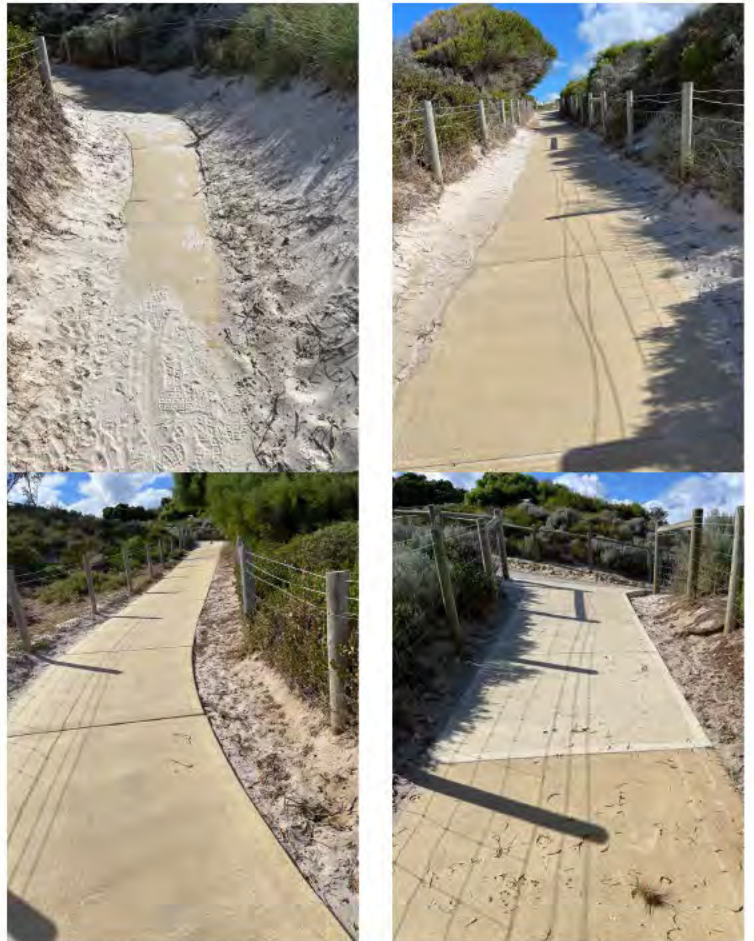
<b>Site No.</b>	C20
<b>Site Name/ Location</b>	North Quinns Rocks Foreshore
<b>Date</b>	09/02/2021
<b>Time</b>	09:08 (8 GMT)
<b>Item Number</b>	2
<b>Costal Asset Type</b>	Fencing
<b>Element</b>	Fencing
<b>Sub-element (Fencing)</b>	Timber posts
<b>Material Type</b>	Timber
<b>2021 Observed Defects (Timber)</b>	Split timber
<b>Defect Description</b>	Minor timber splitting observed to be typical throughout.
<b>Quantity of Defects</b>	71 posts
<b>Condition Rating (0- 10)</b>	3
<b>Health and Safety Concern (Y/N)</b>	No
<b>Consequence of Failure</b>	2
<b>Likelihood of Failure within next 5 years</b>	2
<b>Risk Rating</b>	4
<b>Overall Rating (CR X RR)</b>	12
<b>Maintenance Recommendation</b>	Monitor and reinspect at next scheduled inspection.
<b>Maintenance Timeframe</b>	Greater than 5 years
