# City of Wanneroo Assets Structural Assessment

## Coastal Assets

City Of Wanneroo

30 July 2021

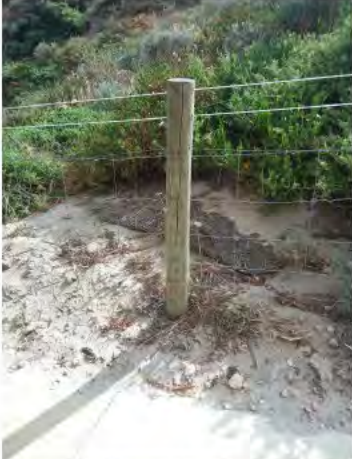
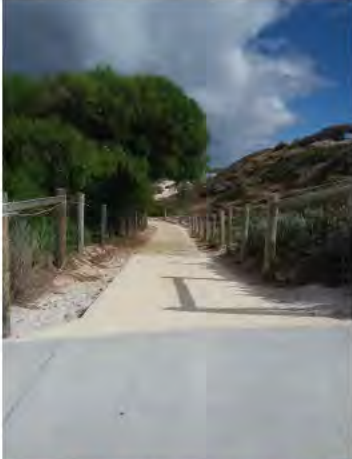
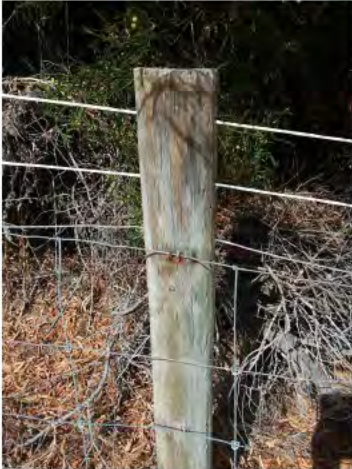
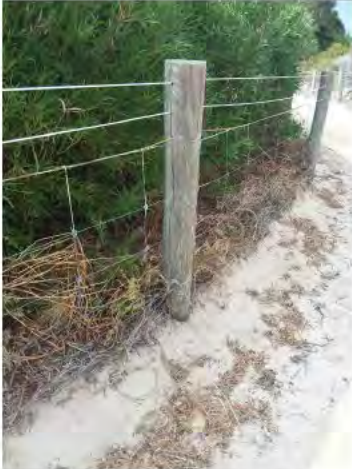
Site No.	C20
Site Name/ Location	North Quinns Rocks Foreshore
Date	09/02/2021
Time	09:06 (8 GMT)
Item Number	3
Costal Asset Type	Fencing
Element	Fencing East
Sub-element (Fencing)	Mesh
Material Type	Galvanised Steel
2021 Observed Defects (Steel)	Surface corrosion, Buckling/deformation
Defect Description	White rust was observed to be typical throughout. Turnbuckles observed to have corroded. Localised areas of red rust breakthrough were found. Top tension wire is corroded. Nylon wires appear in good condition.
Condition Rating (0- 10)	5
Health and Safety Concern (Y/N)	No
Consequence of Failure	2
Likelihood of Failure within next 5 years	2
Risk Rating	4
Overall Rating (CR X RR)	20
Maintenance Recommendation	Replace heavily corroded and rusted areas. Re-tension wires.
Maintenance Timeframe	Within 5 years

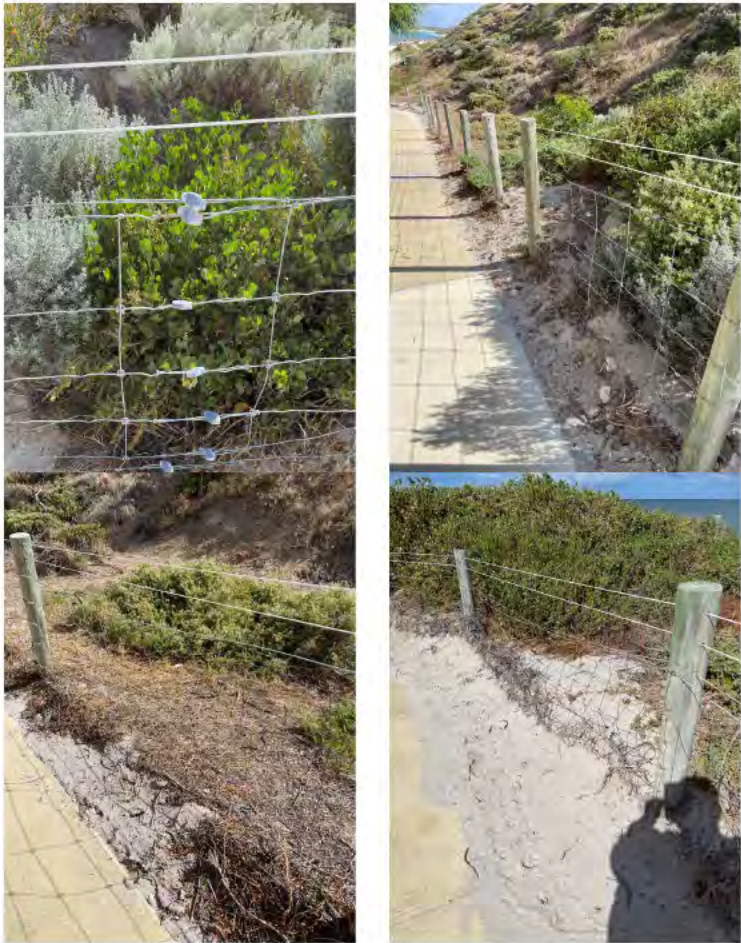
Pertains to east fence

<b>Site No.</b>	C20
<b>Site Name/ Location</b>	North Quinns Rocks Foreshore
<b>Date</b>	09/02/2021
<b>Time</b>	09:12 (8 GMT)
<b>Item Number</b>	4
<b>Costal Asset Type</b>	Fencing
<b>Element</b>	Fencing West
<b>Sub-element (Fencing)</b>	Mesh
<b>Material Type</b>	Coated Steel, Galvanised Steel
<b>2021 Observed Defects (Steel)</b>	Buckling/deformation
<b>Defect Description</b>	Bucking and deformation were observed to be typical throughout. With loose and corroded mesh also typical.
<b>Condition Rating (0- 10)</b>	7
<b>Health and Safety Concern (Y/N)</b>	No
<b>Consequence of Failure</b>	2
<b>Likelihood of Failure within next 5 years</b>	3
<b>Risk Rating</b>	6
<b>Overall Rating (CR X RR)</b>	42
<b>Maintenance Recommendation</b>	Replace damaged mesh. Re-tension wires.
<b>Maintenance Timeframe</b>	Within 1-2 years

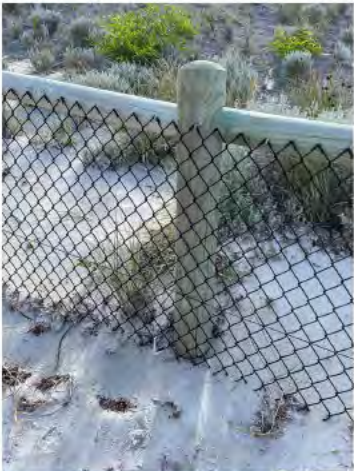
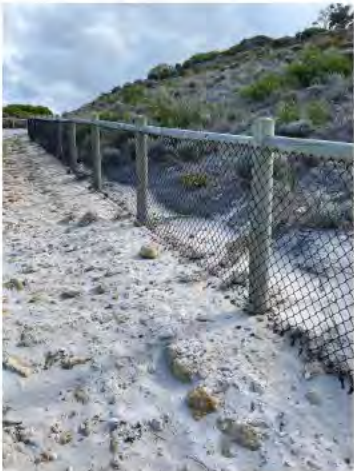
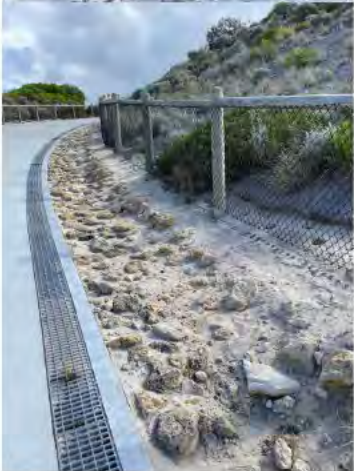
Site No.	C21
Site Name/ Location	North Quinns Rocks Foreshore
Date	09/02/2021
Time	08:40 (8 GMT)
Item Number	6
Costal Asset Type	Fencing
Element	Fencing
Sub-element (Fencing)	Mesh Localised
Material Type	Coated Steel
2021 Observed Defects (Steel)	Impact/mechanical damage
Defect Description	Impact damage at the top of the ramp was noticed, the extent of the damage is approximately 500 mm. Localised corrosion to turnbuckle.
Quantity of Defects	North side fencing
Defect Location	Top of ramp
Condition Rating (0- 10)	4
Health and Safety Concern (Y/N)	No
Consequence of Failure	2
Likelihood of Failure within next 5 years	3
Risk Rating	6
Overall Rating (CR X RR)	24
Maintenance Recommendation	Replace or fix damaged fence section. Replace corroded turnbuckle
Maintenance Timeframe	Within 5 years

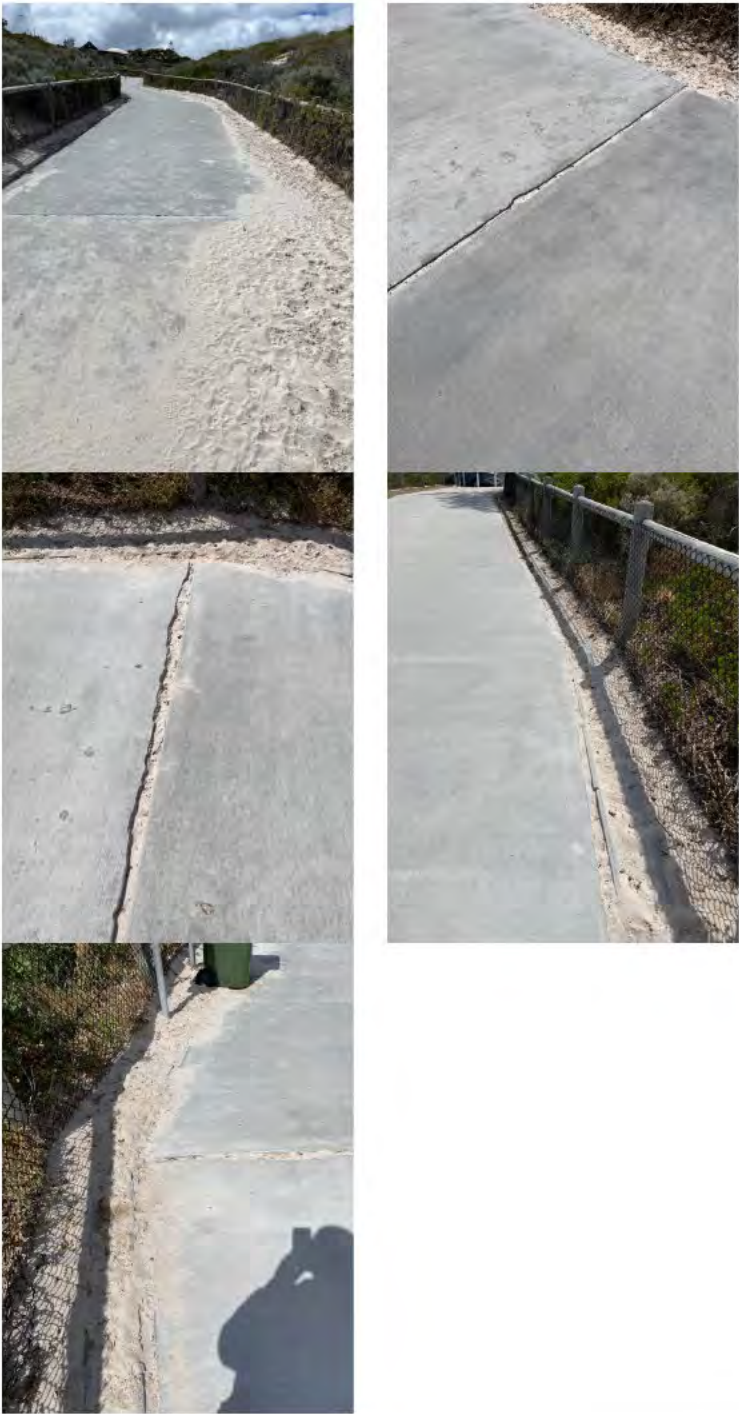
<b>Site No.</b>	C22
<b>Site Name/ Location</b>	North Quinns Rocks Foreshore
<b>Date</b>	09/02/2021
<b>Time</b>	10:33 (8 GMT)
<b>Item Number</b>	1
<b>Costal Asset Type</b>	Concrete path
<b>Element</b>	Surface
<b>Sub-element (Surface)</b>	Concrete paver
<b>Material Type</b>	Reinforced Concrete
<b>2021 Observed Defects (Reinforced Concrete)</b>	Spalling
<b>Defect Description</b>	Localised spalling was observed at the joints, the joint material at the larger joints was also found to be deteriorated
<b>Defect Location</b>	spalls at joints 87 x 3m
<b>Condition Rating (0- 10)</b>	3
<b>Health and Safety Concern (Y/N)</b>	No
<b>Consequence of Failure</b>	4
<b>Likelihood of Failure within next 5 years</b>	1
<b>Risk Rating</b>	4
<b>Overall Rating (CR X RR)</b>	12
<b>Maintenance Recommendation</b>	Monitor and reinspect at next scheduled inspection.
<b>Maintenance Timeframe</b>	Greater than 5 years

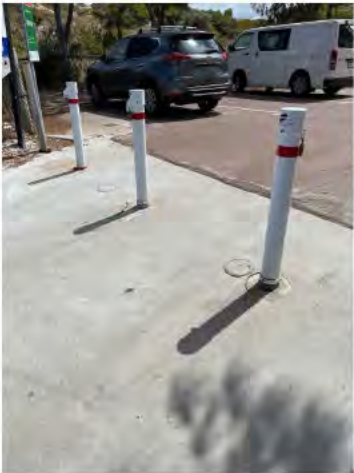
<b>Site No.</b>	C22
<b>Site Name/ Location</b>	North Quinns Rocks Foreshore
<b>Date</b>	09/02/2021
<b>Time</b>	10:39 (8 GMT)
<b>Item Number</b>	2
<b>Costal Asset Type</b>	Bollards
<b>Element</b>	Bollards
<b>Sub-element (Bollards)</b>	Bollards
<b>Material Type</b>	Coated Steel
<b>2021 Observed Defects (Steel)</b>	No visible defects were observed
<b>Defect Description</b>	3 no new bollards
<b>Condition Rating (0- 10)</b>	2
<b>Health and Safety Concern (Y/N)</b>	No
<b>Consequence of Failure</b>	2
<b>Likelihood of Failure within next 5 years</b>	1
<b>Risk Rating</b>	2
<b>Overall Rating (CR X RR)</b>	4
<b>Maintenance Recommendation</b>	Monitor and reinspect at next scheduled inspection.
<b>Maintenance Timeframe</b>	Greater than 5 years

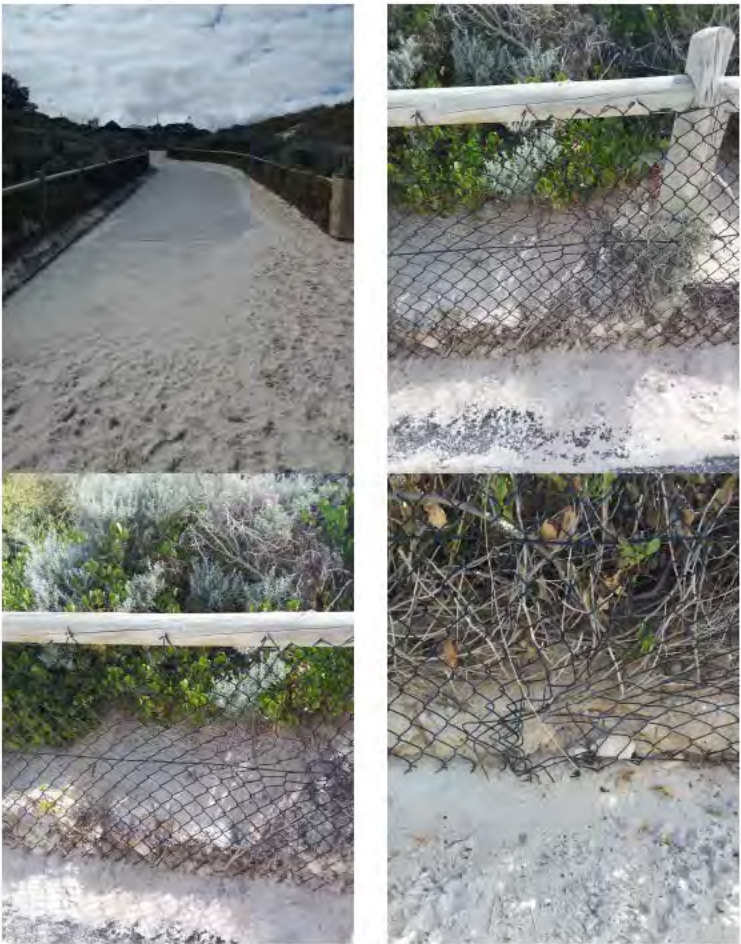
<b>Site No.</b>	C22
<b>Site Name/ Location</b>	North Quinns Rocks Foreshore
<b>Date</b>	09/02/2021
<b>Time</b>	10:34 (8 GMT)
<b>Item Number</b>	4
<b>Costal Asset Type</b>	Fencing
<b>Element</b>	Fencing
<b>Sub-element (Fencing)</b>	Mesh
<b>Material Type</b>	Coated Steel
<b>2021 Observed Defects (Steel)</b>	Rust staining, Coating loss, Impact/mechanical damage
<b>Defect Description</b>	<p>Generally in good condition. With the exception of the following defects:</p> <p>North Side: Impact damage at end of path, hole at base 10m from bottom of path, not secured to top rail at approx 35m from bottom of path , mesh stretched locally at 8m from top.</p> <p>South side: coating loss and corrosion 1m from top of path, mesh not secure at base midway of path, mesh not secure to posts at midheight typical along length, localised stretching at post 40m along length, not secured to top rail well (4m) approx 25m from bottom of path.</p> <p>Typical : Vegetation growth = at ocean end mesh including strainer wire and staples</p>

<b>Quantity of Defects</b>	174m (fence and strainer wire)
<b>Condition Rating (0- 10)</b>	5

<b>Health and Safety Concern (Y/N)</b>	No
<b>Consequence of Failure</b>	2
<b>Likelihood of Failure within next 5 years</b>	3
<b>Risk Rating</b>	6
<b>Overall Rating (CR X RR)</b>	30
<b>Maintenance Recommendation</b>	Replace damaged areas of the mesh
<b>Maintenance Timeframe</b>	Within 5 years

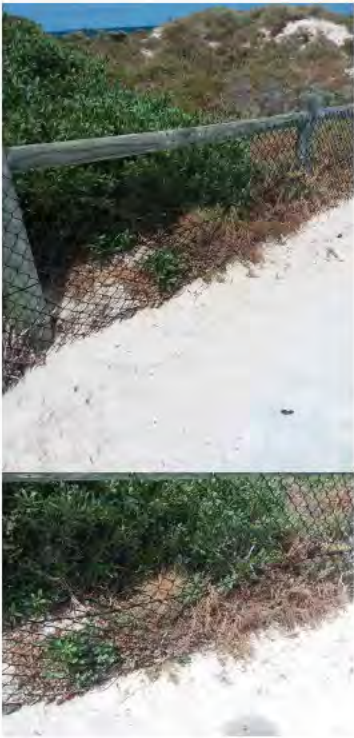
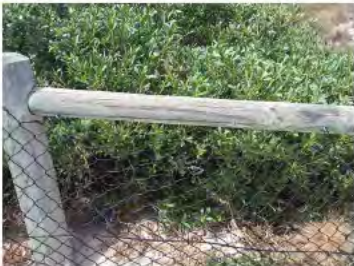
Site No.	C22
Site Name/ Location	North Quinns Rocks Foreshore
Date	09/02/2021
Time	10:48 (8 GMT)
Item Number	5
Costal Asset Type	Fencing
Element	Fencing
Sub-element (Fencing)	Mesh
Material Type	Coated Steel
2021 Observed Defects (Steel)	Buckling/deformation
Defect Description	A 2 m section midway along the path was observed to show deformation and also found not to be secured to the top rail.
Quantity of Defects	2m
Condition Rating (0- 10)	8
Health and Safety Concern (Y/N)	No
Consequence of Failure	2
Likelihood of Failure within next 5 years	4
Risk Rating	8
Overall Rating (CR X RR)	64
Maintenance Recommendation	Replace damaged mesh area
Maintenance Timeframe	Within 1-2 years

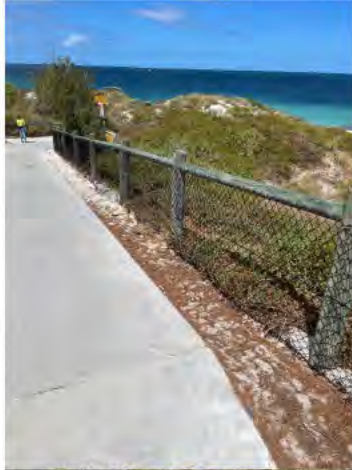
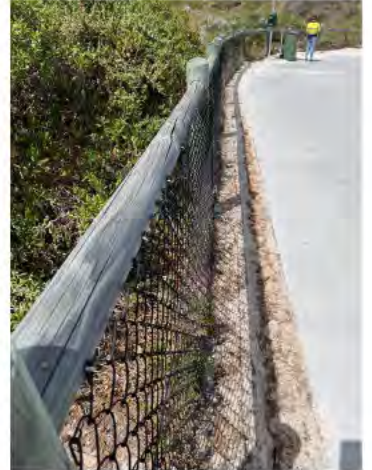
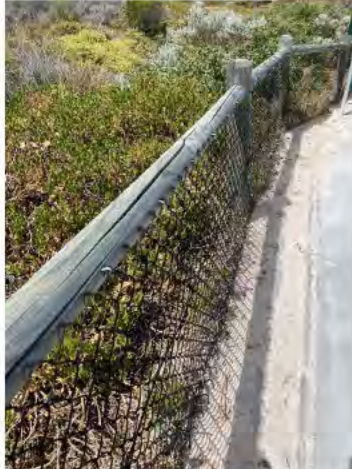
<b>Site No.</b>	C22
<b>Site Name/ Location</b>	North Quinns Rocks Foreshore
<b>Date</b>	09/02/2021
<b>Time</b>	10:46 (8 GMT)
<b>Item Number</b>	6
<b>Costal Asset Type</b>	Fencing
<b>Element</b>	Fencing
<b>Sub-element (Fencing)</b>	Timber Railing
<b>Material Type</b>	Timber
<b>2021 Observed Defects (Timber)</b>	Split timber, Rotted timber
<b>Defect Description</b>	Minor timber splitting was observed to be typical throughout, with heavier splitting on the western and eastern sides of the fencing.
<b>Condition Rating (0- 10)</b>	4
<b>Health and Safety Concern (Y/N)</b>	No
<b>Consequence of Failure</b>	3
<b>Likelihood of Failure within next 5 years</b>	2
<b>Risk Rating</b>	6
<b>Overall Rating (CR X RR)</b>	24
<b>Maintenance Recommendation</b>	Replace timber which contain heavy splitting.
<b>Maintenance Timeframe</b>	Within 5 years

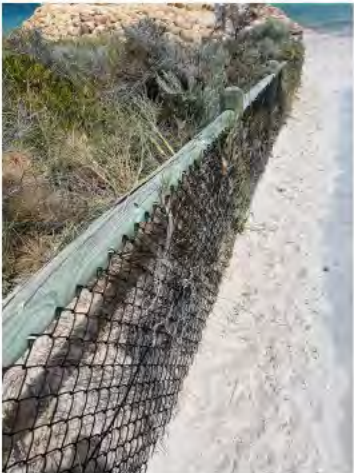
<b>Site No.</b>	C22
<b>Site Name/ Location</b>	North Quinns Rocks Foreshore
<b>Date</b>	09/02/2021
<b>Time</b>	10:49 (8 GMT)
<b>Item Number</b>	7
<b>Costal Asset Type</b>	Fencing
<b>Element</b>	Fencing
<b>Sub-element (Fencing)</b>	Timber rail
<b>Material Type</b>	Timber
<b>2021 Observed Defects (Timber)</b>	Split timber, Rotted timber
<b>Defect Description</b>	Heavy timber splitting was observed between post 5 and 6 from the base of the pathway on the south side fence.
<b>Quantity of Defects</b>	1 no
<b>Defect Location</b>	Between 5th and 6th post from base of pathway, on southern fence
<b>Condition Rating (0- 10)</b>	7
<b>Health and Safety Concern (Y/N)</b>	No
<b>Consequence of Failure</b>	2
<b>Likelihood of Failure within next 5 years</b>	4
<b>Risk Rating</b>	8
<b>Overall Rating (CR X RR)</b>	56
<b>Maintenance Recommendation</b>	Replace locally damaged timber rail
<b>Maintenance Timeframe</b>	Within 1-2 years

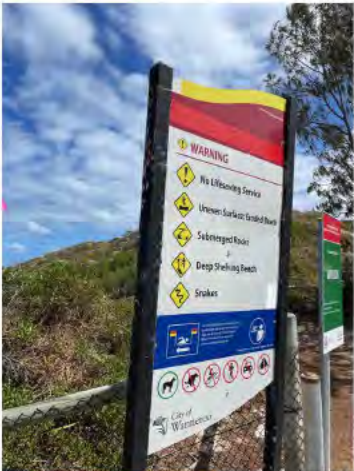
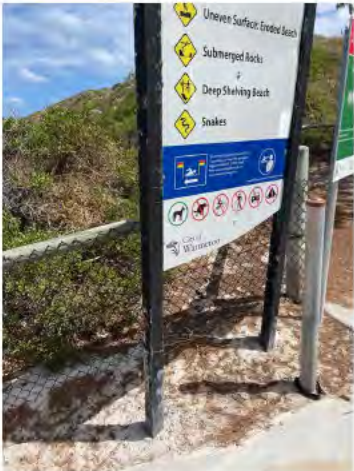
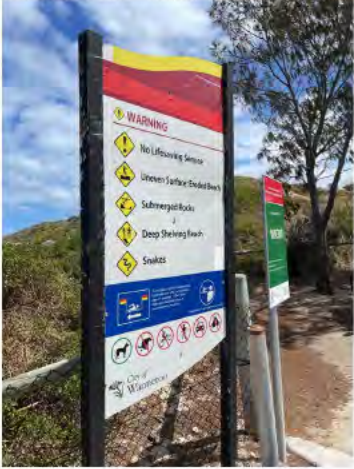
<b>Site No.</b>	C22
<b>Site Name/ Location</b>	North Quinns Rocks Foreshore
<b>Date</b>	09/02/2021
<b>Time</b>	10:40 (8 GMT)
<b>Item Number</b>	8
<b>Costal Asset Type</b>	Sign
<b>Element</b>	Sign
<b>Sub-element (Sign)</b>	Sign
<b>Material Type</b>	Coated Steel
<b>2021 Observed Defects (Steel)</b>	Surface corrosion, Coating loss
<b>Defect Description</b>	Coating loss and corrosion was observed on the signposts.
<b>Condition Rating (0- 10)</b>	6
<b>Health and Safety Concern (Y/N)</b>	No
<b>Consequence of Failure</b>	2
<b>Likelihood of Failure within next 5 years</b>	3
<b>Risk Rating</b>	6
<b>Overall Rating (CR X RR)</b>	36
<b>Maintenance Recommendation</b>	Abrasive blast clean and apply protective coating
<b>Maintenance Timeframe</b>	Within 5 years

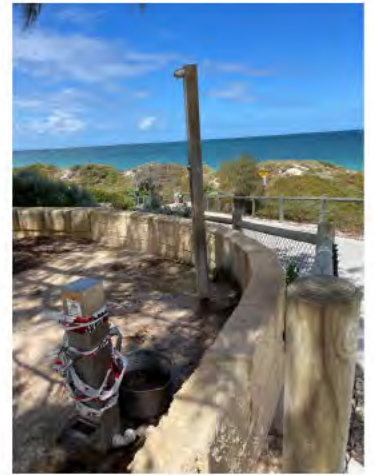
<b>Site No.</b>	C22
<b>Site Name/ Location</b>	North Quinns Rocks Foreshore
<b>Date</b>	09/02/2021
<b>Time</b>	10:42 (8 GMT)
<b>Item Number</b>	9
<b>Costal Asset Type</b>	Shower
<b>Material Type</b>	Stainless Steel, Limestone
<b>2021 Observed Defects (Steel)</b>	Surface corrosion
<b>Defect Description</b>	The fountain was observed to be wrapped in danger tape and marked with an out of order sign. Corrosion was observed on the shower base. The limestone walls and base slab were in good condition.
<b>Quantity of Defects</b>	2 x 4 m
<b>Condition Rating (0- 10)</b>	4
<b>Health and Safety Concern (Y/N)</b>	No
<b>Consequence of Failure</b>	2
<b>Likelihood of Failure within next 5 years</b>	1
<b>Risk Rating</b>	2
<b>Overall Rating (CR X RR)</b>	8
<b>Maintenance Recommendation</b>	Replace or fix damaged fountain, blast clean and recoat the shower base.
<b>Maintenance Timeframe</b>	Within 6 months

Replace drink fountain

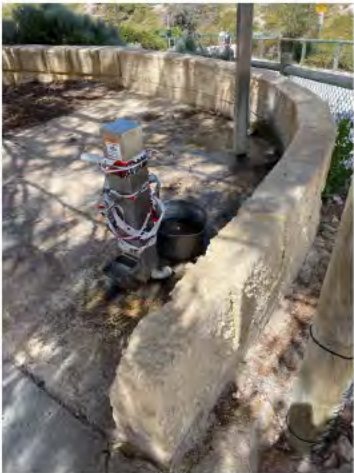
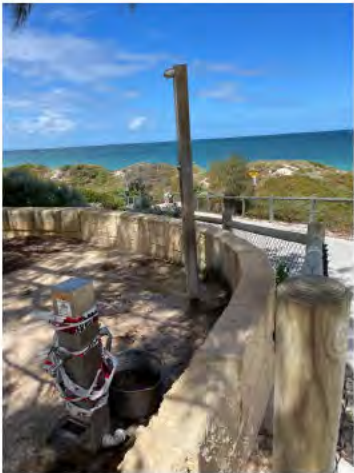
<b>Site No.</b>	C22
<b>Site Name/ Location</b>	North Quinns Rocks Foreshore
<b>Date</b>	09/02/2021
<b>Time</b>	10:42 (8 GMT)
<b>Item Number</b>	10
<b>Costal Asset Type</b>	Shower
<b>Sub Element</b>	Wall
<b>Material Type</b>	Limestone
<b>2021 Observed Defects (Steel)</b>	Surface corrosion
<b>Defect Description</b>	The limestone walls and base slab were in good condition.
<b>Condition Rating (0- 10)</b>	2
<b>Health and Safety Concern (Y/N)</b>	No
<b>Consequence of Failure</b>	2
<b>Likelihood of Failure within next 5 years</b>	1
<b>Risk Rating</b>	2
<b>Overall Rating (CR X RR)</b>	8
<b>Maintenance Recommendation</b>	Monitor and reinspect at next scheduled inspection.
<b>Maintenance Timeframe</b>	Greater than 5 years

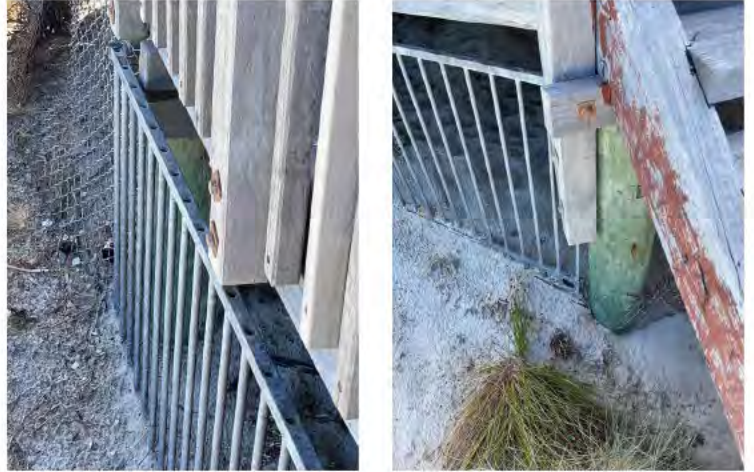
<b>Site No.</b>	C23
<b>Site Name/ Location</b>	North Quinns Rocks Foreshore
<b>Date</b>	09/02/2021
<b>Time</b>	11:30 (8 GMT)
<b>Item Number</b>	1
<b>Costal Asset Type</b>	Covered look out
<b>Element</b>	Foundation
<b>Sub-element (Foundations)</b>	Piles
<b>Material Type</b>	Timber
<b>2021 Observed Defects (Timber)</b>	No visible defects
<b>Defect Description</b>	Generally good condition. Connection bolts observed to be typically corroded.
<b>Quantity of Defects</b>	5 no total
<b>Condition Rating (0- 10)</b>	3
<b>Health and Safety Concern (Y/N)</b>	No
<b>Consequence of Failure</b>	4
<b>Likelihood of Failure within next 5 years</b>	1
<b>Risk Rating</b>	4
<b>Overall Rating (CR X RR)</b>	12
<b>Maintenance Recommendation</b>	Monitor and reinspect at next scheduled inspection.
<b>Maintenance Timeframe</b>	Greater than 5 years

Inspected from stair case due to restricted access

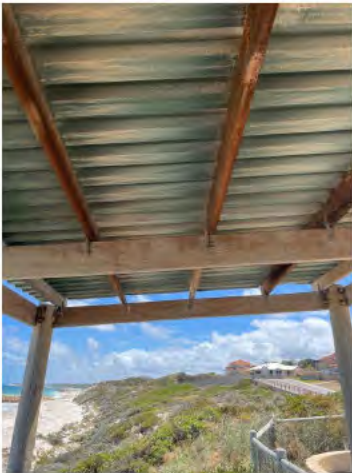
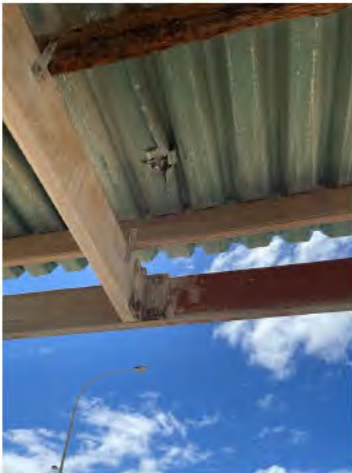
<b>Site No.</b>	C23
<b>Site Name/ Location</b>	North Quinns Rocks Foreshore
<b>Date</b>	09/02/2021
<b>Time</b>	11:24 (8 GMT)
<b>Item Number</b>	11
<b>Costal Asset Type</b>	Covered look out
<b>Element</b>	Roof sheeting
<b>Material Type</b>	Other
<b>Material Type (Other)</b>	Colourbond
<b>Defect Description</b>	Underside typically in good condition. One localised area of damage observed. Inspection limited to underside.
<b>Condition Rating (0- 10)</b>	4
<b>Health and Safety Concern (Y/N)</b>	No
<b>Consequence of Failure</b>	3
<b>Likelihood of Failure within next 5 years</b>	2
<b>Risk Rating</b>	6
<b>Overall Rating (CR X RR)</b>	24
<b>Maintenance Recommendation</b>	Monitor and reinspect at next scheduled inspection.
<b>Maintenance Timeframe</b>	Greater than 5 years

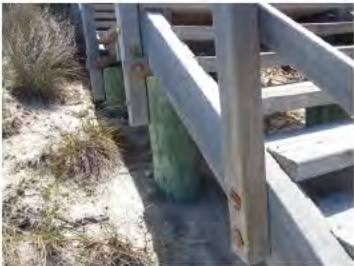
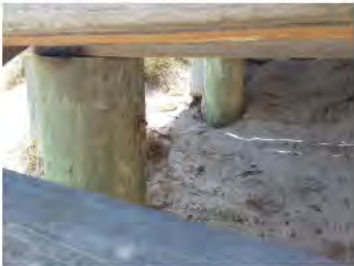
<b>Site No.</b>	C23
<b>Site Name/ Location</b>	North Quinns Rocks Foreshore
<b>Date</b>	09/02/2021
<b>Time</b>	11:28 (8 GMT)
<b>Item Number</b>	12
<b>Costal Asset Type</b>	Stairs
<b>Element</b>	Foundation
<b>Sub-element (Foundations)</b>	Piles
<b>Material Type</b>	Timber, Steel
<b>2021 Observed Defects (Timber)</b>	Split timber
<b>2021 Observed Defects (Steel)</b>	Corrosion with section loss
<b>Defect Description</b>	Timber members observed to contain splitting. Steel bolts observed to contain corrosion with potential section loss on washer plates.
<b>Quantity of Defects</b>	6 x 300m diameter
<b>Condition Rating (0- 10)</b>	5
<b>Health and Safety Concern (Y/N)</b>	No
<b>Consequence of Failure</b>	4
<b>Likelihood of Failure within next 5 years</b>	2
<b>Risk Rating</b>	8
<b>Overall Rating (CR X RR)</b>	40
<b>Maintenance Recommendation</b>	Monitor and reinspect at next scheduled inspection.
<b>Maintenance Timeframe</b>	Greater than 5 years

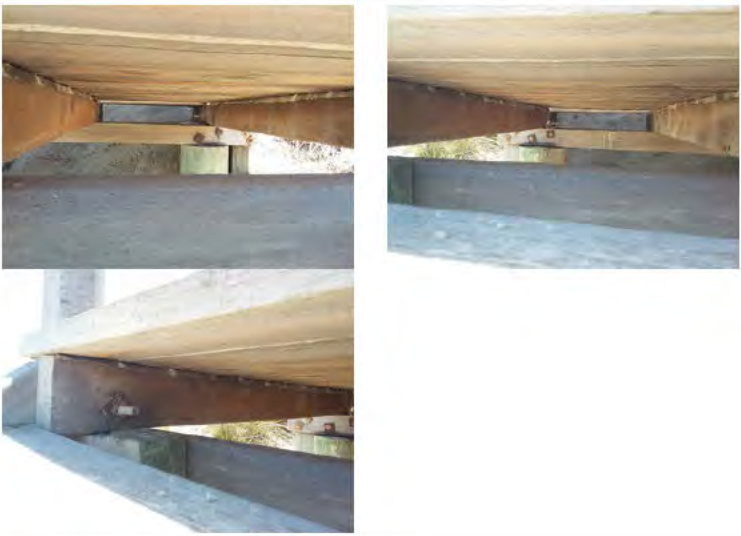
<b>Site No.</b>	C23
<b>Site Name/ Location</b>	North Quinns Rocks Foreshore
<b>Date</b>	09/02/2021
<b>Time</b>	11:33 (8 GMT)
<b>Item Number</b>	13
<b>Costal Asset Type</b>	Stairs
<b>Element</b>	Supports
<b>Sub-element (Stairs and Landing)</b>	Timber sleepers
<b>Material Type</b>	Steel, Timber
<b>2021 Observed Defects (Timber)</b>	No visible defects
<b>2021 Observed Defects (Steel)</b>	Corrosion with section loss
<b>Defect Description</b>	Timber members generally in good condition. Corrosion and section loss to connections observed.
<b>Quantity of Defects</b>	20m
<b>Condition Rating (0- 10)</b>	6
<b>Health and Safety Concern (Y/N)</b>	No
<b>Consequence of Failure</b>	4
<b>Likelihood of Failure within next 5 years</b>	3
<b>Risk Rating</b>	12
<b>Overall Rating (CR X RR)</b>	72
<b>Maintenance Recommendation</b>	Replace corroded connections
<b>Maintenance Timeframe</b>	Within 1-2 years

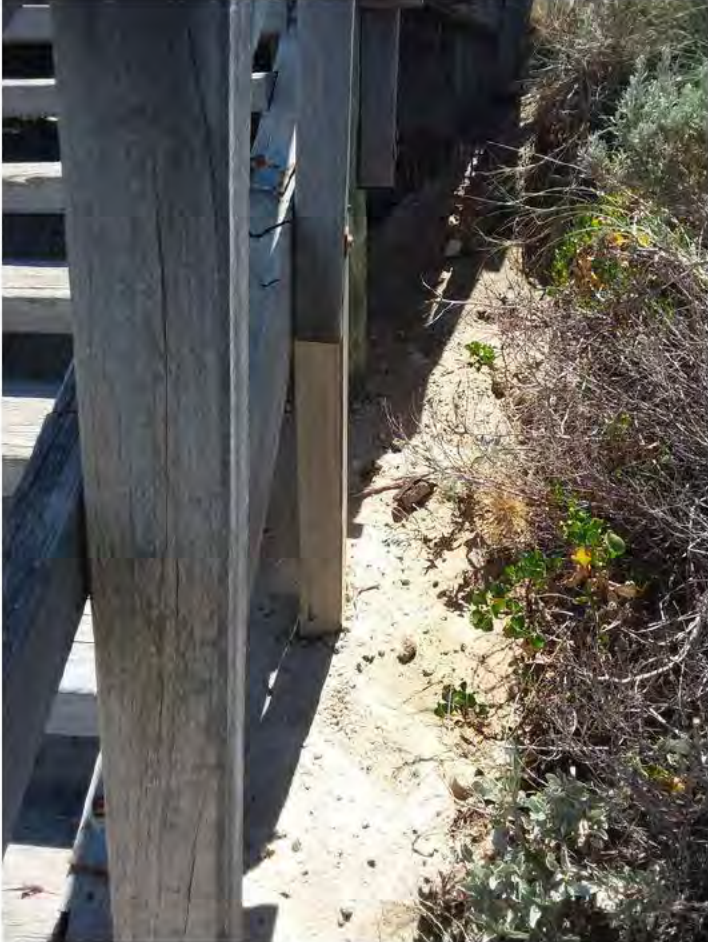
<b>Site No.</b>	C23
<b>Site Name/ Location</b>	North Quinns Rocks Foreshore
<b>Date</b>	09/02/2021
<b>Time</b>	11:22 (8 GMT)
<b>Item Number</b>	14
<b>Costal Asset Type</b>	Stairs
<b>Element</b>	Supports
<b>Sub-element (Stairs and Landing)</b>	Stair support stubs
<b>Material Type</b>	Timber
<b>2021 Observed Defects (Timber)</b>	No visible defects observed.
<b>Defect Description</b>	New support stub added to structure at top on south side. surface corrosion to bolts. Remaining stubs in good condition.
<b>Quantity of Defects</b>	1
<b>Condition Rating (0- 10)</b>	3
<b>Health and Safety Concern (Y/N)</b>	No
<b>Consequence of Failure</b>	4
<b>Likelihood of Failure within next 5 years</b>	2
<b>Risk Rating</b>	8
<b>Overall Rating (CR X RR)</b>	24
<b>Maintenance Recommendation</b>	Monitor and reinspect at next scheduled inspection.
<b>Maintenance Timeframe</b>	Greater than 5 years

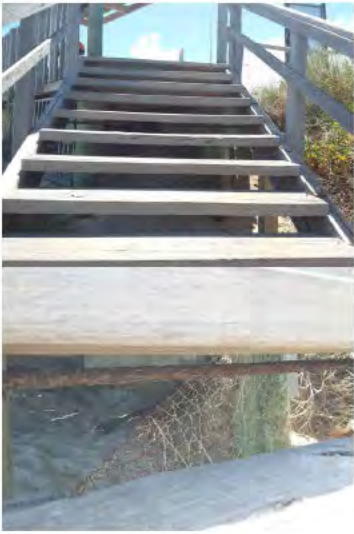
<b>Site No.</b>	C23
<b>Site Name/ Location</b>	North Quinns Rocks Foreshore
<b>Date</b>	09/02/2021
<b>Time</b>	11:25 (8 GMT)
<b>Item Number</b>	15
<b>Costal Asset Type</b>	Stairs
<b>Element</b>	Stairs
<b>Sub-element (Stairs and Landing)</b>	Tie rods
<b>Material Type</b>	Steel
<b>2021 Observed Defects (Steel)</b>	Corrosion with section loss
<b>Defect Description</b>	Severe corrosion with potential section loss observed.
<b>Quantity of Defects</b>	6 x 2m
<b>Condition Rating (0- 10)</b>	8
<b>Health and Safety Concern (Y/N)</b>	No
<b>Consequence of Failure</b>	3
<b>Likelihood of Failure within next 5 years</b>	4
<b>Risk Rating</b>	12
<b>Overall Rating (CR X RR)</b>	96
<b>Maintenance Recommendation</b>	Replace heavily corroded sections.
<b>Maintenance Timeframe</b>	Within 1-2 years

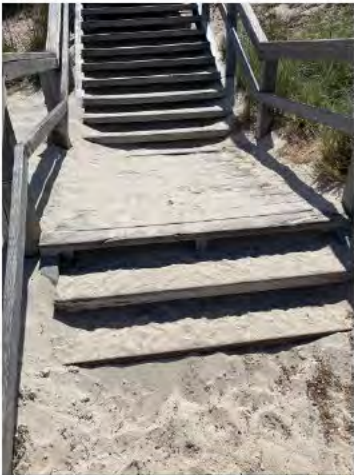
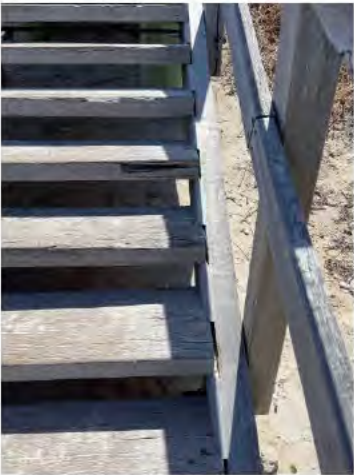
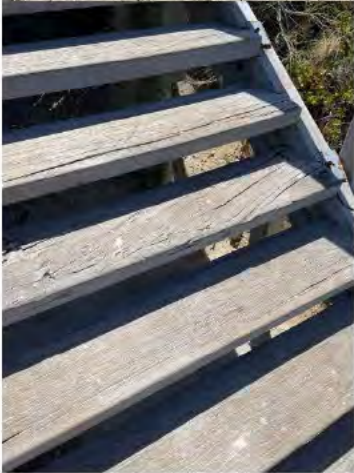
<b>Site No.</b>	C23
<b>Site Name/ Location</b>	North Quinns Rocks Foreshore
<b>Date</b>	09/02/2021
<b>Time</b>	11:08 (8 GMT)
<b>Item Number</b>	17
<b>Costal Asset Type</b>	Stairs
<b>Element</b>	Stairs
<b>Sub-element (Stairs and Landing)</b>	Stair treads
<b>Material Type</b>	Timber
<b>2021 Observed Defects (Timber)</b>	Split timber, Other
<b>Defect Description</b>	Localised rotting and timber splitting observed. Paint observed to be completely deteriorated
<b>Quantity of Defects</b>	37 treads total including landings
<b>Condition Rating (0- 10)</b>	5
<b>Health and Safety Concern (Y/N)</b>	No
<b>Consequence of Failure</b>	4
<b>Likelihood of Failure within next 5 years</b>	3
<b>Risk Rating</b>	12
<b>Overall Rating (CR X RR)</b>	60
<b>Maintenance Recommendation</b>	Replace heavily split or rotted sections
<b>Maintenance Timeframe</b>	Within 5 years

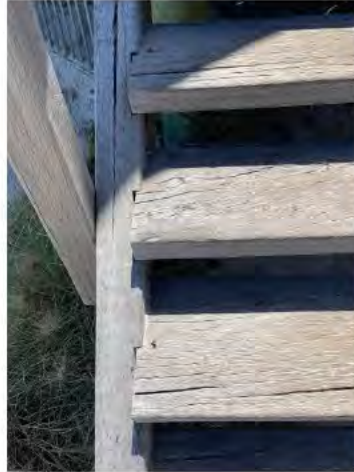
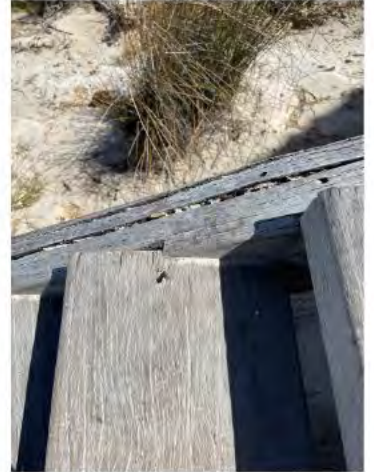
<b>Site No.</b>	C23
<b>Site Name/ Location</b>	North Quinns Rocks Foreshore
<b>Date</b>	09/02/2021
<b>Time</b>	11:12 (8 GMT)
<b>Item Number</b>	18
<b>Costal Asset Type</b>	Stairs
<b>Element</b>	Stairs
<b>Sub-element (Stairs and Landing)</b>	Stair tread nails
<b>Material Type</b>	Steel
<b>Defect Description</b>	Some nails observed to be protruding, causing a safety hazard.
<b>Condition Rating (0- 10)</b>	79
<b>Health and Safety Concern (Y/N)</b>	Yes
<b>Consequence of Failure</b>	2
<b>Likelihood of Failure within next 5 years</b>	3
<b>Risk Rating</b>	6
<b>Overall Rating (CR X RR)</b>	54
<b>Maintenance Recommendation</b>	Replace protruding nails
<b>Maintenance Timeframe</b>	Immediately

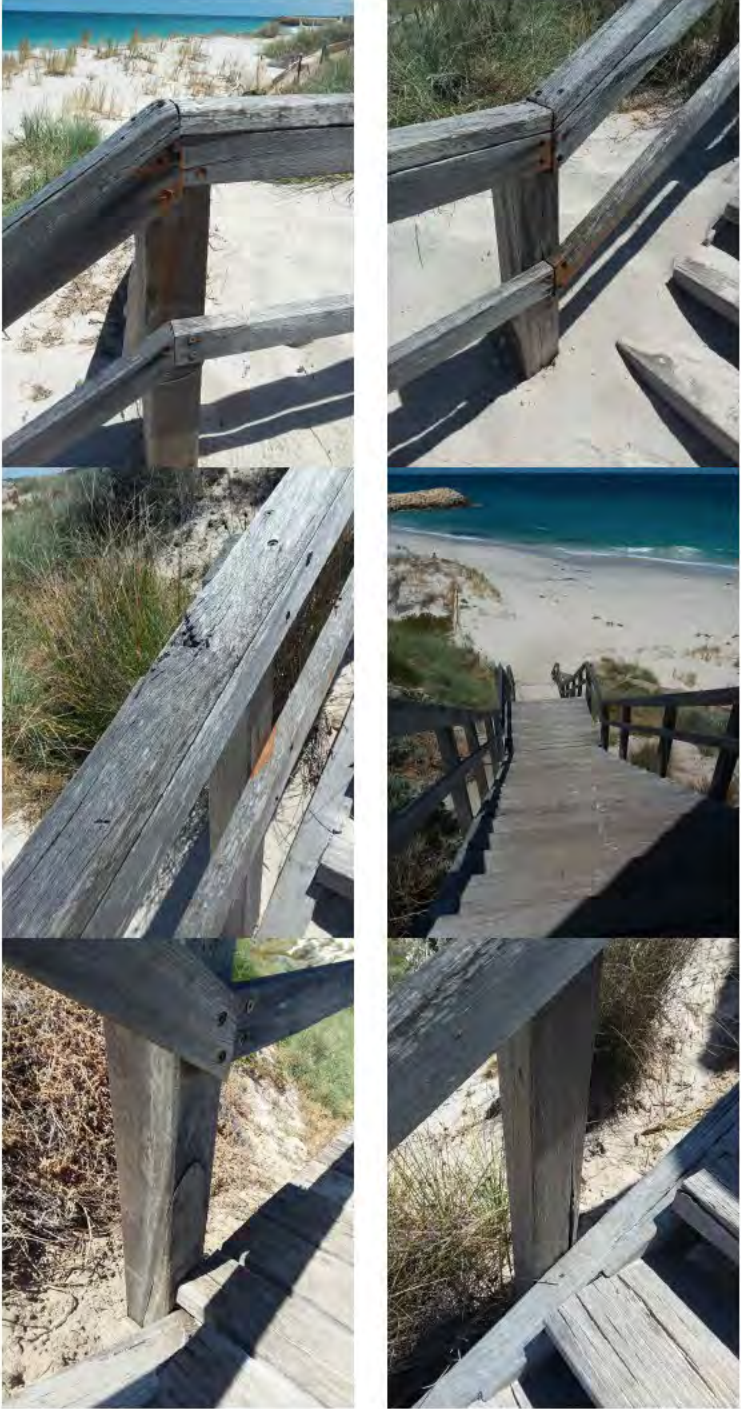
<b>Site No.</b>	C23
<b>Site Name/ Location</b>	North Quinns Rocks Foreshore
<b>Date</b>	09/02/2021
<b>Time</b>	11:07 (8 GMT)
<b>Item Number</b>	19
<b>Costal Asset Type</b>	Stairs
<b>Element</b>	Handrails
<b>Material Type</b>	Timber
<b>2021 Observed Defects (Timber)</b>	Split timber
<b>Defect Description</b>	Paint observed to have completely deteriorated. Splitting timber and corrosion around the bolts observed to be typical throughout. Inspection limited due to buried base.
<b>Quantity of Defects</b>	28m
<b>Condition Rating (0- 10)</b>	5
<b>Health and Safety Concern (Y/N)</b>	No
<b>Consequence of Failure</b>	3
<b>Likelihood of Failure within next 5 years</b>	3
<b>Risk Rating</b>	9
<b>Overall Rating (CR X RR)</b>	45
<b>Maintenance Recommendation</b>	Monitor and reinspect at next scheduled inspection.
<b>Maintenance Timeframe</b>	Greater than 5 years

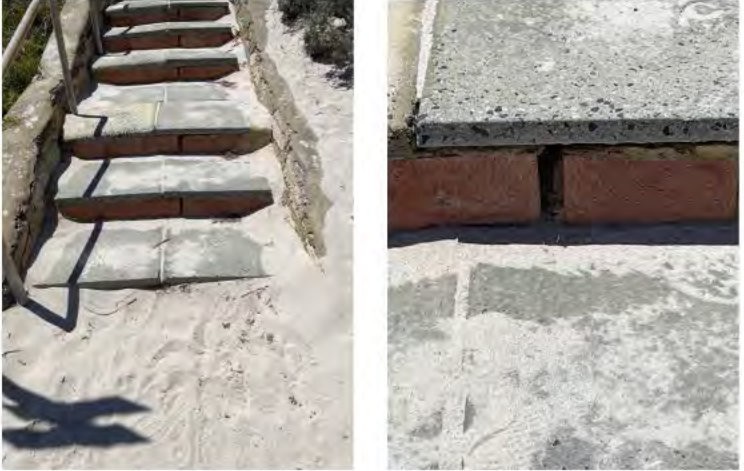
<b>Site No.</b>	C24
<b>Site Name/ Location</b>	Quinns Rocks Beach Foreshore
<b>Date</b>	09/02/2021
<b>Time</b>	11:49 (8 GMT)
<b>Item Number</b>	1
<b>Costal Asset Type</b>	Stairs
<b>Sub-element (Stairs and Landing)</b>	Stair treads
<b>Material Type</b>	Other, Reinforced Concrete
<b>2021 Observed Defects (Reinforced Concrete)</b>	Grout Deterioration
<b>Material Type (Other)</b>	Brick
<b>Defect Description</b>	Generally good condition. Some grout deterioration observed between brick courses. Inspection limited due to sand
<b>Quantity of Defects</b>	36 stairs visible approx 1 x 40m Approx 6 covered with sand
<b>Condition Rating (0- 10)</b>	5
<b>Health and Safety Concern (Y/N)</b>	No
<b>Consequence of Failure</b>	3
<b>Likelihood of Failure within next 5 years</b>	2
<b>Risk Rating</b>	6
<b>Overall Rating (CR X RR)</b>	30
<b>Maintenance Recommendation</b>	Monitor and reinspect at next scheduled inspection.

<b>Maintenance Timeframe</b>	Greater than 5 years
<b>Multi Photo</b>

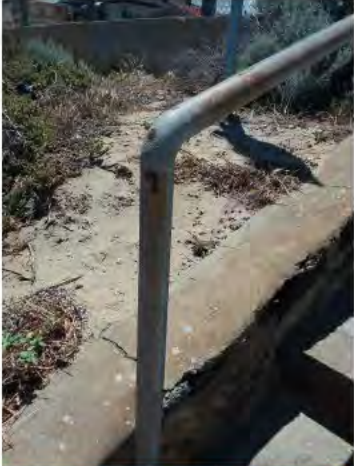
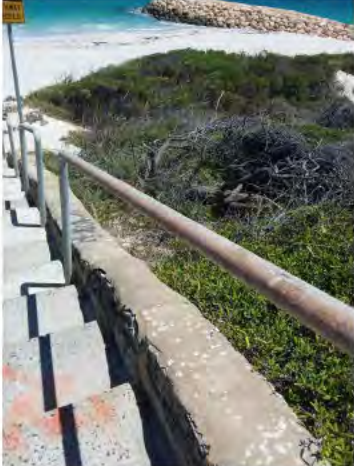
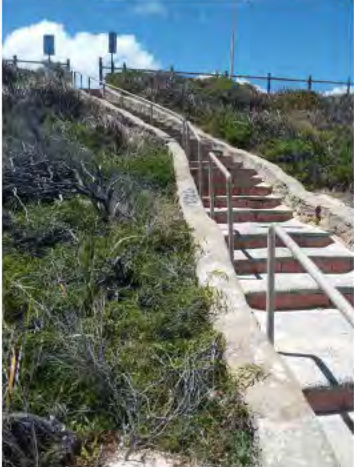
<b>Site No.</b>	C24
<b>Site Name/ Location</b>	Quinns Rocks Beach Foreshore
<b>Date</b>	09/02/2021
<b>Time</b>	11:47 (8 GMT)
<b>Item Number</b>	2
<b>Costal Asset Type</b>	Stairs
<b>Sub-element (Handrails)</b>	Steel
<b>Material Type</b>	Galvanised Steel
<b>2021 Observed Defects (Steel)</b>	Surface corrosion, Blistering/peeling
<b>Defect Description</b>	Widespread surface corrosion and coating loss.
<b>Defect Location</b>	handrail on north side only
<b>Quantity of Defects</b>	11m
<b>Condition Rating (0- 10)</b>	6
<b>Health and Safety Concern (Y/N)</b>	No
<b>Consequence of Failure</b>	3
<b>Likelihood of Failure within next 5 years</b>	3
<b>Risk Rating</b>	9
<b>Overall Rating (CR X RR)</b>	54
<b>Maintenance Recommendation</b>	Abrasive blast clean and apply protective coating
<b>Maintenance Timeframe</b>	Within 1-2 years

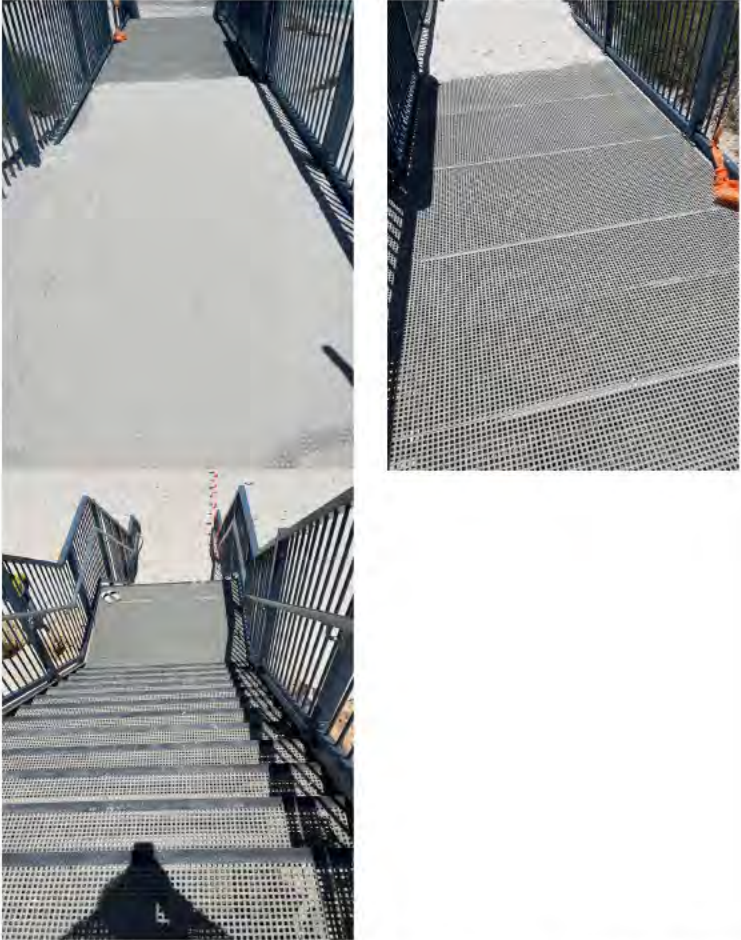
Top and bottom landing partially obstructed by sand and not inspected

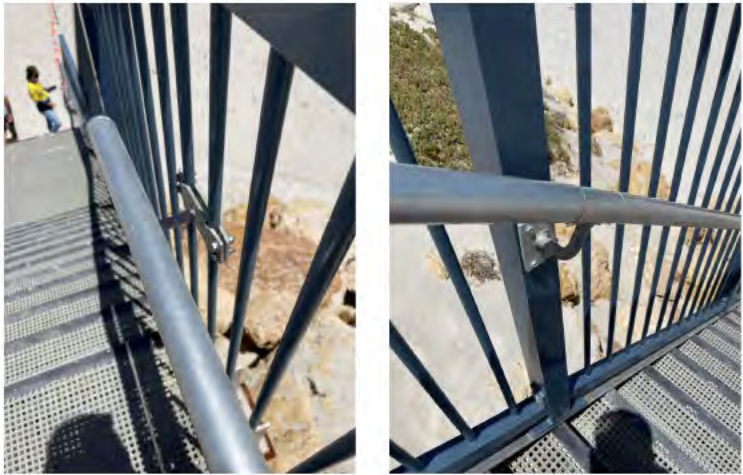
<b>Site No.</b>	C25
<b>Site Name/ Location</b>	Quinns Rocks Beach Foreshore
<b>Date</b>	09/02/2021
<b>Time</b>	12:17 (8 GMT)
<b>Item Number</b>	8
<b>Costal Asset Type</b>	Railing
<b>Element</b>	Handrails
<b>Sub-element (Handrails)</b>	Top rail
<b>Material Type</b>	Stainless Steel
<b>2021 Observed Defects (Steel)</b>	No visible defects observed
<b>Quantity of Defects</b>	Approx 25m
<b>Condition Rating (0- 10)</b>	2
<b>Health and Safety Concern (Y/N)</b>	No
<b>Consequence of Failure</b>	2
<b>Likelihood of Failure within next 5 years</b>	1
<b>Risk Rating</b>	2
<b>Overall Rating (CR X RR)</b>	4
<b>Maintenance Recommendation</b>	Monitor and reinspect at next scheduled inspection.
<b>Maintenance Timeframe</b>	Greater than 5 years

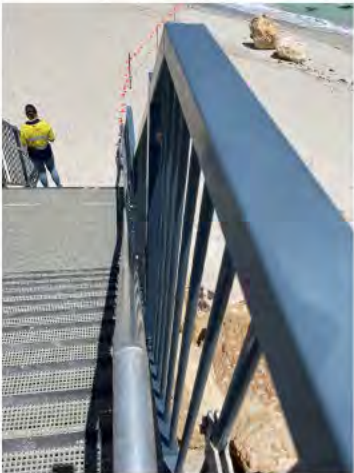
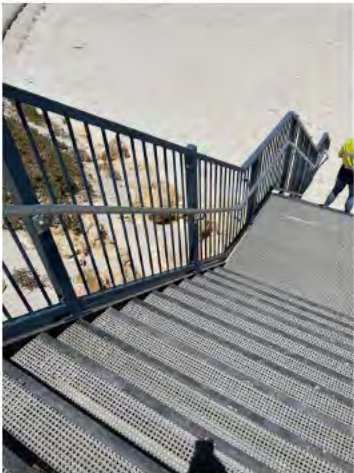
<b>Site No.</b>	C25
<b>Site Name/ Location</b>	Quinns Rocks Beach Foreshore
<b>Date</b>	09/02/2021
<b>Time</b>	12:15 (8 GMT)
<b>Item Number</b>	9
<b>Costal Asset Type</b>	Stairs
<b>Element</b>	Gate
<b>Sub-element</b>	Gate
<b>Material Type</b>	Coated Steel
<b>2021 Observed Defects (Steel)</b>	No visible defects
<b>Defect Description</b>	No visible defects were observed on the gate. Minor white rust noticed on the chain.
<b>Condition Rating (0- 10)</b>	3
<b>Health and Safety Concern (Y/N)</b>	No
<b>Consequence of Failure</b>	2
<b>Likelihood of Failure within next 5 years</b>	1
<b>Risk Rating</b>	2
<b>Overall Rating (CR X RR)</b>	6
<b>Maintenance Recommendation</b>	Monitor and reinspect at next scheduled inspection.
<b>Maintenance Timeframe</b>	Greater than 5 years

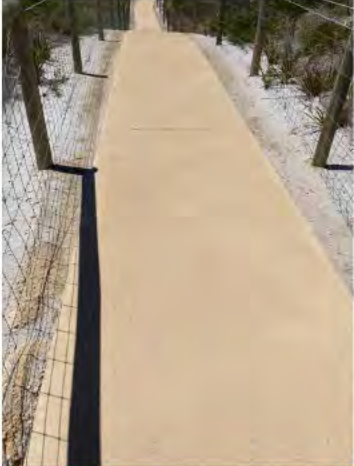
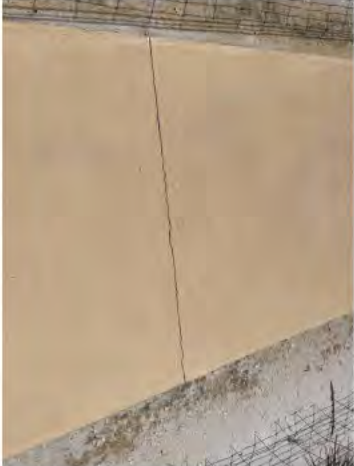
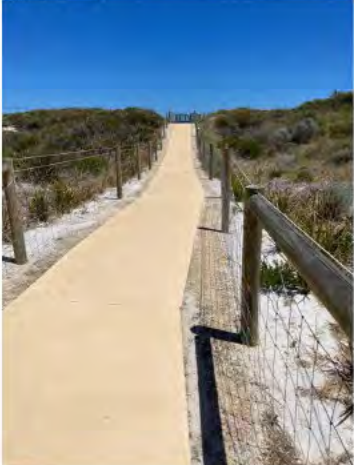
<b>Site No.</b>	C26
<b>Site Name/ Location</b>	South Quinns Rocks Foreshore
<b>Date</b>	09/02/2021
<b>Time</b>	12:58 (8 GMT)
<b>Item Number</b>	1
<b>Costal Asset Type</b>	Concrete path
<b>Element</b>	Foundation
<b>Sub-element (Surface)</b>	Base Slab
<b>Material Type</b>	Reinforced Concrete
<b>2021 Observed Defects (Reinforced Concrete)</b>	Crack
<b>Defect Description</b>	Minor cracks and damage were observed at the joints.
<b>Quantity of Defects</b>	44 x 1.5m
<b>Condition Rating (0- 10)</b>	3
<b>Health and Safety Concern (Y/N)</b>	No
<b>Consequence of Failure</b>	3
<b>Likelihood of Failure within next 5 years</b>	1
<b>Risk Rating</b>	3
<b>Overall Rating (CR X RR)</b>	9
<b>Maintenance Recommendation</b>	Monitor and reinspect at next scheduled inspection.
<b>Maintenance Timeframe</b>	Greater than 5 years

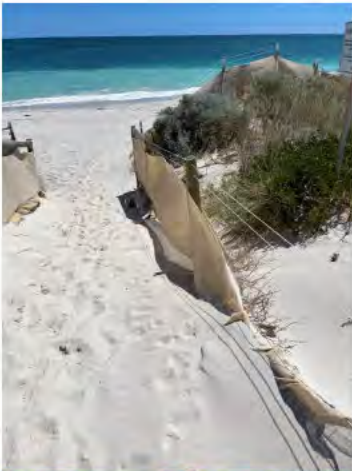
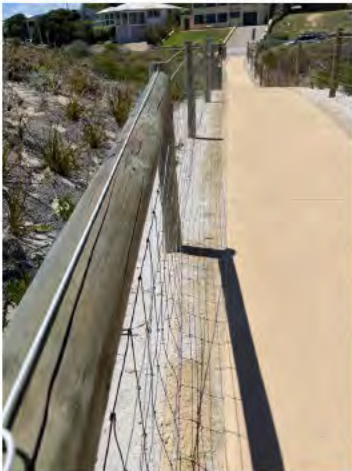
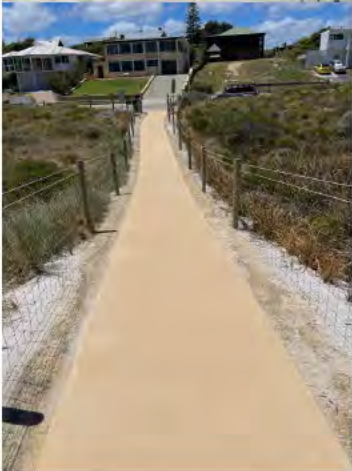
<b>Site No.</b>	C26
<b>Site Name/ Location</b>	South Quinns Rocks Foreshore
<b>Date</b>	09/02/2021
<b>Time</b>	13:03 (8 GMT)
<b>Item Number</b>	2
<b>Costal Asset Type</b>	Fencing
<b>Element</b>	Fencing
<b>Sub-element (Fencing)</b>	Timber Posts and Rails
<b>Material Type</b>	Timber
<b>2021 Observed Defects (Timber)</b>	Split timber
<b>Defect Description</b>	Minor splits, pertains to posts and rails
<b>Condition Rating (0- 10)</b>	3
<b>Health and Safety Concern (Y/N)</b>	No
<b>Consequence of Failure</b>	3
<b>Likelihood of Failure within next 5 years</b>	2
<b>Risk Rating</b>	6
<b>Overall Rating (CR X RR)</b>	18
<b>Maintenance Recommendation</b>	Monitor and reinspect at next scheduled inspection.
<b>Maintenance Timeframe</b>	Greater than 5 years

Bottom 10m covered with sand and not inspected

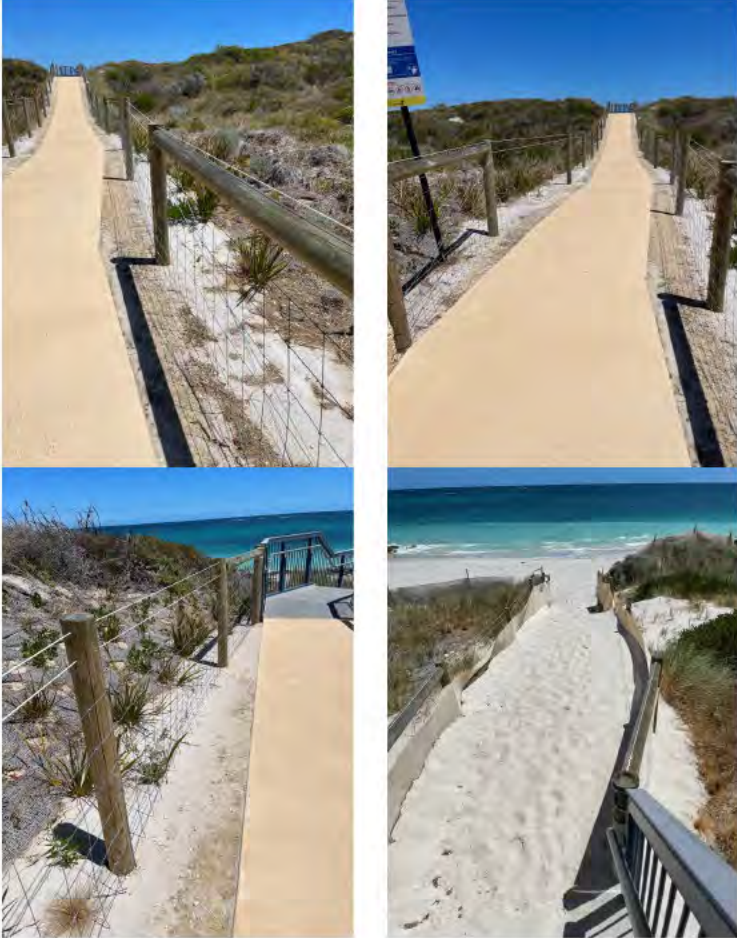
<b>Site No.</b>	C26
<b>Site Name/ Location</b>	South Quinns Rocks Foreshore
<b>Date</b>	09/02/2021
<b>Time</b>	13:00 (8 GMT)
<b>Item Number</b>	3
<b>Costal Asset Type</b>	Fencing
<b>Element</b>	Fencing
<b>Sub-element (Fencing)</b>	Mesh, Cloth Strainer Wire and Staples
<b>Material Type</b>	Galvanised Steel, Coated Steel
<b>2021 Observed Defects (Steel)</b>	No visible defects were observed
<b>Defect Description</b>	Generally good condition. Sand cloth at base of fence has come loose and requires re-fixing
<b>Condition Rating (0- 10)</b>	3
<b>Health and Safety Concern (Y/N)</b>	No
<b>Consequence of Failure</b>	2
<b>Likelihood of Failure within next 5 years</b>	2
<b>Risk Rating</b>	4
<b>Overall Rating (CR X RR)</b>	12
<b>Maintenance Recommendation</b>	Monitor and reinspect at next scheduled inspection.
<b>Maintenance Timeframe</b>	Greater than 5 years

Bottom 10m portion of fencing covers with sand

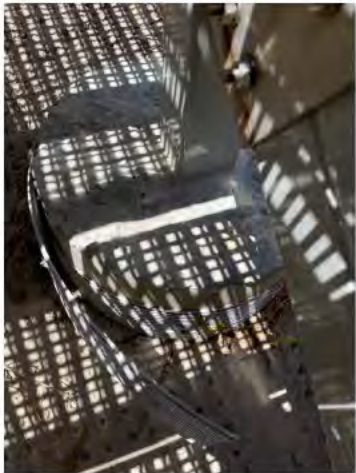
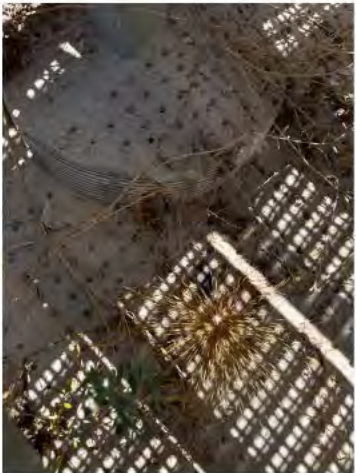
<b>Site No.</b>	C26
<b>Site Name/ Location</b>	South Quinns Rocks Foreshore
<b>Date</b>	09/02/2021
<b>Time</b>	13:08 (8 GMT)
<b>Item Number</b>	4
<b>Costal Asset Type</b>	Stairs
<b>Element</b>	Foundation
<b>Sub-element (Foundations)</b>	Piles
<b>Material Type</b>	Reinforced Concrete
<b>2021 Observed Defects (Reinforced Concrete)</b>	No visible defects were observed
<b>Defect Description</b>	6 no concrete piles with corrugated wrapping
<b>Quantity of Defects</b>	6 no , approx 400mm visible
<b>Condition Rating (0- 10)</b>	2
<b>Health and Safety Concern (Y/N)</b>	No
<b>Consequence of Failure</b>	4
<b>Likelihood of Failure within next 5 years</b>	1
<b>Risk Rating</b>	4
<b>Overall Rating (CR X RR)</b>	8
<b>Maintenance Recommendation</b>	Monitor and reinspect at next scheduled inspection.
<b>Maintenance Timeframe</b>	Greater than 5 years

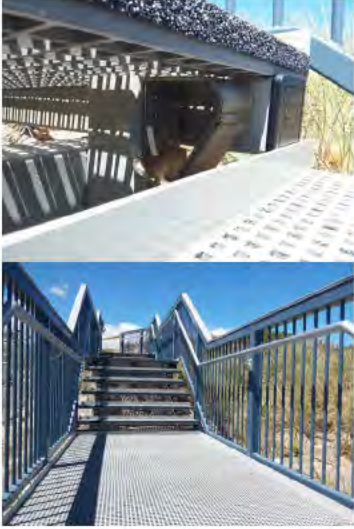
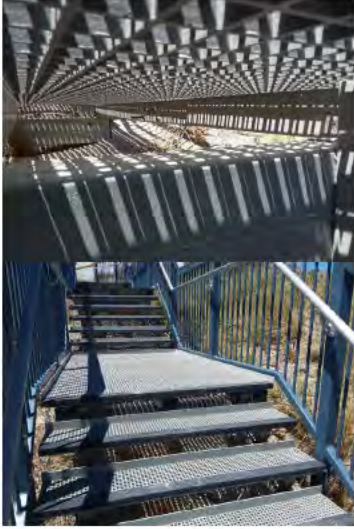
Site No.	C26
Site Name/ Location	South Quinns Rocks Foreshore
Date	09/02/2021
Time	13:08 (8 GMT)
Item Number	5
Costal Asset Type	Stairs
Element	Supports
Sub-element	stringers and support beams
Material Type	FRP, Coated Steel, Steel
2021 Observed Defects (Steel)	Rust staining, No visible defects
2021 Observed Defects (FRP)	No visible defects
Defect Description	Generally good condition. Minor rust staining was observed to unpainted steelwork supporting treads and connection plates.
Condition Rating (0- 10)	2
Health and Safety Concern (Y/N)	No
Consequence of Failure	4
Likelihood of Failure within next 5 years	1
Risk Rating	4
Overall Rating (CR X RR)	8
Maintenance Recommendation	Monitor and reinspect at next scheduled inspection.
Maintenance Timeframe	Greater than 5 years

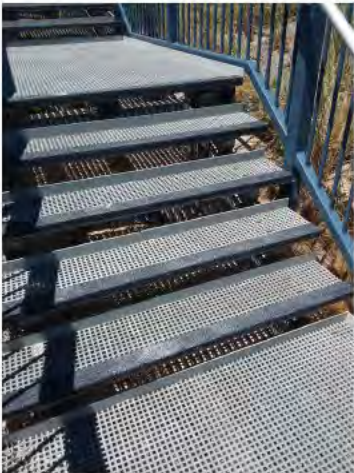
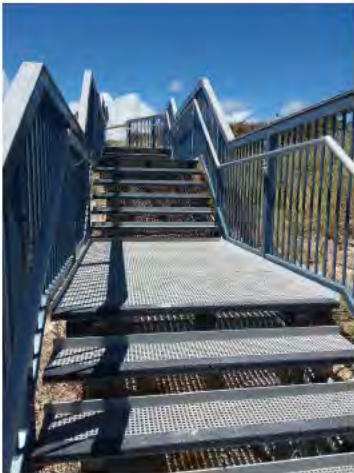
<b>Site No.</b>	C26
<b>Site Name/ Location</b>	South Quinns Rocks Foreshore
<b>Date</b>	09/02/2021
<b>Time</b>	13:04 (8 GMT)
<b>Item Number</b>	6
<b>Costal Asset Type</b>	Stairs
<b>Sub-element (Stairs and Landing)</b>	Tread plate
<b>Sub-element</b>	tread and landing
<b>Material Type</b>	FRP
<b>2021 Observed Defects (FRP)</b>	No visible defects were observed
<b>Defect Description</b>	some non slip grips on treads loose. sand build up. kick plate in good condition.
<b>Quantity of Defects</b>	20 treads, 1.5m wide. 5 landings 2x1.2m
<b>Condition Rating (0- 10)</b>	2
<b>Health and Safety Concern (Y/N)</b>	No
<b>Consequence of Failure</b>	3
<b>Likelihood of Failure within next 5 years</b>	1
<b>Risk Rating</b>	3
<b>Overall Rating (CR X RR)</b>	6
<b>Maintenance Recommendation</b>	Monitor and reinspect at next scheduled inspection.
<b>Maintenance Timeframe</b>	Greater than 5 years
