# City of Wanneroo Assets Structural Assessment

## Coastal Assets

City Of Wanneroo

30 July 2021

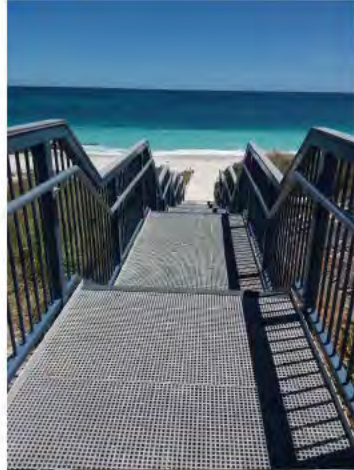
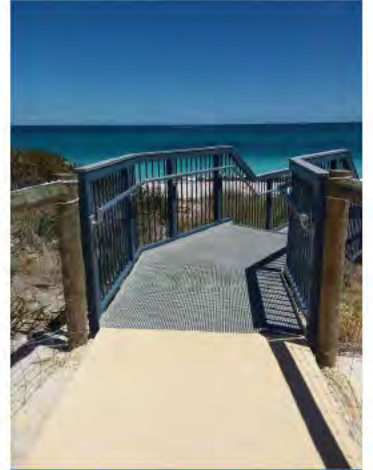
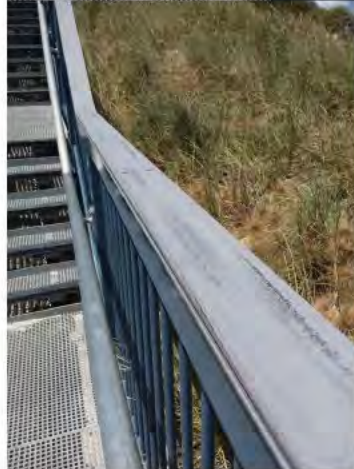
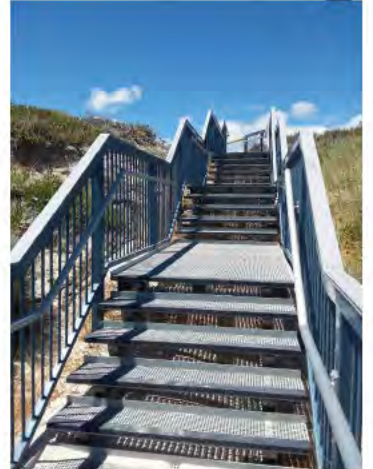
<b>Site No.</b>	C26
<b>Site Name/ Location</b>	South Quinns Rocks Foreshore
<b>Date</b>	09/02/2021
<b>Time</b>	12:57 (8 GMT)
<b>Item Number</b>	7
<b>Costal Asset Type</b>	Stairs
<b>Element</b>	Balustrade
<b>Material Type</b>	FRP, Coated Steel
<b>2021 Observed Defects (Steel)</b>	No visible defects were observed
<b>2021 Observed Defects (FRP)</b>	No visible defects were observed
<b>Defect Description</b>	frp veneer on top good condition - general wear and tear. steel in good condition
<b>Quantity of Defects</b>	35m
<b>Condition Rating (0- 10)</b>	2
<b>Health and Safety Concern (Y/N)</b>	No
<b>Consequence of Failure</b>	3
<b>Likelihood of Failure within next 5 years</b>	1
<b>Risk Rating</b>	3
<b>Overall Rating (CR X RR)</b>	6
<b>Maintenance Recommendation</b>	Monitor and reinspect at next scheduled inspection.
<b>Maintenance Timeframe</b>	Greater than 5 years

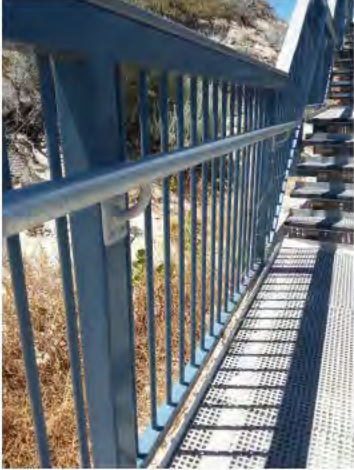
<b>Site No.</b>	C26
<b>Site Name/ Location</b>	South Quinns Rocks Foreshore
<b>Date</b>	09/02/2021
<b>Time</b>	13:02 (8 GMT)
<b>Item Number</b>	8
<b>Costal Asset Type</b>	Stairs
<b>Sub-element (Handrails)</b>	Steel CHS
<b>Material Type</b>	Galvanised Steel
<b>2021 Observed Defects (Steel)</b>	Surface corrosion
<b>Defect Description</b>	Minor surface corrosion.
<b>Quantity of Defects</b>	35m
<b>Condition Rating (0- 10)</b>	3
<b>Health and Safety Concern (Y/N)</b>	No
<b>Consequence of Failure</b>	2
<b>Likelihood of Failure within next 5 years</b>	2
<b>Risk Rating</b>	4
<b>Overall Rating (CR X RR)</b>	12
<b>Maintenance Recommendation</b>	Monitor and reinspect at next scheduled inspection.
<b>Maintenance Timeframe</b>	Greater than 5 years

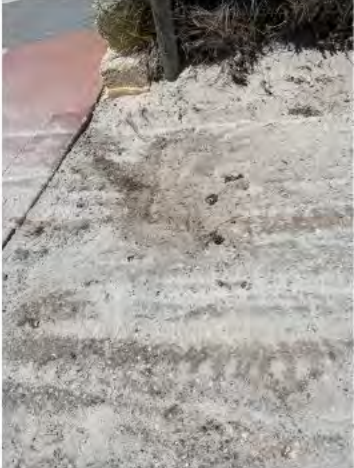
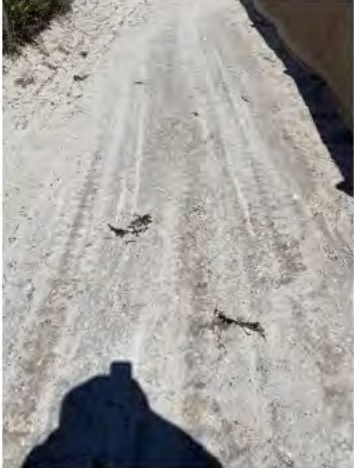
<b>Site No.</b>	C27
<b>Site Name/ Location</b>	South Quinns Rocks Foreshore
<b>Date</b>	20/01/2021
<b>Time</b>	11:07 (8 GMT)
<b>Item Number</b>	1
<b>Costal Asset Type</b>	Vehicle access ramp
<b>Element</b>	Vehicle access ramp asphalt
<b>Sub-element (Surface)</b>	Bitumen base
<b>Material Type</b>	Asphalt
<b>Defect Description</b>	Localised minor potholes in surface.
<b>Condition Rating (0- 10)</b>	4
<b>Health and Safety Concern (Y/N)</b>	No
<b>Consequence of Failure</b>	4
<b>Likelihood of Failure within next 5 years</b>	1
<b>Risk Rating</b>	4
<b>Overall Rating (CR X RR)</b>	16
<b>Maintenance Recommendation</b>	Monitor and reinspect at next scheduled inspection.
<b>Maintenance Timeframe</b>	Greater than 5 years

50% covered with sand

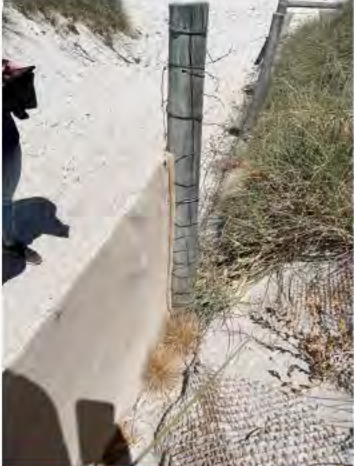
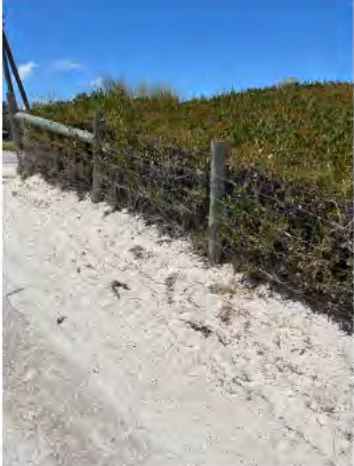
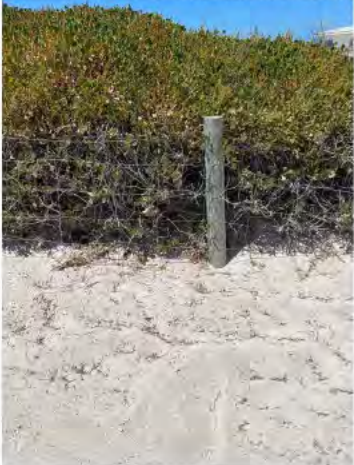
<b>Site No.</b>	C27
<b>Site Name/ Location</b>	South Quinns Rocks Foreshore
<b>Date</b>	20/01/2021
<b>Time</b>	11:14 (8 GMT)
<b>Item Number</b>	2
<b>Costal Asset Type</b>	Fencing
<b>Element</b>	Fencing
<b>Sub-element (Fencing)</b>	Timber posts
<b>Material Type</b>	Timber
<b>2021 Observed Defects (Timber)</b>	Split timber
<b>Defect Description</b>	Minor timber splitting observed
<b>Defect Description</b>	10 posts
<b>Condition Rating (0- 10)</b>	3
<b>Health and Safety Concern (Y/N)</b>	No
<b>Consequence of Failure</b>	2
<b>Likelihood of Failure within next 5 years</b>	2
<b>Risk Rating</b>	4
<b>Overall Rating (CR X RR)</b>	12
<b>Maintenance Recommendation</b>	Monitor and reinspect at next scheduled inspection.
<b>Maintenance Timeframe</b>	Greater than 5 years

Partially buried on western side

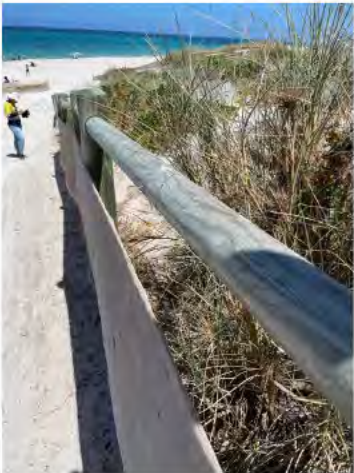
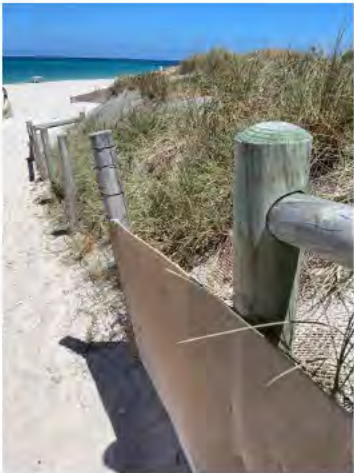
Appears bottom rail removed intentionally

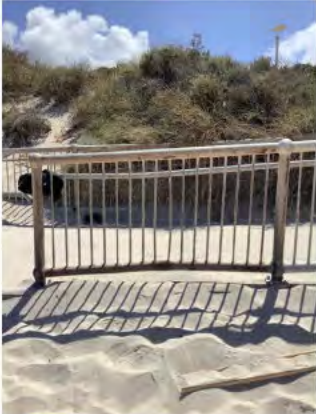
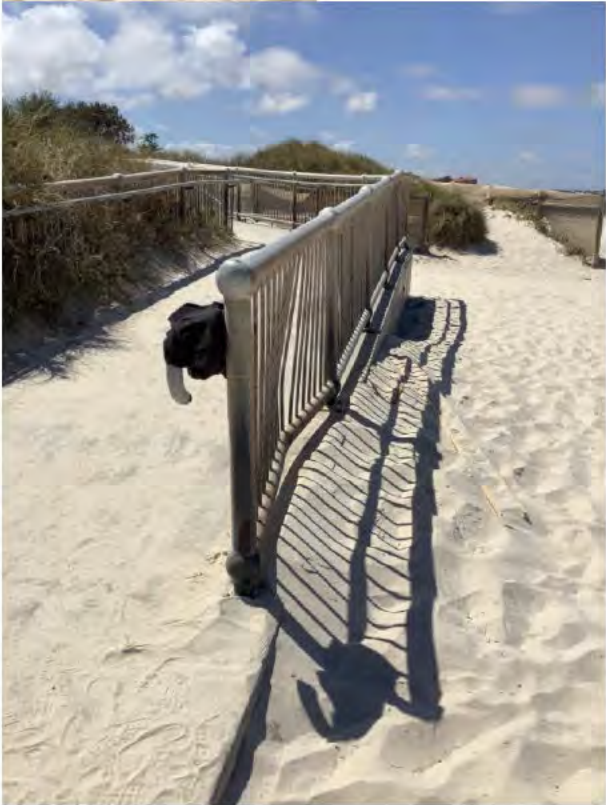
<b>Site No.</b>	C28
<b>Site Name/ Location</b>	North Mindarie Foreshore
<b>Date</b>	20/01/2021
<b>Time</b>	10:47 (8 GMT)
<b>Item Number</b>	6
<b>Costal Asset Type</b>	Ramp disabled beach access
<b>Element</b>	Handrails
<b>Sub-element (Handrails)</b>	Top rail
<b>Material Type</b>	Coated Steel
<b>2021 Observed Defects (Steel)</b>	Surface corrosion, Coating loss, Rust staining
<b>Defect Description</b>	Heavy surface corrosion, coating loss and rust staining observed to be typical. Approximately 30% requires repair.
<b>Quantity of Defects</b>	84m total handrail 30% requires repair
<b>Condition Rating (0- 10)</b>	7
<b>Health and Safety Concern (Y/N)</b>	No
<b>Consequence of Failure</b>	3
<b>Likelihood of Failure within next 5 years</b>	3
<b>Risk Rating</b>	9
<b>Overall Rating (CR X RR)</b>	63
<b>Maintenance Recommendation</b>	Abrasive blast clean and apply protective coating.
<b>Maintenance Timeframe</b>	Within 1-2 years

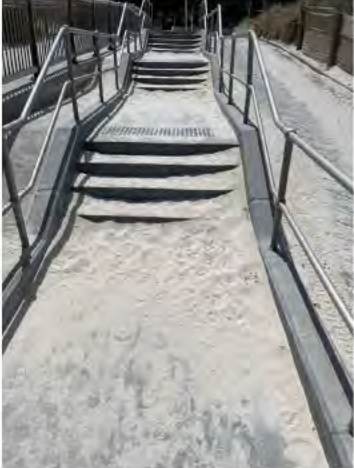
<b>Site No.</b>	C28
<b>Site Name/ Location</b>	North Mindarie Foreshore
<b>Date</b>	20/01/2021
<b>Time</b>	10:29 (8 GMT)
<b>Item Number</b>	9
<b>Costal Asset Type</b>	Stairs
<b>Element</b>	Walls
<b>Sub-element (Walls)</b>	Wall
<b>Material Type</b>	Reinforced Concrete
<b>2021 Observed Defects (Reinforced Concrete)</b>	Crack, Exposed reinforcement, Impact/mechanical damage, abrasion and erosion
<b>Defect Description</b>	Vertical cracks up to 0.3 mm at each balustrade post were observed (typically self-healed). Exposed reinforcement was observed locally after the midpoint of the stairs, towards the ocean.
<b>Quantity of Defects</b>	Exposed reinforcement 600 x 200 30 no cracks
<b>Condition Rating (0- 10)</b>	4
<b>Health and Safety Concern (Y/N)</b>	No
<b>Consequence of Failure</b>	3
<b>Likelihood of Failure within next 5 years</b>	2
<b>Risk Rating</b>	6
<b>Overall Rating (CR X RR)</b>	24

<b>Maintenance Recommendation</b>	Monitor and reinspect at next scheduled inspection.
<b>Maintenance Timeframe</b>	Greater than 5 years
<b>Multi Photo</b>

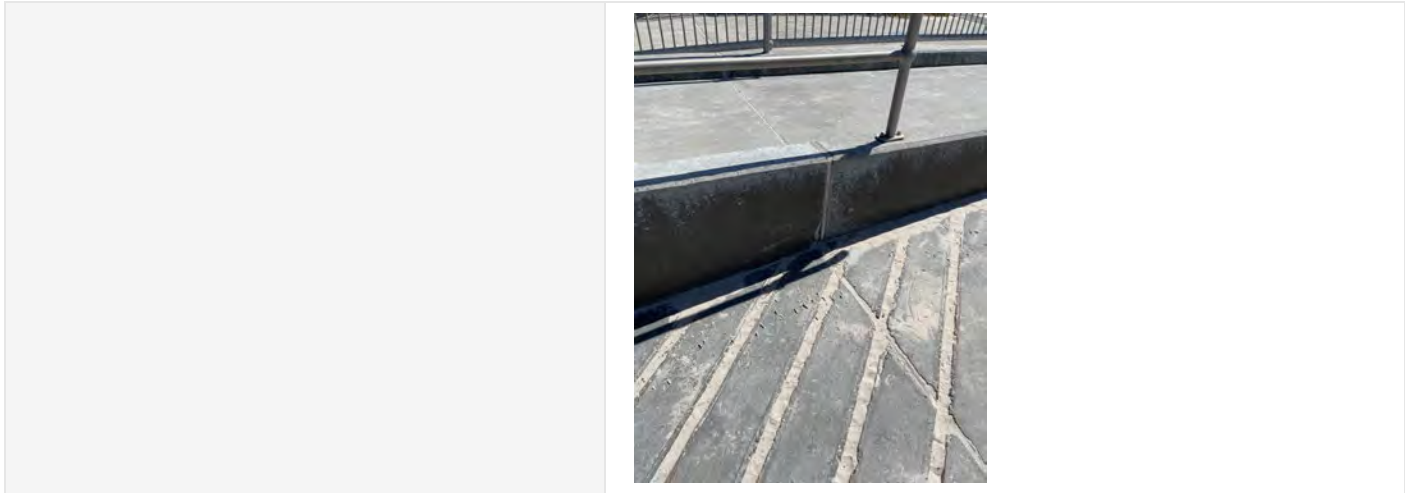
<b>Site No.</b>	C28
<b>Site Name/ Location</b>	North Mindarie Foreshore
<b>Date</b>	20/01/2021
<b>Time</b>	10:39 (8 GMT)
<b>Item Number</b>	10
<b>Costal Asset Type</b>	Stairs
<b>Element</b>	Walls
<b>Sub-element (Walls)</b>	Wall
<b>Material Type</b>	Reinforced Concrete
<b>2021 Observed Defects (Reinforced Concrete)</b>	Exposed reinforcement
<b>Defect Description</b>	Exposed reinforcement was observed locally after the midpoint of the stairs, towards the ocean.
<b>Defect Location</b>	Towards ocean
<b>Condition Rating (0- 10)</b>	6
<b>Health and Safety Concern (Y/N)</b>	No
<b>Consequence of Failure</b>	3
<b>Likelihood of Failure within next 5 years</b>	1
<b>Risk Rating</b>	3
<b>Overall Rating (CR X RR)</b>	18
<b>Maintenance Recommendation</b>	Conventional concrete repair
<b>Maintenance Timeframe</b>	Within 1-2 years

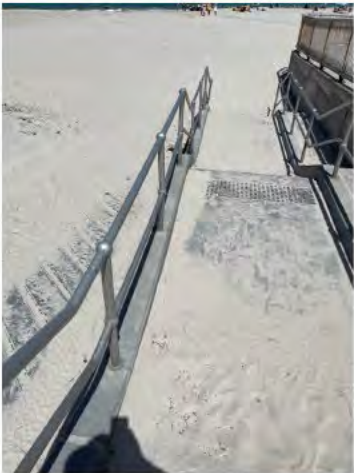
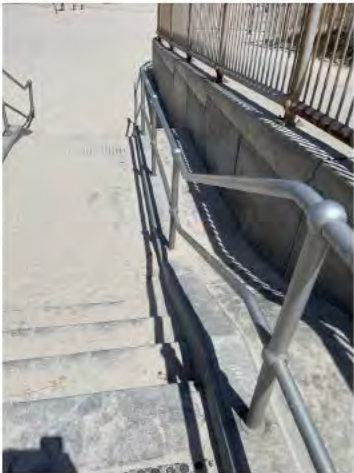
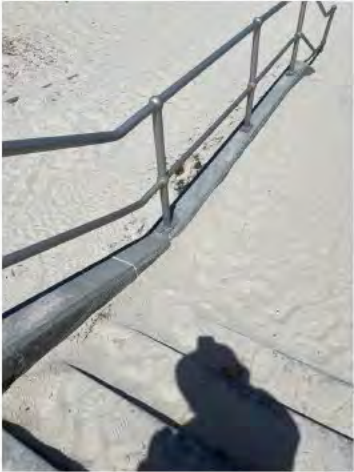
Site No.	C28
Site Name/ Location	North Mindarie Foreshore
Date	20/01/2021
Time	10:33 (8 GMT)
Item Number	12
Costal Asset Type	Stairs
Element	Handrails
Material Type	Steel
2021 Observed Defects (Steel)	Impact/mechanical damage, Other
Defect Description	Localised damage to the base of balustrade 6 from the top, resulting in loose section was observed.
Quantity of Defects	1
Defect Location	6th balustrade on lhs looking towards ocean
Condition Rating (0- 10)	7
Health and Safety Concern (Y/N)	No
Consequence of Failure	3
Likelihood of Failure within next 5 years	3
Risk Rating	9
Overall Rating (CR X RR)	63
Maintenance Recommendation	Replace damaged balustrade.
Maintenance Timeframe	Within 6 months

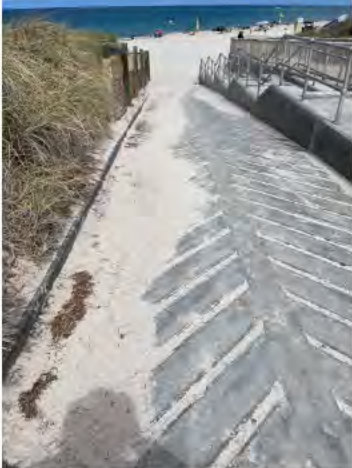
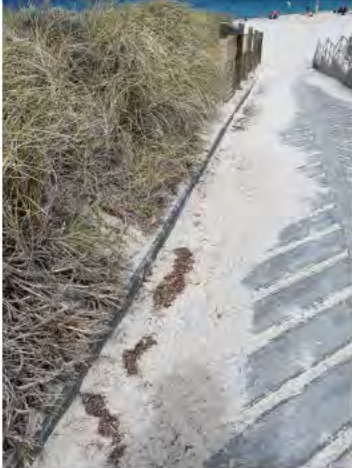
Kerbing similar condition

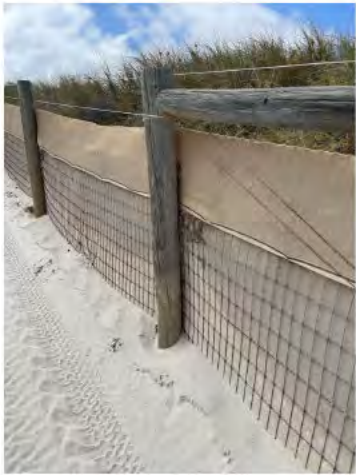
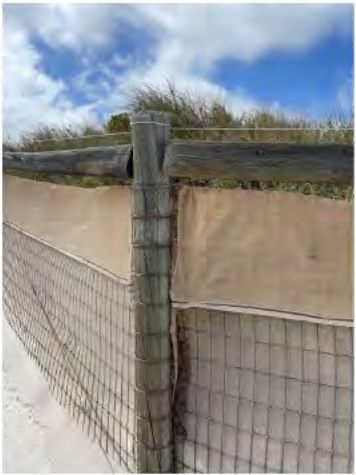
<b>Site No.</b>	C28
<b>Site Name/ Location</b>	North Mindarie Foreshore
<b>Date</b>	20/01/2021
<b>Time</b>	10:13 (8 GMT)
<b>Item Number</b>	15
<b>Costal Asset Type</b>	Vehicle access ramp
<b>Element</b>	Fencing
<b>Sub-element (Fencing)</b>	Mesh
<b>Material Type</b>	Galvanised Steel
<b>2021 Observed Defects (Steel)</b>	Surface corrosion, Impact/mechanical damage
<b>Defect Description</b>	Surface corrosion and impact damage were observed towards seaward edge.
<b>Quantity of Defects</b>	60m2
<b>Defect Location</b>	Towards seaward edge
<b>Condition Rating (0- 10)</b>	3
<b>Health and Safety Concern (Y/N)</b>	No
<b>Consequence of Failure</b>	2
<b>Likelihood of Failure within next 5 years</b>	3
<b>Risk Rating</b>	6
<b>Overall Rating (CR X RR)</b>	18
<b>Maintenance Recommendation</b>	Monitor and reinspect at next scheduled inspection.
<b>Maintenance Timeframe</b>	Greater than 5 years

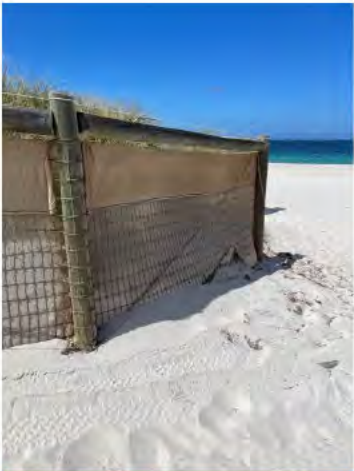
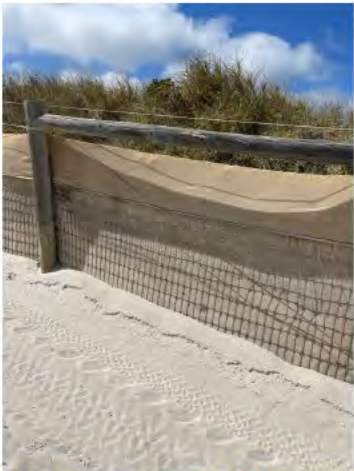
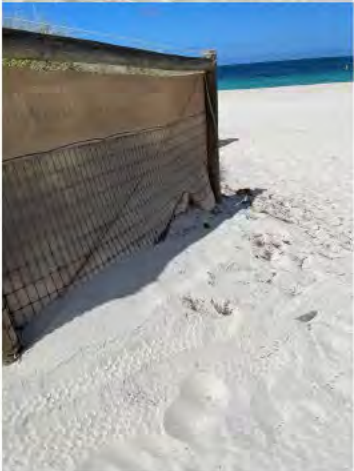
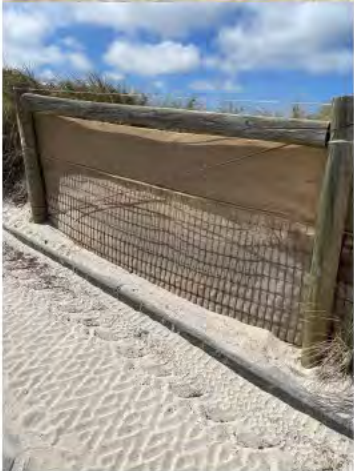
Geofabric behind in good condition

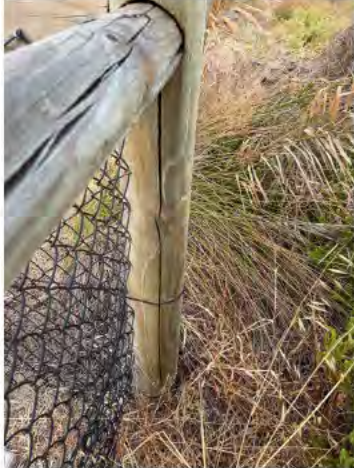
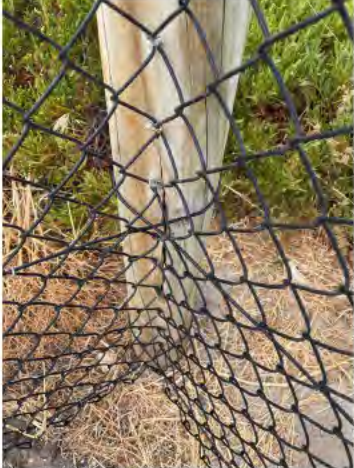
Timber railing similar

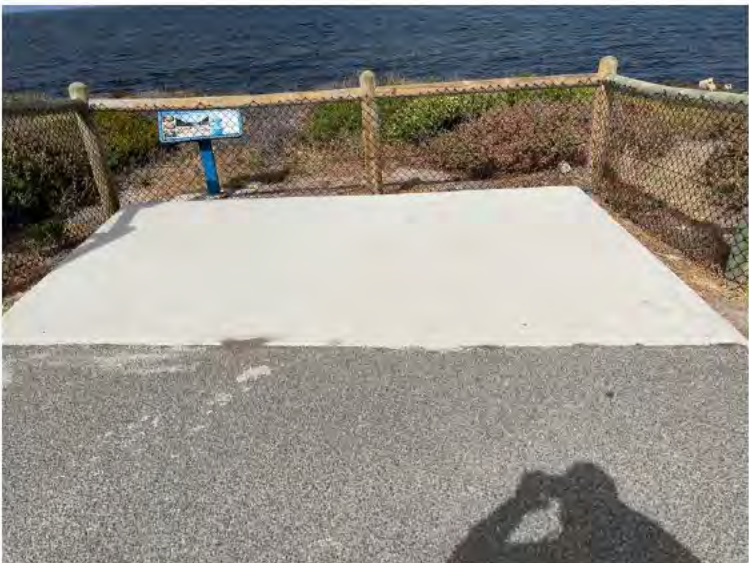
<b>Site No.</b>	C31
<b>Site Name/ Location</b>	North Mindarie Coastal Walk
<b>Date</b>	20/01/2021
<b>Time</b>	09:11 (8 GMT)
<b>Item Number</b>	1
<b>Costal Asset Type</b>	Lookout
<b>Element</b>	Foundation
<b>Sub-element (Foundations)</b>	Concrete Pad
<b>Material Type</b>	Reinforced Concrete
<b>2021 Observed Defects (Reinforced Concrete)</b>	No visible defect
<b>Quantity of Defects</b>	8m <sup>2</sup>
<b>Condition Rating (0- 10)</b>	2
<b>Health and Safety Concern (Y/N)</b>	No
<b>Consequence of Failure</b>	2
<b>Likelihood of Failure within next 5 years</b>	1
<b>Risk Rating</b>	2
<b>Overall Rating (CR X RR)</b>	4
<b>Maintenance Recommendation</b>	Monitor and reinspect at next scheduled inspection.
<b>Maintenance Timeframe</b>	Greater than 5 years

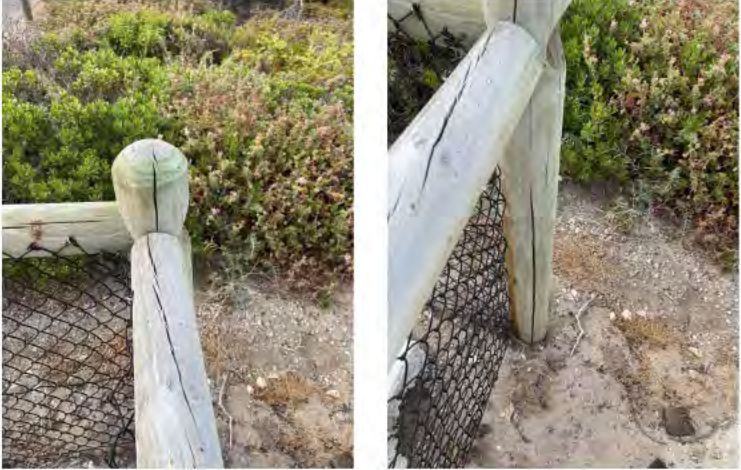
<b>Site No.</b>	C31
<b>Site Name/ Location</b>	North Mindarie Coastal Walk
<b>Date</b>	20/01/2021
<b>Time</b>	09:18 (8 GMT)
<b>Item Number</b>	2
<b>Costal Asset Type</b>	Lookout
<b>Element</b>	Fencing
<b>Sub-element (Fencing)</b>	Timber posts
<b>Material Type</b>	Timber
<b>2021 Observed Defects (Timber)</b>	Split timber
<b>Defect Description</b>	Generally good condition. Minor timber splitting was observed.
<b>Quantity of Defects</b>	5 no posts
<b>Condition Rating (0- 10)</b>	3
<b>Health and Safety Concern (Y/N)</b>	No
<b>Consequence of Failure</b>	2
<b>Likelihood of Failure within next 5 years</b>	2
<b>Risk Rating</b>	4
<b>Overall Rating (CR X RR)</b>	12
<b>Maintenance Recommendation</b>	Monitor and reinspect at next scheduled inspection.
<b>Maintenance Timeframe</b>	Greater than 5 years

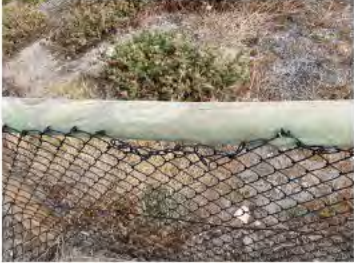
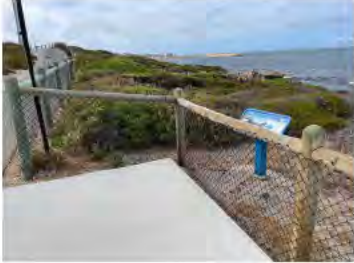
<b>Site No.</b>	C31
<b>Site Name/ Location</b>	North Mindarie Coastal Walk
<b>Date</b>	20/01/2021
<b>Time</b>	09:13 (8 GMT)
<b>Item Number</b>	3
<b>Costal Asset Type</b>	Lookout
<b>Element</b>	Fencing
<b>Sub-element (Fencing)</b>	Mesh
<b>Material Type</b>	Coated Steel
<b>2021 Observed Defects (Steel)</b>	No visible defects were observed
<b>Condition Rating (0- 10)</b>	3
<b>Health and Safety Concern (Y/N)</b>	No
<b>Consequence of Failure</b>	2
<b>Likelihood of Failure within next 5 years</b>	2
<b>Risk Rating</b>	4
<b>Overall Rating (CR X RR)</b>	12
<b>Maintenance Recommendation</b>	Monitor and reinspect at next scheduled inspection.
<b>Maintenance Timeframe</b>	Greater than 5 years

Localised areas where fencing is loose

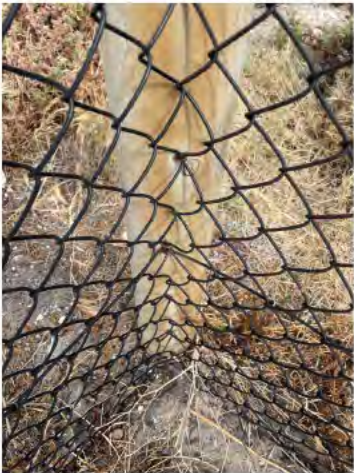
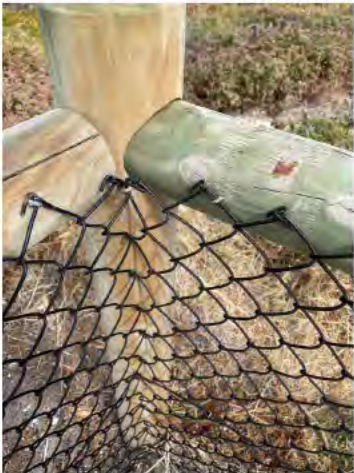
<b>Site No.</b>	C31
<b>Site Name/ Location</b>	North Mindarie Coastal Walk
<b>Date</b>	20/01/2021
<b>Time</b>	09:19 (8 GMT)
<b>Item Number</b>	4
<b>Costal Asset Type</b>	Lookout
<b>Element</b>	Fencing
<b>Sub-element (Fencing)</b>	Mesh staples
<b>Material Type</b>	Galvanised Steel
<b>2021 Observed Defects (Steel)</b>	Surface corrosion
<b>Defect Description</b>	Surface corrosion was observed to be typical throughout.
<b>Defect Location</b>	Located on vertical posts
<b>Condition Rating (0- 10)</b>	5
<b>Health and Safety Concern (Y/N)</b>	No
<b>Consequence of Failure</b>	2
<b>Likelihood of Failure within next 5 years</b>	2
<b>Risk Rating</b>	4
<b>Overall Rating (CR X RR)</b>	20
<b>Maintenance Recommendation</b>	Replace mesh staples
<b>Maintenance Timeframe</b>	Within 5 years

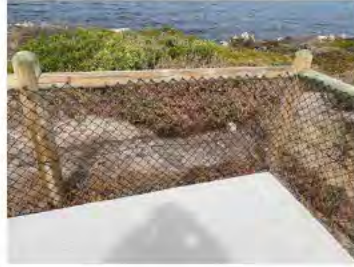
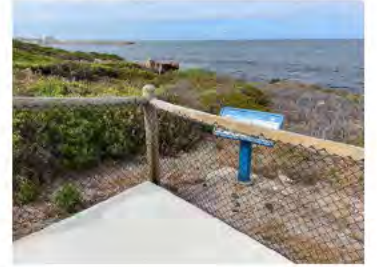
<b>Site No.</b>	C31
<b>Site Name/ Location</b>	North Mindarie Coastal Walk
<b>Date</b>	20/01/2021
<b>Time</b>	09:23 (8 GMT)
<b>Item Number</b>	5
<b>Costal Asset Type</b>	Lookout
<b>Element</b>	Fencing
<b>Sub-element (Fencing)</b>	Mesh strainer wires
<b>Material Type</b>	Coated Steel
<b>2021 Observed Defects (Steel)</b>	No visible defects
<b>Condition Rating (0- 10)</b>	2
<b>Health and Safety Concern (Y/N)</b>	No
<b>Consequence of Failure</b>	2
<b>Likelihood of Failure within next 5 years</b>	1
<b>Risk Rating</b>	2
<b>Overall Rating (CR X RR)</b>	4
<b>Maintenance Recommendation</b>	Monitor and reinspect at next scheduled inspection.
<b>Maintenance Timeframe</b>	Greater than 5 years

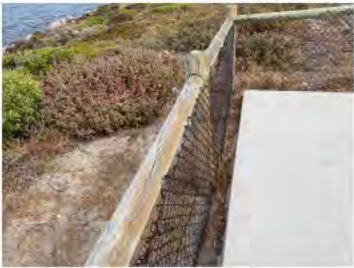
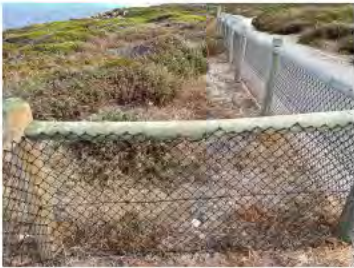
<b>Site No.</b>	C31
<b>Site Name/ Location</b>	North Mindarie Coastal Walk
<b>Date</b>	20/01/2021
<b>Time</b>	09:16 (8 GMT)
<b>Item Number</b>	6
<b>Costal Asset Type</b>	Lookout
<b>Element</b>	Fencing
<b>Sub-element (Fencing)</b>	Timber rail
<b>Material Type</b>	Timber
<b>2021 Observed Defects (Timber)</b>	Split timber
<b>Defect Description</b>	Generally in good condition. Minor timber splitting was observed.
<b>Quantity of Defects</b>	6m of rail
<b>Condition Rating (0- 10)</b>	3
<b>Health and Safety Concern (Y/N)</b>	No
<b>Consequence of Failure</b>	2
<b>Likelihood of Failure within next 5 years</b>	2
<b>Risk Rating</b>	4
<b>Overall Rating (CR X RR)</b>	12
<b>Maintenance Recommendation</b>	Monitor and reinspect at next scheduled inspection.
<b>Maintenance Timeframe</b>	Greater than 5 years

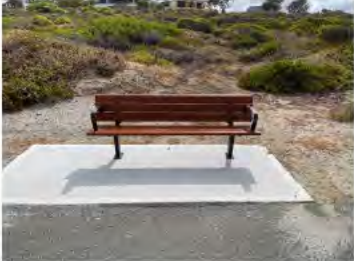
<b>Site No.</b>	C31
<b>Site Name/ Location</b>	North Mindarie Coastal Walk
<b>Date</b>	20/01/2021
<b>Time</b>	09:21 (8 GMT)
<b>Item Number</b>	7
<b>Costal Asset Type</b>	Lookout
<b>Element</b>	Bench
<b>Material Type</b>	Aluminum
<b>2021 Observed Defects (Steel)</b>	No visible defects were observed
<b>Condition Rating (0- 10)</b>	1
<b>Health and Safety Concern (Y/N)</b>	No
<b>Consequence of Failure</b>	2
<b>Likelihood of Failure within next 5 years</b>	1
<b>Risk Rating</b>	2
<b>Overall Rating (CR X RR)</b>	2
<b>Maintenance Recommendation</b>	Monitor and reinspect at next scheduled inspection.
<b>Maintenance Timeframe</b>	Greater than 5 Years

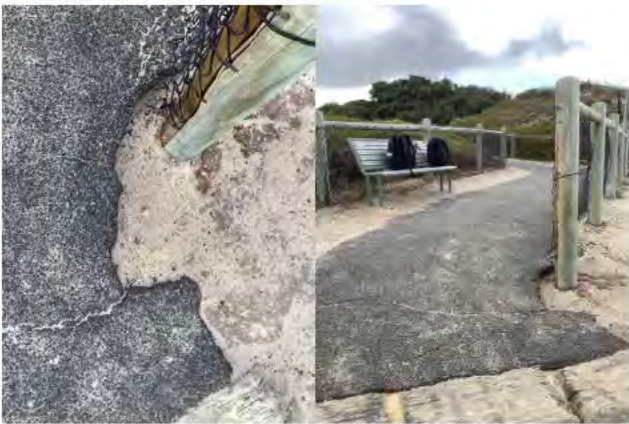
<b>Site No.</b>	C32
<b>Site Name/ Location</b>	North Mindarie Foreshore
<b>Date</b>	20/01/2021
<b>Time</b>	08:13 (8 GMT)
<b>Item Number</b>	1
<b>Costal Asset Type</b>	Asphalt path
<b>Sub-element (Surface)</b>	Bitumen base
<b>Material Type</b>	Asphalt
<b>Defect Description</b>	Towards seaward face asphalt deteriorated near fence post on western side.
<b>Quantity of Defects</b>	400 x 15 mm
<b>Condition Rating (0- 10)</b>	5
<b>Health and Safety Concern (Y/N)</b>	No
<b>Consequence of Failure</b>	3
<b>Likelihood of Failure within next 5 years</b>	3
<b>Risk Rating</b>	9
<b>Overall Rating (CR X RR)</b>	45
<b>Maintenance Recommendation</b>	Patch deteriorated asphalt around post.
<b>Maintenance Timeframe</b>	Within 6 months

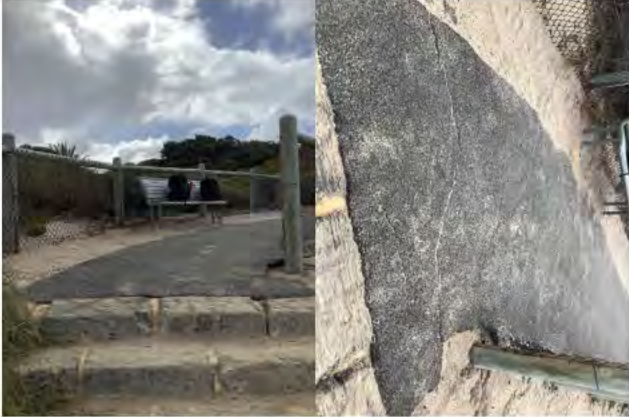
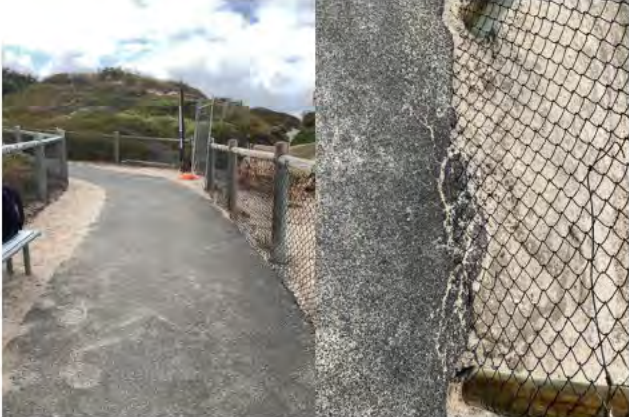
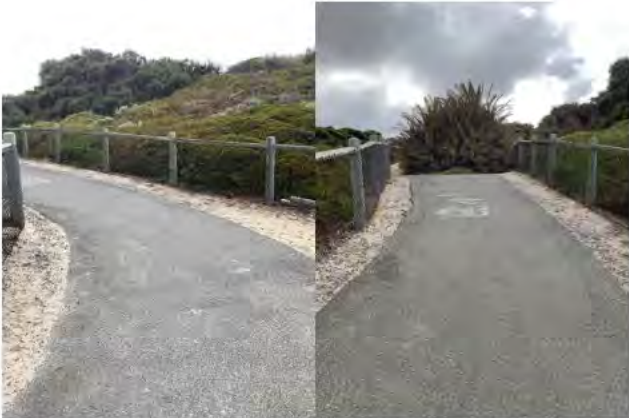
Site No.	C32
Site Name/ Location	North Mindarie Foreshore
Date	20/01/2021
Time	08:21 (8 GMT)
Item Number	2
Costal Asset Type	Asphalt path
Sub-element (Surface)	Bitumen base
Material Type	Asphalt
Defect Description	Generally good condition. 50m2. Some cracks towards stair ends. Minor deterioration in sections
Condition Rating (0- 10)	3
Health and Safety Concern (Y/N)	No
Consequence of Failure	3
Likelihood of Failure within next 5 years	2
Risk Rating	6
Overall Rating (CR X RR)	18
Maintenance Recommendation	Monitor and reinspect at next scheduled inspection.
Maintenance Timeframe	Greater than 5 years

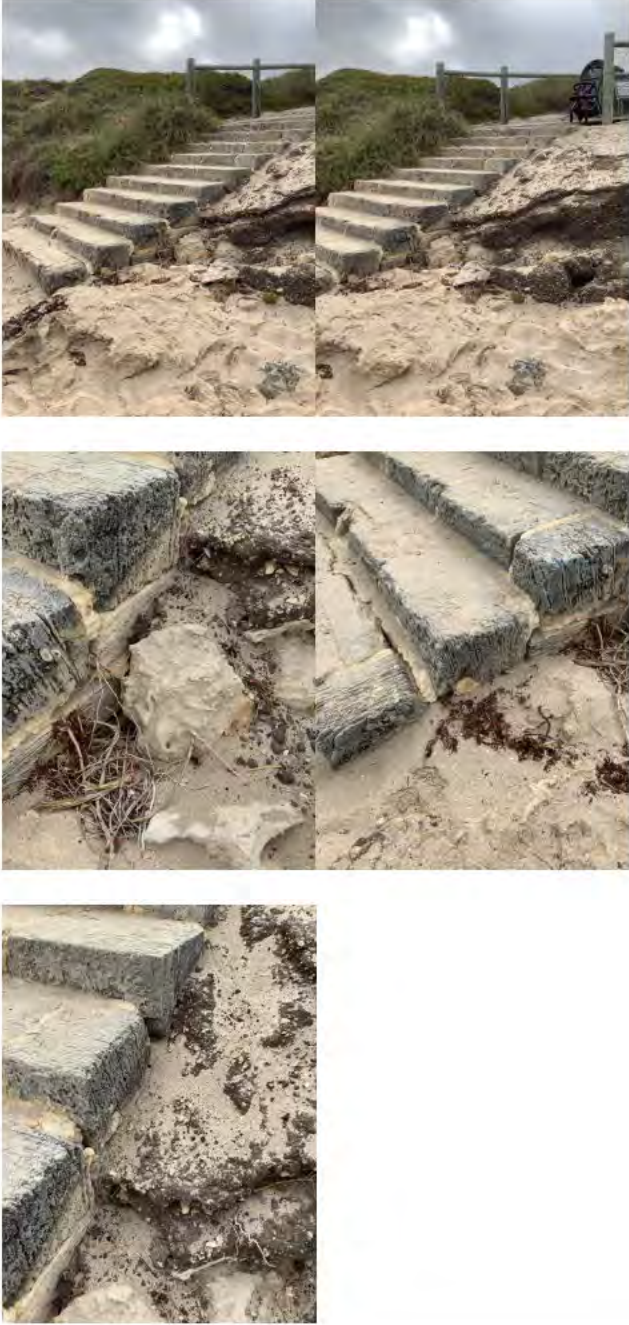
<b>Site No.</b>	C32
<b>Site Name/ Location</b>	North Mindarie Foreshore
<b>Date</b>	20/01/2021
<b>Time</b>	08:09 (8 GMT)
<b>Item Number</b>	3
<b>Costal Asset Type</b>	Stairs
<b>Sub-element (Foundations)</b>	Footing
<b>Material Type</b>	Limestone
<b>Defect Description</b>	Evidence of scour next to stairs.
<b>Condition Rating (0- 10)</b>	5
<b>Health and Safety Concern (Y/N)</b>	No
<b>Consequence of Failure</b>	4
<b>Likelihood of Failure within next 5 years</b>	3
<b>Risk Rating</b>	12
<b>Overall Rating (CR X RR)</b>	60
<b>Maintenance Recommendation</b>	Investigate cause of scour and locally repair.
<b>Maintenance Timeframe</b>	Within 5 years

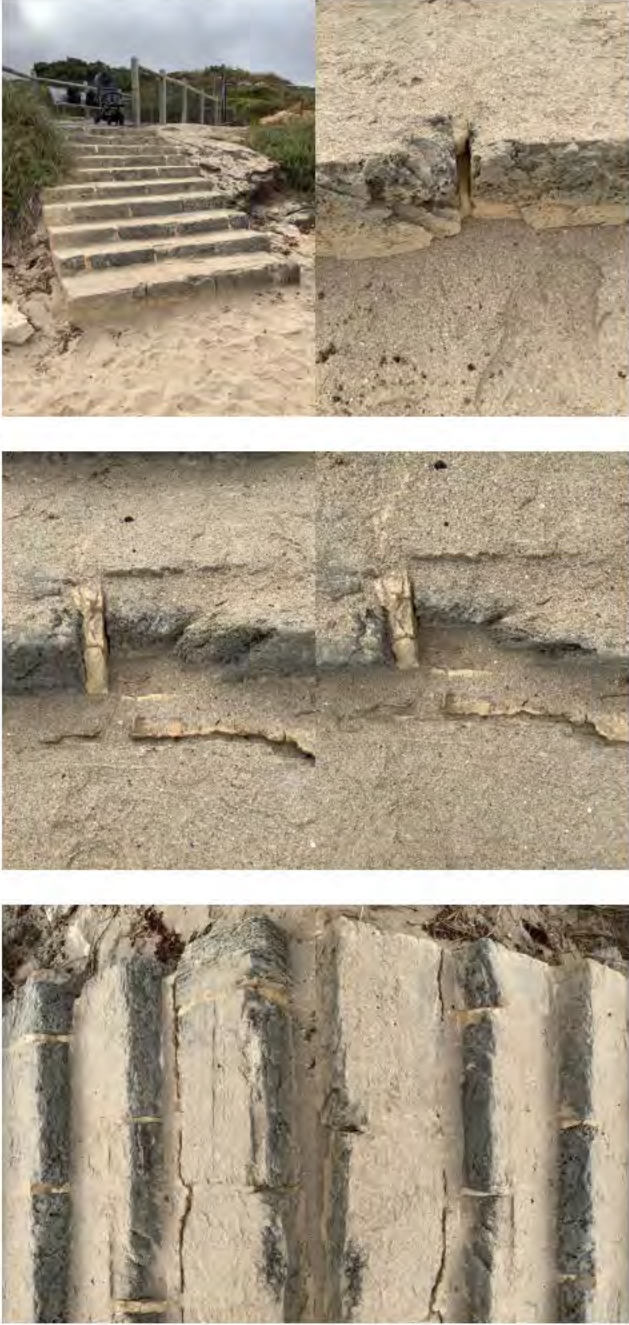
<b>Site No.</b>	C32
<b>Site Name/ Location</b>	North Mindarie Foreshore
<b>Date</b>	20/01/2021
<b>Time</b>	07:59 (8 GMT)
<b>Item Number</b>	4
<b>Costal Asset Type</b>	Stairs
<b>Material Type</b>	Limestone
<b>Defect Description</b>	Limestone block steps to concrete path. 10 steps - 2m wide. Impact damage to 3 steps up to 50mm loss in areas. Deteriorated grout typical. No handrail either side
<b>Condition Rating (0- 10)</b>	7
<b>Health and Safety Concern (Y/N)</b>	No
<b>Consequence of Failure</b>	4
<b>Likelihood of Failure within next 5 years</b>	3
<b>Risk Rating</b>	12
<b>Overall Rating (CR X RR)</b>	84
<b>Maintenance Recommendation</b>	Replace
<b>Maintenance Timeframe</b>	Within 6 months

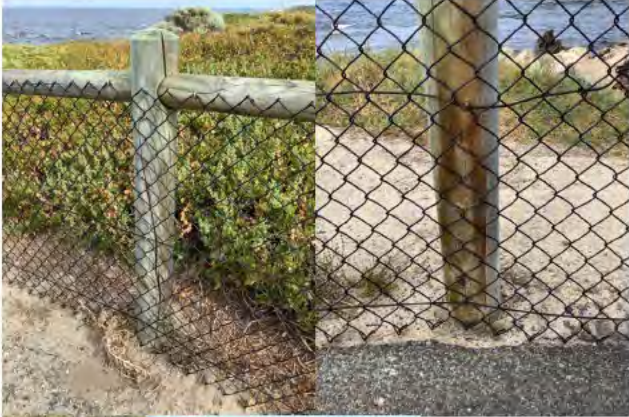
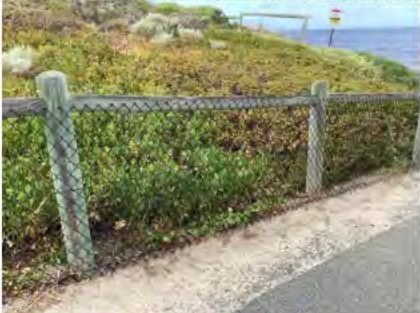
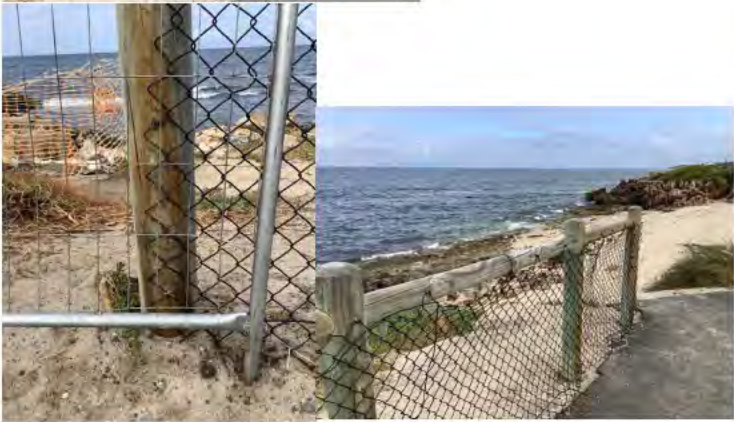
<b>Site No.</b>	C32
<b>Site Name/ Location</b>	North Mindarie Foreshore
<b>Date</b>	20/01/2021
<b>Time</b>	08:45 (8 GMT)
<b>Item Number</b>	5
<b>Costal Asset Type</b>	Fencing
<b>Sub-element (Fencing)</b>	Timber members
<b>Material Type</b>	Timber
<b>2021 Observed Defects (Timber)</b>	Fungi attack, Split timber
<b>Defect Description</b>	22 posts. 50m worth of railing Split timber typical on posts and rails. Minor fungi attack to posts closest to sea on mesh side of posts. Minor staining typical
<b>Condition Rating (0- 10)</b>	4
<b>Health and Safety Concern (Y/N)</b>	No
<b>Consequence of Failure</b>	3
<b>Likelihood of Failure within next 5 years</b>	2
<b>Risk Rating</b>	6
<b>Overall Rating (CR X RR)</b>	24
<b>Maintenance Recommendation</b>	Monitor and reinspect at next scheduled inspection.
<b>Maintenance Timeframe</b>	Greater than 5 years

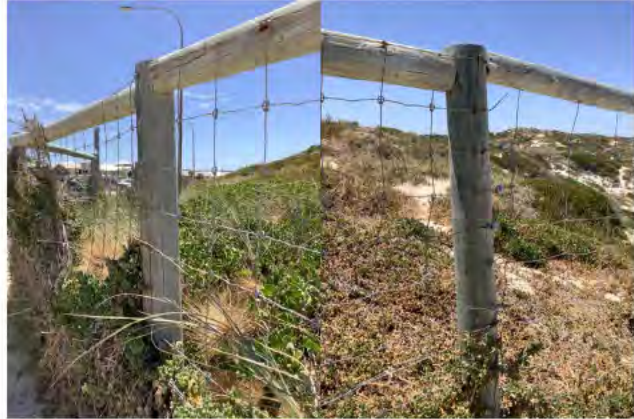
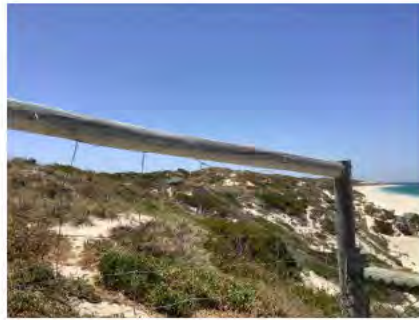
<b>Site No.</b>	C33
<b>Site Name/ Location</b>	South Mindarie Foreshore
<b>Date</b>	15/01/2021
<b>Time</b>	11:07 (8 GMT)
<b>Item Number</b>	6
<b>Costal Asset Type</b>	Lookout
<b>Sub-element (Fencing)</b>	Timber rail
<b>Material Type</b>	Timber
<b>2021 Observed Defects (Timber)</b>	Split timber, salt attack
<b>Defect Description</b>	Significant salt attack causing soft wood along mid rail at northern and southern ends. Minor splitting evident.
<b>Condition Rating (0- 10)</b>	7
<b>Health and Safety Concern (Y/N)</b>	No
<b>Consequence of Failure</b>	4
<b>Likelihood of Failure within next 5 years</b>	3
<b>Risk Rating</b>	12
<b>Overall Rating (CR X RR)</b>	84
<b>Maintenance Recommendation</b>	Replace
<b>Maintenance Timeframe</b>	Within 5 years

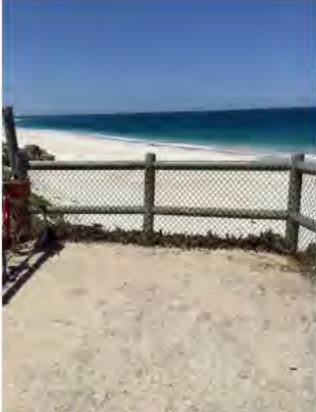
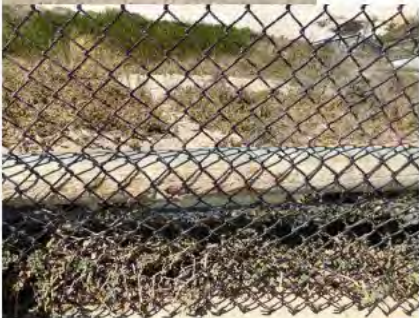
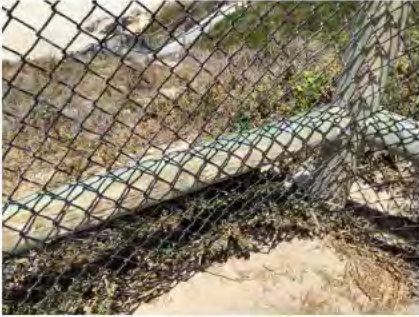
<b>Site No.</b>	C33
<b>Site Name/ Location</b>	South Mindarie Foreshore
<b>Date</b>	15/01/2021
<b>Time</b>	10:41 (8 GMT)
<b>Item Number</b>	7
<b>Costal Asset Type</b>	Lookout
<b>Sub-element (Fencing)</b>	Mesh
<b>Material Type</b>	Coated Steel
<b>2021 Observed Defects (Steel)</b>	Surface corrosion, Noticeable build-up of debris
<b>Defect Description</b>	Fence typical corrosion and coating loss at staples. Generally good condition
<b>Condition Rating (0- 10)</b>	4
<b>Health and Safety Concern (Y/N)</b>	No
<b>Consequence of Failure</b>	2
<b>Likelihood of Failure within next 5 years</b>	2
<b>Risk Rating</b>	4
<b>Overall Rating (CR X RR)</b>	16
<b>Maintenance Recommendation</b>	Replace
<b>Maintenance Timeframe</b>	Greater than 5 years

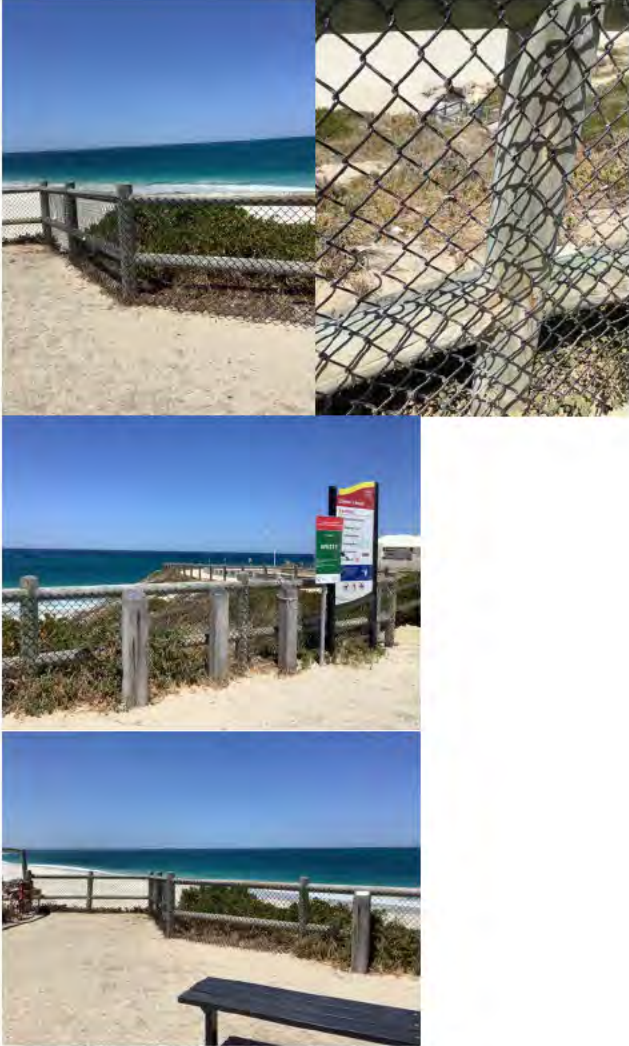
<b>Site No.</b>	C33
<b>Site Name/ Location</b>	South Mindarie Foreshore
<b>Date</b>	15/01/2021
<b>Time</b>	10:53 (8 GMT)
<b>Item Number</b>	8
<b>Costal Asset Type</b>	Lookout
<b>Sub-element (Fencing)</b>	Mesh
<b>Material Type</b>	Coated Steel
<b>2021 Observed Defects (Steel)</b>	Impact/mechanical damage
<b>Defect Description</b>	Hole in fence at western end of lookout
<b>Condition Rating (0- 10)</b>	8
<b>Health and Safety Concern (Y/N)</b>	No
<b>Consequence of Failure</b>	2
<b>Likelihood of Failure within next 5 years</b>	5
<b>Risk Rating</b>	10
<b>Overall Rating (CR X RR)</b>	80
<b>Maintenance Recommendation</b>	Replace
<b>Maintenance Timeframe</b>	Within 1 - 2 years

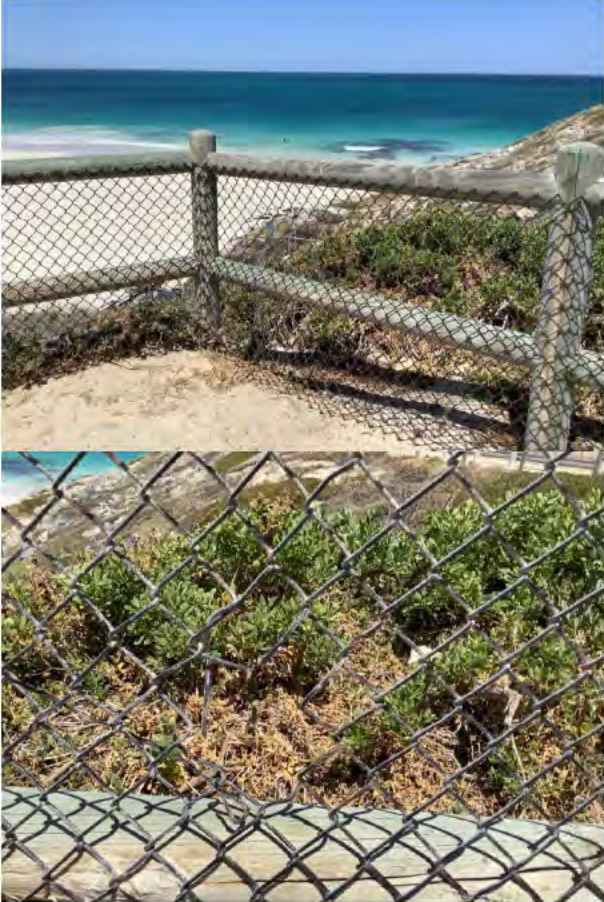
<b>Site No.</b>	C33
<b>Site Name/ Location</b>	South Mindarie Foreshore
<b>Date</b>	15/01/2021
<b>Time</b>	11:14 (8 GMT)
<b>Item Number</b>	9
<b>Costal Asset Type</b>	Lookout
<b>Sub-element (Fencing)</b>	Mesh
<b>Material Type</b>	Steel
<b>2021 Observed Defects (Steel)</b>	Surface corrosion, Noticeable build-up of debris
<b>Defect Description</b>	Steel mesh on south eastern side. Vegetation limiting inspection Typical corrosion to mesh and associated fixings. Strainer wires deteriorated. Mesh not well secured to top beam on western side.
<b>Condition Rating (0- 10)</b>	7
<b>Health and Safety Concern (Y/N)</b>	No
<b>Consequence of Failure</b>	2
<b>Likelihood of Failure within next 5 years</b>	2
<b>Risk Rating</b>	4
<b>Overall Rating (CR X RR)</b>	28
<b>Maintenance Recommendation</b>	Replace
<b>Maintenance Timeframe</b>	Within 5 years

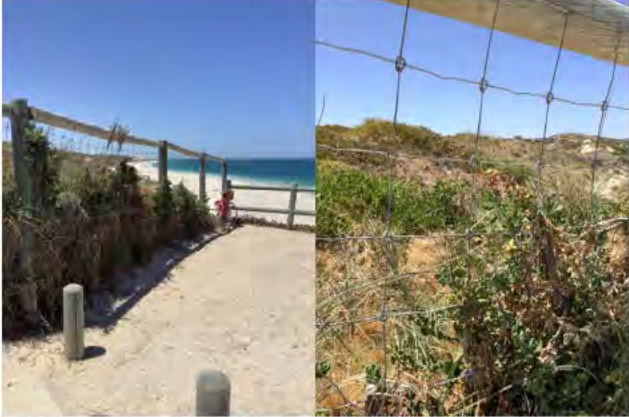
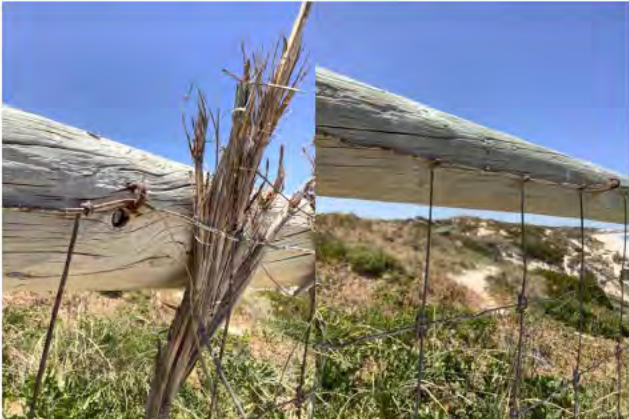
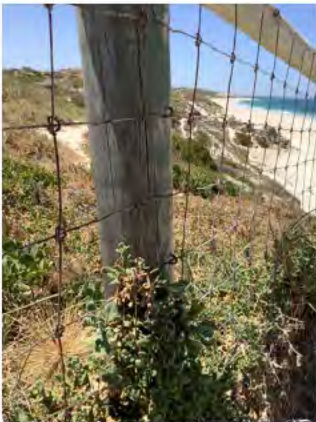
<b>Site No.</b>	C33
<b>Site Name/ Location</b>	South Mindarie Foreshore
<b>Date</b>	15/01/2021
<b>Time</b>	10:56 (8 GMT)
<b>Item Number</b>	10
<b>Costal Asset Type</b>	Lookout
<b>Sub-element (Fencing)</b>	Mesh staples
<b>Material Type</b>	Coated Steel
<b>2021 Observed Defects (Steel)</b>	Surface corrosion, Coating loss
<b>Defect Description</b>	Typical corrosion throughout. Similar condition to other staples on concrete path
<b>Condition Rating (0- 10)</b>	6
<b>Health and Safety Concern (Y/N)</b>	No
<b>Consequence of Failure</b>	2
<b>Likelihood of Failure within next 5 years</b>	2
<b>Risk Rating</b>	4
<b>Overall Rating (CR X RR)</b>	24
<b>Maintenance Recommendation</b>	Replace
<b>Maintenance Timeframe</b>	Within 5 years

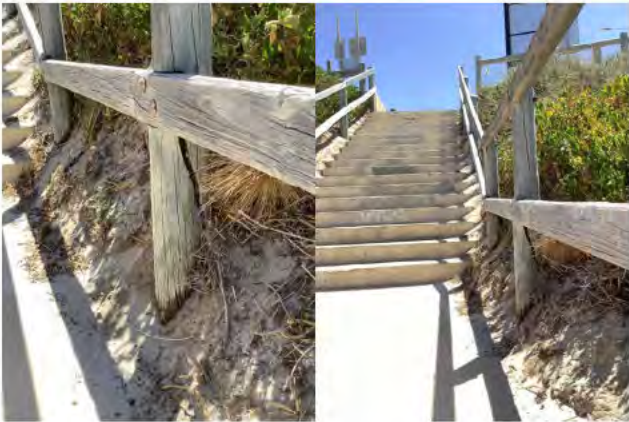
<b>Site No.</b>	C33
<b>Site Name/ Location</b>	South Mindarie Foreshore
<b>Date</b>	15/01/2021
<b>Time</b>	10:13 (8 GMT)
<b>Item Number</b>	19
<b>Costal Asset Type</b>	Stairs
<b>Sub-element (Stairs and Landing)</b>	Timber posts
<b>Material Type</b>	Timber
<b>2021 Observed Defects (Timber)</b>	General damage, Split timber
<b>Defect Description</b>	Typical splits to timber posts.
<b>Condition Rating (0- 10)</b>	4
<b>Health and Safety Concern (Y/N)</b>	No
<b>Consequence of Failure</b>	3
<b>Likelihood of Failure within next 5 years</b>	2
<b>Risk Rating</b>	6
<b>Overall Rating (CR X RR)</b>	24
<b>Maintenance Recommendation</b>	Replace
<b>Maintenance Timeframe</b>	Greater than 5 years

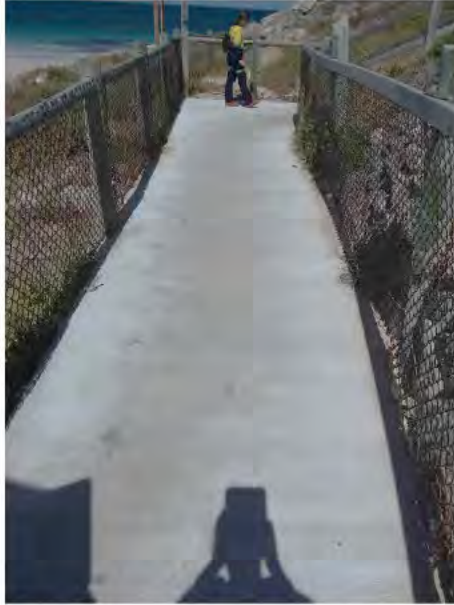
<b>Site No.</b>	C33
<b>Site Name/ Location</b>	South Mindarie Foreshore
<b>Date</b>	14/01/2021
<b>Time</b>	10:10 (8 GMT)
<b>Item Number</b>	24
<b>Costal Asset Type</b>	Concrete Path
<b>Sub-element (Fencing)</b>	Timber posts
<b>Sub-element (Handrails)</b>	Handrail
<b>Material Type</b>	Timber
<b>2021 Observed Defects (Timber)</b>	Rotted timber, Split timber
<b>2021 Observed Defects (General)</b>	Subsidence, sinking, rotation
<b>Defect Description</b>	Splitting of timber observed to all posts, northern posts observed with deflection due to subsidence, minor rot observed
<b>Condition Rating (0- 10)</b>	6
<b>Health and Safety Concern (Y/N)</b>	No
<b>Consequence of Failure</b>	2
<b>Likelihood of Failure within next 5 years</b>	3
<b>Risk Rating</b>	6
<b>Overall Rating (CR X RR)</b>	36
<b>Maintenance Recommendation</b>	Replace
<b>Maintenance Timeframe</b>	Within 5 years

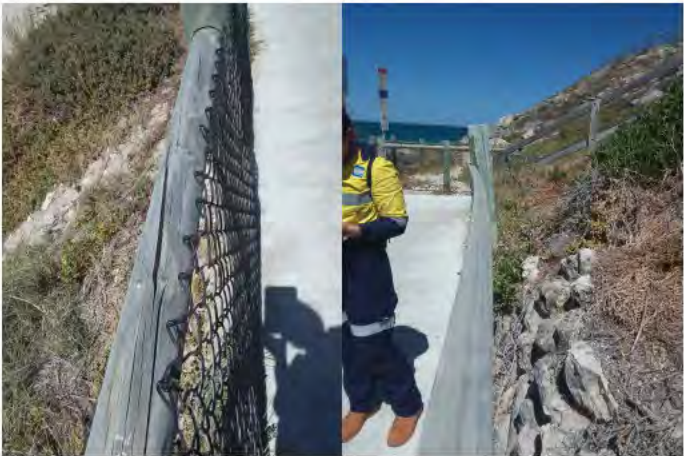
<b>Site No.</b>	C33
<b>Site Name/ Location</b>	South Mindarie Foreshore
<b>Date</b>	15/01/2021
<b>Time</b>	10:03 (8 GMT)
<b>Item Number</b>	26
<b>Costal Asset Type</b>	Concrete path
<b>Sub-element (Fencing)</b>	Timber connection
<b>Material Type</b>	Galvanised Steel
<b>2021 Observed Defects (Steel)</b>	Corrosion with section loss
<b>Defect Description</b>	Heavy corrosion to connection bolts (typical)
<b>Condition Rating (0- 10)</b>	6
<b>Health and Safety Concern (Y/N)</b>	No
<b>Consequence of Failure</b>	2
<b>Likelihood of Failure within next 5 years</b>	3
<b>Risk Rating</b>	6
<b>Overall Rating (CR X RR)</b>	36
<b>Maintenance Recommendation</b>	Replace
<b>Maintenance Timeframe</b>	Within 5 years
