# City of Wanneroo Assets Structural Assessment

## Coastal Assets

City Of Wanneroo

30 July 2021

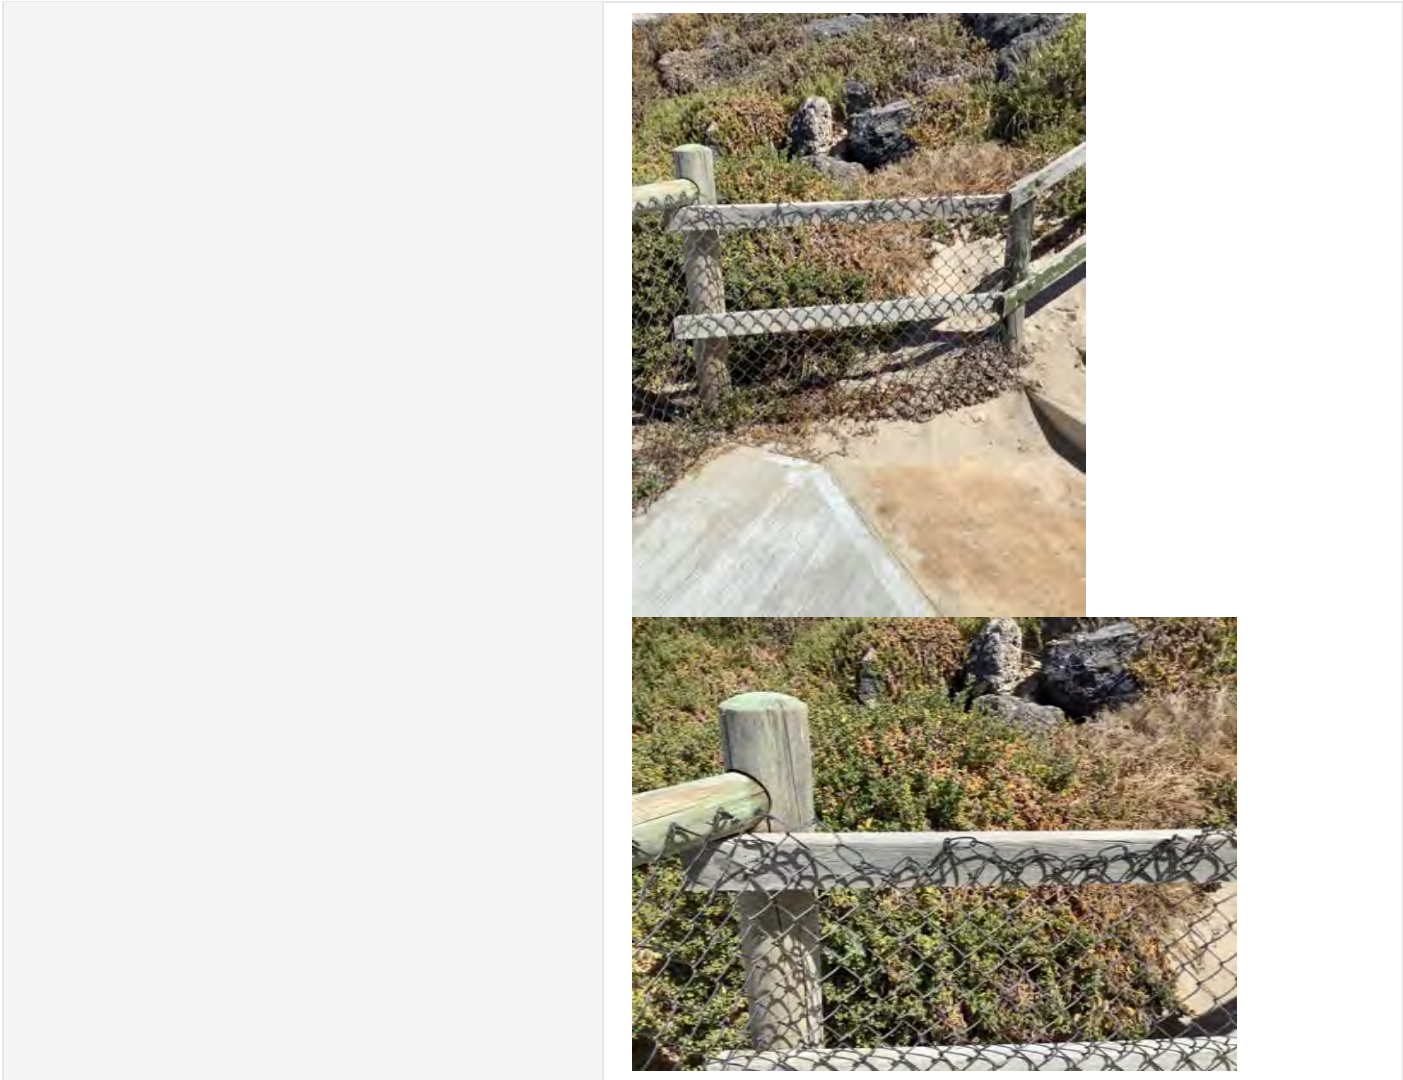
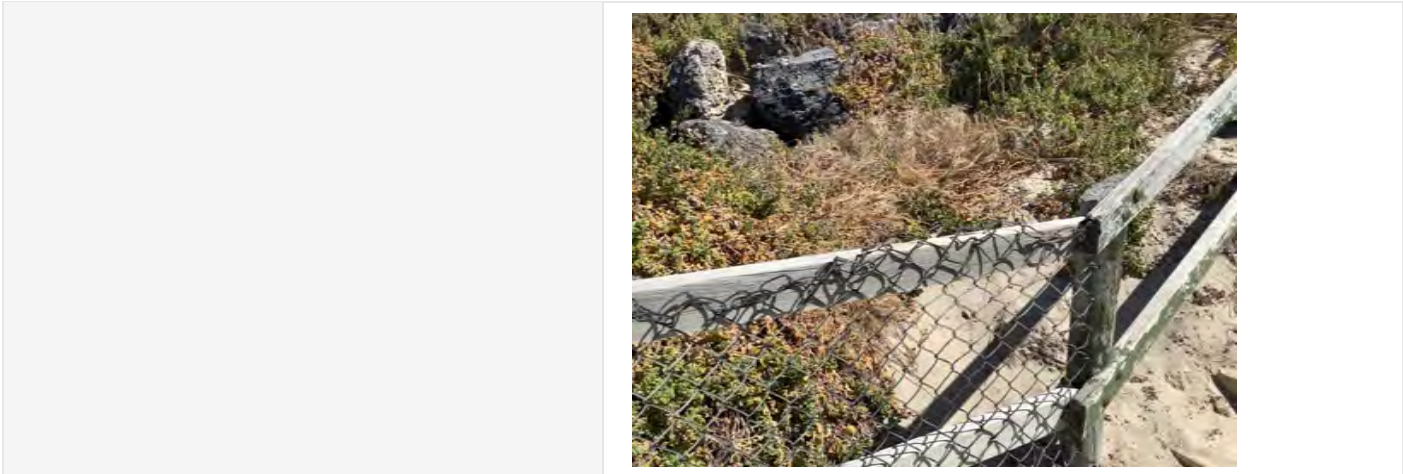
<b>Site No.</b>	C33
<b>Site Name/ Location</b>	South Mindarie Foreshore
<b>Date</b>	15/01/2021
<b>Time</b>	09:57 (8 GMT)
<b>Item Number</b>	28
<b>Costal Asset Type</b>	Concrete path
<b>Sub-element (Fencing)</b>	Mesh staples
<b>Material Type</b>	Coated Steel
<b>2021 Observed Defects (Steel)</b>	Surface corrosion, Noticeable build-up of debris
<b>Defect Description</b>	Corrosion on all staples for mesh. Noticeably worse at eastern side of path.
<b>Condition Rating (0- 10)</b>	6
<b>Health and Safety Concern (Y/N)</b>	No
<b>Consequence of Failure</b>	2
<b>Likelihood of Failure within next 5 years</b>	2
<b>Risk Rating</b>	4
<b>Overall Rating (CR X RR)</b>	24

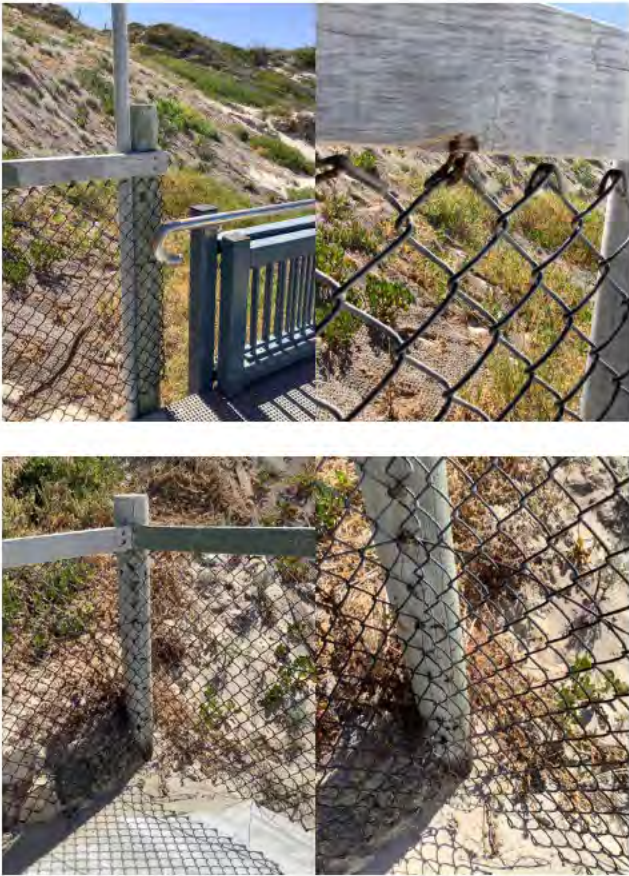
<b>Site No.</b>	C33
<b>Site Name/ Location</b>	South Mindarie Foreshore
<b>Date</b>	15/01/2021
<b>Time</b>	10:02 (8 GMT)
<b>Item Number</b>	29
<b>Costal Asset Type</b>	Concrete path
<b>Sub-element (Fencing)</b>	Mesh strainer wires
<b>Material Type</b>	Coated Steel
<b>2021 Observed Defects (Steel)</b>	Coating loss, Surface corrosion, Noticeable build-up of debris
<b>Defect Description</b>	Coating loss at staples on timber posts. Not fixed to mesh on southern side for mid wire. Mesh fixings have corroded and have noticeable build up of debris. No wires on western side.
<b>Condition Rating (0- 10)</b>	6
<b>Health and Safety Concern (Y/N)</b>	No
<b>Consequence of Failure</b>	2
<b>Likelihood of Failure within next 5 years</b>	2
<b>Risk Rating</b>	4
<b>Overall Rating (CR X RR)</b>	24
<b>Maintenance Recommendation</b>	Replace
<b>Maintenance Timeframe</b>	Within 5 years

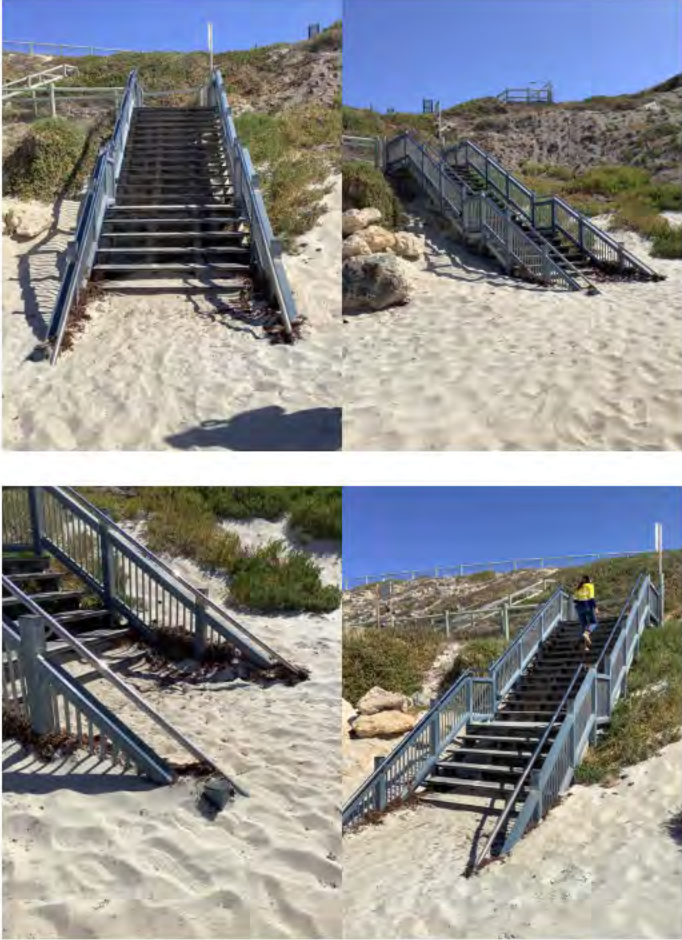
<b>Site No.</b>	C33
<b>Site Name/ Location</b>	South Mindarie Foreshore
<b>Date</b>	13/01/2021
<b>Time</b>	16:23 (8 GMT)
<b>Item Number</b>	32
<b>Costal Asset Type</b>	Stairs
<b>Sub-element (Handrails)</b>	Handrail
<b>Material Type</b>	Stainless Steel
<b>2021 Observed Defects (Steel)</b>	Rust staining
<b>Defect Location</b>	Typical at connections
<b>Condition Rating (0- 10)</b>	2
<b>Health and Safety Concern (Y/N)</b>	No
<b>Consequence of Failure</b>	2
<b>Likelihood of Failure within next 5 years</b>	1
<b>Risk Rating</b>	2
<b>Overall Rating (CR X RR)</b>	4
