PRECINCTS 1 & 2 THOMAS ROAD, CASUARINA

SIGNIFICANT TREE SURVEY

Report Date: 7 March 2018

Report No. 2017-369

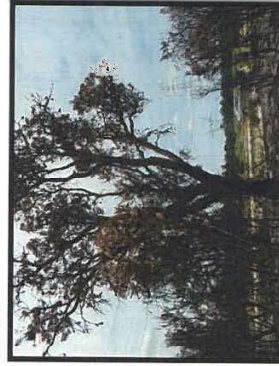
Tree 36

37	391956	6433385	Jarrah (Eucalyptus marginata)	11	43	29	29	52	52	Poor condition recently burnt and fire damage
38	391935	6433429	Candlestick Banksia (Banksia attenuata)	10	40	32	32	51	51	Poor condition recently burnt and fire damage
