CLEARING PERMIT APPLICATION – LILIAN AVE, ARMADALE

Attachment 2: Arboricultural Assessment Report

Attachment 2: Arboricultural Assessment Report (17/12/2018)

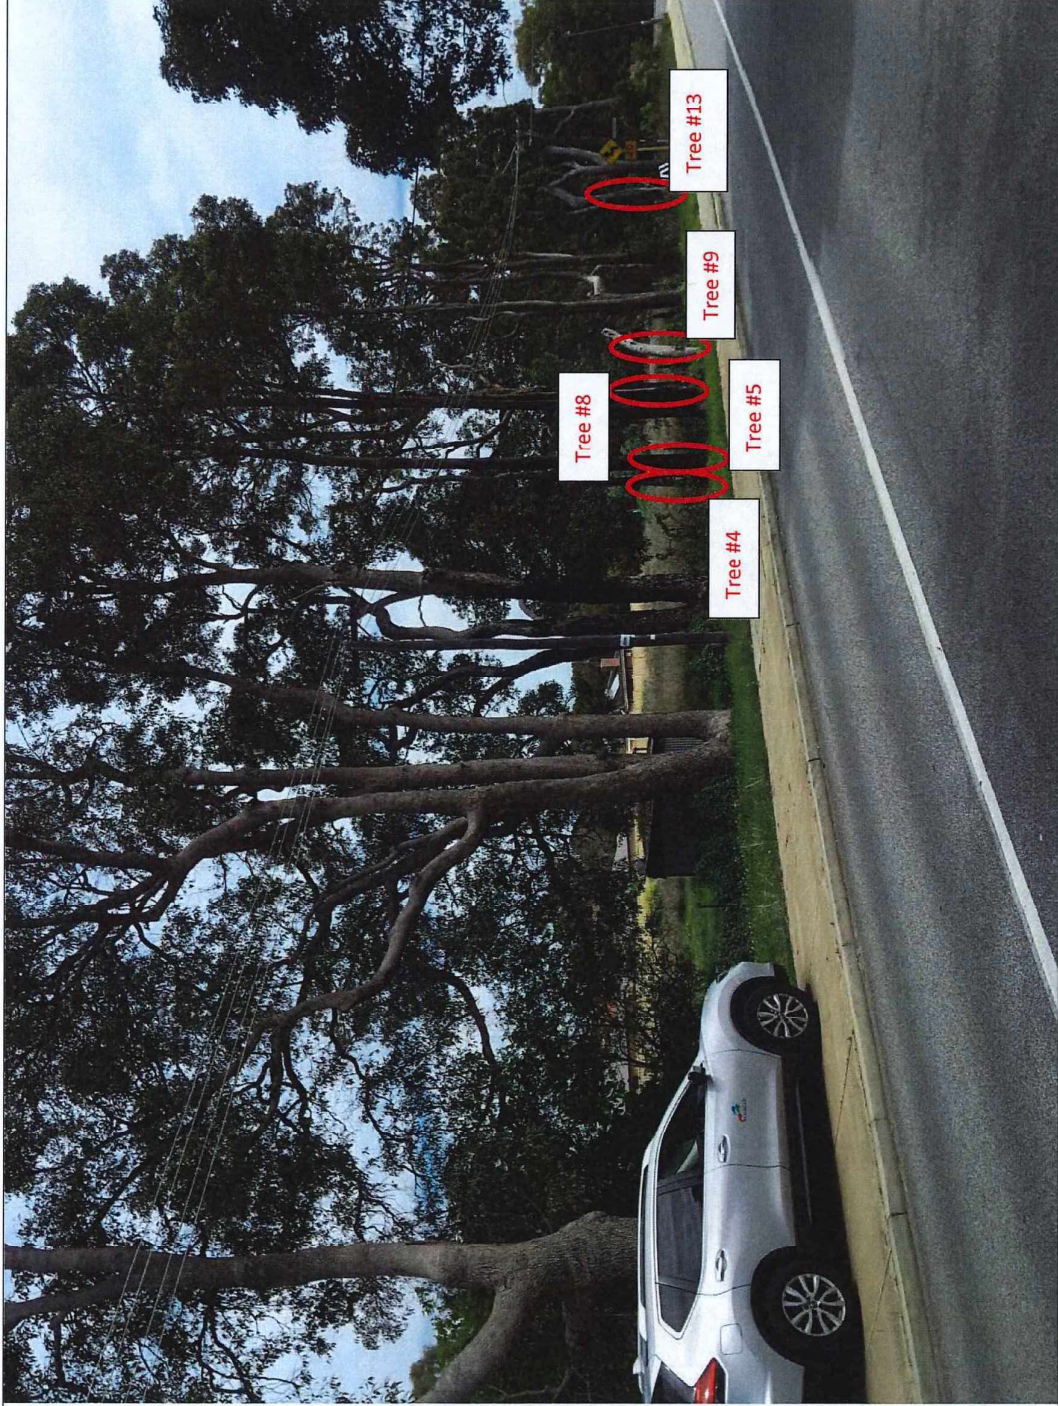
Plate 1 – Row of trees along Lillian Ave showing trees proposed for removal (red circle)

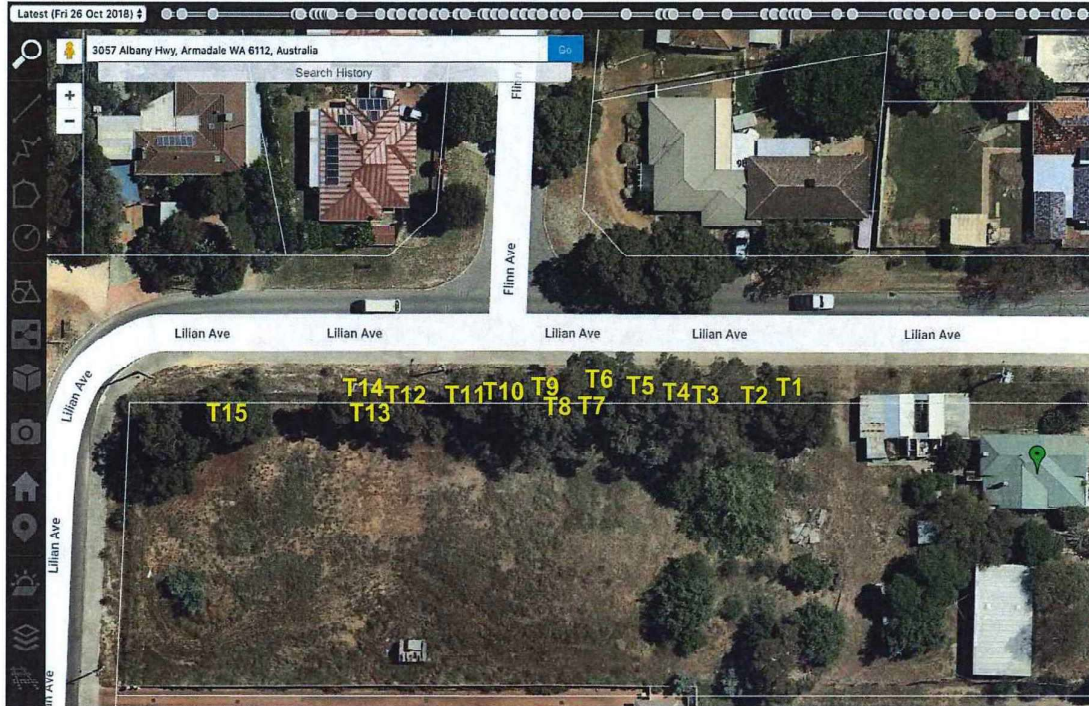
Figure 1. Aerial photo of site with the 15 mature trees located adjacent to the proposed development at 3057 Albany Highway, Kelmscott.

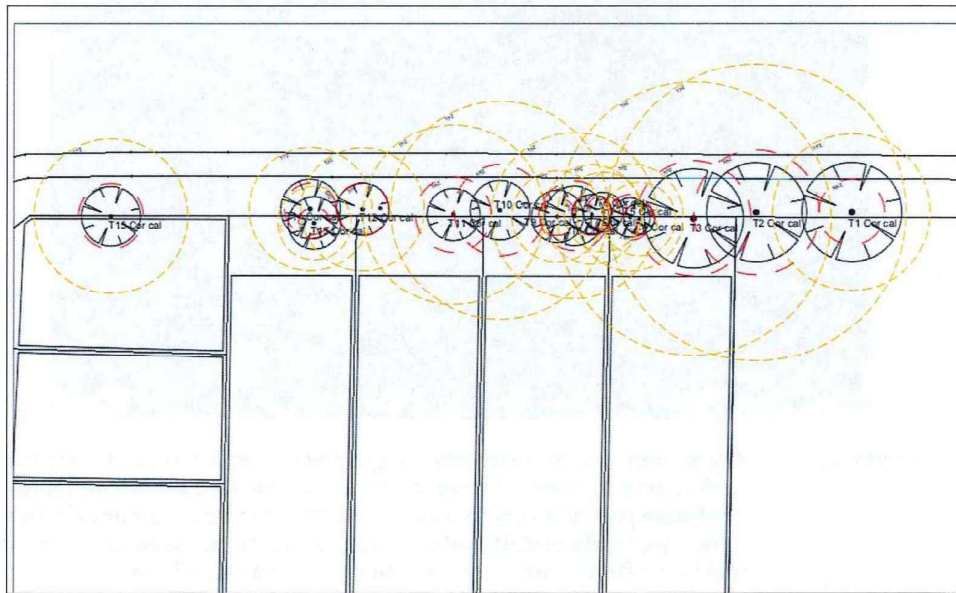
Figure 2. Tree protection plan with the tree numbering T1-15 allocated to the 15 trees assessed adjacent to the proposed construction.

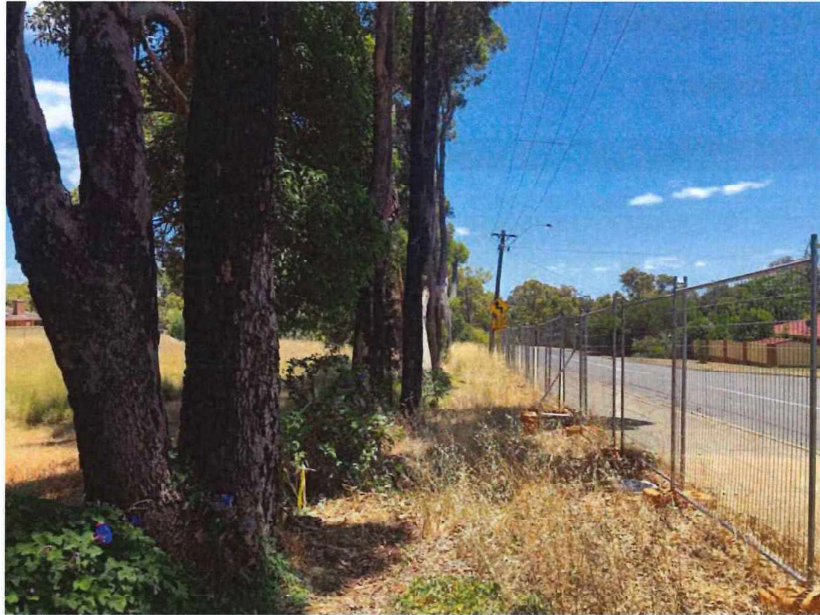
Figure 3. Municipal verge area with existing marri and jarrah trees located adjacent to the proposed construction activity; looking towards the east.

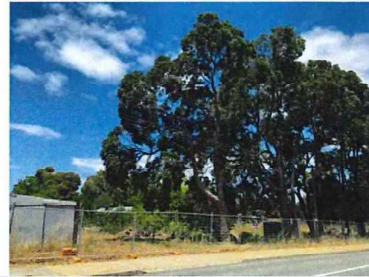
Tree Number: 1
Botanical Name: *Corymbia calophylla*
Common Name: marri
Retention Value: High
Height: 17m
DBH: 0.66m
TPZ radius: 7.9m
SRZ radius: 3.3m
Remedial Options: Crown lifting

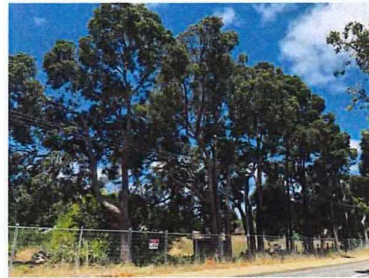
Tree Number: 2
Botanical Name: *Corymbia calophylla*
Common Name: marri
Retention Value: High
Height: 23m
DBH: 1.25m
TPZ radius: 15m
SRZ radius: 6.3m
Remedial options: Deadwooding, crown lifting

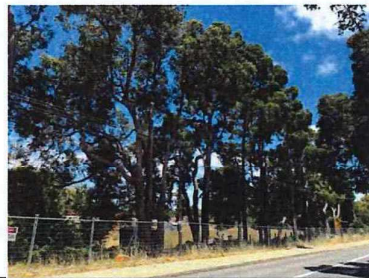
Tree Number: 3
Botanical Name: *Corymbia calophylla*
Common Name: marri
Retention Value: High
Height: 22m
DBH: 1.15m
TPZ radius: 13.8m
SRZ radius: 5.8m
Remedial options: Deadwooding, crown lifting

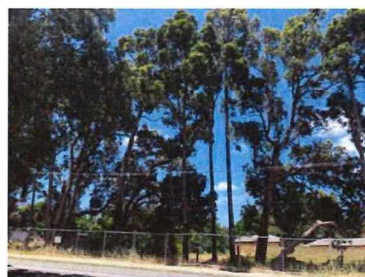
Tree Number: 6
Botanical Name: *Corymbia calophylla*
Common Name: marri
Retention Value: Medium
Height: 21m
DBH: 0.33m
TPZ radius: 4m
SRZ radius: 1.7m
Remedial options: No work required at present

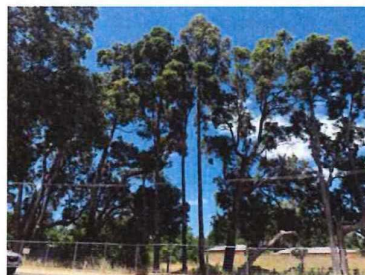
Tree Number: 7
Botanical Name: *Corymbia calophylla*
Common Name: marri
Retention Value: Medium
Height: 24m
DBH: 0.42m
TPZ radius: 5m
SRZ radius: 2.1m
Remedial options: No work required at present

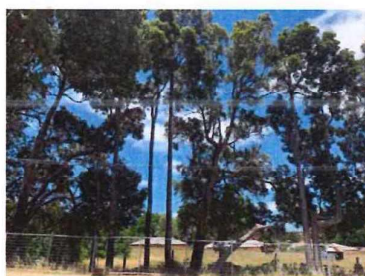
Tree Number: 8
Botanical Name: *Corymbia calophylla*
Common Name: marri
Retention Value: Medium
Height: 21m
DBH: 0.7m
TPZ radius: 8.4m
SRZ radius: 3.5m
Remedial options: Deadwooding, crown lifting

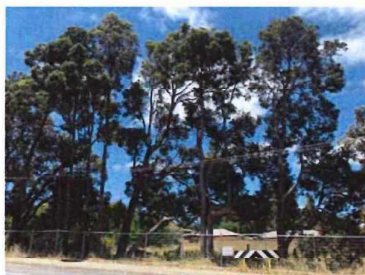
Tree Number: 10
Botanical Name: *Corymbia calophylla*
Common Name: marri
Retention Value: Medium
Height: 19m
DBH: 0.92m
TPZ radius: 11m
SRZ radius: 4.6m
Remedial options: Crown lifting

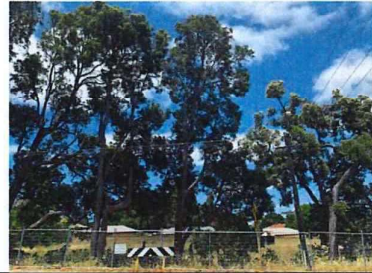
Tree Number: 11
Botanical Name: *Corymbia calophylla*
Common Name: marri
Retention Value: High
Height: 19m
DBH: 0.76m
TPZ radius: 9.1m
SRZ radius: 3.8m
Remedial options: Crown lifting

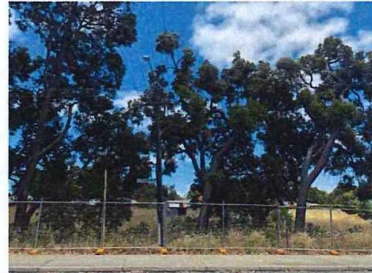
Tree Number: 12
Botanical Name: *Eucalyptus marginata*
Common Name: jarrah
Retention Value: High
Height: 13m
DBH: 0.52m
TPZ radius: 6.2m
SRZ radius: 2.6m
Remedial options: No work required at present

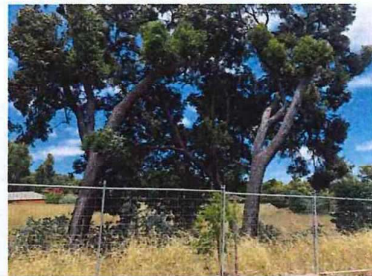
Tree Number: 13
Botanical Name: *Corymbia calophylla*
Common Name: marri
Retention Value: Medium
Height: 8m
DBH: 0.31m
TPZ radius: 3.7m
SRZ radius: 1.6m
Remedial options: Crown lifting

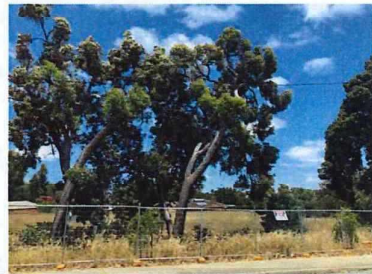
Tree Number: 14
Botanical Name: *Eucalyptus marginata*
Common Name: jarrah
Retention Value: High
Height: 11m
DBH: 0.52m
TPZ radius: 6.2
SRZ radius: 2.6
Remedial options: No work required at present

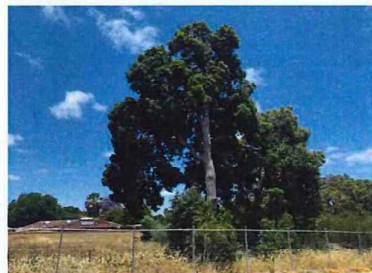
Tree Number: 15
Botanical Name: *Corymbia calophylla*
Common Name: marri
Retention Value: High
Height: 14m
DBH: 0.65m
TPZ radius: 7.8m
SRZ radius: 3.3m
Remedial options: Crown lifting
