**Black Cockatoo  
Habitat Tree Assessment  
CPS 8482/1**

**Lot 12140  
Jones Road  
Yanmah**

December 2019

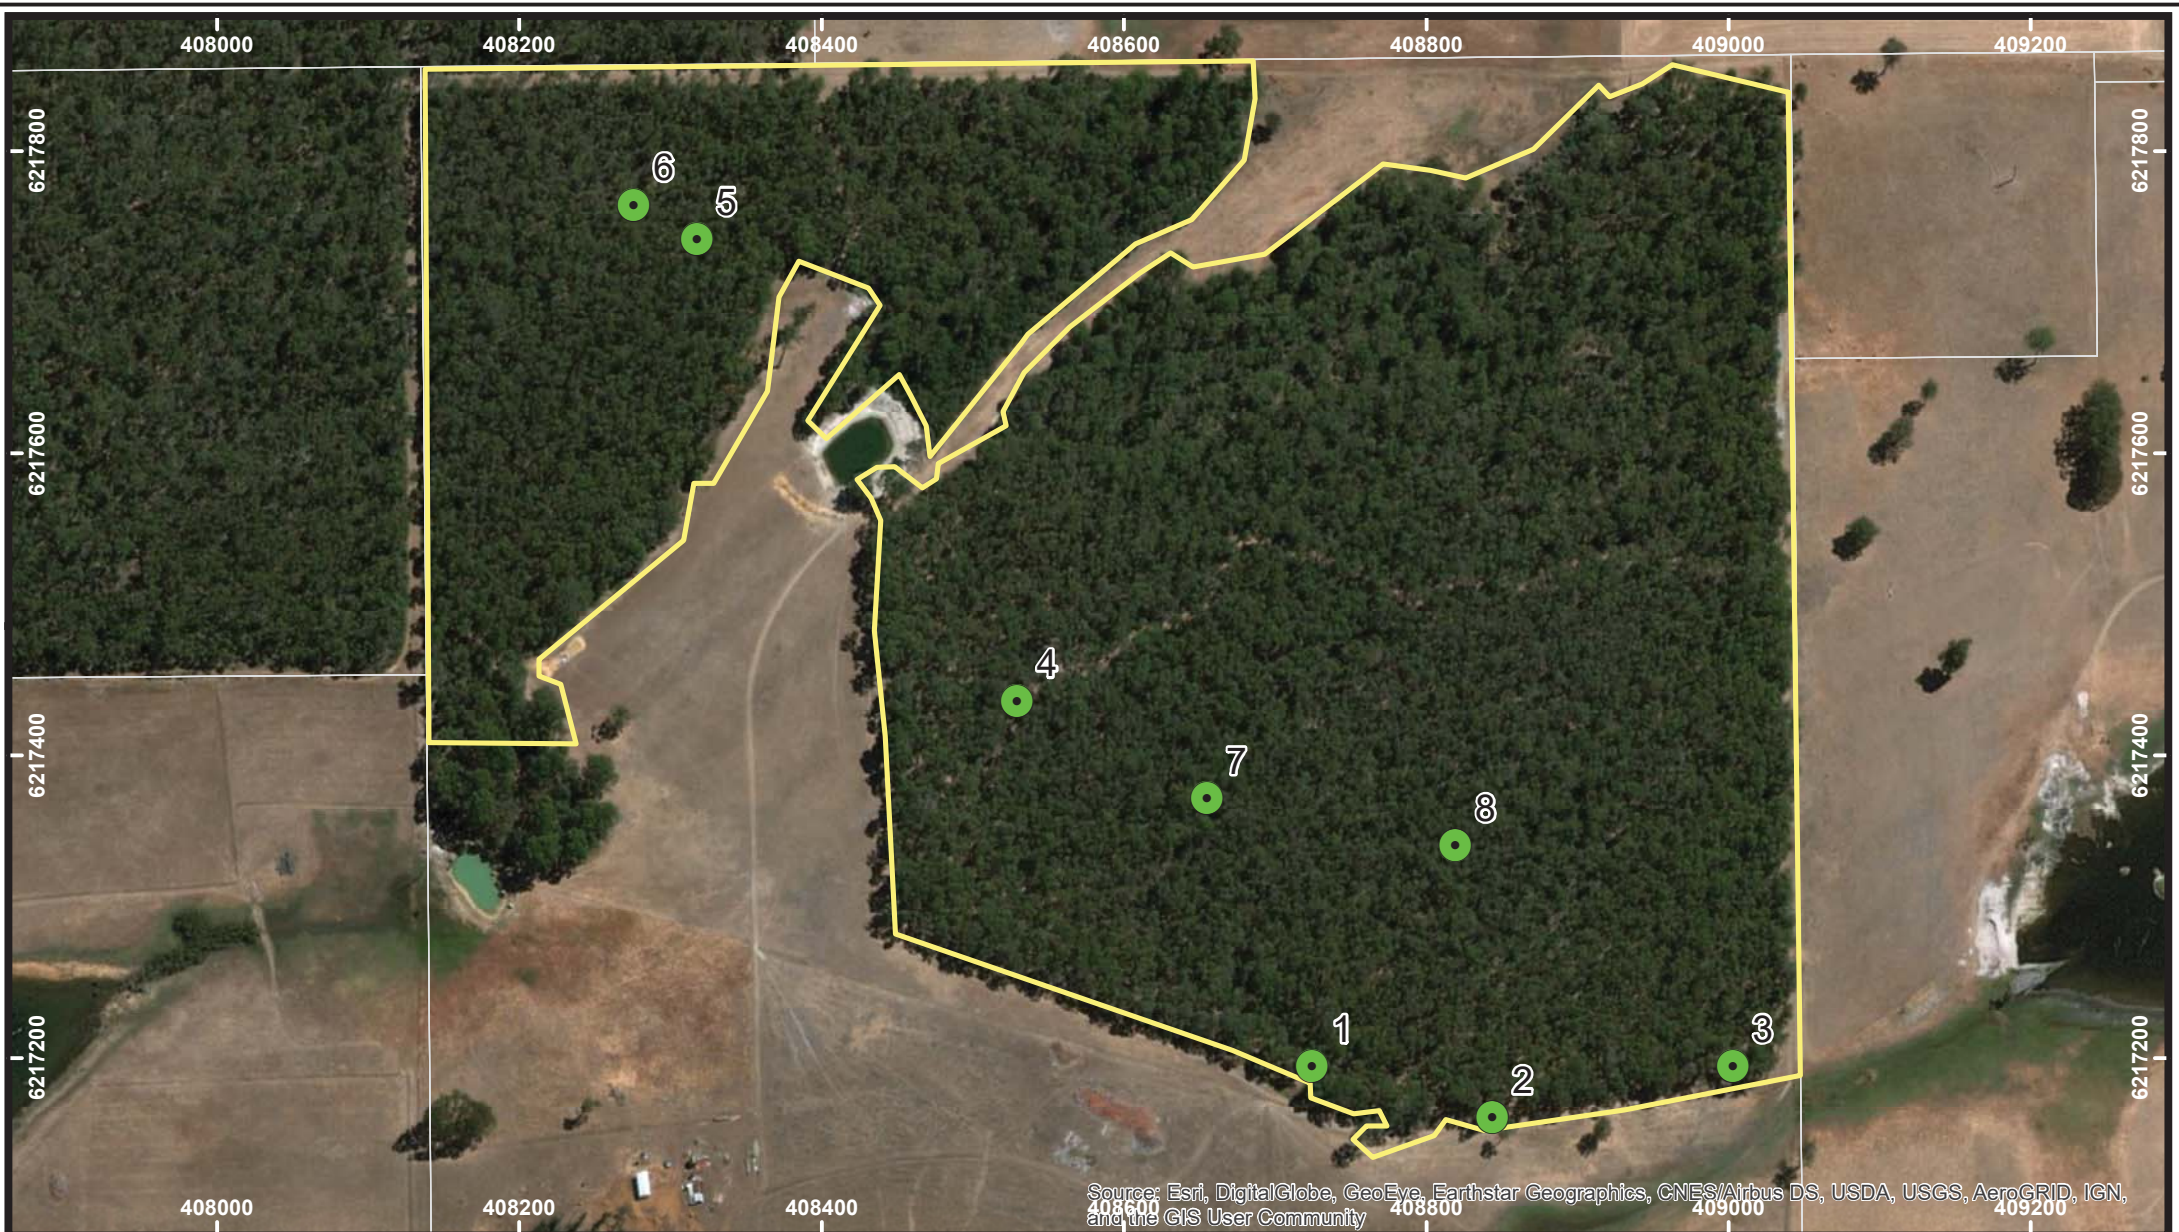
FIGURE 1: Habitat Trees Inspected

No conclusive evidence of black cockatoo nesting activity was observed in any tree within the permit area. Eight trees were identified within the permit area as containing one or more possible hollows potentially suitable for black cockatoos to use for nesting purposes. Upon closer inspection with a drone six of these trees were assessed as not having hollows suitable for black cockatoos to use for nesting.

One tree was observed to contain a large chimney type hollow that appeared to be of a suitable size for black cockatoos but showed no evidence of use. A side entry hollow in Tree 6 showed some minor evidence of use in the form of some apparent chew marks but the actual cause (black cockatoos/galahs nesting/investigating?) was inconclusive. This hollow also seemed marginal in its suitability for cockatoos as it is quite shallow in depth.

If DWER approve the clearing permit it is recommended that an inspection of all the trees be carried out by a suitably qualified "fauna specialist" immediately prior to clearing to determine if any of the hollows are in use at the time. Trees containing hollows found to be in use should not be felled until it is certain no fauna are present.
