## ENVIRONMENTAL SITE INSPECTION REPORT

### Stephenson Avenue, Osborne Park

SITE INSPECTION DETAILS				
<b>Date:</b>	22 <sup>nd</sup> May 2019			
<b>Location:</b>	Stephenson Avenue, Osborne Park			
<b>Region</b>	IDD			
<b>Purpose:</b>	Determine remnant vegetation and condition			
<b>Attendees:</b>	Gaynor Owen	Senior Environment Officer Main Roads Western Australia	Fiona Van Rijnswood	Environment Officer Main Roads Western Australia

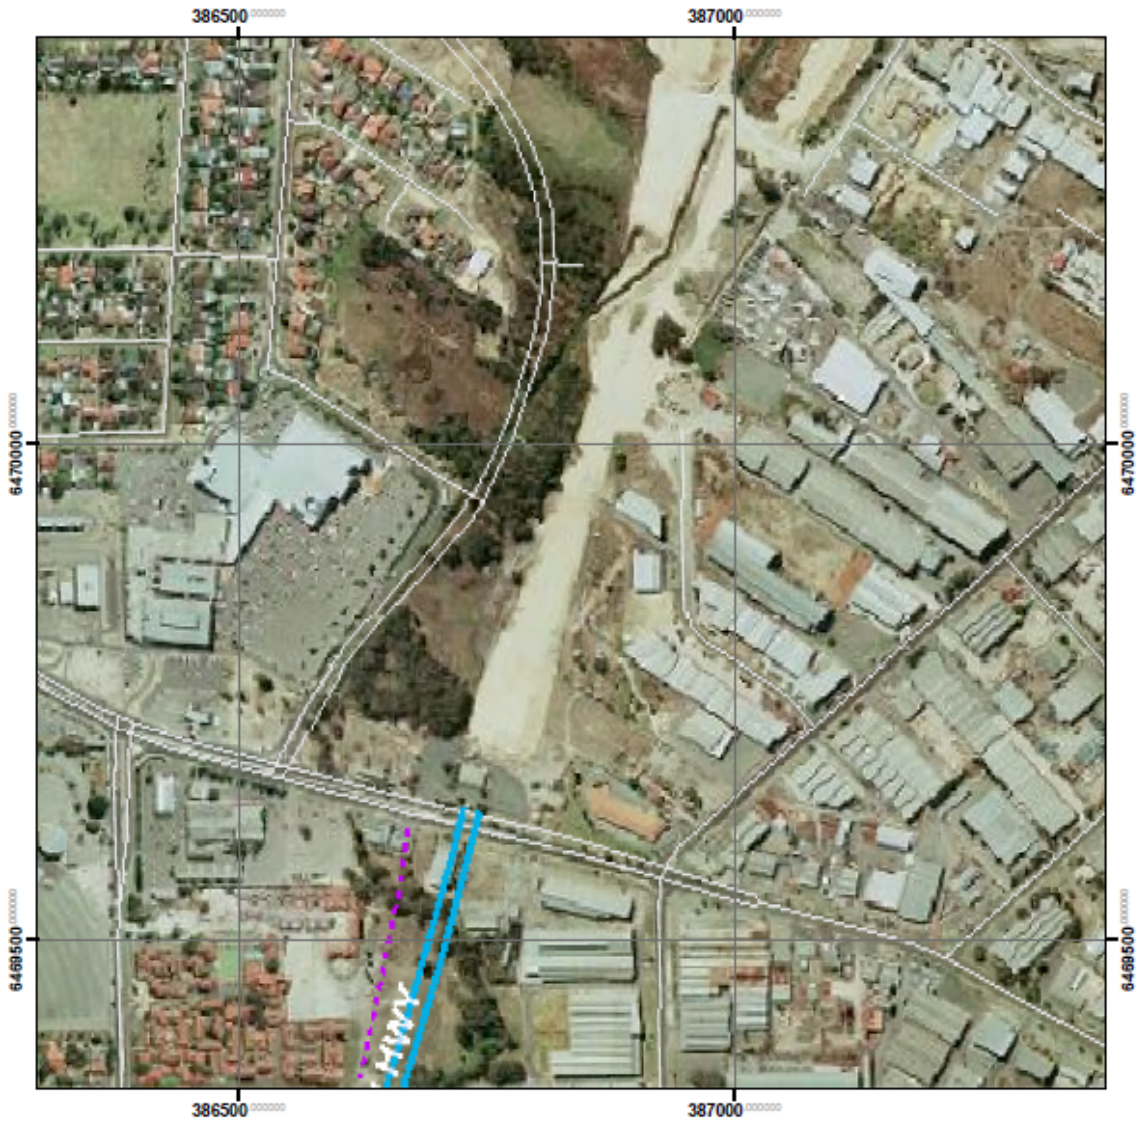
Figure 1. Aerial Imagery from 1987

The remnant vegetation assessed was vegetation remaining from clearing for the Mitchell Freeway in the late 1980's, as shown in Figure 1.
