16 December 2019

Plantecology Consulting was commissioned by B & J Catalano to undertake a reconnaissance vegetation survey at the Donnington Quarry, 4884 Gt Northern Highway, Chittering, which is bounded by Great Northern Highway, Maddern Rd and Blue Plains Rd (the site), in the Shire of Chittering (Figure 1). The site consisted of six separate areas for assessment, of which, Areas 3 – 6 (covering approximately 63 ha) are the subject of this report (Figure 2). Areas 1 and 2 required a detailed survey and will be discussed in a separate report. The purpose of the survey was to inform the proposed expansion of an active quarry and this letter outlines the results of that survey.

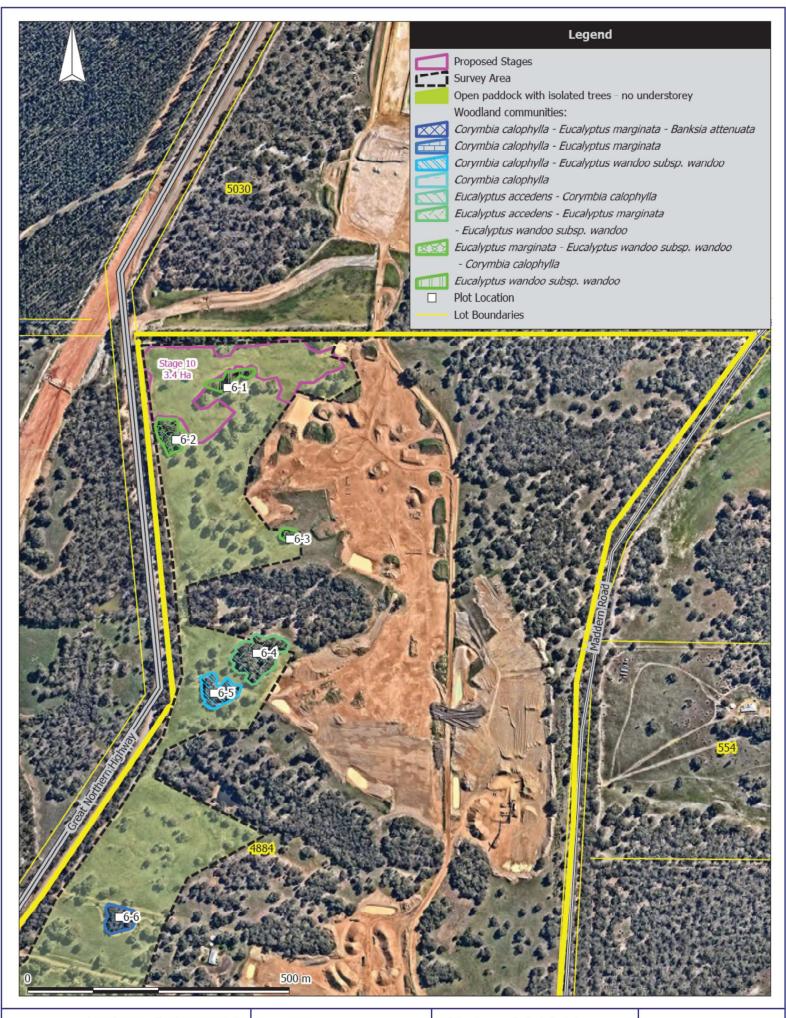
4884 Great Northern Hwy Chittering Figure 2a:

Plant Communities

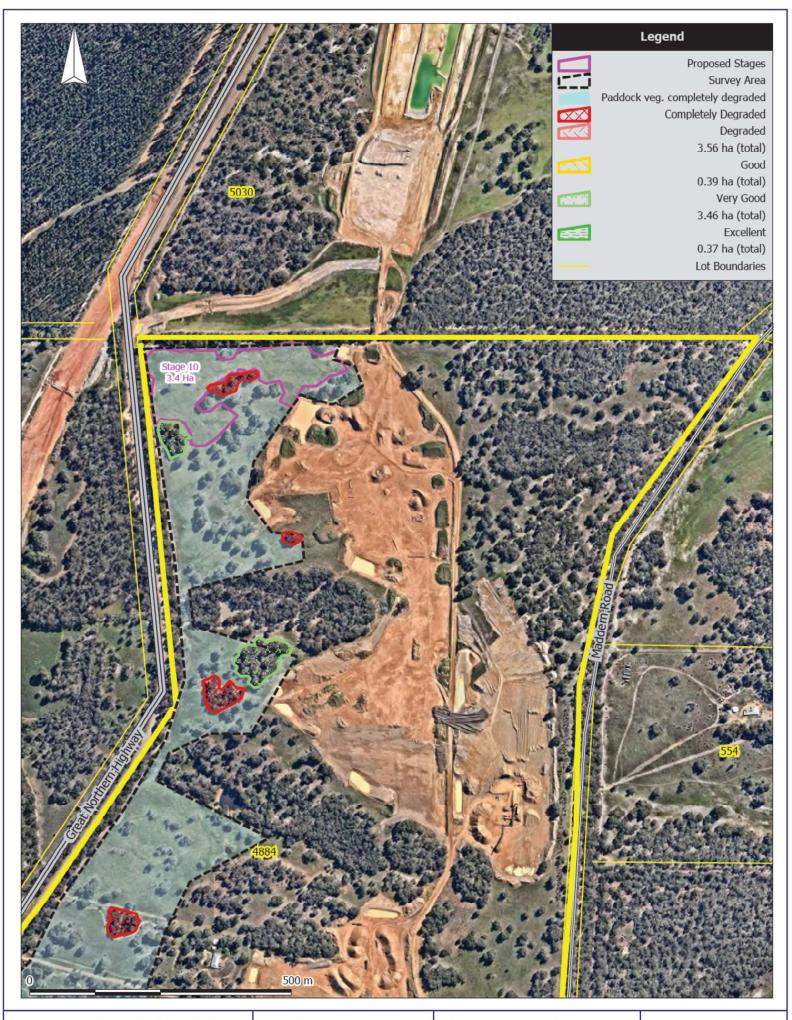
4884 Great Northern Hwy Chittering Figure 3b:

The site has previously been largely cleared for pasture with some remnants of native vegetation. The remnants are mostly smaller than one hectare and range in condition from 'Completely Degraded' where only the native tree stratum remains to 'Excellent' where the original vegetation structure remains intact and few weeds have established (Figure 3).

Vegetation Condition
