Department of Water & Environmental Regulation

# R10407 AA DAM 360 Drainage Assessment

19 September 2019

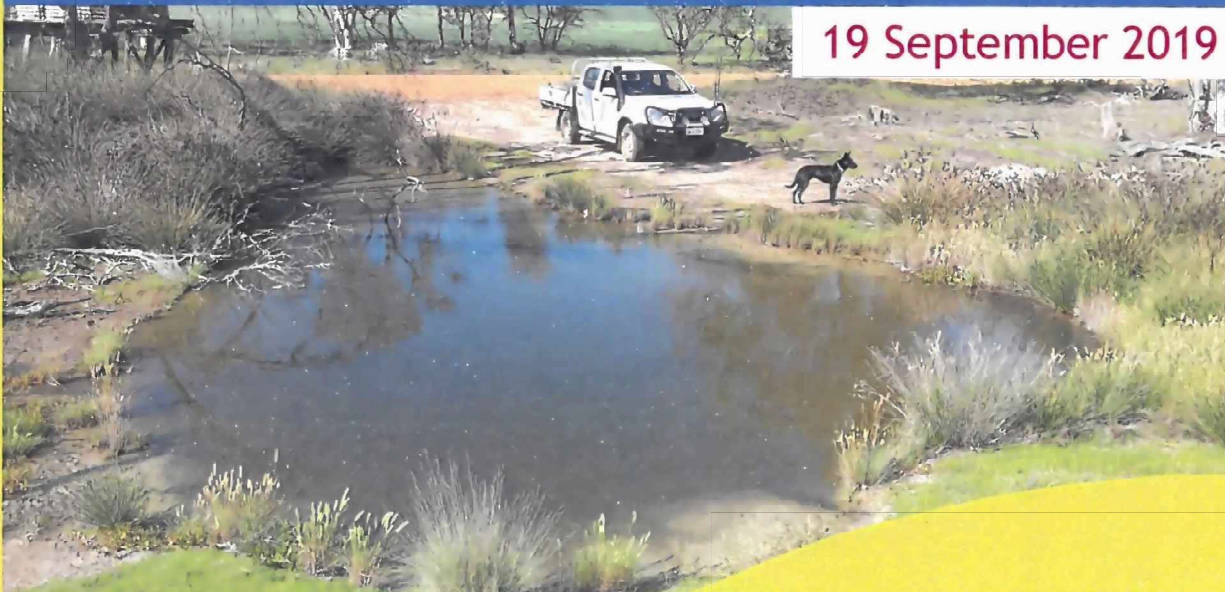
Bare discharge (seepage) area alongside flowline

The key requirement is to encourage vegetative cover of the bare soils. In order to allow natural vegetation to re-establish, the site needs to be dewatered. Once the soil profile is no longer saturated, leaf fall from the remaining trees and accumulation of other vegetative debris will mulch the area and there appears to be sufficient stock of existing understorey vegetation and herbs to gradually recolonise the degraded areas.

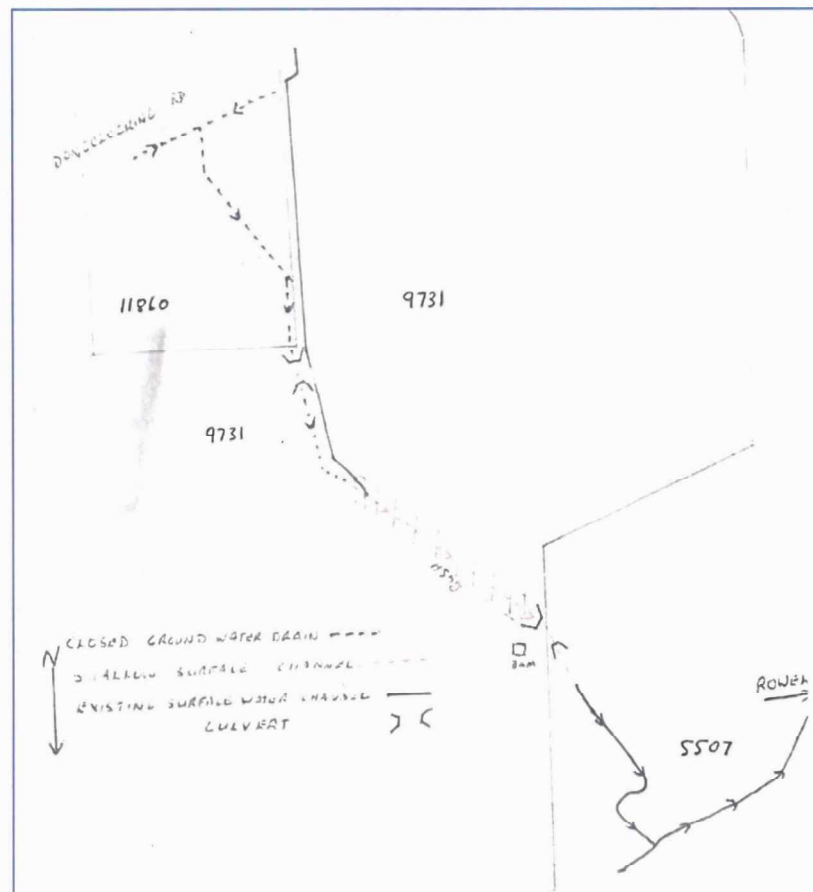
**Figure 1. Reserve 10407 original drainage proposal.**

Neighbouring farmers propose to do some drainage work in the area, and wish to protect the remaining trees and restore vegetation cover in the reserve. The original proposal is shown in Figure 1.
