Nanga Road, Waroona WA

Road Improvements between Slk 0.37 – 2.02.

Road Safety Audit

Stage 3 - Detailed Design

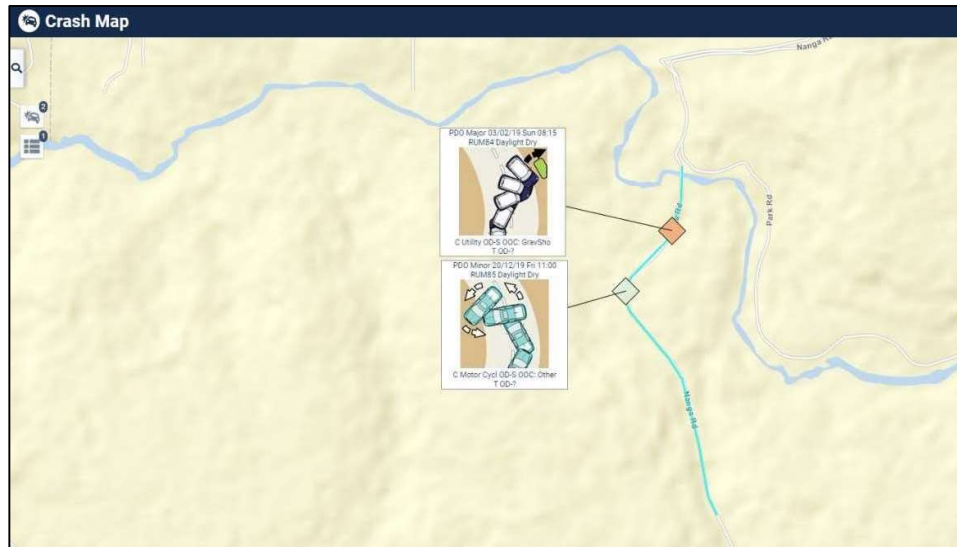
Figure 1 - Crash Map from MRWA CARS website

A study of the recent crash history has been conducted for the Shire of Waroona for the most current five-year period to the end of December 2020. There have been 4 reported crashes along Nanga Road for the current five-year period, 2 of these are within the section Slk 0.37 – 2.02. Note, the previous data that included 2015 included a fatal crash at 2.02 Slk.

All four crashes were in dry conditions and on a curve, resulting in Property Damage.

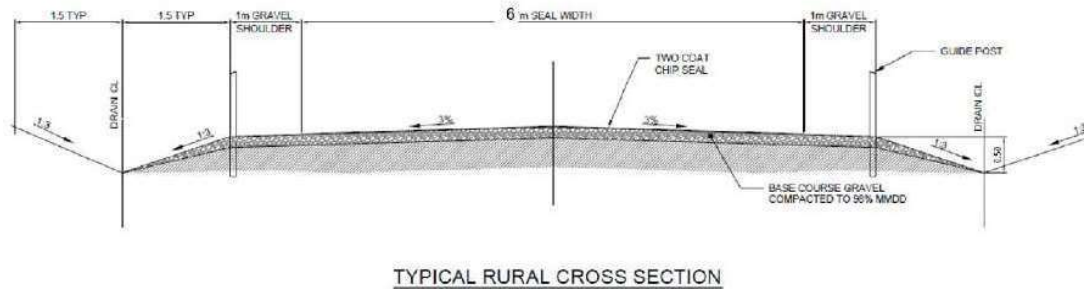
Figure 2 - Typical Cross Section for works

The proposal is to widen the road pavement to achieve a rural road section of two 3.0 m sealed traffic lanes with a 1.0 m gravel shoulder. Delineation is to be guideposts and advance warning signs at curves. W Beam barrier is to be installed where run off crashes is likely to result in a casualty crash.

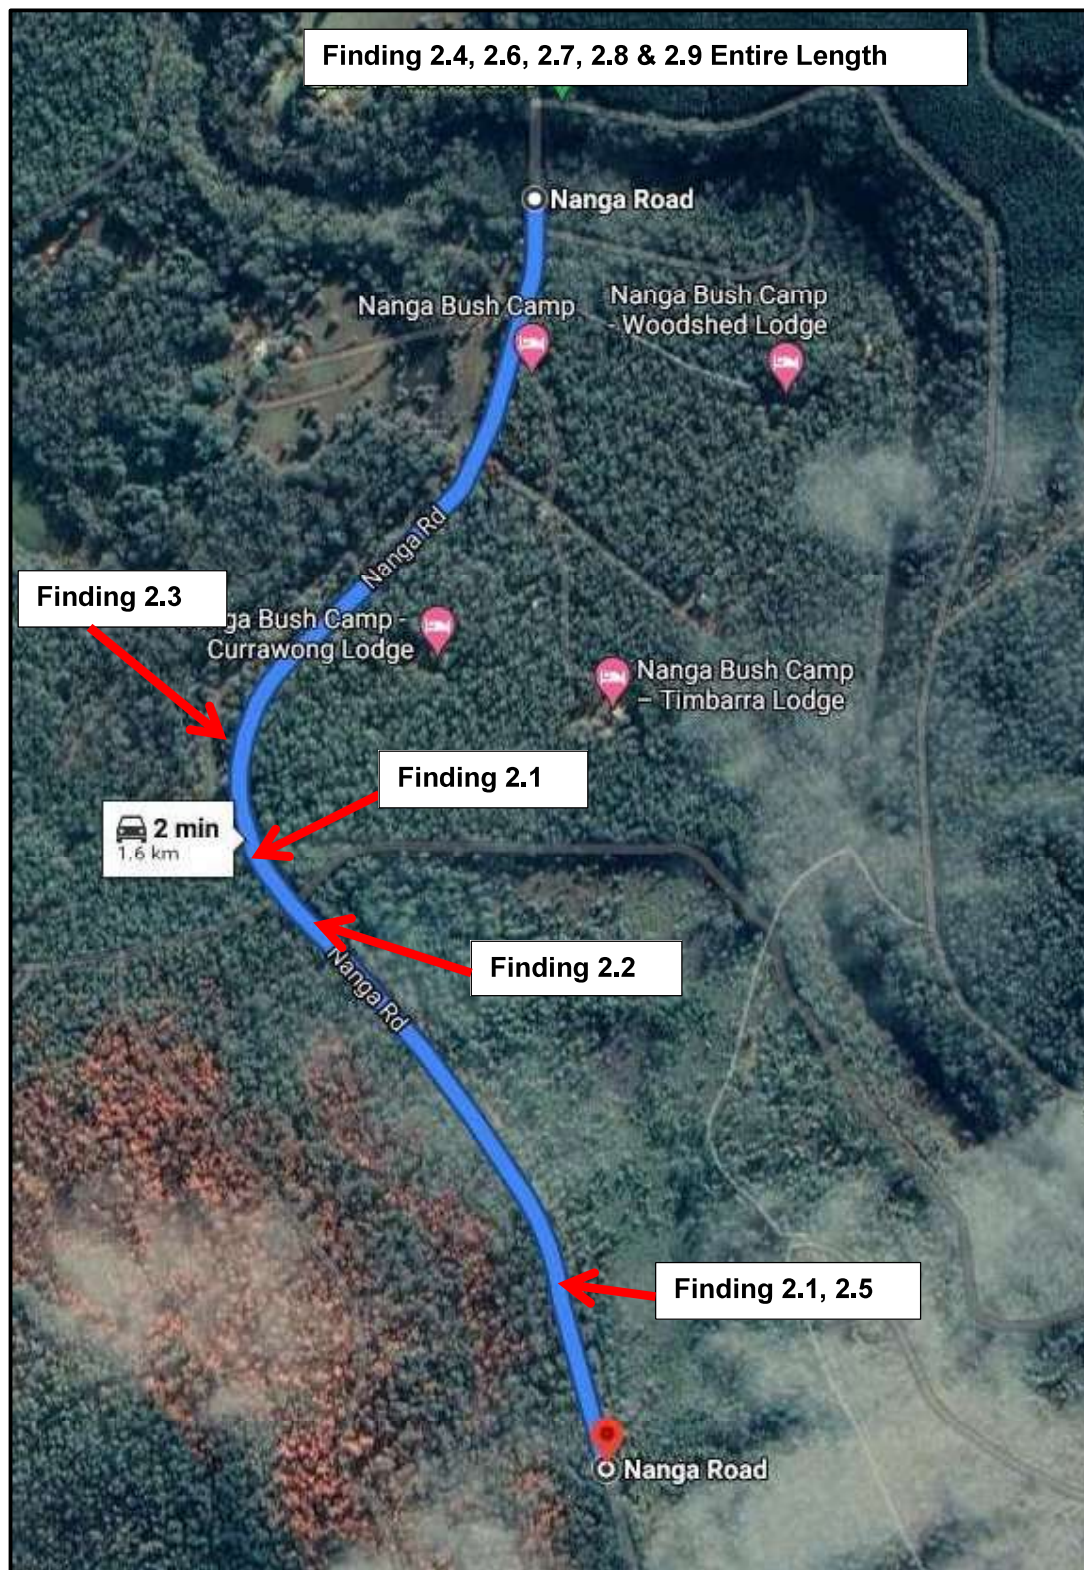
Location Plan

(Many findings are included throughout the length of the road)
