Nanga Road, Waroona WA

Road Improvements between Slk 0.37 – 2.02.

Road Safety Audit

Stage 3 - Detailed Design

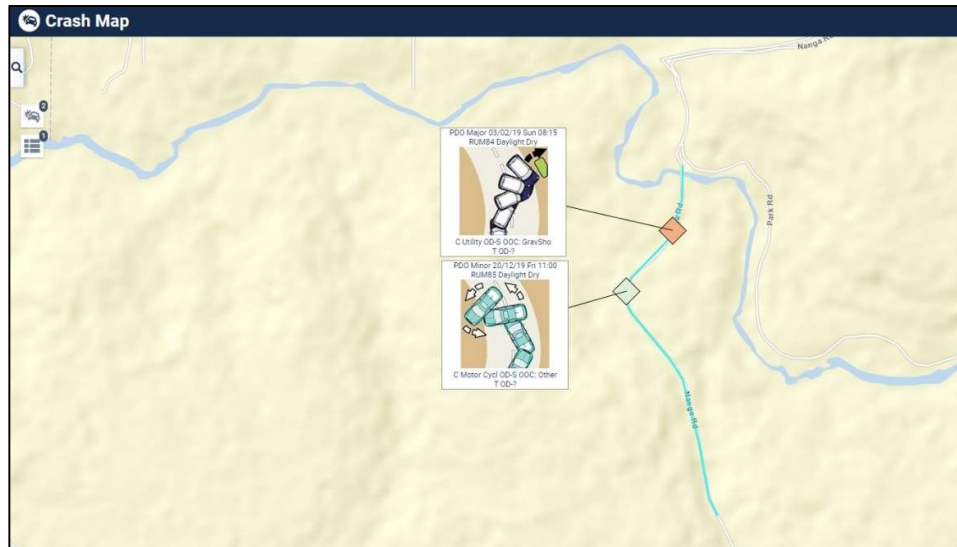
Figure 1 - Crash Map from MRWA CARS website

A study of the recent crash history has been conducted for the Shire of Waroona for the most current five-year period to the end of December 2020. There have been 4 reported crashes along Nanga Road for the current five-year period, 2 of these are within the section Slk 0.37 – 2.02. Note, the previous data that included 2015 included a fatal crash at 2.02 Slk.

All four crashes were in dry conditions and on a curve, resulting in Property Damage.

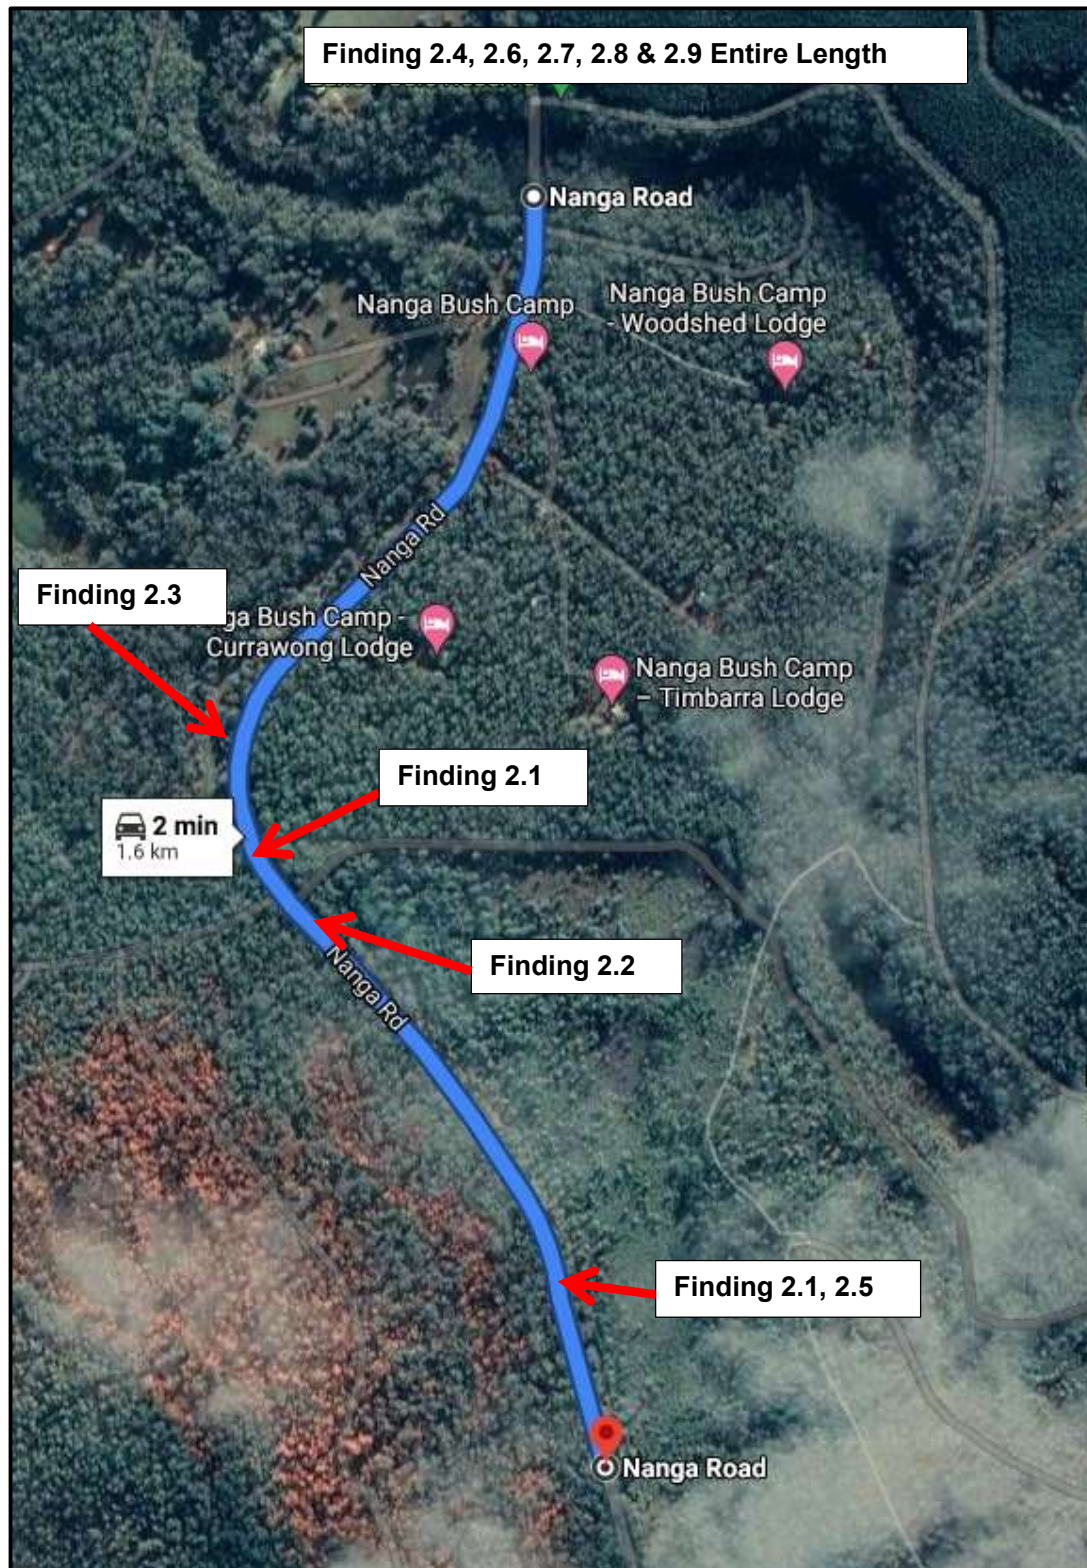
Location Plan

(Many findings are included throughout the length of the road)
