Arboriculture Report

Pete's Treeworx

Shire of Waroona

The purpose of this report is to provide an independent Arboriculture report for the Town centre project and the health of the trees with the impact of the development. This report will outline health issues in the trees and recommended measures to put in place for the site.

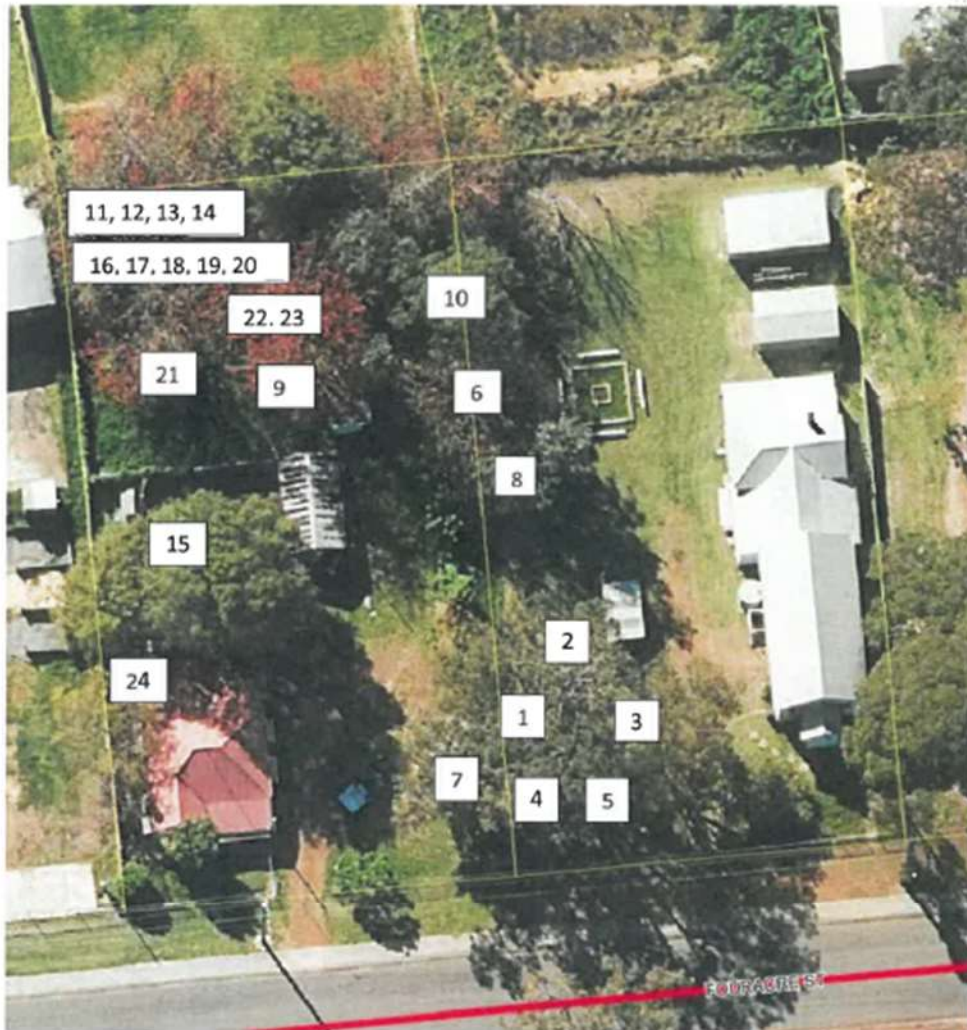
This is a map of all the trees outlined which was supplied by Shire of Waroona
Please note trees 16, 17, 18, 19, 20, 21, 22, 23 are not flame trees and are Coral trees (Erythrina mulungu)

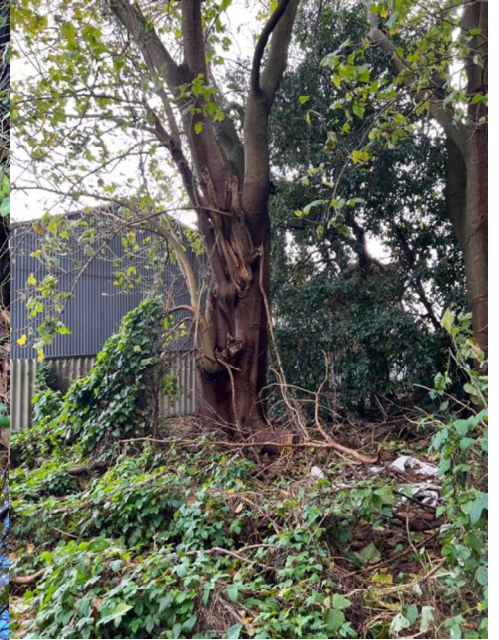
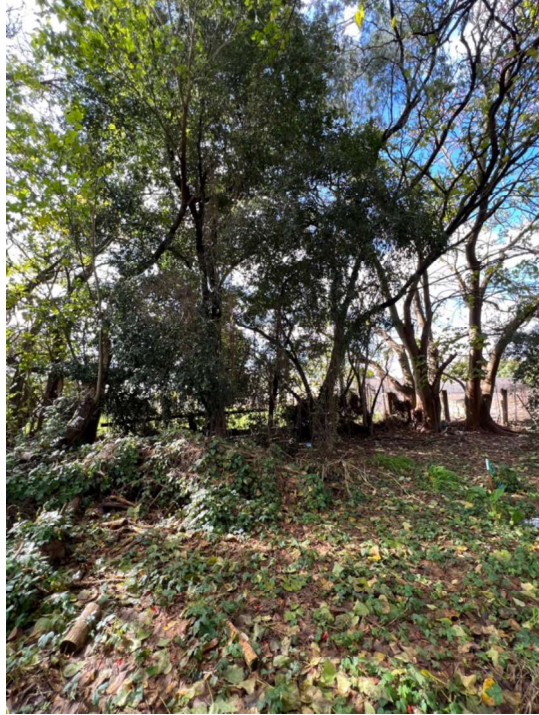
You will notice there are extreme defects throughout these trees and they pose a major risk to the public.

The defects consists of; Poor past pruning, major failures, included unions, failure to compartmentalise, pollards.

Corals trees are a deciduous and would pose an extreme risk in autumn once they loose their leaves and create a hazard on the track.

Risk management – The only risk management solution for these trees is for them to be removed and replace for a more suitable species.
