Our Ref: J22039

9 January 2023

**River Road, Boddington
Powerline Alignment Survey**

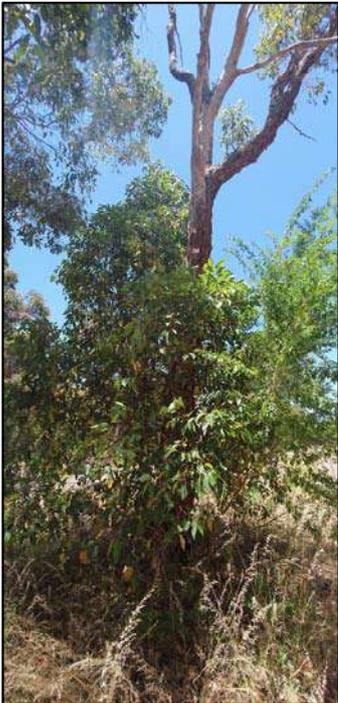
490	594	Marri mostly dead, substantial, 2m off boundary. Possible passable, root trimming required. Marri, mature, 3m off boundary, low overhanging branches might need trimming, root trimming required Next 20m north is messy, lots of dead fallen branches etc., 2 native shrubs ~2m off
491	602	boundary, replaceable. Blackboy, low 30cm high, 2m spike, Tagasaste, Marri 4m from boundary, also Jarrah ~5m from
492	625	boundary, should be trenchable. Jarrah 10m tall, 0.4-0.8m from boundary. Also blackboys & sedges, acacias 2m out. Drilling
493	634	recommended.
494	654	Large Jarrah 20m x 1.5m, mostly dead but significant, smaller Jarrahs for next 10m. Drilling recommended.
