# *Assessment of Trees at Creaney Primary School*

*Prepared For*

*Programmed Facility Management*

The information and opinions provided in this report are based on the observations made during the site assessment undertaken April 11, 2024

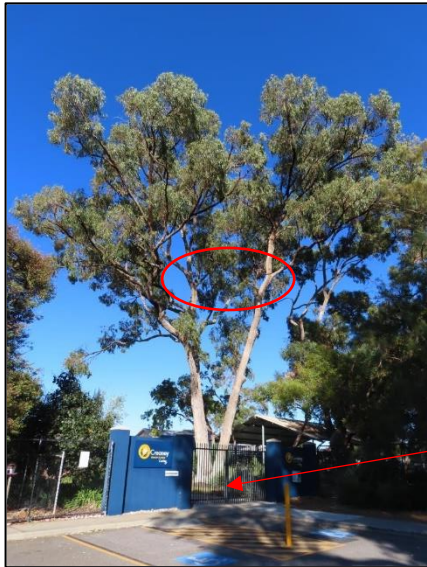
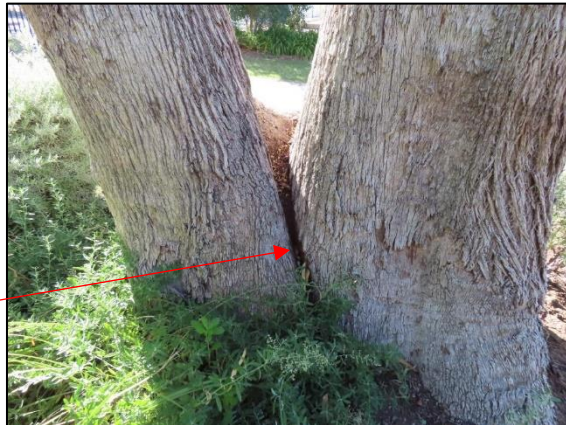
The cable does look slightly tauter than before; but doesn't necessarily look to be tight or under strain.

There are no visible signs of any separation at the union of its two main stems (and they may even be separate trees anyway).

Image taken October 2022  
Note the cable is slightly slack in its appearance
