## **Application for referral to clear native vegetation - Infrastructure Areas Vegetation Assessment February 2025**

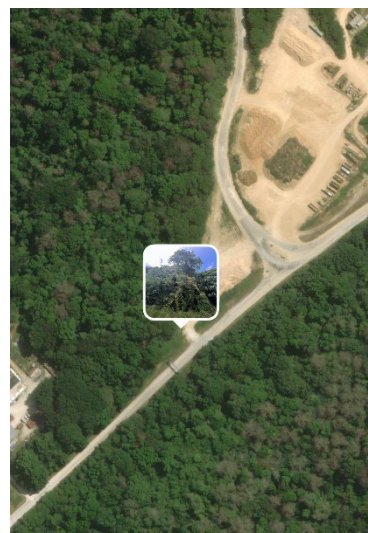
<b>Waypoint Reference</b>	1
<b>Site</b>	LB4/ROM
<b>Tenement</b>	GCI 70/1
<b>GPS Coordinates</b>	N 8845116.0471, E 572652.7407
<b>Photo Direction</b>	280° W
<b>Native Vegetation</b>	<i>Macaranga tanarius</i> <i>Pipturus argenteus</i>
<b>Weed Species</b>	<i>Leucaena leucocephala</i> Other weed species
<b>Vegetation Rating (1=Pristine, 7=Cleared)</b>	5, 6, 7
<b>ESA</b>	Outside, exemptions apply
<b>Notes</b>	Mature trees present, good regeneration. The boundary is ~5-8m into forest from a cleared area, as a buffer zone.

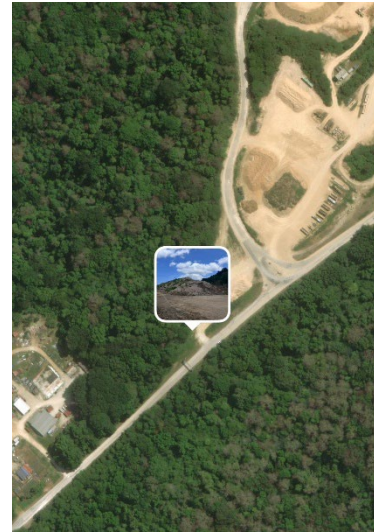
<b>Waypoint Reference</b>	1
<b>Site</b>	LB4/ROM
<b>Tenement</b>	GCI 70/1
<b>GPS Coordinates</b>	N 8845116.0471, E 572652.7407
<b>Photo Direction</b>	75° NE
<b>Native Vegetation</b>	-
<b>Weed Species</b>	<i>Leucaena leucocephala</i> <i>Muntingia calabura</i> Other weed species
<b>Vegetation Rating (1=Pristine, 7=Cleared)</b>	7
<b>ESA</b>	Outside, exemptions apply
<b>Notes</b>	Disturbed, used as a laydown area. Stockpile of product hauled from mining field.

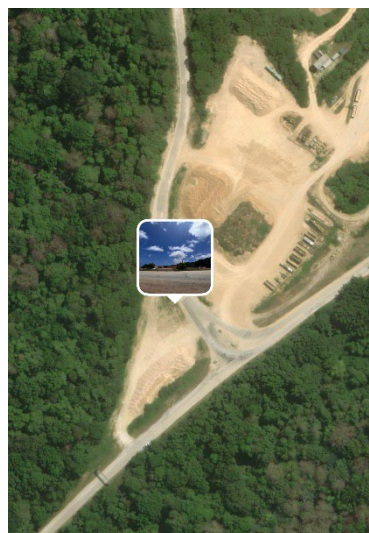
<b>Waypoint Reference</b>	2
<b>Site</b>	LB4
<b>Tenement</b>	GCI 70/1
<b>GPS Coordinates</b>	N 8845213.0198, E 572705.9151
<b>Photo Direction</b>	28° NE
<b>Native Vegetation</b>	-
<b>Weed Species</b>	<i>Leucaena leucocephala</i> <i>Musa acuminata</i> Other weed species
<b>Vegetation Rating (1=Pristine, 7=Cleared)</b>	7
<b>ESA</b>	Outside, exemptions apply
<b>Notes</b>	Road - laydown area. Stockpile of product hauled from mining field.

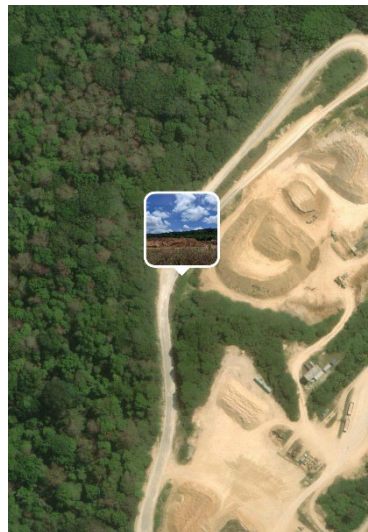
<b>Waypoint Reference</b>	4
<b>Site</b>	ROM
<b>Tenement</b>	MCI 70/1A
<b>GPS Coordinates</b>	N 8845492.0729, E 572720.7307
<b>Photo Direction</b>	68° E
<b>Native Vegetation</b>	-
<b>Weed Species</b>	<i>Muntingia calabura</i> Other weed species
<b>Vegetation Rating (1=Pristine, 7=Cleared)</b>	7
<b>ESA</b>	Inside, exemptions do not apply
<b>Notes</b>	Track / Laydown area. Stockpile of product hauled from mining field. Weed species on windrow.

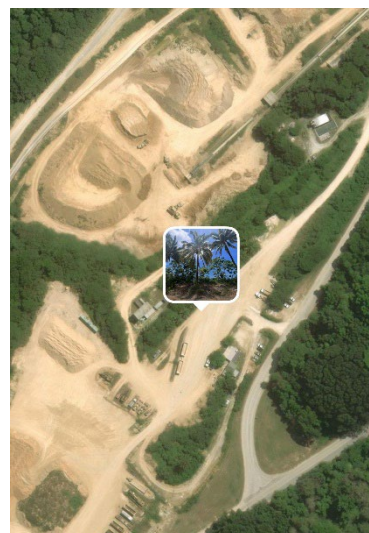
<b>Waypoint Reference</b>	7
<b>Site</b>	LB4
<b>Tenement</b>	MCI 70/1A
<b>GPS Coordinates</b>	N 8845420.4471, E 572866.5946
<b>Photo Direction</b>	277° W
<b>Native Vegetation</b>	<i>Macaranga tanarius</i>
<b>Weed Species</b>	<i>Cocos nucifera</i> <i>Muntingia calabura</i> Other weed species
<b>Vegetation Rating (1=Pristine, 7=Cleared)</b>	6, 7
<b>ESA</b>	Outside, exemptions apply
<b>Notes</b>	Laydown / Road Train Parking.

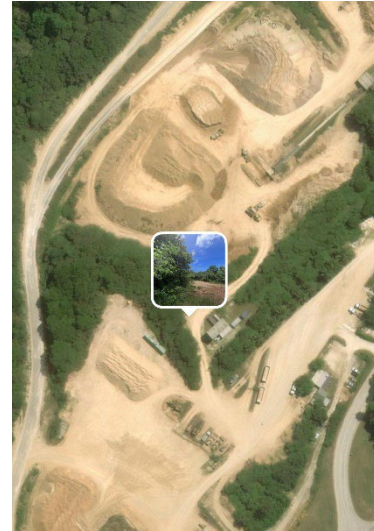
<b>Waypoint Reference</b>	8
<b>Site</b>	Track from LB4 to ROM
<b>Tenement</b>	MCI 70/1A
<b>GPS Coordinates</b>	N 8845427.3278, E 572803.2346
<b>Photo Direction</b>	304° NW
<b>Native Vegetation</b>	<i>Macaranga tanarius</i> <i>Asplenium nidus</i> <i>Schefflera elliptica</i> <i>Tristiropsis acutangula</i> <i>Dysoxylum gaudichaudianum</i>
<b>Weed Species</b>	<i>Leucaena leucocephala</i> <i>Carica papaya</i> <i>Muntingia calabura</i> Other weed species
<b>Vegetation Rating (1=Pristine, 7=Cleared)</b>	5, 6, 7
<b>ESA</b>	Outside, exemptions apply
<b>Notes</b>	Disturbed - vegetation growth dominated by weed species.

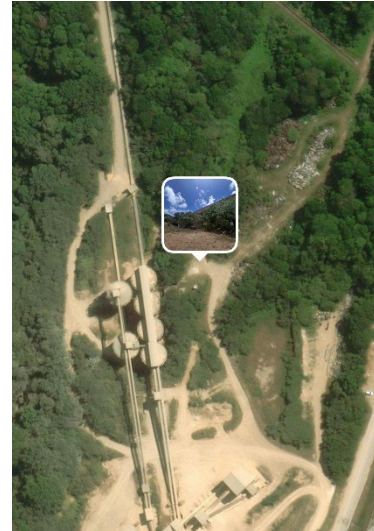
<b>Waypoint Reference</b>	12
<b>Site</b>	Cross Country
<b>Tenement</b>	MCI 70/1A
<b>GPS Coordinates</b>	N 8845922.1007, E 573036.8601
<b>Photo Direction</b>	240° SW
<b>Native Vegetation</b>	<i>Macaranga tanarius</i>
<b>Weed Species</b>	<i>Muntingia calabura</i> <i>Leucaena leucocephala</i> <i>Mangifera indica</i> <i>Cocos nucifera</i> Other weed species
<b>Vegetation Rating (1=Pristine, 7=Cleared)</b>	6, 7
<b>ESA</b>	Outside, exemptions apply
<b>Notes</b>	Operational area. Top of Cross Country Control Room, entrance of Scrap Yard.

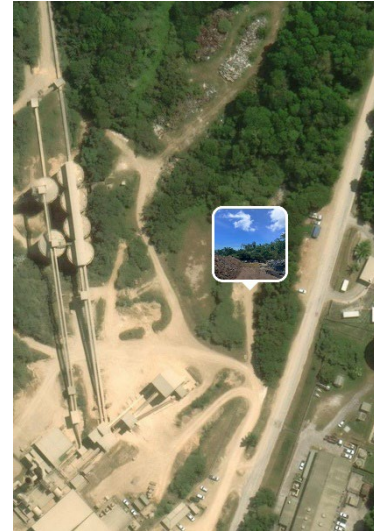
<b>Waypoint Reference</b>	13
<b>Site</b>	Conveyor Belt Storage Area
<b>Tenement</b>	MCI 70/1A
<b>GPS Coordinates</b>	N 8845846.2036, E 573106.9650
<b>Photo Direction</b>	355° N
<b>Native Vegetation</b>	<i>Macaranga tanarius</i> <i>Schefflera elliptica</i> <i>Arenga listeri</i> <i>Maclura cochinchinensis</i> <i>Dysoxylum gaudichaudianum</i> <i>Tristiropsis acutangula</i>
<b>Weed Species</b>	<i>Leucaena leucocephala</i> <i>Muntingia calabura</i> Other weed species
<b>Vegetation Rating (1=Pristine, 7=Cleared)</b>	5, 6, 7
<b>ESA</b>	Outside, exemptions apply
<b>Notes</b>	Laydown. Area for storage of used conveyor belts.

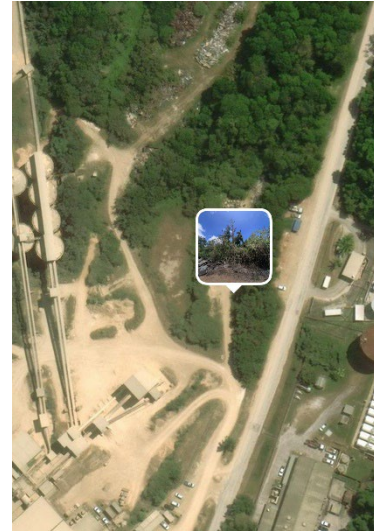
<b>Waypoint Reference</b>	13
<b>Site</b>	Conveyor Belt Storage Area
<b>Tenement</b>	MCI 70/1A
<b>GPS Coordinates</b>	N 8845846.2036, E 573106.9650
<b>Photo Direction</b>	77° E
<b>Native Vegetation</b>	Schefflera elliptica Macaranga tanarius Tristiropsis acutangula Arenga listeri Dysoxylum gaudichaudianum Maclura cochinchinensis
<b>Weed Species</b>	<i>Leucaena leucocephala</i> Other weed species
<b>Vegetation Rating (1=Pristine, 7=Cleared)</b>	5, 6, 7
<b>ESA</b>	Outside, exemptions apply
<b>Notes</b>	Laydown. Area for storage of used conveyor belts.

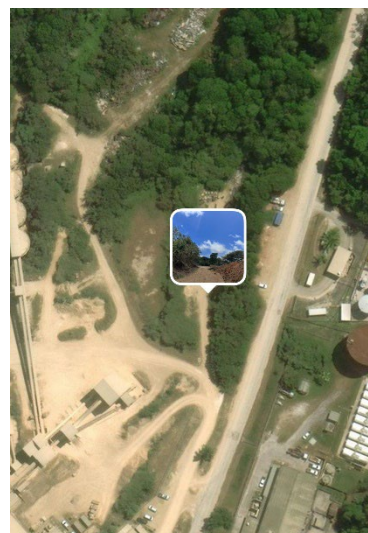
<b>Waypoint Reference</b>	13
<b>Site</b>	Conveyor Belt Storage Area
<b>Tenement</b>	MCI 70/1A
<b>GPS Coordinates</b>	N 8845846.2036, E 573106.9650
<b>Photo Direction</b>	163° S
<b>Native Vegetation</b>	<i>Macaranga tanarius</i>
<b>Weed Species</b>	<i>Leucaena leucocephala</i> <i>Cocos nucifera</i> <i>Muntingia calabura</i> Other weed species
<b>Vegetation Rating (1=Pristine, 7=Cleared)</b>	6, 7
<b>ESA</b>	Outside, exemptions apply
<b>Notes</b>	Laydown. Area for storage of used conveyor belts.

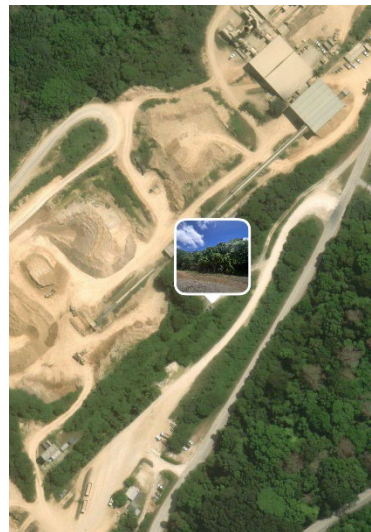
<b>Waypoint Reference</b>	14
<b>Site</b>	Incinerator
<b>Tenement</b>	MCI 70/1A
<b>GPS Coordinates</b>	N 8845534.0592, E 572949.0246
<b>Photo Direction</b>	108° E
<b>Native Vegetation</b>	<i>Macaranga tanarius</i>
<b>Weed Species</b>	<i>Musa acuminata</i> <i>Muntingia calabura</i> <i>Leucaena leucocephala</i> Other weed species
<b>Vegetation Rating (1=Pristine, 7=Cleared)</b>	6, 7
<b>ESA</b>	Outside, exemptions apply
<b>Notes</b>	Operational area. Area for incineration of hydrocarbon waste.

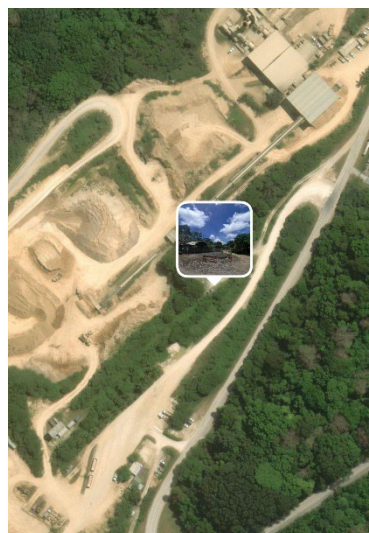
<b>Waypoint Reference</b>	14
<b>Site</b>	Incinerator
<b>Tenement</b>	MCI 70/1A
<b>GPS Coordinates</b>	N 8845534.0592, E 572949.0246
<b>Photo Direction</b>	63° NE
<b>Native Vegetation</b>	<i>Macaranga tanarius</i> <i>Arenga listeri</i>
<b>Weed Species</b>	<i>Leucaena leucocephala</i> Other weed species
<b>Vegetation Rating (1=Pristine, 7=Cleared)</b>	7
<b>ESA</b>	Outside, exemptions apply
<b>Notes</b>	Operational area. Area for incineration of hydrocarbon waste.

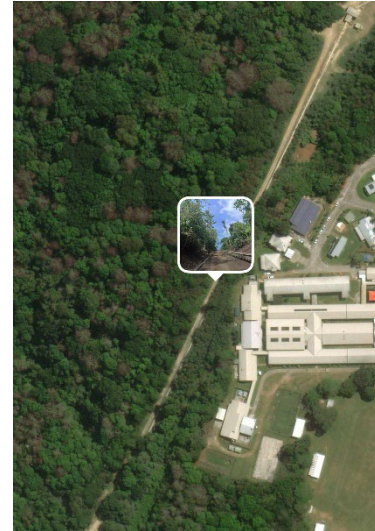
<b>Waypoint Reference</b>	19
<b>Site</b>	Cross Country Conveyors
<b>Tenement</b>	MCI 70/1A
<b>GPS Coordinates</b>	N 8846389.6308, E 573074.1861
<b>Photo Direction</b>	34° NE
<b>Native Vegetation</b>	<i>Arenga listeri</i> <i>Macaranga tanarius</i> <i>Celtis timorensis</i> <i>Maclura cochinchinensis</i>
<b>Weed Species</b>	<i>Leucaena leucocephala</i> <i>Muntigia calabura</i> <i>Musa acuminata</i> Other weed species
<b>Vegetation Rating (1=Pristine, 7=Cleared)</b>	6, 7
<b>ESA</b>	Outside, exemptions apply
<b>Notes</b>	Along C1 Conveyor. Operational area – Vegetation along track and overhanging limbs.

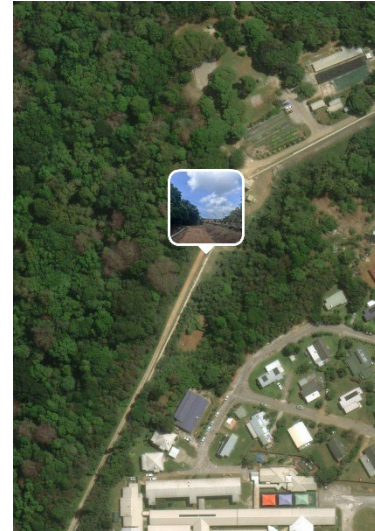
<b>Waypoint Reference</b>	20
<b>Site</b>	Cross Country Conveyors
<b>Tenement</b>	MCI 70/1A
<b>GPS Coordinates</b>	N 8846556.7703, E 573150.3926
<b>Photo Direction</b>	52° NE
<b>Native Vegetation</b>	<i>Macaranga tanarius</i> <i>Ficus microcarpa</i> <i>Maclura cochinchinensis</i>
<b>Weed Species</b>	<i>Leucaena leucocephala</i> <i>Cocos nucifera</i> Other weed species
<b>Vegetation Rating (1=Pristine, 7=Cleared)</b>	7
<b>ESA</b>	Outside, exemptions apply
<b>Notes</b>	Along C1 Conveyor, before C1/C2 Transfer Station. Operational area – Vegetation along track and overhanging limbs.

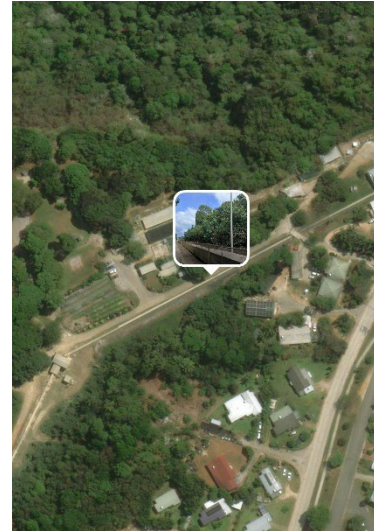
<b>Waypoint Reference</b>	21
<b>Site</b>	Cross Country Conveyors
<b>Tenement</b>	MCI 70/1A
<b>GPS Coordinates</b>	N 8846661.3341, E 573273.2019
<b>Photo Direction</b>	55° NE
<b>Native Vegetation</b>	<i>Hibiscus tiliaceus</i>
<b>Weed Species</b>	<i>Leucaena leucocephala</i> <i>Cocos nucifera</i> <i>Mangifera indica</i> Other weed species
<b>Vegetation Rating (1=Pristine, 7=Cleared)</b>	6, 7
<b>ESA</b>	Outside, exemptions apply
<b>Notes</b>	Along C2 Conveyor, outside Park's Nursery. Operational area - overhanging limbs.

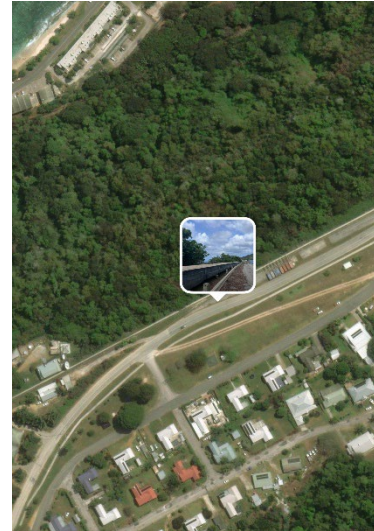
<b>Waypoint Reference</b>	22
<b>Site</b>	Cross Country Conveyors
<b>Tenement</b>	MCI 70/1A
<b>GPS Coordinates</b>	N 8846798.7950, E 573529.2853
<b>Photo Direction</b>	34° NE
<b>Native Vegetation</b>	<i>Tristiropsis acutangula</i> <i>Macaranga tanarius</i>
<b>Weed Species</b>	<i>Delonix regia</i> Other weed species
<b>Vegetation Rating (1=Pristine, 7=Cleared)</b>	6, 7
<b>ESA</b>	Outside, exemptions apply
<b>Notes</b>	Along C2 Conveyor, on Murray Road. Operational area – Vegetation on edge of cliff and overhanging limbs.

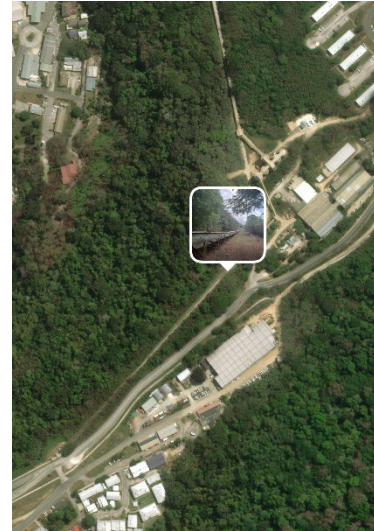
<b>Waypoint Reference</b>	24
<b>Site</b>	Cross Country Conveyors
<b>Tenement</b>	MCI 70/1A
<b>GPS Coordinates</b>	N 8847136.1654, E 573939.4795
<b>Photo Direction</b>	208° SW
<b>Native Vegetation</b>	<i>Macaranga tanarius</i> <i>Maclura cochinchinensis</i> <i>Ficus microcarpa</i> <i>Dysoxylum gaudichaudianum</i>
<b>Weed Species</b>	<i>Leucaena leucocephala</i> <i>Delonix regia</i> Other weed species
<b>Vegetation Rating (1=Pristine, 7=Cleared)</b>	6, 7
<b>ESA</b>	Outside, exemptions apply
<b>Notes</b>	Along C3 Conveyors. Operational area – overhanging limbs.

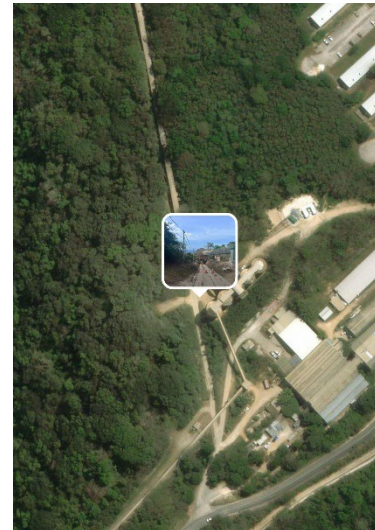
<b>Waypoint Reference</b>	25
<b>Site</b>	Downhill
<b>Tenement</b>	MCI 70/1A
<b>GPS Coordinates</b>	N 8847279.3830, E 573970.7220
<b>Photo Direction</b>	20° NE
<b>Native Vegetation</b>	<i>Macaranga tanarius</i>
<b>Weed Species</b>	<i>Muntingia calabura</i> <i>Leucaena leucocephala</i> <i>Delonix regia</i> Other weed species
<b>Vegetation Rating (1=Pristine, 7=Cleared)</b>	6, 7
<b>ESA</b>	Inside, exemptions do not apply
<b>Notes</b>	Incline. Operational area – vegetation along incline and overhanging limbs.

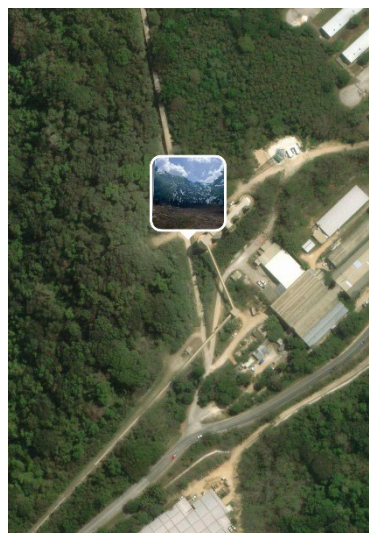
<b>Waypoint Reference</b>	25
<b>Site</b>	Downhill
<b>Tenement</b>	MCI 70/1A
<b>GPS Coordinates</b>	N 8847279.3830, E 573970.7220
<b>Photo Direction</b>	274° W
<b>Native Vegetation</b>	<i>Macaranga tanarius</i> <i>Dysoxylum gaudichaudianum</i>
<b>Weed Species</b>	<i>Delonix regia</i> <i>Muntingia calabura</i> <i>Leucaena leucocephala</i> Other weed species
<b>Vegetation Rating (1=Pristine, 7=Cleared)</b>	7
<b>ESA</b>	Inside, exemptions do not apply
<b>Notes</b>	Parking area outside of lease. Operational area - Parking Area, overhanging limbs.

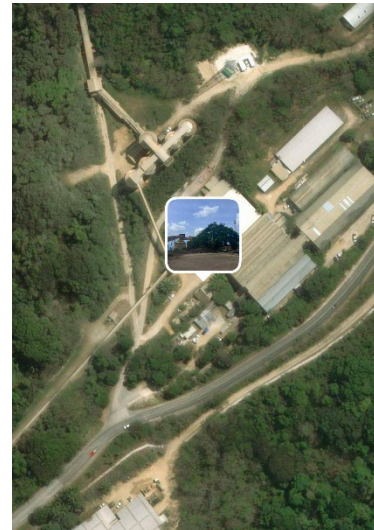
<b>Waypoint Reference</b>	26
<b>Site</b>	Structural Workshop car park
<b>Tenement</b>	MCI 70/1A
<b>GPS Coordinates</b>	N 8847213.3725, E 574029.2889
<b>Photo Direction</b>	5° N
<b>Native Vegetation</b>	<i>Macaranga tanarius</i>
<b>Weed Species</b>	<i>Delonix regia</i> <i>Muntingia calabura</i> <i>Cocos nucifera</i> <i>Leucaena leucocephala</i> Other weed species
<b>Vegetation Rating (1=Pristine, 7=Cleared)</b>	6, 7
<b>ESA</b>	Outside, exemptions apply
<b>Notes</b>	Operational area.

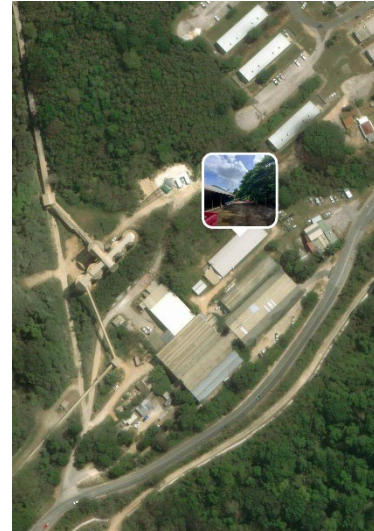
<b>Waypoint Reference</b>	27
<b>Site</b>	Laboratory
<b>Tenement</b>	MCI 70/1A
<b>GPS Coordinates</b>	N 8847306.2640, E 574095.2675
<b>Photo Direction</b>	220° SW
<b>Native Vegetation</b>	<i>Arenga listeri</i> <i>Dysoxylum gaudichaudianum</i> <i>Ficus microcarpa</i>
<b>Weed Species</b>	<i>Delonix regia</i> <i>Leucaena leucocephala</i> <i>Cocos nucifera</i> <i>Muntingia calabura</i> Other weed species
<b>Vegetation Rating (1=Pristine, 7=Cleared)</b>	7
<b>ESA</b>	Outside, exemptions apply
<b>Notes</b>	Operational area – limbs overhanging lease boundary.

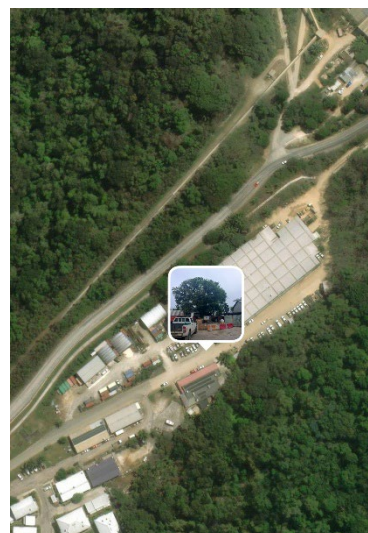
<b>Waypoint Reference</b>	36
<b>Site</b>	Warehouse
<b>Tenement</b>	MCI 70/1A
<b>GPS Coordinates</b>	N 8846981.6921, E 573927.1450
<b>Photo Direction</b>	331° NW
<b>Native Vegetation</b>	-
<b>Weed Species</b>	<i>Mangifera indica</i> <i>Leucaena leucocephala</i> Other weed species
<b>Vegetation Rating (1=Pristine, 7=Cleared)</b>	7
<b>ESA</b>	Outside, exemptions apply
<b>Notes</b>	Weeds surrounding single <i>Mangifera indica</i> . Vegetation along the fence is outside of boundary.

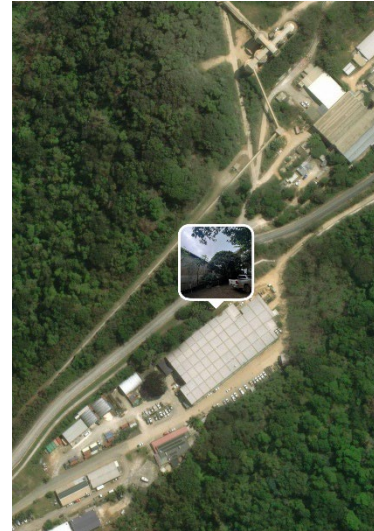
<b>Waypoint Reference</b>	37
<b>Site</b>	MPM Back Gate
<b>Tenement</b>	MCI 70/1A
<b>GPS Coordinates</b>	N 8847097.2100, E 574005.0768
<b>Photo Direction</b>	125° SE
<b>Native Vegetation</b>	<i>Ficus microcarpa</i>
<b>Weed Species</b>	<i>Delonix regia</i> <i>Leucaena leucocephala</i> Other weed species
<b>Vegetation Rating (1=Pristine, 7=Cleared)</b>	6, 7
<b>ESA</b>	Outside, exemptions apply
<b>Notes</b>	Cliff-side vegetation, weed dominated.

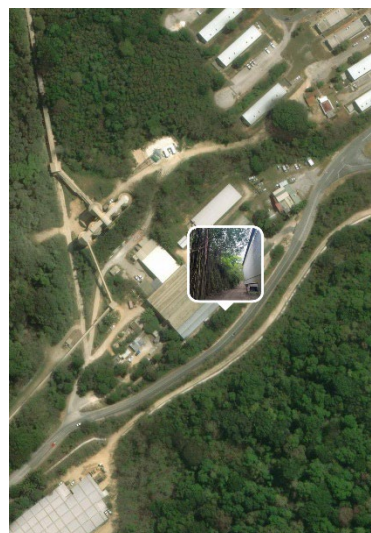
<b>Waypoint Reference</b>	38
<b>Site</b>	Behind Electrical Workshop
<b>Tenement</b>	MCI 70/1A
<b>GPS Coordinates</b>	N 8847065.9627, E 573960.8625
<b>Photo Direction</b>	217° SW
<b>Native Vegetation</b>	<i>Ficus microcarpa</i> <i>Nephrolepis biserrata</i>
<b>Weed Species</b>	<i>Mangifera indica</i> <i>Cocos nucifera</i> <i>Delonix regia</i> <i>Pandanus amaryllifolius</i> <i>Psidium guajava</i> Other weed species
<b>Vegetation Rating (1=Pristine, 7=Cleared)</b>	6, 7
<b>ESA</b>	Outside, exemptions apply
<b>Notes</b>

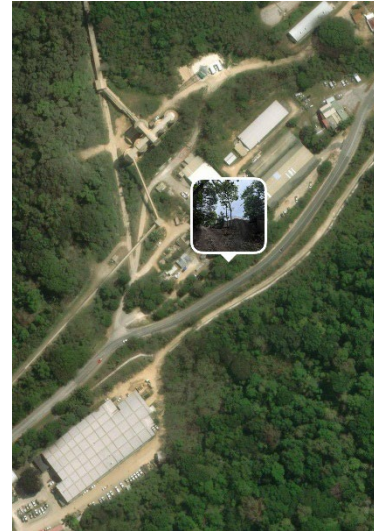
<b>Waypoint Reference</b>	39
<b>Site</b>	Behind the Old Wet Bin/ Structural Workshop
<b>Tenement</b>	MCI 70/1A
<b>GPS Coordinates</b>	N 8847216.1956, E 574104.7099
<b>Photo Direction</b>	207° SW
<b>Native Vegetation</b>	<i>Ficus microcarpa</i> <i>Microsorium scolopendria</i> <i>Guettarda speciosa</i> <i>Schefflera elliptica</i> <i>Nephrolepis biserrata</i> <i>Macaranga tanarius</i>
<b>Weed Species</b>	<i>Leucaena leucocephala</i> Other weed species
<b>Vegetation Rating (1=Pristine, 7=Cleared)</b>	7
<b>ESA</b>	Outside, exemptions apply
<b>Notes</b>	Limbs overhanging lease boundary.

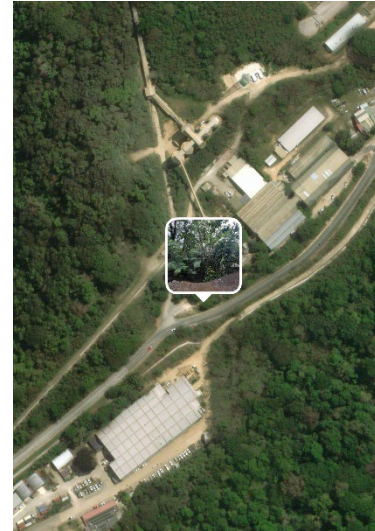
<b>Waypoint Reference</b>	40
<b>Site</b>	Behind the Old Wet Bin/ Structural Workshop
<b>Tenement</b>	MCI 70/1A
<b>GPS Coordinates</b>	N 8847183.1137, E 574067.8285
<b>Photo Direction</b>	272° W
<b>Native Vegetation</b>	<i>Macaranga tanarius</i> <i>Microsorium scolopendria</i> <i>Maclura cochinchinensis</i> <i>Ficus microcarpa</i> <i>Barringtonia racemosa</i>
<b>Weed Species</b>	<i>Mangifera indica</i> <i>Carica papaya</i> Other weed species
<b>Vegetation Rating (1=Pristine, 7=Cleared)</b>	7
<b>ESA</b>	Outside, exemptions apply
<b>Notes</b>	Overhanging limbs and individual trees only.
