## **Henty Road, Burekup WA**

### **Road Improvements between 0.04 - 11.61 Sk.**

## **Road Safety Audit**

### **Stage 3 - Detailed Design**

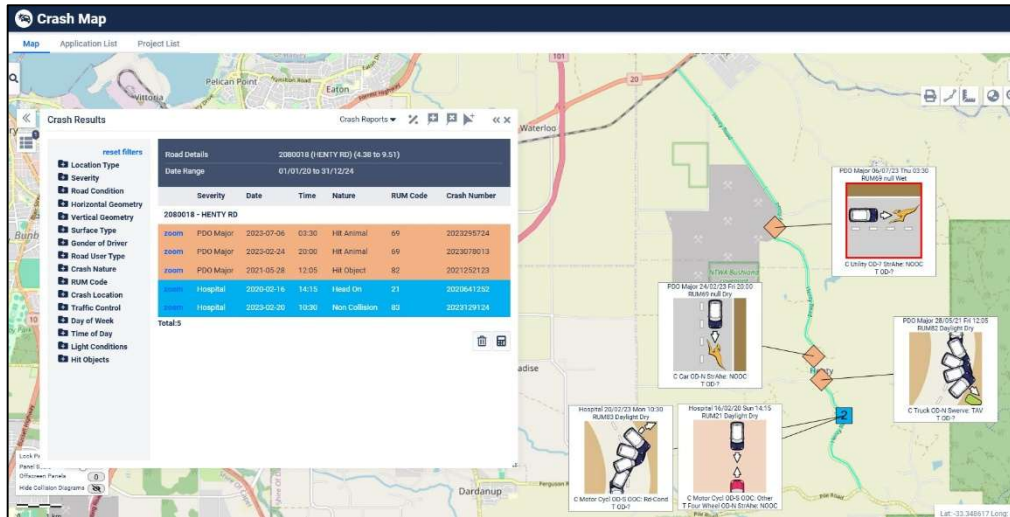
Figure 1 - Crash Map from the Main Roads WA website.

- SIK 4.38 RUM 69 Hit Animal – A Utility travelling southbound at 03:30 (Dark Conditions) in Jul 2023 in wet conditions hit a cow resulting in a Property Damage severity crash.

- SIK 7.85 RUM 69 Hit Animal – A Car travelling southbound at 20:00 (Dark Conditions) in Jan 2023 in dry conditions hit a kangaroo resulting in a Property Damage severity crash.

- SIK 8.49 RUM 82 Off Path on Curve – A Truck travelling southbound at 12:05 (Light Conditions) in May 2021 in dry conditions swerved to avoid a vehicle, lost control, and hit a tree, resulting in a Property Damage severity crash.

- SIK 9.51 RUM 21 Head On – A Four Wheel Drive travelling southbound at 14:15 (Light Conditions) in February 2020 in dry conditions approached a group of 6 Motor Cycles travelling northbound at speed on the wrong side of the road around a tight corner with one Motor Cycle being hit resulting in a Hospital severity crash.

- SIK 9.51 RUM 83 Off Path on Curve – A Motor Cycle travelling northbound at 10:30 (Light Conditions) in February 2023 in dry conditions came across gravel on the sealed road pavement, lost control and hit a fence resulting in a Hospital severity crash.

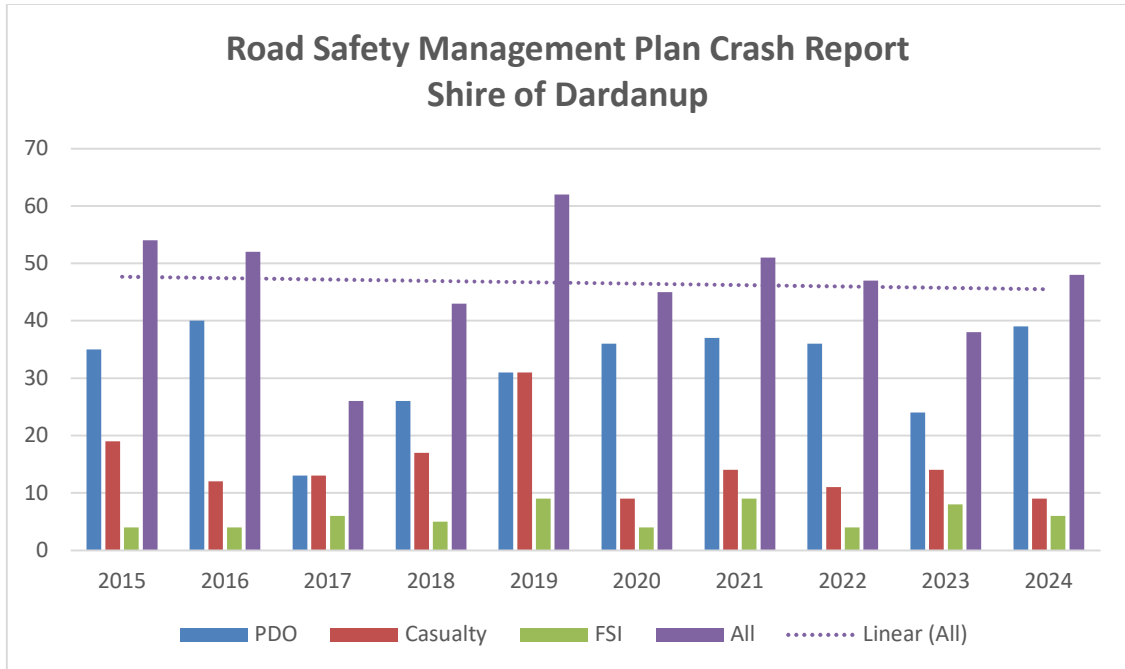
Figure 2 - Graph of recorded crashes with trendline.

The Shire has a low quantity of crashes but a high severity outcome for Off Path crashes. The trendline for all crashes is reducing over time.

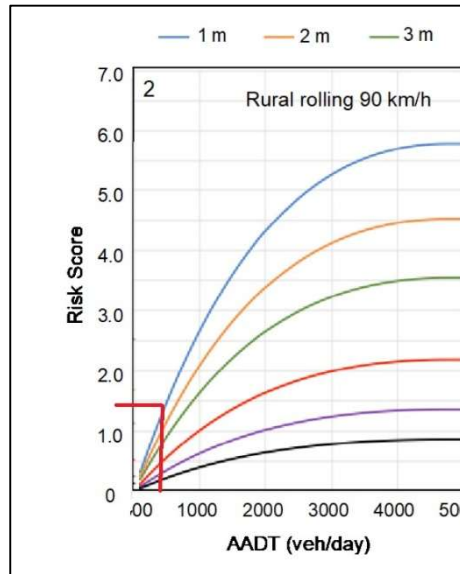
Figure 6 - Chart 2 from Austroads Guide to Road Design.

The charts provided in the Austroads Guide are dependent on traffic volume and speed, low traffic volumes will result in low NRRIT values. Figure D.1 Risk Score for undivided rural roads with significant background hazards at different offsets and for different operating speeds and road types. As an example, Chart 2 shows a risk score of 1.5 for a hazard offset of 1.0 m with 250 vehicles per day in a rural area at 90 km/h.

It should also be noted that road safety barriers also have a risk score when hit by an errant vehicle. Figure D.8, chart 24 shows a risk score of approximately 0.20 for 250 vehicles per day in a rural area at 90 km/h.

The closest trees should be removed and hazards that cannot be removed should be delineated.

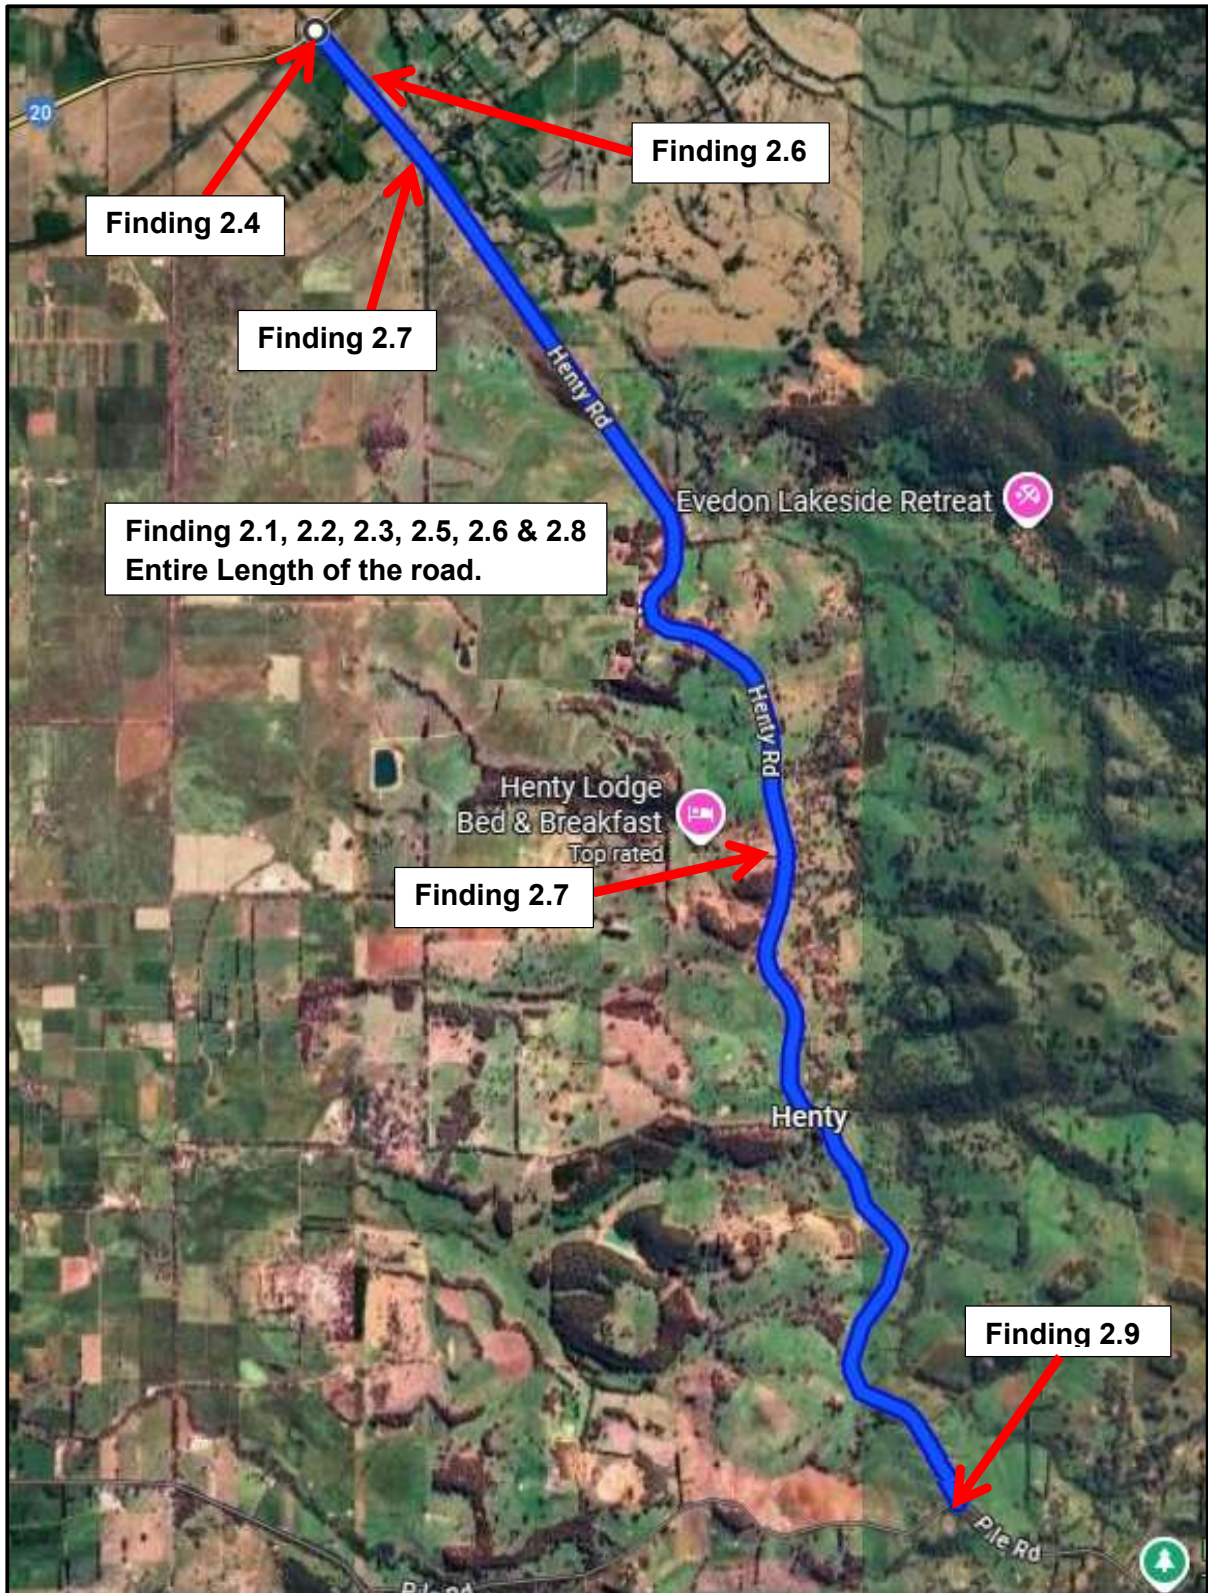
**Location Plan**

(Some findings are included throughout the length of the road).
