Friday 30th September 2022

Arboricultural Assessment – Reserve 48279 Old Broadwater Farm

Prepared for: The City of Busselton

Prepared by: Brett Moir

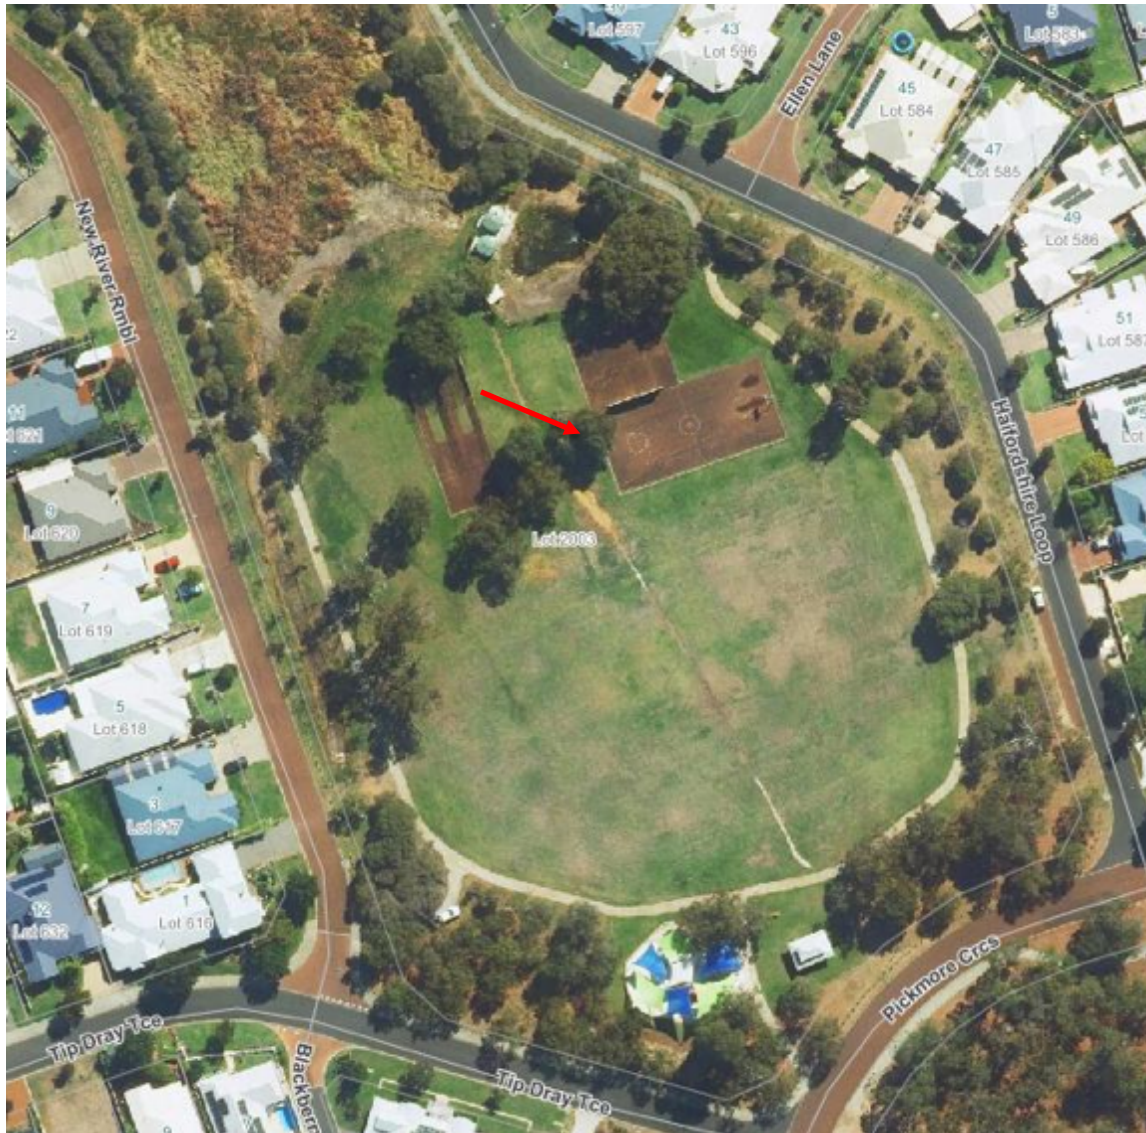
The subject tree is located within a City of Busselton Reserve which comprises Playing fields, Cricket Nets, A Basketball Court and other associated infrastructure. The tree is located at the western edge of the Basketball Court.

Figure 1: Location of subject tree (red arrow)
