## Wandering / Narrogin Rd Clearing Purpose Permit – A Report on Clearing Impact Mitigation and Avoidance by the Shire of Cuballing

Location : Cuballing, WA  
Prepared for : Department of Water & Environmental Regulation and the Shire of  
Cuballing  
Date : July 2025

## **Appendix 1 – Desired and Compromised Road Profile Details**

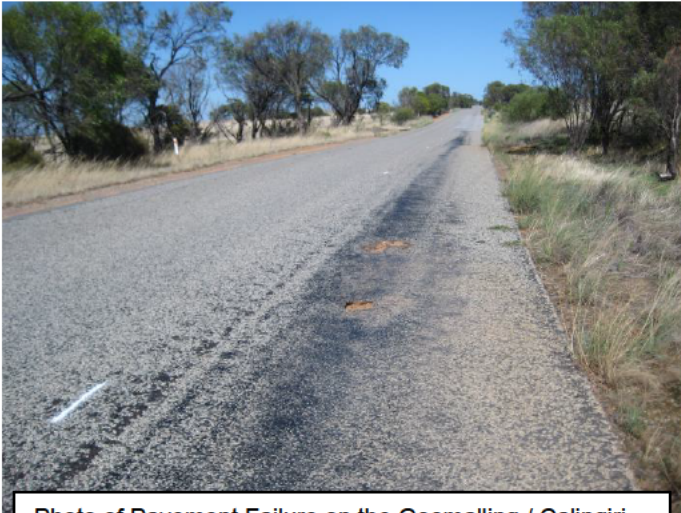
Photo of Pavement Failure on the Goomalling / Calingiri Rd at SLK 5.10 due to non-adequate table drainage and / or subsequent lack of maintenance.

There are many photos of typical similar type sealed Wheatbelt Distributor roads showing accelerated deterioration (than above normal deterioration rate) in Appendix 3 below, as a result of poor, or lack of sufficient Table Drainage.

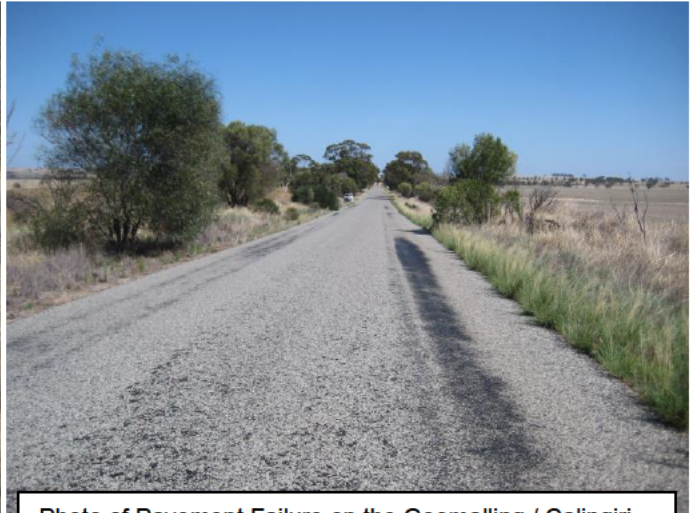
Photo of Pavement Failure on the Goomalling / Calingiri Rd at SLK 6.76 due to non-adequate table drainage and / or subsequent lack of maintenance.

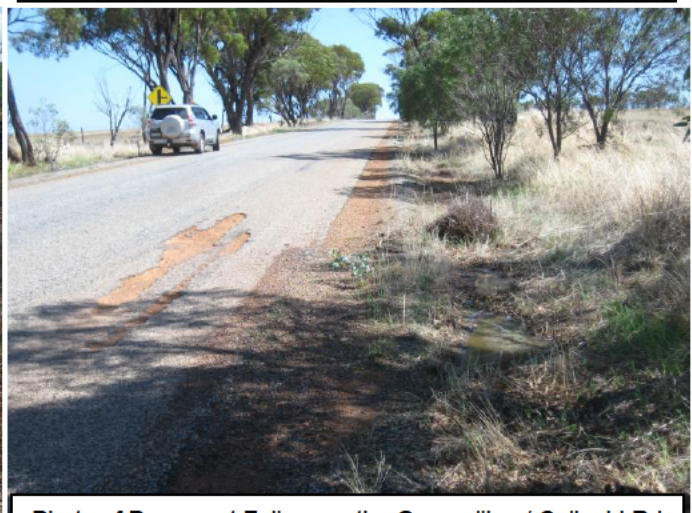
Photo of Pavement Failure on the Goomalling / Calingiri Rd at SLK 11.64 due to non-adequate table drainage and / or subsequent lack of maintenance. Note the surface water sitting in the drain.

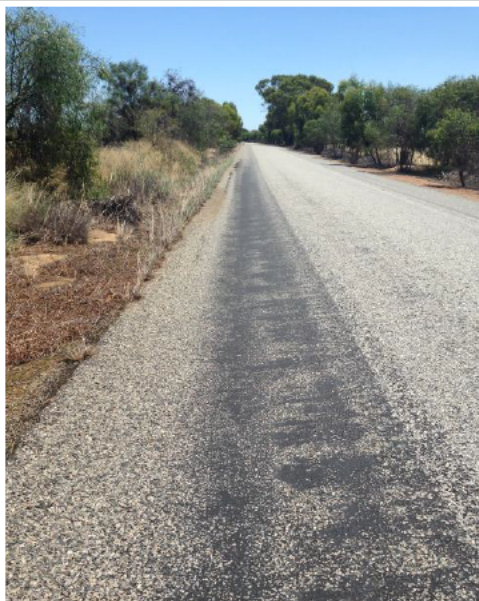
Photo of Pavement Failure on the Goomalling / Calingiri Rd at SLK 24.78 due to non-adequate table drainage and / or subsequent lack of maintenance.

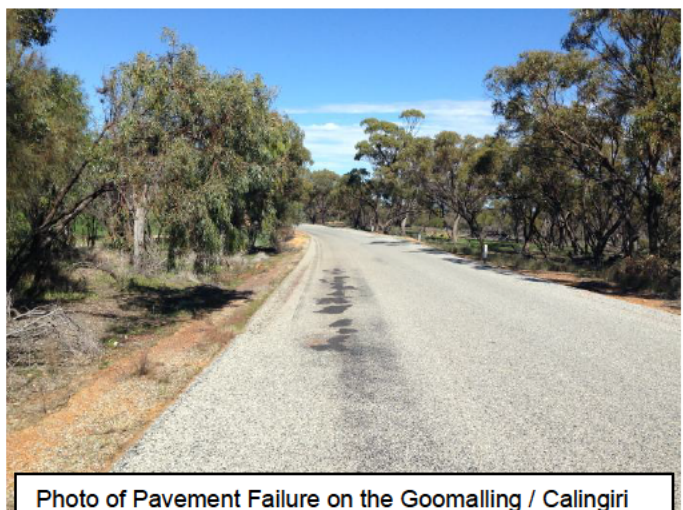
Photo of Pavement Failure on the Goomalling / Calingiri Rd at SLK 26.92 due to non-adequate table drainage and / or subsequent lack of maintenance.

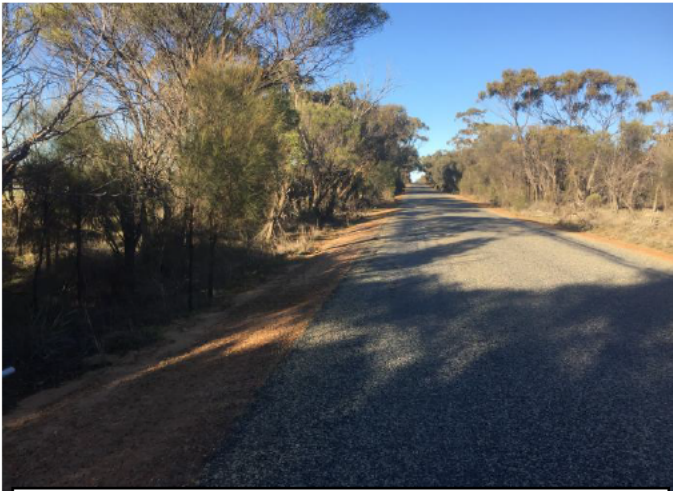
Photo of Pavement Failure on the Kellerberrin / Bencubbin Rd at SLK 13.48 due to non-adequate table drainage and / or subsequent lack of maintenance.

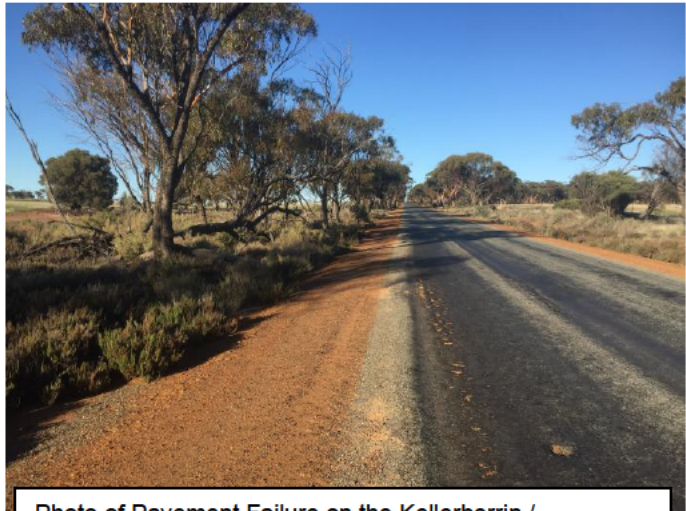
Photo of Pavement Failure on the Kellerberrin / Bencubbin Rd at SLK 16.69 due to non-adequate table drainage and / or subsequent lack of maintenance.

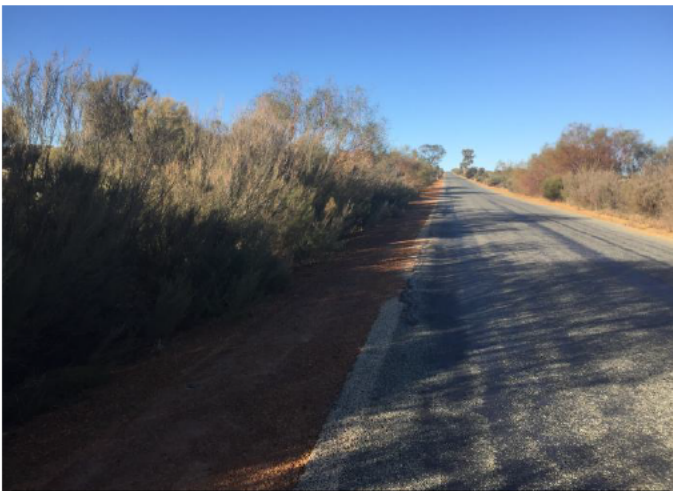
Photo of Pavement Failure on the Kellerberrin / Bencubbin Rd at SLK 22.37 due to non-adequate table drainage and / or subsequent lack of maintenance.

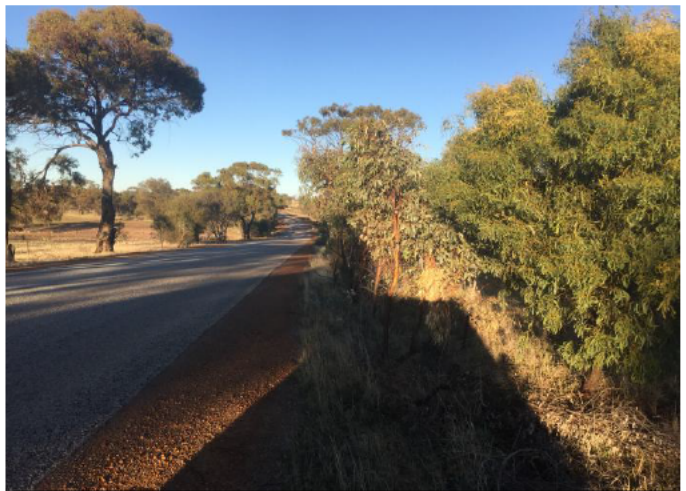
Photo of poorly maintained table drain on the Kellerberrin / Yoting Rd at SLK 17.58 due to insufficient table drain width to allow easy maintenance via Grader. Note this pavement has been upgraded relatively recently and has not had sufficient time to develop potential failure areas.

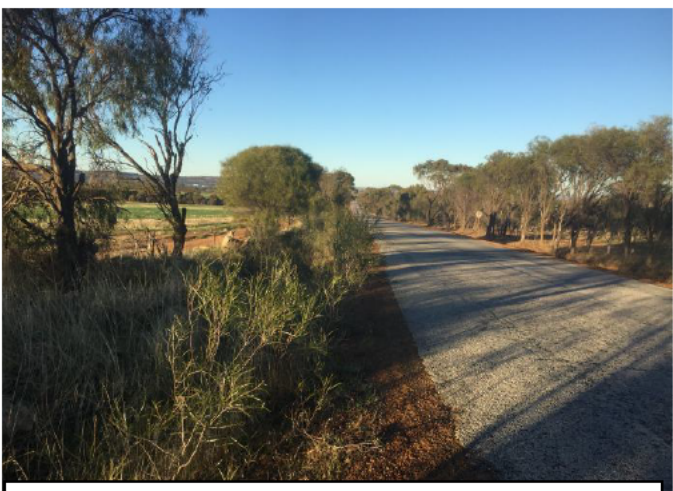
Photo of poorly maintained table drain on the Kellerberrin / Yoting Rd at SLK 19.63 due to insufficient table drain width to allow easy maintenance via Grader. Note this pavement has been upgraded relatively recently and has not had sufficient time to develop potential failure areas.

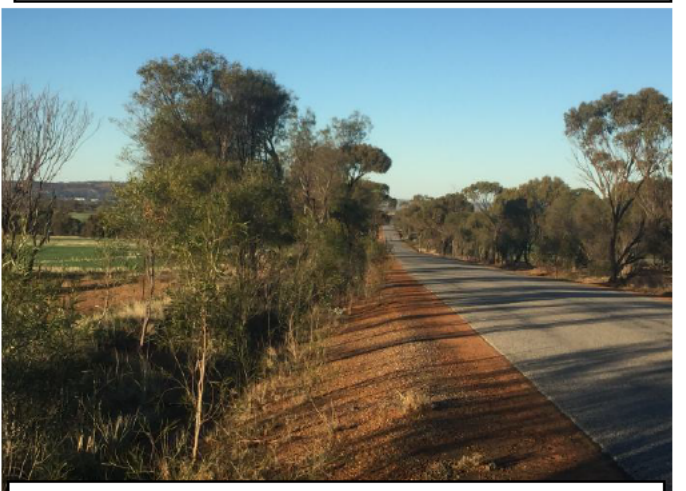
Photo of poorly maintained table drain on the Kellerberrin / Yoting Rd at SLK 19.66 due to insufficient table drain width to allow easy maintenance via Grader. Note this pavement has been upgraded relatively recently and has not had sufficient time to develop potential failure areas.

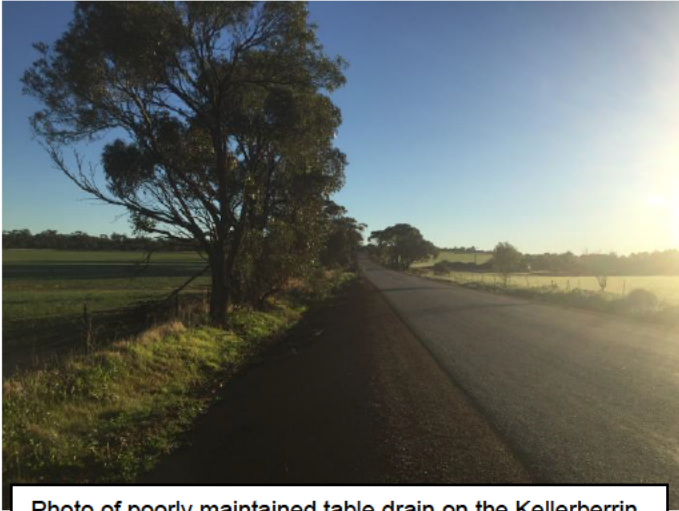
Photo of poorly maintained table drain on the Kellerberrin / Yoting Rd at SLK 20.18 due to insufficient table drain width to allow easy maintenance via Grader. Note this pavement has been upgraded relatively recently and has not had sufficient time to develop potential failure areas.

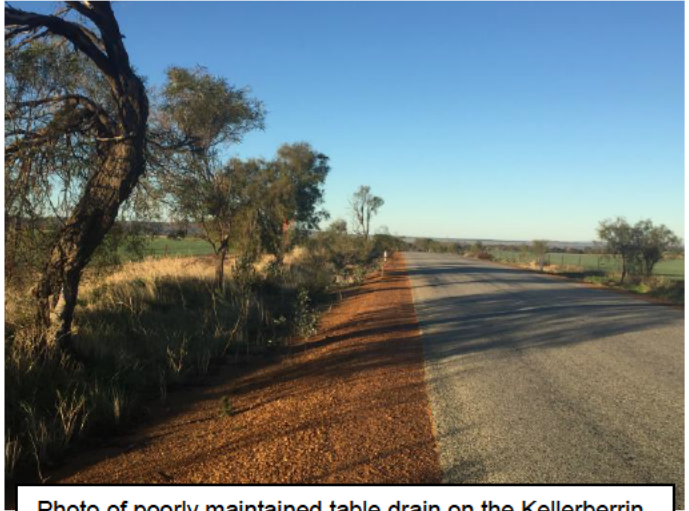
Photo of poorly maintained table drain on the Kellerberrin / Yoting Rd at SLK 20.27 due to insufficient table drain width to allow easy maintenance via Grader. Note this pavement has been upgraded relatively recently and has not had sufficient time to develop potential failure areas.

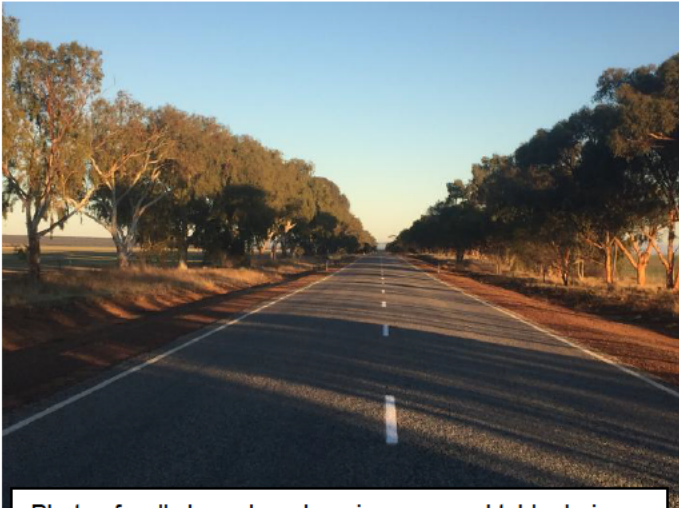
Photo of well shaped road carriageway and table drains on the York / Merredin Rd (MRWA controlled Highway) at SLK 83.66 with well maintained (via Grader) table drains.

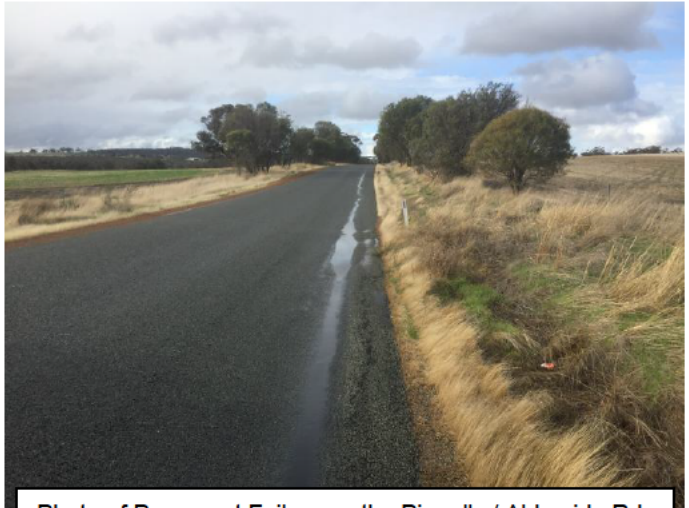
Photo of Pavement Failure on the Pingelly / Alderside Rd at SLK 3.89 due to non-adequate table drainage and / or subsequent lack of maintenance.

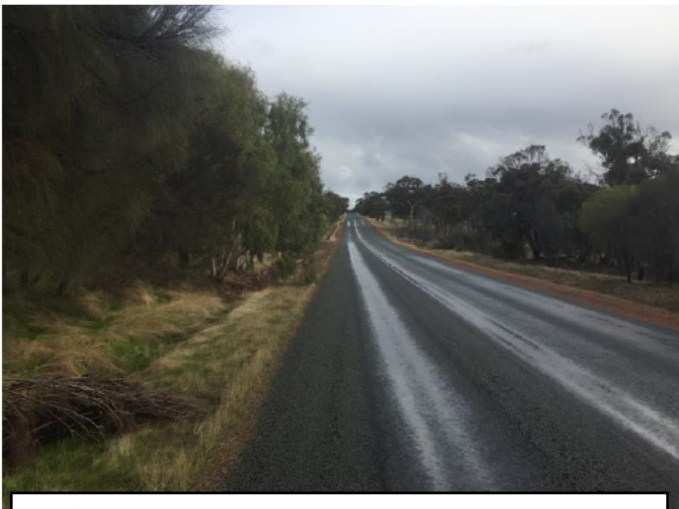
Photo of Pavement Failure on the Pingelly / Alderside Rd at SLK 4.61 due to non-adequate table drainage and / or subsequent lack of maintenance.

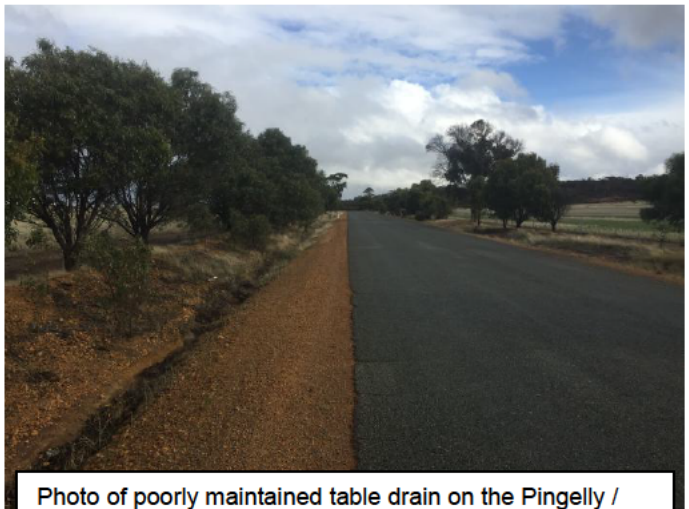
Photo of poorly maintained table drain on the Pingelly / Alderside Rd at SLK 8.53 due to insufficient table drain width to allow easy maintenance via Grader. Note this pavement has no adjacent pavement failures due to the slope on land that is assisting conveying surface water along the table drain. This is evident from the scouring.

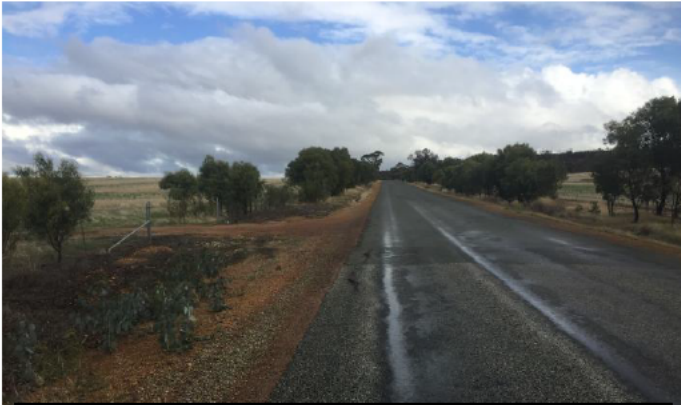
Photo of Pavement Failure on the Pingelly / Alderside Rd at SLK 4.61 due to no adequate table drain and / or lack of maintenance. This pavement failure is the result of no crossover pipe to convey surface water under the crossing and this water has penetrated the underlying soil, resulting in this pavement failure downstream.

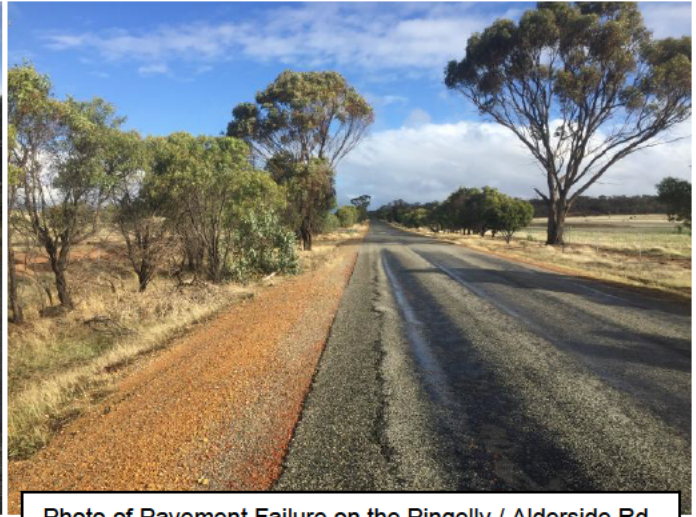
Photo of Pavement Failure on the Pingelly / Alderside Rd at SLK 8.73 due to non-adequate table drainage and / or subsequent lack of maintenance.

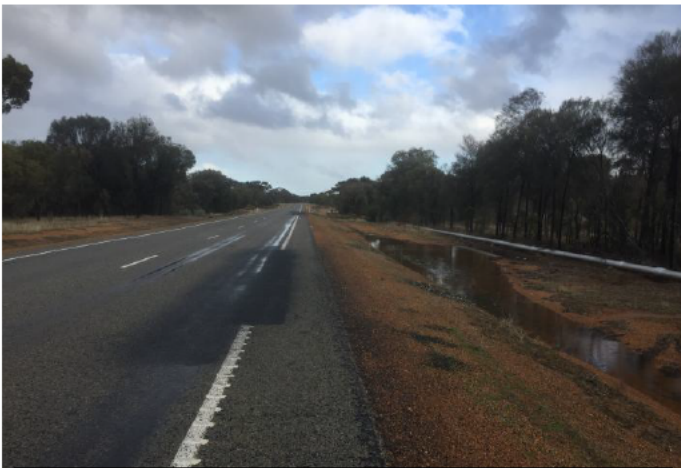
Photo of Pavement Failure on the Great Southern Highway (MRWA Controlled Rd) at SLK 142.53 due to ponding of surface water from no downstream drainage to run water away from pavement (above ground water main has hindered either proper downstream drain construction or limited maintenance of).

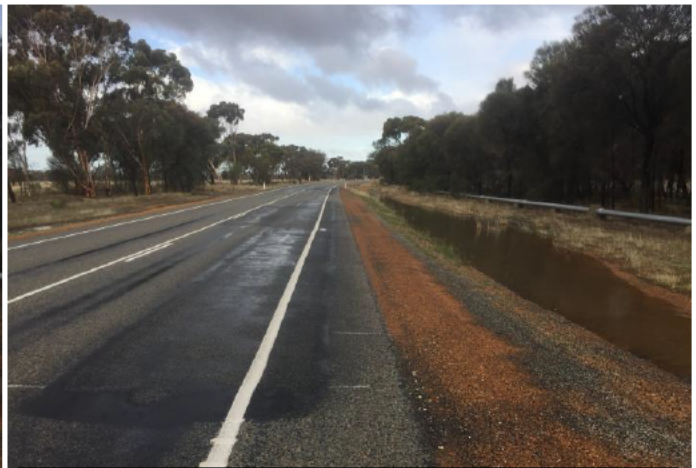
Photo of Pavement Failure on the Great Southern Highway (MRWA Controlled Rd) at SLK 143.15 due to ponding of surface water from no downstream drainage to run water away from pavement (above ground water main has hindered either proper downstream drain construction or limited maintenance of).

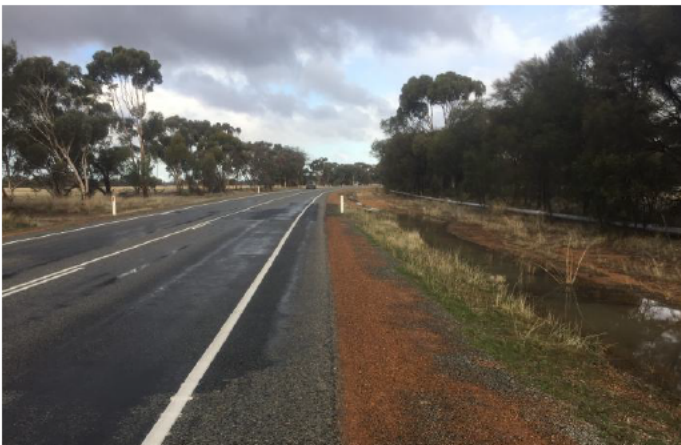
Photo of Pavement Failure on the Great Southern Highway (MRWA Controlled Rd) at SLK 143.20 due to ponding of surface water from no downstream drainage to run water away from pavement (above ground water main has hindered either proper downstream drain construction or limited maintenance of).

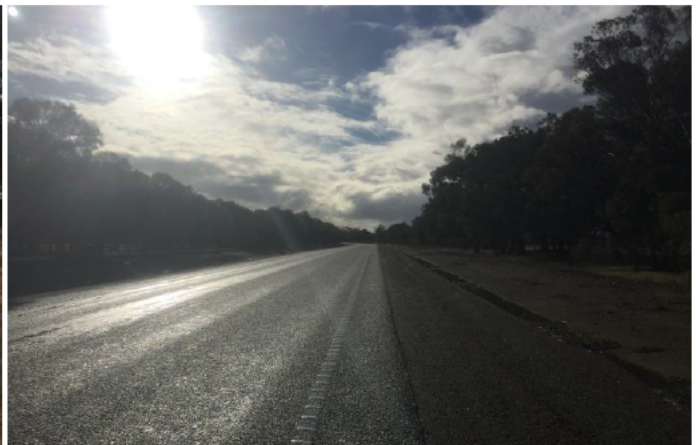
Photo of well shaped road carriageway and table drains on the Great Southern Highway (MRWA controlled Highway) at SLK 148.30 with well maintained (via Grader) table drains. Note the shedding of surface water along the table drain following a large rain event.

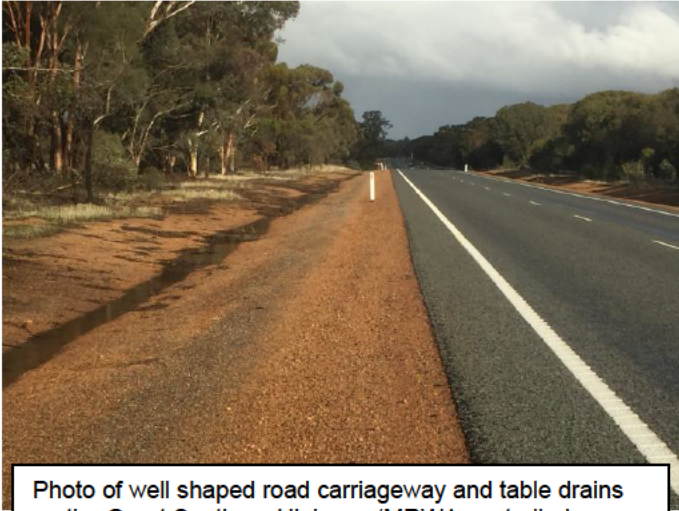
Photo of well shaped road carriageway and table drains on the Great Southern Highway (MRWA controlled Highway) at SLK 149.35 with well maintained (via Grader) table drains. Note the shedding of surface water along the table drain following a large rain event.

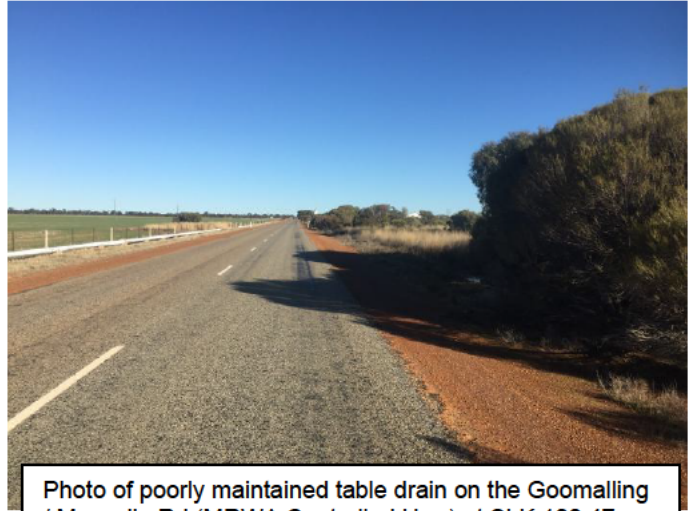
Photo of poorly maintained table drain on the Goomalling / Merredin Rd (MRWA Controlled Hwy) at SLK 102.47 due to insufficient table drain maintenance. Note the surface water sitting in the table drain due to the vegetation in the table drain preventing it from flowing downstream. This has resulted in surface water penetrating the underlying insitu soil, weakening it and causing the adjacent pavement failure.
