Design Report

Indigo Parkway

Prepared for Shire of Serpentine Jarrahdale

Project Number: TC24021

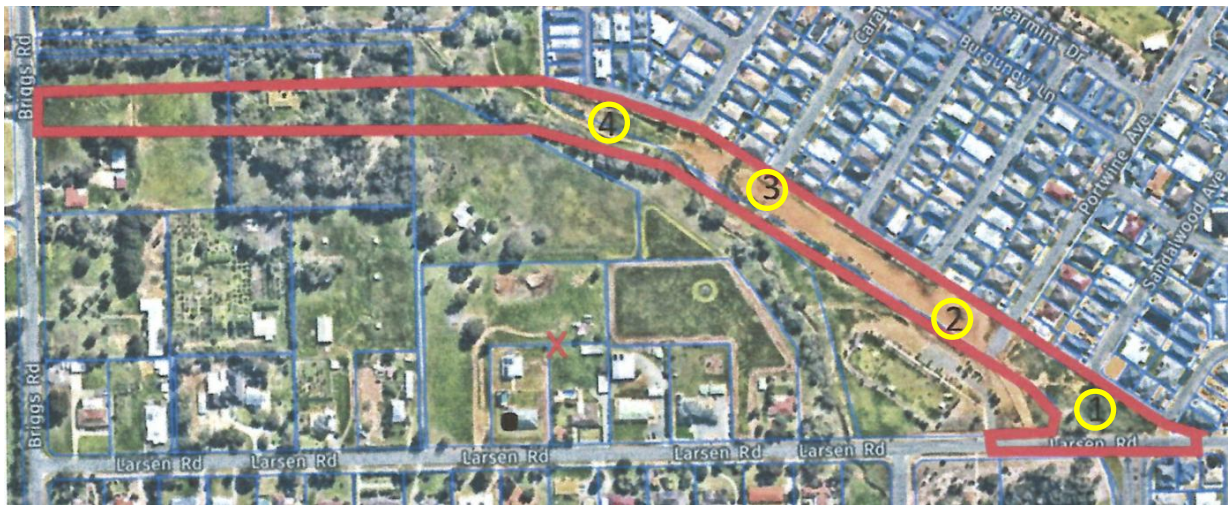
Figure 2-1: Test Pits Locations

A geotechnical site investigation was undertaken by ASLAB Pty Ltd in August 2024 to support the construction of Indigo Parkway. Geotechnical investigation test site locations are shown in Figure 2-1.

Laboratory testing was undertaken on 4x field samples for CBR, particle size distribution, Atterberg, and moisture content characteristics. CBR values of the in-situ material ranged between 19% and 35%. For design purposes, a value of 12% CBR has been adopted. A copy of laboratory test results is shown in Appendix D.

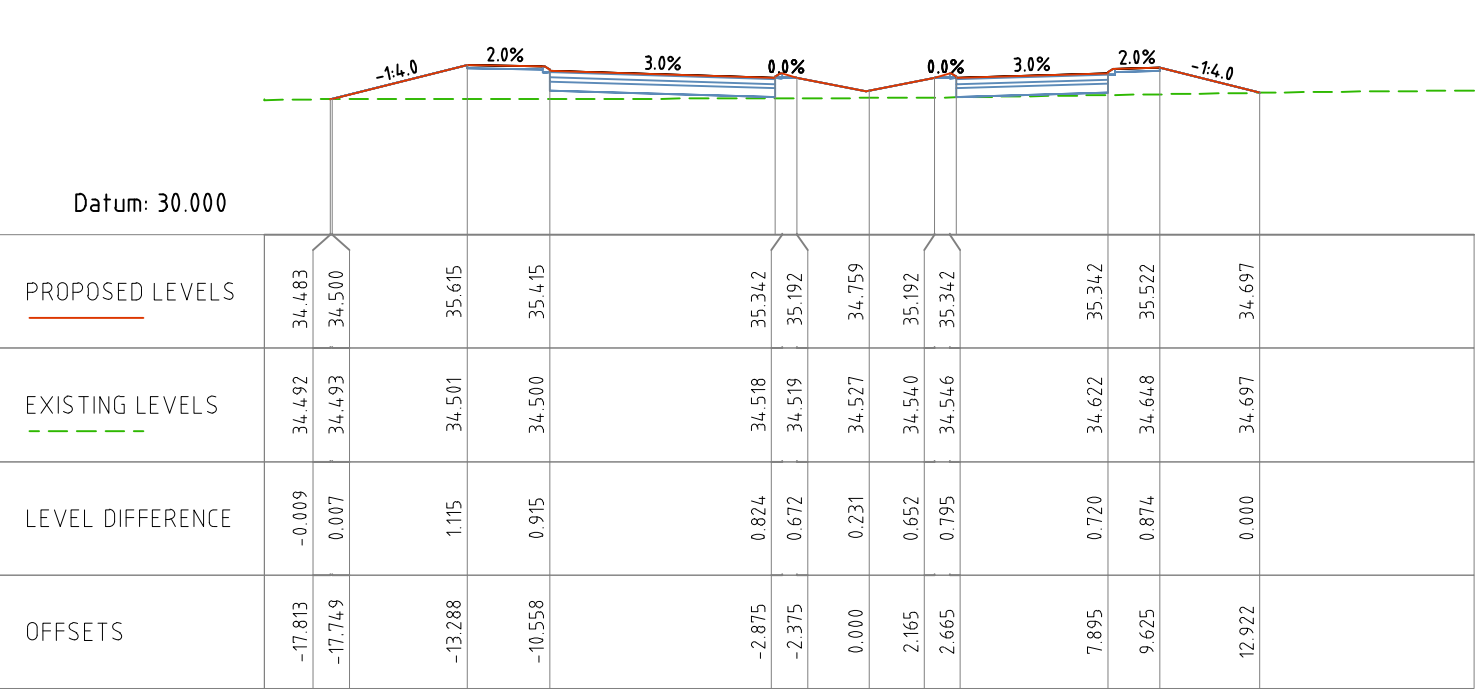
| Job No: TC24021 | Drg. No: C-202 | Rev: B |

PAVEMENT LAYERS SHOWN ON CROSS SECTIONS ARE INDICATIVE ONLY. REFER TO SSJ DETAIL DRAWINGS AND C-301

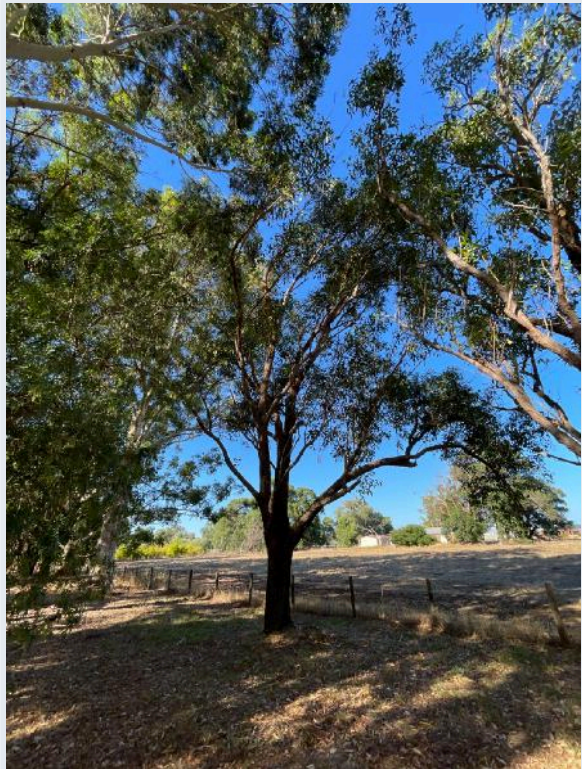
image.jpg
28/01/2025

A photograph of a Swamp Mahogany tree in a field. The tree is mature with a thick, dark trunk and a dense canopy of green leaves. It is situated in a grassy field with some dry patches. In the background, there are other trees and a clear blue sky. The photo is taken from a low angle, looking up at the tree.
