Eneabba Mineral Sands Mine

Allied Tails Mining Proposal

October 2007

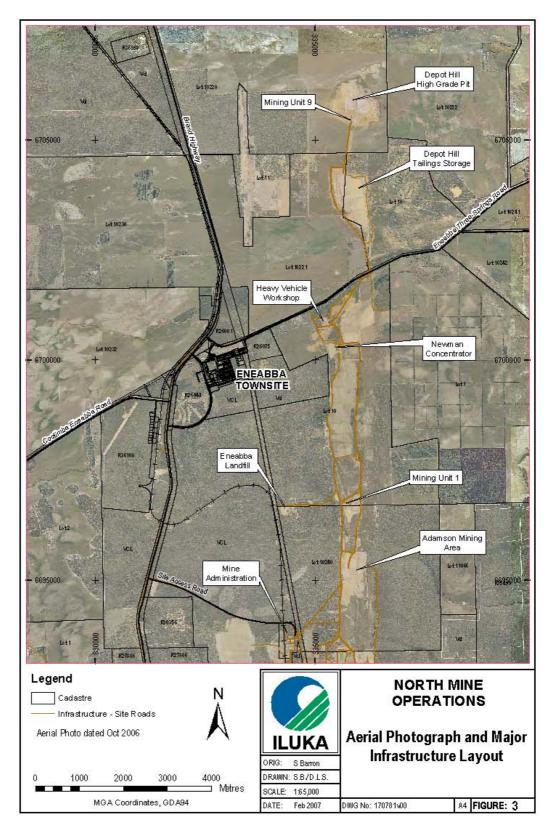
Figure 2. North Mine layout and major infrastructure, 2006.

Ore is separated using wet gravity techniques at the Newman Concentrator. Final Heavy Mineral Concentrate (HMC) is sent via truck to the South Secondary Concentrator. Sand tails and the clay/slimes fractions are co-disposed back into the previously mined pits. Pits are tailed into and rehabilitated progressively as mining ceases in each pit. North Mine mining areas and major infrastructure are shown in Figure 2.

In early 2006, mining activities were focussed on the Depot Hill Central and Depot Hill High Grade deposits. Following completion of mining in Depot Hill Central, Mining Unit 1 was relocated to the Adamson area, where it remains in its current location (Figure 2). Tailings deposition continues in Depot Hill Central, and also commenced in Depot Hill High Grade (Dam 5) in early 2007. The Blue 17 tailings storage facility remains operational for emergency deposition (short leg).

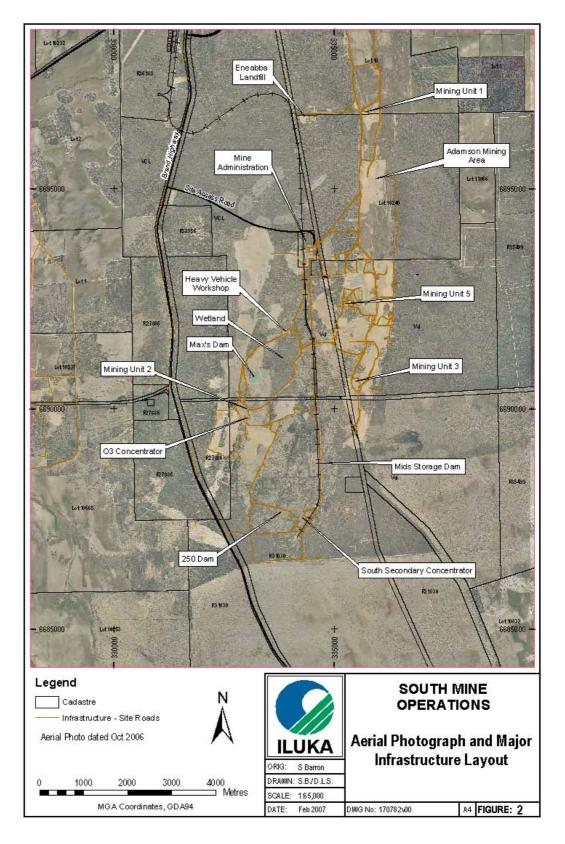
Figure 3. South Mine layout and major infrastructure, 2006.

At the PC03 concentrator the slurried ore is separated using wet gravity techniques. The Heavy Mineral Concentrate (HMC) produced from this process is pumped to the South Secondary Concentrator for blending and further processing before it is dried and transported by rail to the Minerals Separation Plant at Narngulu. Process wastes, sand and fine clay/slimes, is co-disposed back into the previously mined pits. South Mine mining areas and major infrastructure are shown in Figure 3.

Concentrate produced at the North Mine, South Mine and Gingin operation was further processed at the Eneabba South Secondary Concentrator. Throughput and tailings disposal is summarised in Table 5. Tailings from South Secondary Concentrator continued to be deposited in the "Mids Storage Dam", shown in Figure 3.

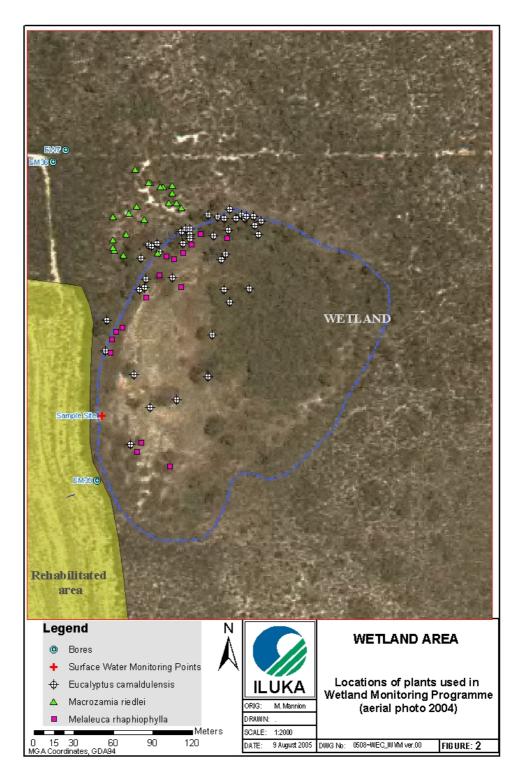
Figure 4. Eneabba South Wetland with water and vegetation monitoring locations.

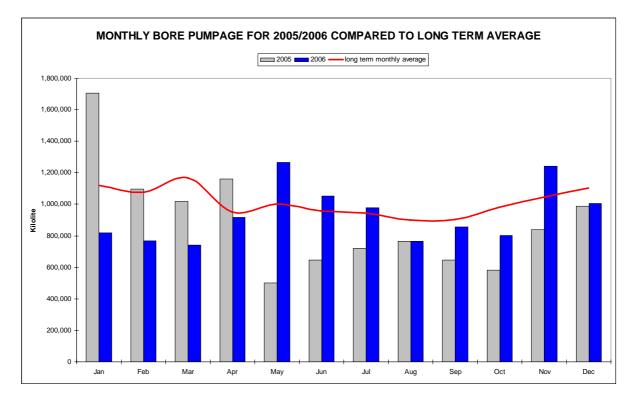
Figure 5. Iluka Eneabba groundwater extraction, 2006.

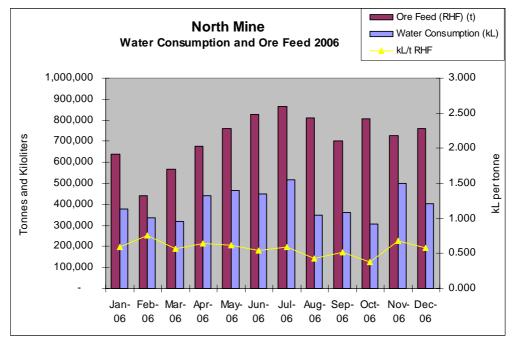
Figure 6. Newman Concentrator Water Consumption (North Mine) 2006.

Water consumption in the North Mine remained relatively constant throughout 2006, with an average of 0.575kL of water used per tonne of ore fed to the Newman Concentrator. Water use efficiency for the North Mine is shown in Figure 6.

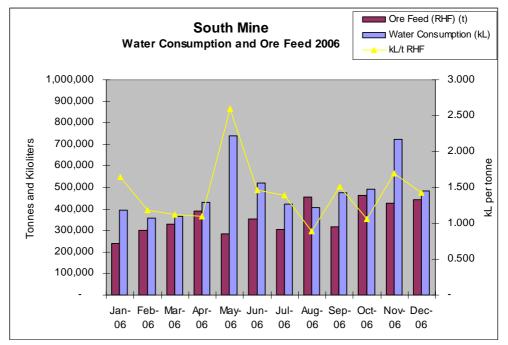
Figure 7. O3 Concentrator Water Consumption (South Mine) 2006.

Water consumption in the South Mine is shown in Figure 7. The elevated water usage in May is believed to be partially attributed to commencement of tailings deposition into the new 115B pit, with high losses through infiltration.

From October 2006, the design throughput at the O3 concentrator increased from 550 tph, to above 700 tph. This was following the installation of a scrubber at MU05 and improved thickener control. Iluka will be targeting 750 tph average during 2007. Some increase in water consumption is expected, however, this will be off-set by an increase in tailings density to be achieved with new pumping systems.

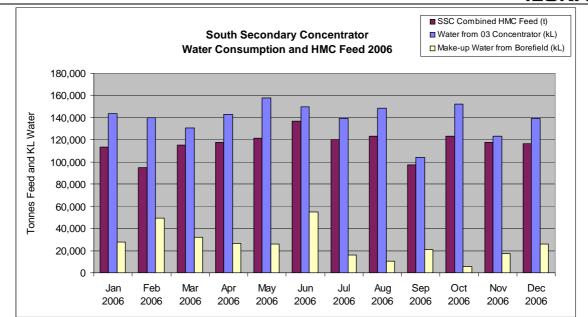
Figure 8. Water consumption per tonne of HMC Feed to South Secondary Concentrator 2006.

Water supply for the South Secondary Concentrator is predominantly recycled water direct from the O3 concentrator. During 2006, an average of 1.2 kL per tonne of ore feed was supplied from the O3 concentrator, equivalent to 211 kL per hour. Additional water required for processing is supplied from production bores, at an average rate of 0.228 kL per tonne of HMC feed in 2006. Water consumption at South Secondary Concentrator is shown in Figure 8.

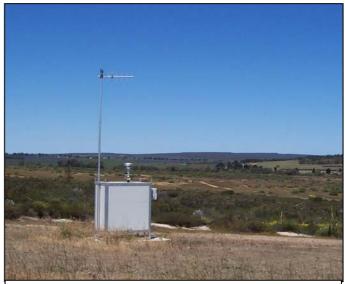
Background Dust Monitor at Depot Hill, Eneabba

Dust monitors are located between the town of Eneabba and the North Mine Operations, and at Depot Hill on the eastern boundary of the North Mine Operations (Figure 9). Background dust levels are recorded at the Depot Hill unit during strong easterly winds which typically prevail in summer and can cause dust problems for the township located 2Km due west of the Newman concentrator. Dust is monitored at the 10 micron level (PM₁₀) using two Rupprecht & Patashnick 1400a TEOM Ambient Particulate Monitors with direct telemetry to the operational control room.

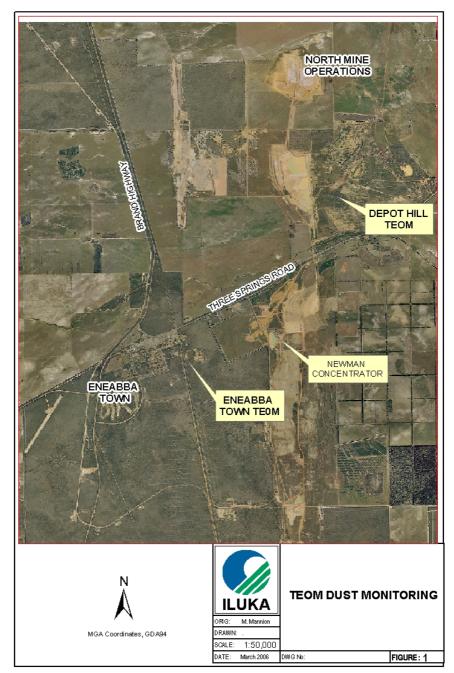
Figure 9. Iluka Eneabba TEOM dust monitoring station locations.

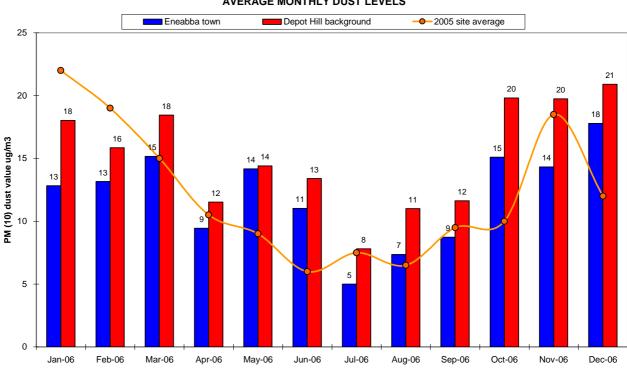
AVERAGE MONTHLY DUST LEVELS

Figure 11. Average monthly TEOM dust levels at Eneabba and Depot Hill, 2005 - 2006.

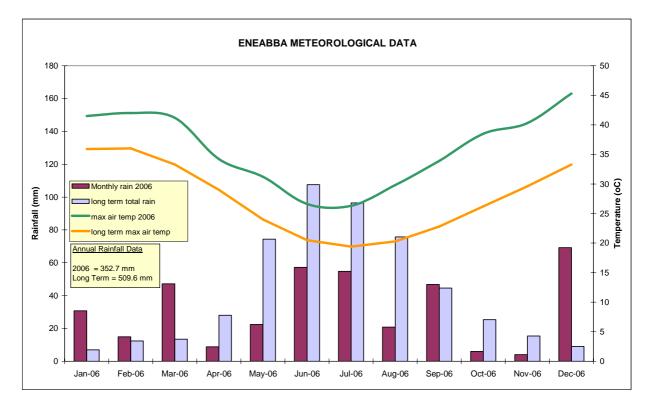
Figure 12. Eneabba Meteorological data, 2006.

Long term rainfall trends show a typical sinusoidal pattern between winter and summer seasons with the wettest periods being from May through September (Figure 12). Total rainfall in 2006 was well below the long term average (30%). Monthly rainfall patterns however were considerably more variable and show some months were as much as 70% below long term trends (April, May, August, October and November). Overall, seven months recorded below average rainfall. Seasonally, there was a reversal of long term trends with the hottest months also receiving higher than average rainfall, while very little rain fell during winter. Maximum monthly temperatures were significantly higher for the duration of 2006. Rainfall events (periodicity and magnitude) have significant affects on minesite rehabilitation and groundwater recharge.

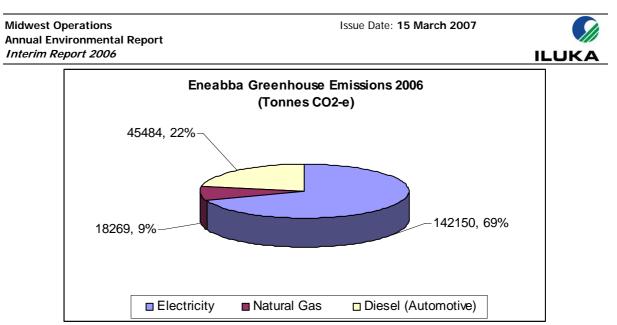
Figure 13. Eneabba Greenhouse Emissions, 2006.

The main energy sources for the mining operation at Eneabba is electricity, gas and diesel fuel. Electricity is supplied externally from the Western Power grid, and used for powering the concentrators, field generators, groundwater production bores and general use in administration buildings and workshops. As shown in Figure 13, electricity use accounted for 69% of Eneabba's total greenhouse emissions in 2006 (143,296 MWh).

Gas is used to run the drying process at the South Secondary Concentrator, with 300,974 GJ consumed in 2006. Diesel fuel is required to run the heavy vehicle mining fleet, mobile pumps, generators and light vehicle use. A total of 15,161,404L of diesel was consumed in 2006, accounting for 22% of Eneabba's greenhouse emissions.

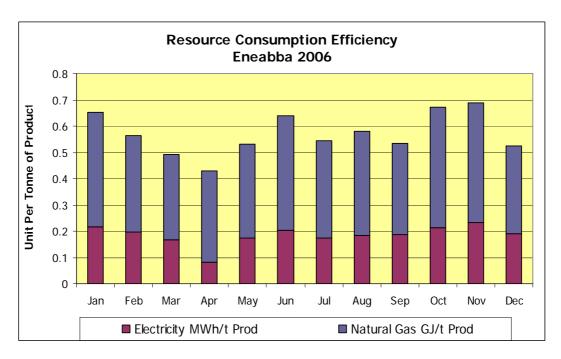
Figure 14. Energy use at Eneabba per tonne of final product, 2006.

Energy use (electricity and gas) per tonne of product produced at Eneabba is shown in Figure 14.

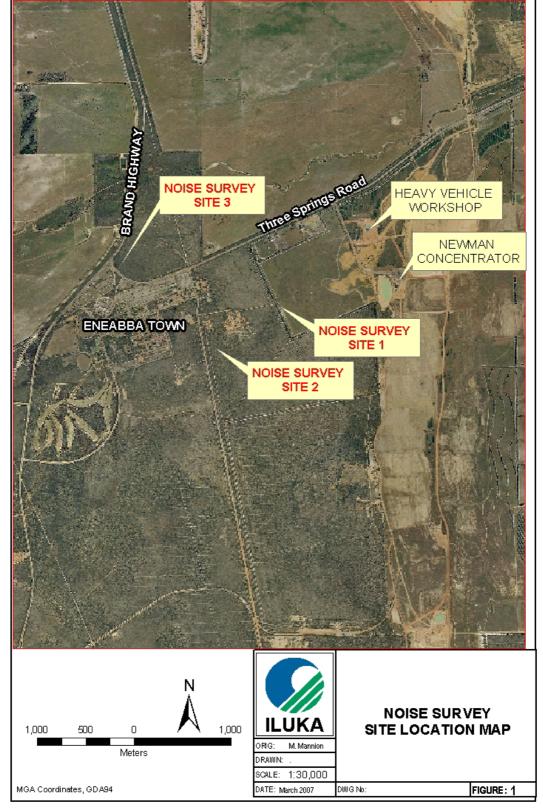
Figure 15. Environmental Noise Survey Locations, Eneabba, 2006.

Quarterly noise surveys were conducted in the vicinity of Eneabba, during 2006. Locations of noise surveys are shown in Figure 15. Noise levels were found to be substantially compliant against the Environmental Protection (Noise) Regulations 1997 and no complaints have been received. It is not considered warranted to continue quarterly noise surveys at Eneabba, and they will be discontinued in 2007. If noise levels are shown to create a concern for residents in future, or mining operations change significantly, monitoring will be re-initiated.
