# Nungarin North Road, McGregor Road, and Koorda–Bullfinch Road

VEGETATION CONDITION SURVEY

DYLAN COPELAND SHIRE OF MUKINBUDIN 15 Maddock St, Mukinbudin WA 6479

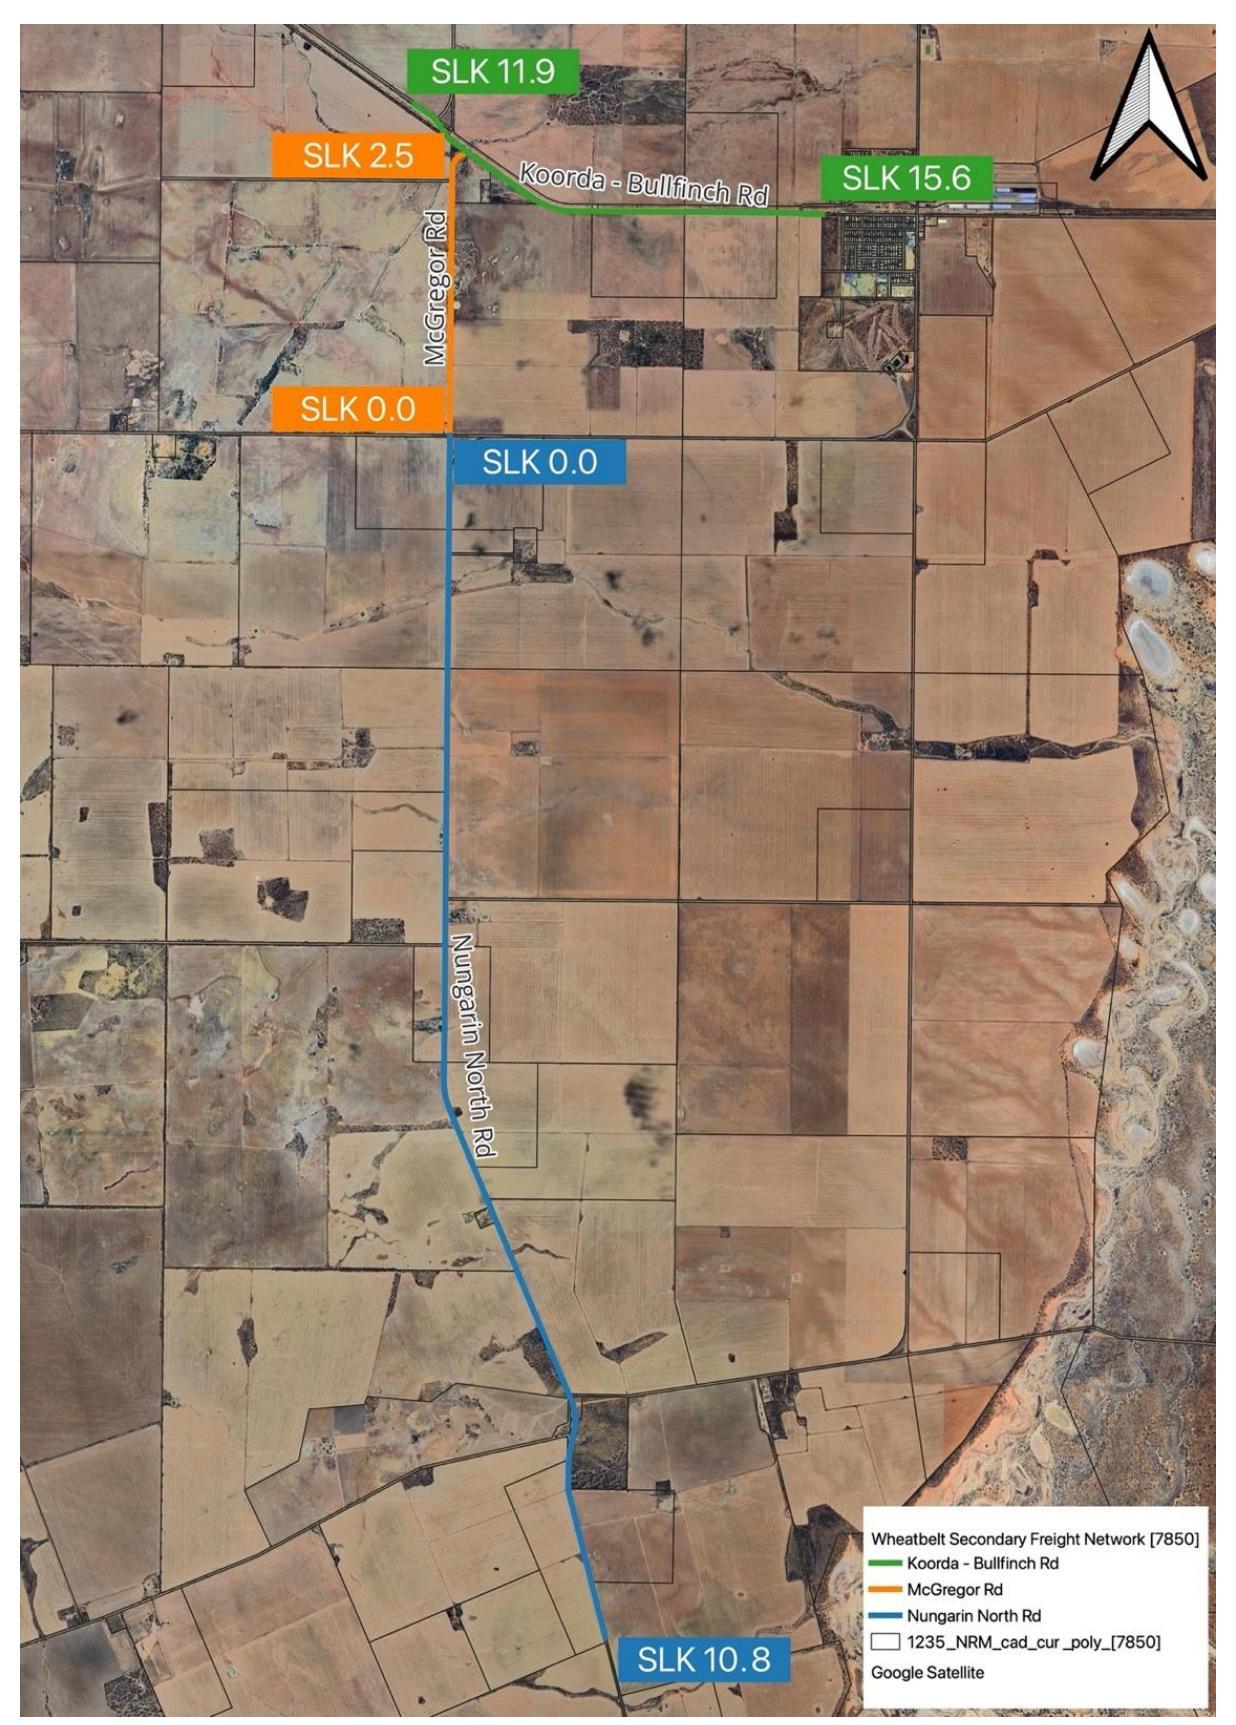
Figure 2. Surveyed Road Sections

There are approximately 10.8 km along Nungarin North Road, 2.5 km along McGregor Road, and 3.7 km along Koorda–Bullfinch Road that the Shire plans to upgrade.

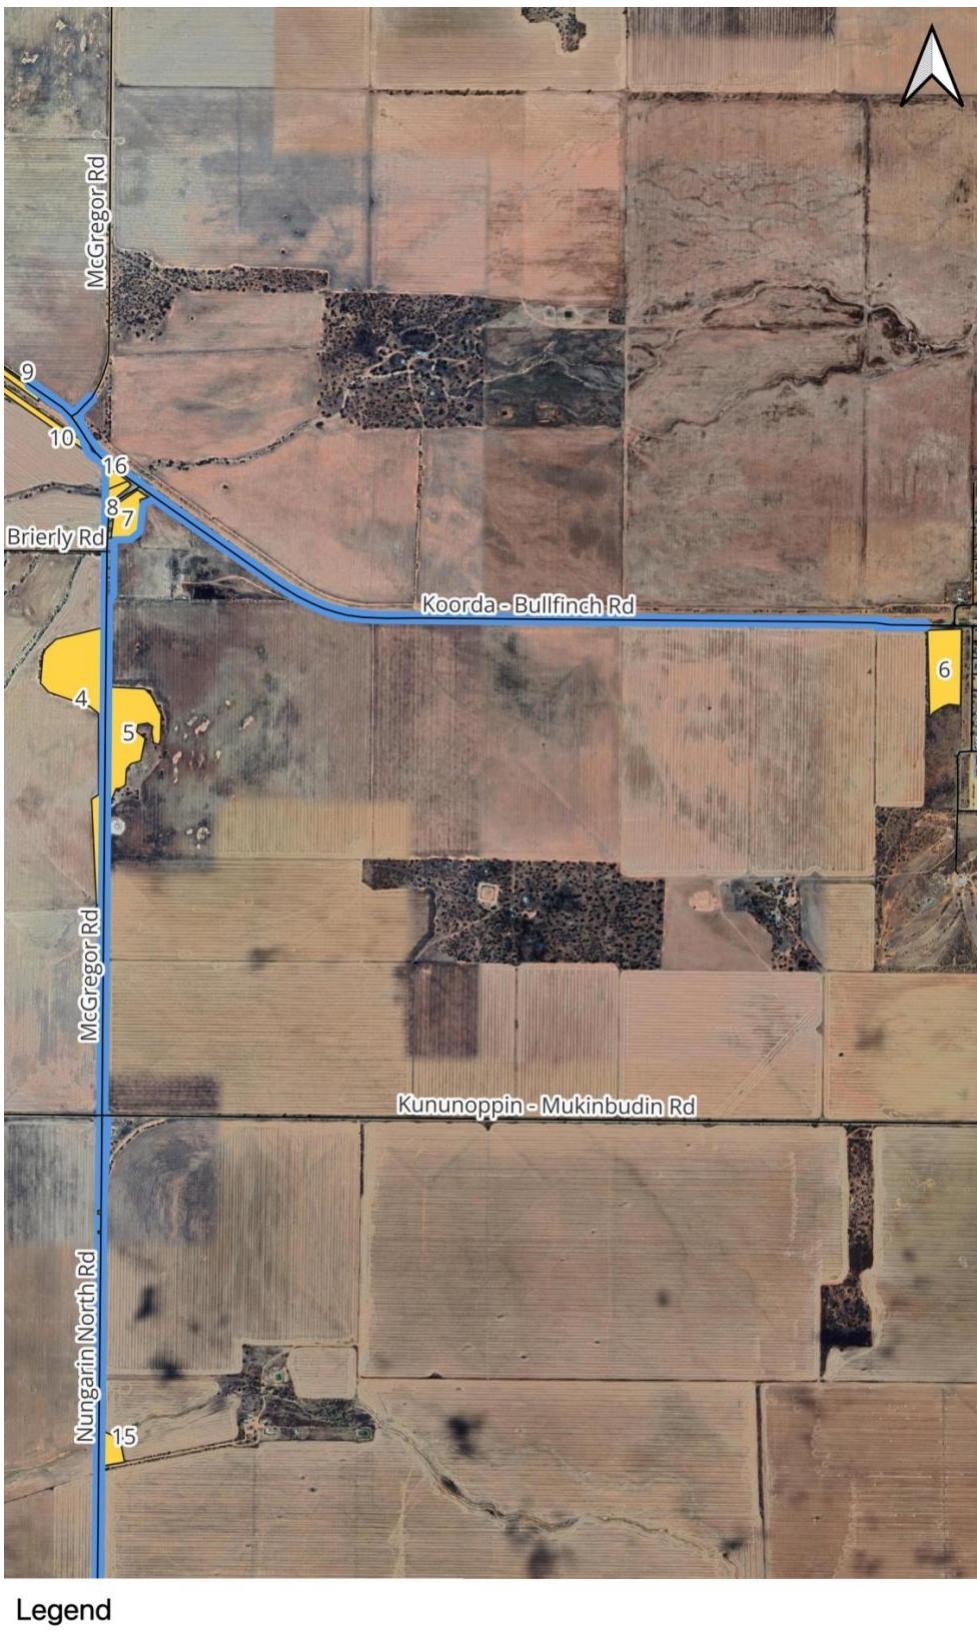
Figure 6. Remnant Vegetation—North Section

There is also a wider section of road reserve to the west of R 17855, but as noted below, the road in this area has been constructed within the reserve itself and not in the road reserve. This means that an assessment of the presence/absence of the TEC is not dependent on the width of the road reserve, and instead is considered on the vegetation types of R 17855 and R 21364. These two reserves are grouped together under "ID 1" in both Table 3 and Figure 4 because they are contiguous.

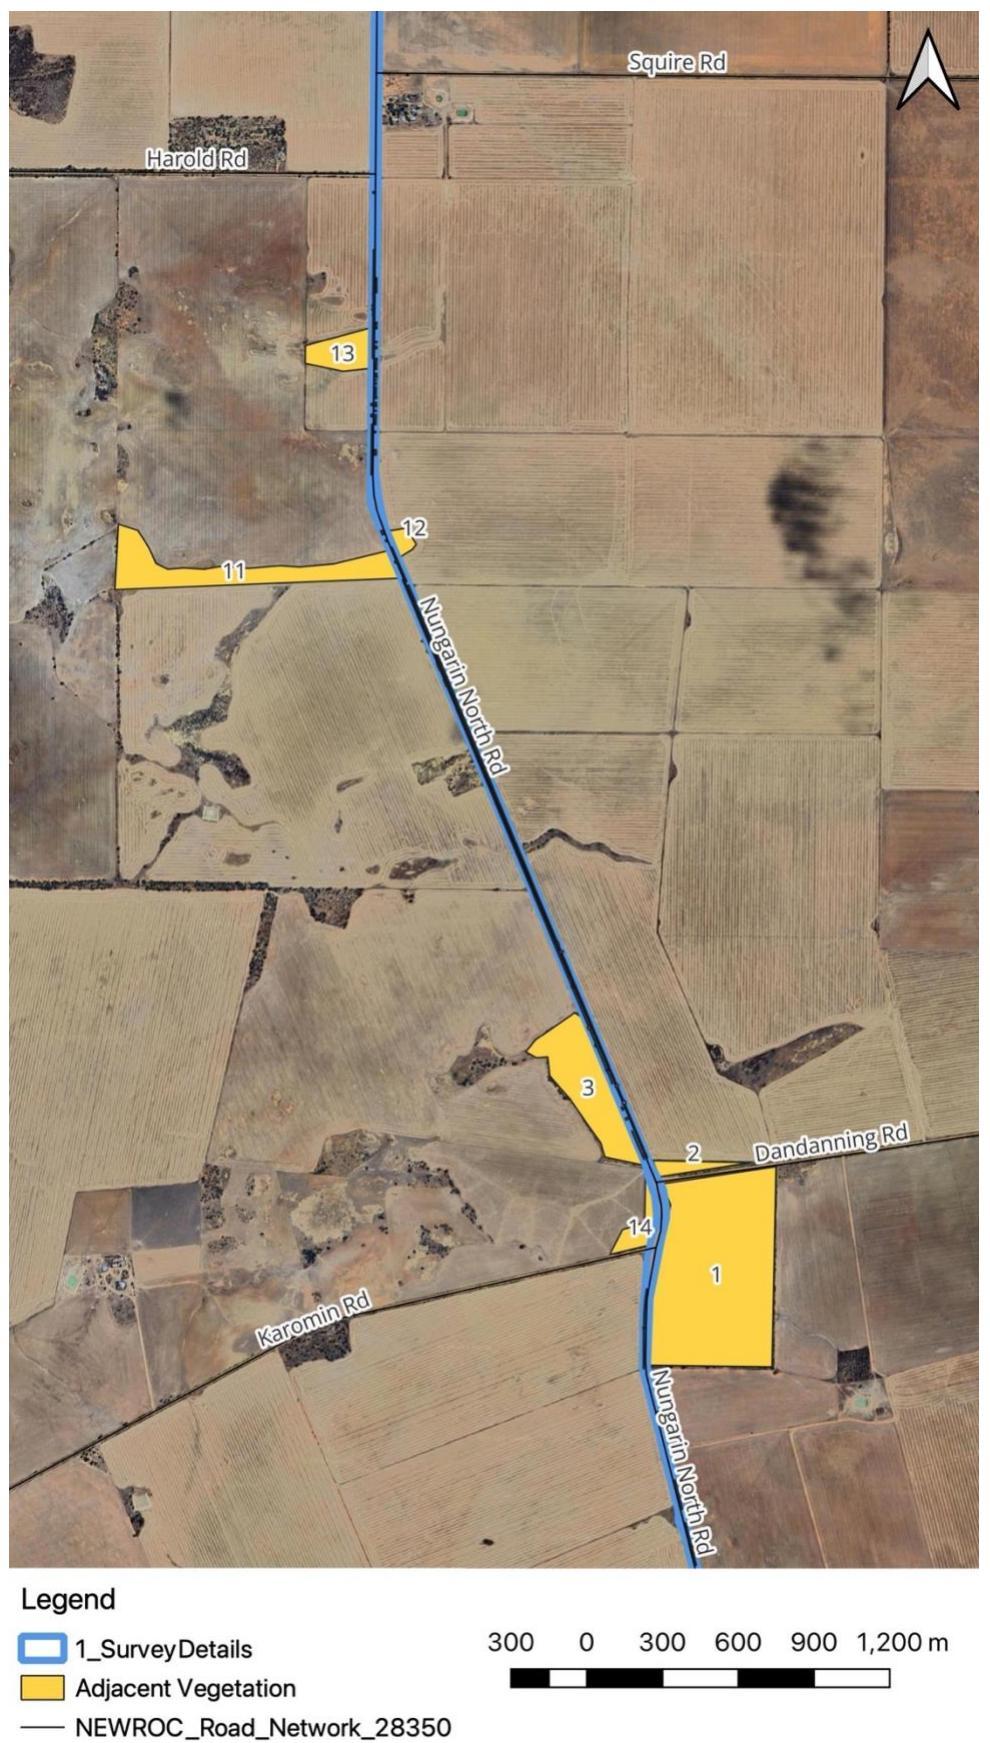
Figure 7. Remnant Vegetation—South Section

ID	Area (ha)	Source	Impacted by Proposed Works?	Quantum of Impact	Significant Impact	Vegetation Type
1	34.751	Shape file	No	Nil	No	Eucalypt woodlands in the south. Grading to mallee and then quickly to <i>Acacia-Hakea-Grevillea</i> associated with granite. Potential to grade back to eucalypt in the north-east corner.
2	1.2367	Shape file	No	Nil	No	Mostly Hakea recurva and Grevillea paniculata regrowth.
3	10.8073	Shape file	Yes	161.34 m2	No	Predominantly multi-stemmed mallee. Occasional single-stemmed eucalypt. Abrupt change to <i>Acacia-Melaleuca</i> woodland in the south.
4	7.8235	Shape file	No	Nil	No	Mostly mallee with pockets of Acacia woodland.
5	5.6329	Shape file	No	Nil	No	Mostly mallee with pockets of Acacia woodland.
6	3.9245	Shape file	No	Nil	No	Planted mallee with the occasional remnant single-stemmed eucalypt.
7	1.7234	Shape file	Yes	<del>3,173 m2</del>	<del>Yes</del>	Remnant mallee. Occasional single-stemmed eucalypt. Please see discussion on page 15.
