**Cranbrook Fixed Rail Outloading Facility
Mitigation and Rehabilitation Plan
P1020A-01-00
CBH
June 2023**

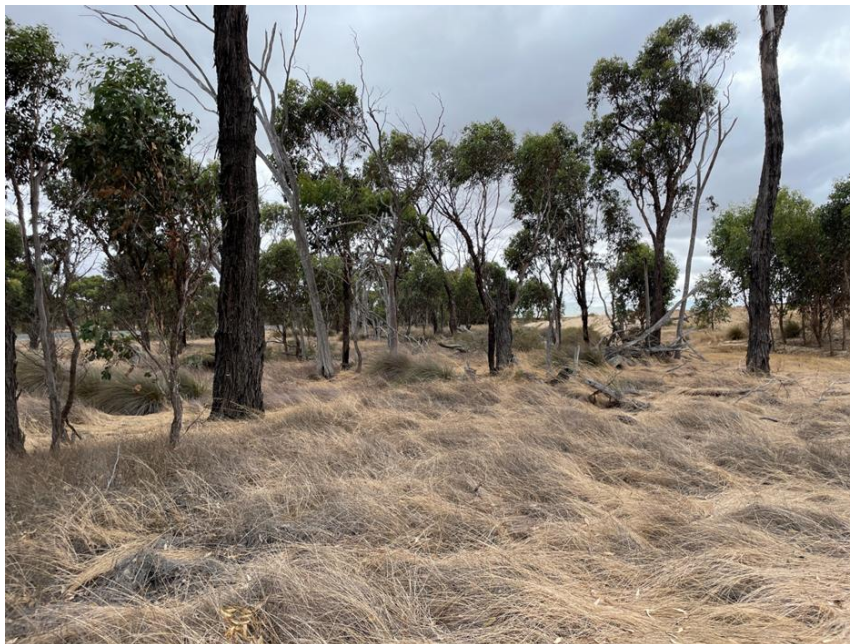
Figure 1 Infill Yate Zone

This zone is the largest at the site with 1.79 ha. It is largely winter wet *Eucalyptus occidentalis* (swamp yate) dominated woodland, with scattered understorey shrubs including *Callitris pyramidalis* (swamp cypress), Melaleuca's and various sedges. There is an outlet from the CBH retention basin that is particularly wet with *Gahnia trifida* (saw sedge) tussocks in the understorey (Figure 1).

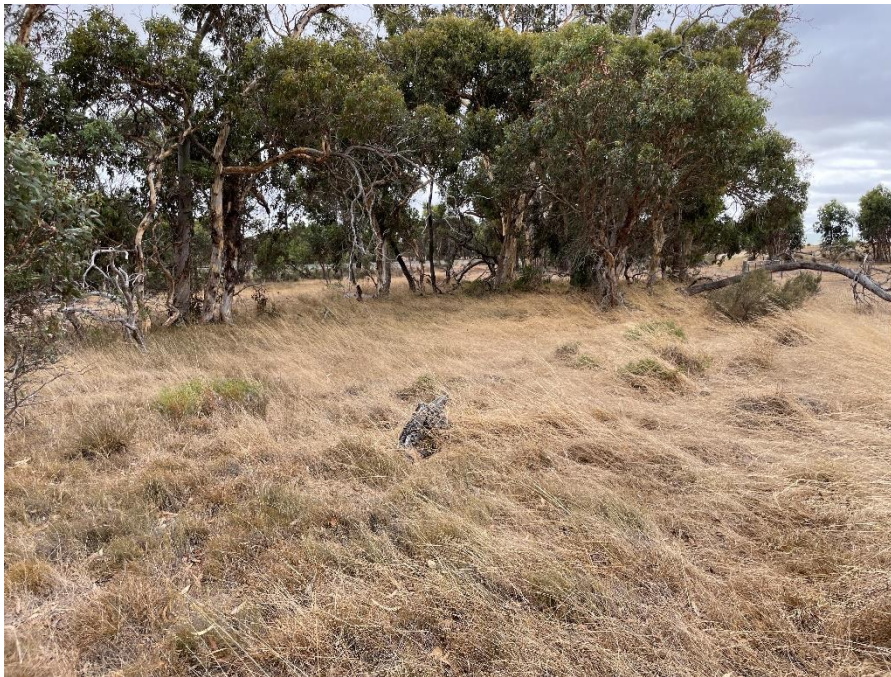
Figure 2 Infill Wandoo Zone

Figure 2 shows typical vegetation of Management Zone 2 – Infill Wandoo. This zone is 0.62 ha and comprises scattered *Eucalyptus wandoo* (wandoo) trees with a highly degraded understorey. This zone will have intensive weed control in year one and pre-planting in year two when infill planting of overstorey and understorey species will occur, with a focus on woodland understorey species that are less winter-wet than Management Zone 1 – Infill Yate.

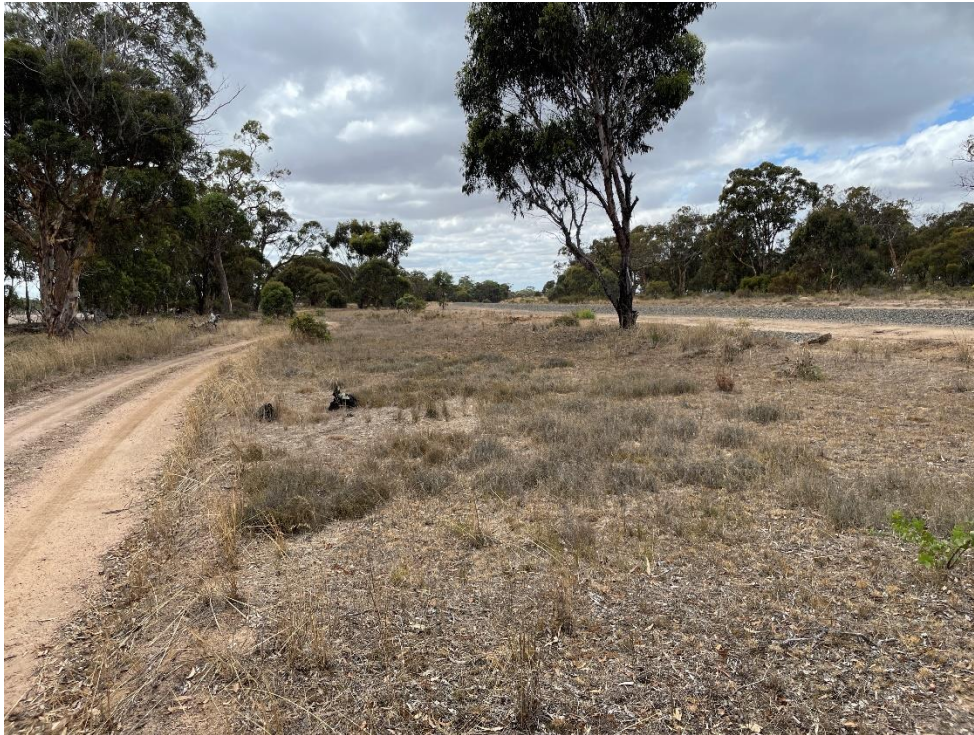
Figure 3 Wandoo Open Zone

Management Zone 3 – Wandoo Open is a strip of 2,254 m² almost fully cleared (Figure 3) but with scattered native understorey species present. It provides an opportunity to install a higher density of plants, with a focus on restoring the overstorey of wandoo and creating a species rich understorey.

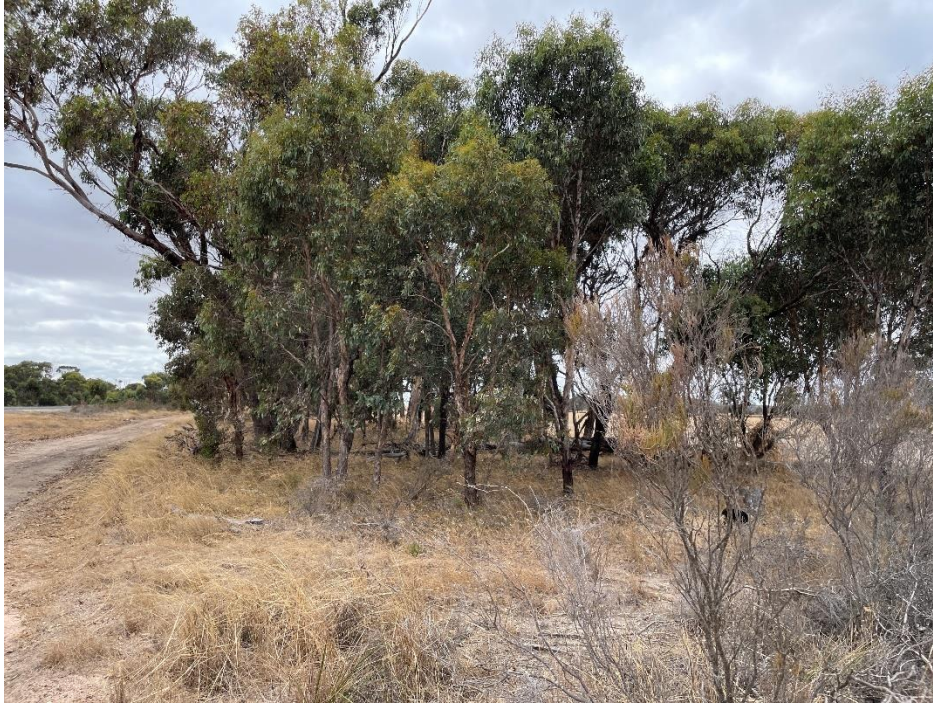
Figure 4 Closed Canopy Zone

Management Zone 4 is a small parcel of 1,588 m² with near-continuous canopy of relatively intact overstorey vegetation so is likely to require fewer infill plants, although some understorey species will be established where possible (Figure 4).
