➤ Supporting Document for Amendment to CPS 6323/1

Christmas Island Phosphates
August 2024

Prepared by: SK, JK, RG
Version No: V001
Version date: 15/08/2024

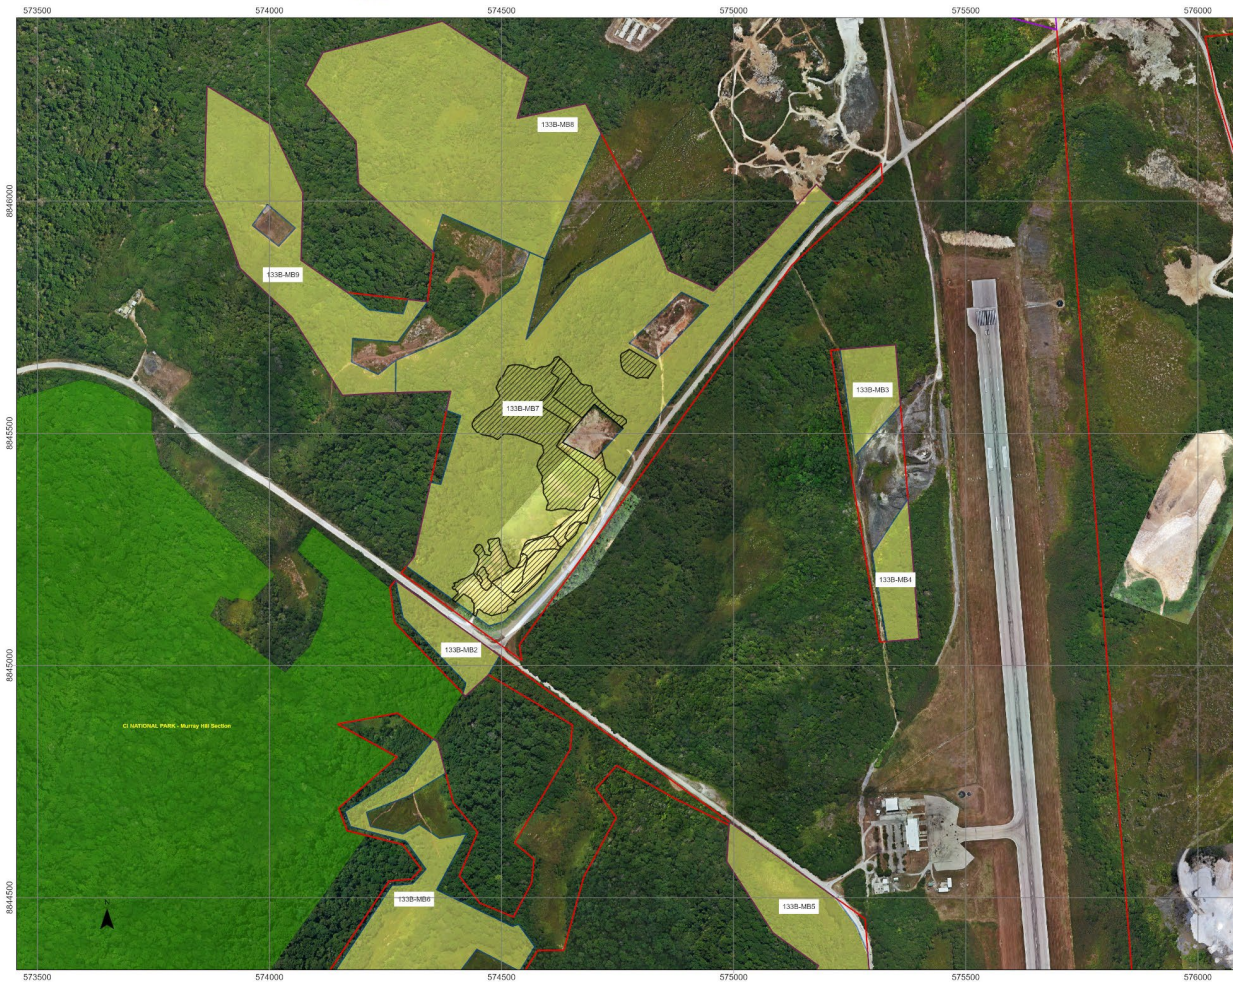
**Phosphate Resources Limited
Site Plan - CIP Clearing To Dec 2023
CPS6323**

Approximately, 9.17 hectares has been cleared under CPS 6323/1 (Table 1; Figure 3; Figure 4).

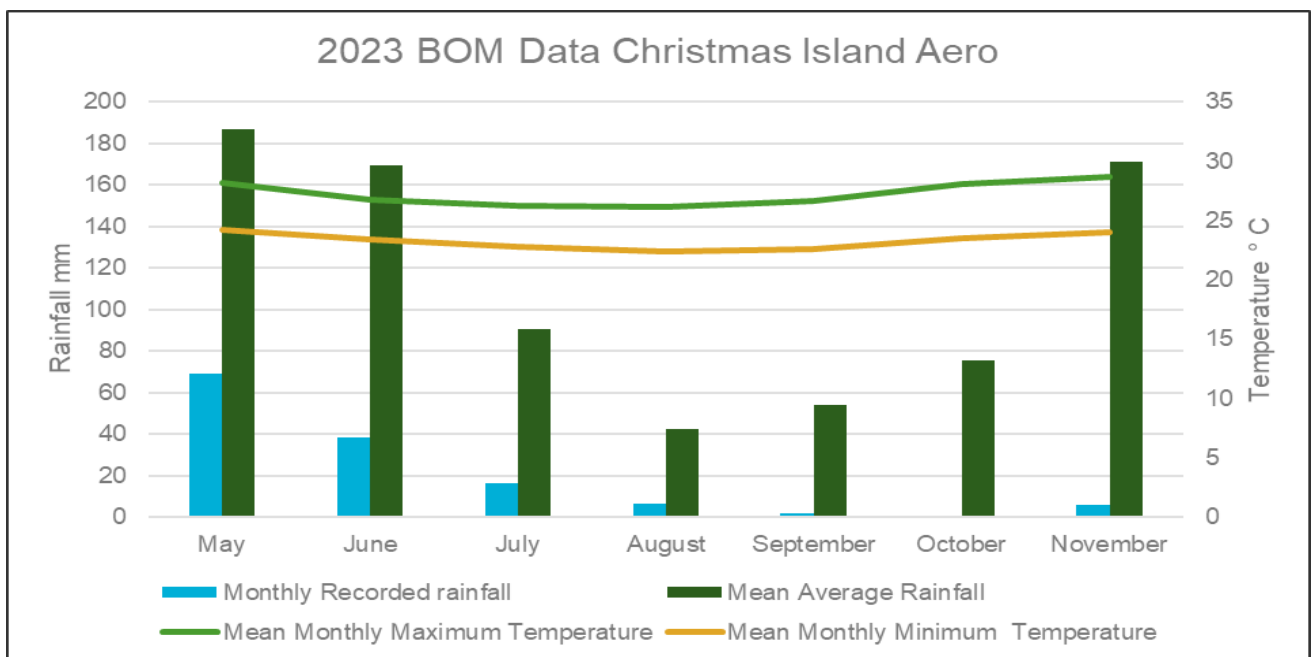
The island has distinct microclimates due to the island's geography, with rainfall measurements indicating that there are significant variations in rainfall (Falkland, 1999) across the island. Average rainfall at Rocky Point (Settlement), Jedda Cave and South Point (1 931, 2 375, & 1 907mm respectively) for example shows the significant variation across the Island. Daily evaporation generally exceeds rainfall between July and October. In the six-month period preceding and during the survey, covering the dry season (May 2023 to November 2023), Christmas Island received significantly less than long-term average for rainfall, with temperatures slightly above the mean average (Figure 5).

The Christmas Island Aero weather station (Station Number 200790) has operated from 1972 to the current date and is situated on the plateau near the airport at an elevation on 261m.

Figure 5: Rainfall and Temperature 2023 at Christmas Island Aero (BoM 2023)

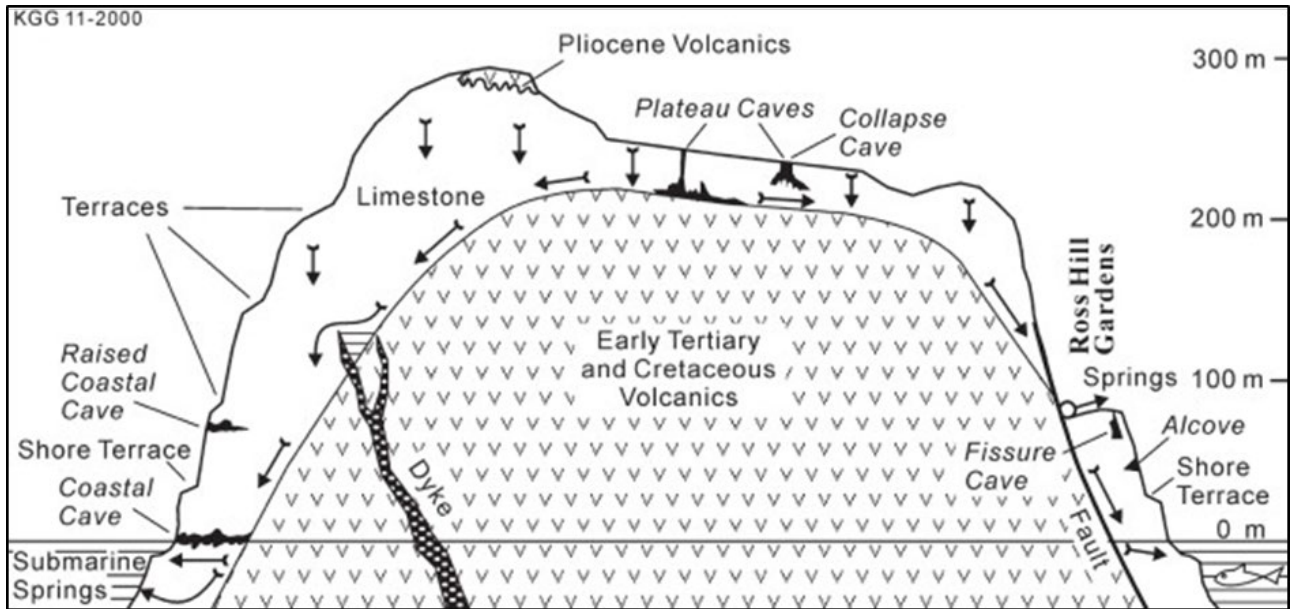
The oldest (Upper Eocene) limestones are found near the island summit, 330 m above sea level and the youngest (Pliocene) near present sea level. The limestone is mixed with dolomite sediments, basalts, and tuffs. A layer of phosphate-rich soil material covers the limestone over about half of the island. The island is characterised by sea cliffs that rise via a series of terraces to a central plateau. The shoreline is dominated by cliffs and extensive shore platforms with a few small beaches and Flying Fish Cove which has a relatively large beach and shallow platform being the only safe harbour for much of the year. The island's natural landscape is dominated by karstic surface landforms and cave systems (Grimes, 2001). Figure 6 shows a cross section of Christmas Island (exaggerated vertical scale) showing volcanic core, limestone capping, water flow lines and typical cave development (source Grimes 2001).

Figure 6: Diagrammatic cross-section of Christmas Island (Grimes 2001)

near the peak of the Island formed during the Eocene period (Grimes, 2001). Most of the Island's limestone deposits were formed during the Tertiary (late Oligocene to mid Miocene age), with the youngest limestones deposited on the lowest terrace in the late Quaternary (Grimes, 2001).

The limestone is mixed with dolomite sediments, basalts, and tuffs. A layer of phosphate-rich soil material covers the limestone over about half of the Island. Marine sediments and guano deposition have formed the Island's phosphatic soils.

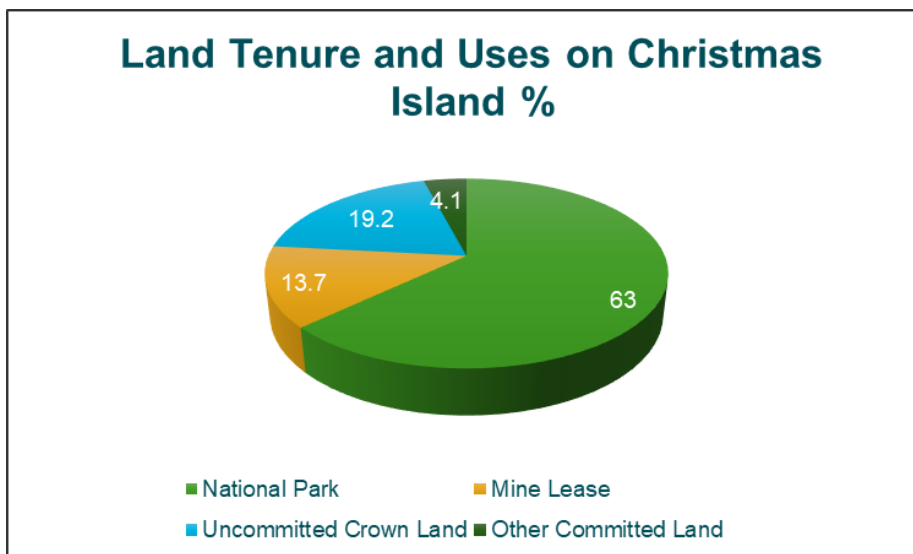
Figure 7: Land Tenure and Uses (Environment Australia 2014, Geoscience Australia 2014)

There are a range of current land uses on Christmas Island with the largest land use by area being nature conservation in the form of the Christmas Island National Park (CINP), which occupies 63% of the island. Other land uses include residential housing, tourism, recreation, transport and the provision of utility services (Figure 7). Numerous businesses and services have been developed on the island to support the phosphate mine, detention centre, tourism industry and the island population, including construction, retail/hospitality, training/education, Government services, maritime services, agriculture, sport/recreation, maintenance, arts, and the airport.

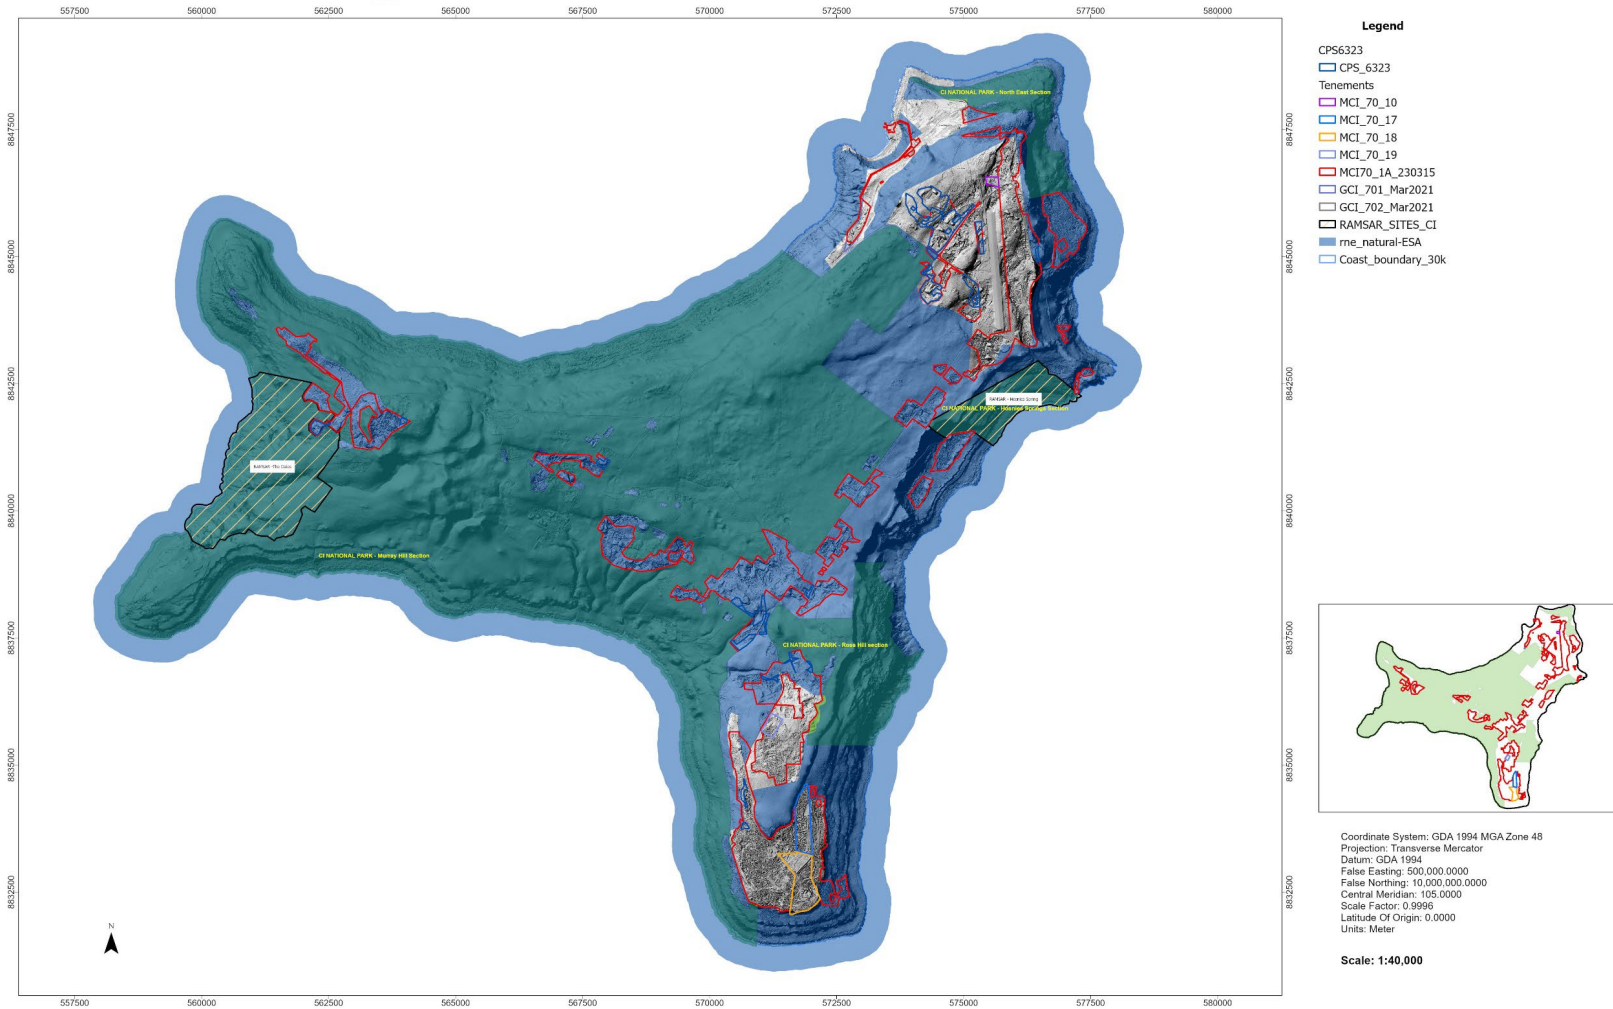
**Phosphate Resources Limited
Environmentally Sensitive Area
Christmas Island**

Figure 9: Map of ESA, RAMSAR and CPS 6323/1

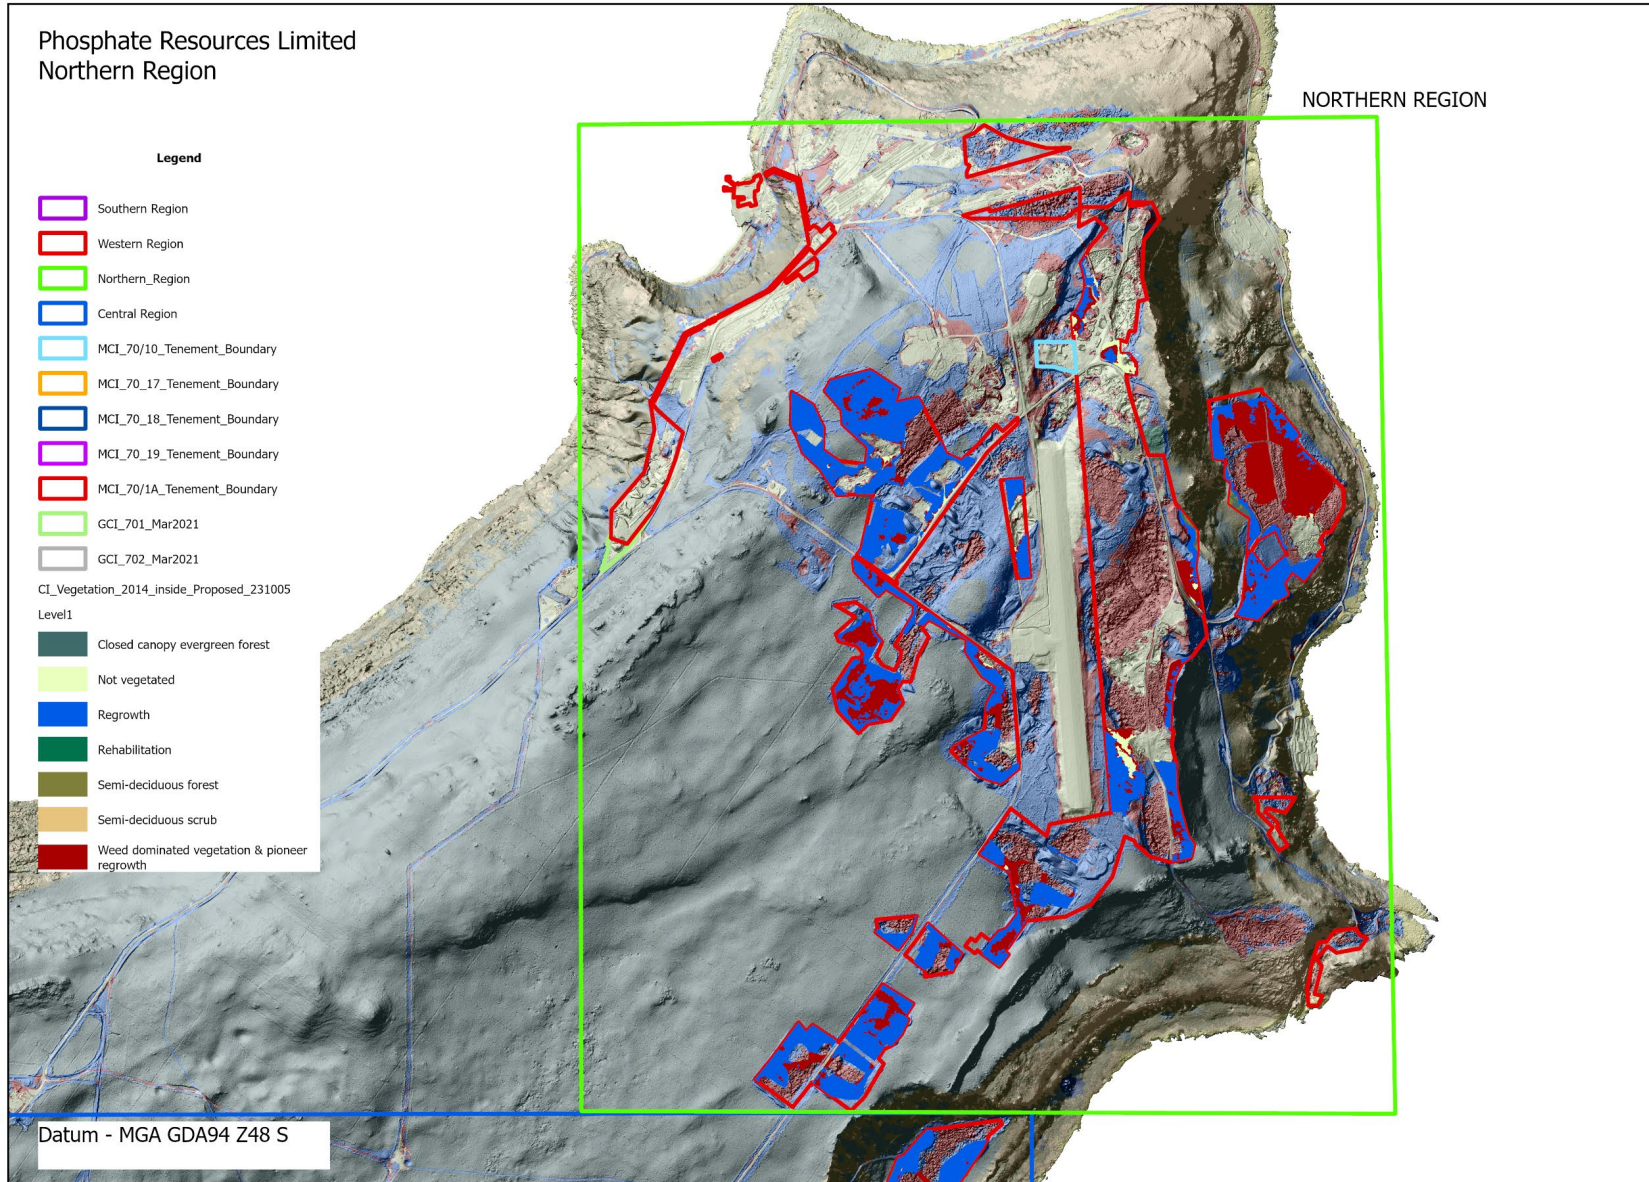
Figure 10 Geoscience 2014 Classified Vegetation within Northern Region

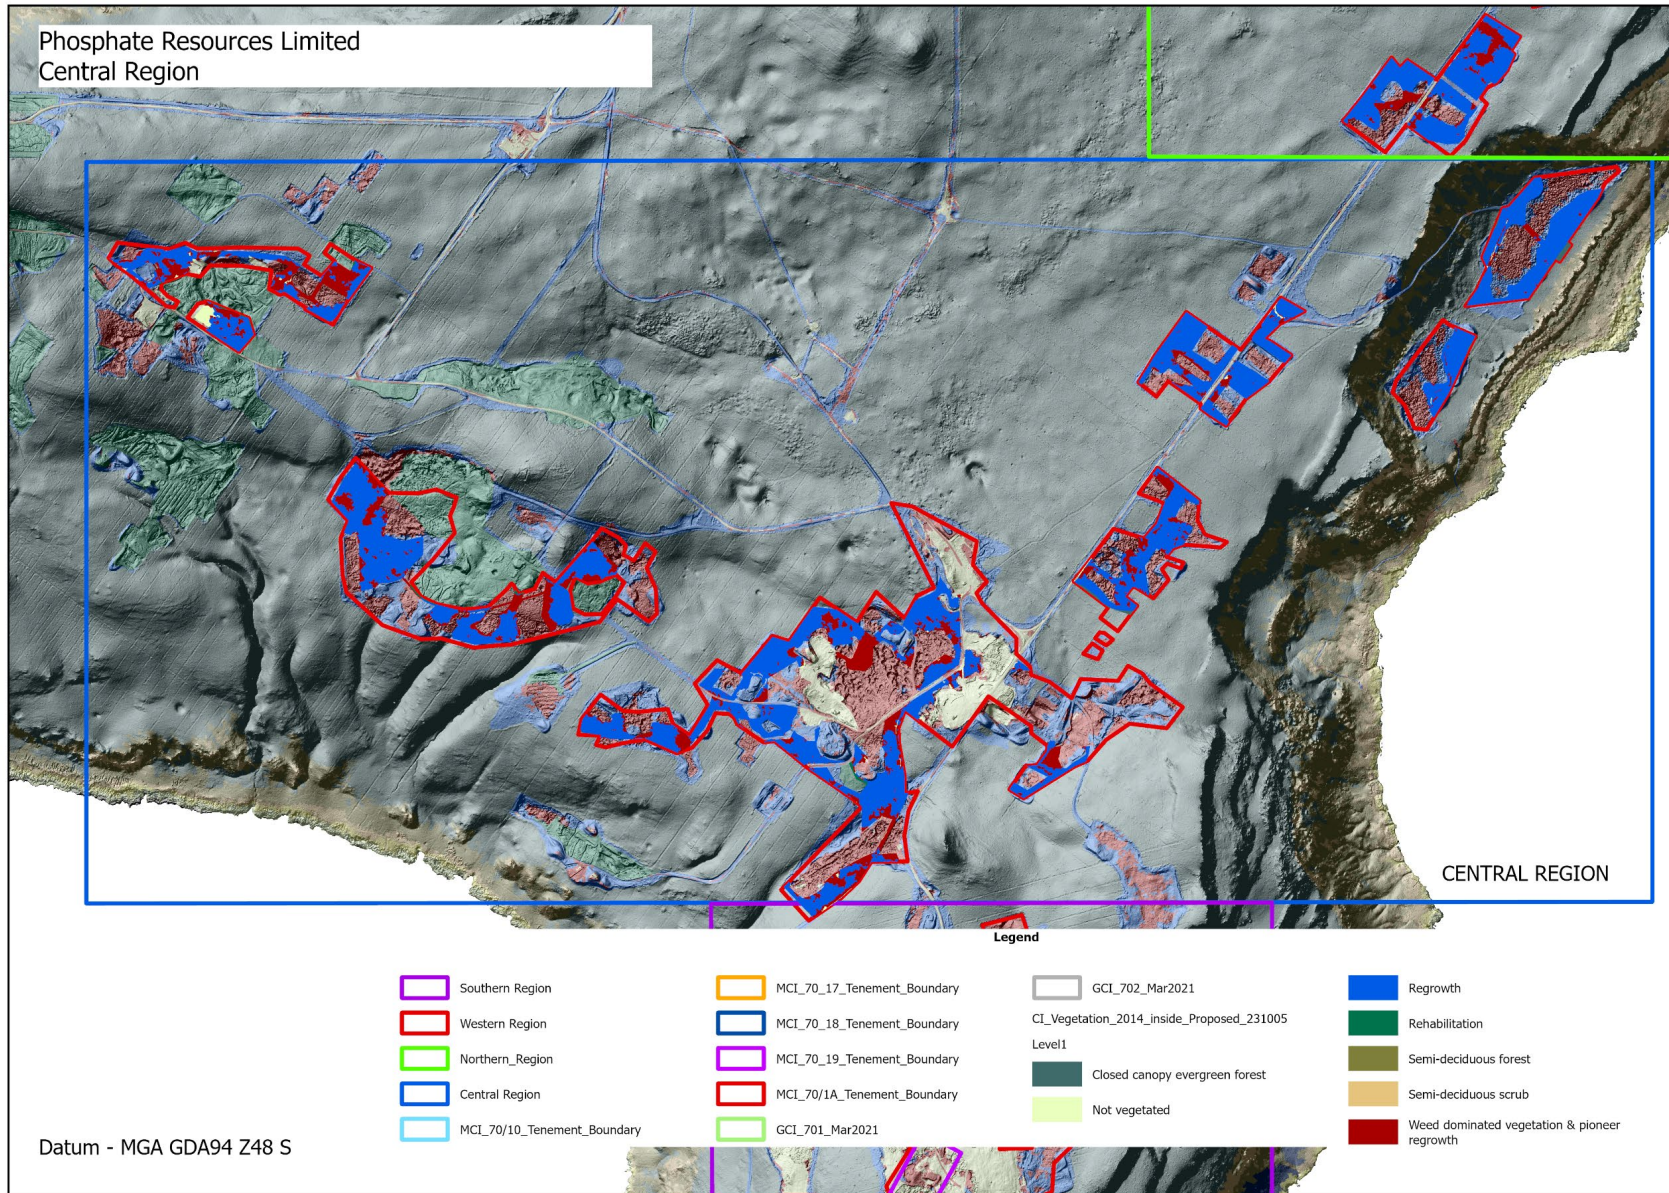
Figure 11 Geoscience 2014 Classified Vegetation within Central Region

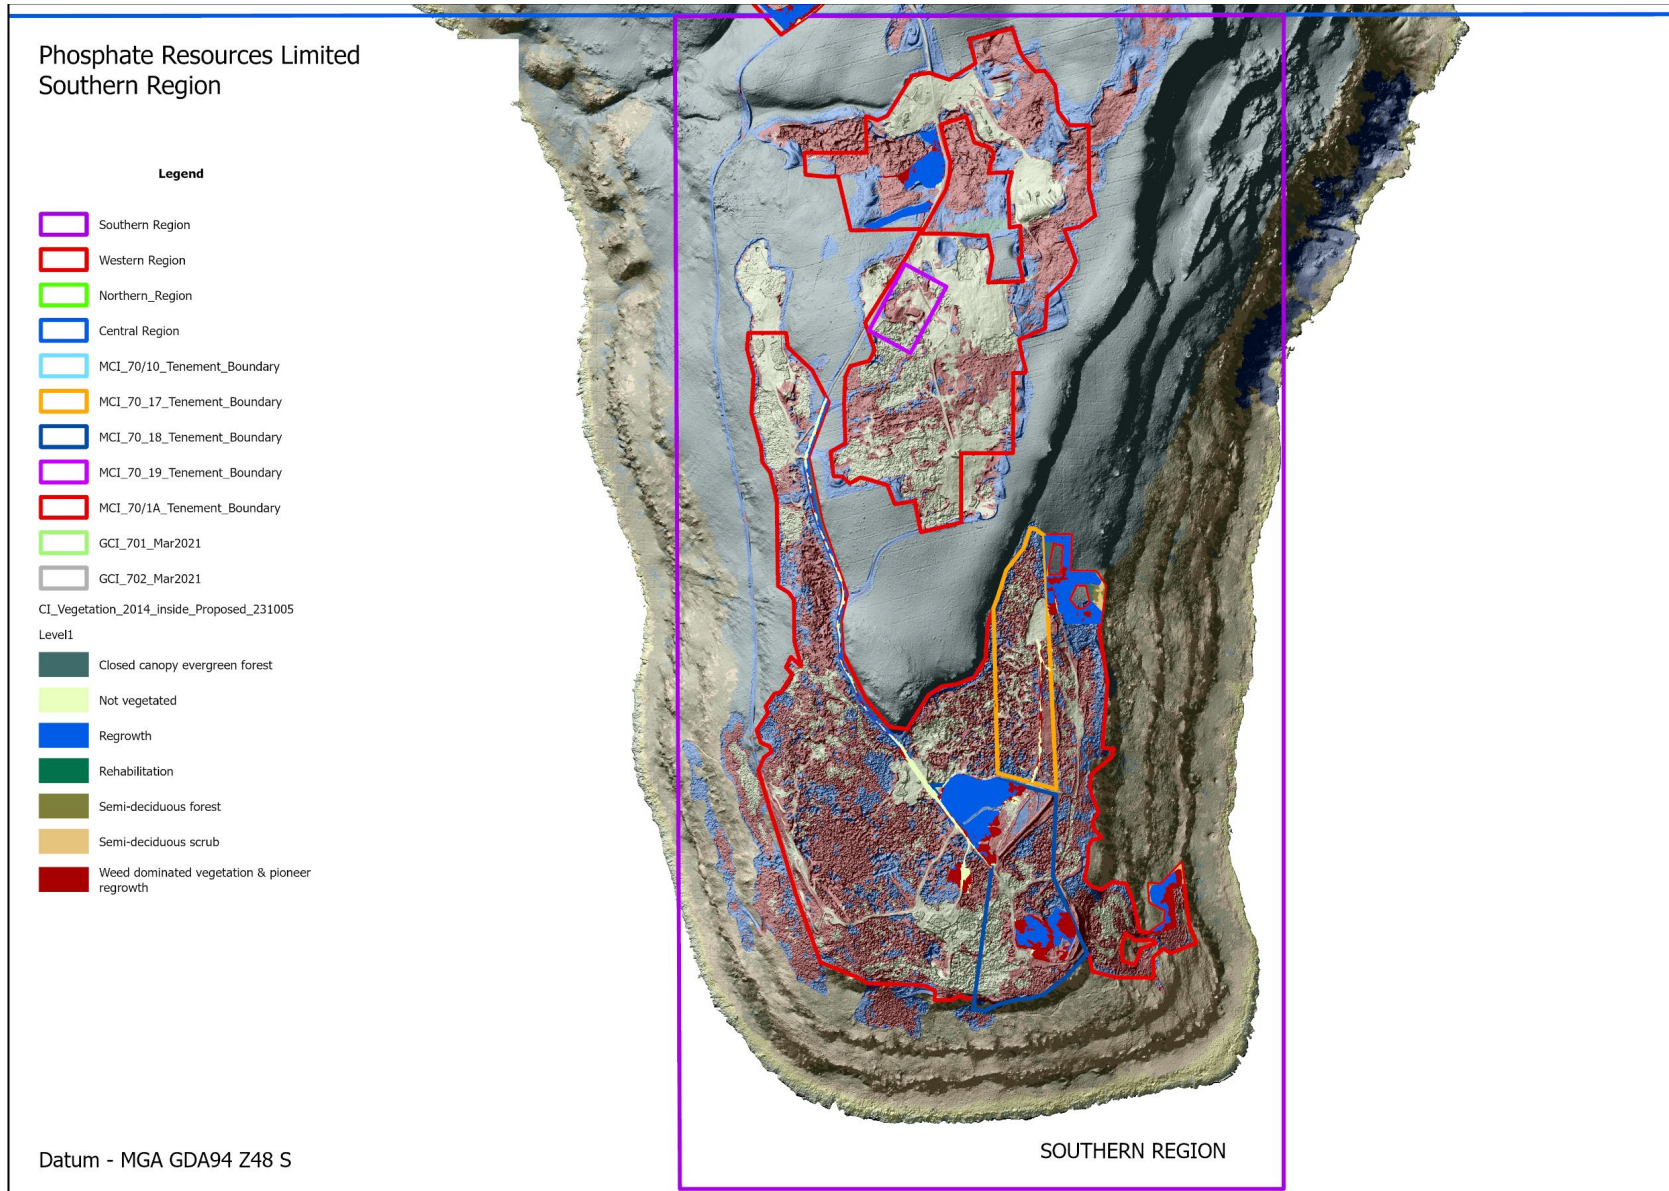
Figure 12 Geoscience 2014 Classified Vegetation within Southern Region

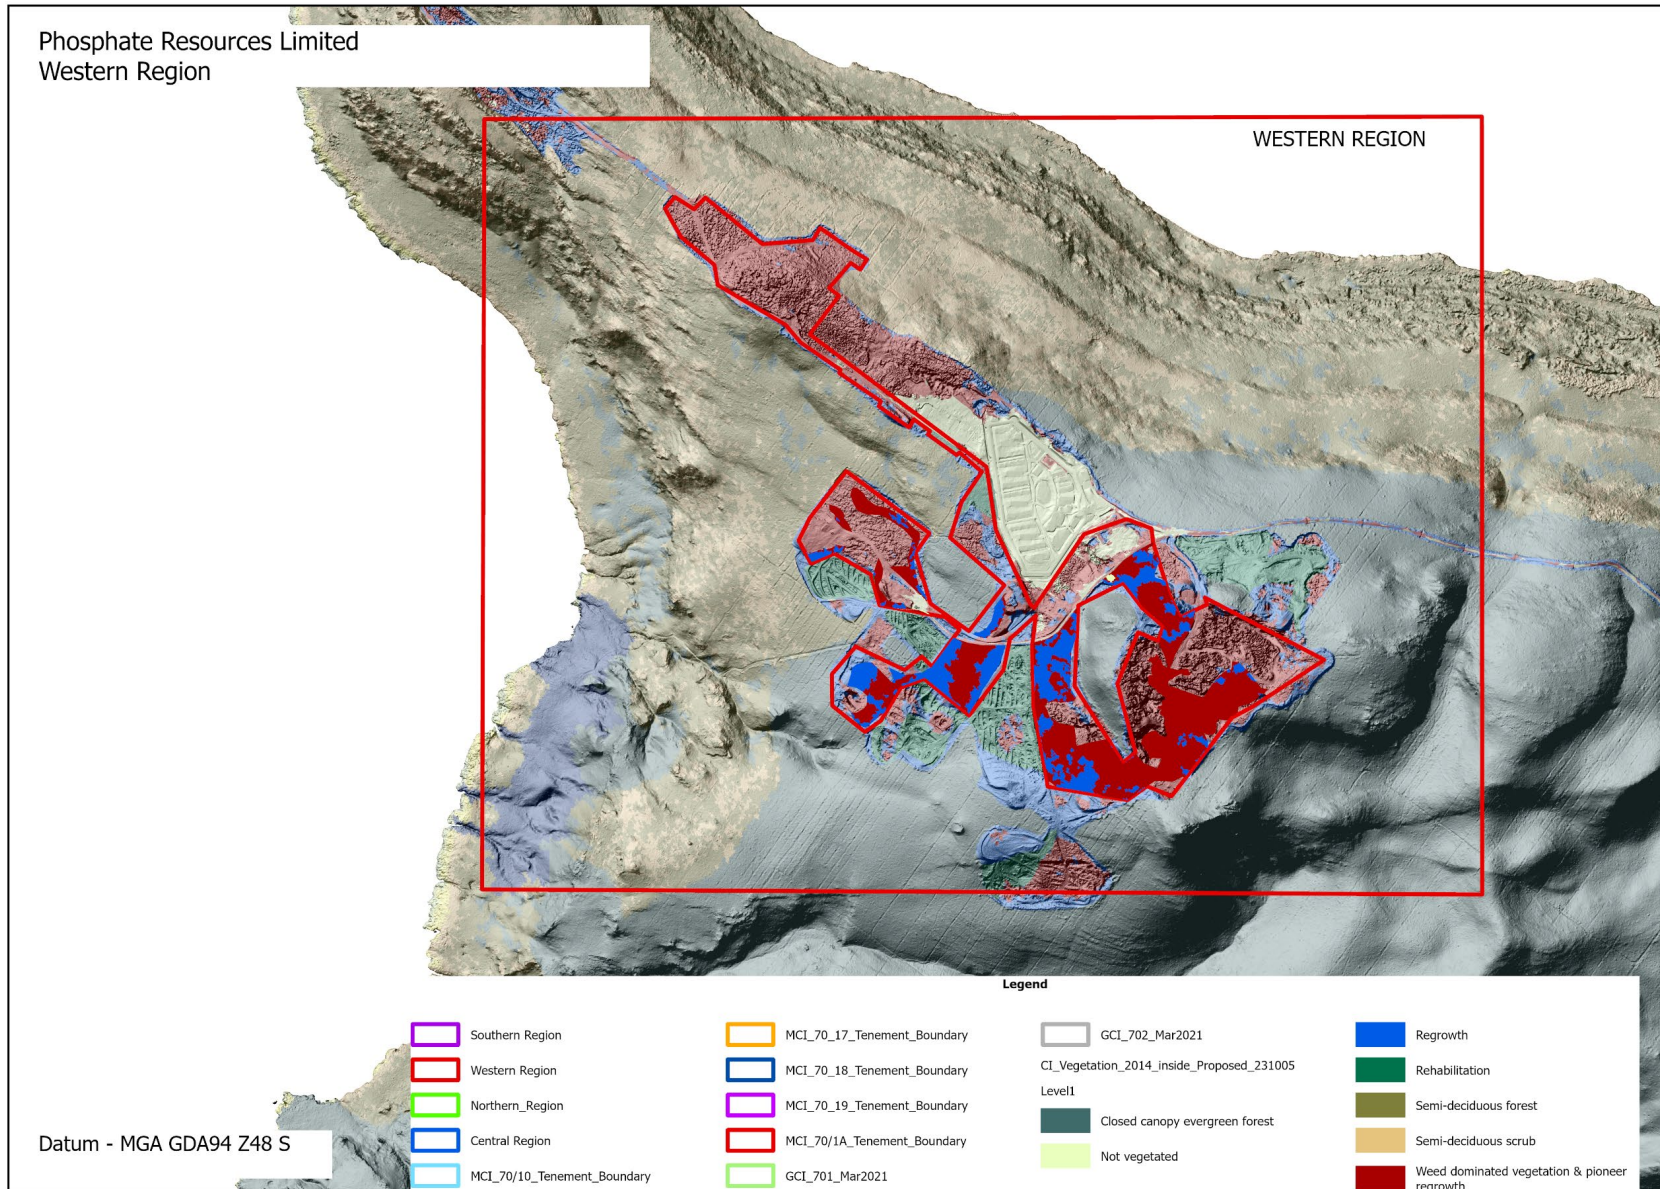
Figure 13 Geoscience 2014 Classified Vegetation within Western Region

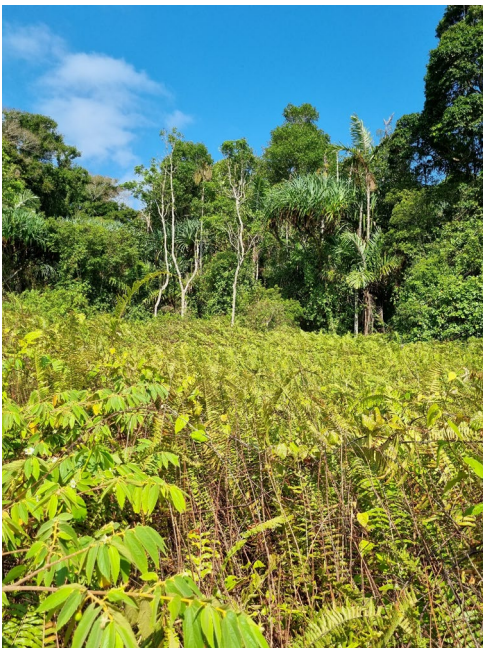
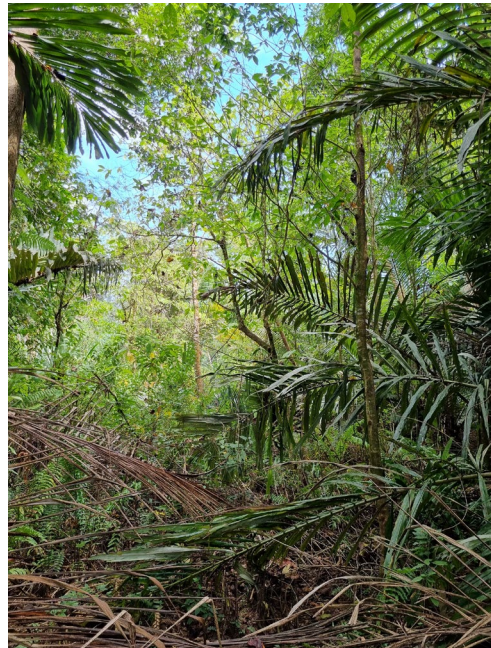
Figure 14 (left) Example of Classified Category 6 Vegetation (Field 133B -MB6); (right) Example of Classified Category 4 Vegetation (Field 133B - MB6)

The reconnaissance survey was conducted ranking sites vegetation conditions scores based on the Keighery Condition Scale (Keighery, B.J. 1994), with some allowances and modifications made to accommodate the unique tropical environment on Christmas Island (Table 3).
