Gravel Pit Revegetation Plan for Holland Tank Road Gravel Pit Extension, Kent.

Prepared for the Shire of Kent
March 2019

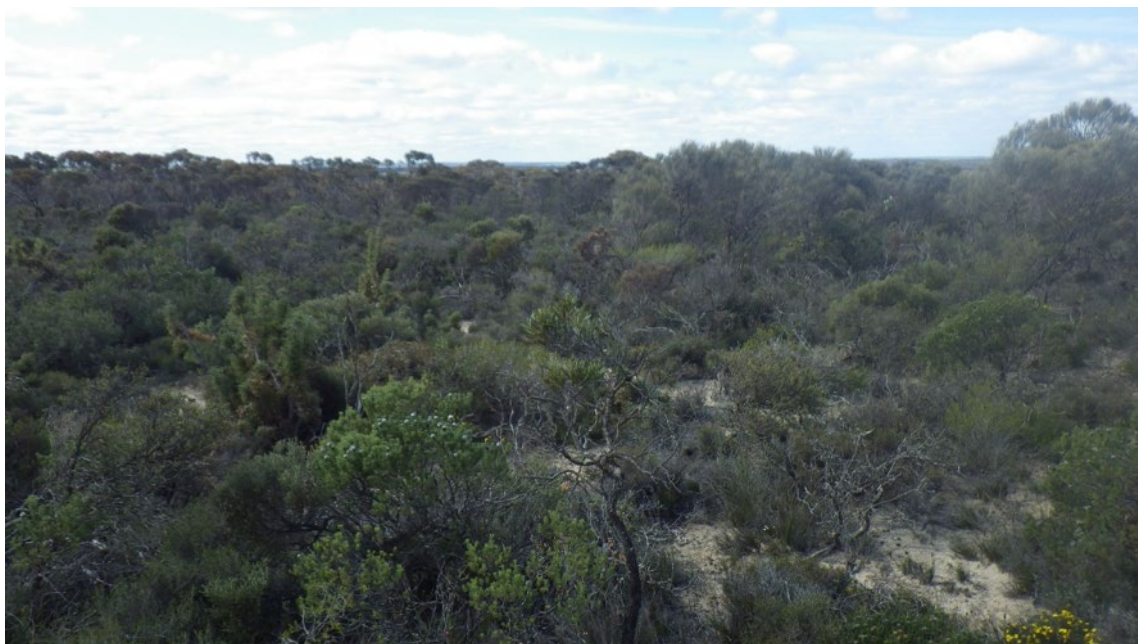
Figure 4. Tall Open Shrubland over Shrubland.

Tall open shrubland of *Allocasuarina acutivalvis* over shrubland of *A. microstachya*, *Banksia armata*, *B. erythrocephala*, *B. pteridifolia*, *Grevillea cagiana*, *Hakea cygna* subsp. *cygna*, *H. incrassata*, *Leptospermum erubescens*, *Melaleuca pungens* and *Verticordia grandiflora* on yellow-grey sandy loam over laterite (**Figure 4**).
