Foreshore Management Plan

Catalina Estate Coastal Access Infrastructure

Revision 6, February 2019

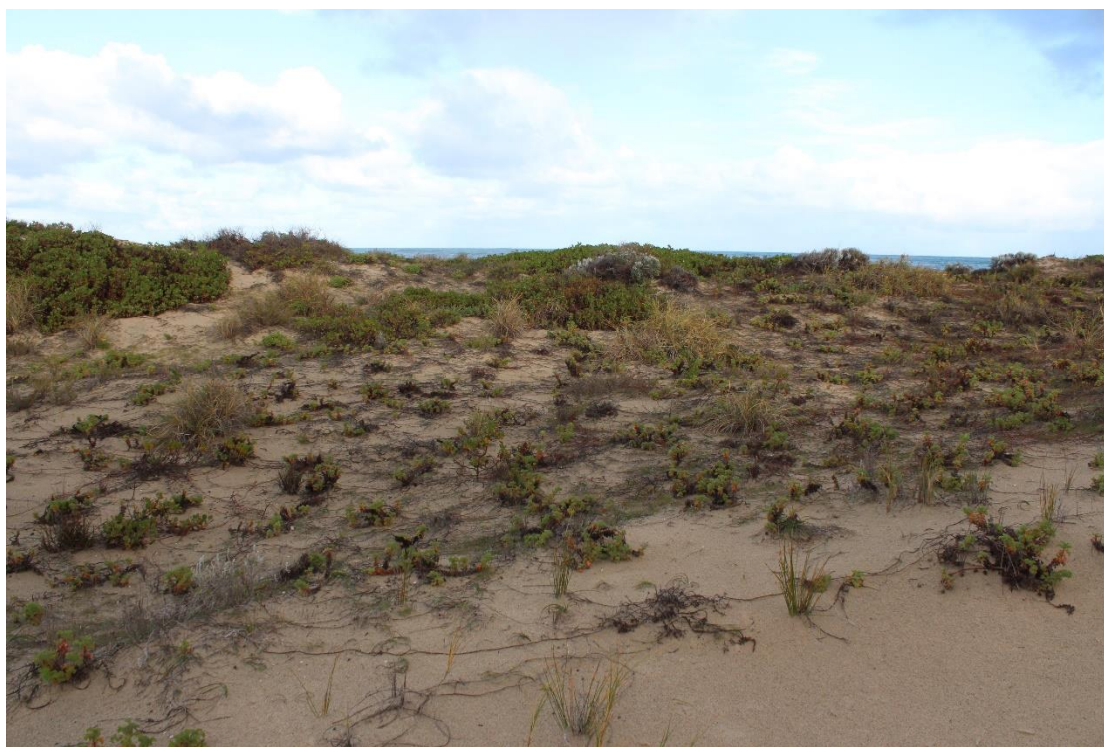
Plate 6: Foredune over which an access track will be constructed to provide pedestrian and maintenance vehicle accessway to the beachfront (photo taken facing west)

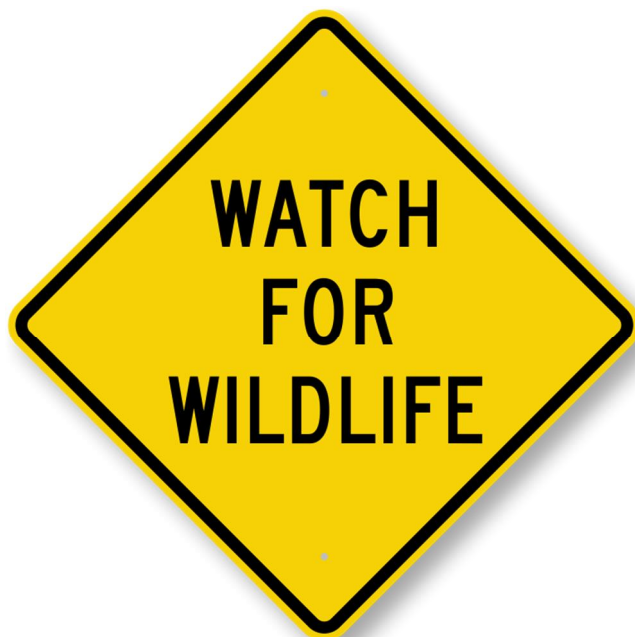
Plate 7: Example wildlife road awareness sign

To improve awareness of facility users, wildlife crossing signage shall be installed at both entrance points to the access road. Examples of signage are provided in Plate 7.

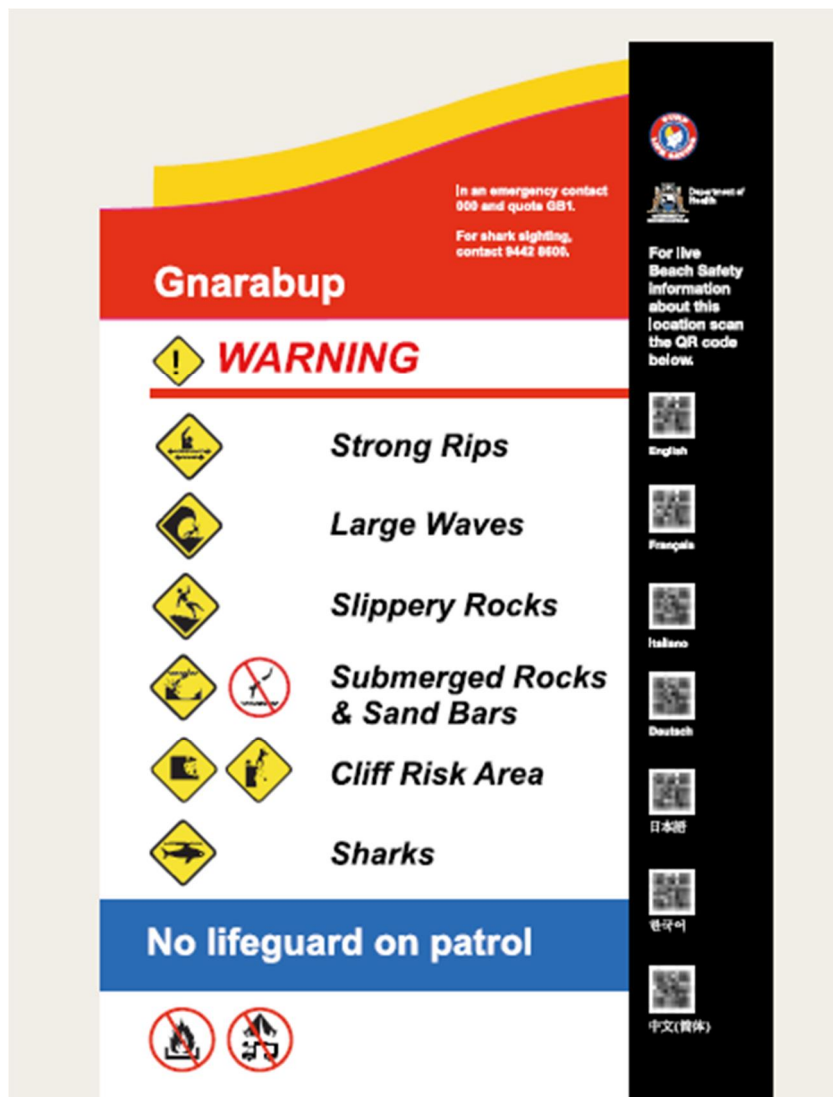
Plate 8: Example of recommended safety signage

Appropriate coastal hazard signage is recommended to be installed at the beach access carpark outlining the hazards of the area and encouraging awareness and vigilance, as part of a greater education and awareness program (SLSWA, 2014). An example of this type of signage is provided in Plate 8. In this case, QR code signs are used to enable those with smart phone technology to access the beachsafe.org website for live and local beach conditions in a number of foreign languages. Generally this is an initiative assisted by the Department of Health and the Surf Life Saving Association of WA through local government recommendations (SLSWA, 2014).

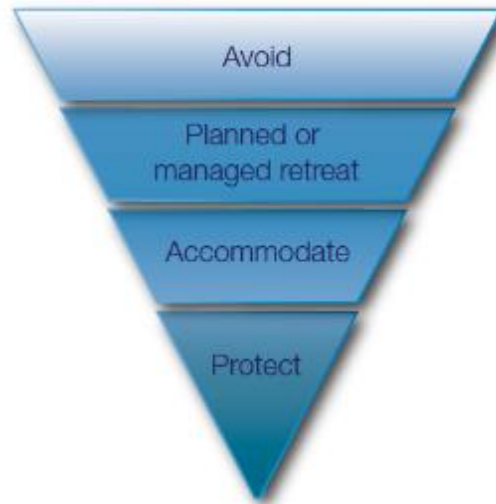
Figure 7.1 Risk Management & Adaptation Hierarchy

SPP2.6 outlines a hierarchy of risk adaptation and mitigation options, where options that allow for a wide range of future strategies are considered more favourably. This hierarchy of options is reproduced in Figure 7.1.

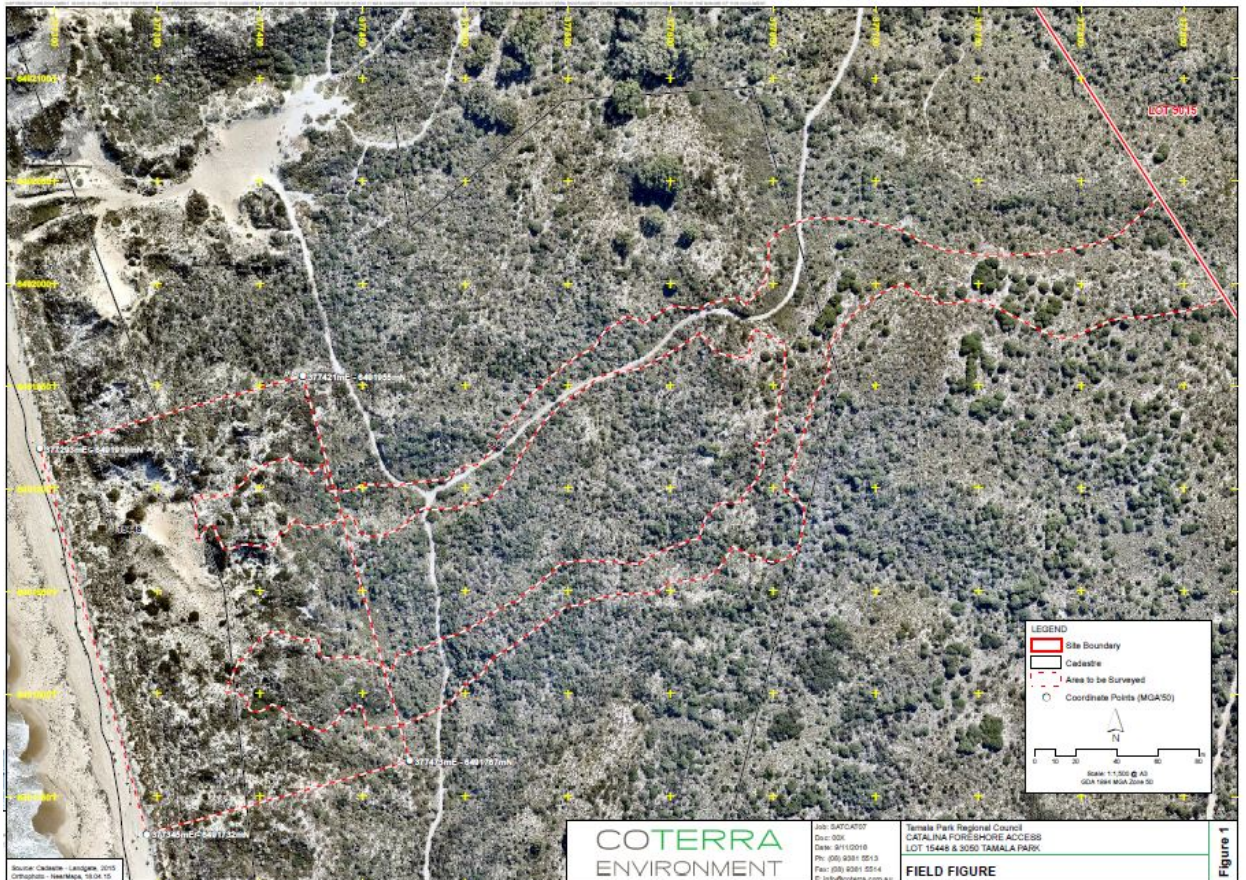
Diagram 1. Study area outlined in red/white lines. The white area indicates current tracks and the red line at the top right hand corner is where the current expansion will terminate.

Both of the tracks in Diagram 1 end in a rectangular area where it is proposed to construct a car park.

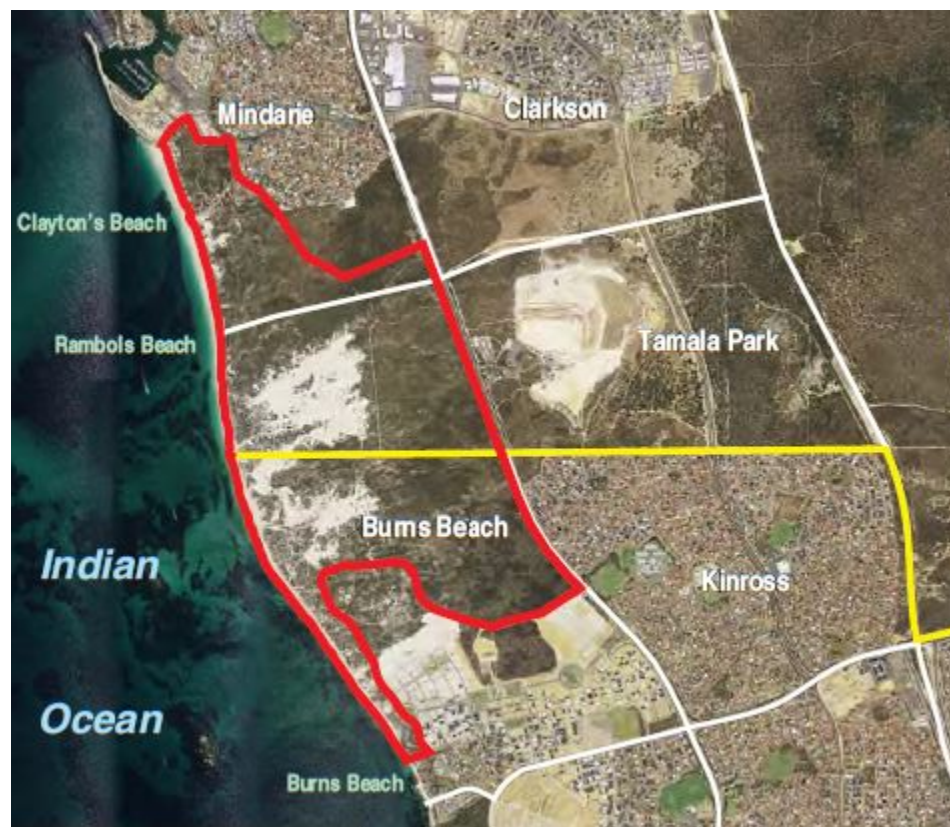
Diagram 3. Area outlined in red proposed as Tamala Conservation Park.

3. In March 2012 a Tamala Conservation Park was proposed and an establishment plan prepared (Western Australian Planning Commission, 2012). The area under consideration is outlined below in Diagram 3 and it can be seen that it includes the current survey area. This was proposed to be managed by the Department of Environment and Conservation (now Department of Parks and Wildlife). The Establishment Plan did not include a timetable for creation of the Conservation Park as it is understand that part of the land covered remains in private ownership. The Tamala Conservation Park has three broad zones of usage, conservation and protection, natural environmental use and recreational use (Western Australian Planning Commission, 2012). With conservation and protection the primary management concern is to ensure no further disturbance to the bushland ensuring that public access is restricted and only via walk paths. Access to the beach has been poorly managed with off road vehicle tracks crossing the bushland.

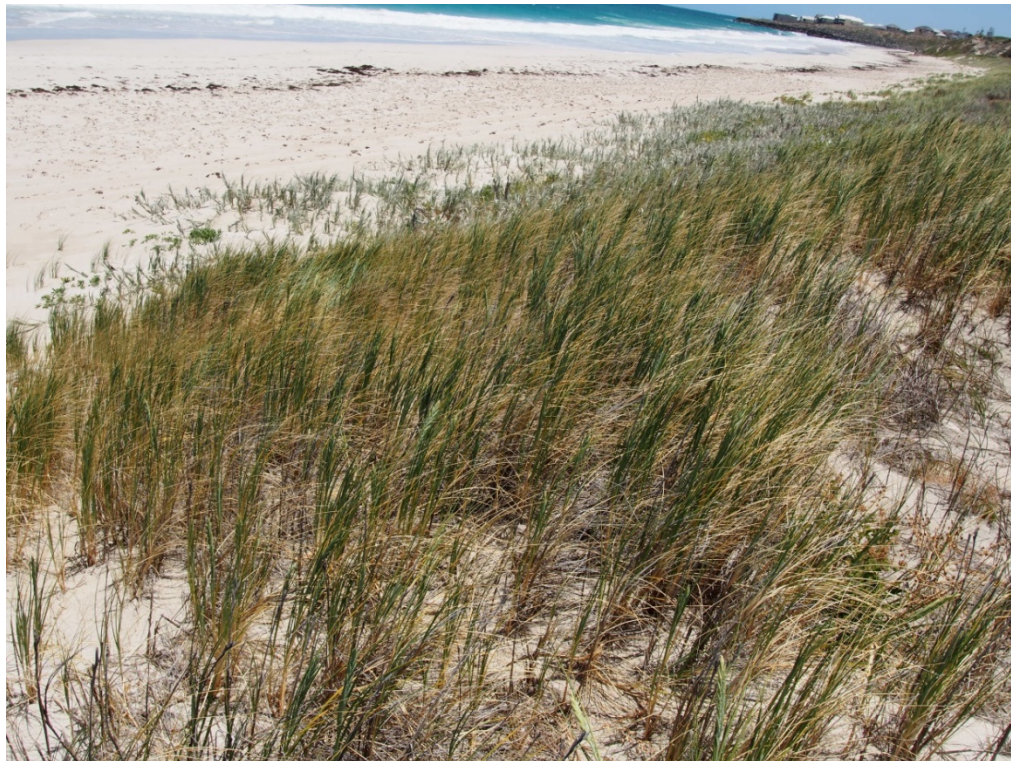
Photograph of Marram Grass established above the strand line.

Marram grass (**Ammophila arenaria*) was established in amongst *Spinifex longifolius* plants above the strand. The Marram plants were all relatively young so it was uncertain if they had been planted or if they had established from rhizomes which had come down on the current from Mindarie.

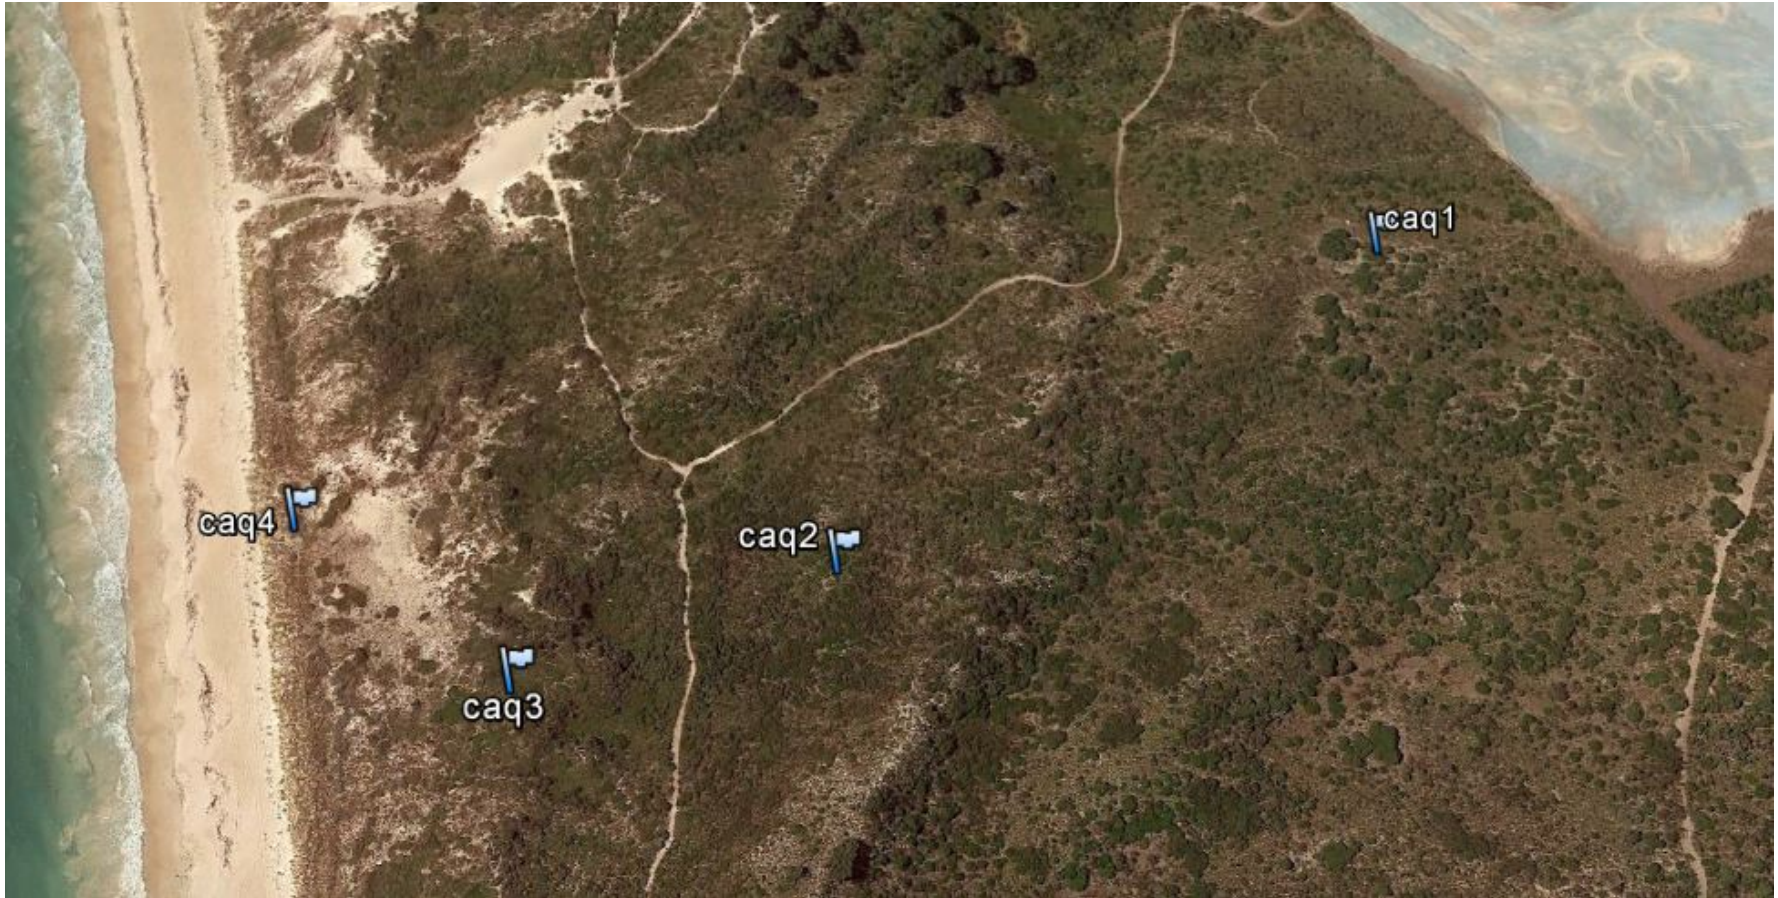
Map 1. Location of quadrats

1. Location of quadrats
2. Vegetation units
3. Vegetation condition
