Kuzich Clearing application

Lot 9523 Graphite Road

Client: Rob Kuzich
Drawing MJO2021-002
Drawn: 30 August 2021
By: Mick Owens of
Arris Pty Ltd ACN: 092 739 574

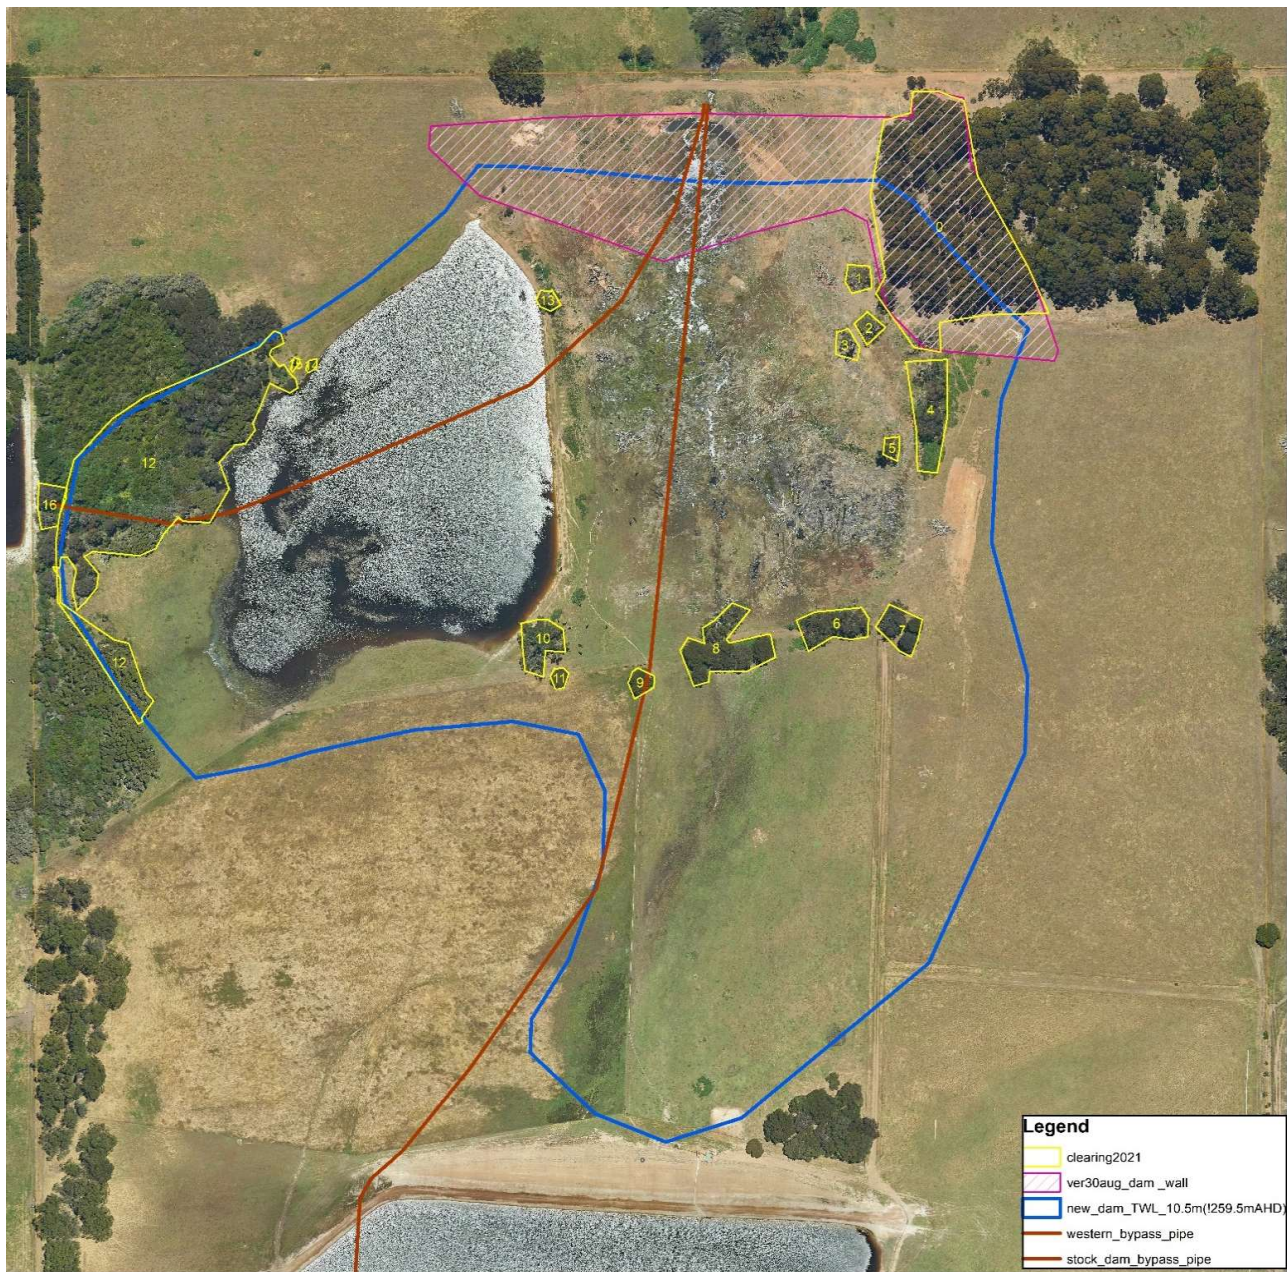
FID	Shape *	Id	Area	Clearing
0	Polygon	0	6703	dam footprint RiWI
1	Polygon	0	151	flooding
2	Polygon	0	129	flooding
3	Polygon	0	133	flooding
4	Polygon	0	870	flooding
5	Polygon	0	77	flooding
6	Polygon	0	497	flooding
7	Polygon	0	346	flooding
8	Polygon	0	951	flooding
9	Polygon	0	131	flooding
10	Polygon	0	416	flooding
11	Polygon	0	69	flooding
12	Polygon	0	7451	flooding
13	Polygon	0	83	flooding
14	Polygon	0	25	flooding
15	Polygon	0	17	flooding
16	Polygon	0	243	bypass sump RiWI

Total clearing = 1.82 ha

Dam Wall includes footprint for machinery works and turnaround and for diversion of watercourse via spillway; all constructed under RiWI approval.

The bypass-sump to be constructed on the watercourse via RiWI approval

Remainder clearing is from flooding caused by dam ponding set at 259.5m AHD to Landgate Topography.
