RE – Broadwater site, Busselton - Clearing Referral Application

The City of Busselton are implementing the Storm Surge Risk Mitigation (SSRM) project which involves Coastal Sand Dune Resilience Works. The project seeks to mitigate the risk of coastal flooding associated with tropical cyclone storm surges to the City of Busselton.

APPENDIX A – DUNE CONCEPTS

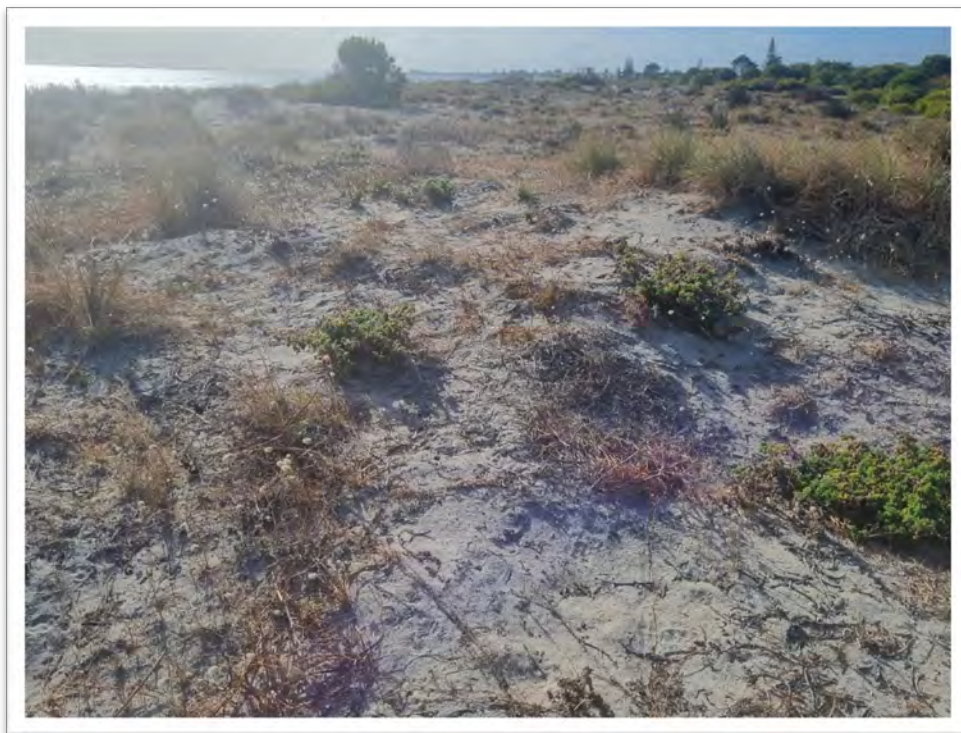
Plate 1: Proposed dune profiling area at the Broadwater site.

Works involving soil disturbance have been limited to areas identified as being in a 'Degraded' condition (refer to **Plate 1** and **2**), noting the following:

- Small machinery will be used to establish/profile the dunes;
- Any substantial plants within these Degraded areas will be left in place, with works taking place around them;
- Degraded vegetation will be left in place to provide an organic substrate for dune planting, and to control weeds; and
- The completed works will enhance the ecological function of the coastal dunes, and their resilience to erosion.

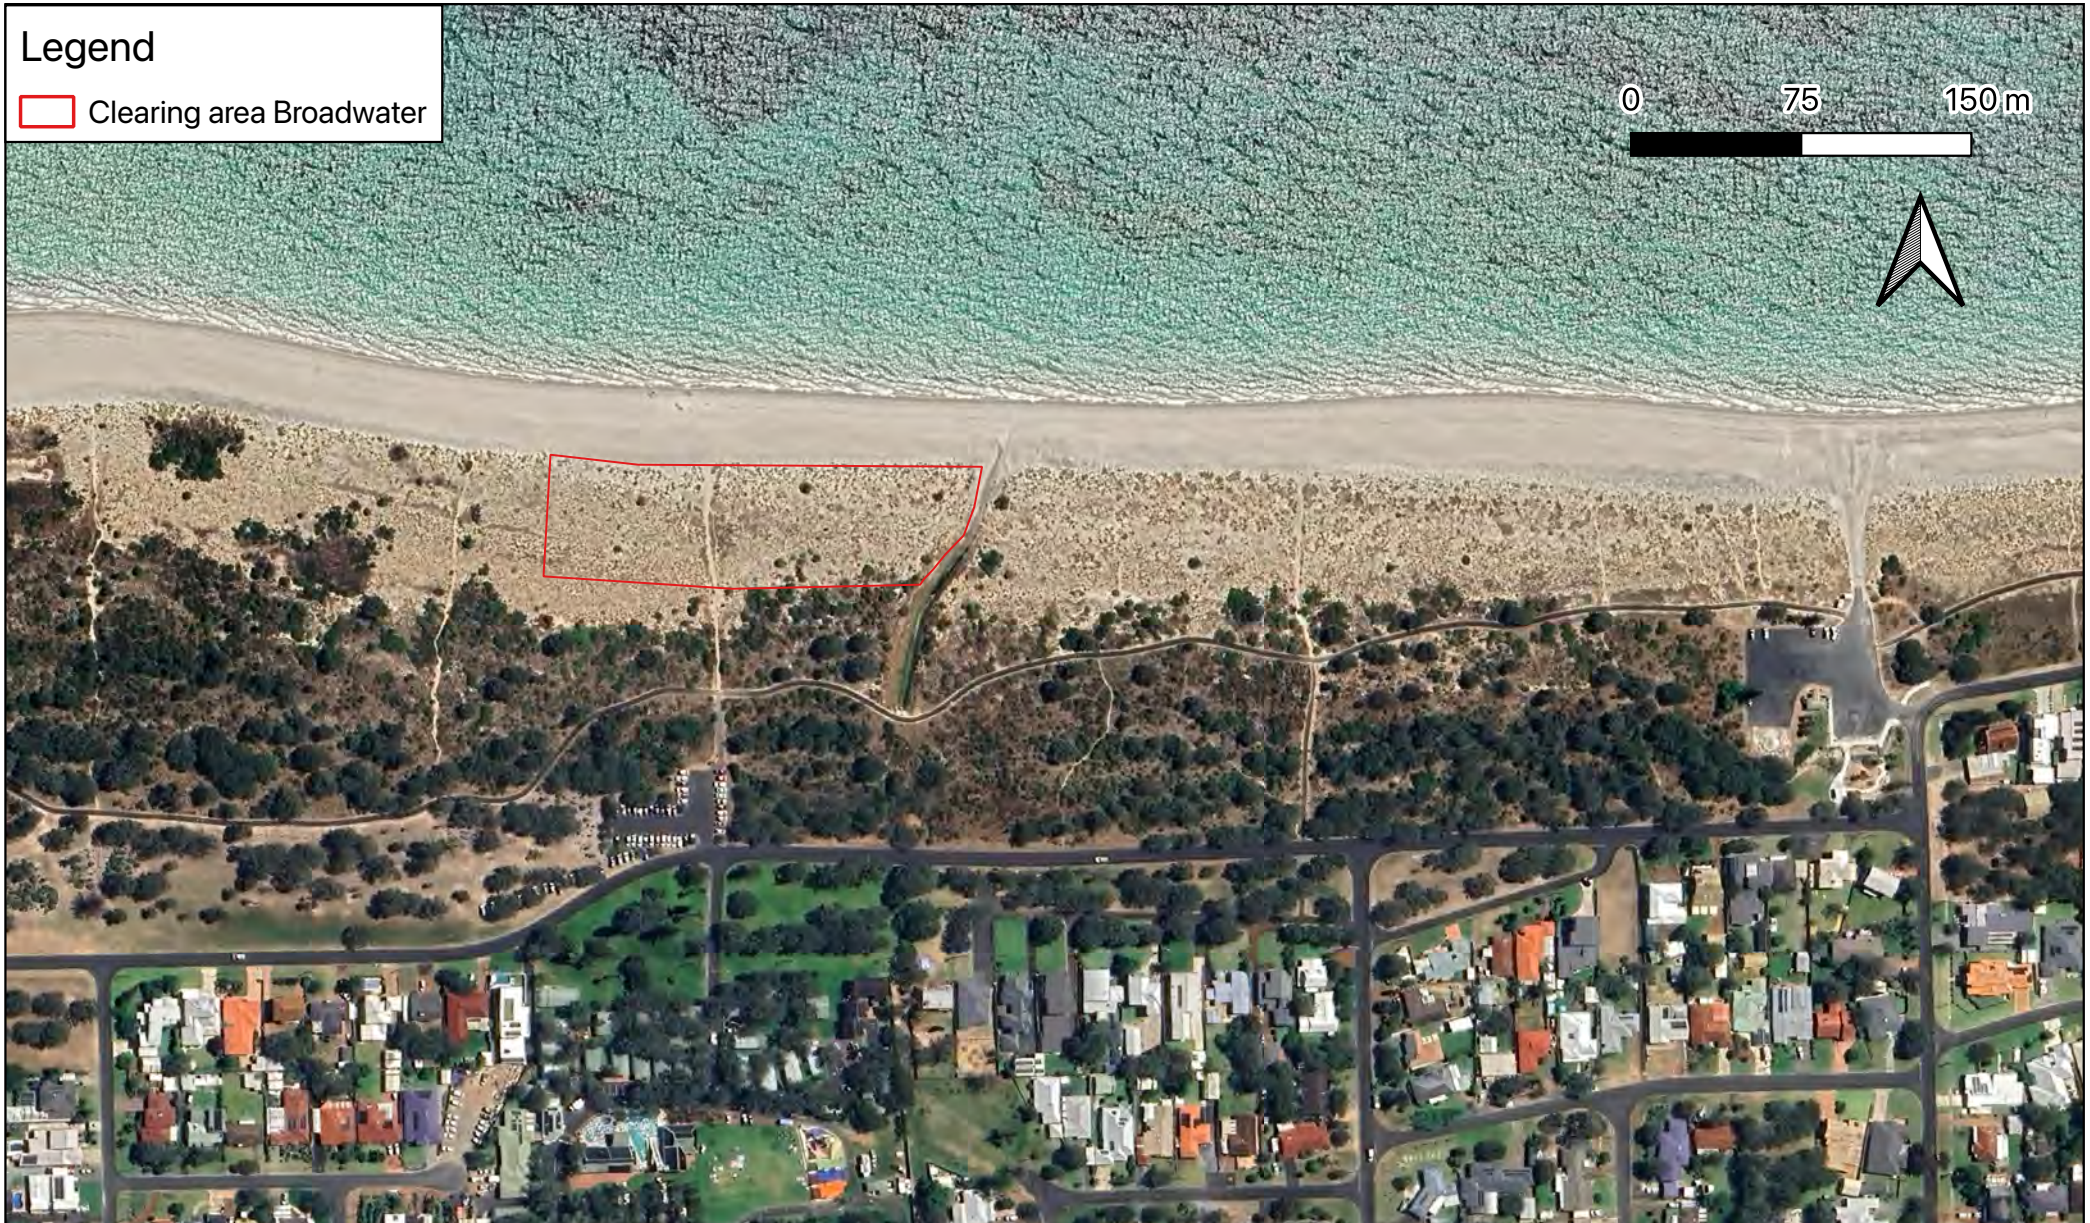
DRAWING TITLE Figure 1 - Clearing Area

Please find herein information pertaining to a clearing referral application for a 0.96 hectare (ha) area (refer to **Figure 1**) at the Broadwater site (Lot 60 on Deposited Plan 194383 and Lot 62 on Deposited Plan 220436) on behalf of the City of Busselton.

Clearing area Broadwater

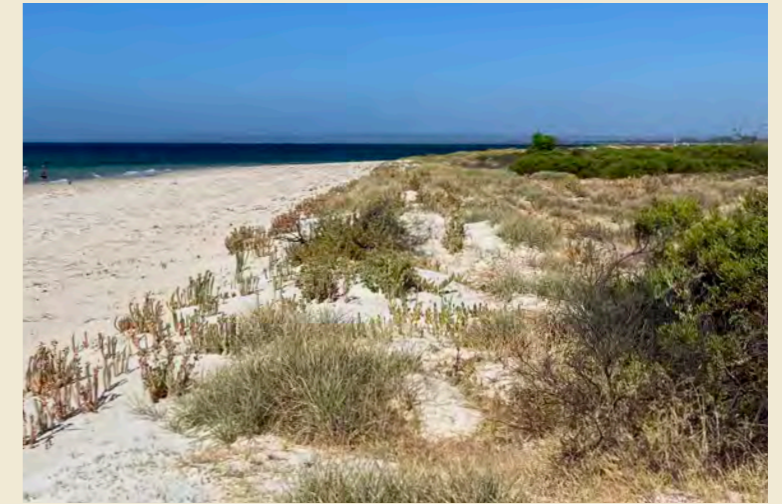
A BEACH BERM NOURISHMENT

-   Clearing
-   COIR Matting
-   Beach Sand
-   Imported Sand
-   Wrack
-   Vegetation

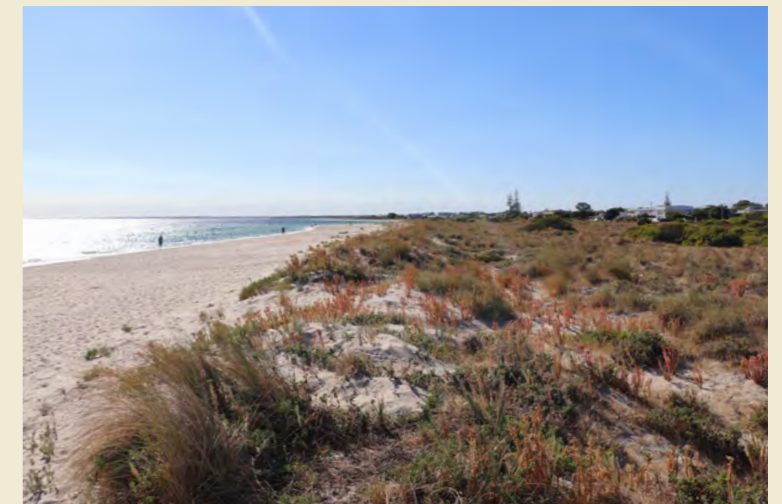
B FOREDUNE ENHANCEMENT

-   Clearing
-   COIR Matting
-   Beach Sand
-   Imported Sand
-   Wrack
-   Vegetation

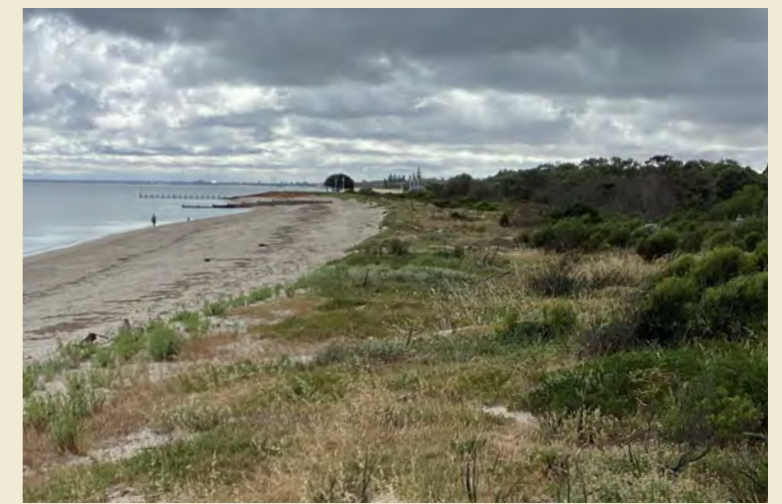
C FOREDUNE WIDENING LANDWARD

-   Clearing
-   COIR Matting
-   Beach Sand
-   Imported Sand
-   Wrack
-   Vegetation

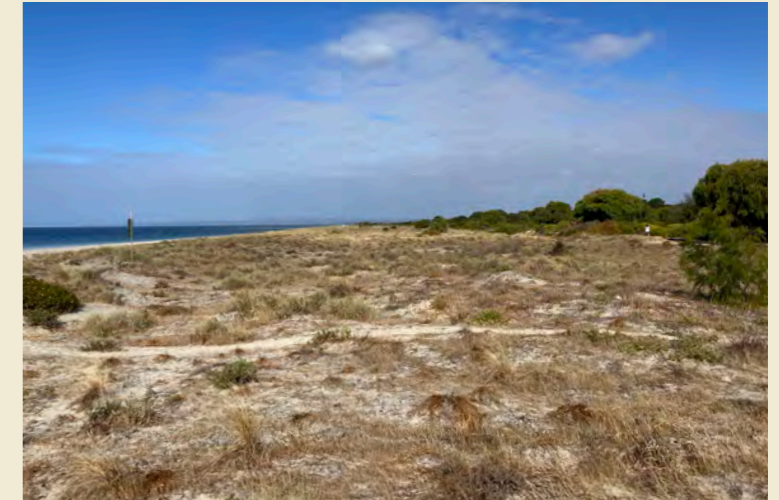
D MID DUNE RIDGE (DISCONTINUED)

-   Clearing
-   COIR Matting
-   Beach Sand
-   Imported Sand
-   Wrack
-   Vegetation

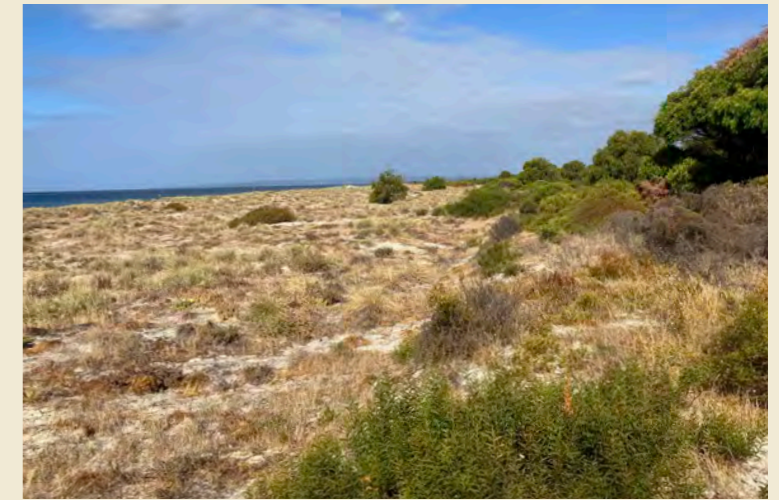
E BACK DUNE WIDENING SEAWARD

-   Clearing
-   COIR Matting
-   Beach Sand
-   Imported Sand
-   Wrack
-   Vegetation

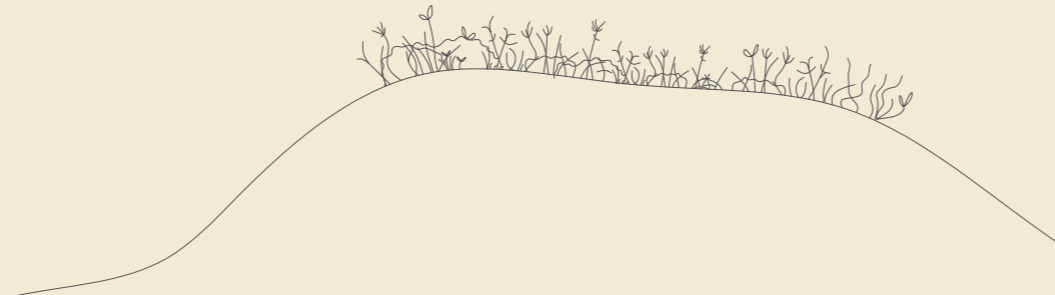
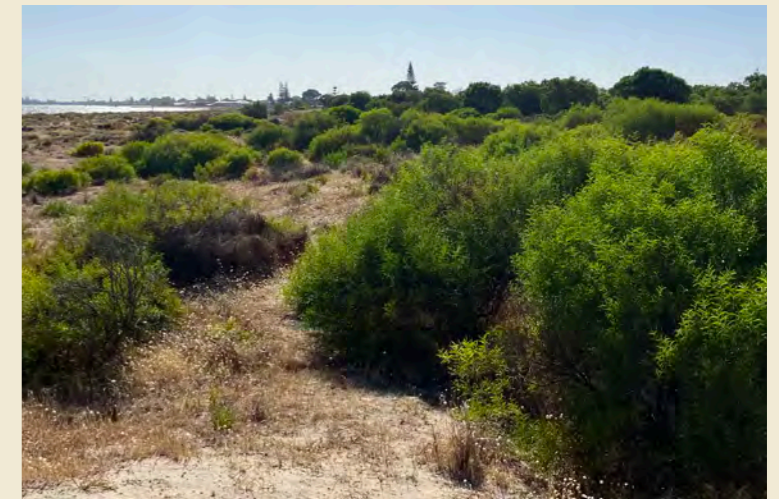
F REVEGETATION

-   Clearing
-   COIR Matting
-   Beach Sand
-   Imported Sand
-   Wrack
-   Vegetation
